CONTINUED EVALUATION OF NOISE BARRIERS IN FLORIDA

FL-ER-85-02

The University of Central Florida Community Noise Laboratory Civil & Environmental Engineering Department P.O. Box 162450 Orlando, Florida 32816-2450

August 22, 2002

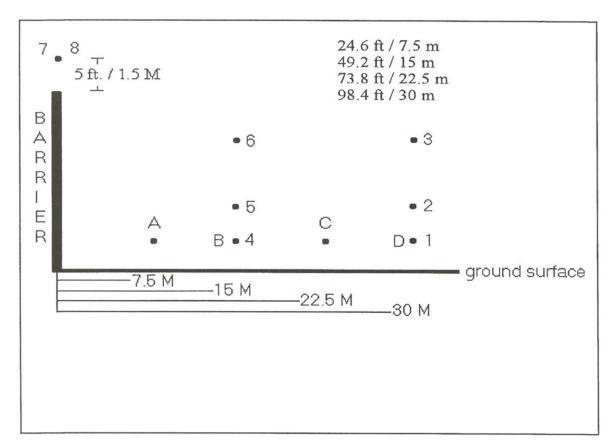
Figure 1 indicates the standard microphone positions used at each measurement site while Table 2 provides a description of each site for Part 2 of the project. It should be noted that the microphone positions shown in Figure 1 are identical to those used in Part 1 of this study. These microphone positions are defined by the ANSI standard [6] and allow continuity between Part 1 and 2 of the study. However, in Part 1, it was determined that more sites, farther from the noise barrier, were needed to better define the shadow zone behind the barrier. To accomplish this, "rover" sites were used when open space was available at greater distances.

Figure 1. Microphone Locations Above and Behind the Barrier.

The effectiveness of the barrier was evaluated by placing the primary emphasis on the receiver locations at a height of 5 feet (1.5 meters) above the ground plane. These were microphone locations 1, 4, A, B, C and D. All rover sites were also at 5 feet above the local ground plane and used in the barrier shadow zone determination. Significant attenuation was assumed to occur if at least 5 dB:L_{Aeq} of insertion loss (noise reduction after the barrier is constructed compared to the no-barrier case) occurred. A 5 dB:L_{Aeq} reduction in noise levels represents a perceptible change in the soundscape for most individuals. This also agrees with FDOT policy as stated in

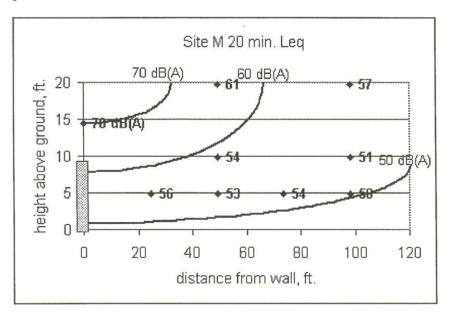
Figure 2. Examples of Sound Level Plots Behind the Barrier.

Figure 2a. Measured sound levels at Site M.

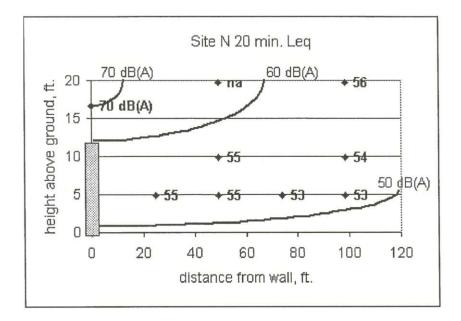
Figure 2b. Measured sound levels at Site N.

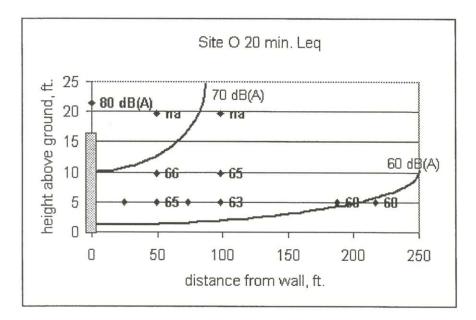
Figure 2c. Measured sound levels at Site O.

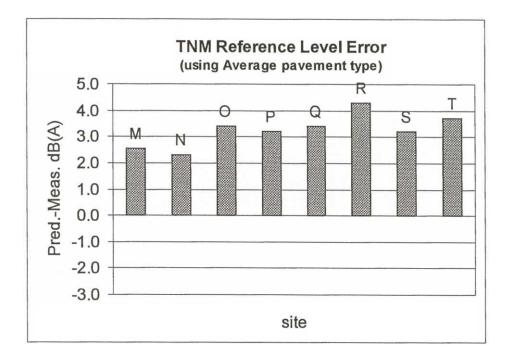
Figure 3. TNM Reference Level Errors (using "Average" pavement type) for Part 2.

Figures 3-6 depict the REMEL prediction errors based on measured values for each site. It can be seen that when "Average" pavement is used in TNM, significant over-prediction occurs at all sites. Figure 4 shows that when the older National REMELs [9] are used in STAMINA 2.0 there are both over-predictions and under-predictions with no clear trend. Figure 5 shows similar results for STAMINA 2.1 with Florida specific REMELS. Of importance, is that even though the average error is less for STAMINA 2.1, STAMINA 2.0 was better at five of the eight sites.

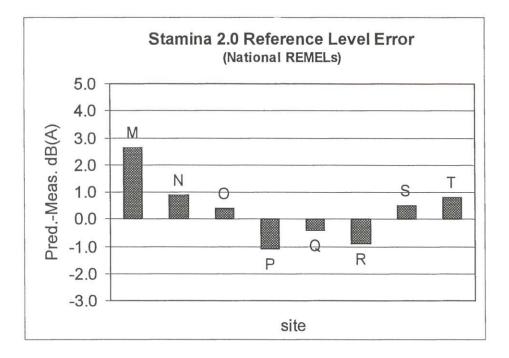
Figure 4. STAMINA 2.0 Reference Level Errors for Part 2.

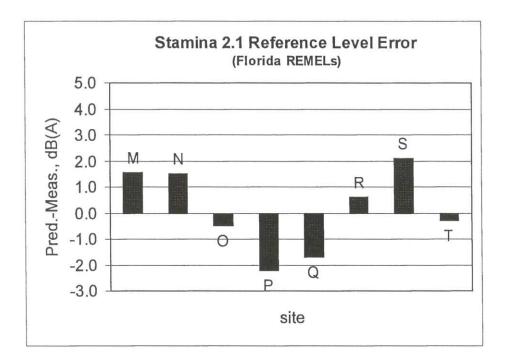
Figure 5. STAMINA 2.1 Reference Level Errors for Part 2.

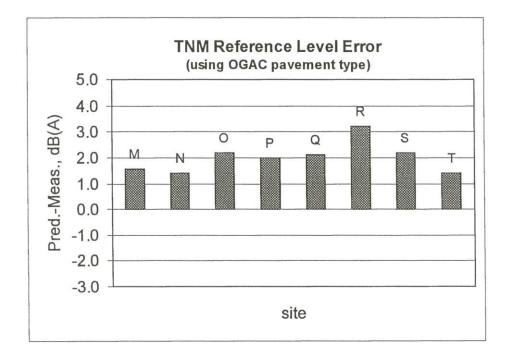
Finally, when TNM is evaluated using "OGAC" as input for the pavement type, the errors are reduced by about 2 dB(A) as shown in Figure 6. Over-prediction still occurs, but with a much smaller error than when using the "Average" payment type.

Figure 6. TNM Reference Level Errors (using "OGAC" pavement type) for Part 2.

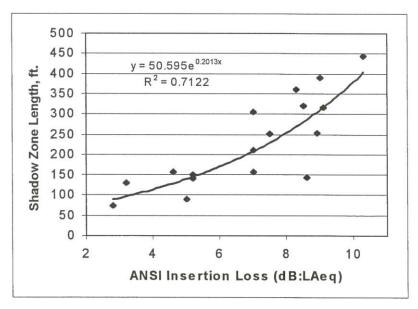
$$SZL = 50.6 \exp(0.2 \text{ IL}_{30})$$
 [2]

Figure 7. Comparison of ANSI Corrected Insertion Loss and Shadow Zone Length.

It should be noted that this method is only an approximation. Exact values should not be used at this time. Rather, the analyst should use the information to determine how many rows of homes will be benefitted. For example if the shadow zone length is predicted to be 250 feet (76.2 meters) then the rows of homes inside this distance should be considered to be in the "benefitted zone." Then, using prediction modeling, those predicted to receive 5 dB: L_{Aeq} in this "benefitted zone" could be identified. Those beyond this "benefitted zone," even if predicted to receive 5 dB: L_{Aeq} should not be counted because background levels or other effects may not truly allow this insertion loss to occur. It should be remembered that the models only predict the highway noise and do not consider the background levels. As such, the models predict shadow zones extending farther than really occur.

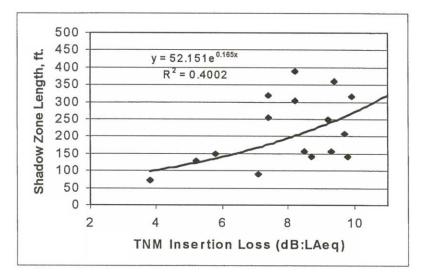
where: IL_{TNM} = Insertion loss predicted by TNM at 98.4 feet (30 meters) behind the barrier

Figure 8. Comparison of TNM Predicted Insertion Loss and Shadow Zone Length.

Again, conservatism is suggested in using the TNM direct insertion loss approach.

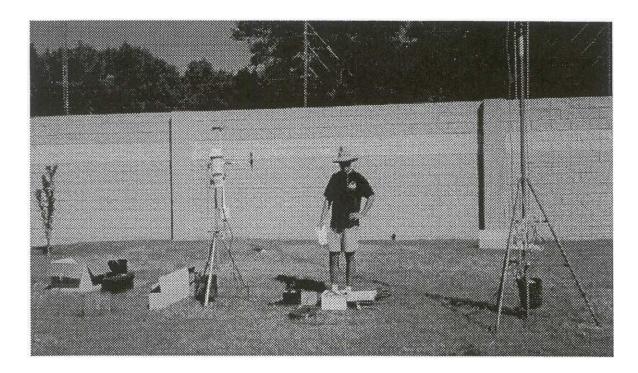
Date 11/30/2000 Actual Wall height: 9.4 ft

Residential View of Noise Wall

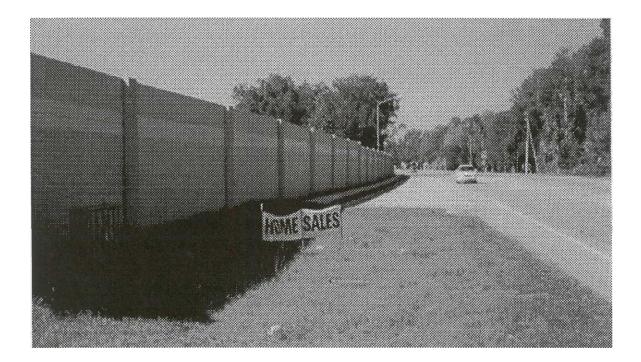
Roadway View of Noise Wall

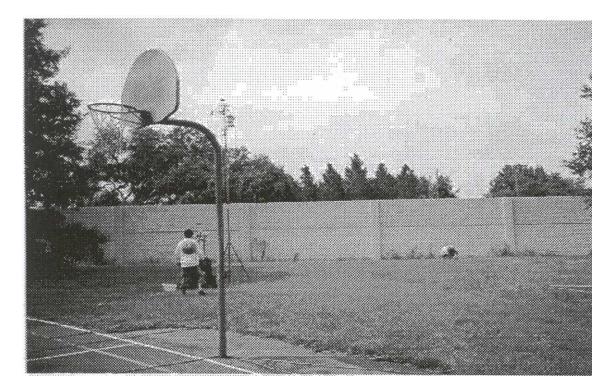
Date 07/10/2001 Actual Wall height: 12.1 ft

Residential View of Noise Wall

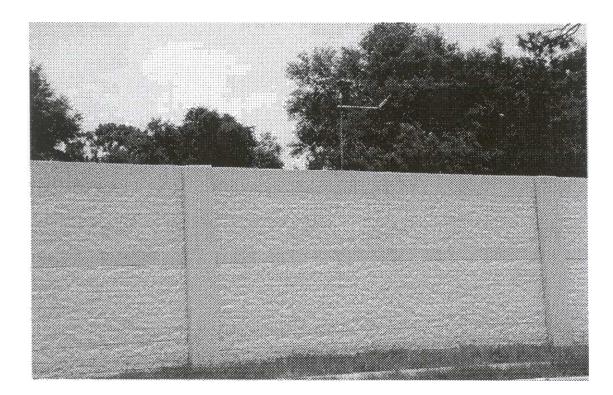
Roadway View of Noise Wall

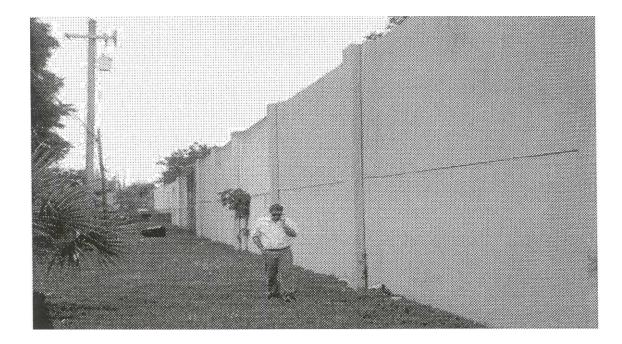
Date 9/11/2001 Actual Wall height: 16.3 ft

Residential View of Noise Wall

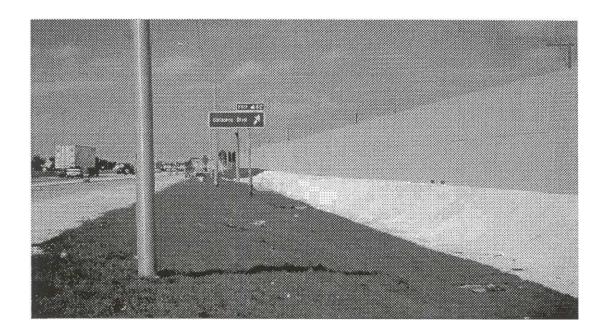
Date 02/25/2002 Actual Wall height: 20.9 ft

Roadway View of Noise Wall

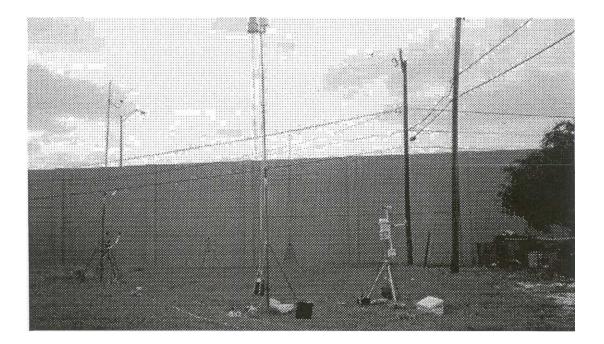
Residential View of Noise Wall

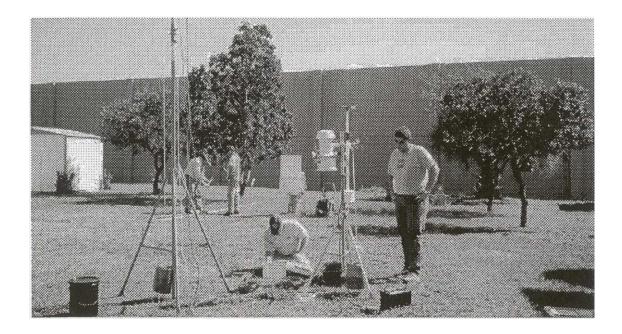
Date 02/26/2002 Actual Wall height: 19.8 ft

Residential View of Noise Wall

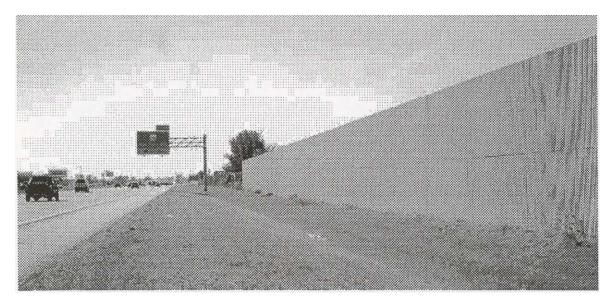
Roadway View of Noise Wall

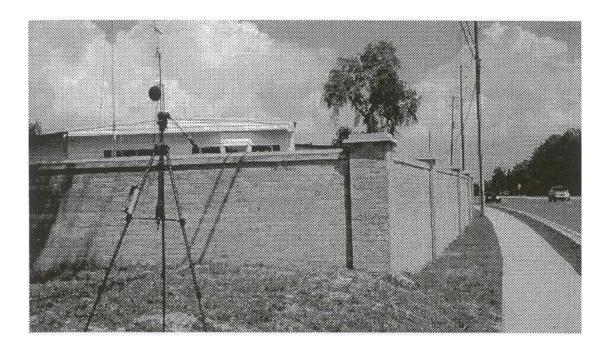
Date 03/25/2002 Actual Wall height: 5.7 ft

Roadway View of Noise Wall

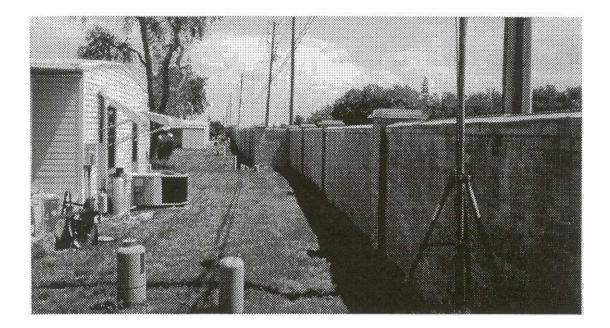
Residential View of Noise Wall

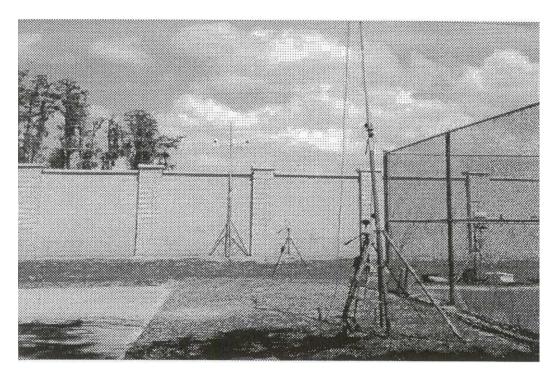
Date 03/26/2002 Actual Wall height: 11.0 ft

Residential View of Noise Wall

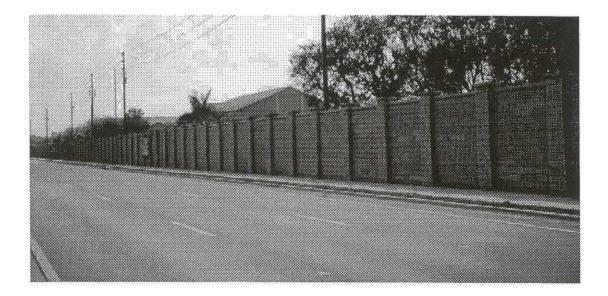
Roadway View of Noise Wall
