# **Evaluation of Stainless Steel Reinforcement Construction Report**

RI 00-027

February, 2003

## **Evaluation Of Stainless Steel Reinforcement Construction Report**

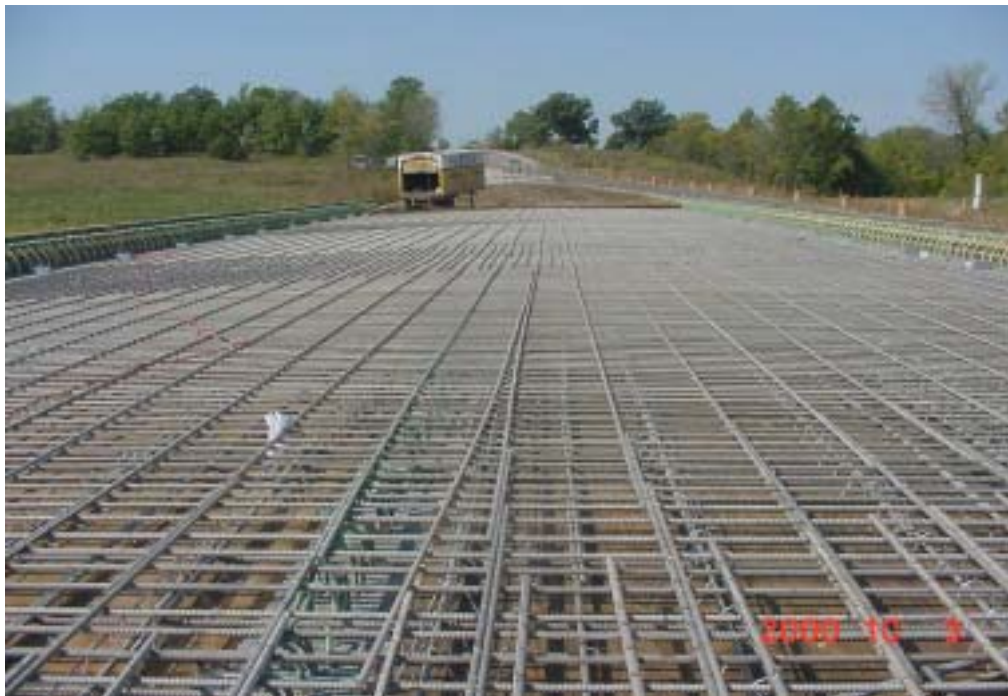
Figure 1. Stainless Steel Reinforcement of Bridge A6059

The only difficulty in placing the stainless steel rebar was at splices to black rebar needed at the solid diaphragms, at the abutment and pier caps. Specifications called for using 1" plastic spacers so there would be no reaction between the two dissimilar metals. The rebar could not be firmly fastened in this way, and the contractor installed additional epoxy coated rebar so that both the black and stainless steel rebar could be attached to the epoxy without touching each other. This problem will be fixed in the next project, described below, in which all the conventional rebar spliced to stainless steel clad rebar will be designed to be epoxy coated.

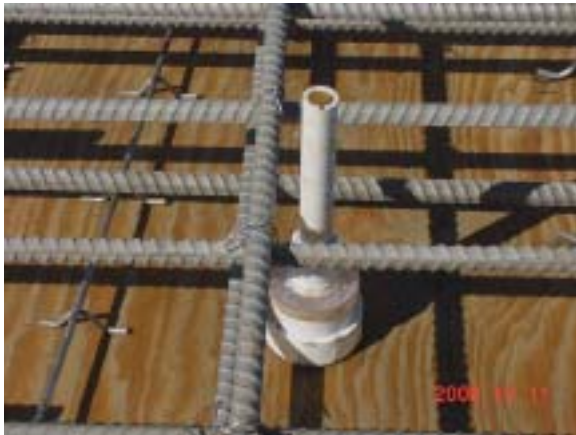
Figure 2. Sensor Housing Attached to Forms of CIP Deck

In this project, non-destructive fiber optic chloride testing will be performed on both the experimental and control bridge decks. Fiber optic chloride sensors were incorporated into both bridge decks. 20 sensors were set on each bridge at different horizons. Before the sensors were put in, the sensor housings were installed during the deck construction. See Figure 2, 3 for the installation of sensor housings, and Figure 4, 5, 6 and 7 for their horizontal locations and depths. The most popular sensor openings are set at ½", 1 ½" and 3" (rebar level) from the top of the deck. The sensor housings were literally nailed to the bottom formwork. On bridge A6060, the conventional construction using epoxy rebar, prestressed precast deck panels were used instead of forming. Holes had to be cored to allow installation of four (4) of the chloride sensor housings. After measuring to make sure none of the prestressing strands would be cut, 2" diameter holes were cored in the 4" thick panels. Epoxy glue was used to hold the sensor housings in place. The remaining six (6) sensor housings were set on each side of the bridge where they could be nailed into the conventional forming needed on the overhangs. After the concrete was cured, and formwork was removed, the nails sticking through the bottom PVC cap of the sensor housing protruded from the concrete. With the assistance of ladders to reach the deck bottom, these housing caps were unscrewed on June 28, 2001 to remove the steel and plastic bars which kept concrete out of the throat area of the housings. Since the old caps were damaged during the unscrewing, new caps were screwed back onto the housings.

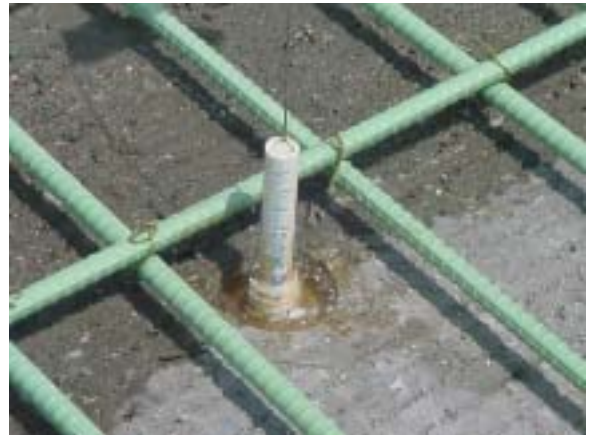
Figure 3. Sensor Housing Glued into Deck Panel Core Hole

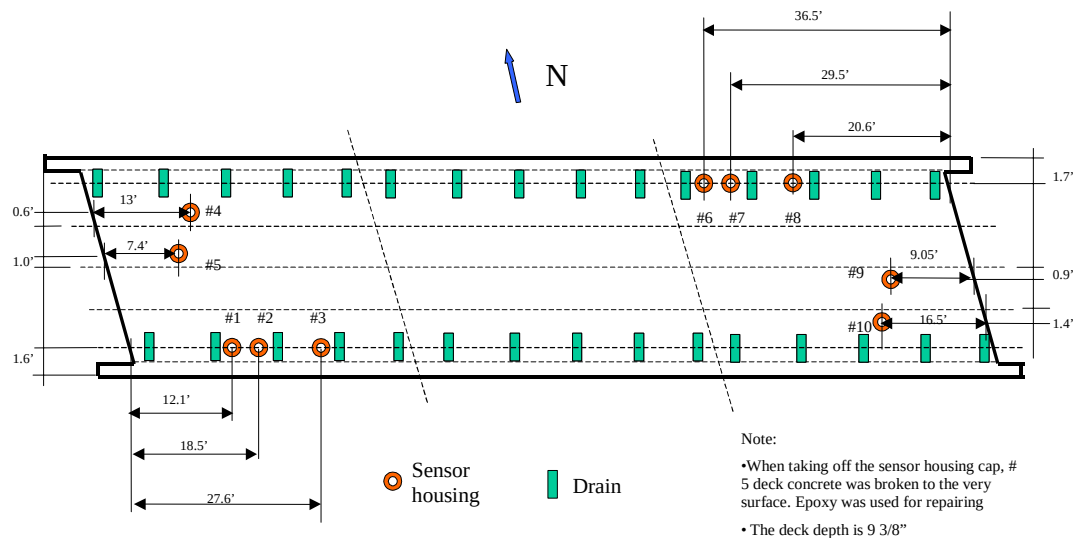
Figure 4. Locations of Sensor Housings of Stainless Steel Bridge A6059

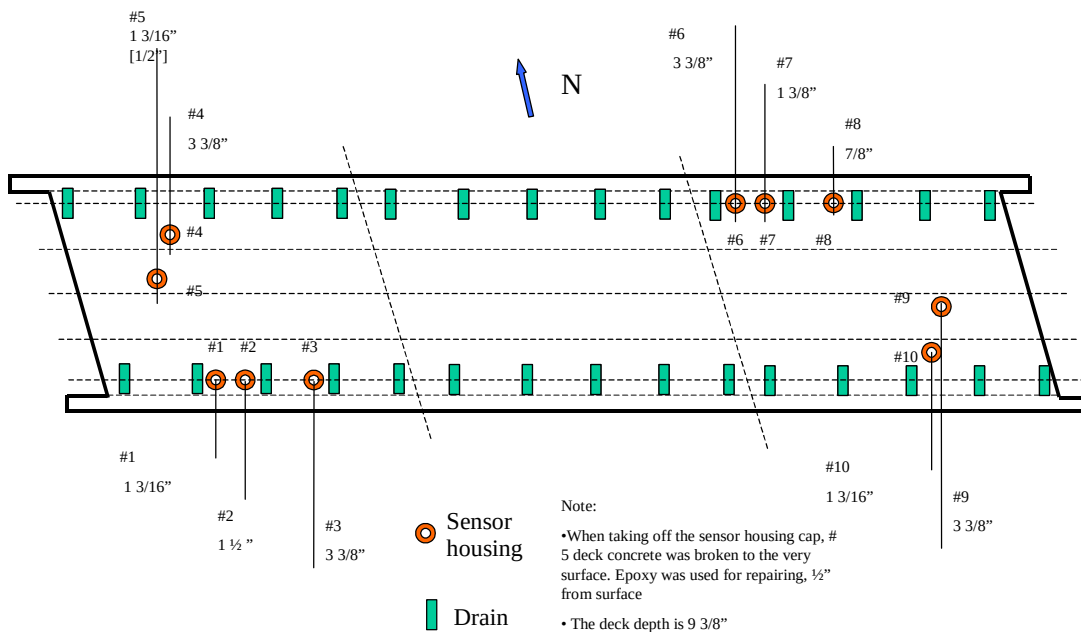
Figure 5. Depths of Sensor Housings of Stainless Steel Bridge A6059

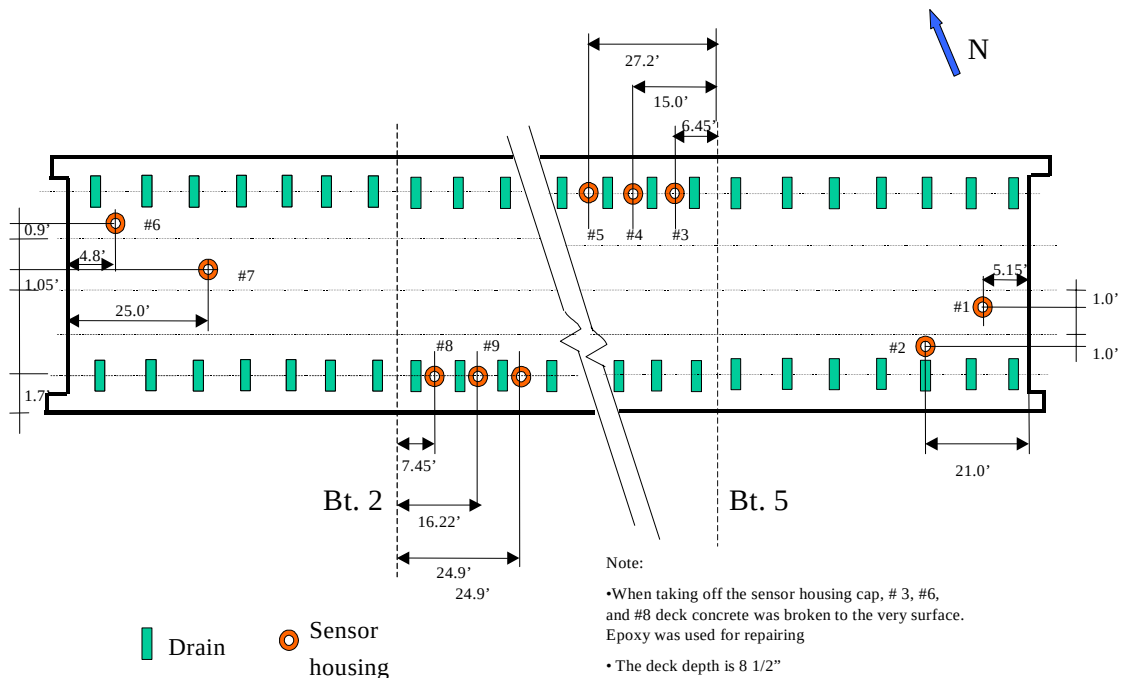
Figure 6. Locations of Sensor Housings of Epoxy Steel Bridge A6060

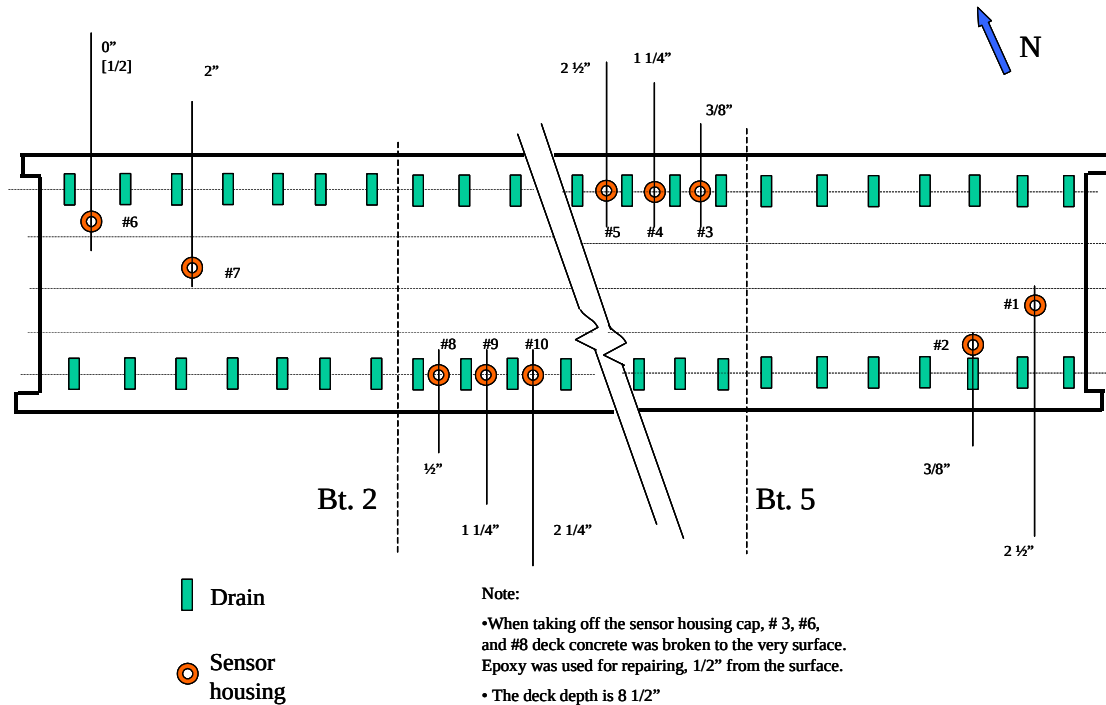
Figure 7. Sensor Housing Depths of Epoxy Bridge A6060

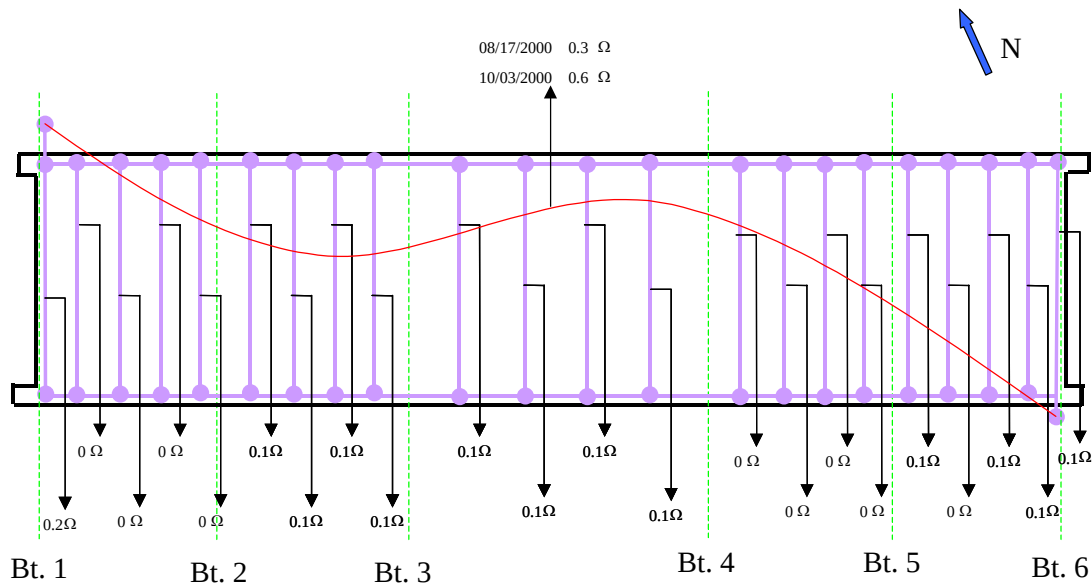
Figure 8. Continuity Test of Bridge A6060

In order to use AC impedance testing on the epoxy coated reinforcement, a test grid was set up with 22 bars made electrically continuous and a bar at each end of the bridge left protruding from the side of the deck for an electrical connection. Continuity tests were done on August 17, 2000 before the deck pour and on October 3, 2000 after the deck pour. Resistance readings of each circuit are shown on Figure 6.

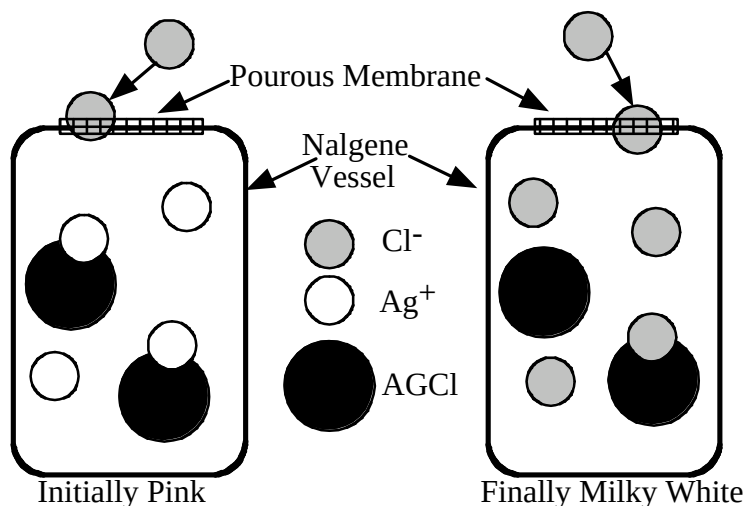
Figure 1. As the chloride ion concentration increases, the adsorption process causes a chemical reaction within the solution that results in a color variation.

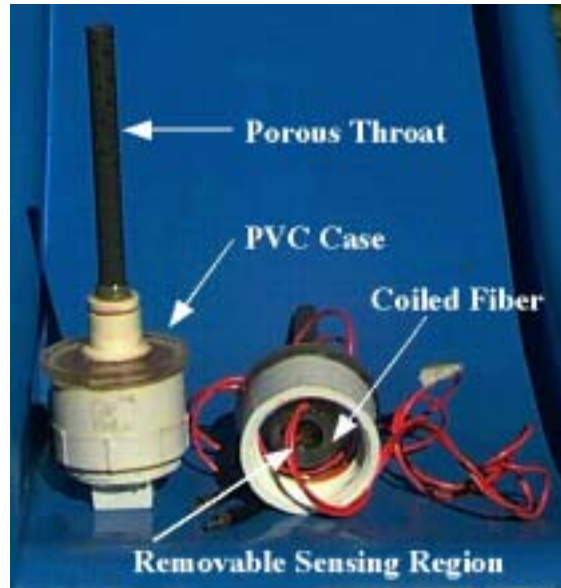
Figure 2. The final design, suitable for bridge deck installation, is shown.

Packaging of this "chemistry" has resulted in the field worthy fiber optic sensor shown in

Figure 2. The fibers, reagent chemistry cell, and micro-optics are cast in epoxy into a threaded section that allows this section to be literally screwed into the sensor housing in line with the porous throat's tube section. More details on the sensor design and motivations are presented in the following section.

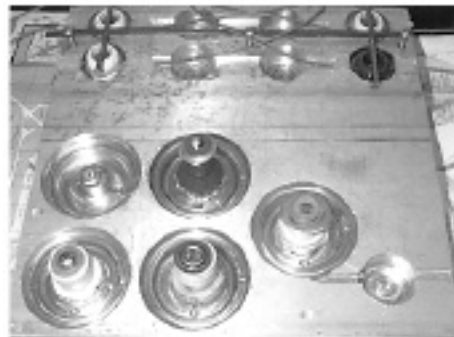
Figure 3. This machined master component allows for multiple chemical reservoirs to be fabricated simultaneously.

The components comprising this sensor include a number of custom-machined composite pieces. In certain instances, it has proven to be prudent to injection mold the pieces. The master for these pieces, which include the Nalgene chemical reservoirs, are shown in Figure 3.

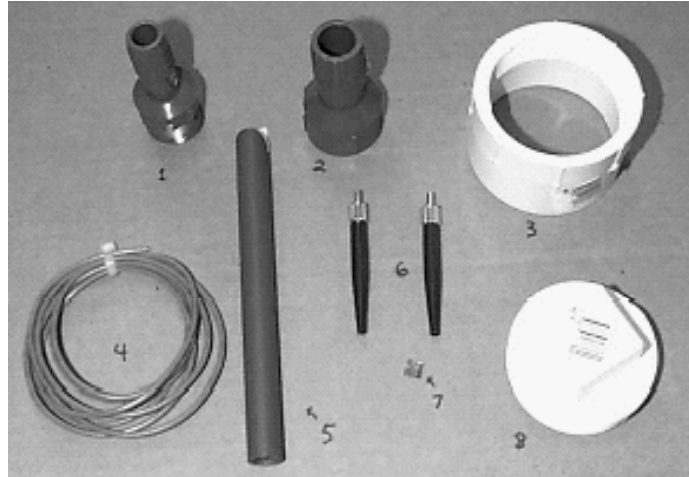
Figure 4. This photo shows a few of the components used in the embeddable sensor.

accelerants, for rapid curing, is used, the construction site personnel acknowledge the noninvasive chemistry of PVC into the mixture. Therefore a PVC cylinder with female insert is used for the sensing region housing. Certain components are shown in Figure 4.

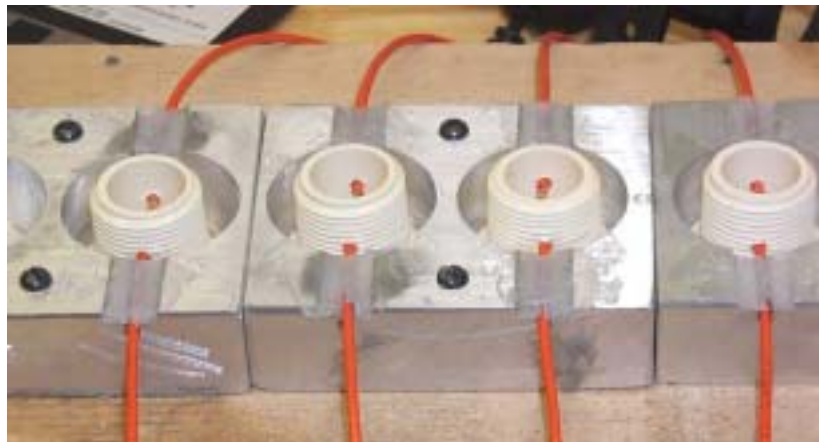
Figure 5. Optical fibers are glued into place and threaded through drilled holes in the PVC screw on cap.

A detailed view of key aspects within the chloride sensor fabrication phase is shown in Figures 5 through 7.

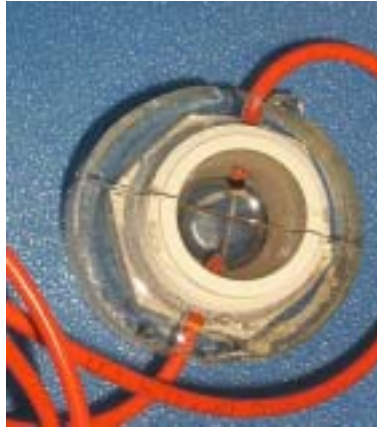
Figure 6. Note that the cap and fiber have been cut. This was achieved using a diamond saw. Into this notch is placed the active chloride sensing element. The fibers act as transmit and receive light pipes.

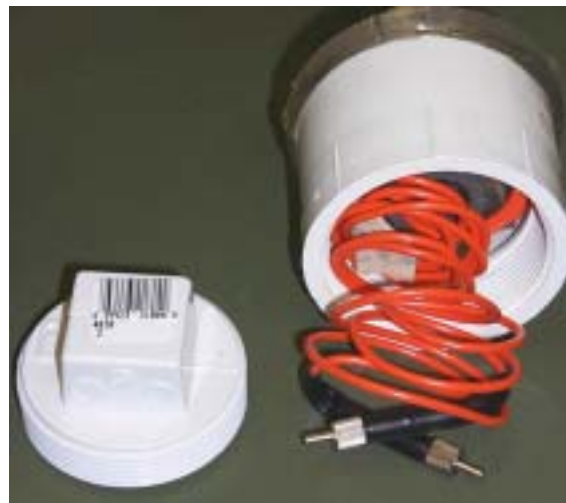
Figure 7. The transmit/receive fibers coil into the base of the sensor unit.

Referring to Figure 7, the sensor housing, or case, is made of 2" stock PVC. A transparent plastic case top is epoxied to the PVC. Through this top extends a hard plastic tube whose length varies according to the placement requirements of the bridge deck (e.g., if the deck is relatively thin then this tube is shorter than if the deck is considerably thicker). The tube has holes drilled throughout it and a wire mesh covering the tube's top opening (to keep aggregate and other materials out of the sensor). Waterborne chloride enters the tube through any of the openings where it falls to the bottom of the tube. There it interacts with the sensor chloride-sensitive reagent. Once the chloride concentration reaches a certain predetermined level a change in the optical transmission characteristics will occur. For these particular bridges, this "minimum activation level" was chosen to be 1ppm of chloride. This sensitivity level is

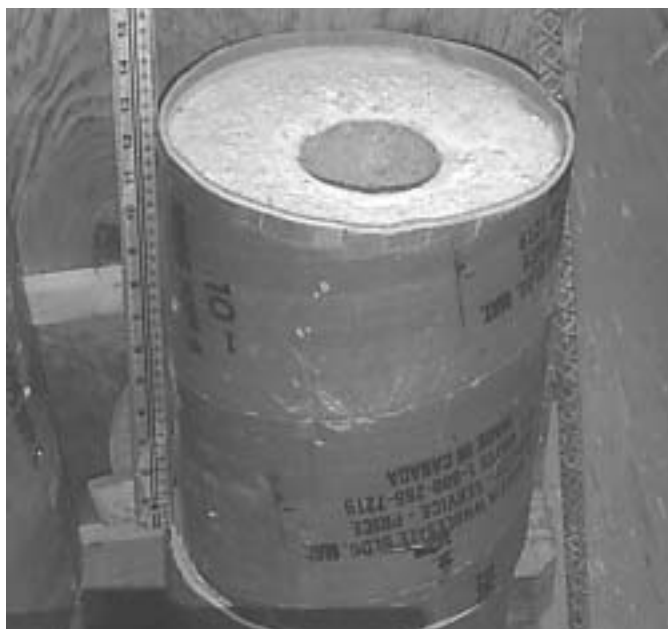
Figure 8. This test cylinder allows ponding of chloride ions in solution. The ions then propagate through the cylinder eventually reaching the fiber optic chloride sensor.

Testing of the sensors' performance after they were embedded into concrete was conducted following ASTM Standard 1202-94 (chloride ion penetration) and the American Association of State Highway and Transportation Officials "Manual for Maintenance Inspection of Bridges". A representative chloride ponding test cylinder into which a fiber optic chloride sensor was embedded is shown in Figure 8. By replicating prior ASTM testing methods (McPadden, 1997), results indicated that the embedded fiber optic sensor was able to accurately establish the presence of chloride traveling within this test cylinder.

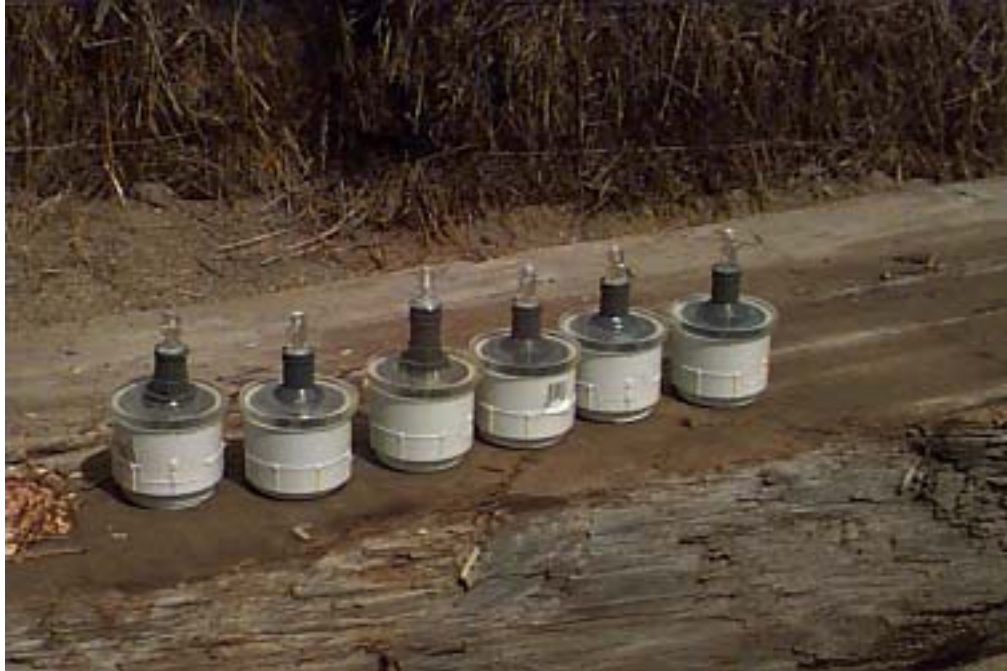
Figure 11. The length of the sensor housing's throat may be modified.

To reiterate, Missouri Department of Transportation employees placed the sensor housings into the twin bridges. Details regarding the installation (e.g., ambient conditions, type of concrete, deck work details, etc) must be obtained from MoDOT. It is envisioned that the sensor housings that were embedded are similar to those shown in Figure 11.

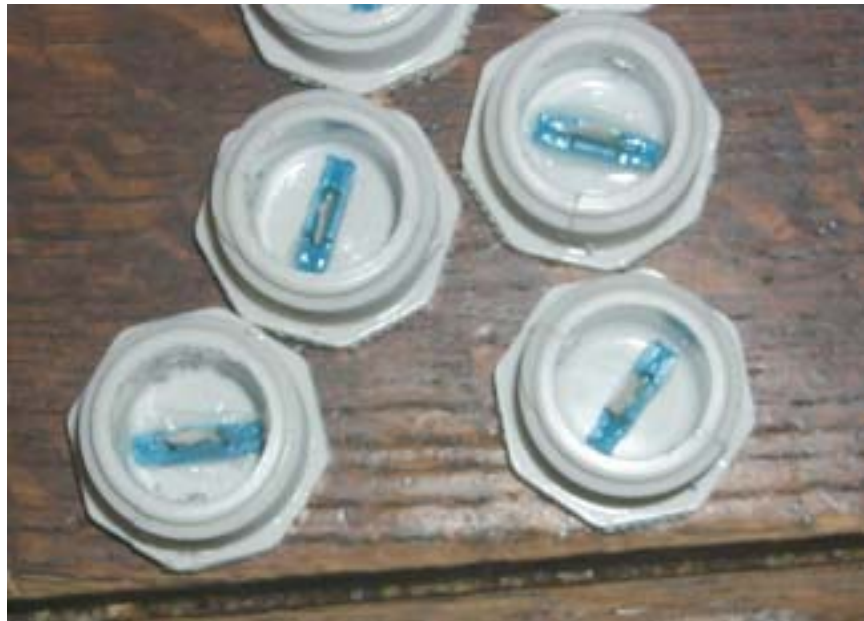
Figure 12. Close-up view of the chloride sensing insert.

As previously mentioned, the sensor housings were embedded into the twin bridge decks in 2000. The actual sensing "inserts" were designed, fabricated and tested during the summer-early Fall of 2001. As opposed to earlier efforts in fiber optic chloride sensing within concrete structures, the sensors used in these bridges had a true analog varying chloride measurement insert, shown in Figure 12.

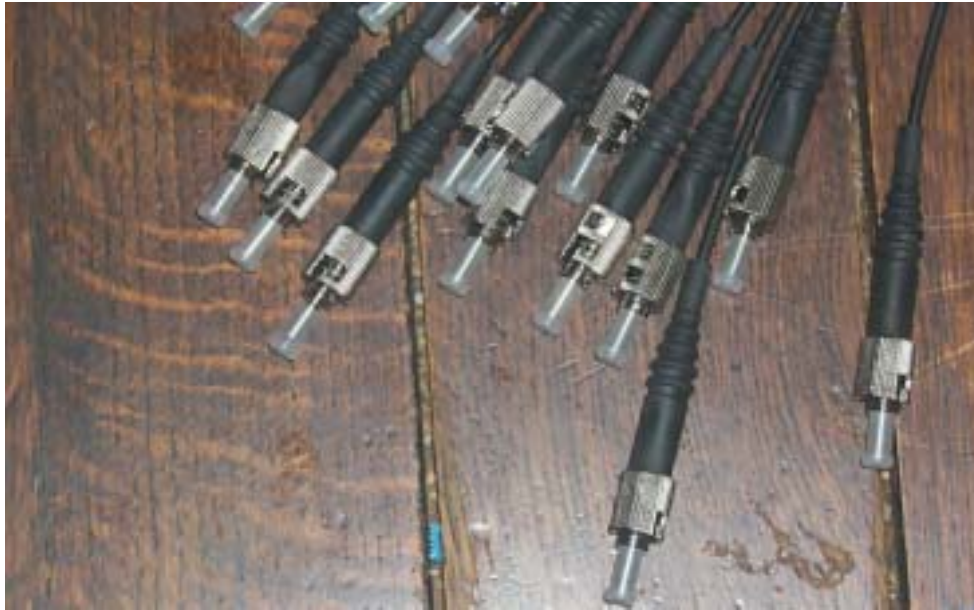
Figure 13. Multimode 960mm diameter polymer optical fiber with ST connectors is used.

Polymer optical fibers, 960  $\mu\text{m}$  diameter, each being 25cm in length had ST fiber optic connectors placed onto their ends (as shown in Figure 13) and served as the ingress/egress to the chloride sensing insert. These fibers were shown in a laboratory setting to have excellent mechanical properties while providing ample light to the sensor insert for an adequate signal-to-noise ratio for chloride sensing.

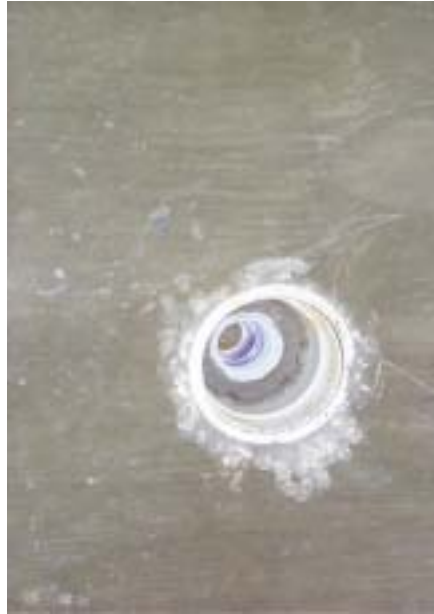
Figure 15. View of an exposed sensor housing located in bridge#1.

In most cases, the embedded sensor housing was in a nearly pristine condition (see Figure 15) thereby providing an excellent conduit for the waterborne chloride ions to reach the sensing insert.

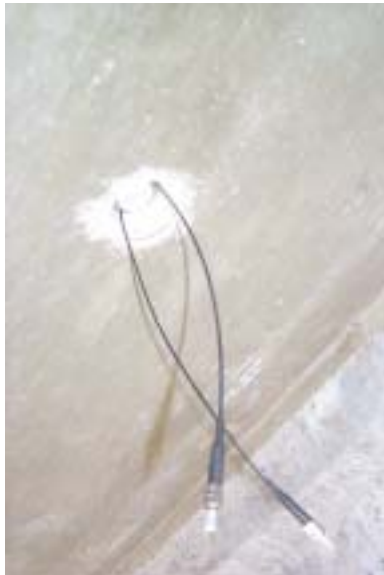
Figure 16. A modular design allows for the sensor insert to be simply screwed into the housing.

The view of a sensor insert that has been installed into the sensor housing within the concrete deck of Bridge #1 is shown in Figure 16. The fiber optic leads were then coiled and placed into the housing with a PVC cap screwed onto the housing. This leaves an embedded sensor that is relatively unobtrusive and hopefully not of "interest" to anyone who may wander under either bridge.

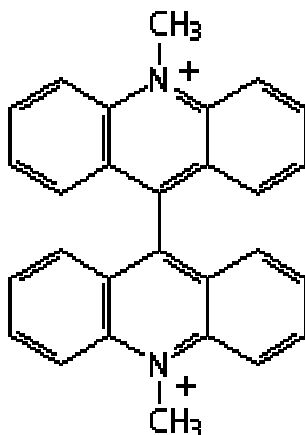
Figure 17. Chemical "schematic" diagram of Lucigenin; 9,9'-Bis(N-methylacridinium nitrate).

The two types of chloride sensing chemicals used lie within the fluorescent dye family: Lucigenin; 9,9'-Bis(N-methylacridinium nitrate),  $C_{28}H_{22}N_4O_6$ , MW 510.51 (chemical diagram shown in Figure 17); and, N-(3-sulfopropyl)acridinium, inner salt (SPA),  $C_{16}H_{15}NO_3S$ , MW 301.36 (chemical diagram shown in Figure 18). These two reagents provide two different sensitivity levels for minimum activation chloride ion concentration.

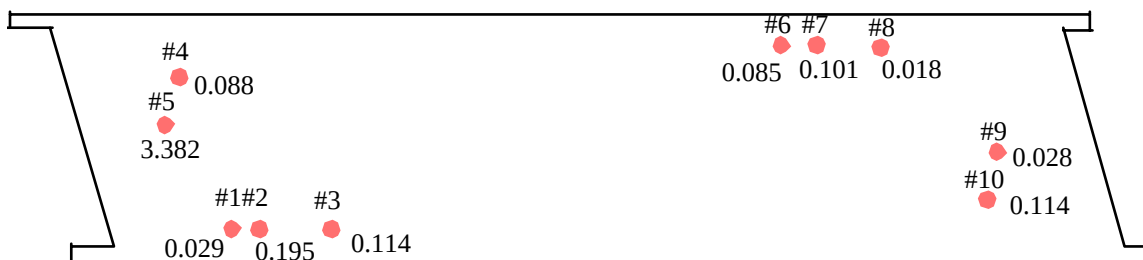
Figure 19.a. Baseline power readings for sensors within bridge A6059.

Baseline readings taken during the sensor insert installation were based strictly on intensity. A FOTEC optical source ( $\lambda=822\text{nm}$ ) and an associated Si photo detector power meter (ST connector adaptor) were connected to the input and output fiber optic leads. The received intensity for identical launched power configurations were recorded. While the actual chloride concentration levels are measured spectroscopically, the spectrometer must have a minimum amount of received optical power. The power transmitted through the twenty (20) installed sensors varied from  $0.018\mu\text{W}$  (min) to  $2.881\mu\text{W}$  (max). A diagram of each bridge's sensor baseline transmitted power readings is presented as Figure 19a and b. The detection process requires a signal level of at least  $0.004\mu\text{W}$ , thus each sensor passed the minimum power requirements.

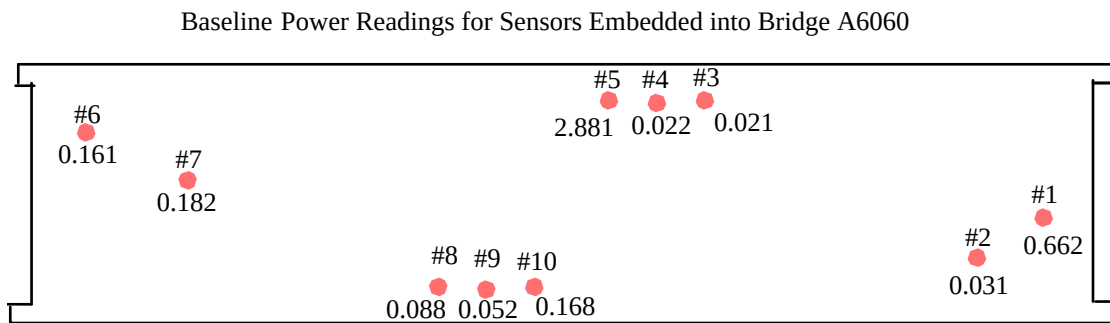
Figure 19.b. Baseline power readings for sensors within bridge A6060.
