PERFORMANCE OF THE FIRST STRUCTURE BUILT WITH HIGH PERFORMANCE CONCRETE IN VIRGINIA

1. Report No. FHWA/VTRC 02-R1		2. Government Accession No.		3. Recipient's Catalog No.	
4. Title and Subtitle Performance of the First Structure Built with High Performance Concrete in Virginia				5. Report Date August 2001

This report documents the preparation and placement operations, concrete properties, cost-effectiveness, and performance over 5 years of the first bridge built by VDOT containing HPC.

The bridge was built on Rte. 40 over Falling River in Campbell County, Virginia. It has four spans, each 80 ft (24.4 m) long and 44 ft (13.4 m) wide. The prestressed concrete beams were prepared at a prestressing plant in Bristol. The cast-in-place concretes for the substructure and the superstructure were furnished by a ready-mix concrete plant in Brookneal, 1.5 mi (2.5 km) from the job site. Condition surveys were conducted after the first and fifth years for cracking and scaling.

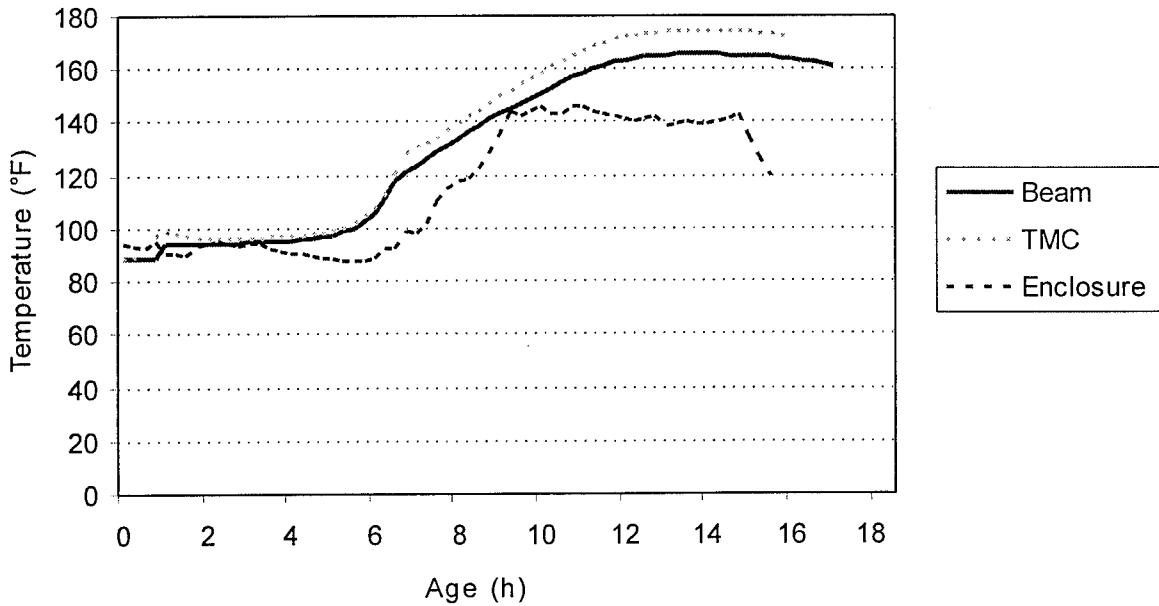
Figure 1. Temperature Rise for B2

The temperatures in the steam enclosure, the TMC cylinder, and the beam containing B2 at 2 ft (600 mm) from the end and 6 in (150 mm) from the bottom are given in Figure 1. Because of the heat of hydration, the temperature rose continuously in the beam and, after a peak, gradually decreased. The TMC molds were covered to protect them from the environment. The temperature rise in the molds was higher than in the beam.

The temperature rise in the cylinders cured along the beam in the enclosure was expected to be less than in the beam because of size. The enclosure temperature and the temperature of the cylinder within the enclosure alongside the beam containing B4 are given in Figure 2. The temperature of the cylinder followed that in the enclosure. The temperature rose continuously in the beam and then dropped gradually, even though sudden changes occurred in the temperature in the enclosure. The strength difference between the TMC and regular cylinders in the enclosure in concretes representing B3 and B4 was higher than with B1 and B2. This larger difference, more than 2,000 psi (14 MPa), was attributed to the higher cement factor and the higher enclosure temperature for B1 and B2. The location of cylinders with respect to the member and the steam ducts would also have an effect.

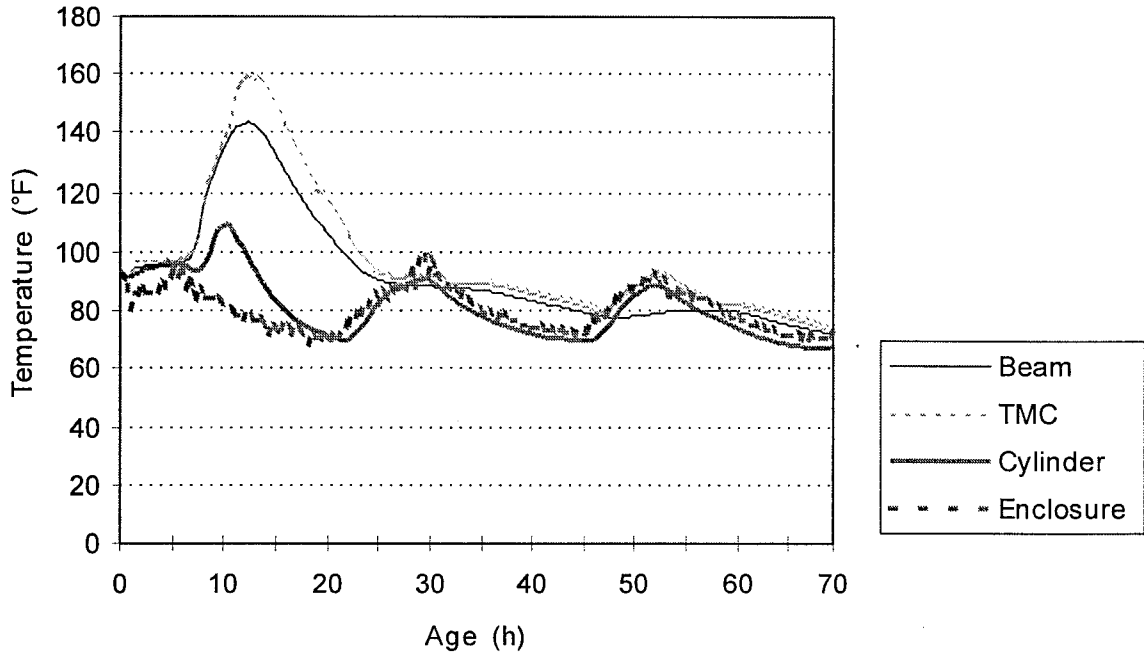
Figure 3. Temperature Rise for B6

The temperature development in the moist-cured beam B6 is given in Figure 3. The data indicated that the beams and TMC cylinders had a high temperature development, unlike the regular cylinders kept under the covers next to the beams. The results for the TMC cylinders indicate the possibility of attaining a release strength of 6,000 psi (41 MPa) with moist curing in 1 day.

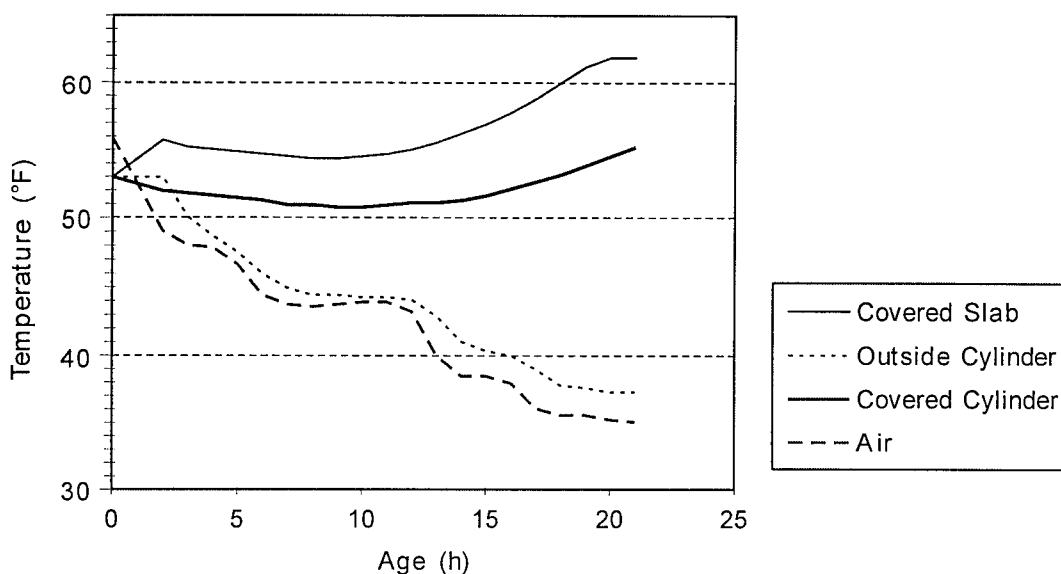
Figure 4. Temperature Rise of Deck Concrete

The strength of the A4 concrete for the deck was low at 1 day. The air temperature was also low, as shown in Figure 4. The specimens were covered with insulating blankets and kept near the structure. The temperatures of a cylinder under cover and a cylinder kept outside the cover and the slab under cover are displayed in Figure 4. The temperature of the cylinder left outside the cover follows the air temperature. The cylinder under the blankets retains its temperature and then shows a slight gradual increase. The slab had higher temperatures than the cylinders because of their larger size. The actual bridge deck is expected to have a higher temperature because of its size and heating from the underside. Thus, even though the cylinders had a low 1-day strength, a higher strength is expected in the deck concrete because of the higher heat generation. At 28 days, the compressive strength of deck concrete was more than twice the minimum required value of 4,000 psi (28 MPa). Batches A43 and A44 were brought to the laboratory on Monday, 3 days after casting on a Friday. They had low 3-day strengths because of cool temperatures.
