Geopolymer for Protective Coating of Transportation Infrastructures

FINAL REPORT
September 1998

Submitted by
Dr. P. Balaguru
Professor

Center for Advanced Infrastructure and Transportation (CAIT)
Civil & Environmental Engineering
Rutgers, The State University
Piscataway, NJ 08854-8014

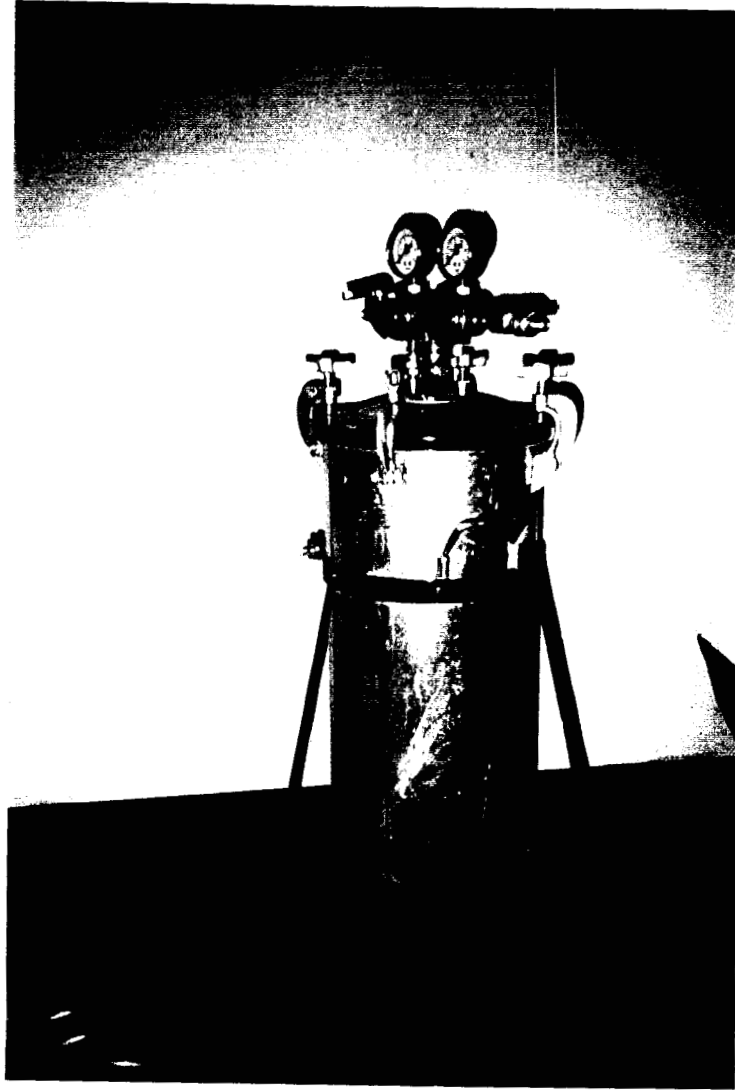
Fig. 2 (a). Spray system used for demonstration.

The matrix with or without short fibers can be applied with brush, squeeze, or sprayer. Commercial spraying system shown in Fig. 2 was successfully used for spraying. The matrix can also be easily applied by brush. For smaller areas, it is recommended to use brush and for larger areas, sprayers can be used. The pot life is about 1 hour at 75° F. At higher temperatures, precautions should be taken to cool the constituent materials to prevent the reduction of working time.

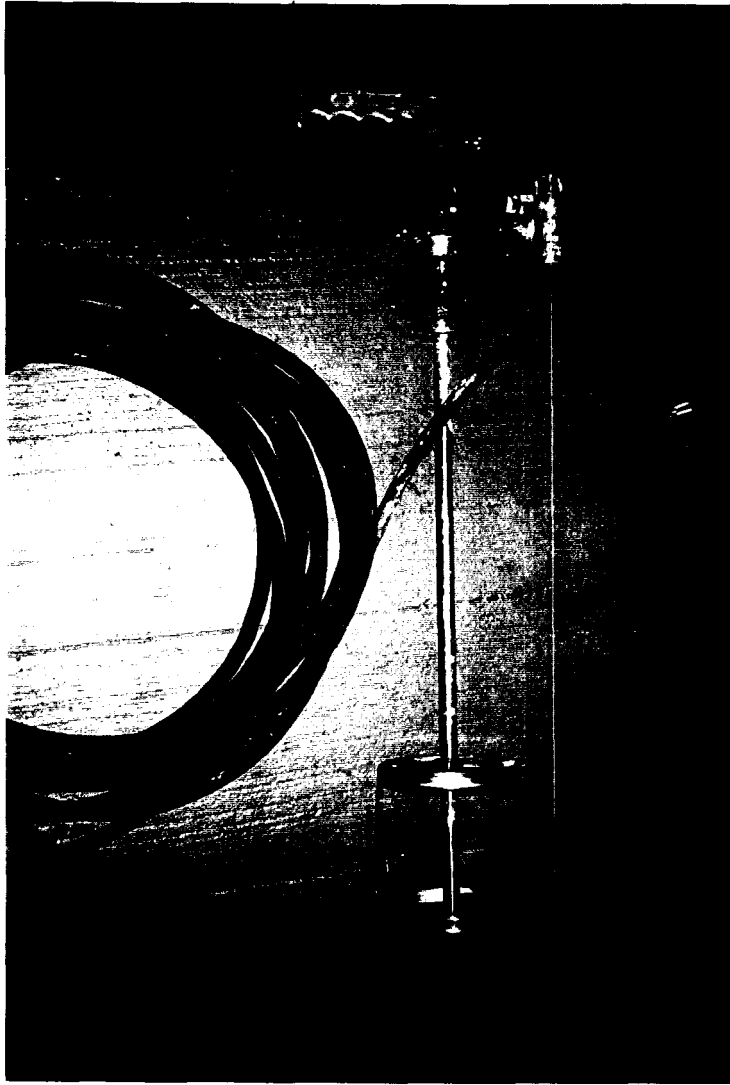
Fig. 2 (b). Setup for field mixing.

The components can be mixed with the paddle mixers used for mixing paint. The tools can be cleaned with water. Special surface preparation is not needed. It is recommended to wet the parent surface to obtain saturated-surface dry condition.
