1. Report No. FHWA/TX-09/0-4701-5		2. Government Accession No.		3. Recipient's Catalog No.	
4. Title and Subtitle EVALUATION OF TRAFFIC CONTROL DEVICES: FIFTH-YEAR ACTIVITIES				5. Report Date October 2008 Published: February 2009

**EVALUATION OF TRAFFIC CONTROL DEVICES:
FIFTH-YEAR ACTIVITIES**

Project Title: Traffic Control Device Evaluation and Development Program

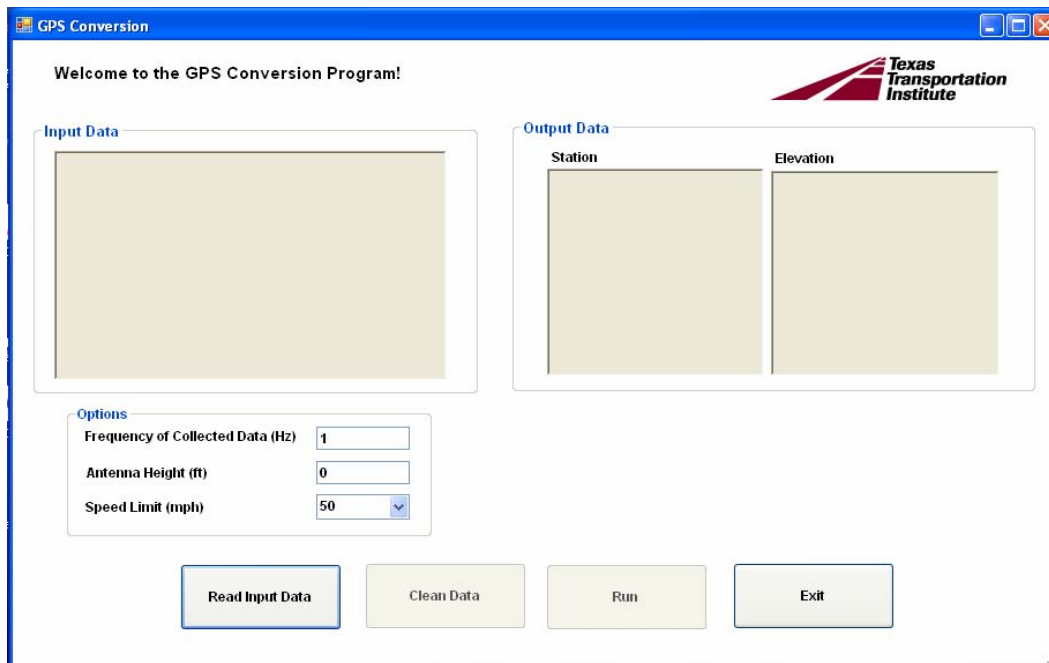
Figure 2-2. Main Window of GPS Conversion Program.

After saving the file, the user can run the GPS conversion program by double clicking on the GPS_conversion executable file. This opens the main window of the program (see Figure 2-2).

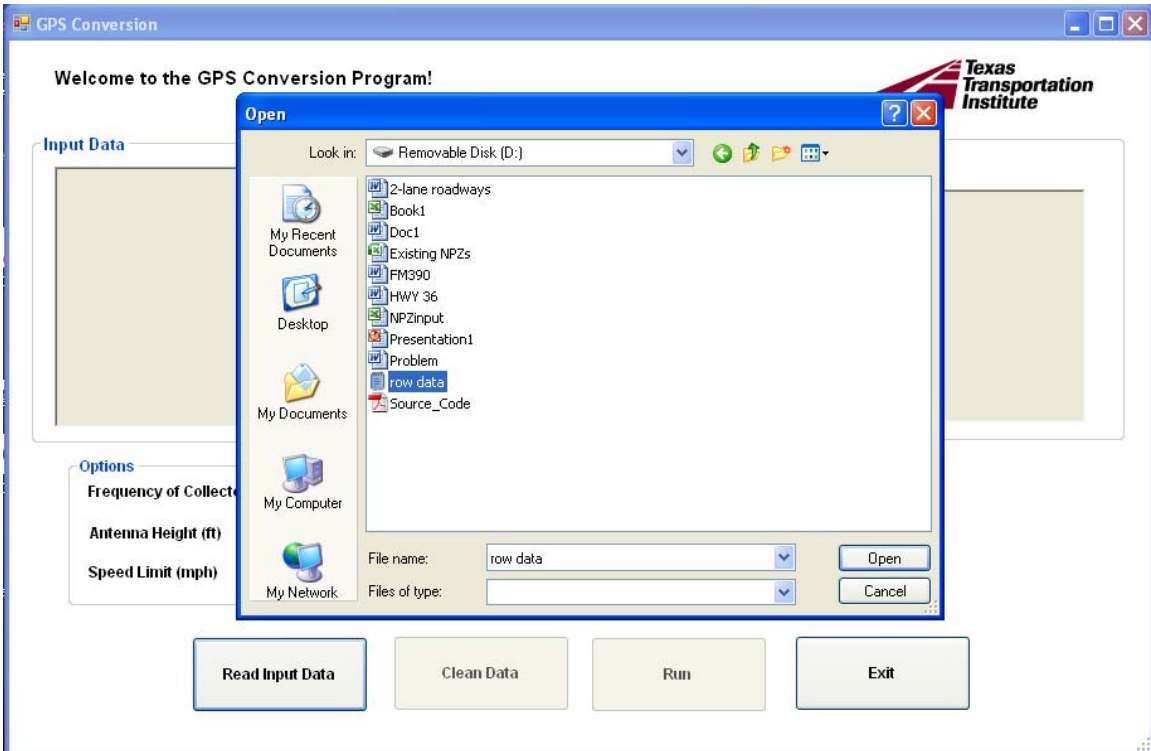
Figure 2-3. Addressing the Text File and Reading Input Data.

By clicking on the Read Input Data button and giving the address of the text file (see Figure 2-3), the GPS data can be loaded into the program, as shown in the left box of the main window (see Figure 2-4).

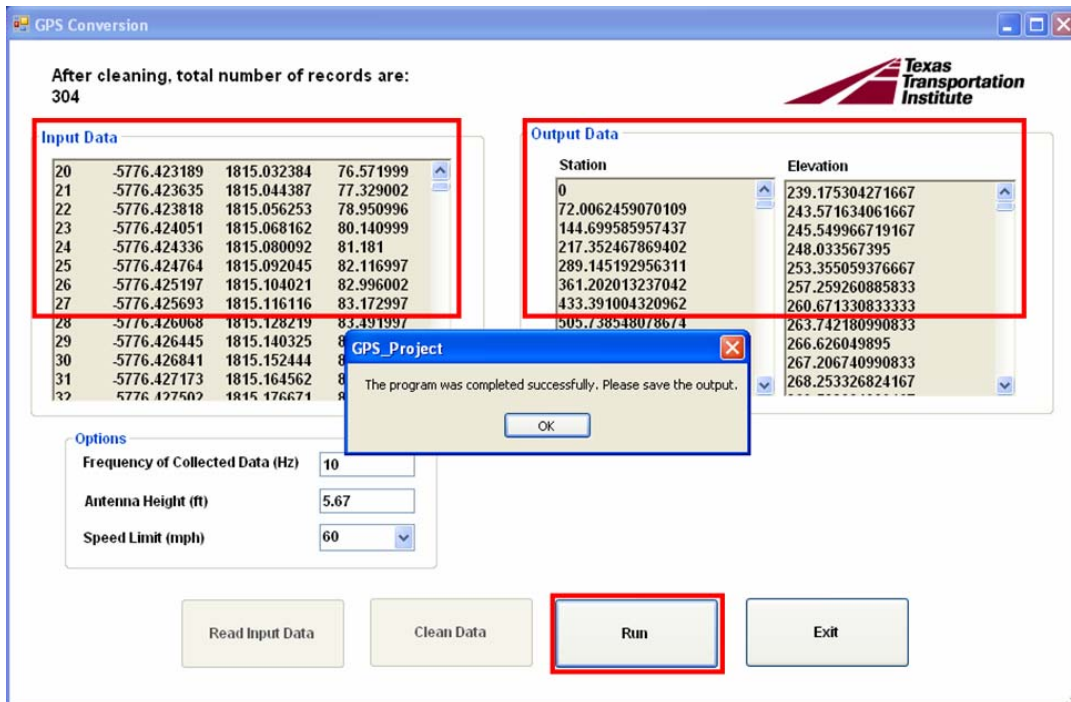
Figure 2-6. Running the Program and Getting the Results.

After the data are loaded, the frequency of the collected data should be entered in the options part of the main window. The no-passing zone algorithm written in the no-passing zone program is based on the data collected every one second. If GPS data collected a value other than 1 Hz (one time per second) during the data collection, the related frequency should be entered. Additionally, the height of the antenna of the GPS instrument during data collection and the design speed/speed limit of the roadway should be entered (see Figure 2-4). If the user does not change the default frequency and goes to the next step, the program confirms that he/she has not forgotten to enter the frequency value by giving a warning (see Figure 2-5). After the user enters the values and clicks on the Clean Data button (see Figure 2-4), the extra data points are eliminated so that the only data points left are one second apart, and the left box of the main window is updated, including the clean data (see Figure 2-6).

Next, by clicking on the Run button, the longitude and latitude values are converted to northing and easting values, the stations and elevations of the segment of the roadway are calculated, and the results, which can be used as the input file of the no-passing zone program, are shown in the right box of the main window (see Figure 2-6). Then a window is automatically opened to save the results in an Excel file. The important items in this step are the name and location of the file to be saved. The name of the file must be typed as “NPZinput,” and it should be saved in the folder where the no-passing zone program (NoPassing_Final.exe) is located. Finally, by clicking the Exit button, the user can terminate the GPS conversion program.

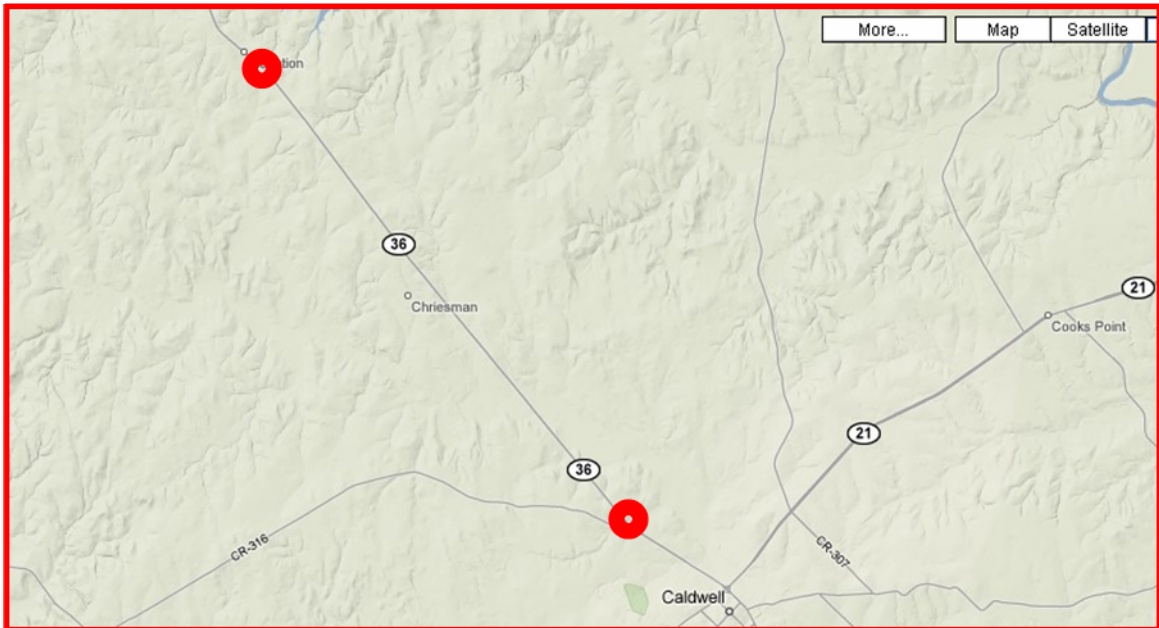
Figure 2-8. SH 36 Alignment.

The SH 36 study site is in Burleson County, northwest of Caldwell, Texas (see Figure 2-7). It is a two-lane road with a shoulder and is approximately 8 miles long. The horizontal alignment of this test section is straight, and there are no horizontal curves (see Figure 2-8). The posted speed limit is 70 mph on this roadway. The dots in Figure 2-8 represent the beginning and the end of the roadway segment evaluated. Researchers made five runs in each direction of the roadway. But after retrieving the GPS raw data, one of the runs was rejected because the collected data were corrupted.

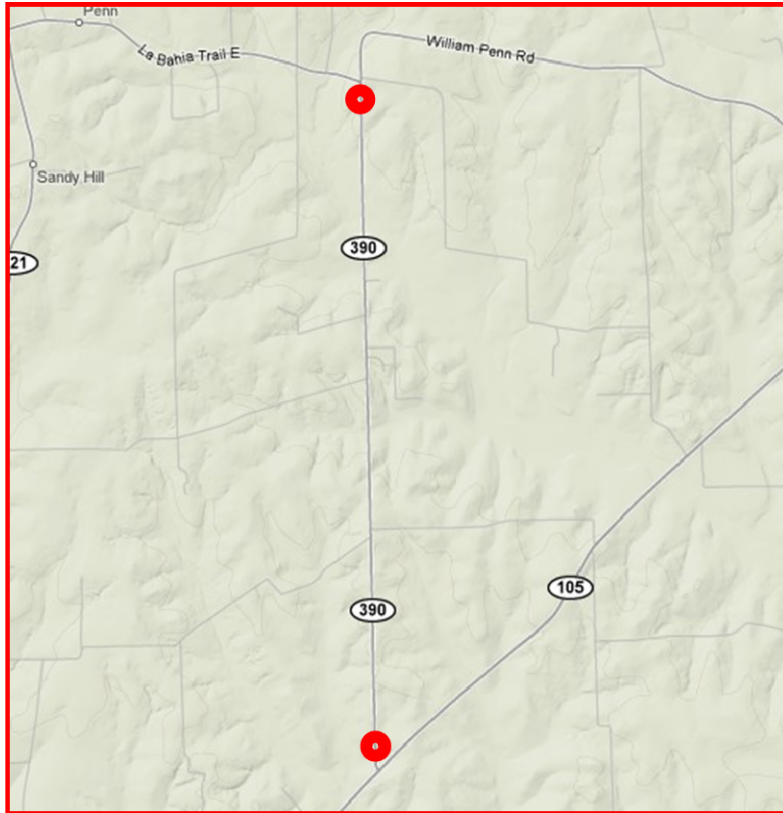
Figure 2-10. FM 390 Alignment.

The FM 390 site, designated as a scenic route by the state of Texas, is located in Washington County. The roadway starts at SH 105 northeast of Brenham and ends at US 290 in Burton. It is a two-lane roadway with no shoulder, and the roadway speed limit is 60 mph. The study segment is the part of FM 390 that begins at SH 105 and runs northward approximately 4 miles (see Figure 2-9). The horizontal alignment of this test section is straight, and there are no horizontal curves (see Figure 2-10). The dots in Figure 2-10 represent the beginning and the end of the roadway segment evaluated. Researchers made four runs in each direction at this sign. But after retrieving the GPS raw data, one of the runs was rejected because the collected data were corrupted.

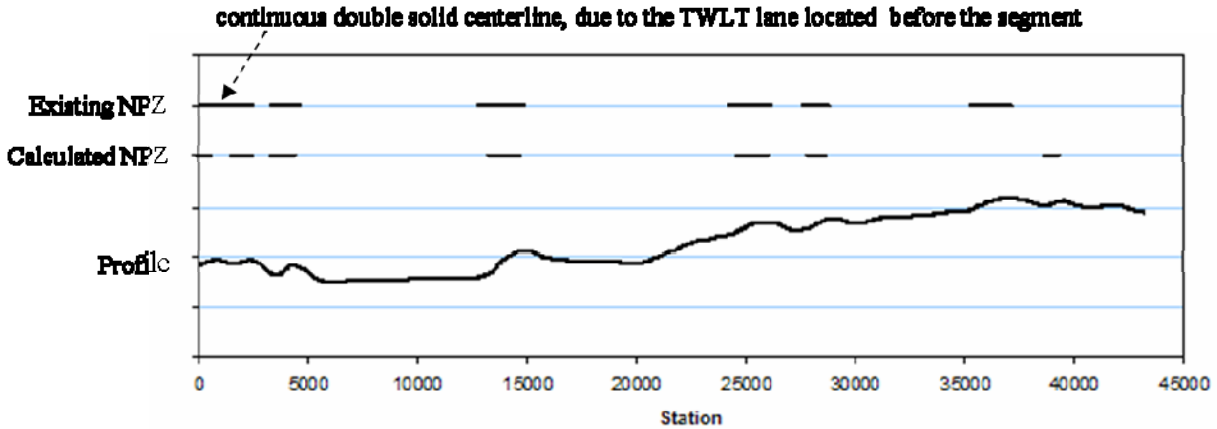
Figure 2-11. SH 36 Northbound.

Figure 2-11 shows the profile of SH 36 in the northbound direction, along with the calculated no-passing zones (NPZ). It also shows the existing no-passing zones whose information was collected during the site visit. There is a continuous centerline at the beginning of the northbound direction of the study segment of SH 36 (as can be seen in Figure 2-11) due to the existing two-way left-turn lane (TWLTL) that is located before the starting point of the segment. Figure 2-12 shows the profile of SH 36 in the southbound direction, along with the calculated and existing no-passing zones.

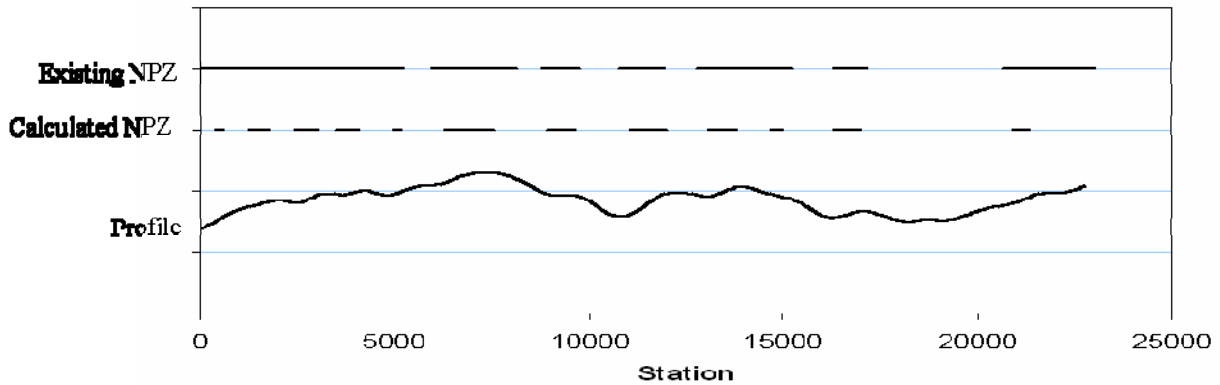
Figure 2-13. FM 390 Northbound.

Figure 2-13 shows the profile of FM 390 northbound, along with the calculated no-passing zones and the existing no-passing zones, whose information was collected during the site visit. According to the MUTCD, where the distance between successive no-passing zones is less than 400 feet, no-passing markings should connect the zones. The no-passing zone program automatically checks this guideline, and the output results are based on it. Figure 2-13 illustrates that for some part of the segment, the program has calculated short, individual no-passing zones, but in the field, the existing no-passing markings are continuous in those locations. To validate the program, the distances between the short no-passing zones were calculated and confirmed to be no shorter than 400 feet. Therefore, it is concluded that at this site, the adjacent no-passing zones that are close together have been connected in the field, even if they are more than 400 feet

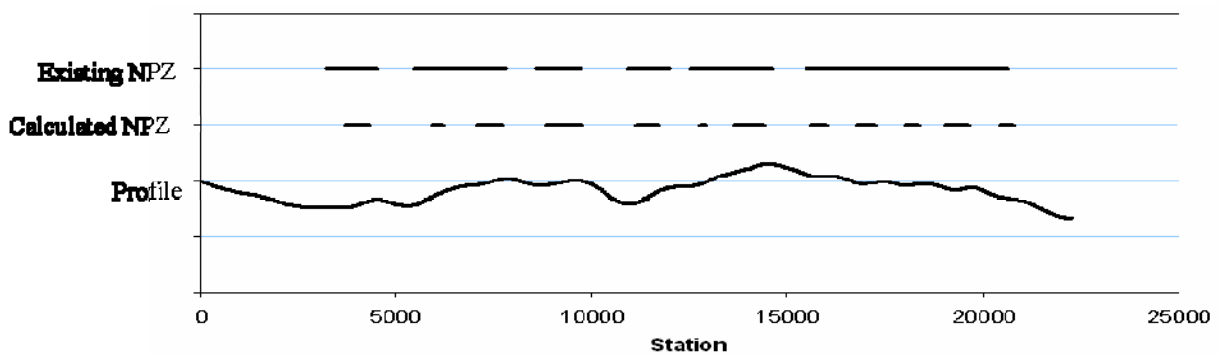
Figure 2-14. FM 390 Southbound.

apart. Figure 2-14 shows the profile of FM 390 in the southbound direction, along with the calculated and existing no-passing zones.

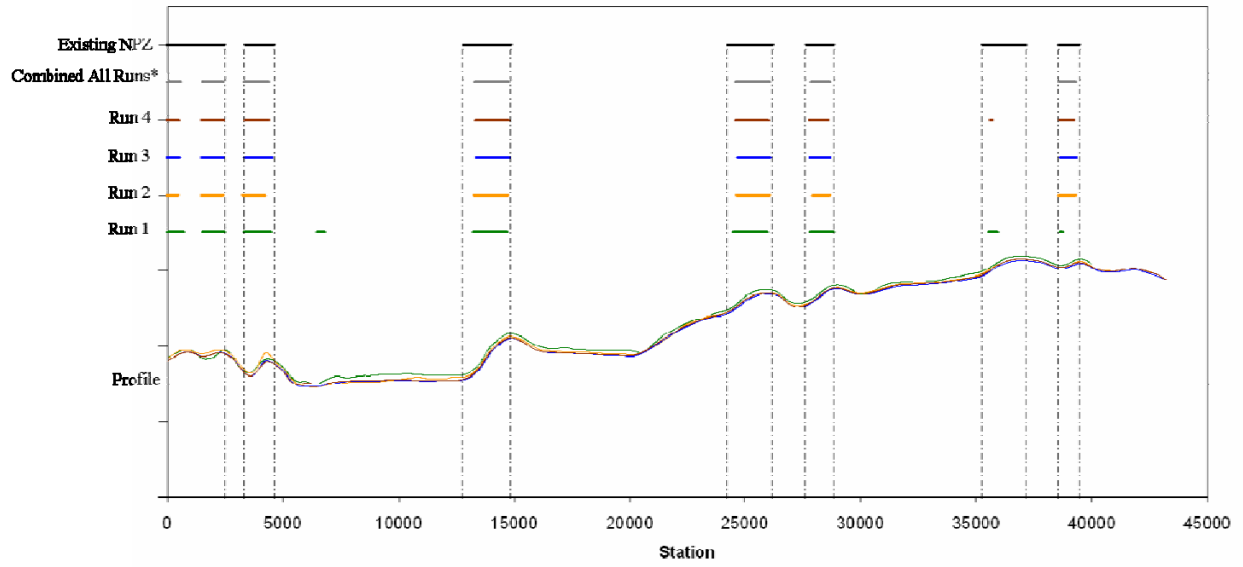
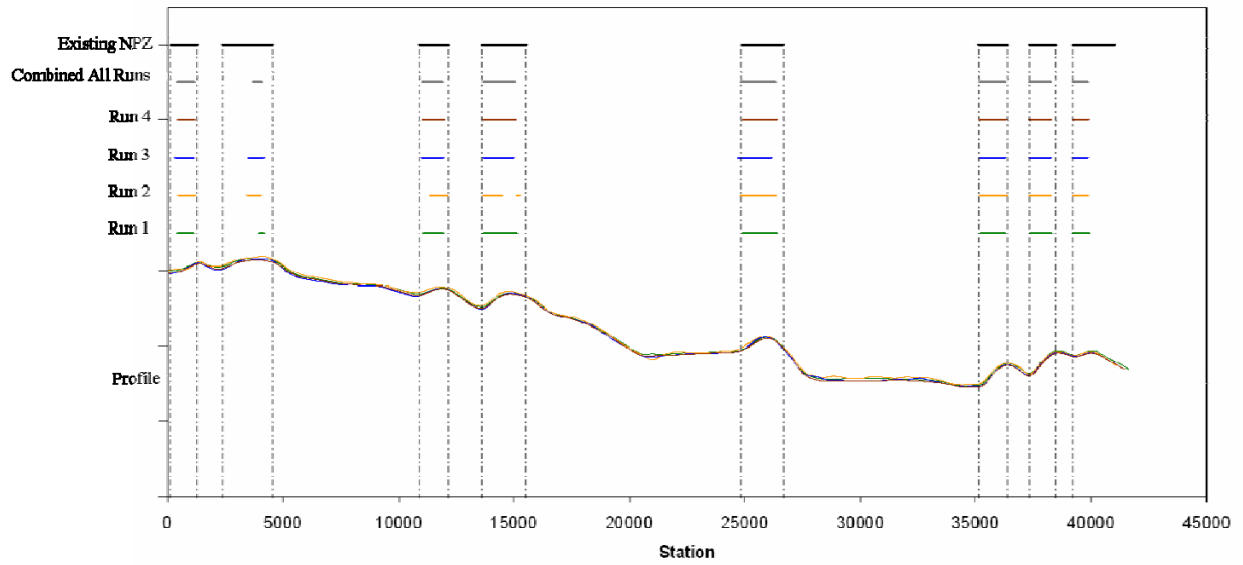
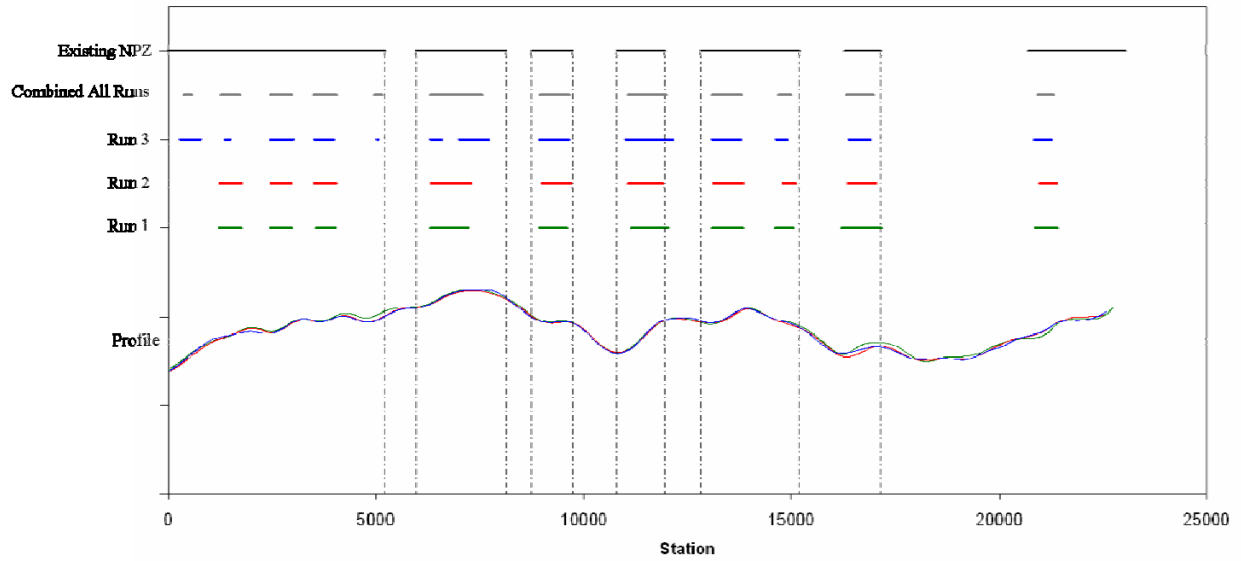
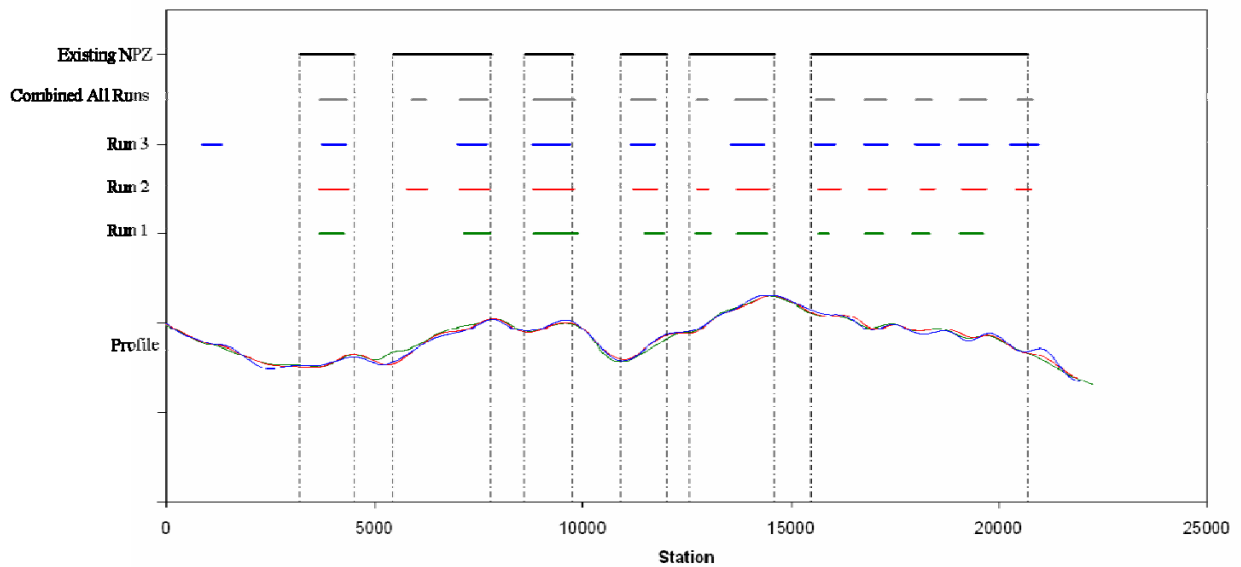
In addition to calculating no-passing zones based on the combined runs of collected data, as was explained previously in the report, researchers calculated no-passing zones based on the individual runs for each direction of the test roadways. Figures 2-15 to 2-18 illustrate the graphs that show existing no-passing zones and calculated no-passing zones based on the individual and combined runs. Comparing all the results to the existing ones, it seems that existing no-passing zones in the field are conservatively longer than what they should be based on the recommendation. Additionally, some adjacent no-passing zones are close enough that they are connected in the field, even though they may be far enough apart to exist as separate no-passing zones according to the MUTCD.

Note: * Data from all runs were combined, and NPZs were calculated based on the combined profiles.

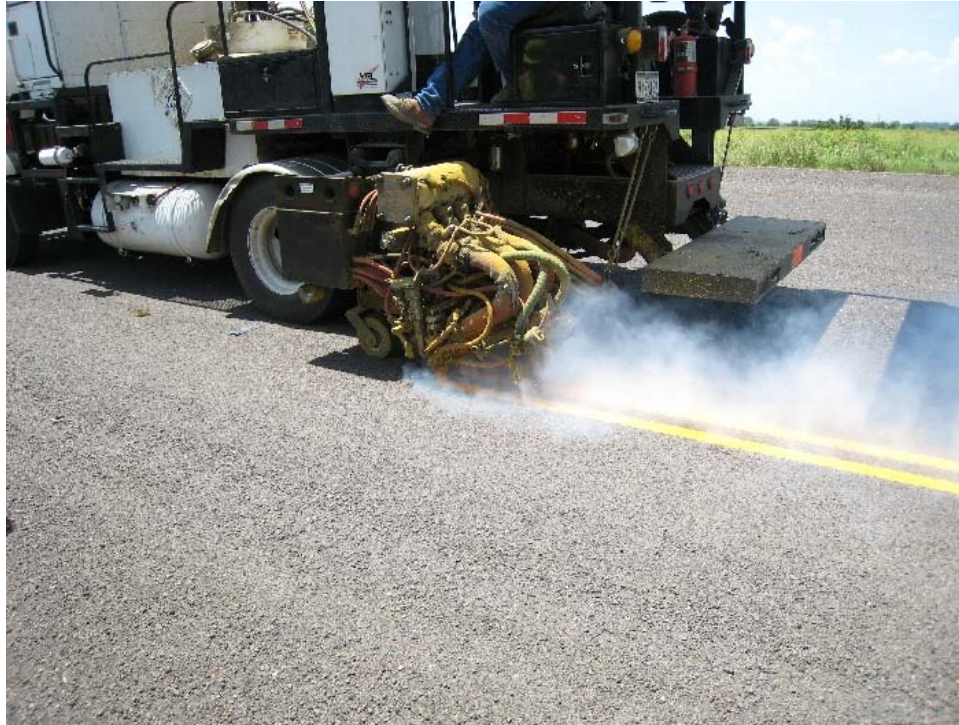
Figure 3-1. SH 21 Lead-Free Thermoplastic Installation.

The US 79 site included both lead-free and standard yellow thermoplastic materials that were installed on consecutive days in a two-way left-turn lane in the city. The SH 21 site consisted only of lead-free thermoplastic installed as the left edge line on a divided highway, transitioning to a double solid centerline on an undivided highway (see Figure 3-1). The US 79 section has approximately 6000 average daily traffic (ADT), and the SH 21 section has approximately 10,000 ADT. At each site, researchers measured retroreflectivity and color. The initial measurements were made at the time of installation, and then at approximately 3, 7, and 11 months after installation.

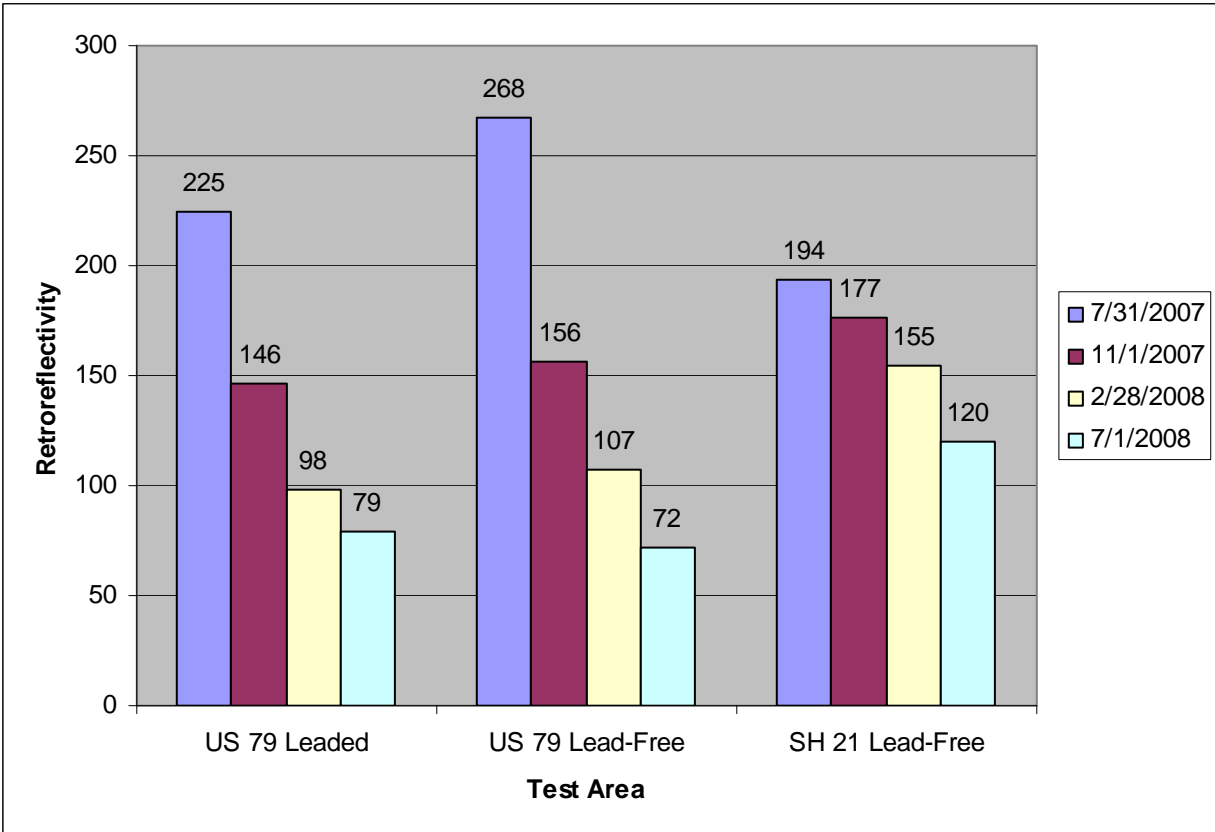
Figure 3-2. Yellow Thermoplastic Retroreflectivity Summary.

As seen in Figure 3-2 the retroreflectivity at each location decreased as the markings aged. A greater decrease in retroreflectivity is observed at the US 79 site than at the SH 21 site. The ADT on US 79 is less than that on SH 21, but since the marking is a two-way left-turn lane, it is subject to more turning movements and traffic than the marking on SH 21. The leaded and lead-free markings on US 79 are decreasing at similar rates, with the lead-free marking losing retroreflectivity slightly quicker.

The retroreflectivity (R_L) measurements were made with the LTL 2000Y retroreflectometer. All of the initial measurements on both the leaded and lead-free material were above the 175 mcd/m²/lx minimum level required in the TxDOT specification. It is worth noting that the markings measured on the pavement were applied to surface treatment (seal coat). This surface represents a very rough pavement surface, which may have an impact on the measured retroreflectivity. However, there were no application sites included where the lead-free marking material was applied to a smoother pavement surface.

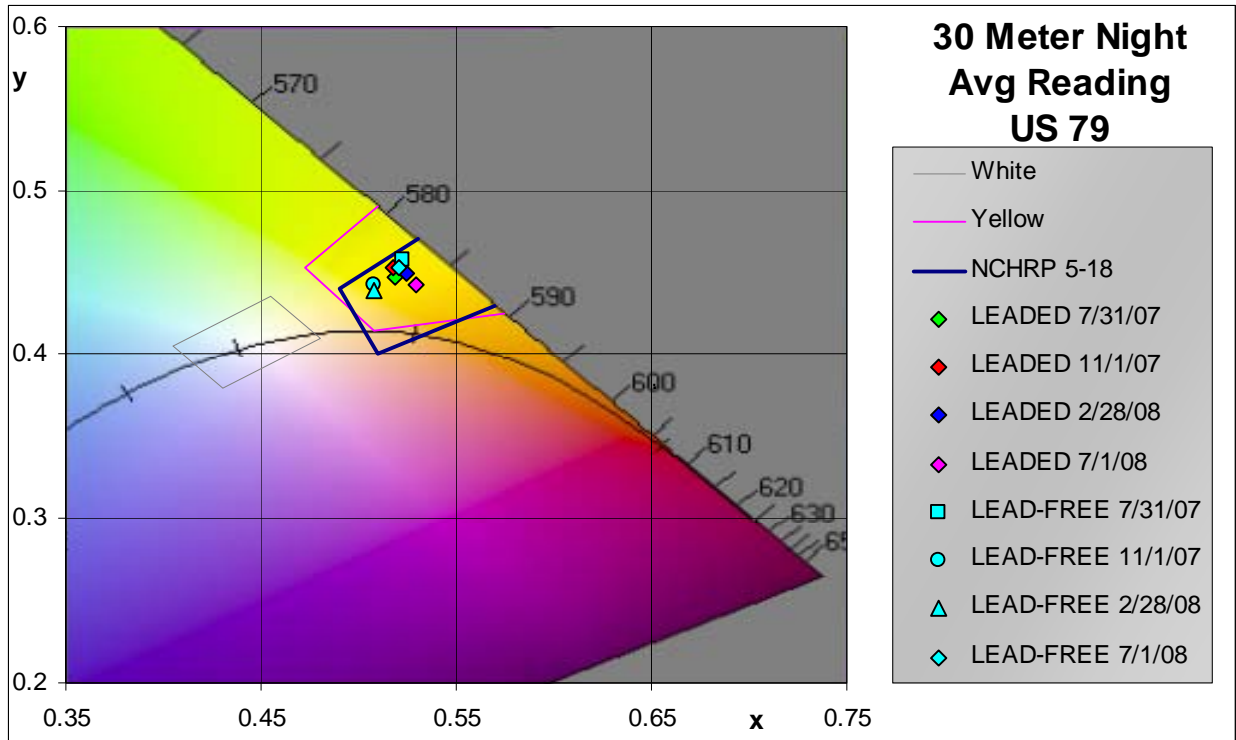
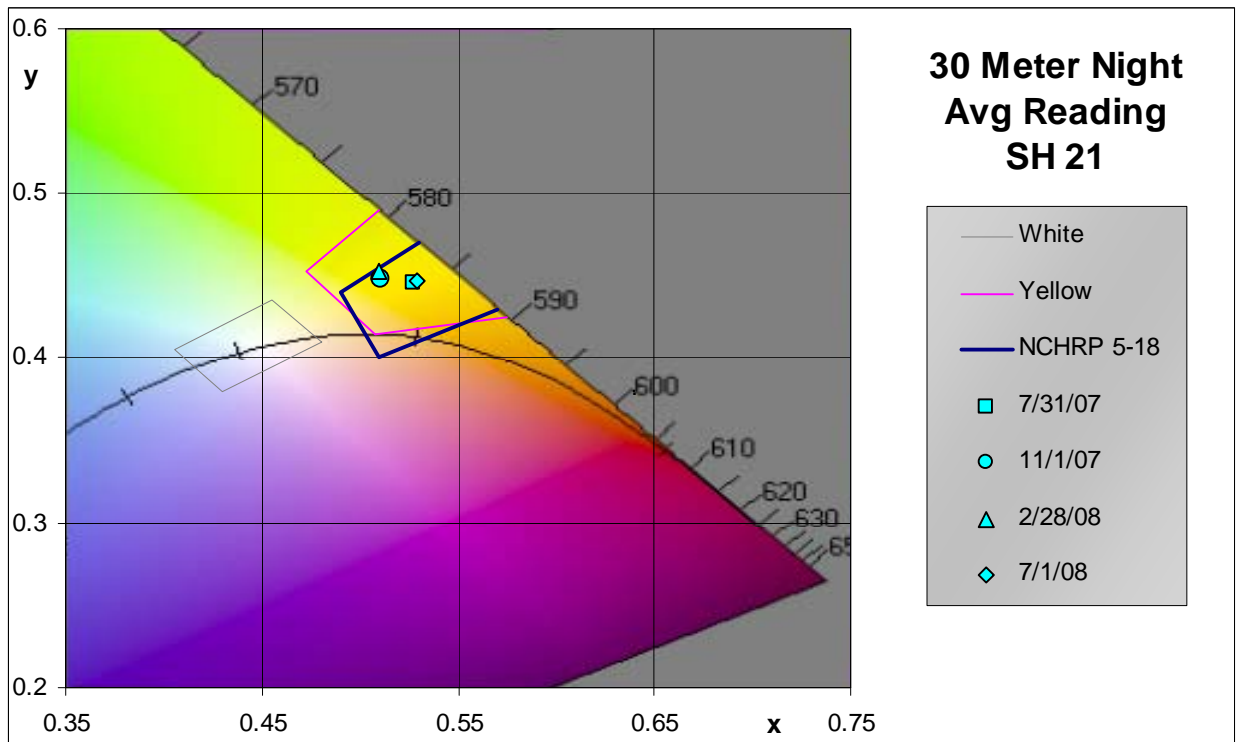
The average 30 meter color values from each data collection period were plotted against the x-y points defining the color box from the FHWA final rule on marking color. This color box is based on Illuminant A and a viewing geometry that is the same as the 30 meter retroreflectivity geometry. The NCHRP recommended color box is also illustrated to show the difference. Figures 3-3 and 3-4 illustrate the plot of the average color points for the color measurements with the LTL 2000Y at both sites. All of the average measurements from each data collection period on both the leaded and lead-free markings are within the FHWA color box. It is worth noting that the markings measured on the pavement were applied to surface treatment (seal coat). As with the retroreflectivity measurement, this surface represents a very rough pavement surface, which may have an impact on the measured color. However, there were no application sites included in the initial evaluation where the lead-free marking material was applied to a smoother pavement surface.

Figure 3-3. Average 30 Meter Night Color of Both Thermoplastic Materials at US 79 Site.

Figure 3-4. Average 30 Meter Night Color of Lead-Free Thermoplastic at SH 21 Site.

for 30 meter yellow marking materials. The initial measurements are also within the recommended color box from the NCHRP 5-18 project but not in the center of the box. The initial 30 meter nighttime color of the lead-free thermoplastic marking material appears to be acceptable.

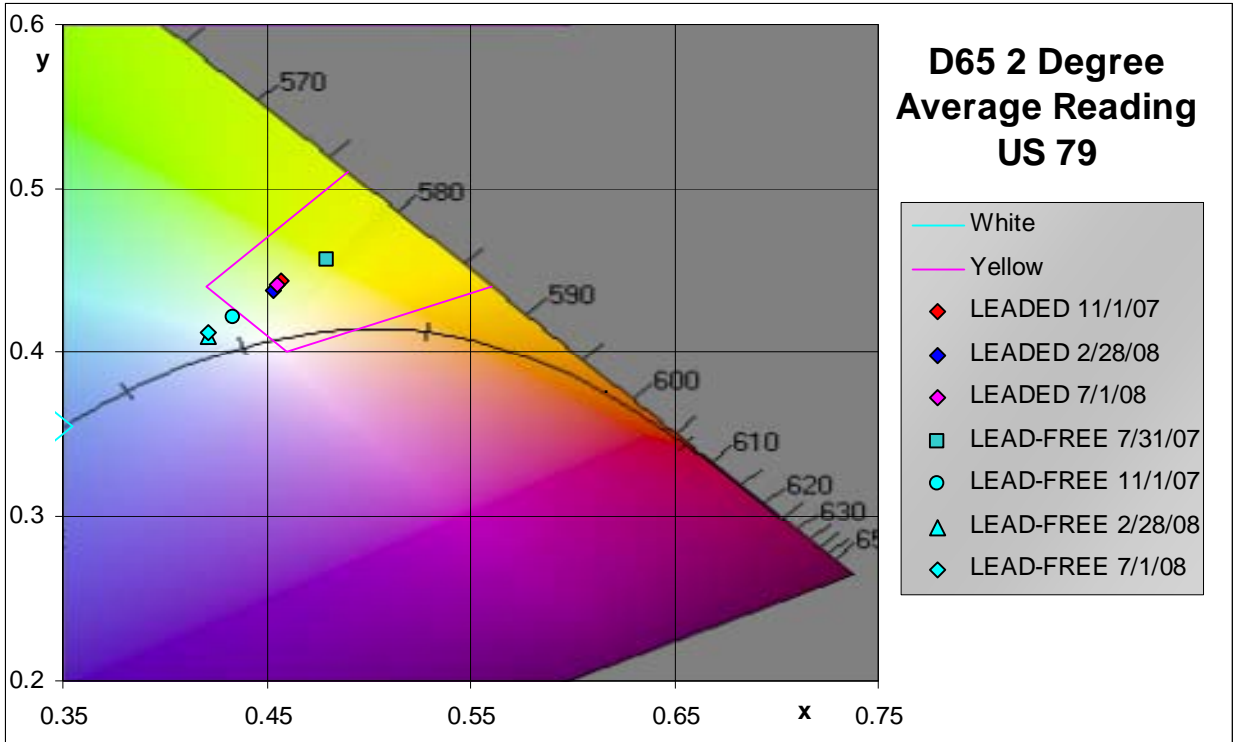
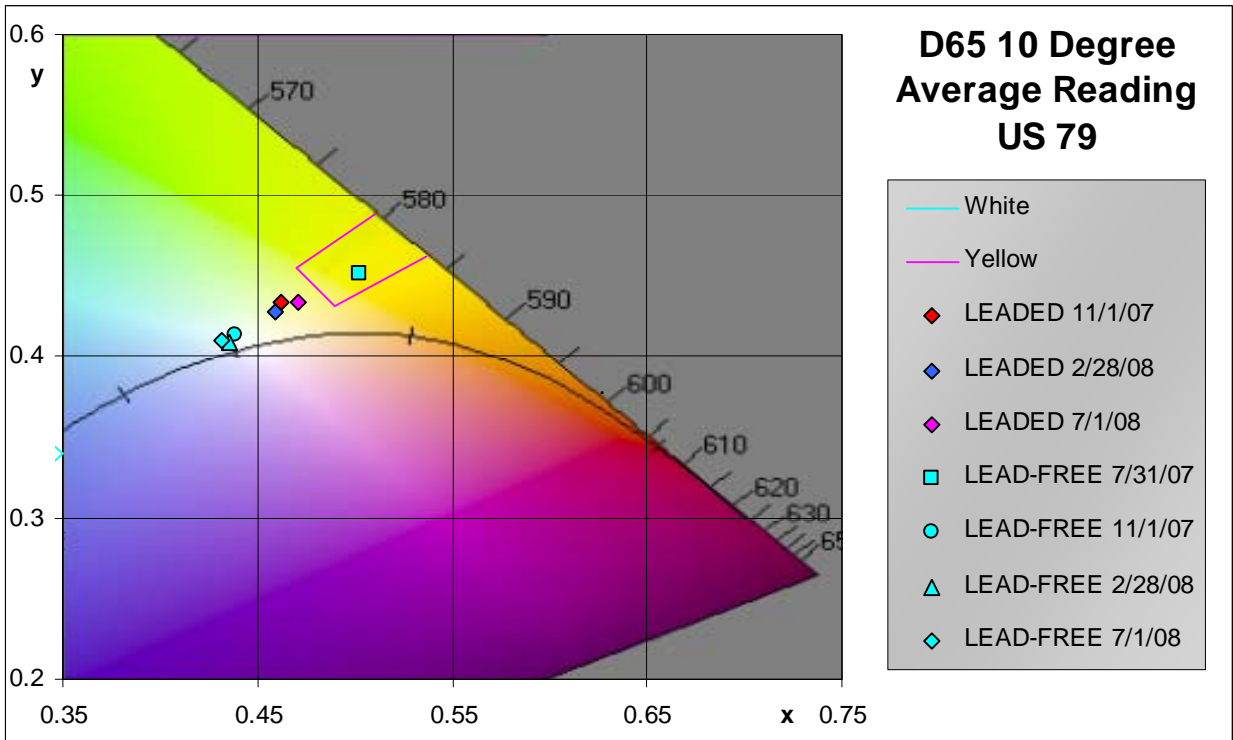
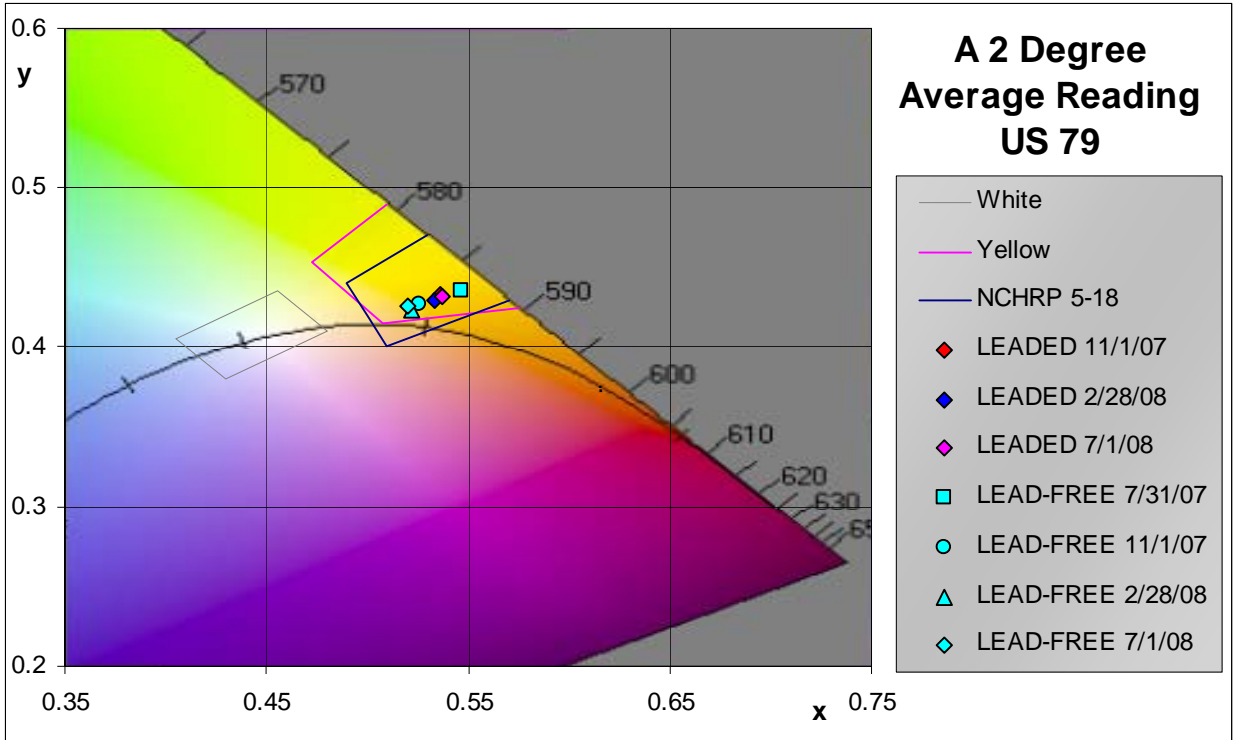
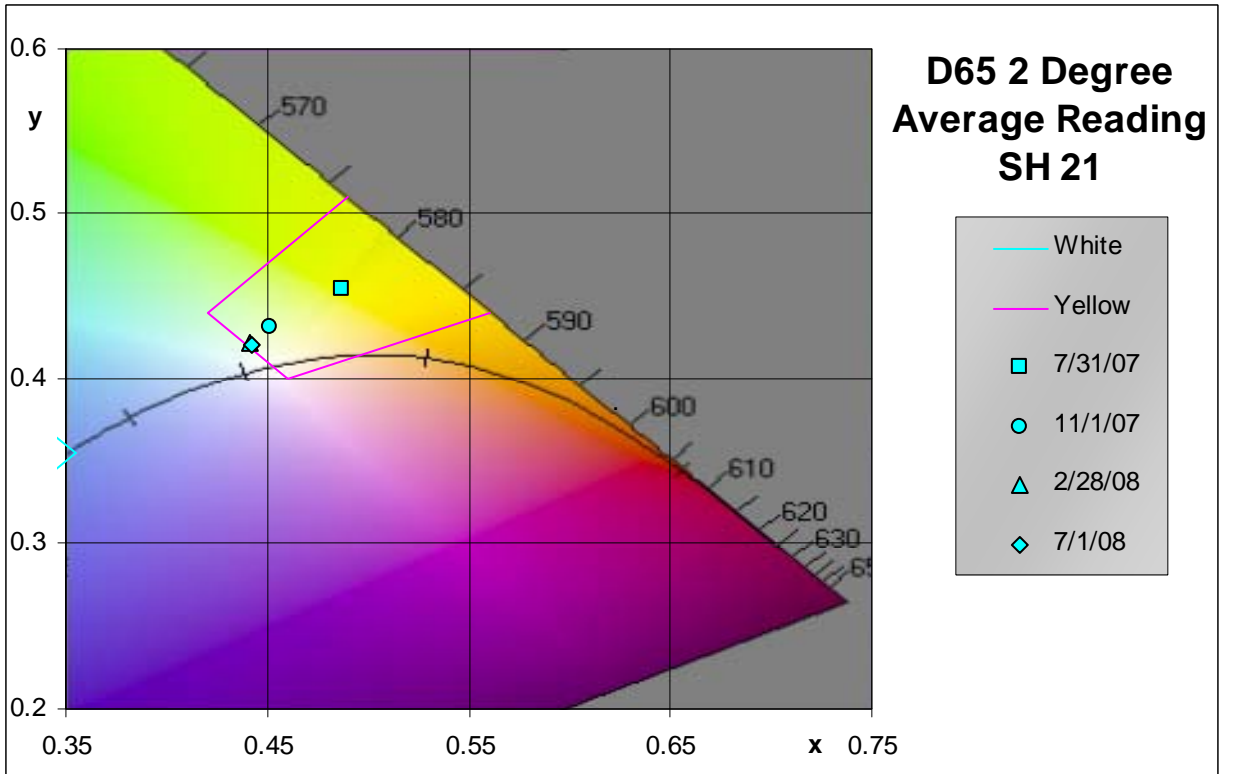
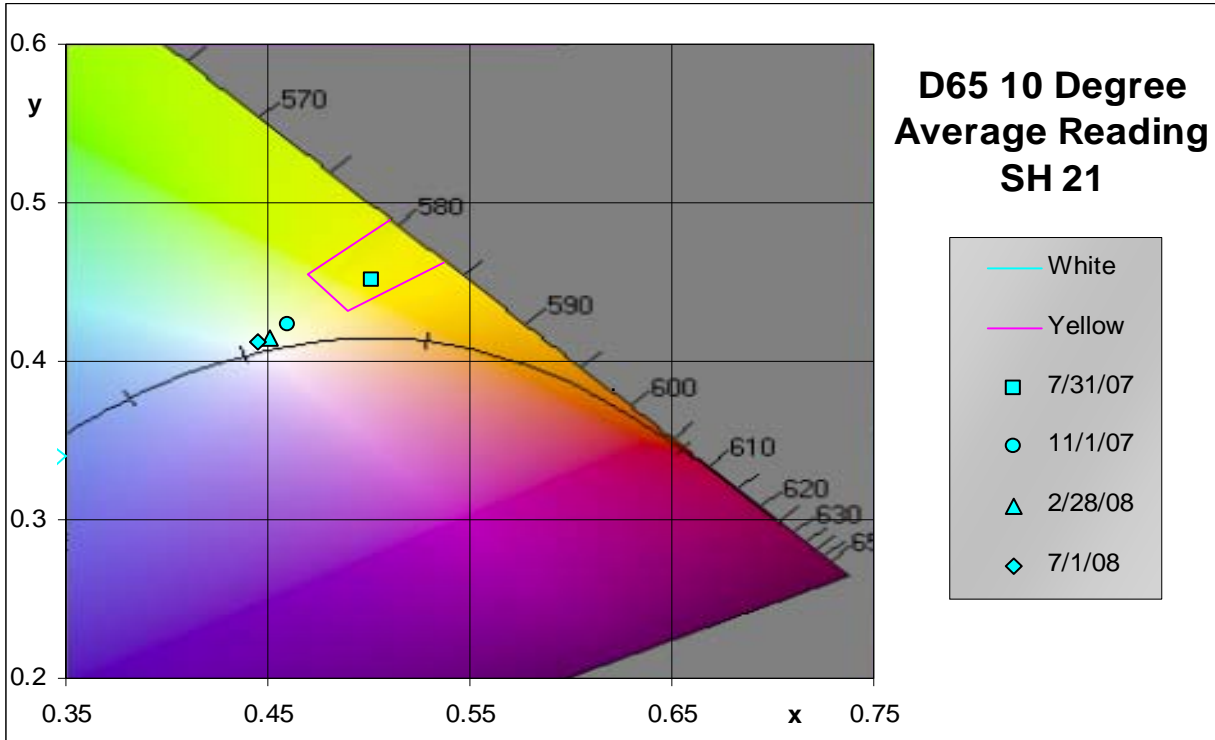
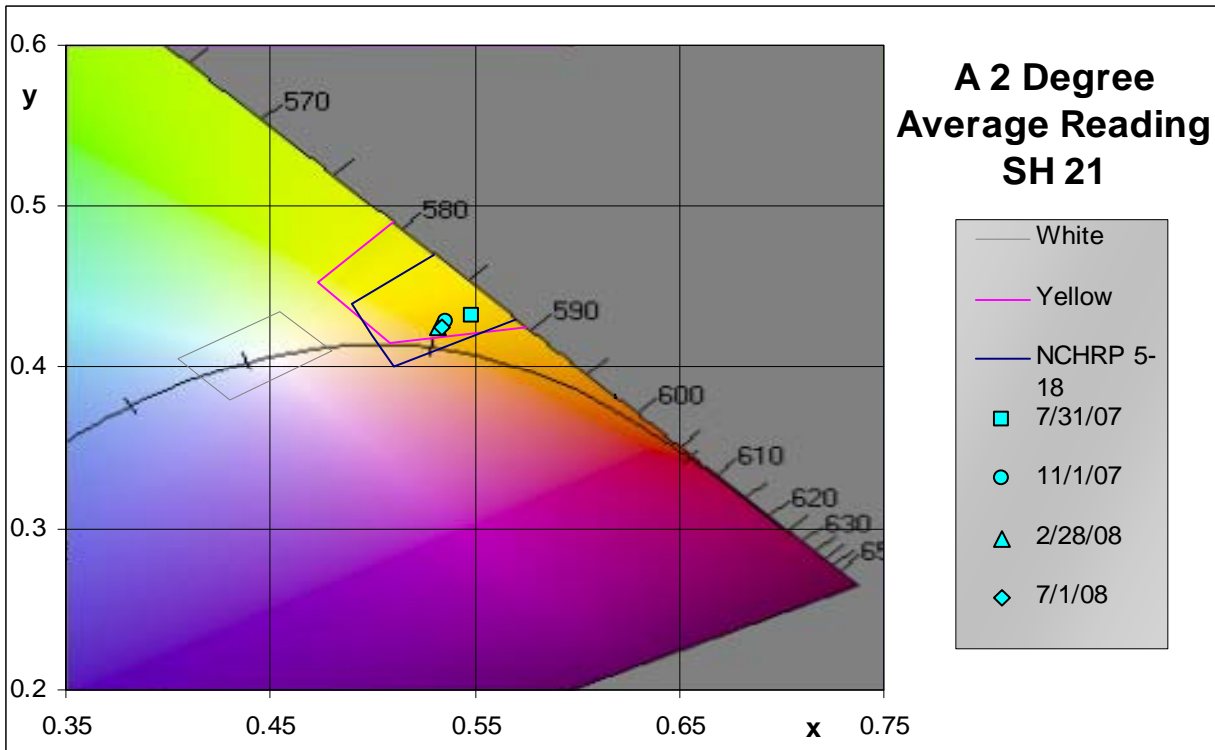
The researchers also measured the color of the yellow thermoplastic marking materials containing beads and no beads using a range of illuminants and standard observers at a 45° illumination geometry and a 0° observation geometry. The color measurements on the beaded and non-beaded sections were pooled together after little difference was found between the two measurement sets. The average color values for each of the illuminants and standard observers for each measurement period at both locations are indicated in Figures 3-5 through 3-10. These points were plotted with the appropriate day or night color boxes. The TxDOT color box from DMS 8220 was used for the D65 10° standard observer measurements.

All of the initial measurements were within the TxDOT and FHWA color boxes for both standard observers. All of the Illuminant A 2° standard observer average readings at both sites for each data collection period were within the FHWA nighttime color box. For the daytime color measurements using Illuminant D65, some average measurements have fallen outside of the color box requirements. The D65 10° measurements of both the leaded and lead-free material at both sites fall outside of the TxDOT color box. The leaded material was outside of the box but much closer to the box than the lead-free material was. The D65 2° measurements of the leaded material all fall within the FHWA color box, but the lead-free material color readings do not at the US 79 site. At the SH 21 site, the lead-free color readings all fall within the FHWA color box but are trending away from the center of the box. It should be noted that the TxDOT color box is much smaller than the FHWA color box.

- 45°/0° color
 - ♦ The standard color measurements using Illuminants D65 and A of the leaded and lead-free material were initially found to be within the FHWA and TxDOT color boxes for yellow markings. The initial 45°/0° color of the lead-free marking material appears to be acceptable.

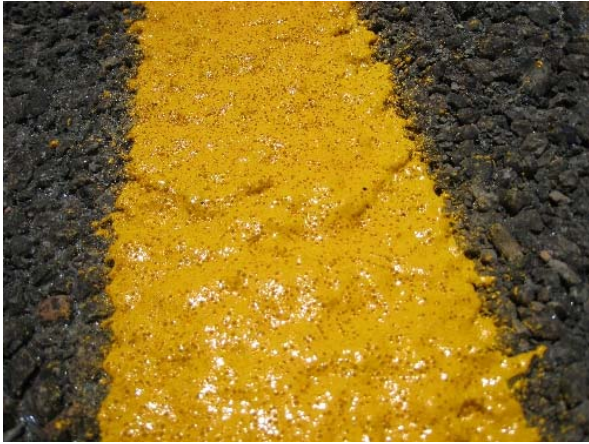
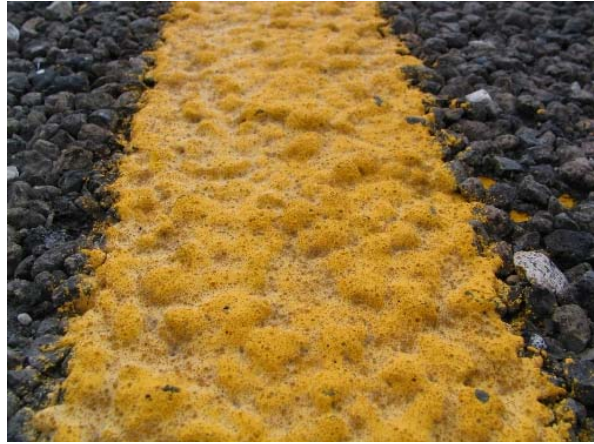
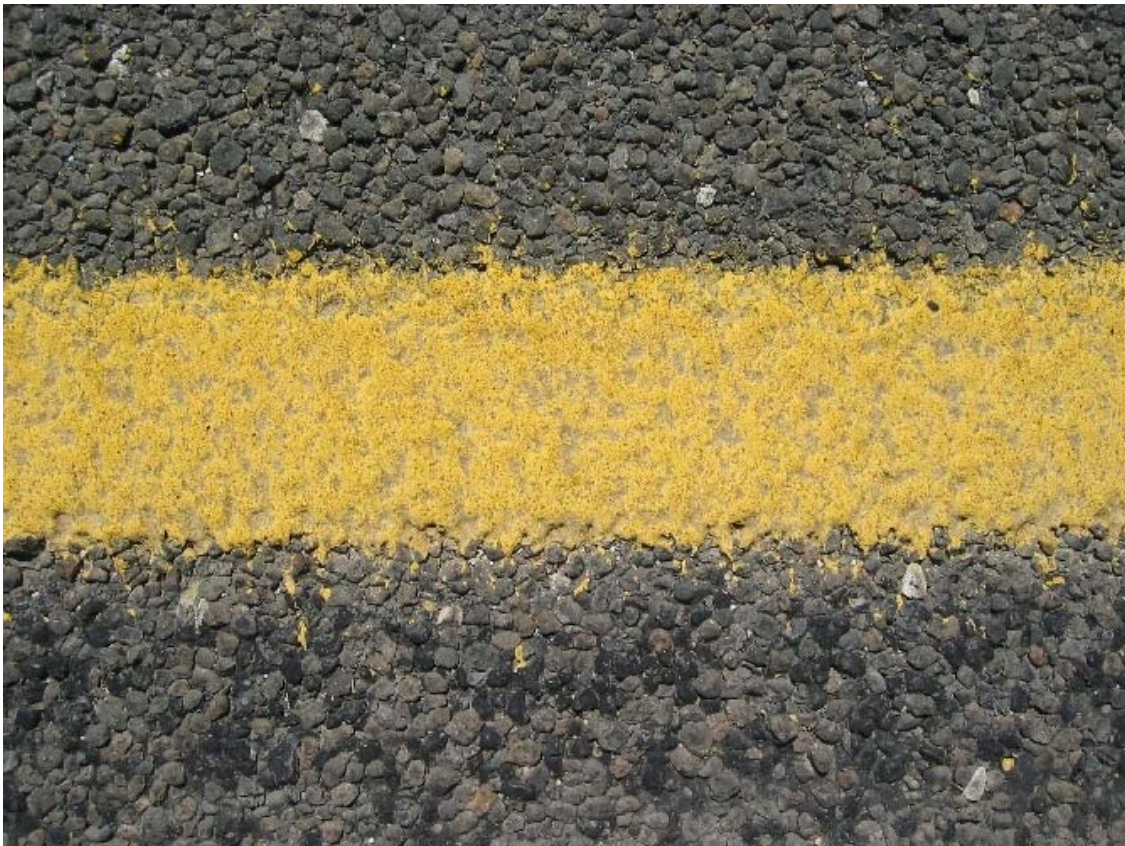
Figure 3-11. Images of SH 21 Pavement Marking Color Change.

Subjective visual inspection of color during the data collection indicated a reduction in the yellow quality of the marking. This daytime visual inspection would seem to match the D65 color data that were collected on the markings, as the color data showed that the markings were moving away from yellow and toward white during daytime conditions. Figure 3-11 shows three images taken while conducting data collection. In the pictures, the color change and fading of the marking is noticeable. It should be noted that some of the color change is due to the accumulation of dirt, but some of the color change is also due to the aging of the marking and its pigments.

7/31/2007 Initial Install SH 21

11/12/2007 SH 21

7/1/2008 SH 21
