1. Report No. FHWA/TX-09/0-4701-5		2. Government Accession No.		3. Recipient's Catalog No.	
4. Title and Subtitle EVALUATION OF TRAFFIC CONTROL DEVICES: FIFTH-YEAR ACTIVITIES				5. Report Date October 2008 Published: February 2009

**EVALUATION OF TRAFFIC CONTROL DEVICES:
FIFTH-YEAR ACTIVITIES**

Project Title: Traffic Control Device Evaluation and Development Program

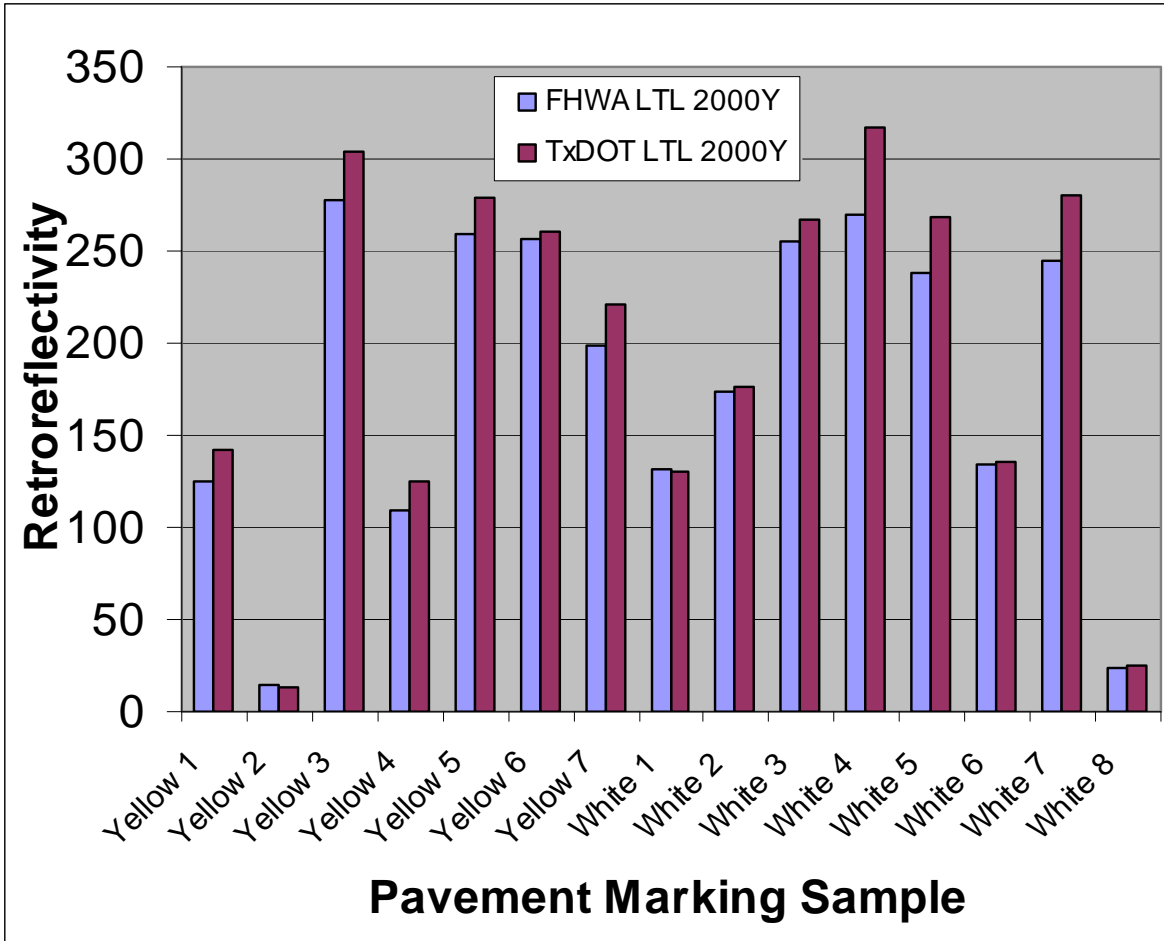
Figure 3-12. Retroreflectivity Summary of LTL 2000Y Comparison.

Two LTL 2000Y retroreflectometers were tested to compare the repeatability and reproducibility of their retroreflectivity and color measurements. Researchers measured 15 pavement marking samples, 8 white and 7 yellow, with each device. Three sets of data were collected with each retroreflectometer on each pavement marking sample. Prior to the measurement of the pavement marking samples, each unit was calibrated. A separate calibration was conducted for each set of data. The first two sets of calibration were conducted with the calibration blocks that were associated with that particular retroreflectometer. The third calibration was conducted with the calibration blocks from the other retroreflectometer. Calibrating with the other retroreflectometer's calibration blocks was conducted to see if the calibration blocks were biasing the readings in any way.

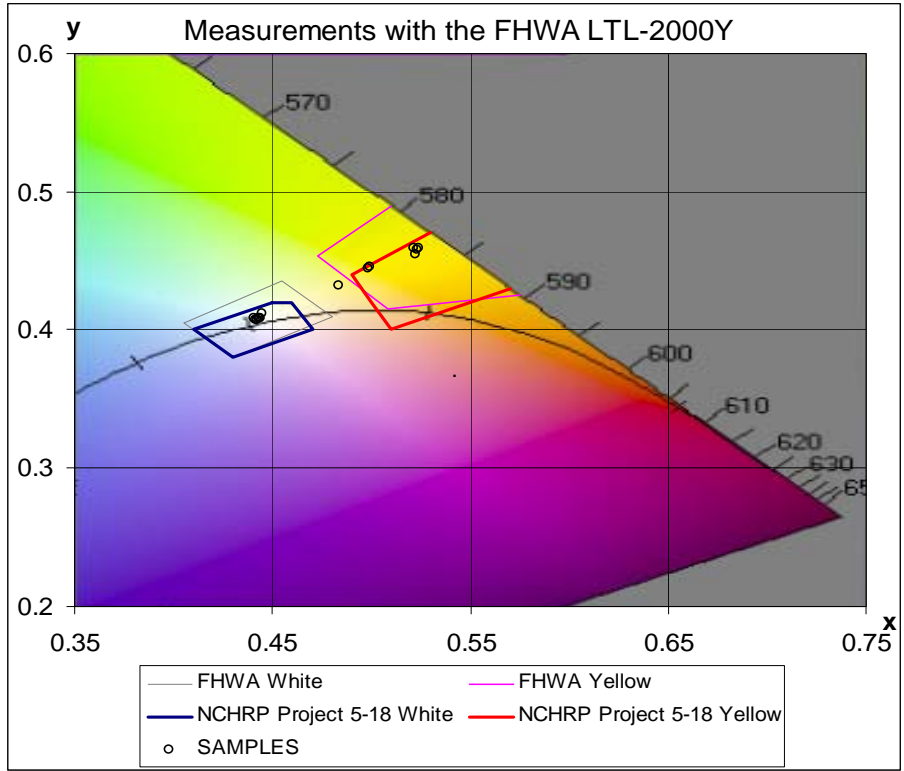
Figure 3-13. FHWA LTL 2000Y 30 Meter Nighttime Color Data Summary.

The results of the 30 meter nighttime color measurements with each device can be seen in Figure 3-13, Figure 3-14, and Table A-5. Again, a general bias between the devices can be seen in the data. The FHWA unit typically has coordinates that are farther down and to the right compared to the TxDOT device (closer to the red spectrum and more saturated). The average magnitude of the difference is about 0.002 in both the x and y directions with no bias toward color. Within the three measurements for each device on each sample, the measurements were typically within 3 percent of each other and within 2 percent of the average value.

It should be noted that the yellow marking with no beads (Yellow 2) had significantly different color coordinates between the retroreflectometers, whereas the retroreflectivity values on this marking only differed by 1 between the retroreflectometers. The actual readings that are output from the retroreflectometer that are then converted into the color coordinates also typically only differed by 1. The problem lies in that the values were very low, so a difference of 1 is a large percent, and the uncertainty created by not displaying a decimal place when taking the readings plays a significant role. The units tested only display whole number output values.
