Integrated Vehicle-Based Safety Systems Heavy Truck Extended Pilot Test Summary Report

Developed under
U.S. Department of Transportation
Cooperative Agreement DTNH22-05-H-01232

Prepared by
University of Michigan Transportation Research Institute
2901 Baxter Rd., Ann Arbor, Michigan 48109

May 2009

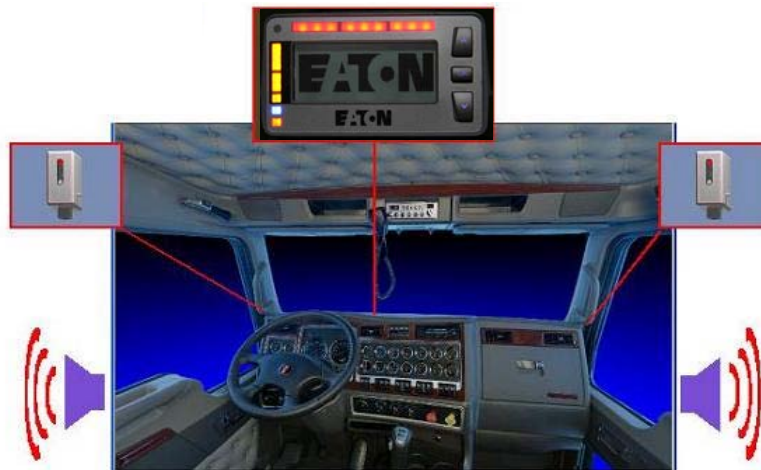
Figure 2. Heavy-truck DVI components

To communicate warnings and system status to drivers, the integrated crash warning system uses a combination of cab-mounted modules as illustrated in Figure 2. The main component of the driver-vehicle interface (DVI) resides in the center of the instrumentation cluster and allows driver input for selection of trailer length, volume and brightness control. This unit also provides visual feedback to the driver for each alert and audio warning for forward crash warning (FCW) alerts. Side-mounted LED modules provide visual feedback to the driver when the area adjacent to the vehicle is restricted by the presence of another vehicle, and speakers mounted just behind the A-pillar on each

side of the cab provide directional alert sounds for the lateral warning subsystems [lateral drift warning (LDW) and lane change/merge (LCM) warnings].

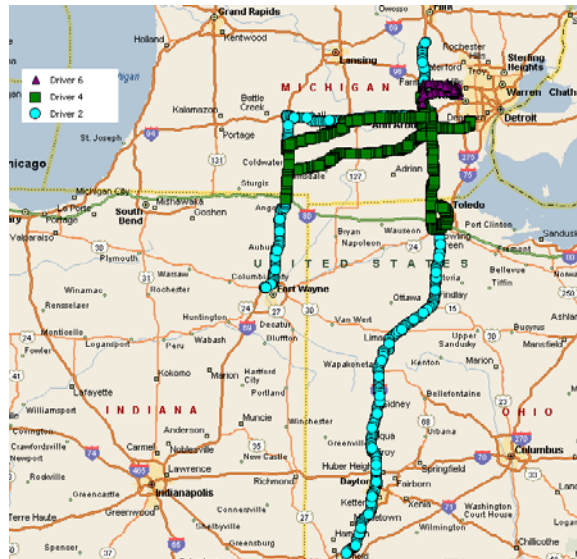
Figure 9. Line-haul routes for the IVBSS extended pilot test

Maps of the P&D and line-haul routes are shown in Figure 8 and Figure 9, respectively. A closer look at the distribution of distance traveled as a function of driver and route type is illustrated in Figure 10
