## Florida Department of Transportation Research

Investigation of Automated and Interactive Crack Measurement Systems  
BD544-36

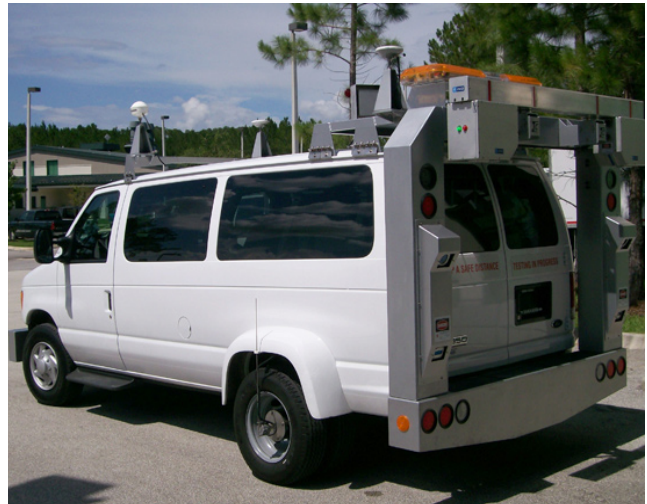
*FDOT's Multi-Purpose Survey Vehicle uses image scans to evaluate highway conditions.*

The use of imaging techniques to evaluate roadway pavements for crack damage has proven to be a safe, rapid, and cost-effective alternative to traditional highway survey techniques. The Multi-Purpose Survey Vehicle (MPSV) developed by FDOT captures digital images of the pavement surface at highway speed, and stores them in on-board computers for post-survey analysis. To evaluate the images to identify crack damage in a timely manner, FDOT needed to identify a software application that could analyze the data and quickly produce accurate and repeatable results. While several vendors were invited to participate in the study, only two vendors accepted. University of South Florida researchers evaluated the image analysis software applications those participants provided: Crackscope and Workstation.
