Customer Behavior Relative to Gap Between Platform and Train

FINAL REPORT

July 2009

Janice R. Daniel, Ph.D., Associate Professor
Department of Civil and Environmental Engineering
New Jersey Institute of Technology

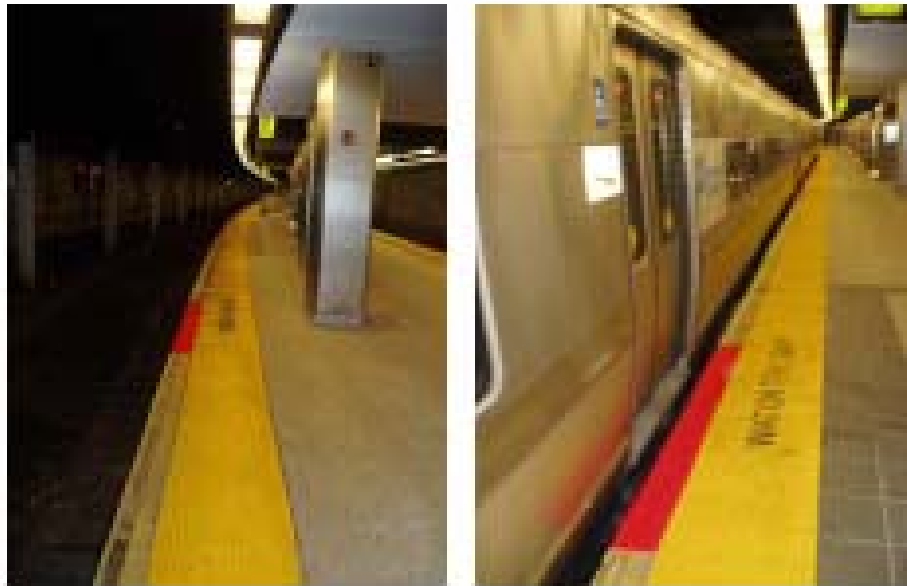
Figure 2. LIRR Flatbush Ave. Station with Red Lines Underscoring Wider Gap

A frequent suggestion regarding platform design is the use of yellow lines to call passenger attention to the edge of the platform. (RIAC notes, Jan. 10, 2006; RSSB T426, 2006, Kenny Report to the FRA, 2007). Currently the RSSB is undergoing an evaluation of the effectiveness of yellow lines on non-high speed platforms (RSSB, 2008). LIRR however has gone a step further and has added red stripes and stenciled “watch the gap” to call attention to the platform edge as shown in as shown in Figure 2. The second photo (Figure 3) also shows a yellow stripe at the edge of the train door threshold as well. Figure 4 illustrates NJ TRANSIT Rail’s stencil of Watch the Gap on the train platform. Figure 5 shows additional views of the LIRR Flatbush Avenue station gaps of 10 inches and Figure 6 shows a second view of the matching yellow stripe at train edge and the platform edge is seen in this photo of the Syosset station.

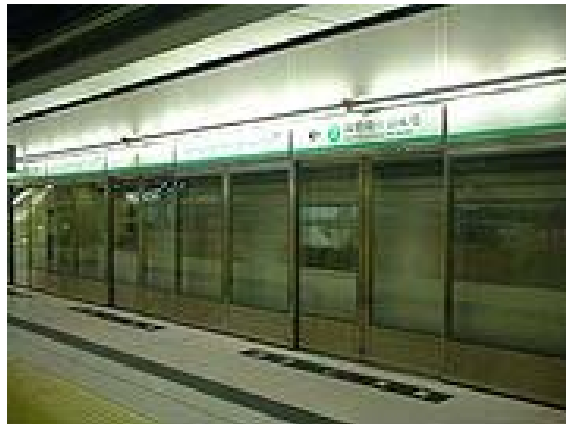
Figure 7. Platform Screen Doors at Hong Kong's Tiu Keng Leng Station

In another attempt to mitigate the problem through platform design, MTR Corporation which operates Hong Kong's rail and metro systems, installed rubber moldings to the platform edge to reduce the gap. Additionally, this system has platform screen doors as an additional safety mechanism to reduce to risk of accidents and to enhance station security (see Figure 7) (RIAC, 2007).

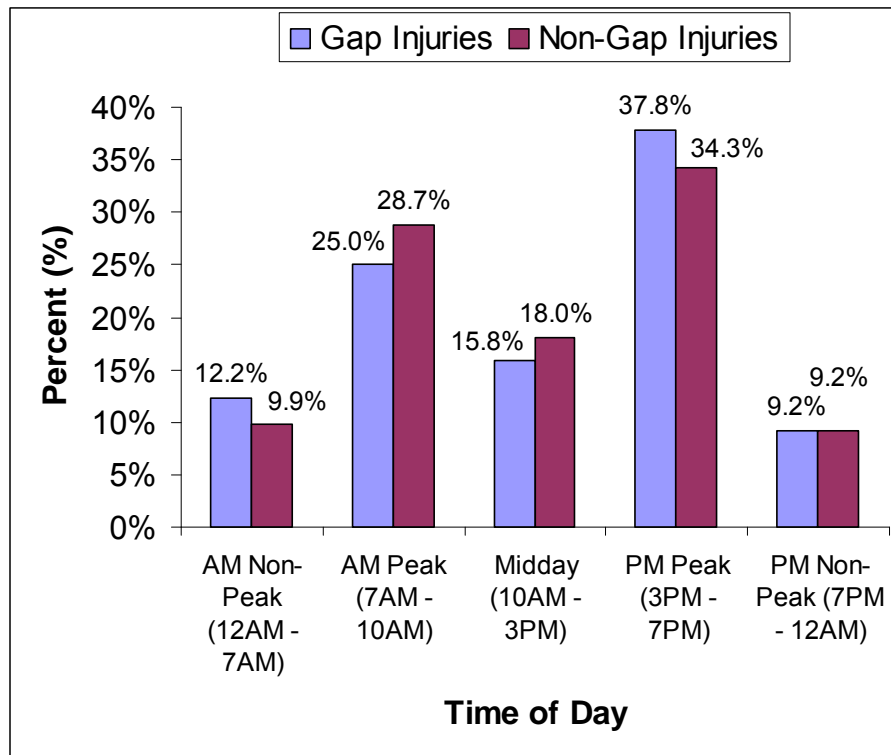
Figure 15. Gap Injuries by Time of Day

Figure 15 shows the percentage of gap and non-gap injuries by time of day. The majority of injuries on NJ TRANSIT Rail, both gap and non-gap injuries, occurred during the AM and PM peak periods with about 63 percent of injuries occurring within these periods. For both gap and non-gap injuries, the highest percentage of injuries occurred during the PM peak period with 37.8 percent of gap injuries occurring between 3 and 7 pm and 34.3 percent of non-gap injuries occurring within the same time period. Twenty-five percent of gap injuries occurred during the AM peak period (7 to 10 AM) and 28.7% of non-gap injuries occurred during the AM peak period. That injuries are higher in the AM and PM Peak periods than at other times reflects passenger volumes and is thus not unexpected. Data on boarding and detraining passenger volumes by time of day could be used to calculate injury rates per passenger by time of day. These gap injury rates would be expected to be lower during the peak period than for other periods given the typical peaking of commuter rail passenger traffic during the peak period.

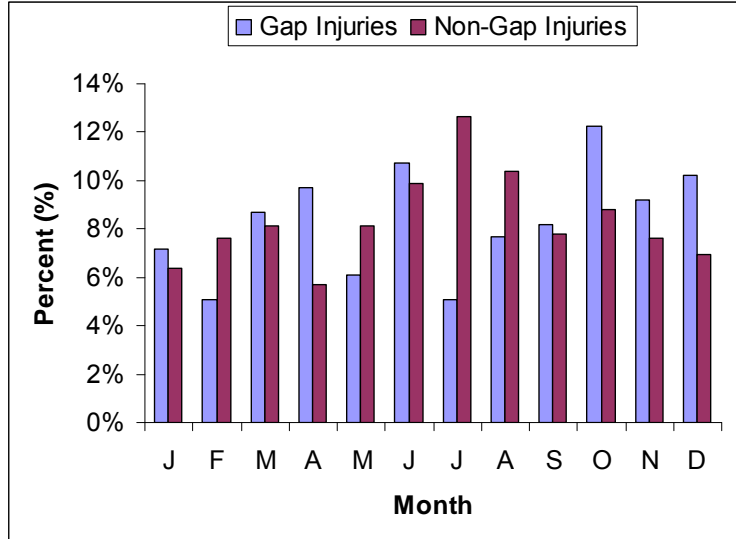
Figure 16. Gap Injuries by Month

The monthly distribution of gap injuries was determined for gap injuries occurring between 2005 and 2007 and shown in Figure 16. The figure shows differences between the gap and non-gap injuries by month. The highest percentage of gap injuries occurred in October with a percentage of 12.2% of gap injuries, followed by June with 10.7% and December with 10.2%. The highest percentage of non-gap injuries occurred in July with 12.6%.

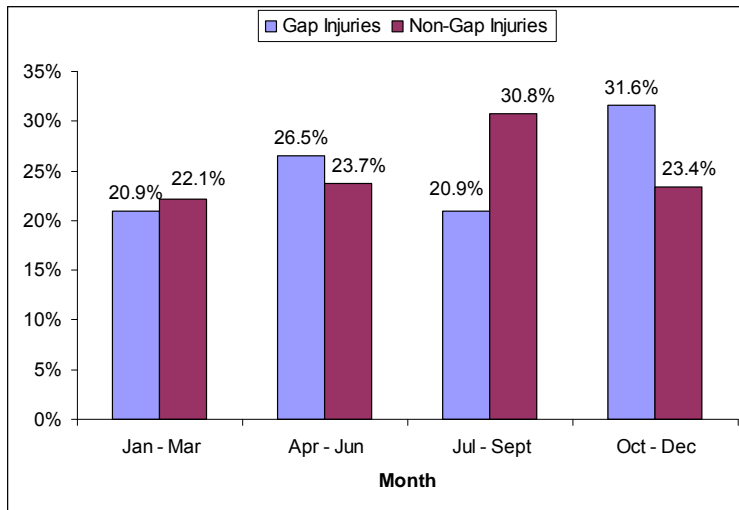
Figure 17. Gap Injuries by Quarter

Monthly gap injuries were further combined over a three-month period and the distribution of gap injuries determined and shown in Figure 17. The highest percentage of gap injuries occurred during the October to December period with 31.6% of gap injuries occurring within these months. The highest percentage of non-gap injuries occurred during July to September with 30.8% of non-gap injuries. The data showed differences in the percentage distribution of gap and non-gap injuries by month. This difference suggests gap injuries have particular characteristics that may be influenced by the month of the injury. Information about variations in passenger volumes, lighting, weather, level of distraction and other behavioral factors that change by month would be needed to better understand the specific characteristics that lead to differences in gap and non-gap injuries by month.

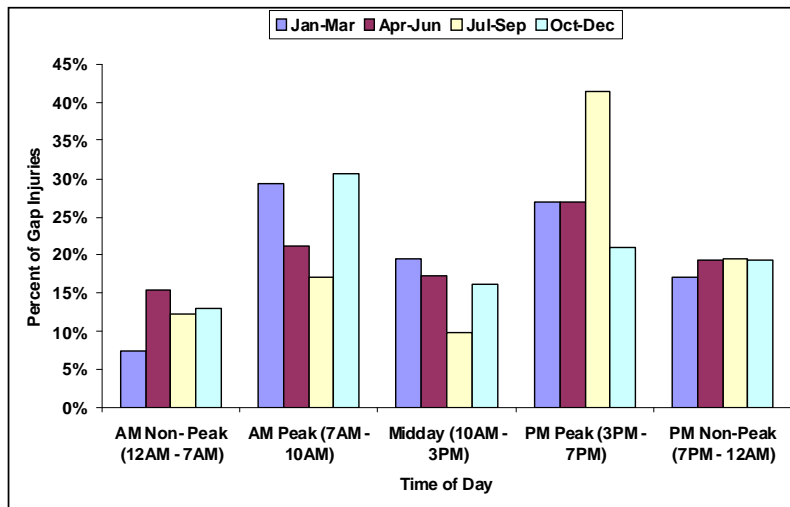
Figure 18. Gap Injuries by Time of Day and Month

Relationships between the time of injury and the month of injury were also investigated to determine whether lighting may have some impact on gap injuries. Figure 18 shows the percent of gap injuries occurring within each time period and for each quarter of the year. The figure shows that the peak occurrence of gap injuries is in the AM and PM peak regardless of the quarter of the year that the injury occurs. As previously stated, this is likely due to higher passenger volumes occurring within the peak period. The injury data is not conclusive about the impact of light conditions on the occurrence of gap injuries. Within the AM peak period, gap injuries occurred during the January to March and October to December months with the highest frequency. As daylight is shortest during these months and a portion of the AM peak would occur during dark conditions, lighting may be a factor in some of these gap injuries. During the PM peak period, however, gap injuries occurred with the highest frequency during the July to September months with these months experiencing longer daylight conditions and all of the PM peak period occurring in lighted conditions. Therefore although the data supports lighting as a possible factor contributing to gap injuries during the AM peak period, the data does not support this during the PM peak period. Information about station lighting may provide additional insight into whether light conditions have an impact on gap injuries

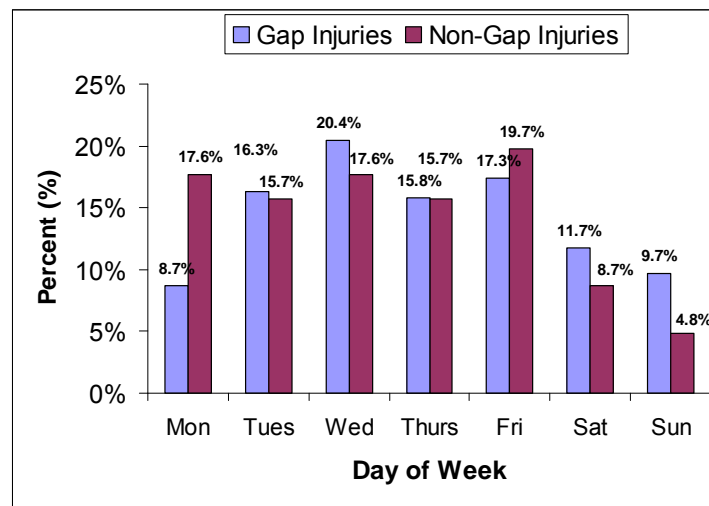
Figure 19. Gap Injury by Day of Week

Almost 80 percent of gap injuries occurred during the weekday, compared to 86.5% of non-gap injuries that occurred during the weekday. Figure 19 shows the distribution of gap injuries by day of week. The highest percent of gap injuries, or 20.4%, occurred on Wednesdays compared to 17.6% of non-gap injuries occurring on Wednesdays. The lowest percent of gap injuries occur on Mondays with 8.7% compared to 17.6% of non-gap injuries occurring on a Monday. The peaking of gap injuries on Wednesdays may be associated with increased passenger volumes on Wednesdays. However, data on passenger volumes by day of week would be needed to support this conclusion.

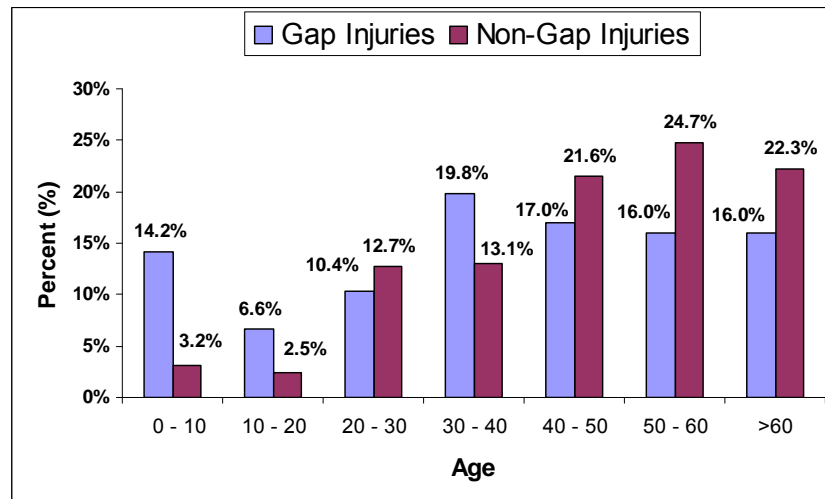
Figure 20. Gap Injuries by Age of Injured

Figure 20 shows the distribution of the ages of those injured in both gap and non-gap accidents. For gap injuries, the highest percent of injured fell within the age group of 30 and 40 years old with 19.8 percent of gap injuries falling within this age range. For non-gap injuries, the highest percent of injuries occurred for ages between 50 and 60 years old with 24.7 percent of non-gap injuries falling within this age range. The percent of non-gap injuries generally increases as age increases. For gap injuries the percent of injuries peaked for the very young, under 10 years old, then increases with age until the 30-40 year group. After this age group the percent of injuries remains flat for older age groups. The data indicates that unlike non-gap injuries, gap injuries do not increase with age. The very young, under 10 years old, and the middle age, between 30 and 40 years old, have the highest percentage of gap injuries.

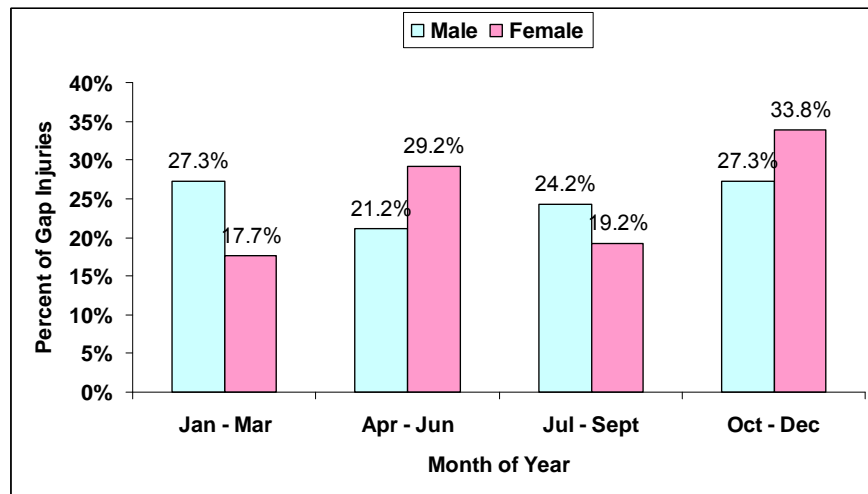
Figure 21. Gap Injuries by Quarter of Year and by Gender

Figure 21 compares the percentage of gap injuries by quarter for men and women. As the figure shows, for men there are small differences in the percentage of injuries by quarter with the highest percentage of gap injuries at 27.3 percent occurring during both January to March and October to December quarters. For women, there are larger differences between quarters with the highest percentage of gap injuries at 33.8 percent occurring during the October to December quarter compared to 27.3 percent of injuries for men during the same quarter.

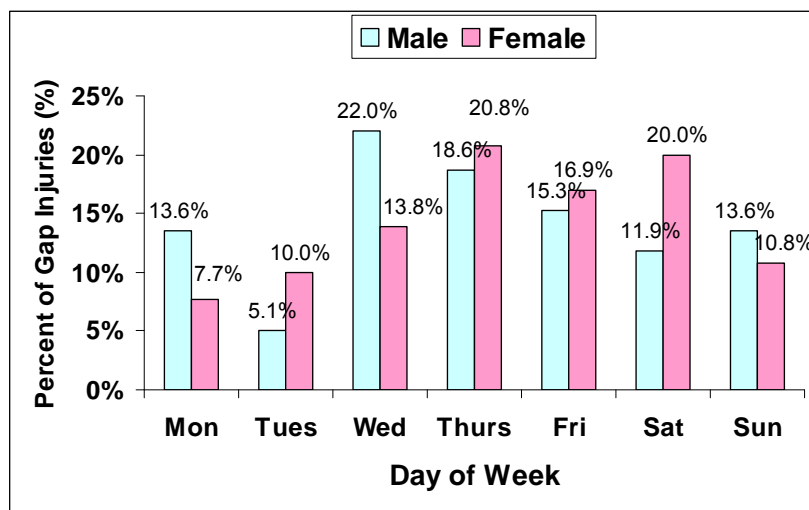
Figure 22. Gap Injuries by Day of Week and by Gender

Figure 22 shows the distribution of gap injuries by day of week and by gender. Overall there are similarities in the distribution of gap injuries with the lowest percentage of gap injuries for both men and women occurring on Mondays and Tuesdays. For men the highest percentage of gap injuries occurred on Wednesdays with 22.0% of gap injuries compared to 13.8 percent of gap injuries for women. The highest percentage of gap injuries for women occurred on Thursday with 20.8 percent of gap injuries compared to 18.6 percent of gap injuries for men.

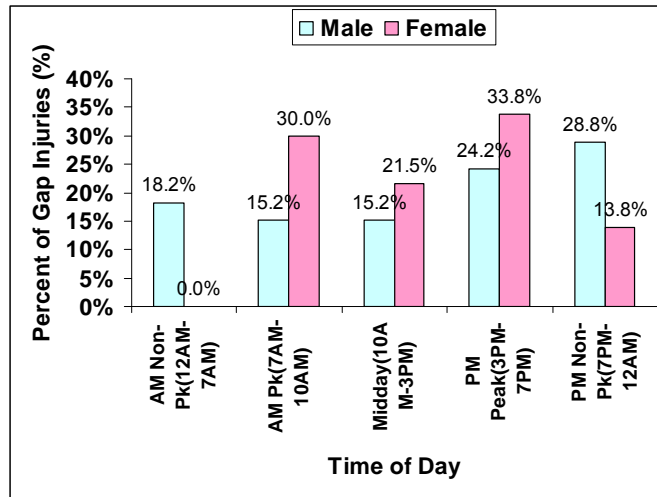
Figure 23. Gap Injuries by Time of Day and Gender

Figure 23 shows the percentage distribution of gap injuries by time of day and by gender. The figure shows great differences between gap injuries for men and women. For men, gap injuries are distributed throughout the day with the highest percentage (28.8%) of gap injuries occurring during the PM non-peak (7 PM to 12 AM). For women, 63.8 percent of gap injuries occur during the AM and PM peak period compared to 39.4 percent for men. For women, no gap injuries occurred during the AM non-peak period (12 AM to 7 AM).

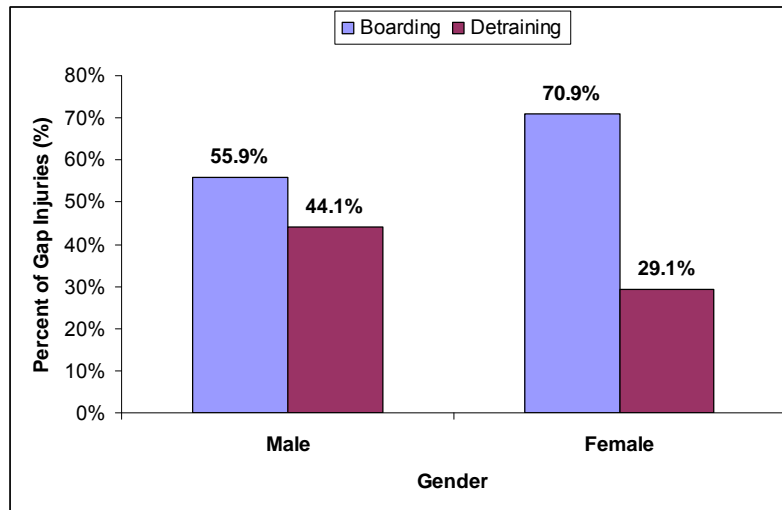
Figure 25. Boarding and Detraining Gap Injuries by Gender

Sixty-six percent of gap injuries occurred while passengers were boarding. Figure 25 shows the percent of gap injuries by boarding and detraining and by gender. As the figure shows, there is a higher percentage of female passengers involved in gap injuries while boarding compared to male passengers. Seventy percent of gap injuries for female passengers occurred while boarding compared to 56 percent for male passengers.

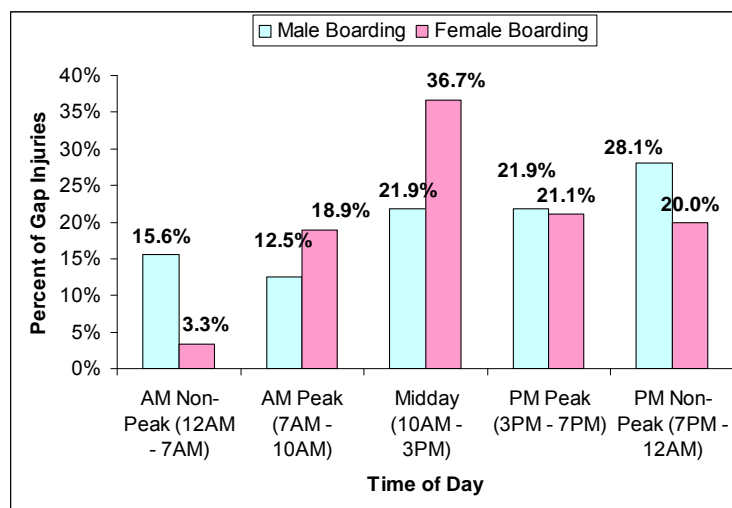
Figure 26. Percent of Boarding Gap Injuries by Time of Day and Gender

To better understand why females are twice as likely to have a gap injury while boarding, gap injuries by time of day were compared for boarding and detraining passengers and by gender. Figures 26 and 27 show the percent of boarding and detraining injuries, respectively, by time of day and gender. Figure 26 shows that the highest percent (37 percent) of boarding injuries for women occurred during the midday, 10 am to 3 pm, compared to 22 percent of injuries for male gap injuries in the same time period. The highest percent (28 percent) of boarding injuries for men occurred during the PM Non-peak, 7 pm to 12 am. The higher percentage of boarding gap injuries for women during the midday suggest that these injuries are associated with women who are non-commuters and may also be infrequent users of NJ TRANSIT Rail and therefore susceptible to gap injuries.

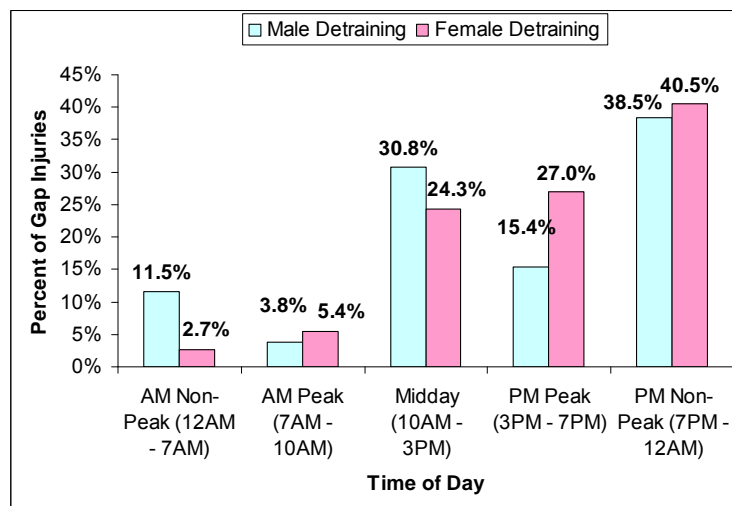
Figure 27. Percent of Detraining Gap Injuries by Time of Day and Gender

Figure 27 shows that the highest percent of detraining injuries occurred during the PM Non-peak, 7 PM to 12 AM, for both male and female passengers.

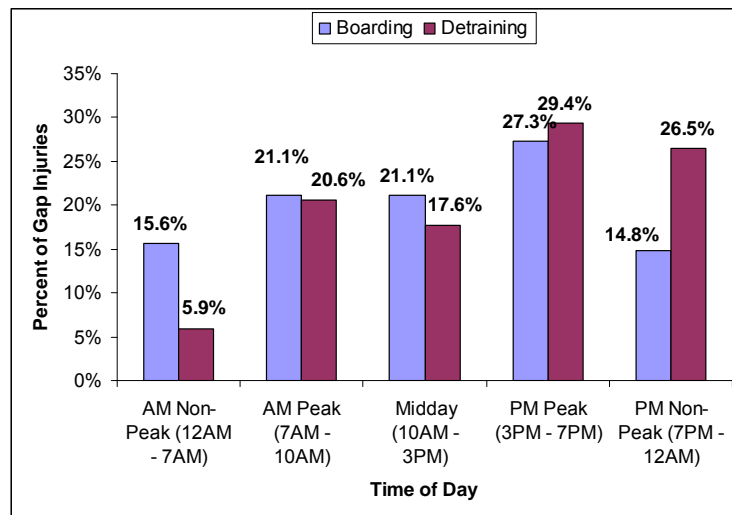
Figure 28. Boarding and Detraining Gap Injuries by Time of Day

Little difference exists in the percent of gap injuries by boarding or detraining during the AM, Midday and PM peak periods, as shown in Figure 28. Differences exist during both the AM and PM non-peak periods. During the AM non-peak there is a much higher percentage of gap injuries for boarding passengers (16 percent) than for detraining passengers (9 percent). During the PM non-peak, there is much higher percentage of gap injuries for detraining passengers (27 percent) than for boarding passengers (15 percent). It would be incorrect to conclude that the higher percent of gap injuries for boarding passengers in the AM and detraining passengers in the PM was due to a higher number of boarding passengers in the AM and detraining passengers in the PM. Each passenger must board and detrain at least once, so the numbers of boardings and detrainings would be roughly equal within the AM period, and the same for other periods. However, the number of boardings and detrainings would be predominantly at different types of stations, i.e., board at suburban stations in the AM while detraining at Newark or Penn Station in the AM, and the reverse in the PM peak.

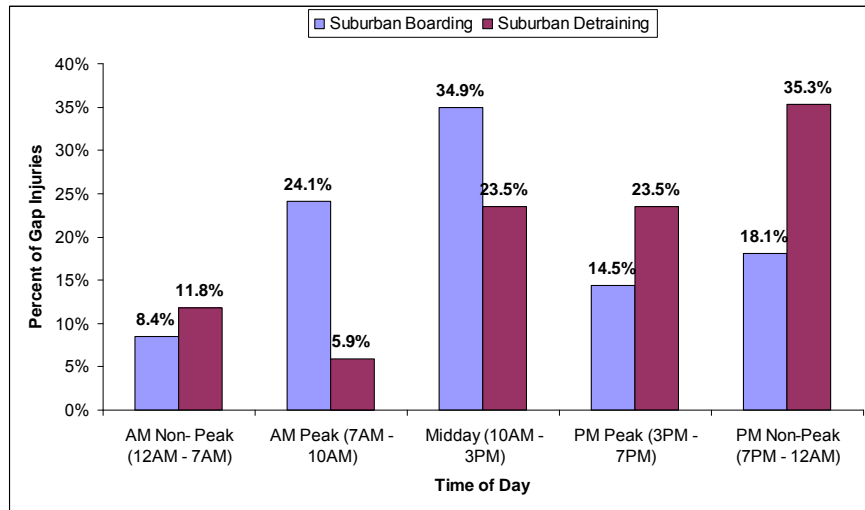
Figure 29. Gap Injuries by Time of Day at Suburban Stations

Figure 29 shows the gap injuries by boarding and detraining at NJ TRANSIT Rail’s suburban stations. The suburban stations include all stations except for New York Penn Station and Newark Penn Station. Gap injuries from Long Branch and Secaucus were also excluded in looking at the suburban stations due to the increased number of transfer passengers at these stations. The figure shows a slightly higher percentage (24 percent) of gap injuries in the AM peak period at suburban stations compared to all NJ TRANSIT Rail stations (21 percent). The largest difference between boarding and detraining at suburban stations compared to all NJ TRANSIT Rail stations is the higher percent of boarding gap injuries occurring during the Midday at suburban stations (35 percent) compared to all NJ TRANSIT Rail stations (21 percent). This higher percentage indicates that gap injuries at these suburban stations may be associated with non-commuters or unfamiliar passengers.

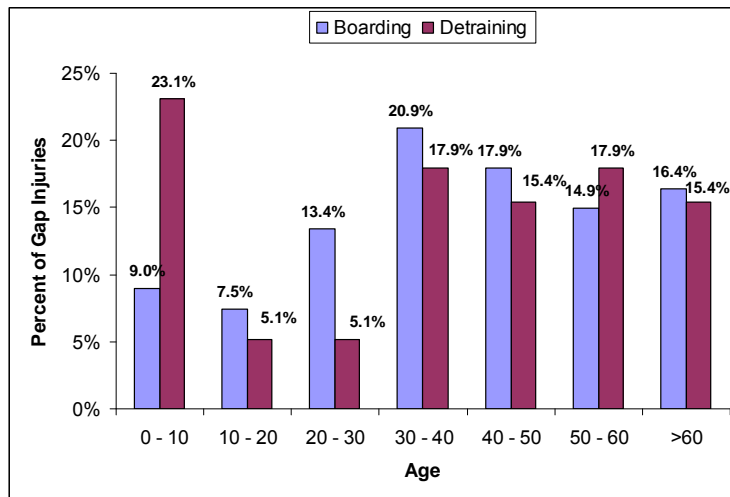
Figure 30. Boarding and Detraining Gap Injuries by Age

Figure 30 shows the percent of gap injuries boarding and detraining by age. There are very small differences between the percent of gap injuries boarding and detraining by age for ages greater than 30. The largest differences between boarding and detraining passengers occur for those under 10 years old. Twenty-three percent of gap injuries for detraining passengers fell within this age group compared to 9 percent of gap injuries for boarding passengers. Another age group with significant differences between boarding and detraining gap injuries is in the 20 to 30 year olds where 13 percent of gap injuries for boarding passengers fell within this age group compared to 5 percent of gap injuries for detraining passengers. The study indicates that young children are particularly vulnerable to gap injuries while detraining.

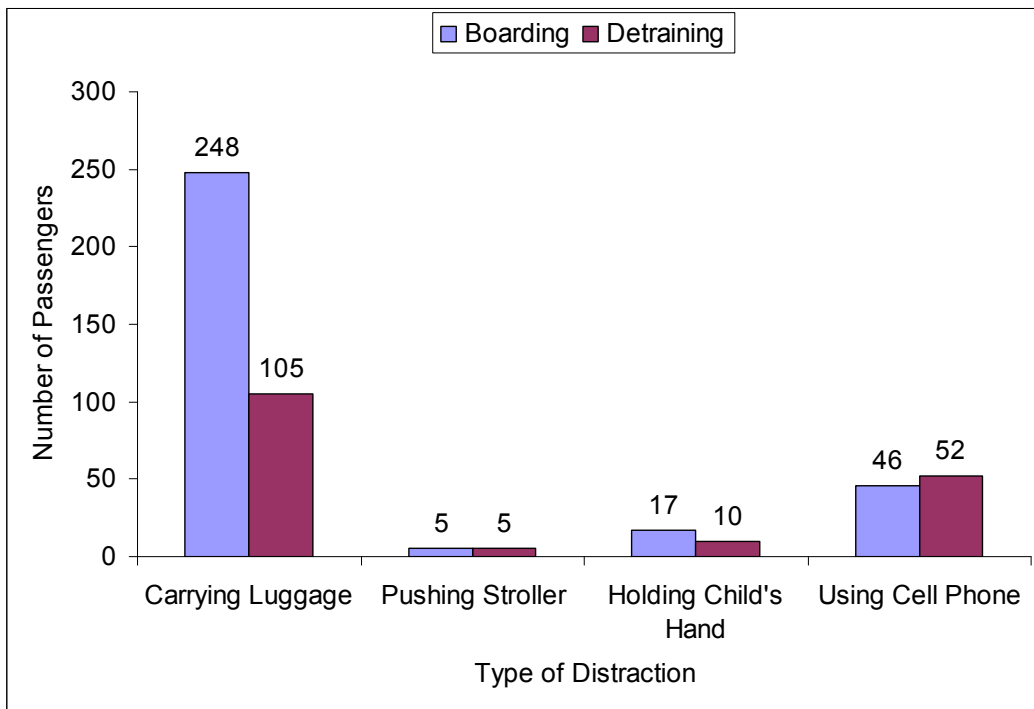
Figure 32. Boarding and Detraining Distractions

Figure 32 shows the frequency of these distractions by boarding and detraining passengers. As the figure shows, of the 1212 passengers observed, the largest type of distraction were passengers carrying luggage. For the stations studied, passengers with luggage were more likely to be boarding than detraining. Prior to performing the study, cell phone usage was believed to be one of the largest distractions to boarding and detraining passengers. The observational studies showed that cell phone usage was not as large as expected. This may be due to the high noise levels on the platform that may make cell phone use impractical.

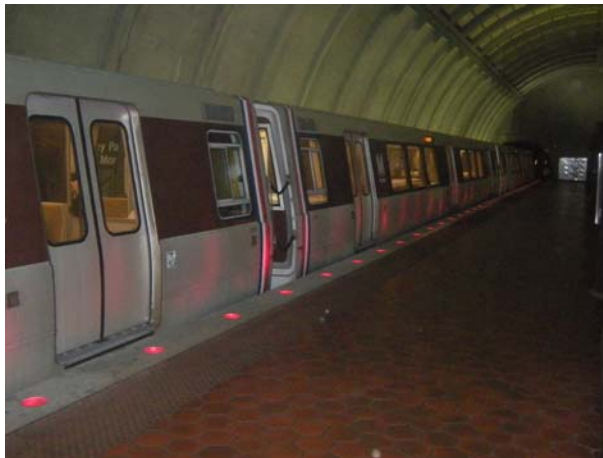
Figure 35. Washington D.C. Platform Edge Lights

The Washington D.C. Metro uses flashing lights on the platform of train stations to alert hearing-impaired riders that a train is entering the station. The flashing lights are also used by all riders to identify when the next train is arriving. The transit authority recently improved the platform edge lights on station's platforms as part of a six-month pilot program. The authority installed amber LED platform edge lights on the "Yellow" and "Green" line and red LED platform edge lights on the "Red" line platform (see Figure 35). The hope is that customers would take note of the red edge lights and step away from the edge of the platform when an oncoming train is expected.

Each lamp contains 34 LED bulbs and consumes approximately ten watts of power and is estimated to last ten to twelve years. The bulb burns steady at 50 percent power, and flashes at 100 percent power when a train approaches or is at the station. The red and amber LED lamps costs \$76 and the traditional white LED lamps cost \$108. It takes more than 269,000 bulbs, lamps and tubes and costs up to \$11 million a year to light the Metro system, including stations, parking garages, bus garages and rail yards. Metro is currently focusing its stepped up lighting efforts on rail stations, which have more than 73,836 lights.
