ANALYSIS OF LOAD-INDUCED STRAINS IN A HOT MIX ASPHALT PERPETUAL PAVEMENT

WisDOT Report FEP 01-09

Wisconsin Research Study # FEP-02-02
“EVALUATION OF AN ASPHALTIC CONCRETE PERPETUAL
PAVEMENT”
(Kenosha Safety & Weigh Station Facility)

James A. Crovetti
Marquette University
Transportation Research Center
Department of Civil and Environmental Engineering

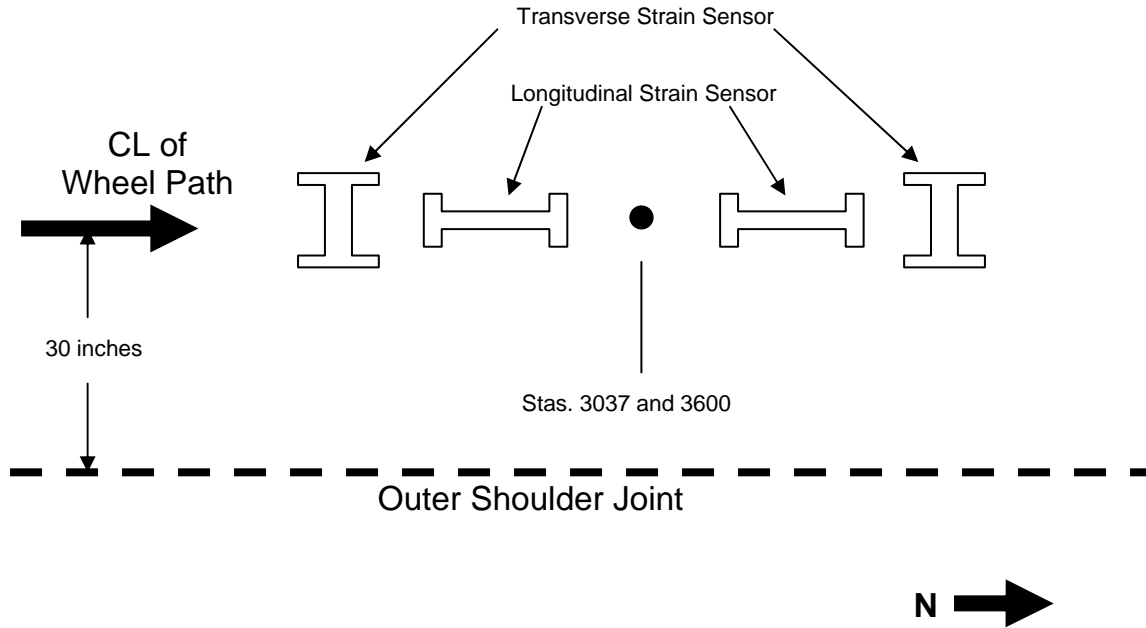
Figure 1: Schematic Illustration of Strain Sensor Configurations

Marquette University was contracted to design, build and install asphalt strain sensors to record load-induced strains within the HMA perpetual pavement system. A total of 16 H-Type strain sensors were fabricated and installed in the outer wheel path at stations 3037 and 3600. Eight sensors were installed at the bottom of the lower HMA layer and the remaining eight sensors were installed at the interface of the lower and middle HMA layers. Figure 1 provides a schematic illustration of the sensor arrangement used at each placement/depth location. As shown, there is a redundant set of longitudinal and transverse oriented strain sensors at each instrumented location.

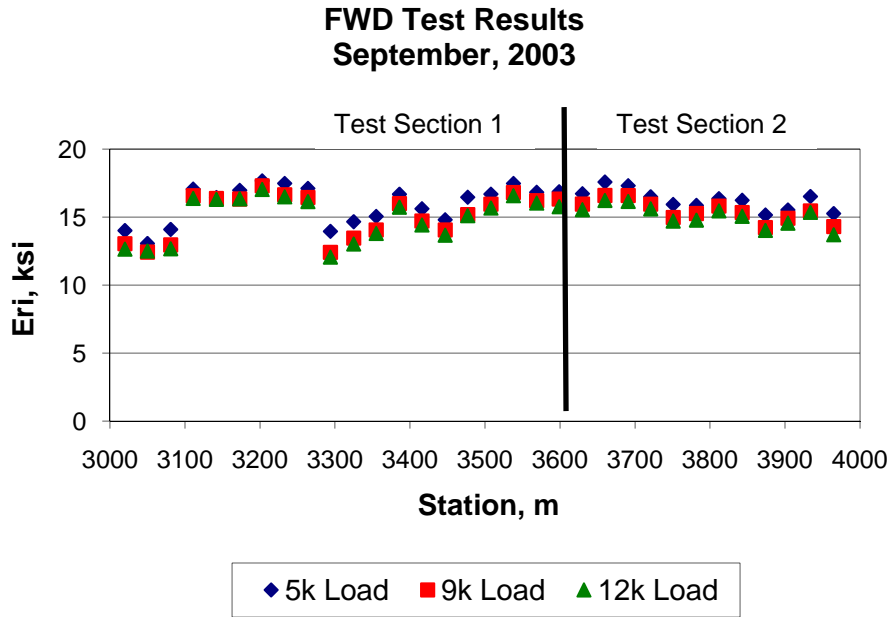
Figure 2: Backcalculated Subgrade Eri Profile, Sept. 2003

As shown in Figure 2, the backcalculated subgrade Eri values are relatively consistent within Test Section 2 and more variable in Test Section 1. Furthermore, the deflection results indicate a slight stress sensitivity in the lean clay soils, whereby there is a minor reduction in the backcalculated Eri values with increasing FWD load levels. This trend of stress-softening is typical for fine grained, cohesive soil materials. Summary statistics for the backcalculated subgrade Eri values are provided in Table 1.

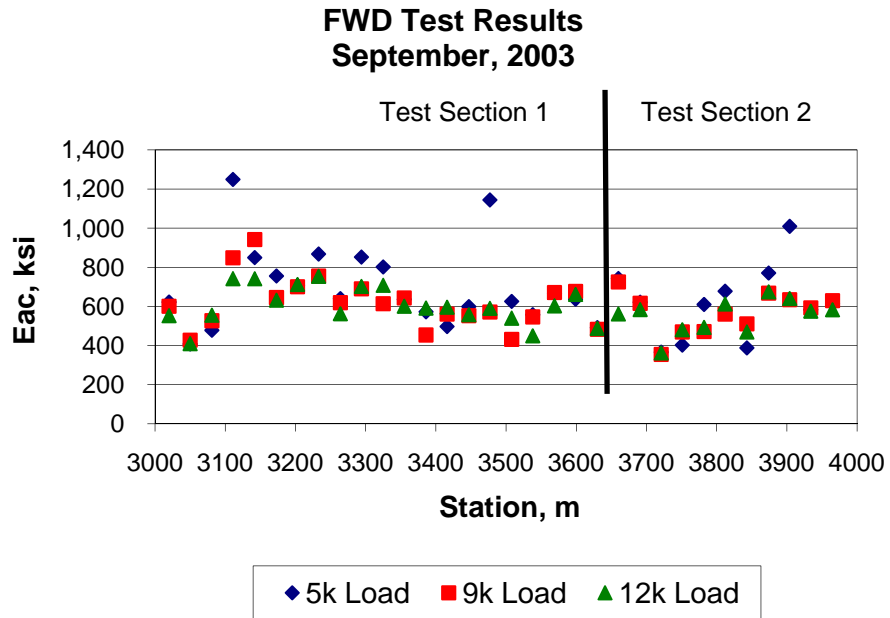
Figure 3: Backcalculated HMA Modulus Profile, Sept. 2003

The backcalculated E_{AC} values illustrated in Figure 3 and provided in Table 2 indicate relative consistency within each test section; however, there is more variability compared to the backcalculated Eri values (i.e., higher COV values). Also, the overall average E_{AC} values are increased within Test Section 1 as would be expected due to the reduced air voids in the lower HMA layer.

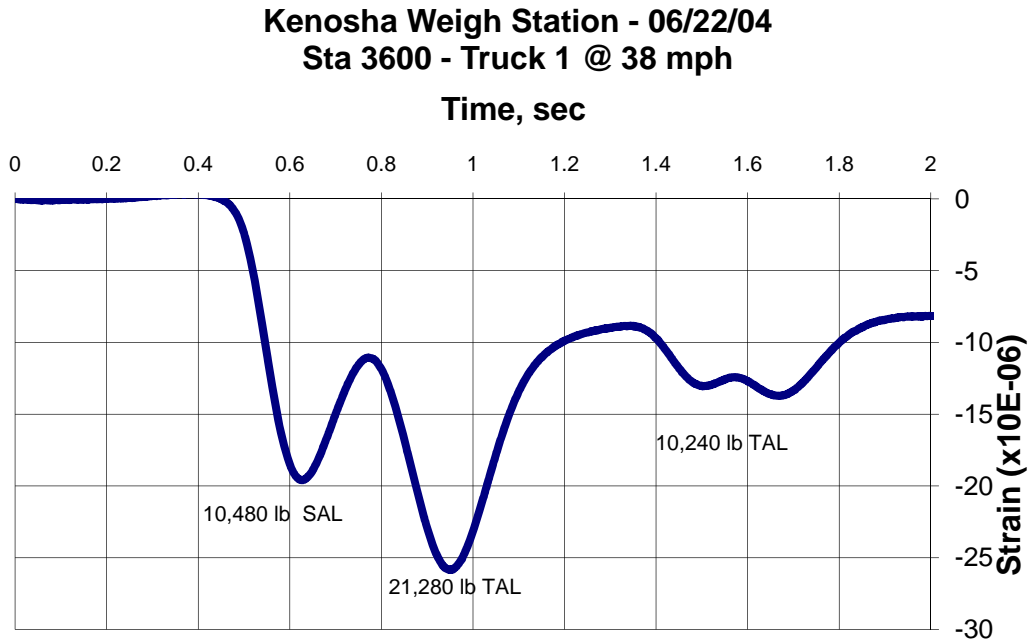
Figure 4: Strain Measurement from Truck 1 – June 2004

Strain measurements were made in conjunction with moving truck loadings to establish trends of strain data as a function of speed, load magnitude and position. On June 24, 2004 a series of strain measurements were obtained in Test Section 2 (Station 3600) under the action of FHWA Class 9 trucks (WisDOT Designation 3S-2). Strain measurements were captured at the bottom of the HMA layer for four separate trucks traveling between 37 – 42 mph. Axle loadings were obtained from the weigh station records and ranged from 10,480 – 12,740 lb on the steering axle and from 10,240 – 34,680 lb on the dual-tandem axle. Figures 4 – 7 illustrate the maximum strain readings obtained under each axle of the four truck loadings. As shown, the peak strain values (tension is negative) produced by the single axle loads (SAL) and tandem axle loads (TAL) are well correlated to the magnitude of the axle loadings and all strain reading are below 50 microstrain.

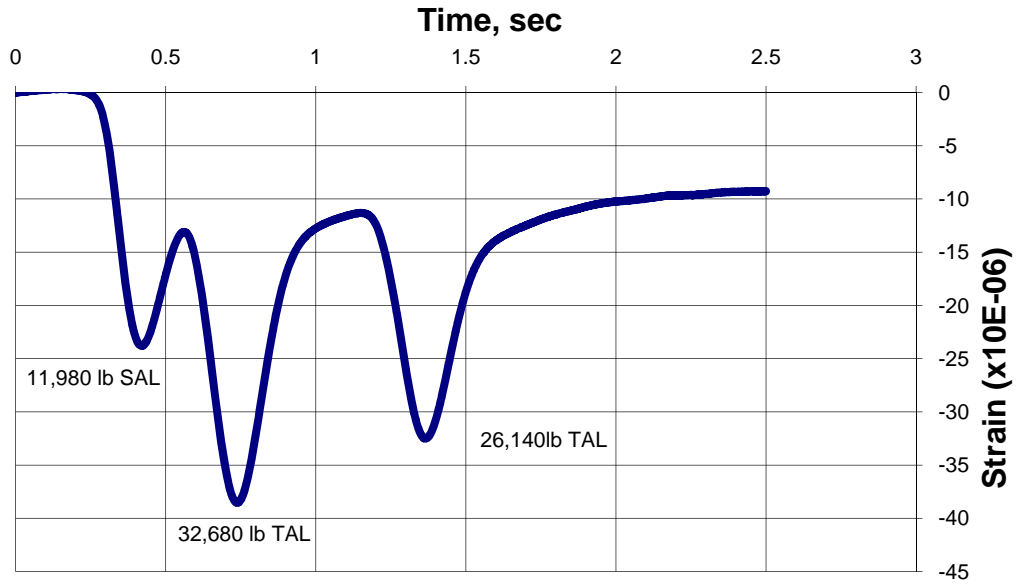
**Kenosha Weigh Station - 06/22/04
Station 3600 - Truck 2 @ 41 mph**

Figure 5: Strain Measurement from Truck 2 – June 2004

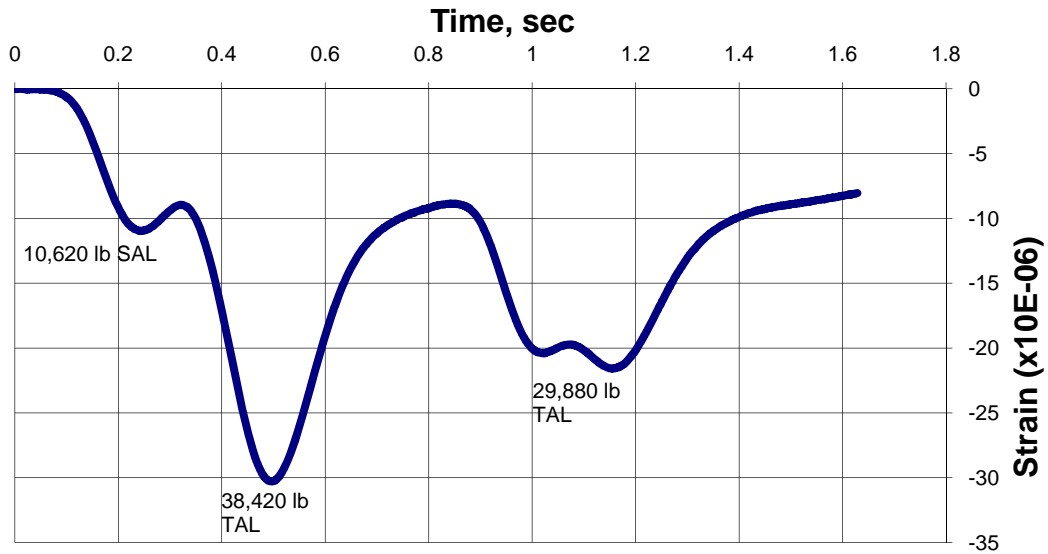
**Kenosha Weigh Station - 06/22/04
Station 3600 - Truck 3 @ 42 mph**

Figure 6: Strain Measurement from Truck 3 – June 2004

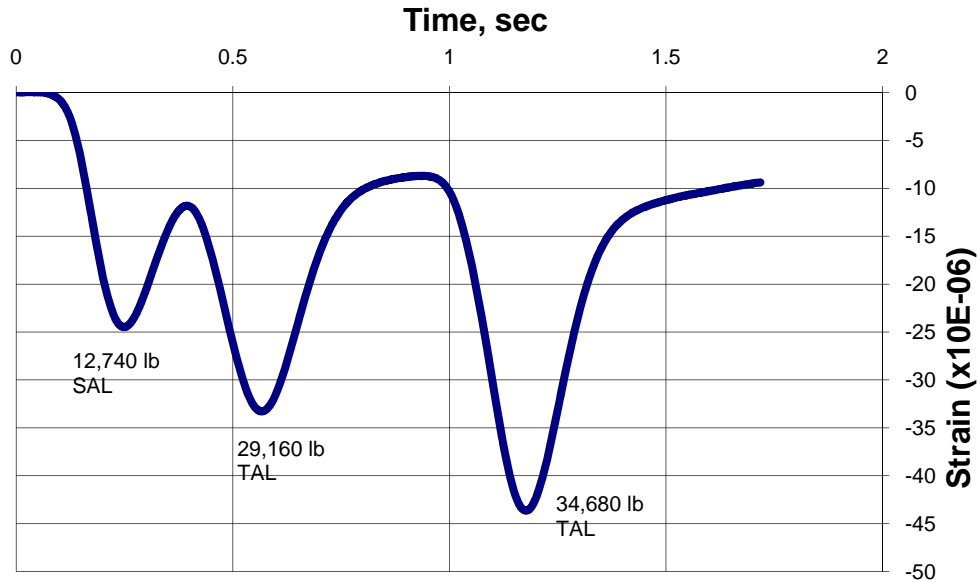
**Kenosha Weigh Station - 06/22/04
Station 3600 - Truck 4 @ 37 mph**

Figure 7: Strain Measurement from Truck 4 – June 2004

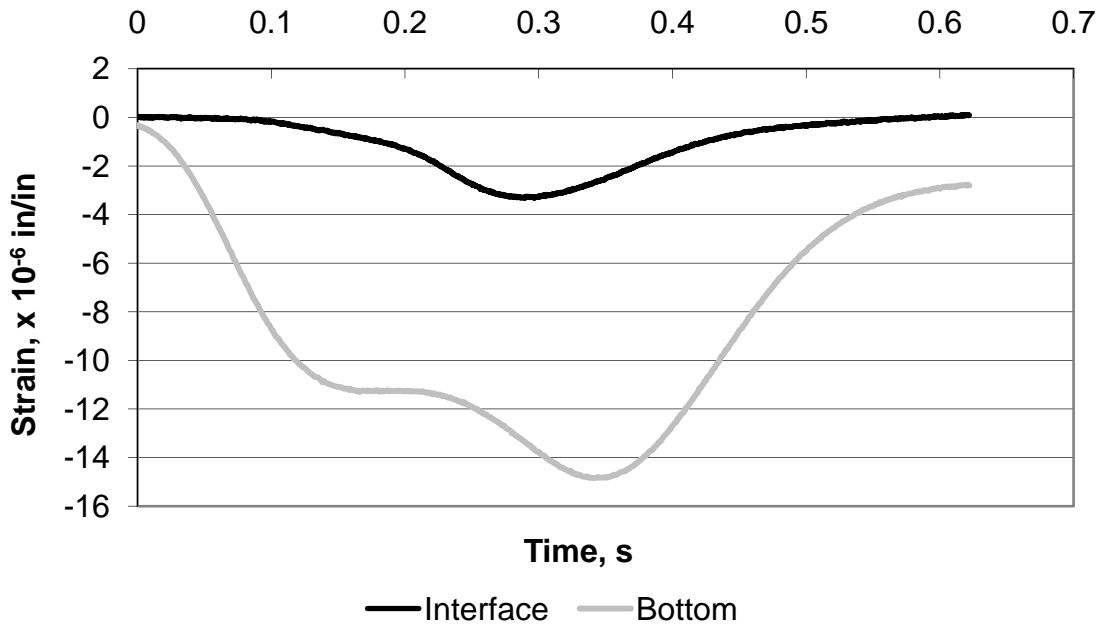
**Kenosha Weigh Station - April 2005
Dump Truck Run 1- Pushers Down @ 55 Mph**

Figure 8: Strain Measurement from Truck Run 1 – April 2005

A second series of truck measurements were made on April 18, 2005 using a loaded quad-axle dump truck with a total gross vehicle weight of approximately 72,700 lb. Strain measurements were obtained from the bottom and interface sensors at Station 3600. Pavement surface temperatures ranged from 80.2 to 90.8 °F during testing. Two truck runs were recorded with the pusher wheels up, which results in a steering axle loading of approximately 25,400 lb and a rear dual-tandem axle loading of approximately 47,300 lb. An additional truck run was recorded with the pusher axles down, resulting in a steering axle loading of approximately 19,000 lb, a rear dual-tandem axle loading of approximately 38,600 lb and a pusher axle loading of approximately 15,000 lb. Figures 8 - 10 illustrate the results of these truck tests. As shown, the bottom strain readings are significantly higher than the interface values, as expected. Furthermore, all strain readings are below 25 microstrain.

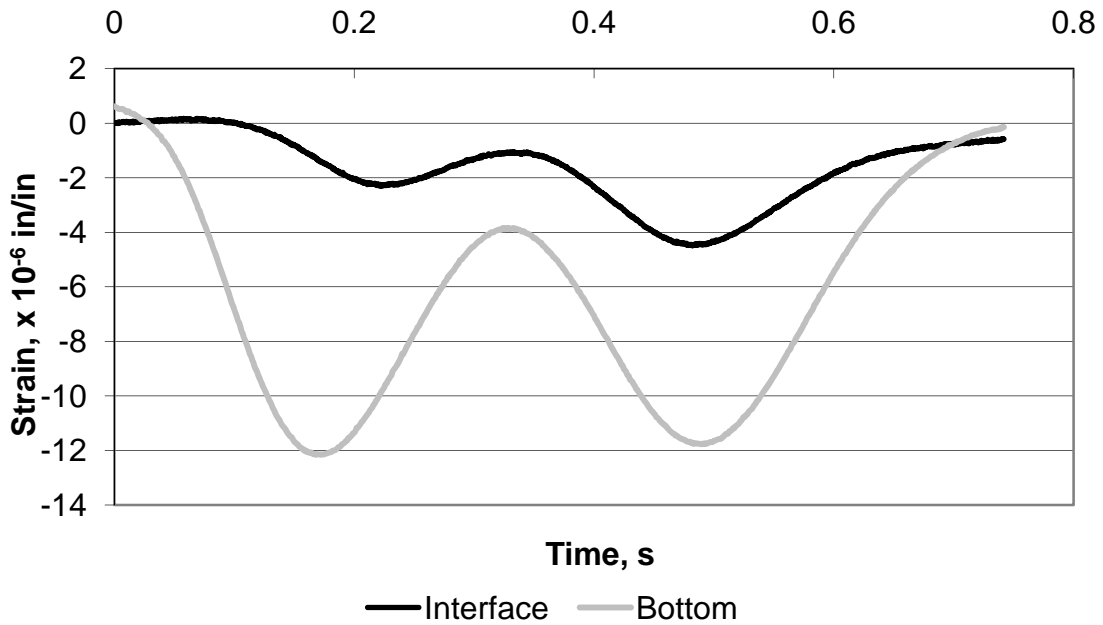
**Kenosha Weigh Station - April 2005
Dump Truck Run 2 - Pushers Up @ 40 Mph**

Figure 9: Strain Measurement from Truck Run 2 – April 2005

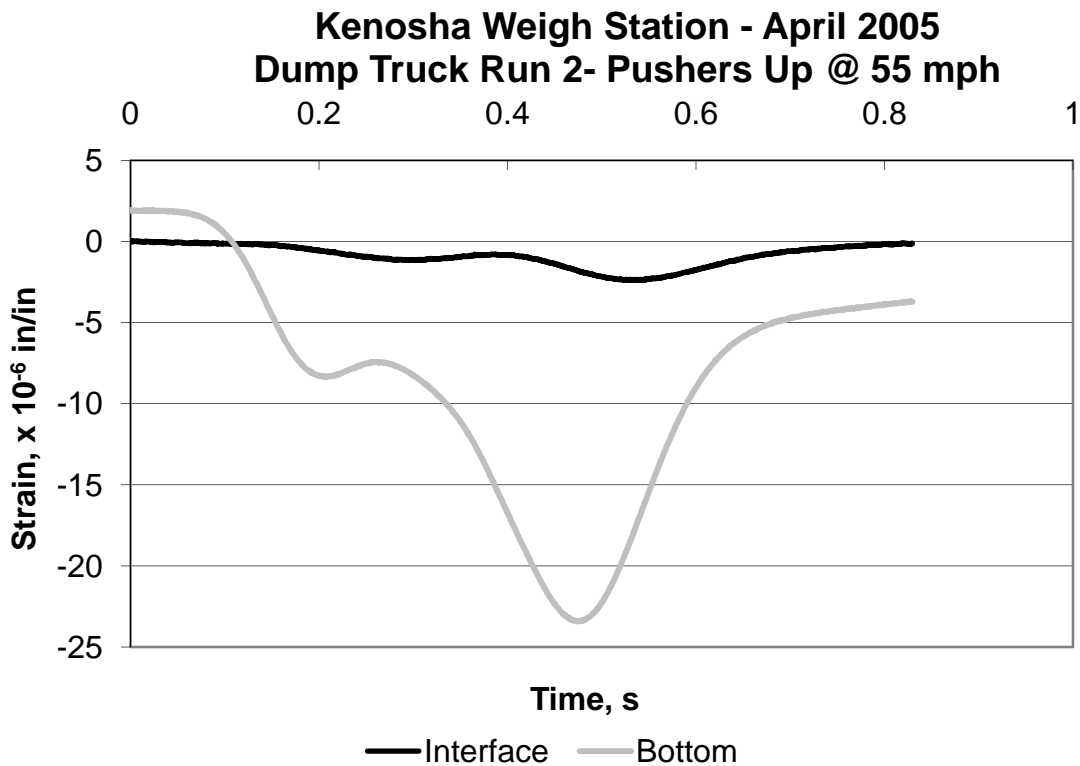
Figure 10: Strain Measurement from Truck Run 3 – April 2005

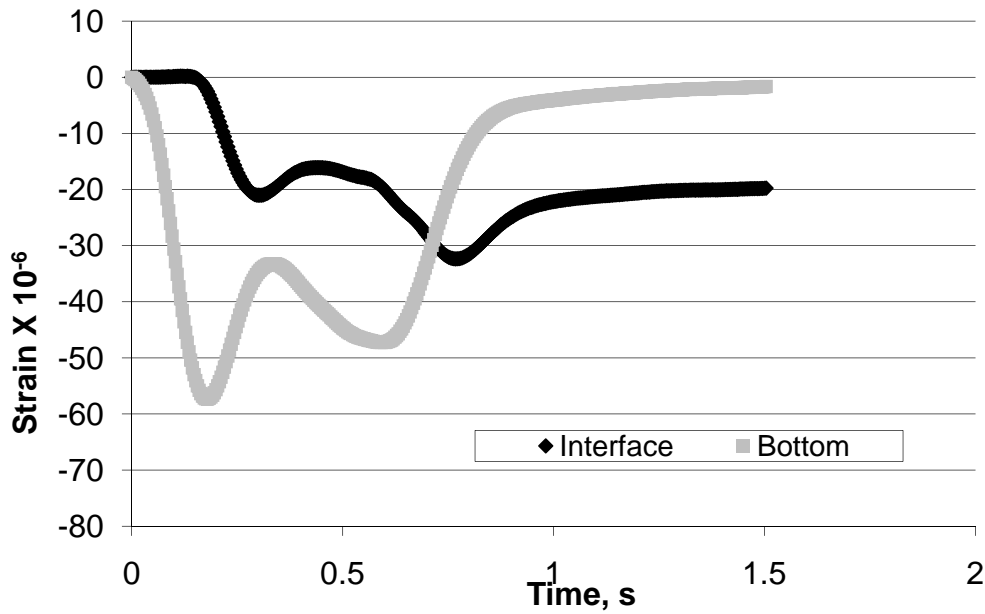
**Test Truck - Wheels Down - Run 1
7/26/2005 - 28 mph - 11" Right**

Figure 11: Strain Measurement from Truck Run 1 – July 2005

A final series of truck measurements were conducted on July 26, 2005. Strain measurements were obtained from the bottom and interface sensors at Station 3600. These measurements were again made under the action of the loaded quad-axle dump truck with a total gross vehicle weight of approximately 72,700 lb. Pavement surface temperatures ranged from 90 to 103 °F during testing. Four truck runs were recorded with the pusher wheels down (19,000 lb SAL, 38,600 lb TAL, 15,000 lb PAL). Four additional truck runs were recorded with the pusher axles up (25,400 lb SAL and 47,300 lb TAL). During each run, the position of the right front steering wheel was recorded in reference to the centerline of the right wheel path. Figures 11 - 18 illustrate the results of these truck tests. As shown, the strains recorded during this testing are substantially higher than during the previous test series in April 2005, likely due to the higher pavement temperatures and slower truck speeds. In particular, the effects of speed on strain development can be seen by comparing Figures 12 and 13, which clearly demonstrate the increase in strains resulting from reduced truck speeds (equal offset values). When the pusher axles were lowered (legal loadings) all strain readings were below 70 microstrain. With the pusher axles raised, slower truck speeds produced bottom layer strains in excess of 100 microstrain under the heavily loaded single axle (steering axle).

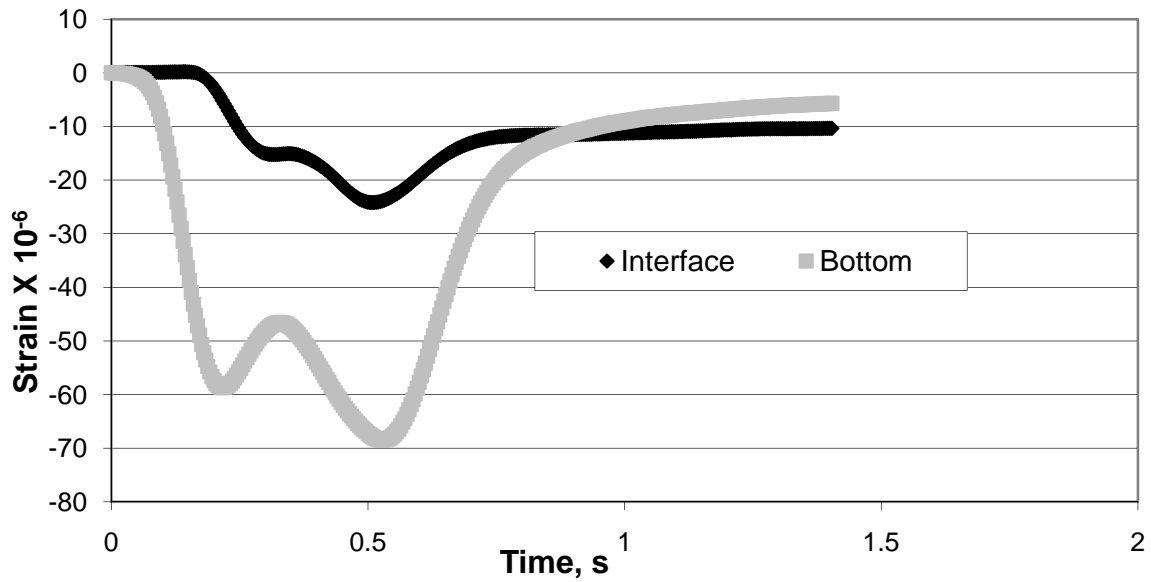
**Test Truck - Wheels Down - Run 2
7/26/2005 - 26 mph - 6" Right**

Figure 12: Strain Measurement from Truck Run 2 – July 2005

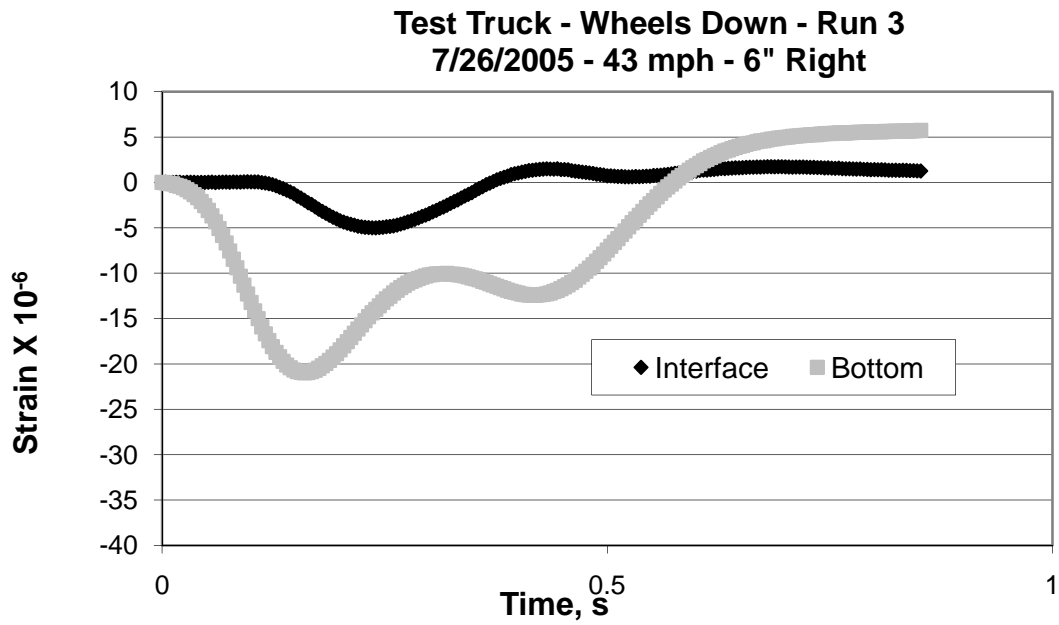
Figure 13: Strain Measurement from Truck Run 3 – July 2005

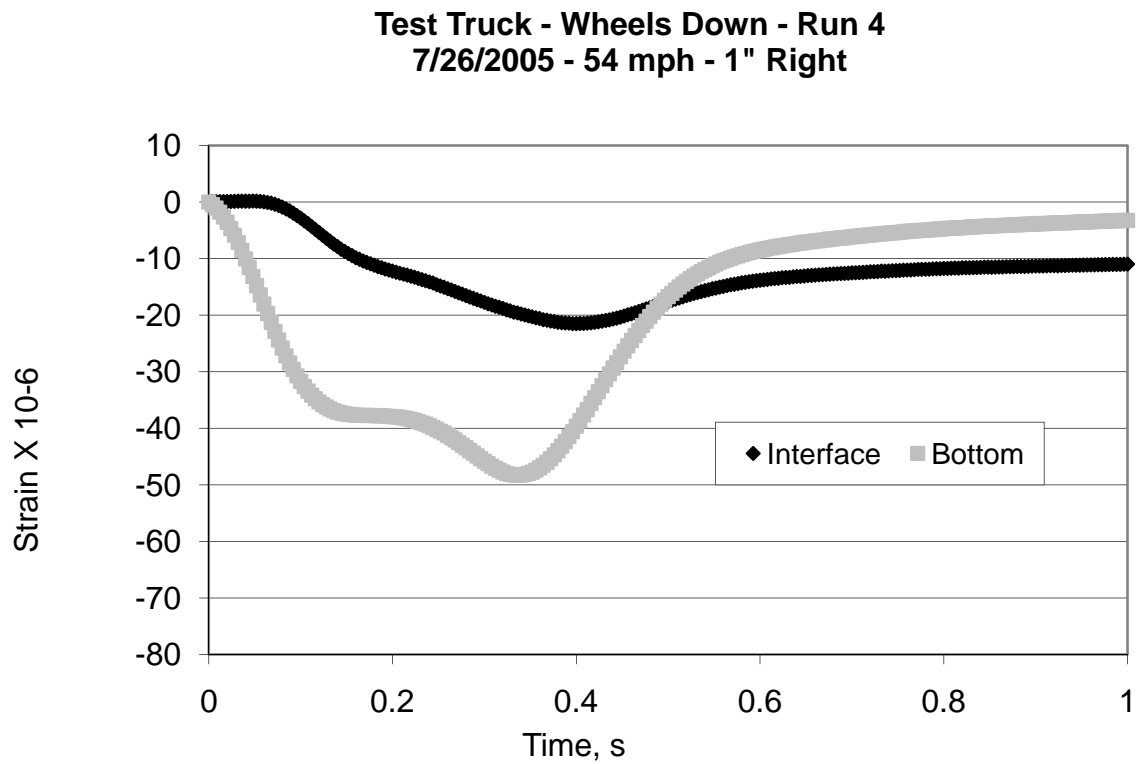
Figure 14: Strain Measurement from Truck Run 4 – July 2005

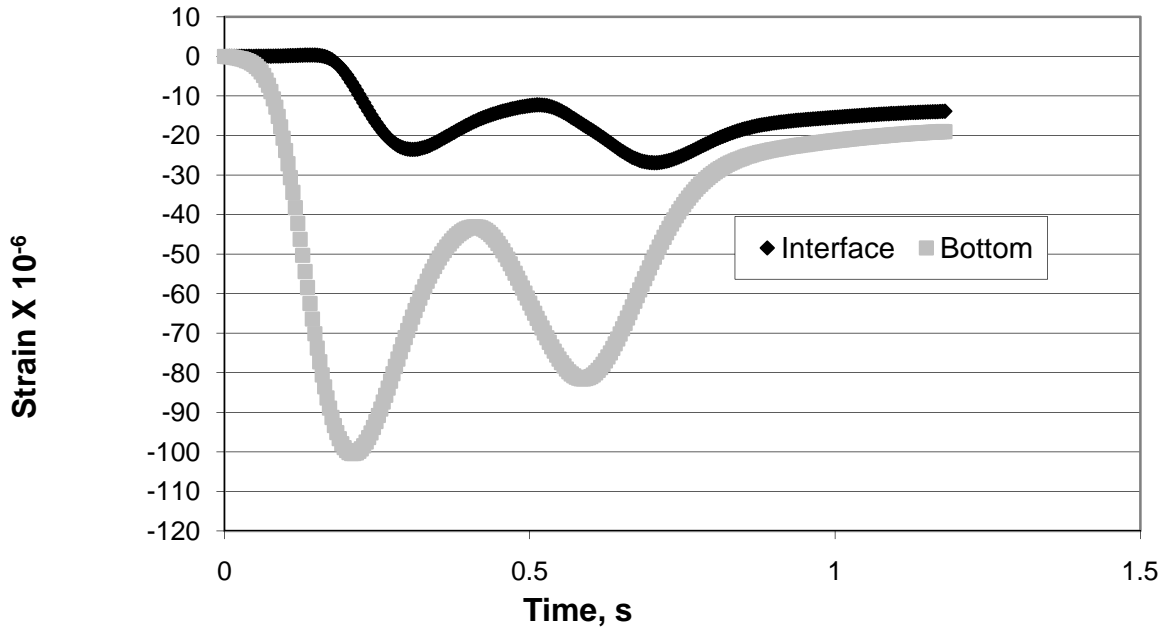
Test Truck - Wheels Up - Run 1
7/26/2005 - 32 mph - 2" Left

Figure 15: Strain Measurement from Truck Run 5 – July 2005

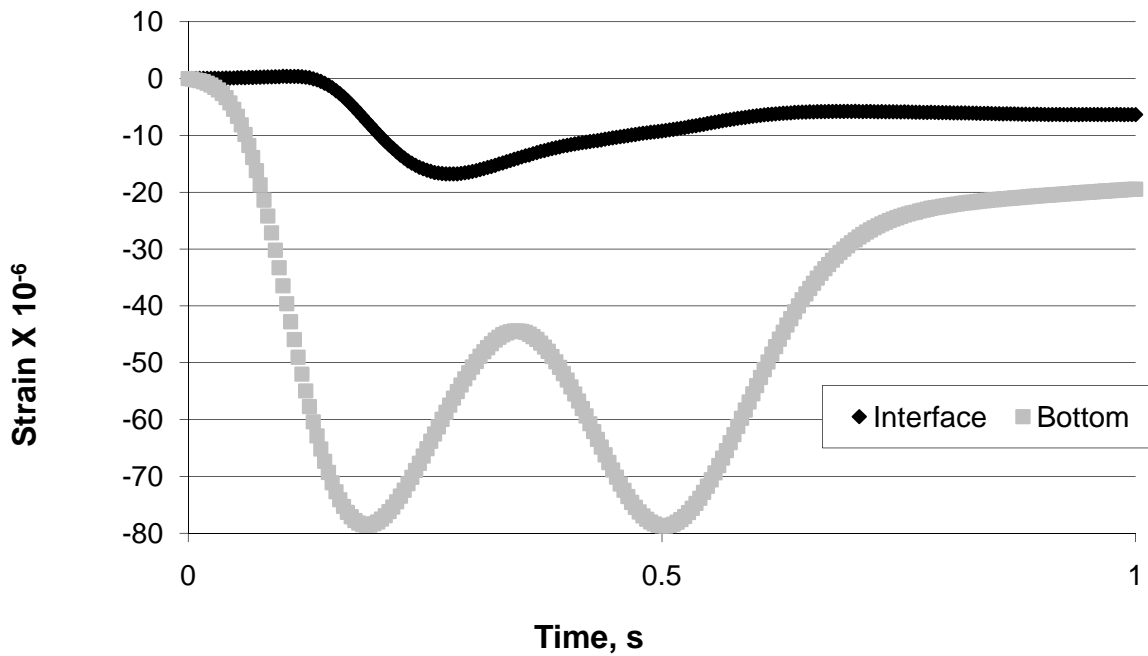
Test Truck - Wheels Up - Run 2
7/26/2005 - 39 mph - 5" Right

Figure 16: Strain Measurement from Truck Run 6 – July 2005

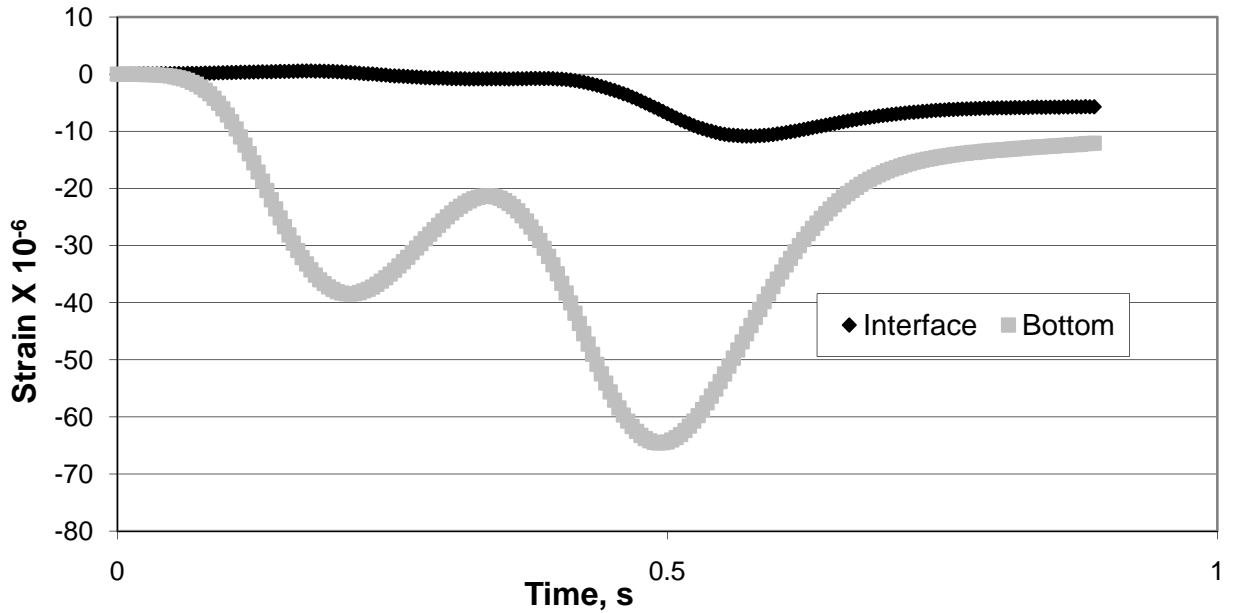
**Test Truck - Wheels Up - Run 3
Kenosha 7/26/2005 - Speed Unknown - 13" Right**

Figure 17: Strain Measurement from Truck Run 7 – July 2005

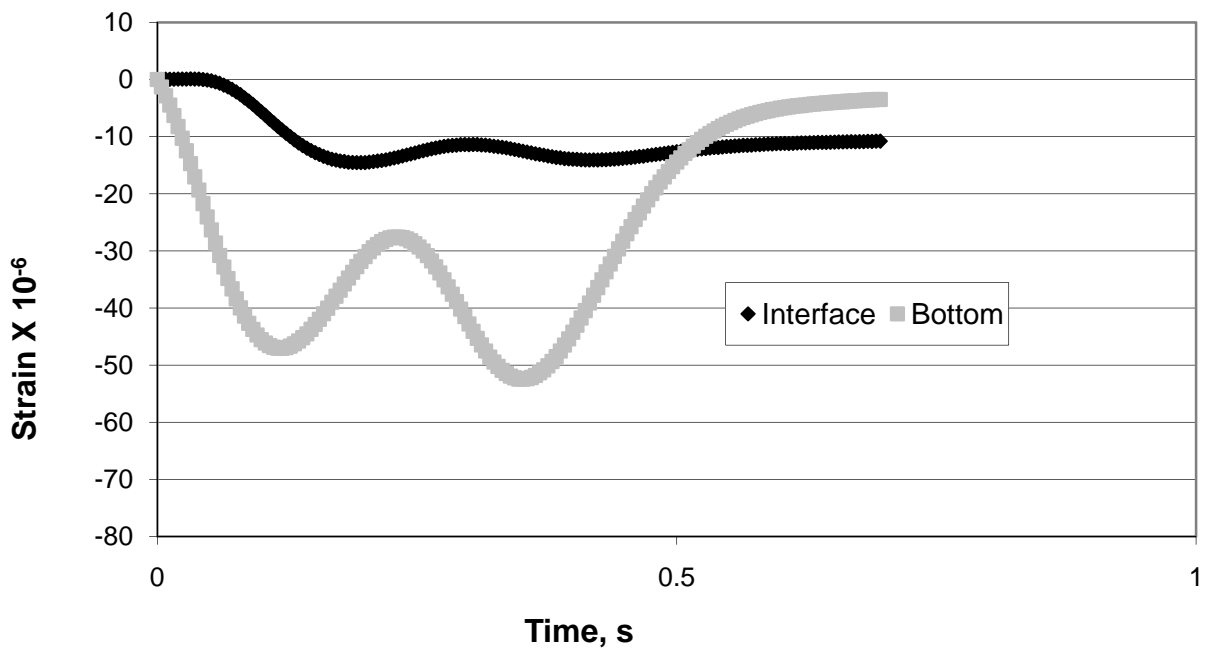
**Test Truck - Wheels Up - Run 4
Kenosha 7/26/2005 - 52 mph - 8" Right**

Figure 18: Strain Measurement from Truck Run 8 – July 2005

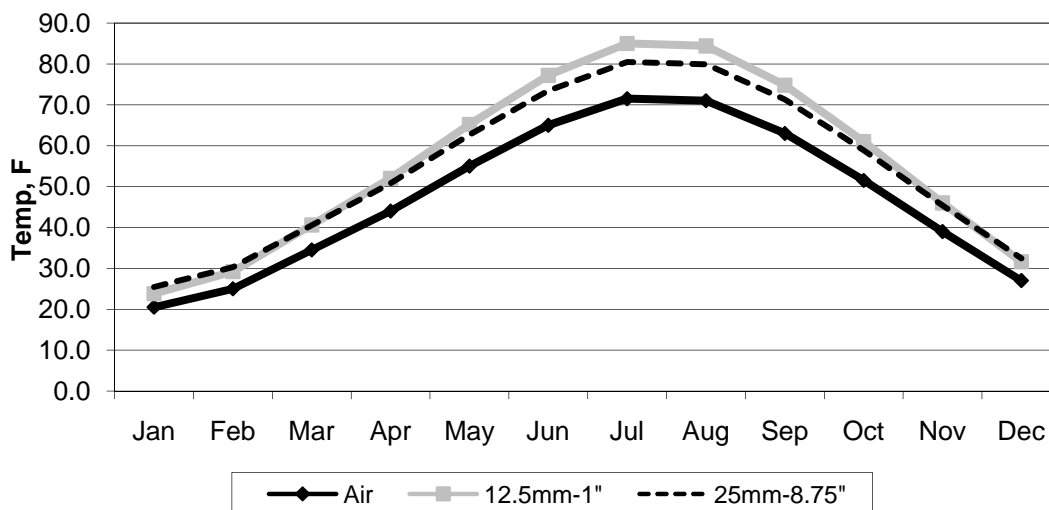
Mean Monthly Temperature Variations Kenosha, WI

Figure 19: Mean Monthly Temperature Variations for Kenosha, WI

Figure 19 illustrates the variations in MMAT and MMPT established for Kenosha, WI.

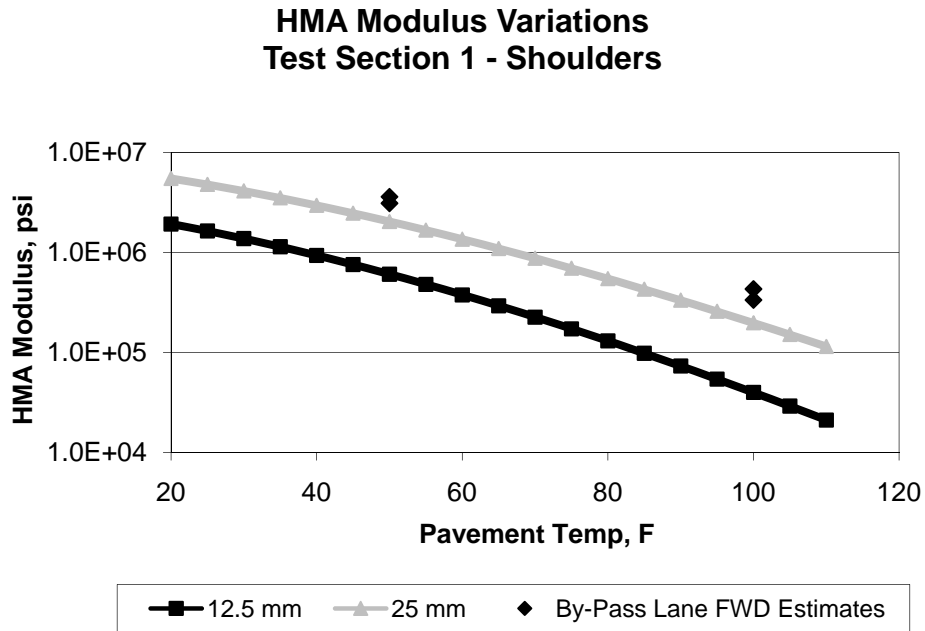
Figure 20: Predicted HMA Moduli Variations for Test Section 1 Shoulders

Equations for predicting the resilient HMA modulus versus NMAS, pavement temperature, % voids and % AC were developed during WHRP Project 0092-03-14 for the HMA shoulder layers used at the Kenosha facility. Figures 20 and 21 illustrate the trends in predicted HMA modulus versus pavement temperature based on the in-place % air voids and design % AC for the HMA shoulder in each test section. Also shown on Figure 20 are the FWD estimates of the by-pass lane combined E_{AC} layer values backcalculated from deflection data obtained during comparative strain measurements. As shown, the combined modulus estimated from the FWD data closely match the 25 mm NMAS E-30X predicted modulus for Test Section 1. The bias of the 25 mm NMAS

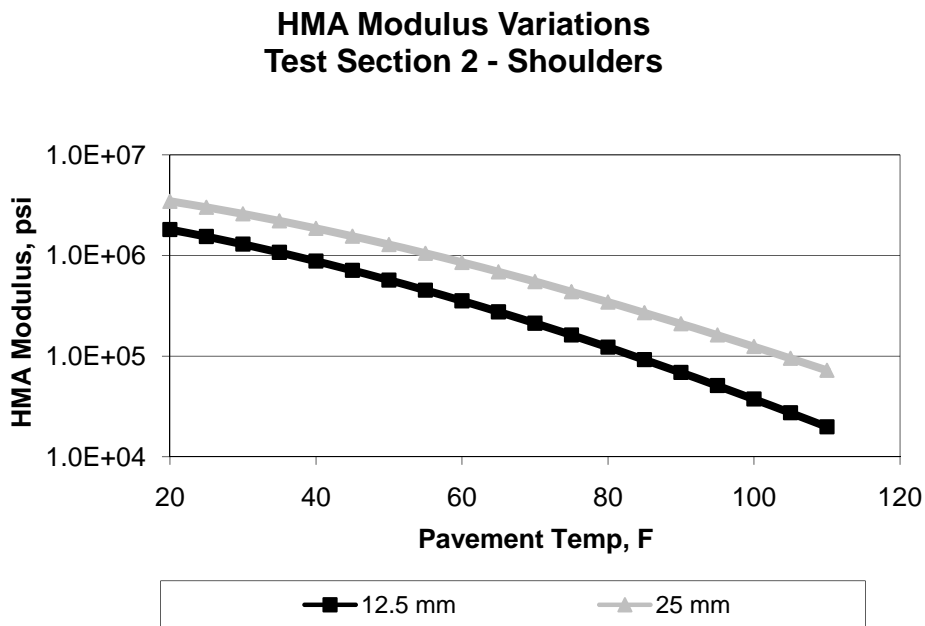
Figure 21: Predicted HMA Moduli Variations for Test Section 2 Shoulders

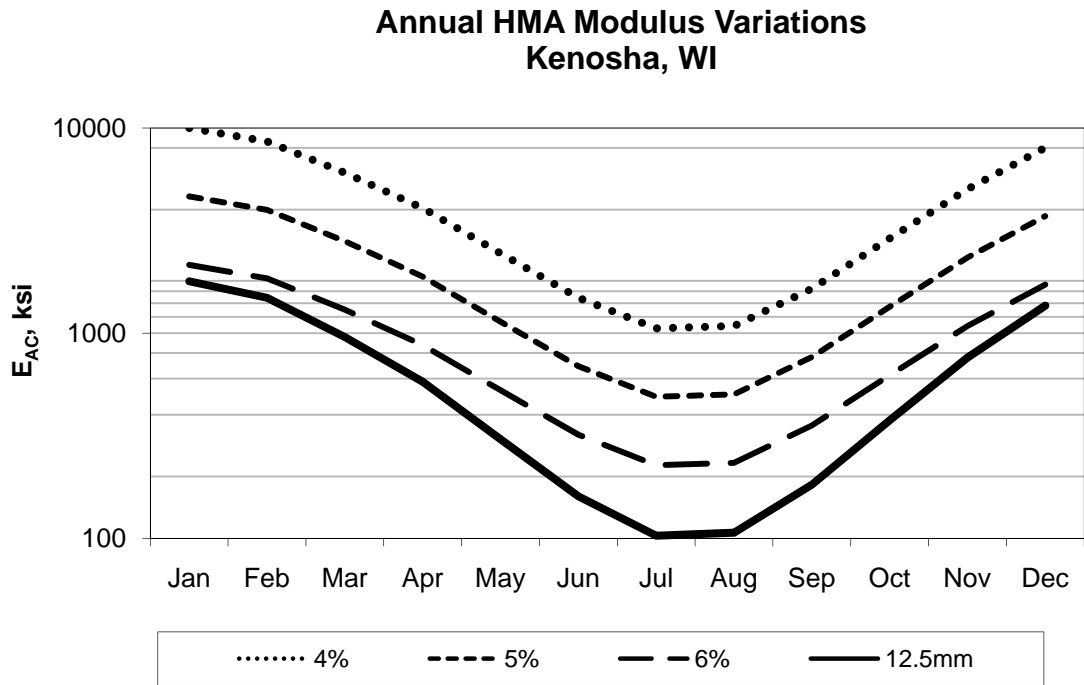
Figure 22: Monthly HMA Moduli Trends for Layer Type

The general trends of HMA modulus versus temperature were combined with the monthly pavement temperature variations typical for Kenosha, WI to develop a trend of average monthly HMA moduli values for the 12.5 mm surface layer at the design values of 6% air voids and for the 25 mm lower layers at air void contents ranging from 4% to 6%, as shown in Figure 22 and Table 6. It should be noted that the average monthly moduli values shown for September are significantly higher than values backcalculated during September 2003 FWD testing (Tables 1–3). This is due to the significant differences in the MMPT = 70°F and the FWD test temperature of 100°F. Conversely, the average monthly moduli values shown for October are less than those backcalculated from FWD testing in October 2003 (Table 4). This is again due to the difference in temperatures (MMPT = 59°F, FWD Test Temp = 50°F).

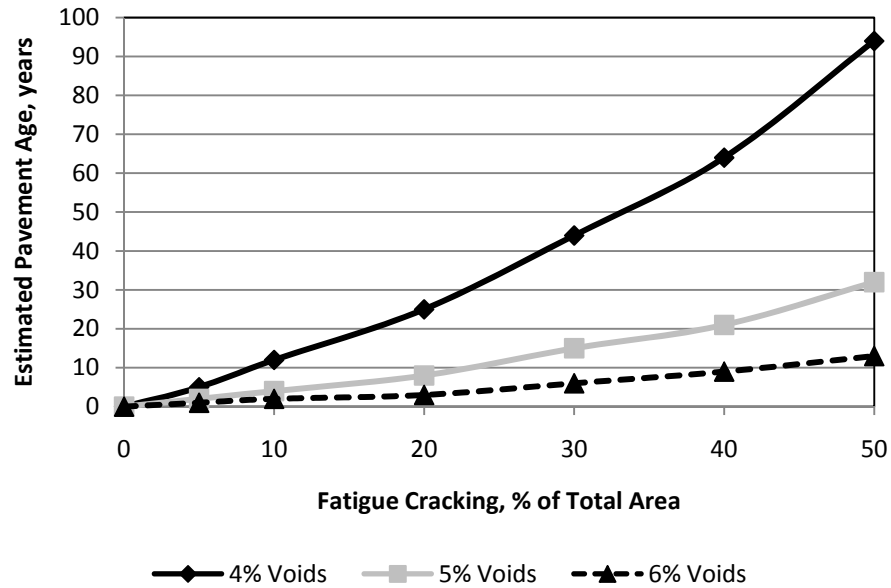
Figure 24: Fatigue Life Estimates Based on Lower Layer Air Void Content

The expected yearly damage is computed as the simple summation of the expected monthly damage values. An estimate of the pavement fatigue life can be computed as the inverse of the yearly damage (decimal value). Table 8 provides the outputs of the HMA fatigue cracking analysis conducted for the range of 4% - 6% air voids within the lower 25mm layers. As shown, the cumulative yearly damages estimated increase significantly as the void content increases. These damage values can be used to estimate the service lives to varying levels of bottom-up fatigue cracking, as shown in Table 9 and Figure 24. As indicated, the estimated fatigue life of the pavement sections is significantly reduced as air voids are increased.
