EVALUATION OF SCOUR POTENTIAL OF COHESIVE SOILS

FINAL REPORT PROJECT 930-644

Highway Research Center Auburn University, Alabama

Sponsored by Alabama Department of Transportation Montgomery, Alabama

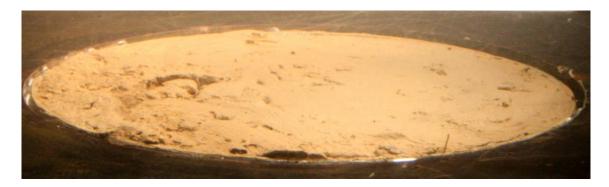
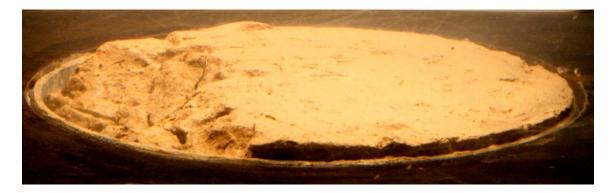
Figure 7: Talladega EFA Test 316B

Test 316B was conducted for approximately 4.60 hours. Velocity was set to 0.65 m/s for the first 3.17 hours and 0.90 m/s for the final 1.43 hours. At 2.25 hours, a large spall suddenly flew out of the upstream 1/3 end, as shown in Figure 7. Along with the silty emission from the edges, this void grew larger at V = 0.90 m/s for the final 1.43 hours. After testing, this sample was ejected 5 cm above the Shelby tube surface for examination (Figure 8). Around a pocket of small pebbles, erosion was obvious at the leading edge of the sample. In contrast, the downstream 2/3 of the sample surface showed very little erosion.

Test 316B, Test Start

Δt = 2.25 Hours, V = 0.65 m/s

Δt = 4 Hours, v = 0.90 m/s

These tests illustrate the difficulties encountered when testing real soils. Surface preparation and discontinuities (such as the small chert pebbles) can cause erratic sample erosion. For comparison, reasonably consistent erosion functions developed for homogeneous prepared samples of model soils will be presented later.

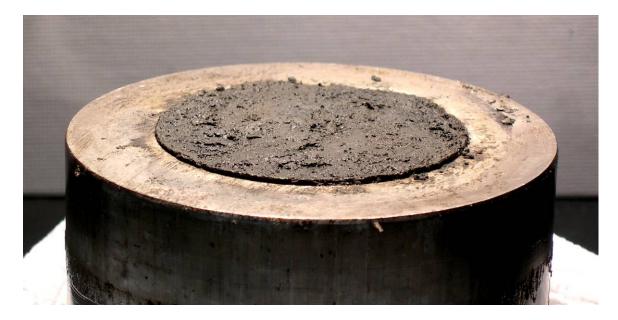
Figure 11: Sucarnoochee07 Prepared Surface at 1 mm Protrusion

This type of erosion development is illustrated in Figures 11 and 12. Figure 11 shows the as prepared sample surface. As shown in Figure 12, some initial erosion occurred at a velocity of 0.32 m/s but equilibrium was soon achieved (Time = 24 minutes). More erosion occurred when the velocity was increased to 0.74 m/sec, but the surface stabilized and remained so for some time (Time = 2 hours, 10 minutes). The entire 1 mm of sample was not eroded until the velocity was increased to 0.99 m/s (Time = 2 hours, 14 minutes).

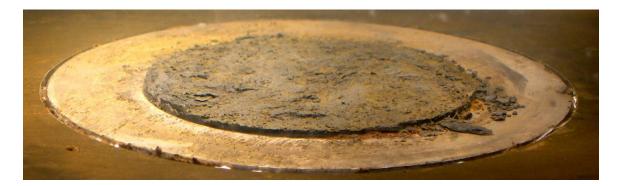
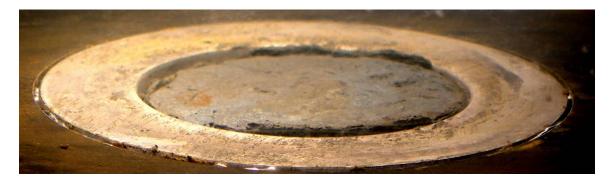
Figure 12: Sucarnoochee07 EFA Testing

Time = 24 minutes, V = 0.32 m/s

Time = 2 hours 10 minutes, V = 0.74 m/s

Time = 2 hours 14 minutes, V = 0.99 m/s

This type behavior made interpretation difficult. However, seven samples were tested and based on some creative interpretation it is estimated that the critical shear stress for the hard silt is between 0.2 and 1.2 N/m² which corresponds to velocities from 0.3 to 0.7 m/s. This would mean the hard silt at the Sucarnoochee River crossing would be susceptible to scour at velocities less than the maximum of 3 - 3.5 m/s which might be expected for Alabama Rivers.

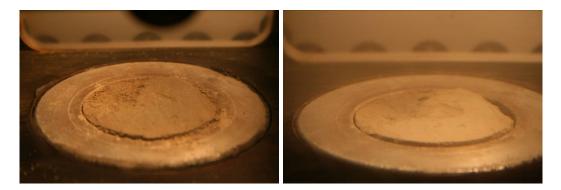
Figure 13: EFA Testing on Dallas County Samples

Conventional EFA testing was performed on three Mooreville chalk core samples. Surface preparation was not an issue. The flow control valve on the EFA was set to produce the highest possible EFA velocity (approximately 6 m/s), where it remained for entire test durations. The tests yielded minimal erosion as shown in Figure 13. Chalk core 78935 was tested for roughly two hours. About 1/3 of the surface above the flume bed suddenly separated and eroded after an hour of testing but there was no evidence of any additional erosion. Sample 78936 did not show any signs of erosion for two hours. A small amount of erosion occurred for sample 78956 during the first hour of testing, but no erosion occurred during the second hour. Based on these tests, it is reasonable to conclude that the Mooreville chalk tested would not scour if subjected the highest velocities that might be expected for Alabama Rivers, i.e., the critical shear stress for Mooreville chalk is greater than 15.3 N/m²

78935, ∆t = 1 Hour

78936, Test End, $\Delta t = 2$ Hours

78956, $\Delta t = 0$

78956, Δt = 1 Hour

78956, ∆t = 2 Hour

The Mooreville chalk from Dallas County did not erode when subjected to a shear stress of 45.0 N/m² (V = 6 m/sec).
