Report No. CDOT-2009-13
Final Report

LATERAL VEHICLE ACCELERATION DUE TO LONGITUDINALLY TINED PORTLAND CEMENT CONCRETE PAVEMENT

Robert V. Rinehart
Michael A. Mooney

December 2009

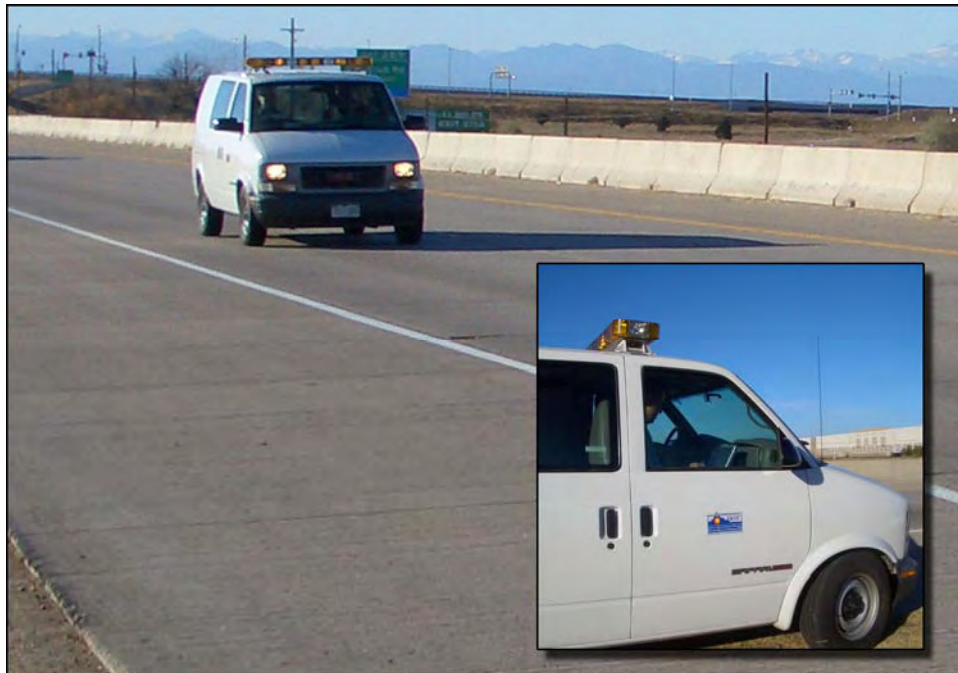
Figure 3-1. The 2000 GMC Safari cargo van employed during field measurements of vehicle wander

As pictured in Figure 3-1, a 2000 GMC Safari cargo van owned by CDOT and known to experience wander was used in this study. CDOT personnel drove the van and a single passenger accompanied the driver to perform the data collection. The specifics of the van and tires are summarized in Table 3-A. To the authors' best knowledge, the van, including its suspension system, was in good mechanical repair and the tires were properly inflated.

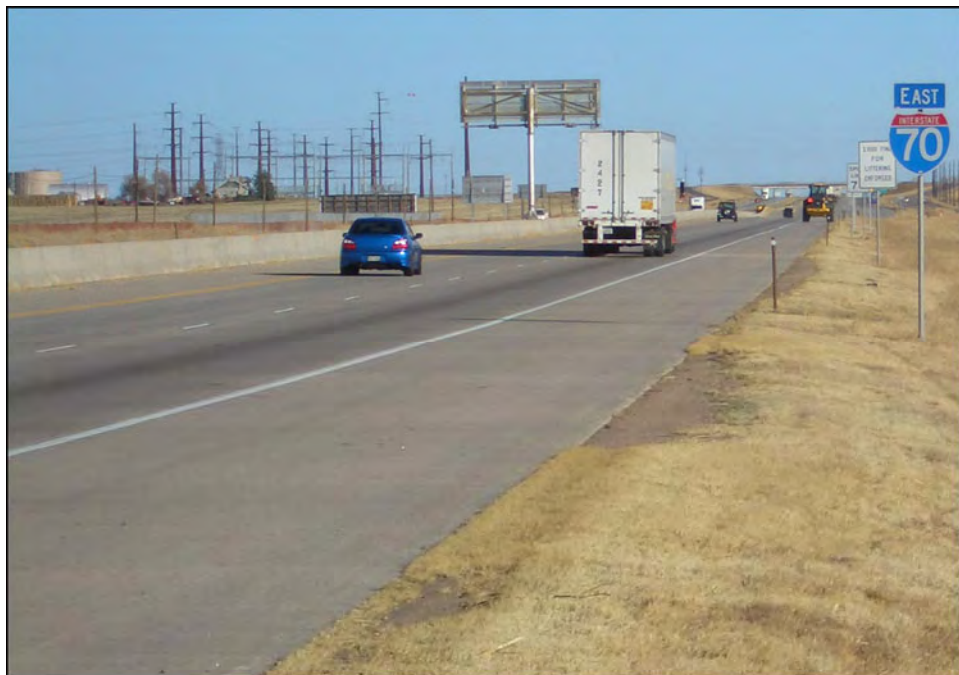
Figure 3-2. The I-70/E-470 testing site

Field measurements of vehicle wander were carried out on a 4.8km (3.0mi) stretch of I-70 between E-470 and SH 36 Airport Road constructed in the early 1990's and textured according to the current specification (hereafter referred to as the I-70/E-470 site). Data was collected during traverses over both the east- and west-bound alignments between mile markers 289 and 292. The PCC pavement at this location features longitudinal tining and the CDOT van was known to squirm in this area. Figure 3-2 shows the I-70/E-470 site and Figure 3-3 details the tire tread and the tining encountered.

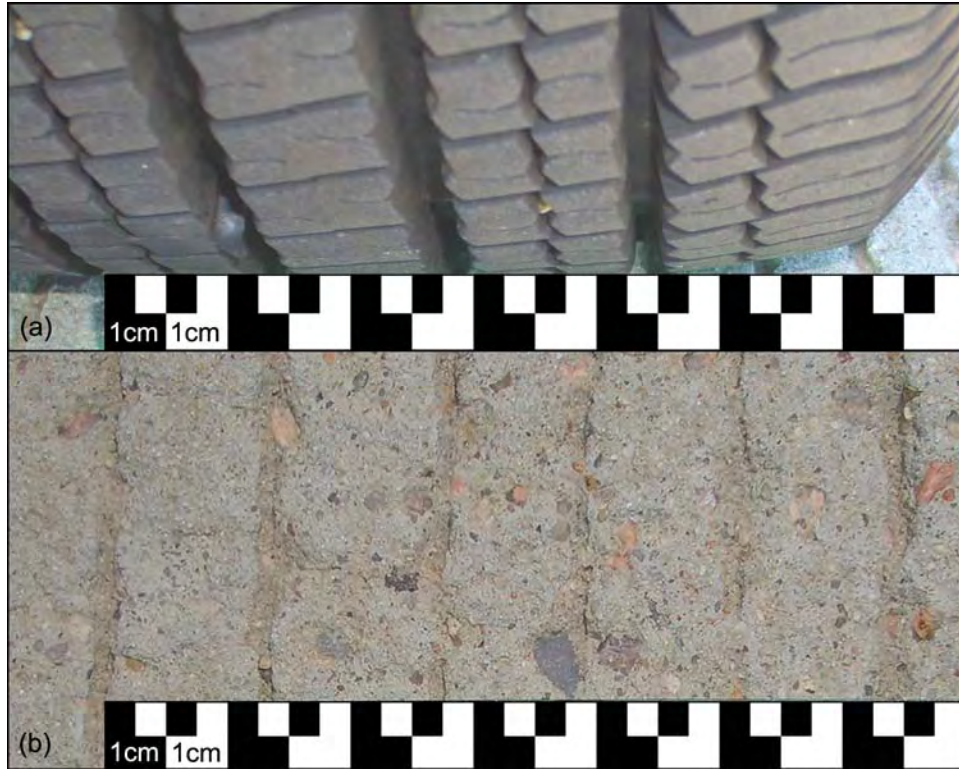
Figure 3-3. The (a) tire tread on the Uniroyal Laredo van tire and (b) longitudinal tining at the I-70/E-470 site

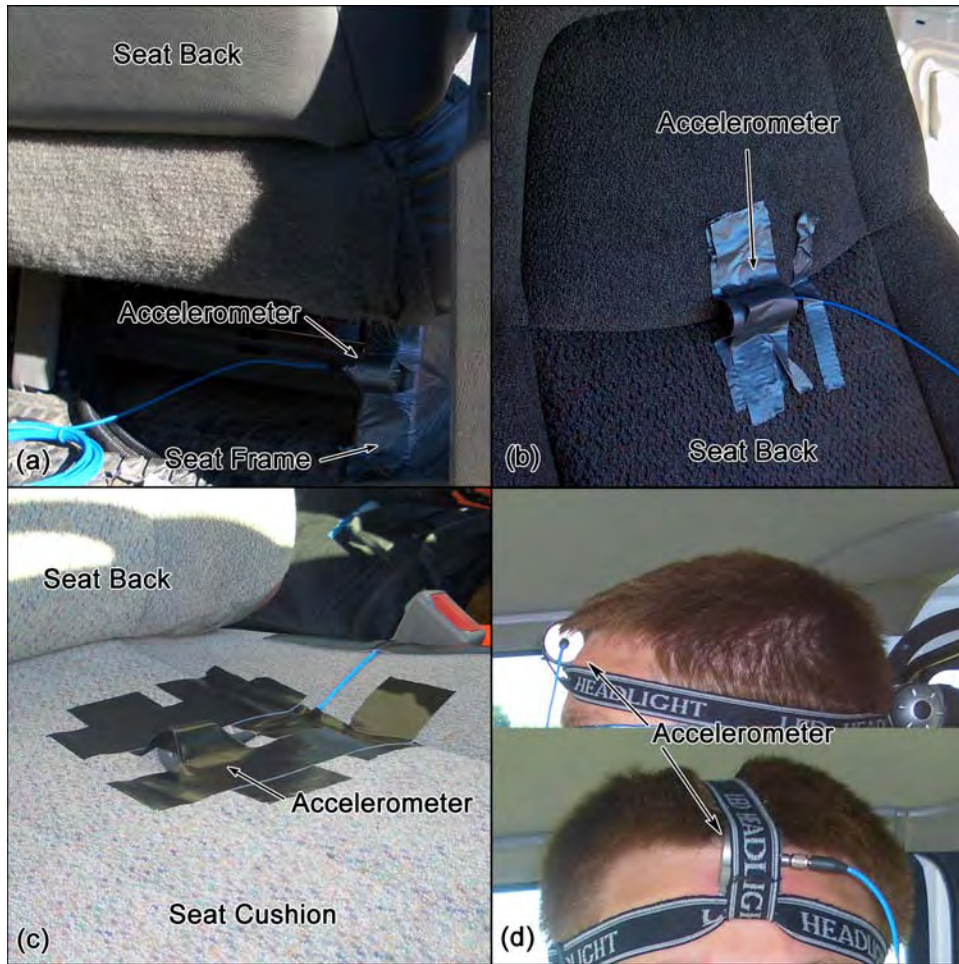
Figure 3-4. Accelerometers placed on the (a) seat frame, (b) seat back, (c) seat cushion, and (d) passenger's head

Field testing was first conducted on November 19, 2008. Lateral (perpendicular to the forward travel of the vehicle) acceleration data was collected from two different accelerometers during each test pass, and several different accelerometer placements were tested. The first accelerometer was fixed to the seat frame and oriented to measure lateral acceleration, perpendicular to the direction of forward vehicle travel (Figure 3-4a). This accelerometer placement was the same for all test runs and provided data similar to that collected in the 2006 preliminary study. The location of the second accelerometer varied based on the results of the literature review (see Chapter 2). Locations included two positions on the seat itself: the seat back (Figure 3-4b) and the seat cushion (Figure 3-4c). These locations were chosen because of their specification in ISO-2631, because the seat assembly has low pass filter characteristics, and because vibrations enter the passenger's body through the seat (see Corbridge and Griffin, 1986; Nishiyama et al., 2000). The other location tested was the passenger's head (Figure 3-4d). This placement was chosen because of the human body's tendencies to amplify low frequencies and attenuate high frequencies and because it is the vibration experienced by vehicle occupants (in contrast to vehicle vibrations) that gives rise to the negative feedback. In each of these cases, the sensor was oriented to measure lateral acceleration.

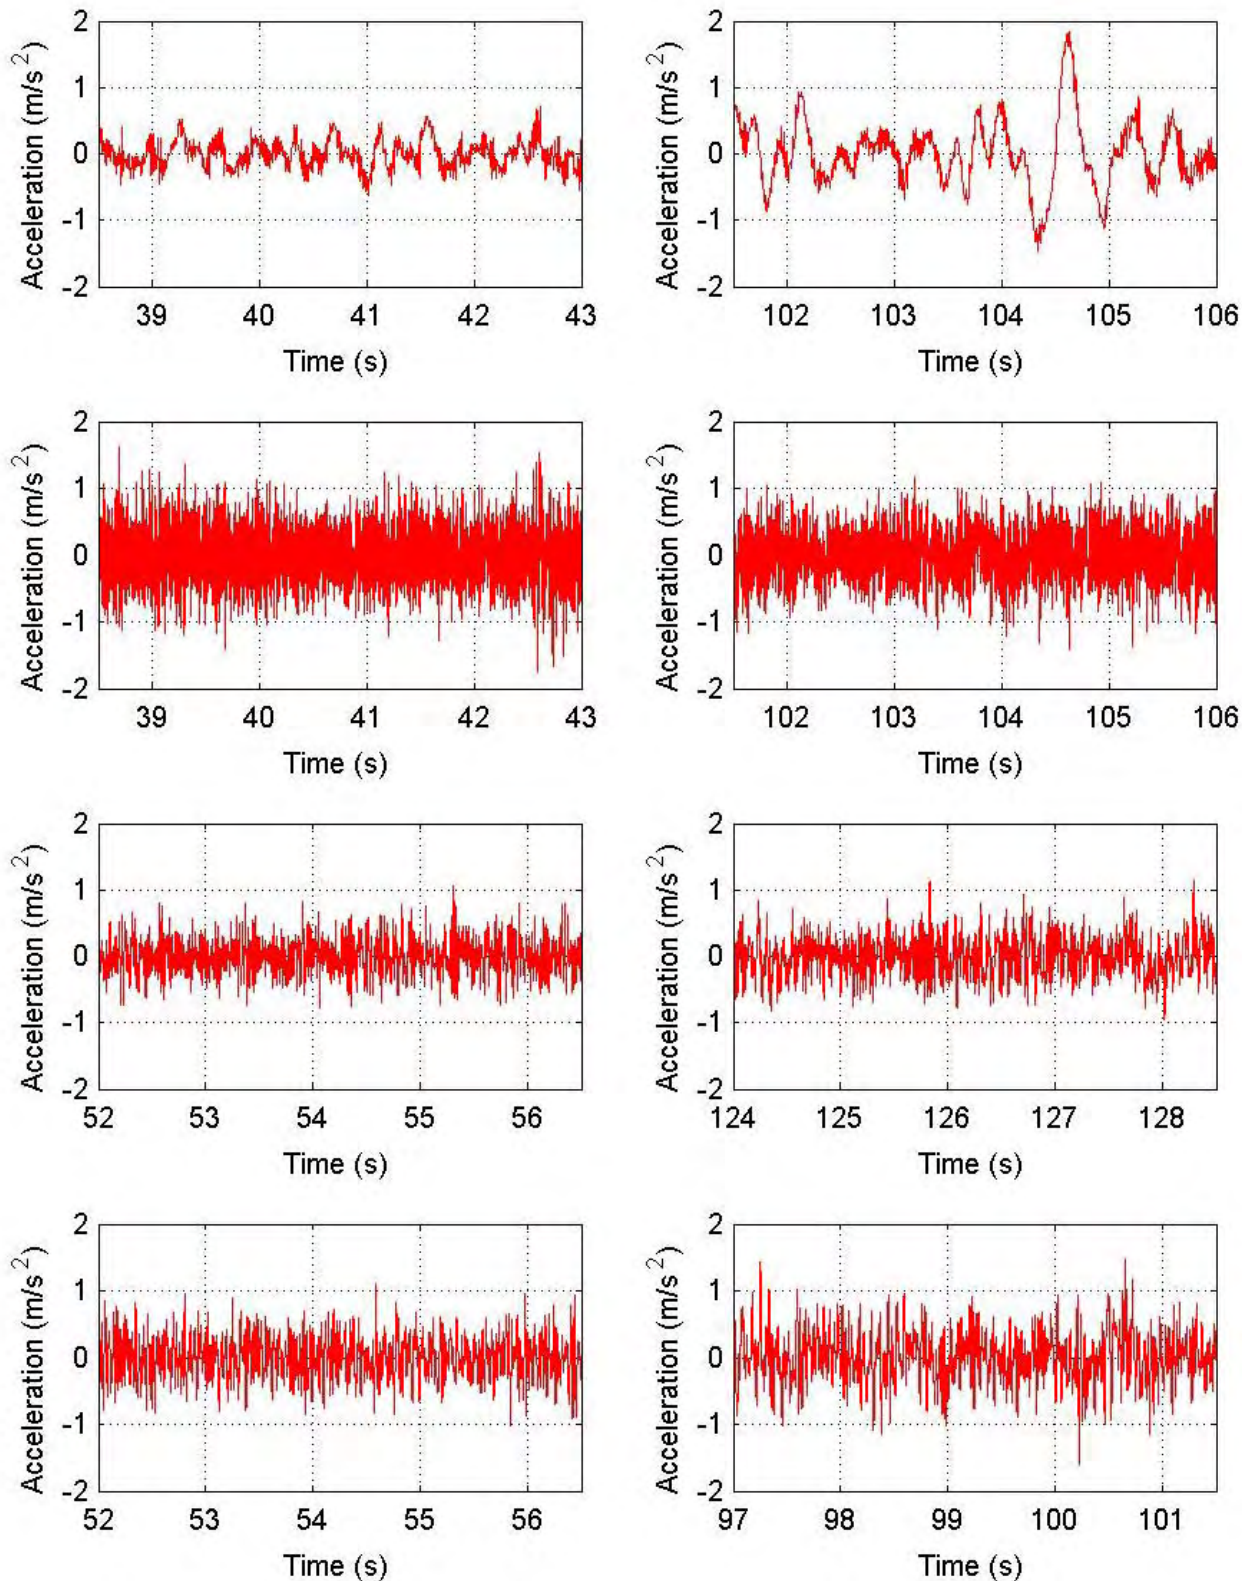
Figure 4-1. Raw lateral acceleration data measured at the passenger's head, seat frame, seat cushion and seat back (from top to bottom) with data from non-wander behavior on the left and wander behavior on the right

As shown in Figure 4-1, depending on the sensor location, there can be little visually discernable difference between the raw acceleration records during wander and non-wander behavior. This is particularly true for the seat frame position. The seat frame is rigidly attached to the vehicle body, and while the vehicle suspension does dampen some vibration, the low-frequency wander vibrations are masked by other, higher frequency signals (e.g., engine vibration, tire rotation). The high frequency noise that obscures wander in the seat frame measurements is somewhat attenuated by the low pass characteristics of the seat cushion and seat back (see Griffin, 2007) and limited differences are visually discernable between the wander and non-wander data sets. The high frequency noise is further attenuated by the body (and in fact, 0.5-2Hz signals may be amplified, see Paddan and Griffin, 1988, 1998), and Figure 4-1 shows clear differences between wander and non-wander behavior when acceleration is measured at the passenger's head. For this reason, the characteristics of wander vibration will be explored using the passenger's head measurement runs from testing day one (Runs 1-7 through 1-11). Note that Section 4.2 details the results of the studies regarding the optimal sensor location to measure wander vibrations.

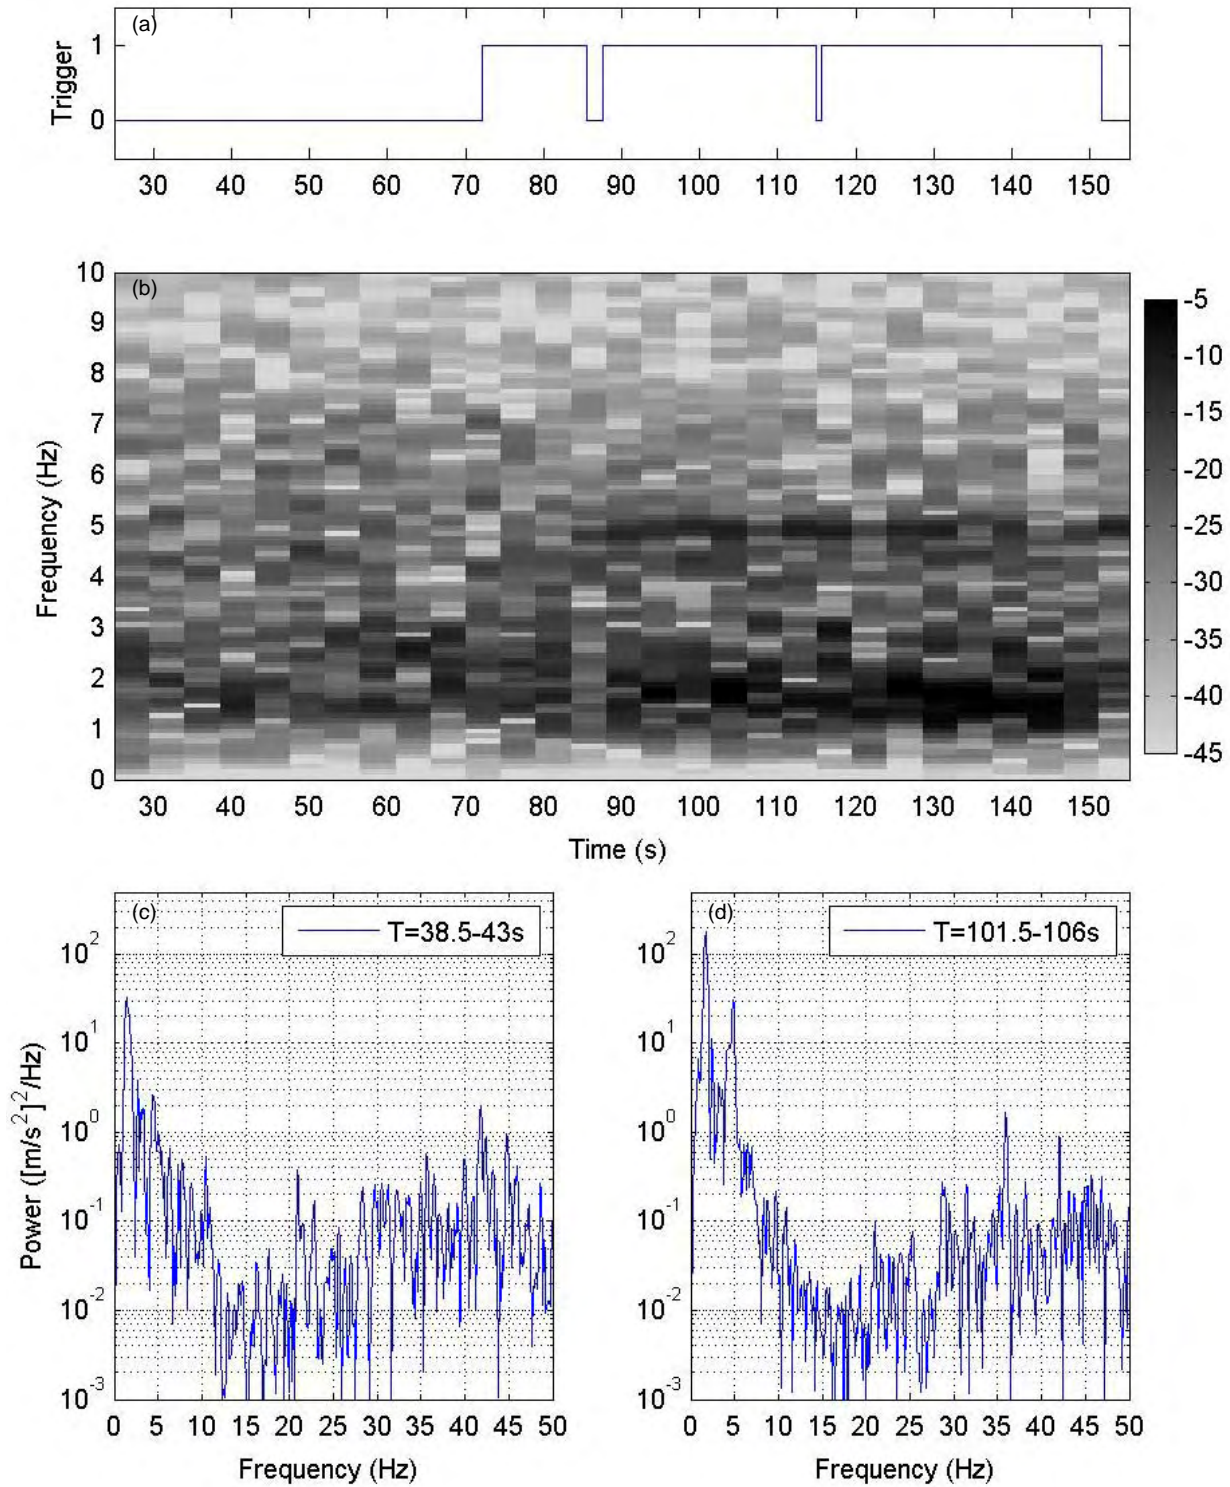
Figure 4-2. Frequency domain analysis of Run 1-10: (a) trigger, (b) spectrogram, and power spectra from (c) non-wander and (d) wander stretches

Frequency domain analysis was performed to determine the frequency content of each signal and to identify a characteristic frequency range where wander occurs. Spectrogram analysis is performed by computing Short Time Fourier Transforms (STFT) for adjacent or overlapping segments of a data file (i.e., stretches of road). This type of analysis, also referred to as the time-dependent Fourier Transform, is commonly used to analyze nonstationary signals (see Oppenheim and Schaffer, 1999). Spectrogram analysis is useful here as it allows comparison of the frequency content of wander and non-wander stretches from the same test run. Figure 4-2b presents the spectrogram from the passenger's head acceleration from Run 1-10. The spectrogram was computed with five-second windows with one-half-second overlap between adjacent windows. To show where wander was observed; the hand trigger signal is shown (Figure 4-2a). A trigger value of zero (i.e., off) corresponds to no wander being observed and a trigger value of one (i.e., on) corresponds to wander being observed. The spectrogram in Figure 4-2 is presented in decibels (dB) and therefore a value closer to zero (darker) indicates more power than a value further from zero (lighter). Given that wander is a low-frequency phenomenon, the spectrogram is only shown for 0-10Hz.

Inspection of Figure 4-2 reveals that areas where wander is observed generally have more power in the 1-3Hz frequency band than areas where wander is not observed. For example, compare the window of time $T=40-60s$ where the trigger indicates that wander was not observed to the $T=120-140s$ window where the trigger indicates that wander was observed. Examining individual power spectra from non-wander and wander stretches (see Figure 4-2c, d) confirms that wander corresponds to additional power in the 1-3Hz frequency band. These results are further corroborated by Figure 4-3, which presents the total power present in the 0-5Hz band as a function of time (i.e., the integral of the power from 0-5Hz for each time window in the spectrogram). In general, areas where wander occurred exhibit higher vibration signal power than those where wander did not occur.

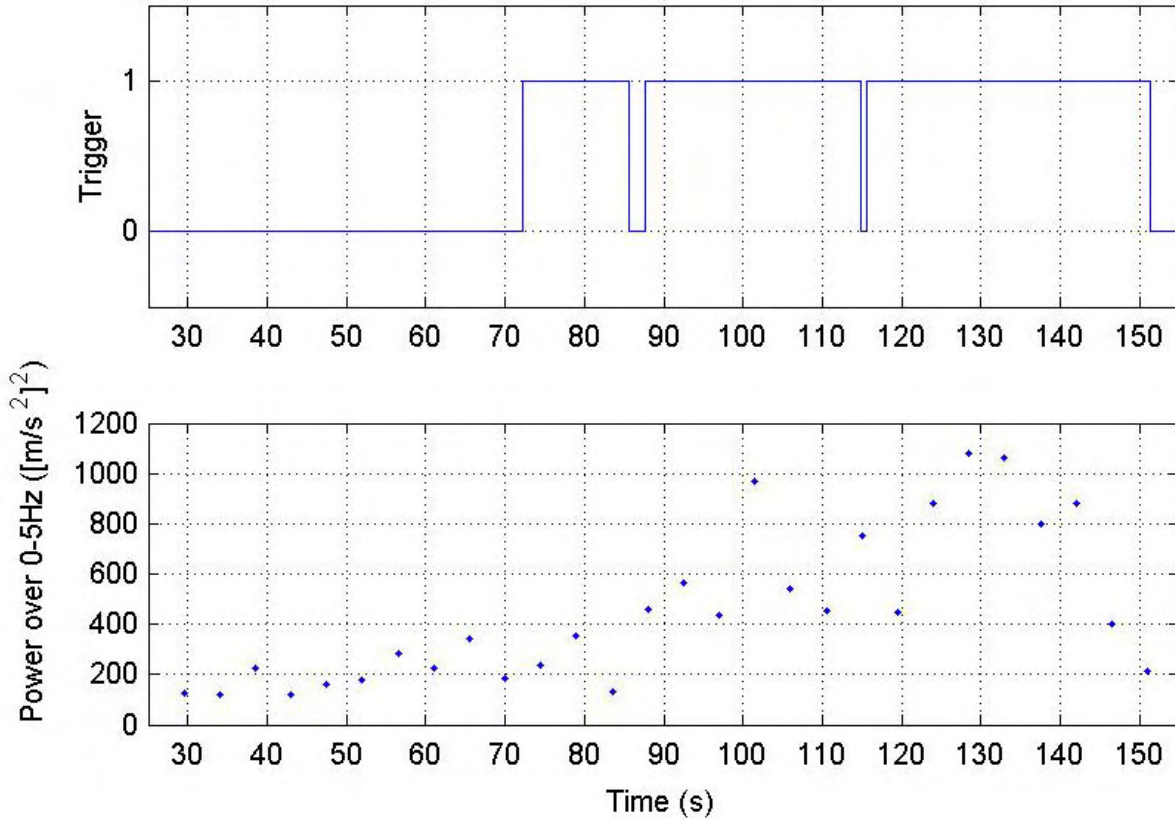
Figure 4-3. Run 1-10 trigger signal (top) and total power in the 0-5Hz band (bottom) (note that the integration time windows correspond to those used in the spectrogram)

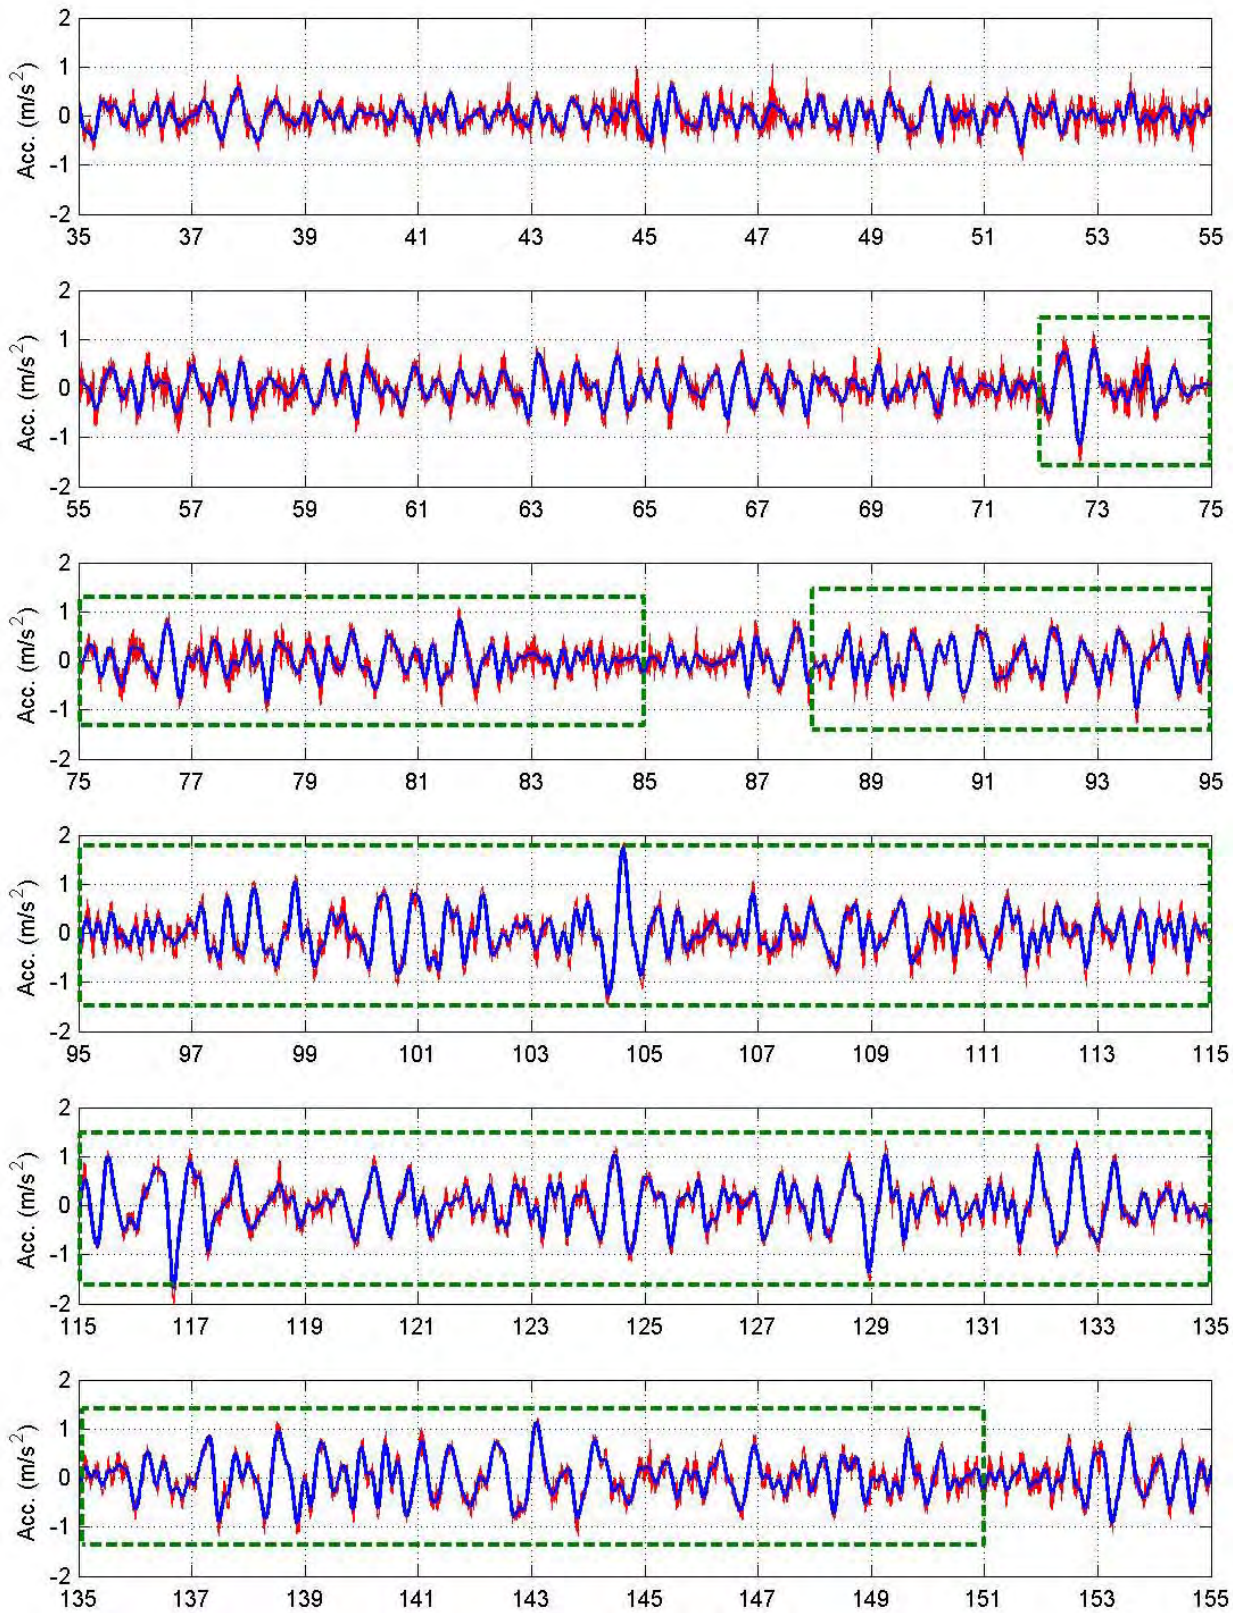
Figure 4-4. Raw (red) and low pass filtered (5 Hz cut-off frequency) (blue) lateral acceleration data from Run 1-10. Hatched areas indicate where wander was prevalent according to the hand trigger.

Some discussion of the triggering technique used here is appropriate before further presentation of the results. By means of a push-button device, the vehicle occupant is able to indicate, or trigger, when wander is observed. However, when driving at highway speeds it is very difficult to trigger individual or isolated wander events – the process of assessing whether or not the observed vibration is wander or not (i.e., deciding whether or not to push the trigger button) is not an instantaneous process. There is a lag-time associated with triggering. This is illustrated in the time window T=82-88s in Figure 4-4. It appears that wander ceases at about T=82s, but the trigger is not released until T=85s – a delay of three seconds. Wander then resumes at T=86.5s, but the trigger is not pressed until T=88s – a delay of one and a half seconds.

Due to the difficulty of triggering individual wander events, the trigger was used to indicate larger-scale areas where wander was prevalent. Specifically, if an individual wander event was observed, but subsequent vibration was normal, the trigger was likely not pressed. This can be observed at several locations in Figure 4-4, including T = 38s and 152-154s. Conversely, if wander was prevalent in an area and therefore the trigger was pressed, but stopped for a short time (e.g., 1-2 seconds) before wander resumed, the trigger was likely not released. This can be observed at T = 95-97s and 130-131.5s in Figure 4-4.

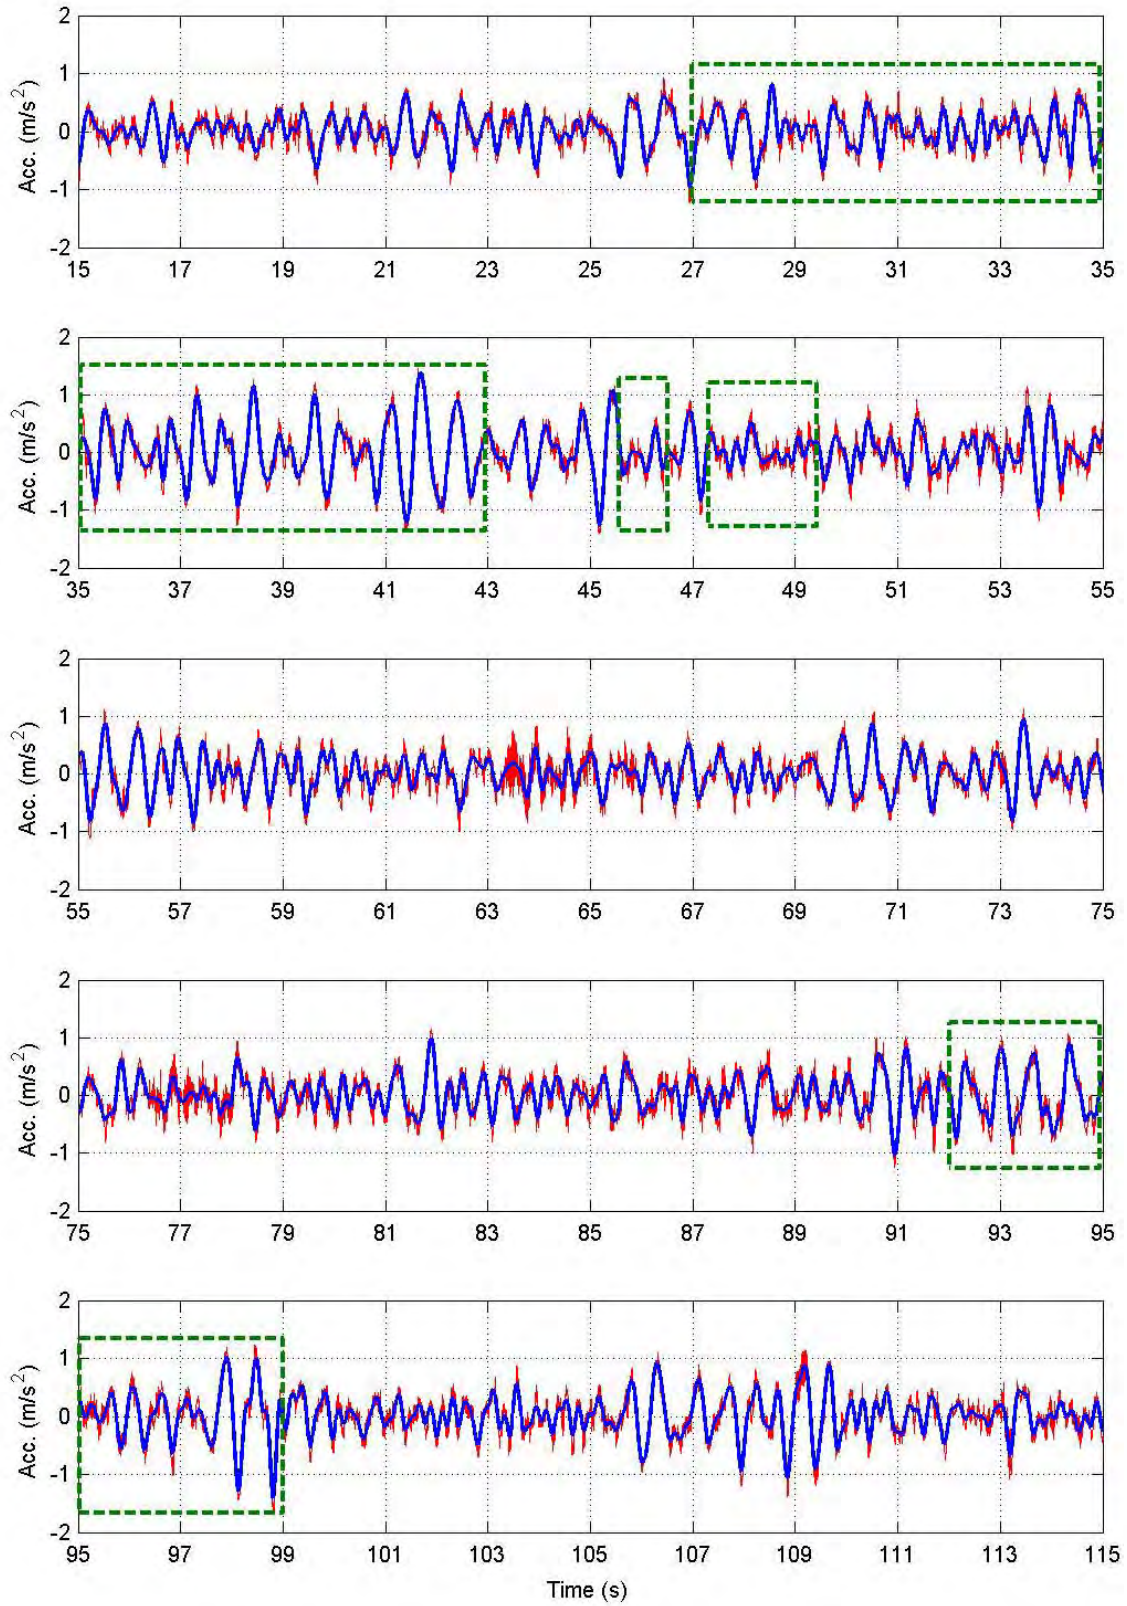
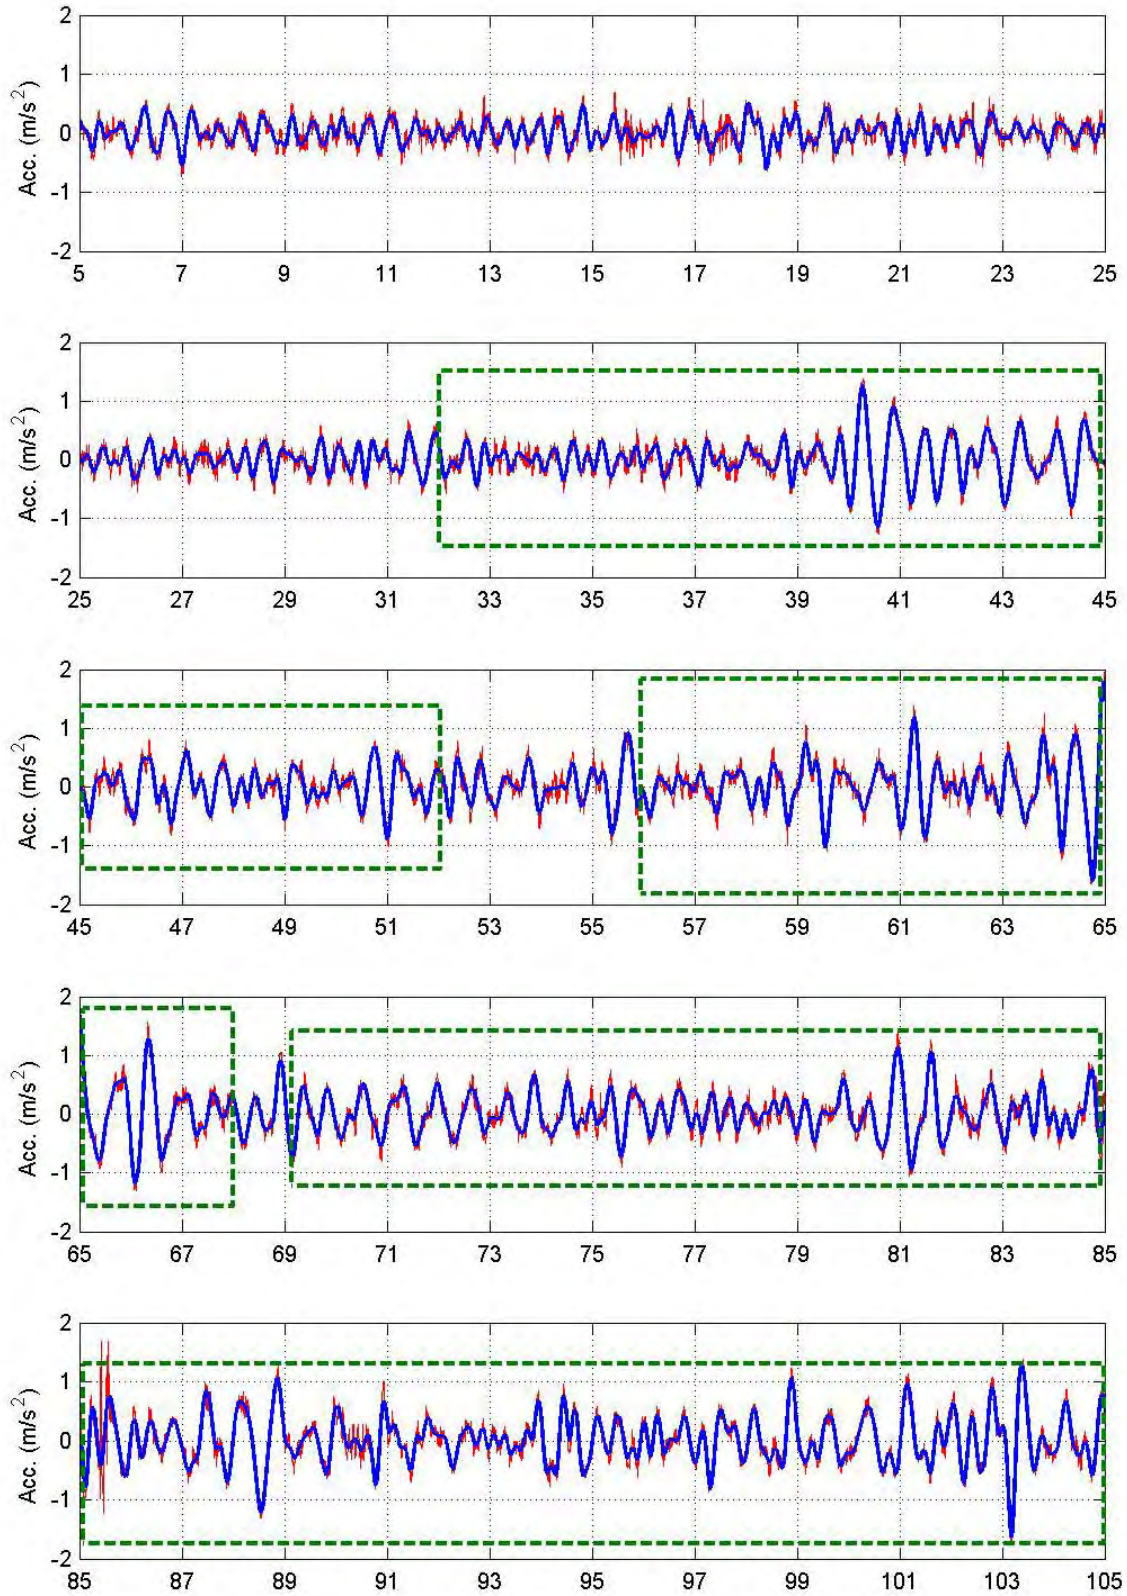
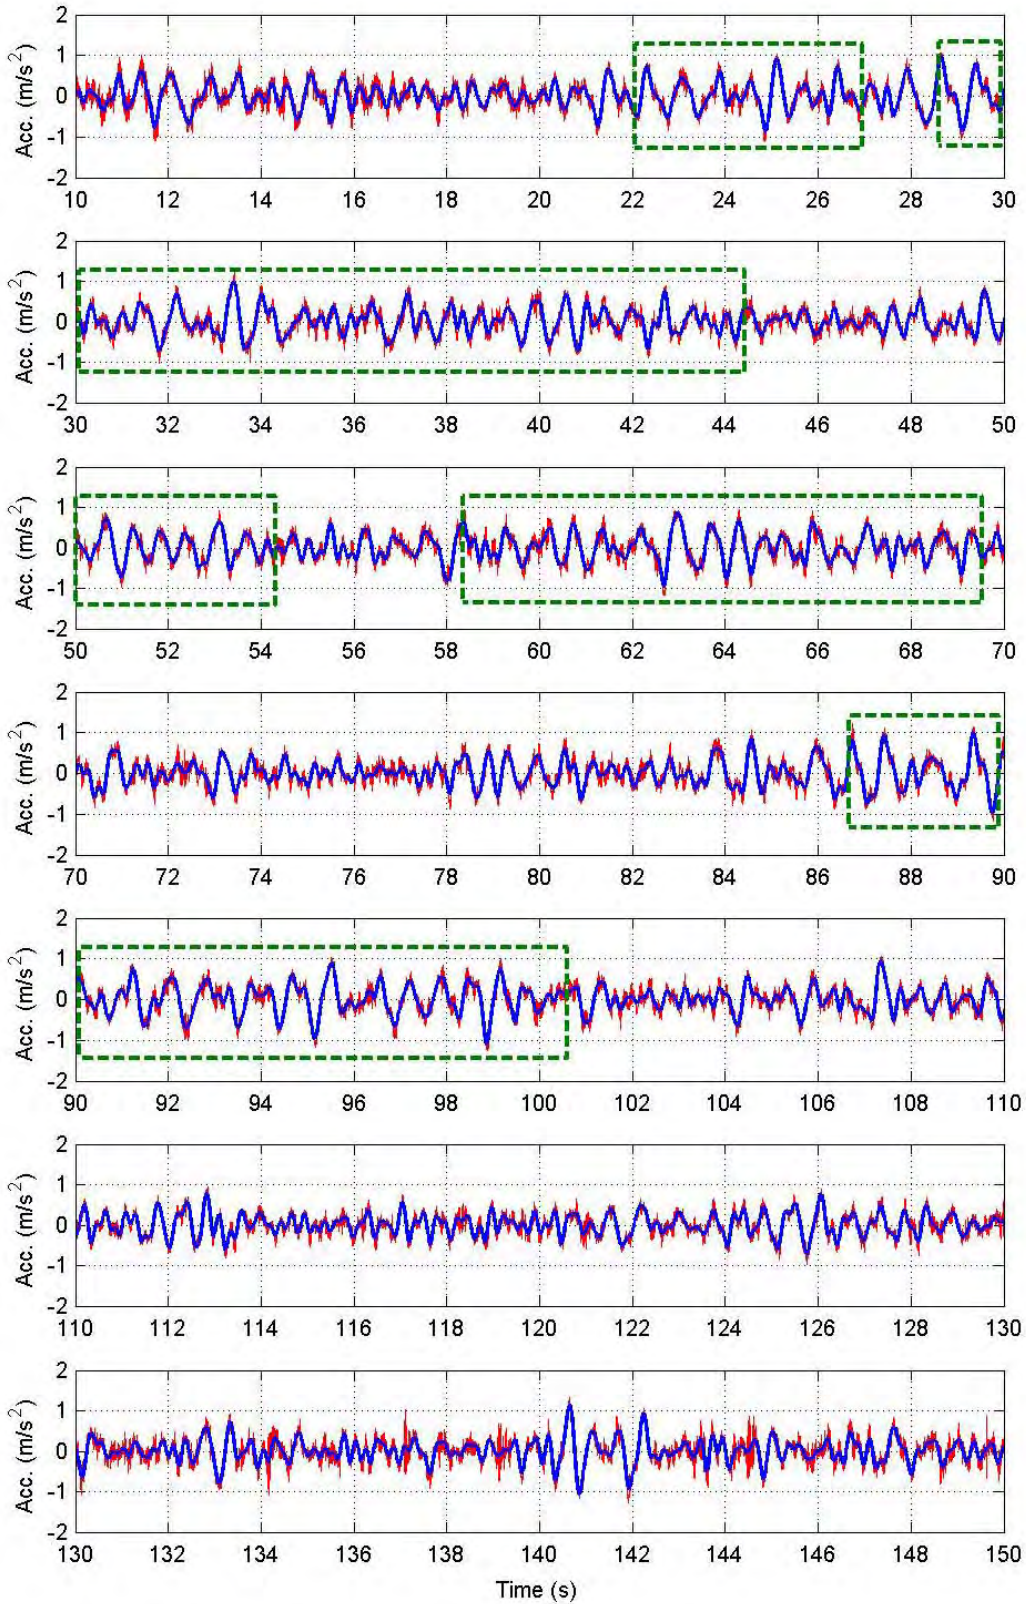
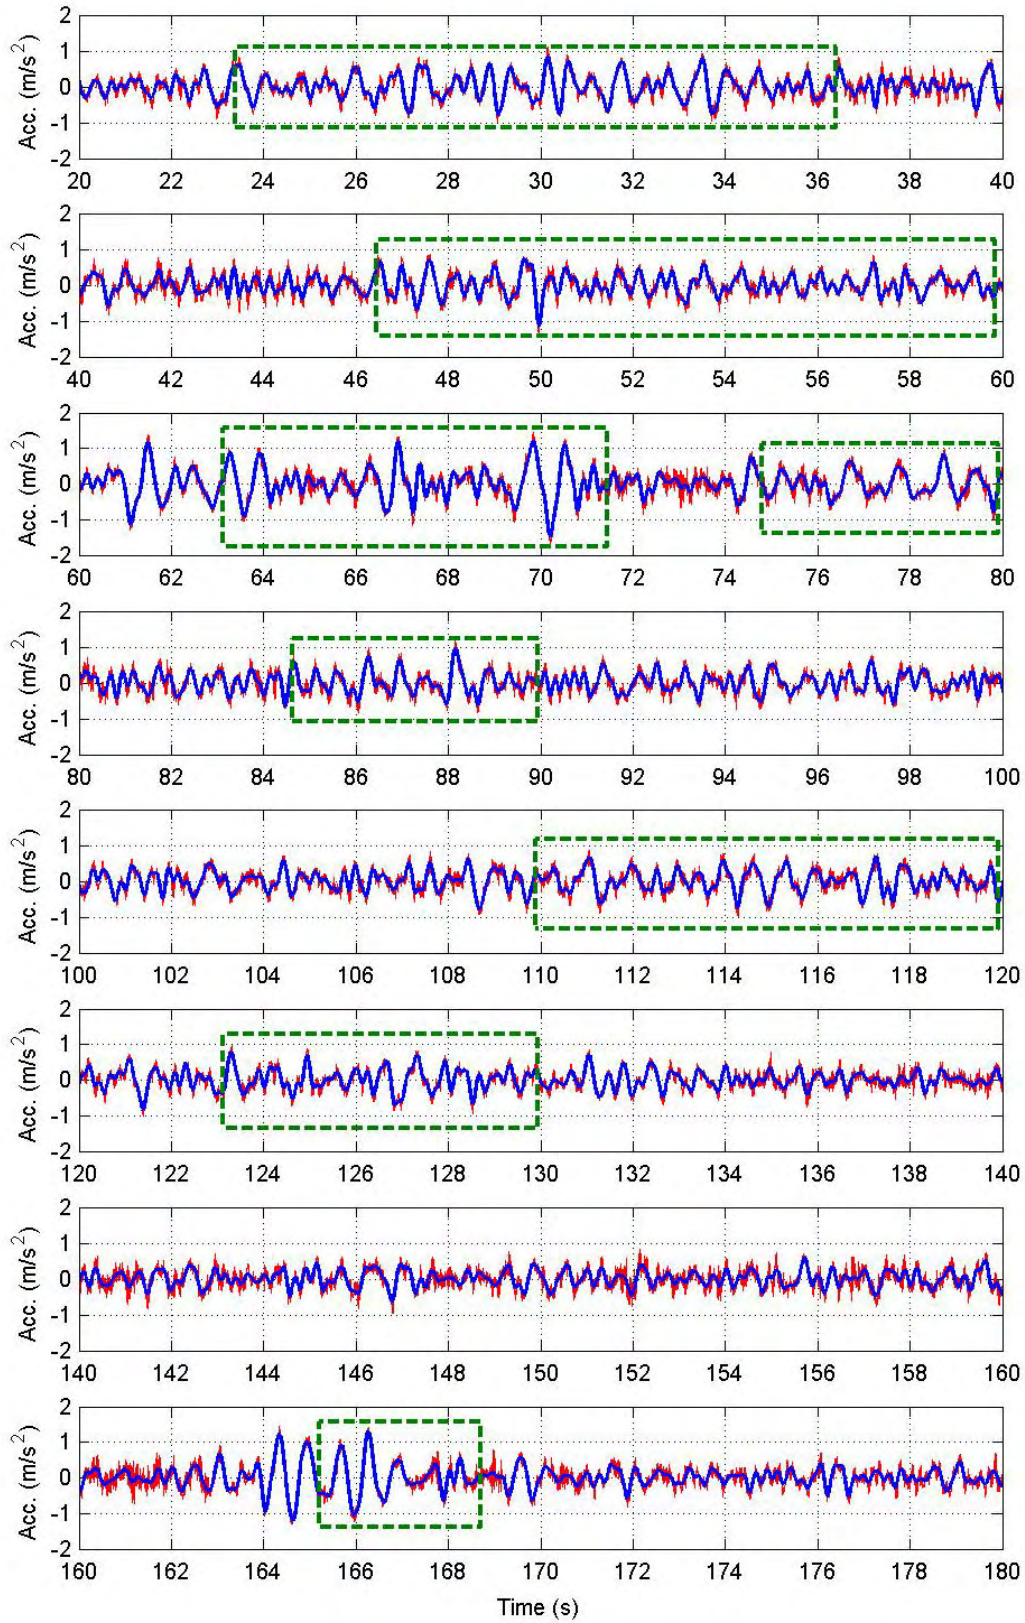
Figure 4-5. Raw and low pass filtered (5 Hz cut-off frequency) lateral acceleration data from Run 1-7

Figure 4-6. Raw and low pass filtered (5 Hz cut-off frequency) lateral acceleration data from Run 1-8

Figure 4-7. Raw and low pass filtered (5 Hz cut-off frequency) lateral acceleration data from Run 1-9

Figure 4-8. Raw and low pass filtered (5 Hz cut-off frequency) lateral acceleration data from Run 1-11

Similar results to those discussed above are found in the time histories for Runs 1-7, 1-8, 1-9 and 1-11, shown in Figures 4-5 through 4-8, respectively. Table 4-A summarizes the mean lateral acceleration (in terms of root mean square, RMS) observed in wander zones versus that observed in non-wander zones for Runs 1-7 through 1-11. As shown, the RMS acceleration in wander zones is about 37% (0.1 m/s² [0.010g]) greater than that in non-wander zones. Further, there is no overlap between the non-wander and wander data – the greatest non-wander RMS acceleration (Run 1-7, 0.319 m/s² [0.033g]) is less than the least wander RMS acceleration (Run 1-11, 0.334 m/s² [0.034g]). These results show that computing the lateral RMS acceleration is a suitable way to compare wander and non-wander areas. It follows that a system to measure

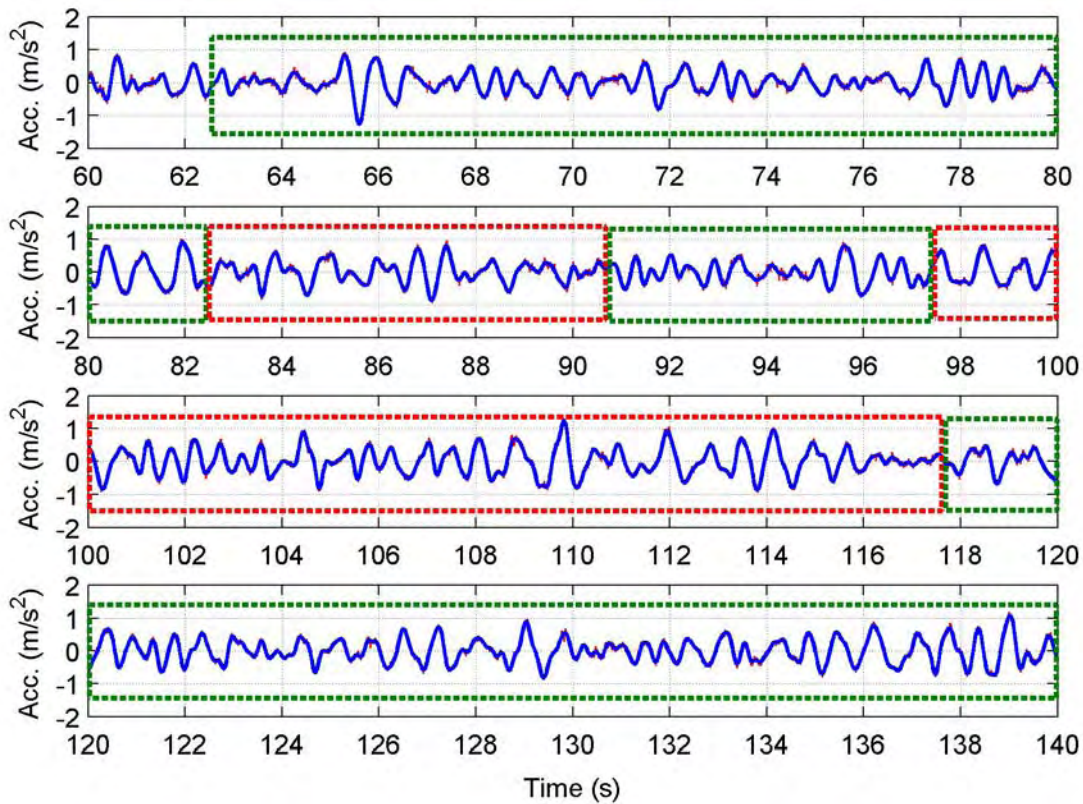
Figure 4-9. Raw and low pass filtered (5 Hz cut-off frequency) lateral acceleration data from Run 2-13

Further analysis was performed with data collected during the second round of field testing, where an attempt was made to quantify wander into two distinct levels, low and high. Figure 4-9 shows the acceleration time history from Run 2-13, where low- and high-severity wander are indicated in green and red boxes, respectively. The low- and high-severity zones are visually discernable, with the high-severity zones having a higher concentration of waveforms in excess of 1m/s^2 . However, as expected inspection reveals that the low-severity wander zones contain isolated instances of high-severity wander, and vice versa. This corroborates the current understanding that wander is due to individual, constantly changing interactions between the tires and the tread (see section 2.1). Given small scale variations in the timing pattern and complicated tire tread designs, wander is a transient, stochastic phenomenon – it is expected that trends can be discerned through larger scale averaging, but examination of individual events may appear random. Table 4-B summarizes the RMS levels from all the 113km/h runs (both east- and west-bound) from day two. The results indicate that on average, low- and high-severity wander consist of RMS accelerations of 0.297 and 0.349 m/s^2 , respectively, representing 16% and 37%

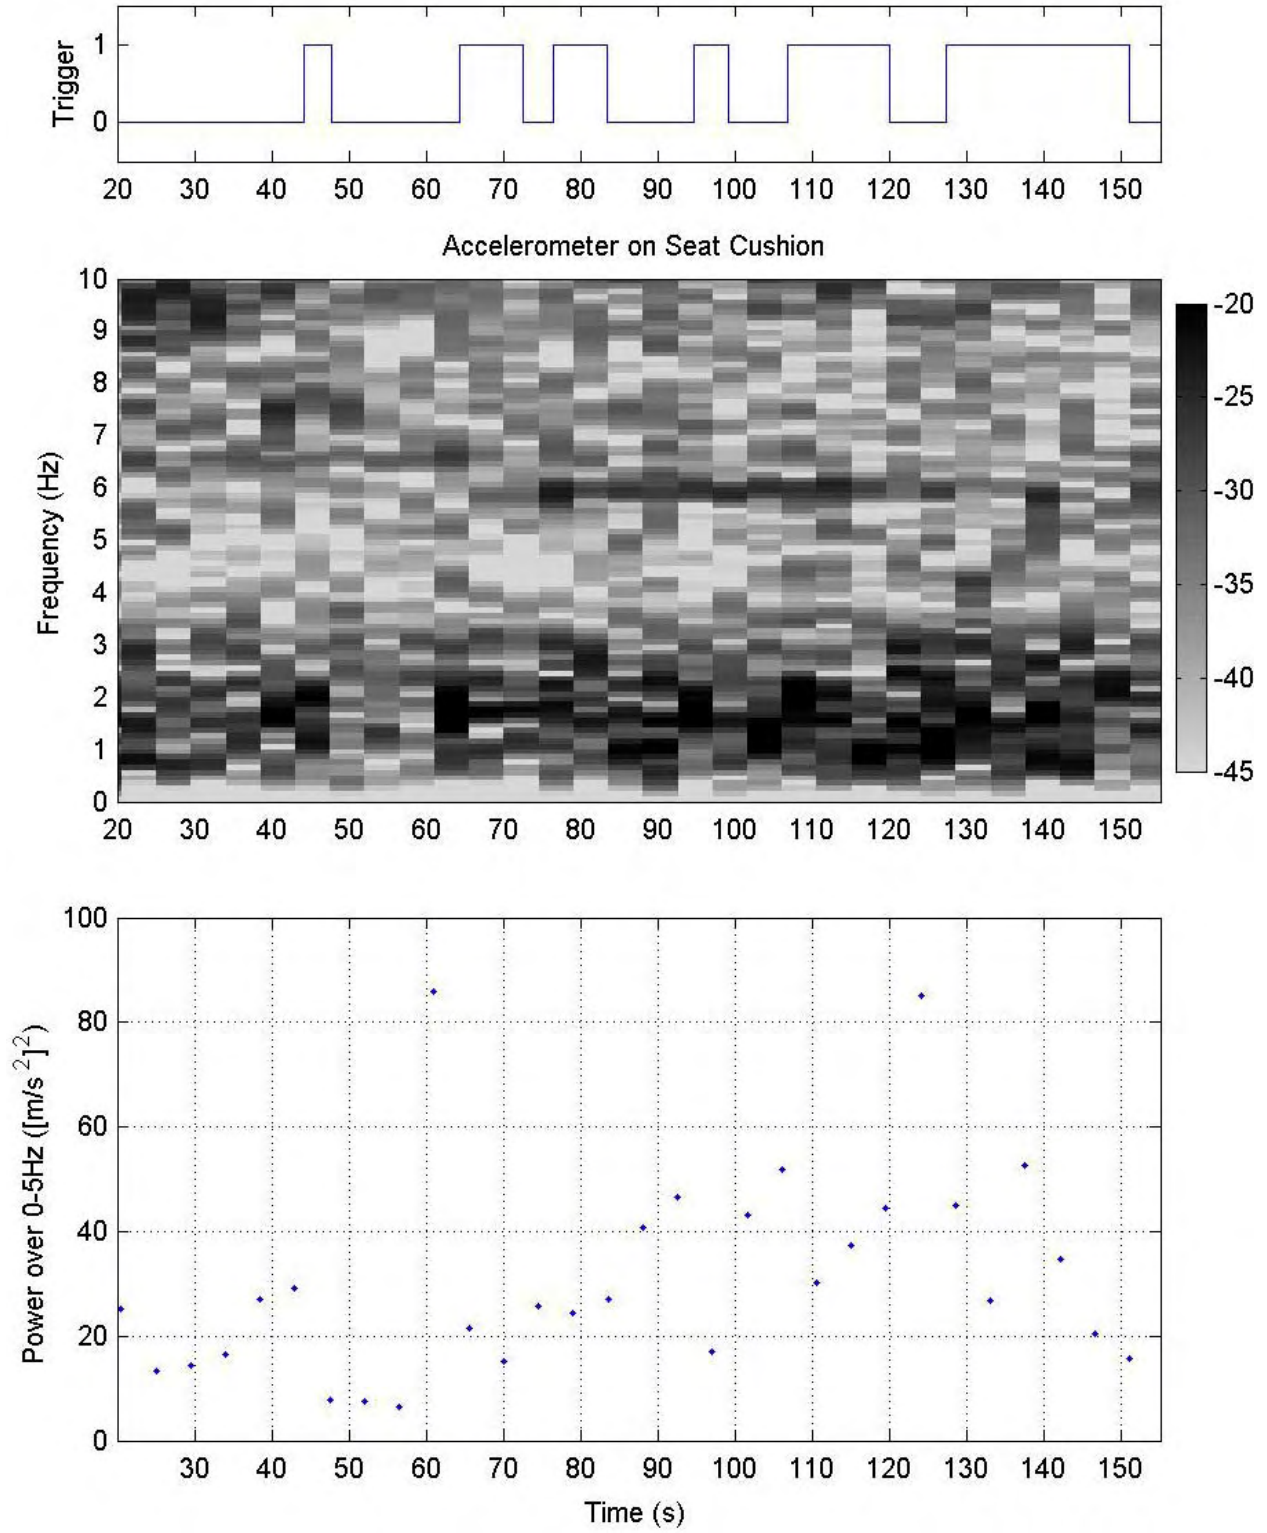
Figure 4-11. Frequency domain analysis of the seat cushion placement (Run 1-3)

Another objective of this research was to identify the optimal accelerometer placement to capture vehicle wander. As described in Section 3.4, four different accelerometer placements were evaluated: seat frame, seat cushion, seat back, and passenger's head. Frequency and time domain analyses were used to evaluate each placement. Spectrograms (see Figure 4-2 above) allow visualization of the frequency content of the measured acceleration in a moving time window fashion. Comparing spectra of wander and non-wander zones via spectrograms allows for the sensitivity of each placement to be evaluated. Further, computing the total power in the 0-5 Hz frequency band (see Figure 4-3 above) allows further insight into the sensitivity of each placement to the low-frequency wander vibrations. Figures 4-10 through 4-13 present the frequency domain analysis for the seat frame, seat cushion, seat back and passenger's head placements, respectively. The frequency domain analysis reveals that the passenger's head placement is the most sensitive to wander vibrations.
