Report No. CDOT-2009-13
Final Report

LATERAL VEHICLE ACCELERATION DUE TO LONGITUDINALLY TINED PORTLAND CEMENT CONCRETE PAVEMENT

Robert V. Rinehart
Michael A. Mooney

December 2009

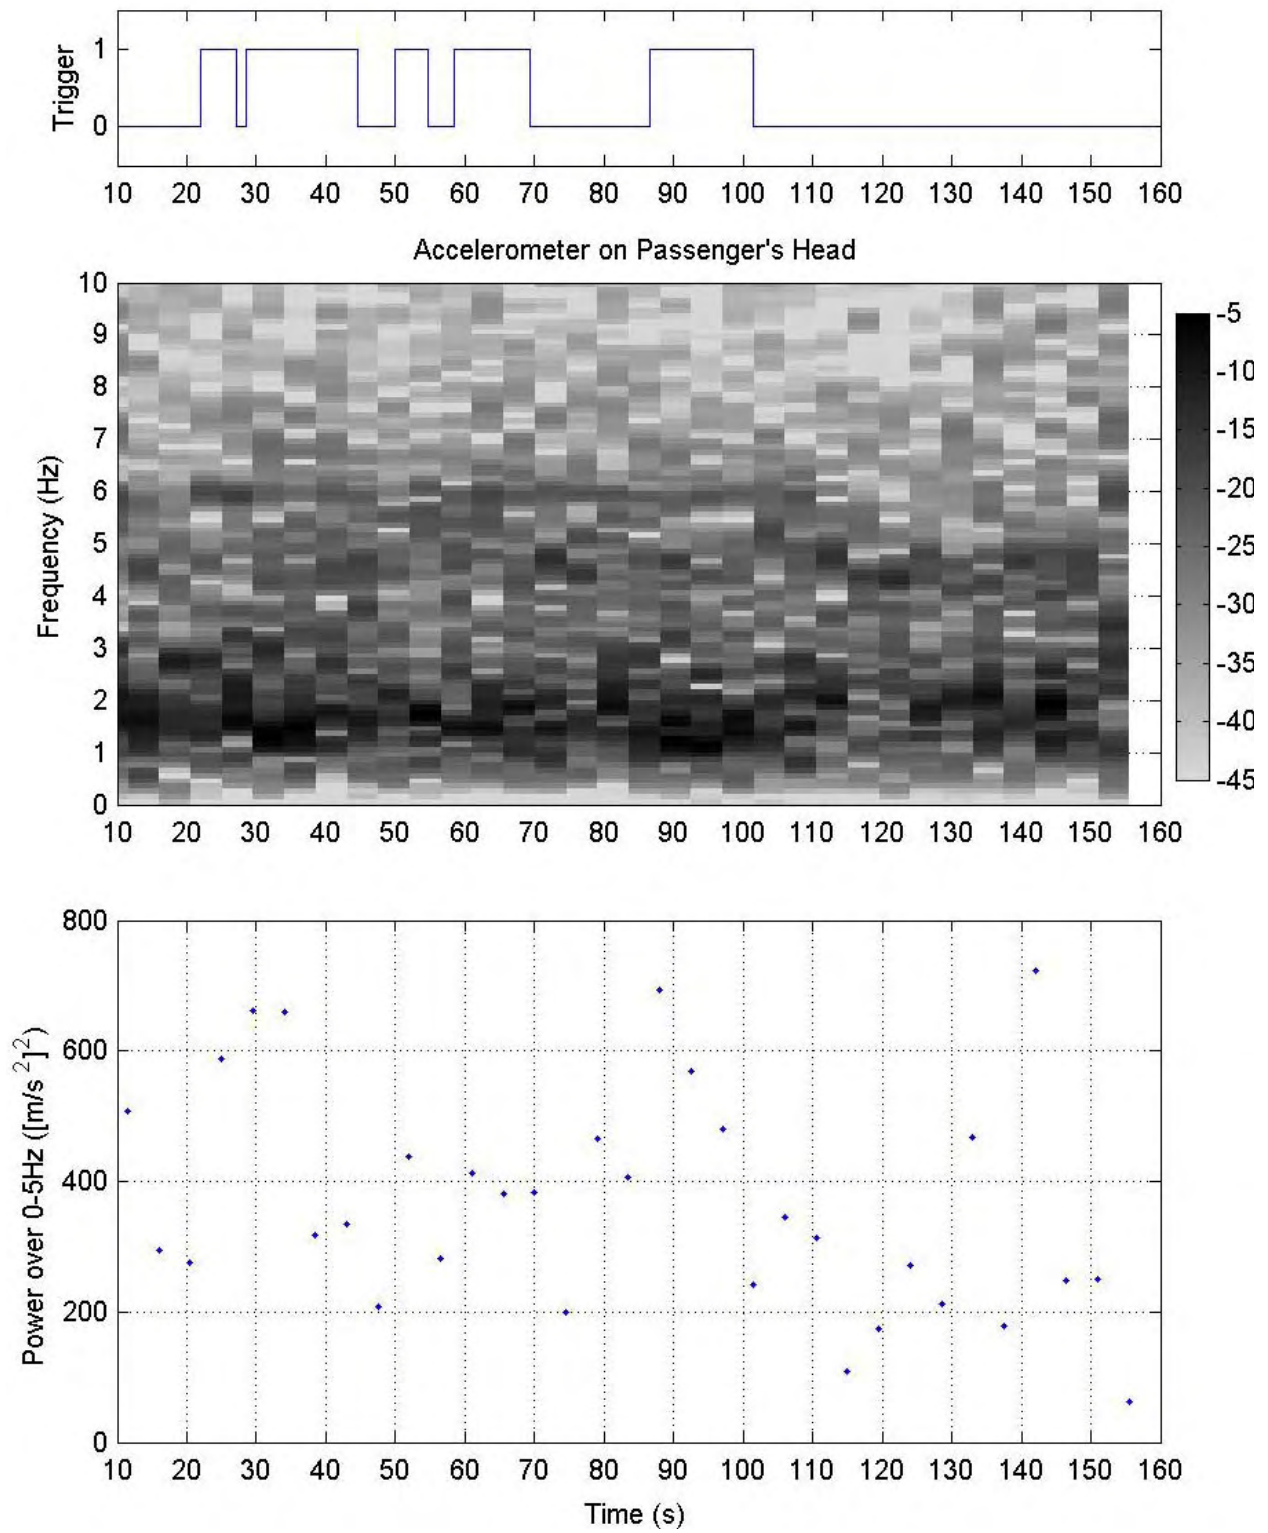
Figure 4-13. Frequency domain analysis of the passenger's head placement (Run 1-9)

Another objective of this research was to identify the optimal accelerometer placement to capture vehicle wander. As described in Section 3.4, four different accelerometer placements were evaluated: seat frame, seat cushion, seat back, and passenger's head. Frequency and time domain analyses were used to evaluate each placement. Spectrograms (see Figure 4-2 above) allow visualization of the frequency content of the measured acceleration in a moving time window fashion. Comparing spectra of wander and non-wander zones via spectrograms allows for the sensitivity of each placement to be evaluated. Further, computing the total power in the 0-5 Hz frequency band (see Figure 4-3 above) allows further insight into the sensitivity of each placement to the low-frequency wander vibrations. Figures 4-10 through 4-13 present the frequency domain analysis for the seat frame, seat cushion, seat back and passenger's head placements, respectively. The frequency domain analysis reveals that the passenger's head placement is the most sensitive to wander vibrations.

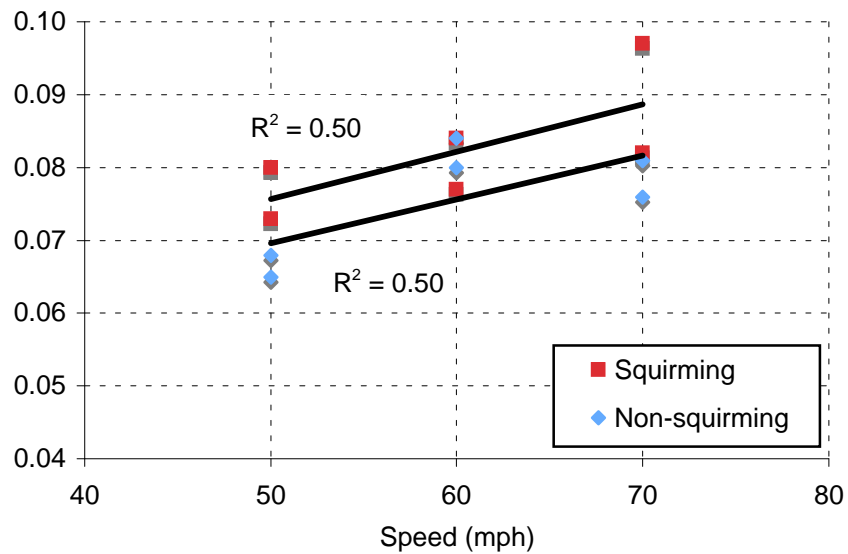
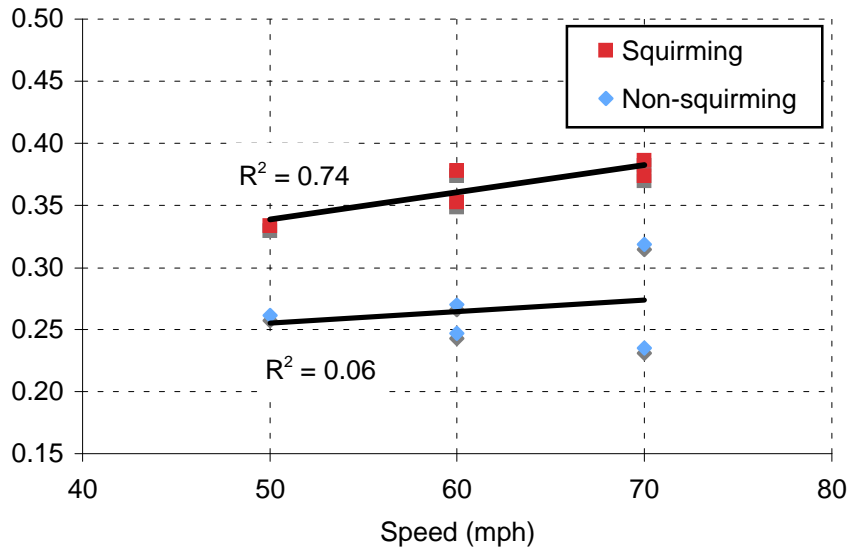
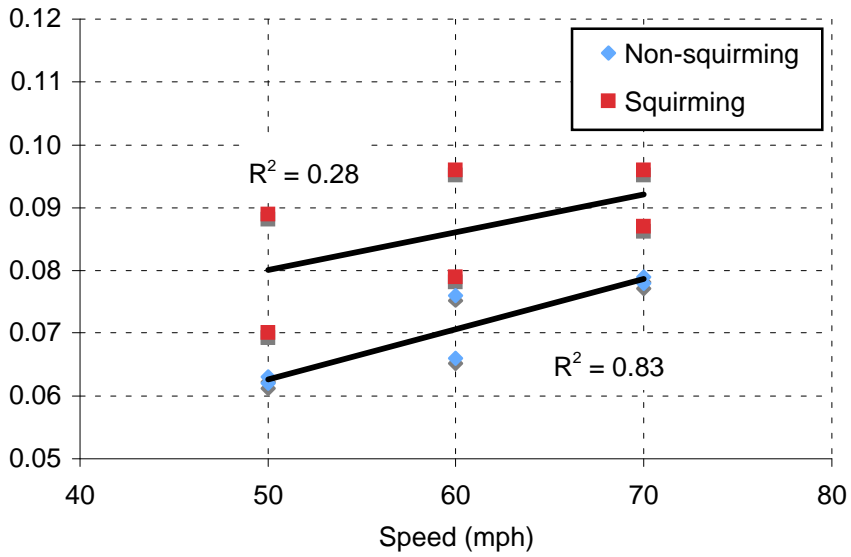
Figure 4-14. Effects of vehicle speed on seat cushion vibration

Figure 4-15. Effects of vehicle speed on head vibration

Figure 4-16. Effects of vehicle speed on seat back vibration

As summarized in Table 3-B (Section 3.4), day one test runs were performed with vehicle speeds of 80, 97 and 113kmh (50, 60 and 70mph). Figures 4-14, 4-15 and 4-16 show the influence of speed on mean acceleration levels for wander and non-wander areas. The results show that speed increases vibrations in both wander and non-wander areas. Further, in most cases, the rate of increase in vibration with speed is similar between both wander and non-wander areas. Therefore, it is not possible to infer if increased speed leads to increased severity of wander, or just vibration in general. These results are supported by the qualitative observation made during testing that vehicle speed had little discernable affect on wander.

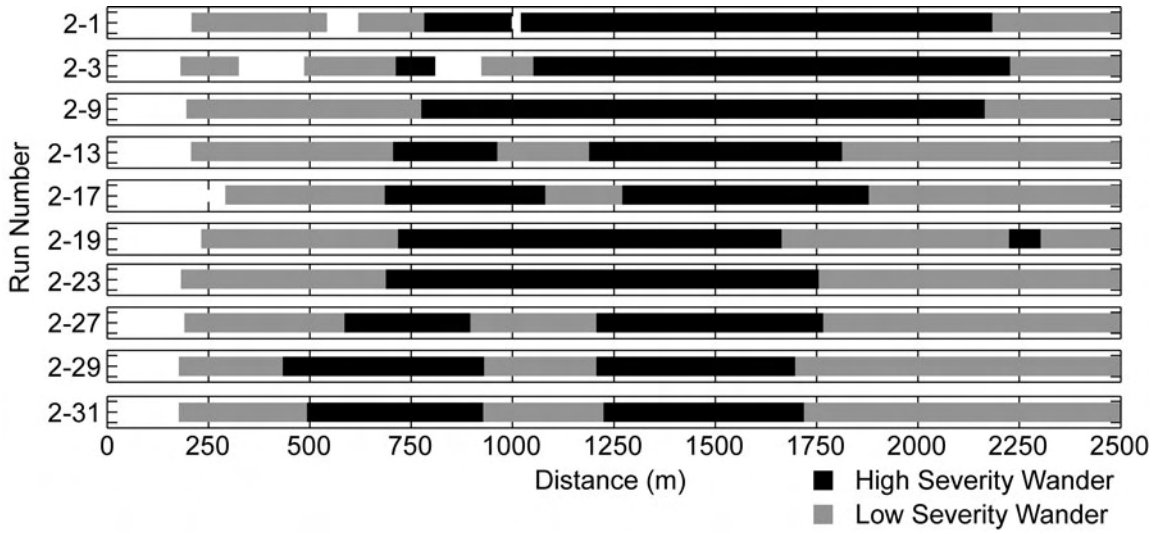
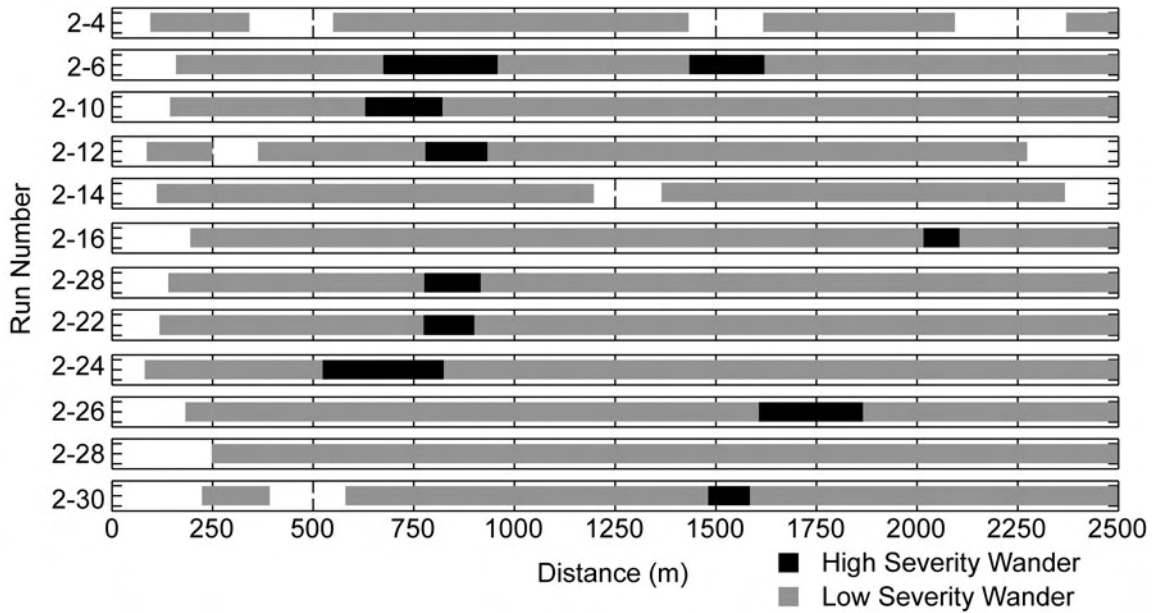
Figure 4-17. Trigger signals for 113km/h (70mph) day two east-bound runs

Figure 4-18. Trigger signals for 113km/h (70mph) day two west-bound runs

In order to assess the overall measurement system's repeatability, several consecutive passes were performed over the same stretch of roadway. The van driver paid particular attention to maintaining a similar wheel track (estimated to be consistent to within 15-30cm) and the passenger marked the data files with a consistent start and stop point to allow for comparison of the different runs. Figures 4-17 and 4-18 present the trigger signals for all of the 113km/h east- and west-bound runs, respectively. Inspection reveals that there are some general consistencies between various runs, but a high level of repeatability does not emerge. For example, in the east-bound runs, the stretch of road from 250-500m is generally associated with low-severity wander and the stretch of road from 1250-1750m is generally associated with high-severity wander. These trends however, are far from precise.

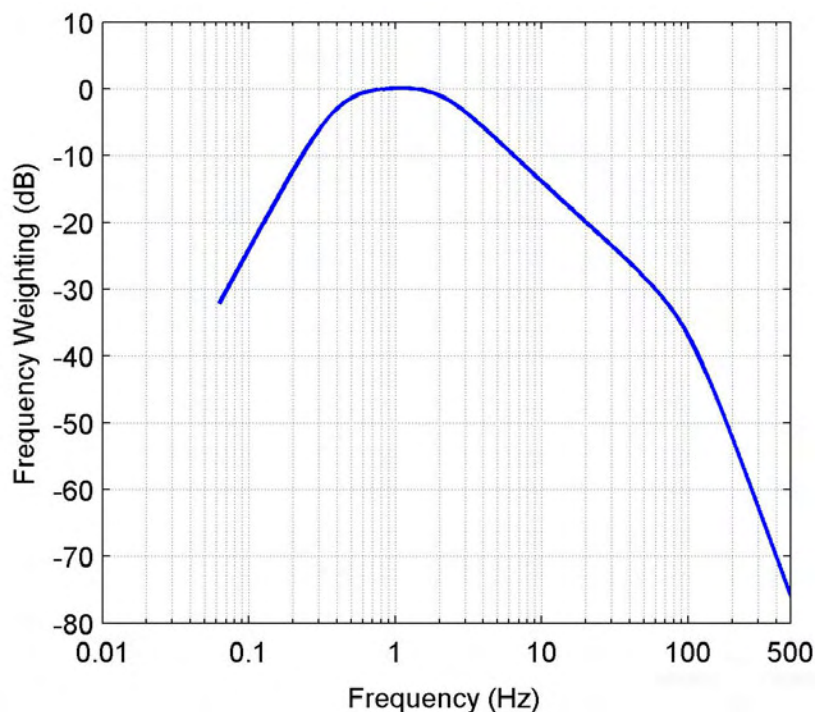
Figure 4.19. Frequency weighting function for lateral seat cushion acceleration measurements (per ISO-2631)

According to ISO-2631 several vibration measurements (e.g., seat cushion, seat back, vertical, lateral, longitudinal directions) may be combined to assess discomfort, or alternatively, a single measurement location may be used to examine a specific phenomenon (e.g., seat back *or* seat cushion). In the case of wander, it is desirable to isolate the lateral direction. Table 4-G presents the mean RMS ISO acceleration levels from no, low-, and high-severity wander zones along with
