Evaluation of an Alternative Deicing
Chemical vs. Conventional Sodium Chloride

Final Report

Prepared by the New Hampshire Department of Transportation, in cooperation with the
U.S. Department of Transportation, Federal Highway Administration

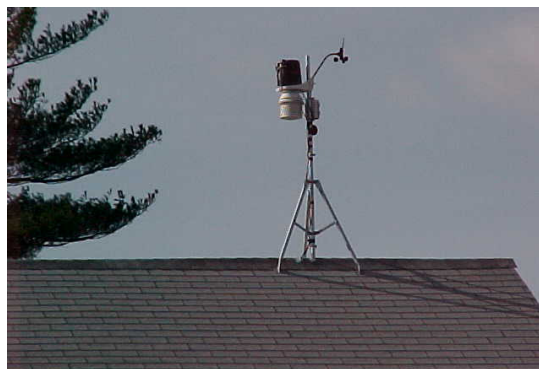
Figure 3: Weather Station at Bristol Maintenance Shed

Figure 3 shows the weather station in Bristol. Weather information recorded during the study included: date, time, temperature, humidity, dew point, wind speed, wind direction, wind chill, heat and thaw indices, barometric pressure, rain and rate (water equivalent, through heating of snow), and other data. The instruments do not record the type of precipitation or snow depth.

Weather Data. In addition to the regular, statewide weather forecasting resources utilized by NHDOT, weather data were collected and recorded at 30-minute intervals by weather stations mounted on the roof of the Bristol and Sunapee patrol sheds (Appendix D).

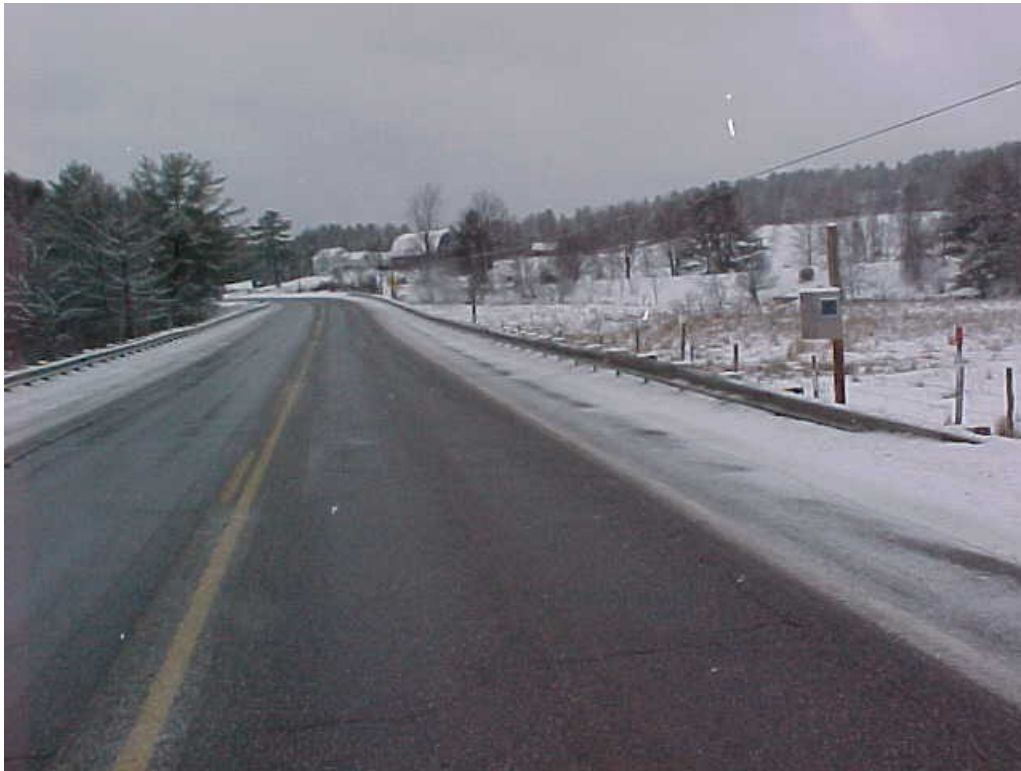
Figure 4: Traffic Counter Site on Route 103 in Sunapee

Traffic Data. NHDOT personnel installed and maintained traffic monitoring stations at both test sites. Traffic counts and vehicle speeds were recorded every 30 minutes. Collected data were transmitted to the District 2 office approximately once a week. Locations monitored include the eastbound and westbound lanes of the Bristol East test section, the westbound lane of the Bristol West section, and the westbound lane of both Sunapee sections. Figure 4 shows the traffic data collection station at the Sunapee test site.
