BUS-STOP SHELTERS – IMPROVED SAFETY
(Phases 1 and 2)

Colorado State University
Fort Collins, Colorado

July 2010

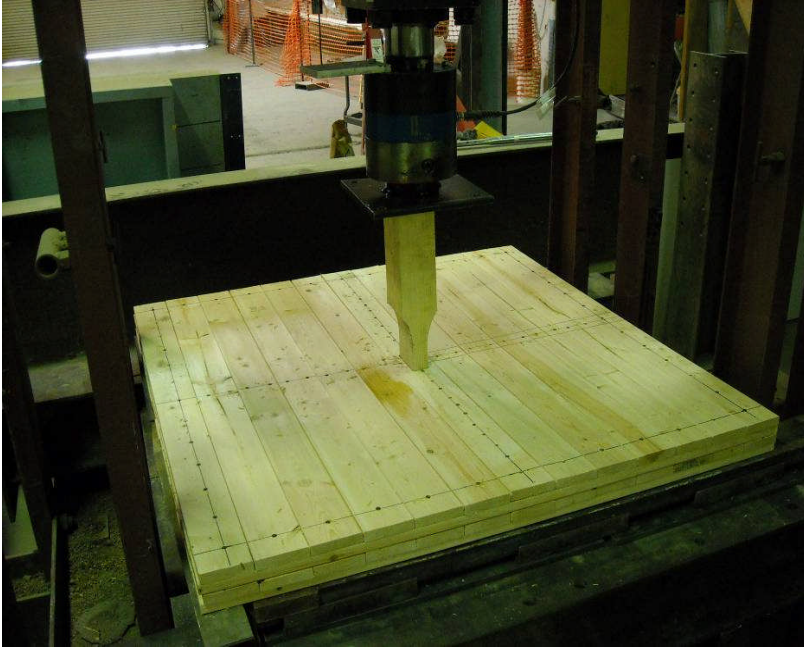
Figure 1.5 Isometric View Diagram of Static Load Test

A static test was developed using a nominal 4x4 modified at the end to the cross-sectional size of a 2x4 to transfer the load from the load cell to the specimen (Figure 1.5) that supported the specimen with similar edge conditions to the specimens in the impact loading test setup. The purpose of this testing was to observe the response of a specific specimen type under ramp loading, which has substantially longer load durations than the impact tests.³

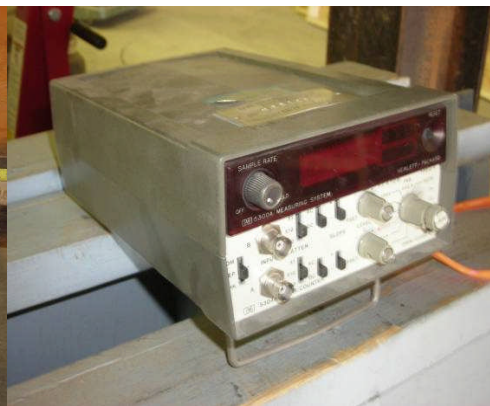
Multiple methods were used to calibrate and measure the velocity of the missile. First, a Hewlett Packard 5300A timer was employed with accuracy to within a nanosecond (Figure 2.9). The timer system uses two sets of electrodes. Each set is an interconnected pair. The timer is started when the first circuit is broken (i.e., first pair separated) and continues until the second circuit is broken. For the purposes of this testing, the circuit was created by attaching the gator clamps on the electrodes to two nails, running a strip of aluminum foil between the nails, and placing this system at the end of the cannon support beam (Figure 2.10). The circuit would be broken as the projectile cut each piece of aluminum foil. For this test, the distance between the two foil strips was set as 18" (45 cm). Consequently, a reading of 10.23 milliseconds between circuit breaks would indicate a velocity of 100 mph (161 km/h).

Figure 2.10 HP 5300A Timer

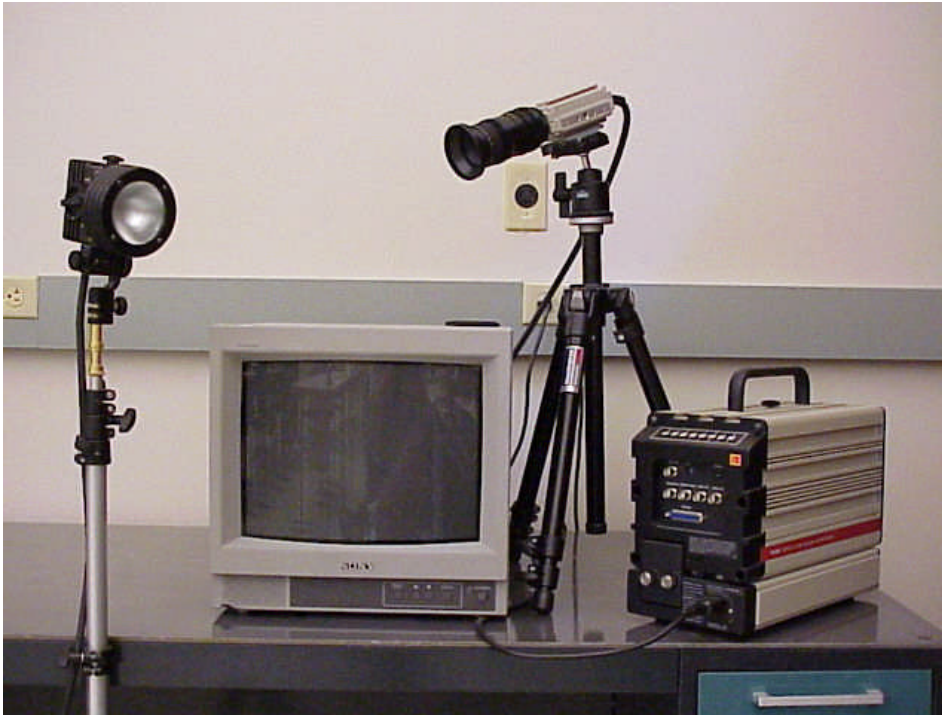
High speed camera footage was utilized to capture the missile events. This was done for multiple reasons. First, it was desired to see how the projectile and the target reacted to the shot in the period of a few milliseconds. Second, the projectile was marked at every 2 in. (51 mm), resulting in the ability to calculate velocity by recording the time durations for it to travel a known distance. Lastly, it was also possible to determine the deflection of the wall at the impact point, as described in Section 2.2.2. The camera used was a Kodak Motion Corder Analyzer PS-110 with RGB CCD that could record at up to 10,000 frames per second, but was used at 3,000 frames per second.

Figure 2.11 Kodak Motion Corder Analyzer PS-110 (Alciatore)

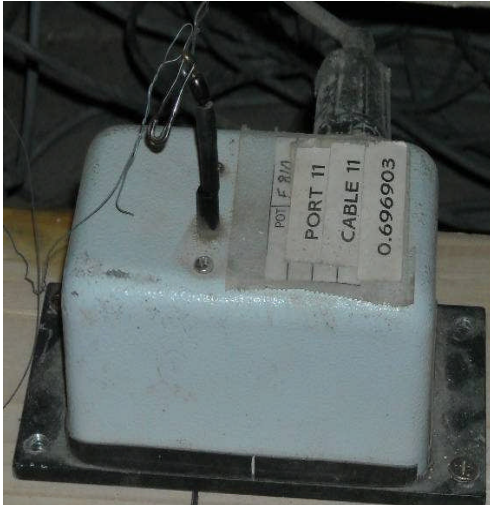
To measure the deflection of the specimens, nine string potentiometers were arranged in a 3x3 grid pattern. The potentiometers (Figure 2.13) were placed at 11.25 in. (28.6 cm) spacings (45 in. divided into four sections) and were attached to eye-hooks screwed into the bottom (rear) layer of the specimen. Potentiometers were calibrated before use, and the deflections provided in the results are the corrected deflections.

Figure 2.13 String Gauge Deflection Measurement

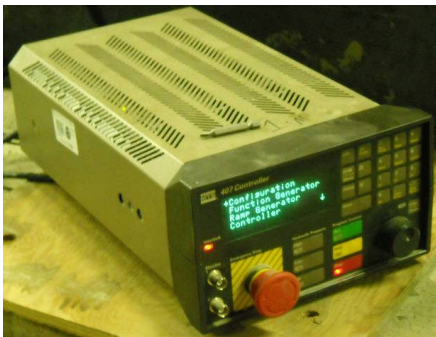
Figure 2.14 Static Load Control

The device used to control the static load was an MTS 407 Controller (Figure 2.14). This control unit is capable of controlling the load cylinder through either load or displacement control.⁵

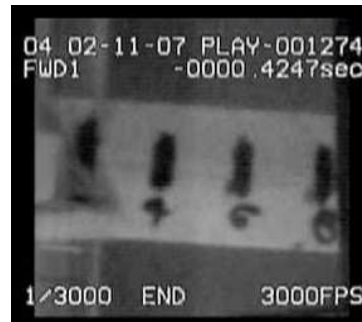
Figure 3.1e Impact+ 0.0113s

Test #19 and #21 were the first specimens to pass a 90° impact test with bending about the components' strong axes (Figure 2.14). High speed video was taken of Test #19.⁷ Test #19 consisted of three layers of 2x4s bending about the strong axis, with only approximately 0.5 in. (12 mm)⁸ of deflection in the back layer while crushing the front layer around the impact zone. Test #21 consisted of two layers of 2x2s in front of two layers of 2x4s with the back layer only pushed out approximately 0.25 in. (6.4 mm) and both layers of 2x2s crushed around the impact zone. Figures 3.1a through 3.1e show five frames of the impact on Test #19. Figure 3.1a shows the moment of impact, while Figures 3.1b and 3.1c show the missile entering the specimen halfway and fully through the time of impact, respectively. Figures 3.1d and 3.1e show the missile exiting the specimen, breaking a section of a board with it. The high speed videos are located at the CSU Structures Lab website (CSU 2009).

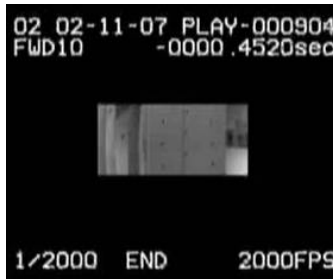
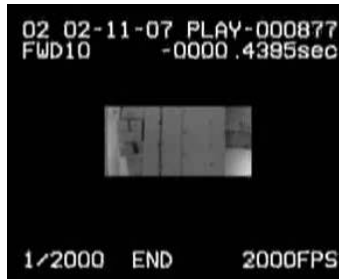
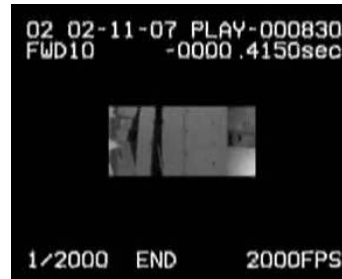
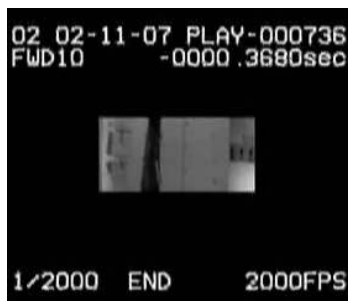
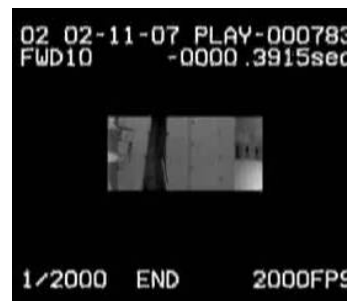
Although Tests #19 and #21 were successful, it was necessary to retest these specimens.⁹ Tests #20 and #22 were the second tests of these specimens. Figures 3.2a through 3.2e are high speed camera stills at 0.0235 second intervals throughout the impact, pushing the rear layer back 5 in. (127 mm). Figures 3.2d and 3.2e show the missile being stopped by the specimen, though the specimen was significantly damaged. Being the second test on this specimen, more deformation was expected and the camera was zoomed farther out so as to capture 4 in. (102 mm) of deflection and/or deformation on the rear layer.¹⁰

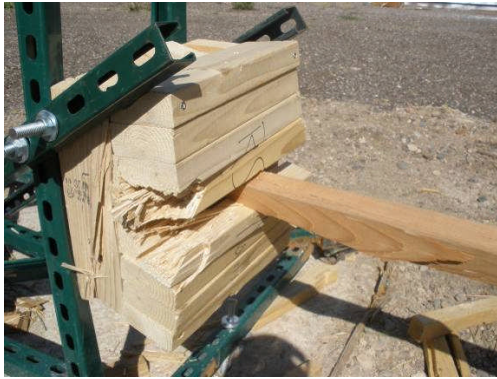
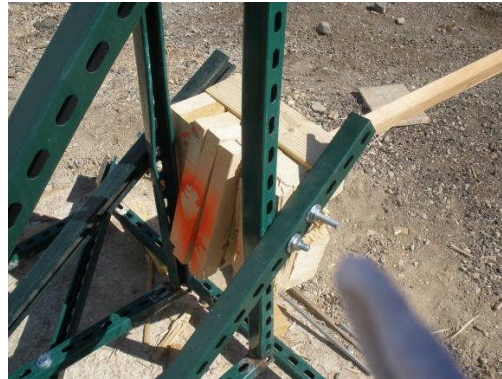
One design idea was to build 1 ft. (30 cm) x 1 ft. (30 cm) specimens that would be adjoined to make a larger structure (Section 2.3.1). The idea of this structure was to minimize the unbraced length of the members under stress, which would aid in survival of the specimen. Tests #25 and #26 served to investigate this. Figures 3.3a and 3.3b give front and rear views of Test #26.¹¹ Specimens in Tests #25 and #26 were exactly alike with the exception of the fasteners utilized: screws and ring-shanked nails, respectively. These tests were considered failures because the specimen was significantly damaged and the rear layer was pushed out, even though the missile was stopped. Additional photographs are included at the CSU Structures Lab Web site (CSU 2009).

Figure 3.3a Front View of 1 ft. x 1 ft.
Impact (Test #26)

Figure 3.3b Rear View of 1 ft. x 1 ft.
Impact (Test #26)

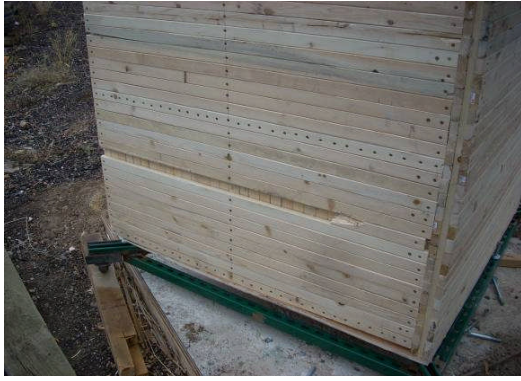
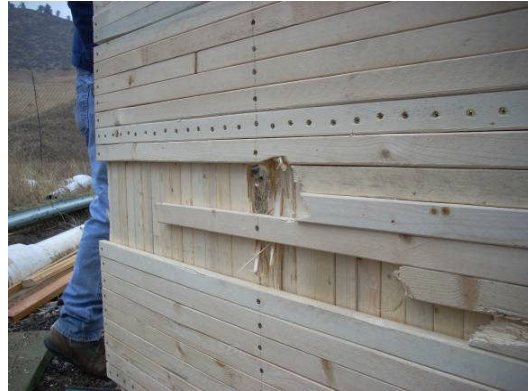
Tests #27 through #34 were all constructed using four crossing layers of 1x2s and the Edge/Cross fastener configuration and the Method 1 fastener direction. Tests #27 and #33 were fired at an impact angle of 30° with both specimens surviving with minimal damage. Since these tests easily withstood the load, Tests #28 and #32 were the second shot for each of these specimens and were fired at an impact angle of 45°. The missiles of both tests punctured the specimens with minimal damage to the missile. Figures 3.4a and 3.4b give post impact images for Tests #27 and #28, respectively.

Figure 3.4a Test #27 Post Impact

Figure 3.4b Test #28 Post Impact

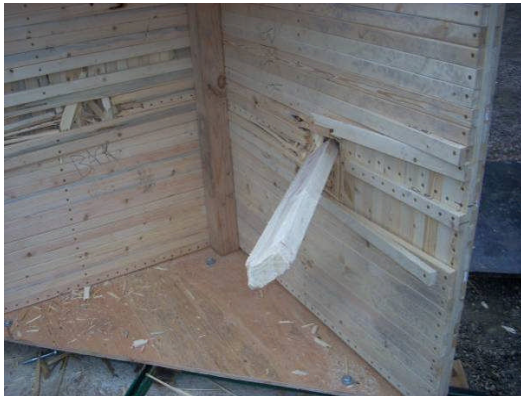
Figure 3.5a Test #34 Post Impact

Test #34 was different from Tests #28 and #32 in that while the missile punctured the specimen, it did not completely pass through the specimen, instead protruding approximately 3.5 ft. (1.1 m) after penetrating the specimen. Figures 3.5a and 3.5b show the post impact view of Test #34.

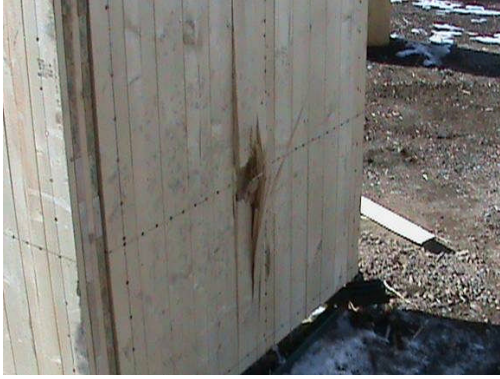
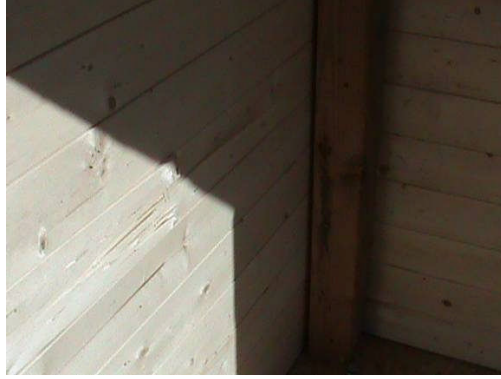
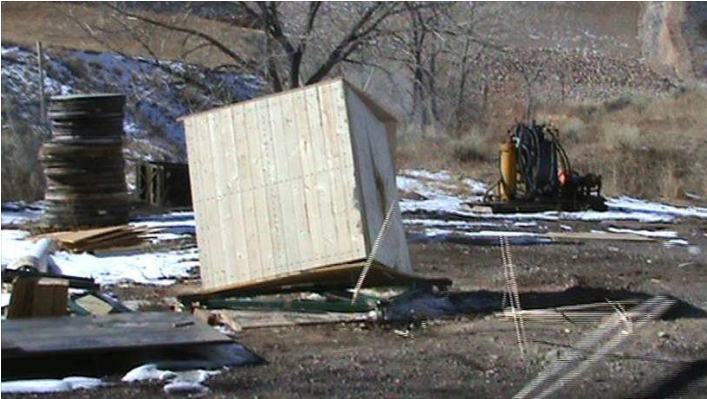
The specimens used for Tests #35 and #36 consisted of three layers of 1x4s connected using the Edge/Cross and Method 1 fastener configurations. Test #36 was the only test in which the specimen was fastened together using the Edge/Star distribution and also used the Method 1 fastener direction. The specimen for Test #37 was the first to survive a 45° angle of impact while bending about the weak axis (Figure 2.15). This specimen was the same configuration, and all subsequent specimens utilized the Edge/Cross and Method 2 fastener configurations. The major difficulty with this specific test is that a nut was accidentally not attached to the bolt at the front vertex of the base support. As a result, the specimen support structure rotated about the rear bolts and lifted up in the front directly after impact and then returned to its original position along with breaking approximately half the screws attaching the specimen to the support structure; even with this mistake, the test results were interesting as only the front layer was punctured with minimal damage on the rear layer. Figures 3.6a and 3.6b show the post-impact damage to the specimen, while Figure 3.6c is a video still at the moment the specimen support structure lifted up in the front. Regular speed video is included at the CSU Structures Lab Web site (CSU 2009).

Figure 3.6a Test #37 Post Impact
Front View

Figure 3.6b Test #37 Post Impact
Rear View

Figure 3.6c Test #37 Video Still of Front Vertex Uplift

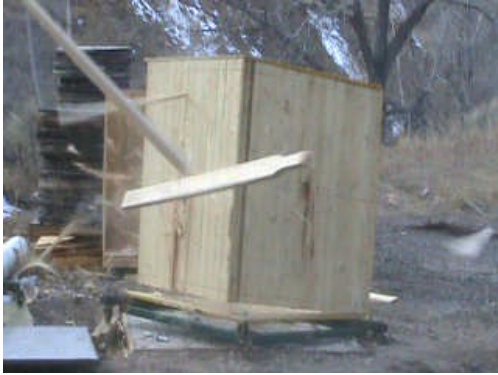
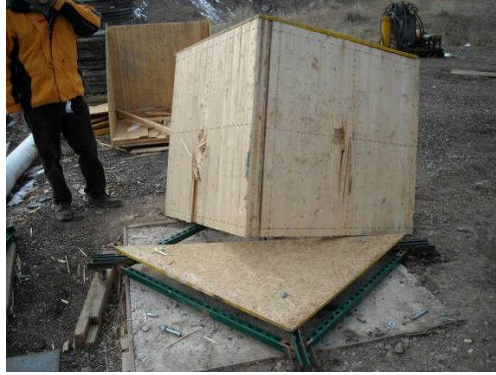
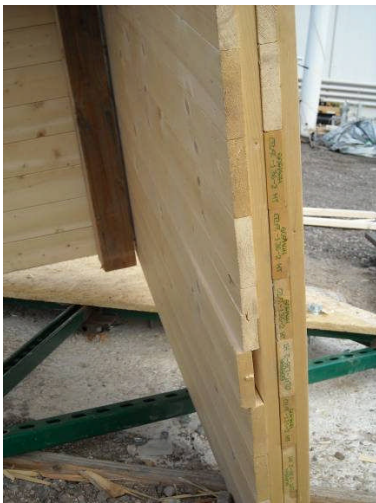
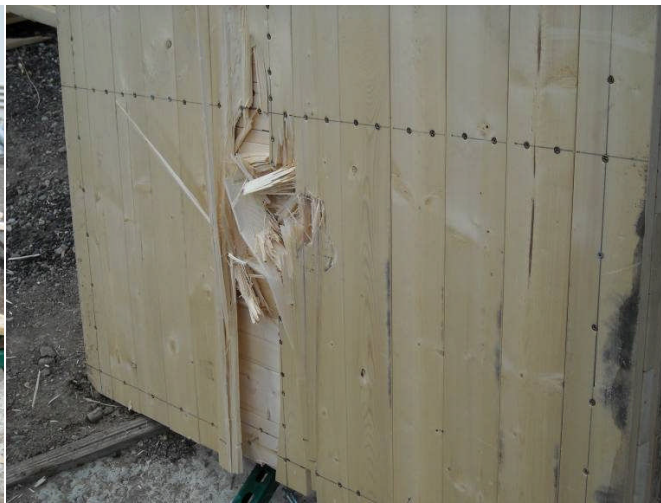
Test #38 also had an impact angle of 45° , with the key difference being that the both of the specimen walls separated from the base support while still stopping the missile. Figures 3.7a and 3.7b give front and rear views of the specimen after impact, while Figures 3.7c and 3.7d show the regular speed video impact still and post impact general view. In the figures, note that the missile impacted on the left specimen, though the right side is also damaged from a prior test.

Figure 3.7a Test #38 Impact Video Still

Figure 3.7b Test #38 Post-Impact General View

Figure 3.7c Test #38 Post-Impact Rear View

Figure 3.7d Test #38 Post-Impact Front View

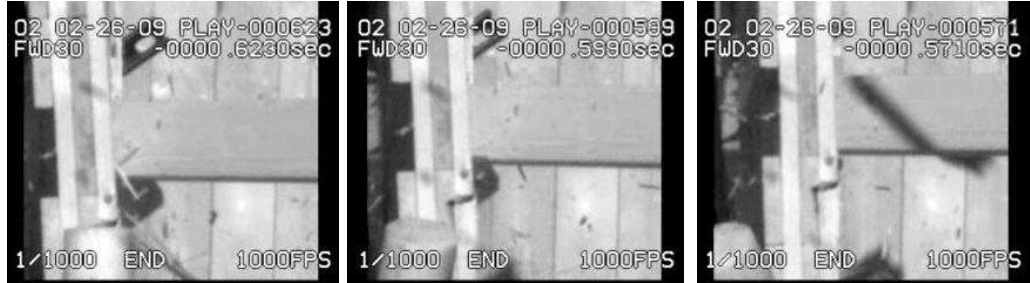
Figure 3.8a through 3.8f are high speed video stills from Test #39, in which the missile penetrated the specimen, but was stopped (similar to Test #33). Figure 3.8a shows the missile at the moment of impact with the specimen.

Figure 3.8a Test #39 (Impact)

Figure 3.8d Impact+ 0.071s

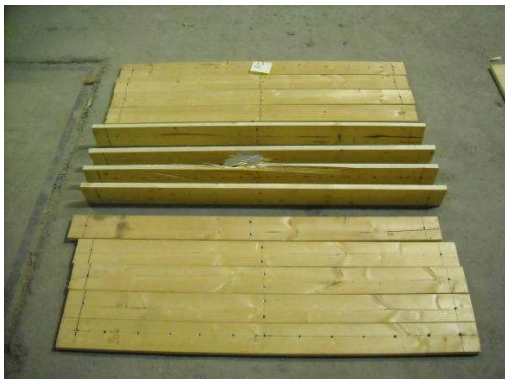
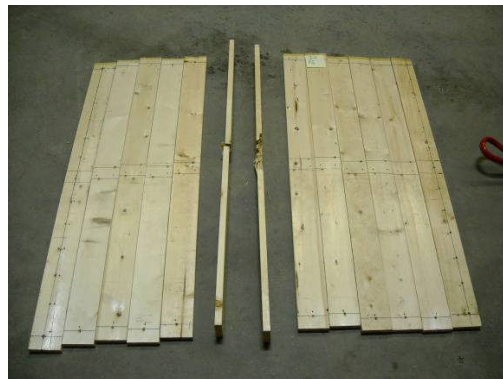
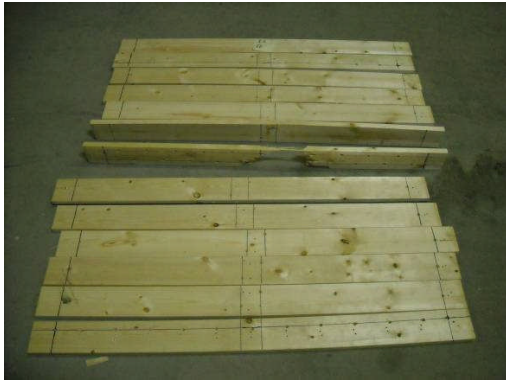
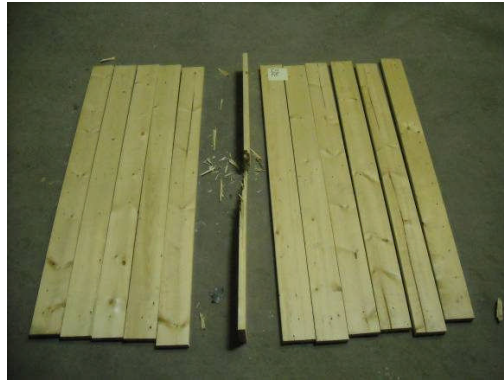
Since the distribution of the impact load was crucial toward the ability of the specimen to resist the test, the specimen used for Test #39 was disassembled layer by layer. Figures 3.8g through 3.8j show each layer, in which the boards that had a deflection of 0.25 in. (6.4 mm) or were severely damaged were turned on their side. This will be used for comparison to the statically loaded specimen layers shown in Section 3.2.2.

Figure 3.8g Test #39 Front Layer

Figure 3.8h Test #39 Second Layer

Figure 3.8i Test #39 Third Layer

Figure 3.8j Test #39 Rear Layer

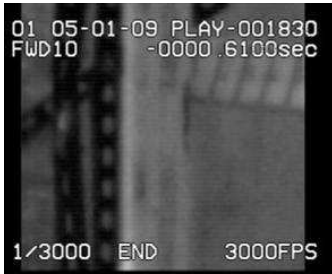
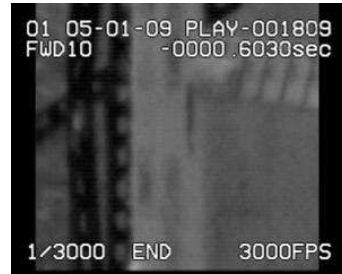
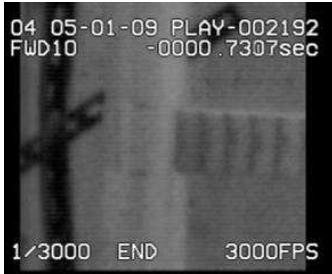
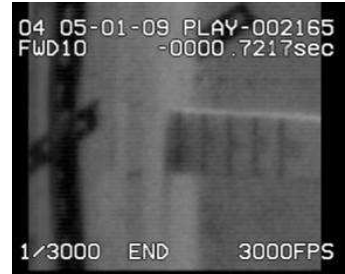
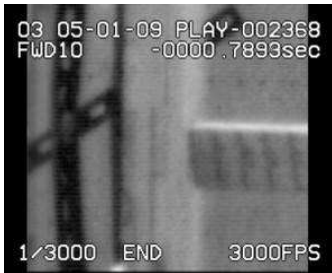
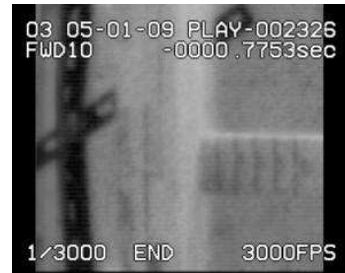
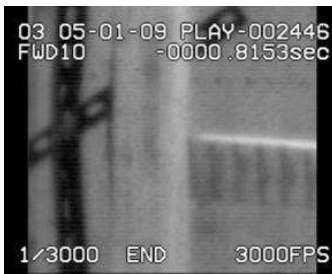
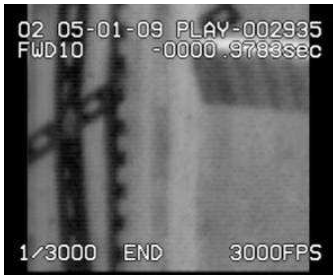
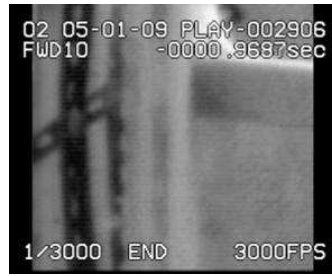
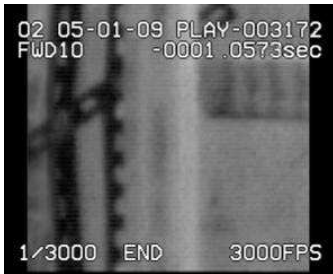
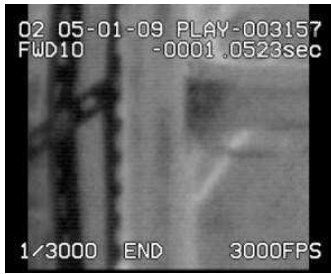
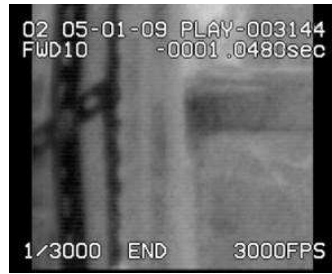
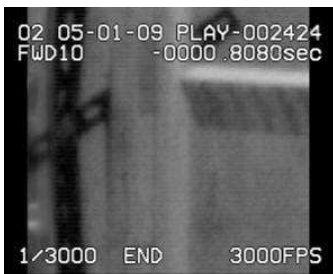
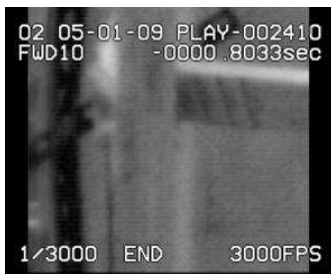
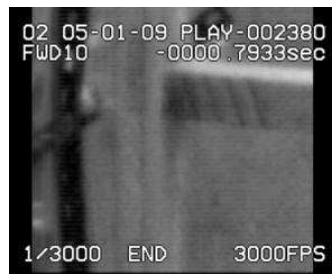
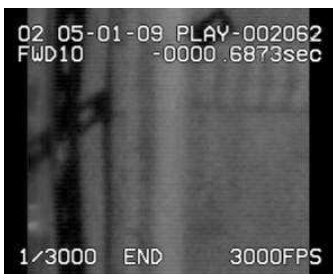
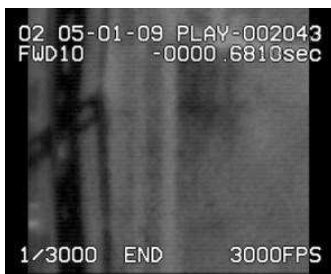
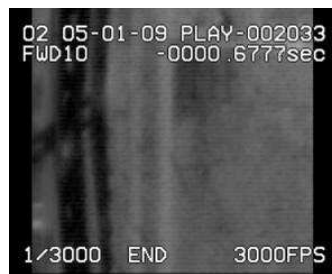
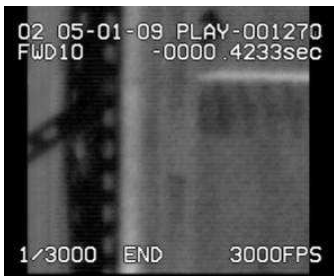
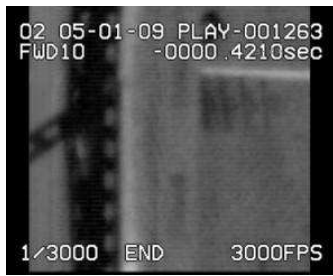
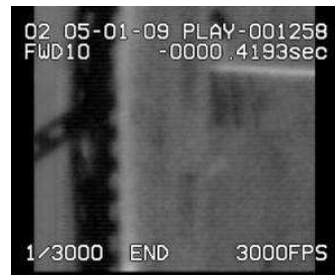
Tests #41 through #49 were the second to last set of impact tests conducted in which high speed camera footage was taken. These tests were conducted at varying velocities at a 45° angle of impact with either rigid or flexible supports as indicated in Table 3.1. Figures 3.9a through 3.17c represent each of these successful tests, with three high speed camera stills for each test: a) at impact, b) at the moment of maximum local deflection, and c) at maximum global deflection. All tests stopped the missile, though Tests #45 and #48 were damaged too much to be considered successful tests (would obviously not pass a second test).

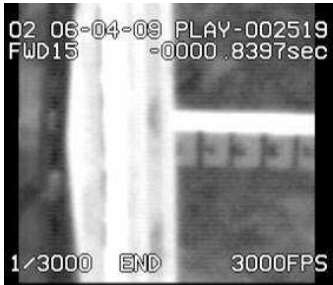
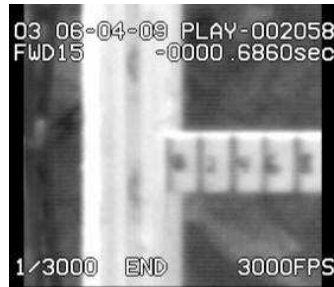
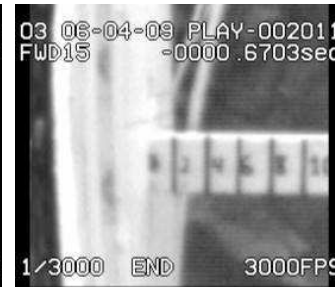
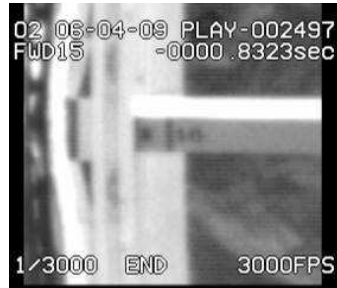
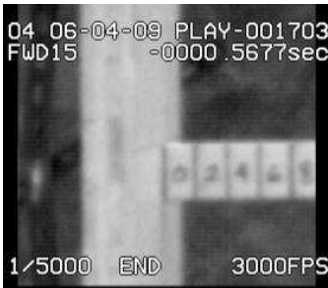
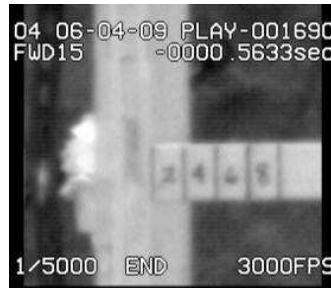
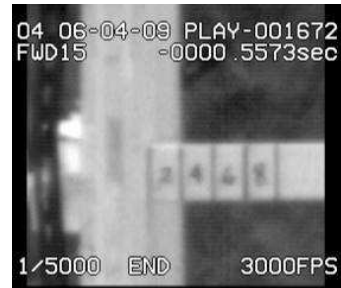
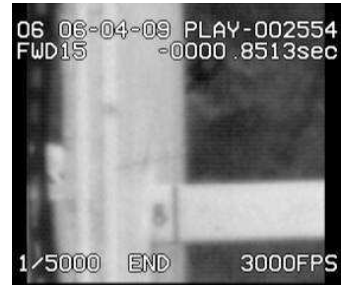
Tests #50 through #56 were the last set of impact tests conducted in which high speed camera footage was taken. These tests were conducted at varying velocities with a 90° angle of impact with either rigid or flexible supports as indicated in Table 3.1. Figures 3.18a through 3.24c represent each of these successful tests, with three high speed camera stills for each test: a) at impact, b) at the moment of maximum local deflection, and c) at maximum global deflection (successful tests) or post-penetration (failed tests). Tests #50, #51, and #54 successfully stopped the missile without significant damage, while Tests #52 and #53 were failures that still stopped the missile (Figures 3.20d, 3.21d, and 3.23d).

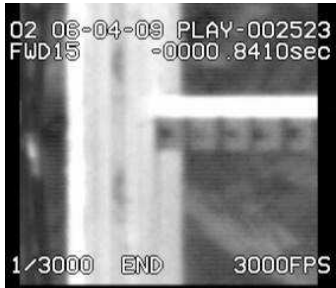
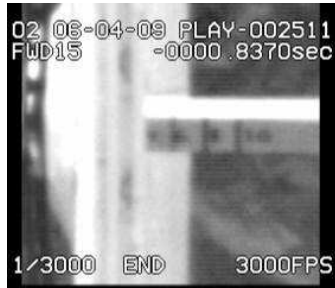
Figure 3.20a Test #52 Impact (Fail)

Figure 3.20b Impact + 0.0040 sec

the testing showed that the flexibly supported specimen failed the test but stopped the missile at about 100 mph (161 km/h) (Figures 3.20d and 3.21d) with Shot #53 only allowing approximately 14 in. (36 cm) of penetration. This suggests that the envelope for success at a 90° angle of impact is in the 90-95 mph (145-153 km/h) velocity range.

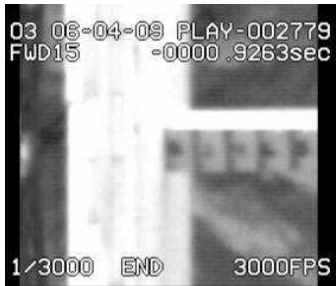
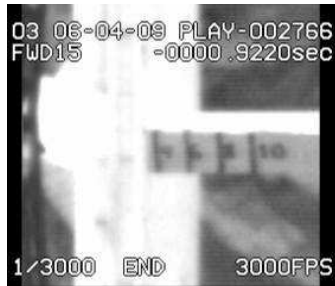
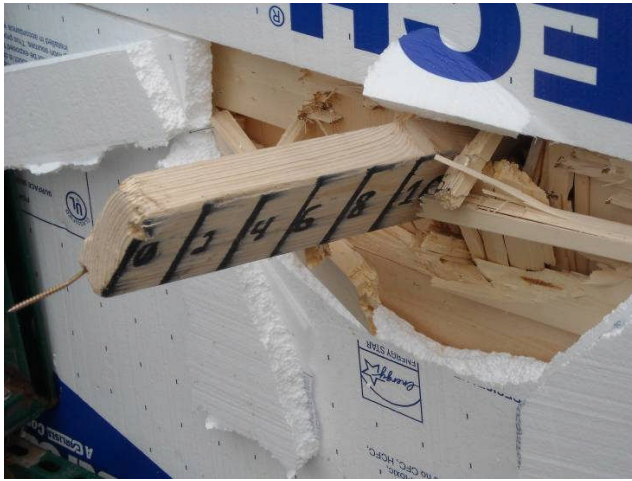
Figure 3.21a Test #53 Impact (Fail)

Figure 3.21b Impact + 0.0043 sec

Figure 3.21d Test #53 Post Impact

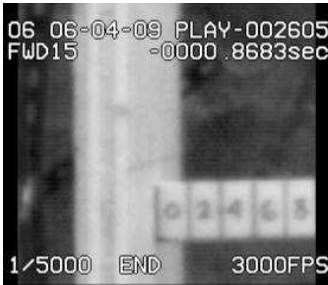
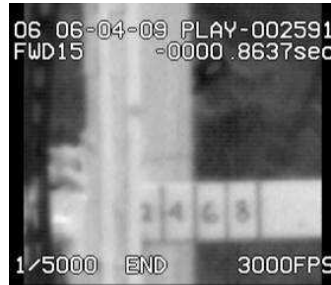
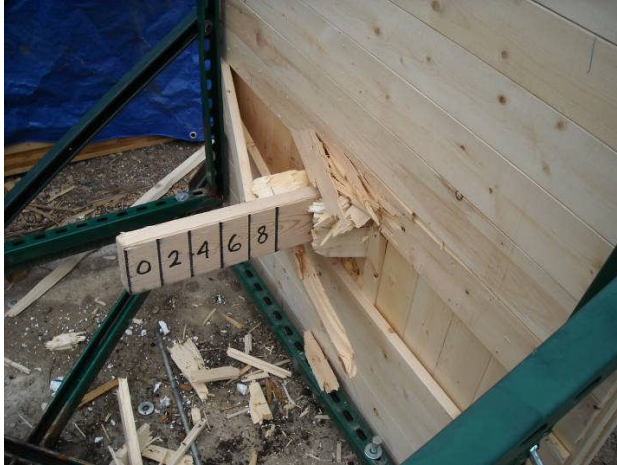
Figure 3.23a Test #55 Impact (Fail)

Figure 3.23b Impact + 0.0044 sec

Figure 3.23d Test #55 Post Impact

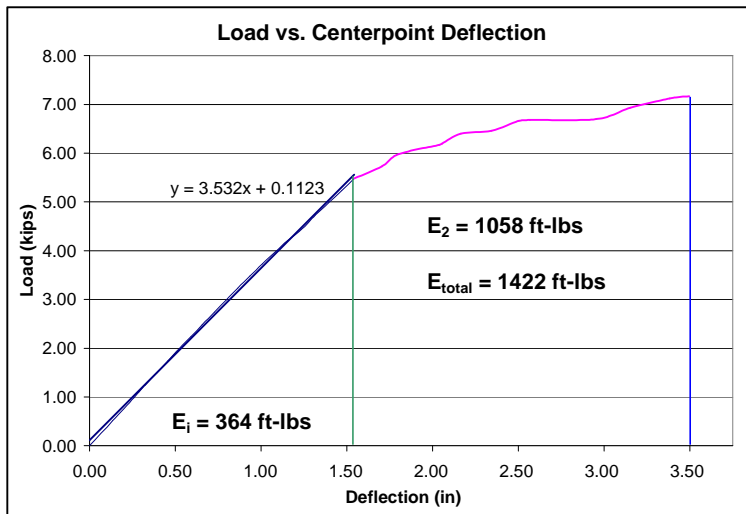
At the 5.60 kip (25 kN) load level, the specimen began to progressively crack (quick drop in load at same deflection also evident from cracking sounds) as the load was increasing. Figure 3.25 is an illustration of the load versus centerpoint deflection for the specimen. At the 5.48 kip (24 kN) load level, the specimens reached an apparent elastic limit. At 7.15 kips (32 kN), the specimen failed (increased in deflection without a load increase) and the test was terminated. The area under the load-deflection curve, which is also provided in Figure 3.25, constitutes the energy stored in the specimen during loading. The energy stored at the elastic limit was 364 ft.-lb. (494 J) while the energy stored at failure was 1422 ft.-lb. (1928 J).

Figure 3.25 Static Test #1 Load vs. Centerpoint Deflection

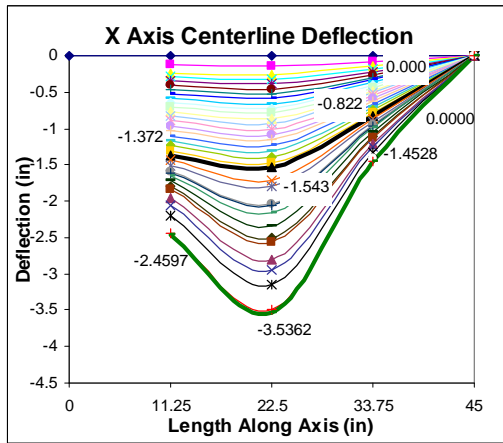
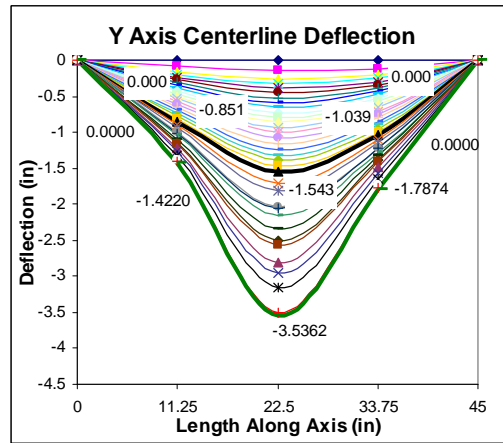
Figure 3.26 X-Axis Deflection

Figure 3.27 Y-Axis Deflection

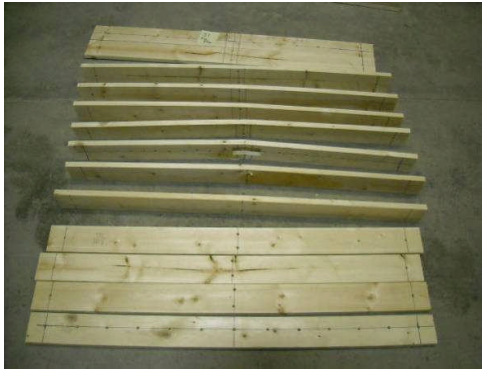
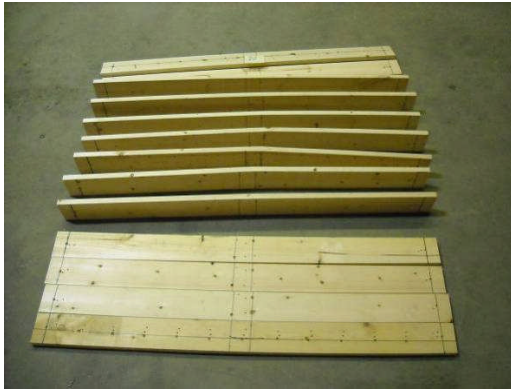
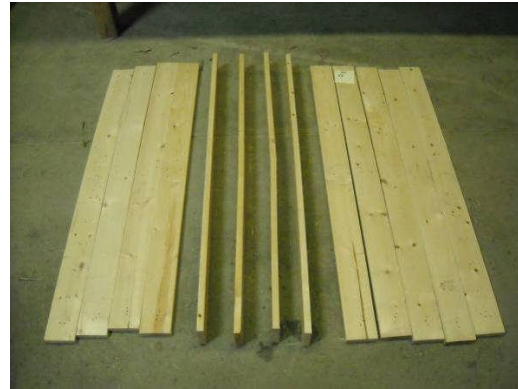
Since a possible key factor in specimen survival is the ability to distribute the load throughout the various layers, the failed specimen was taken apart layer by layer. Figures 3.28 through 3.31 show each layer after removal from the overall specimen. The boards that are turned on their sides are boards in which the deflection at either end, when laid flat, was greater than 0.25 in. (6.4 mm), giving a general representation as to how the load was spread throughout the specimen. This is also in comparison with Figures 3.8g through 3.8j to show how a statically loaded specimen in which the duration of loading is significantly longer spreads the load between the various layers, thus providing a significantly different response than in the impact loading tests.

Figure 3.28a Static Load 1 Front Layer

Figure 3.28c Static Load 1 Third Layer

Figure 3.28d Static Load 1 Rear Layer

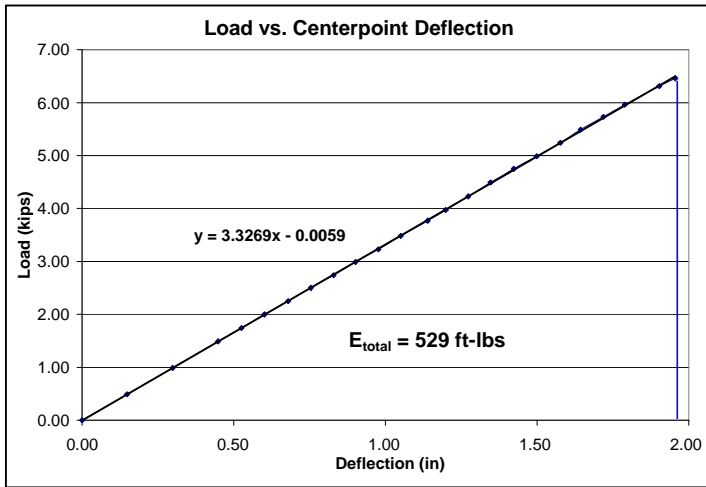
In Static Test #2, load was applied to the specimen only until it cracked for the first time. As such, this test was stopped at the initial cracking, occurring at the 6.77 kip (30 kN) load level. However, the final deflection reading had been taken at 6.46 kips (28.7 kN), which resulted in a centerpoint deflection of 1.96 in. (50 mm), as shown in Figure 3.29. The energy stored in the specimen at the elastic limit was calculated as 529 ft.-lb. (717 J) (Equation 1.3). Table 3.7 provides selected load vs. adjusted deflection values for the second test at approximately 1.0 kip (4.5 kN) intervals with the results at 6.46 kips (28.7 kN), also provided. Figure 3.30 and 3.31 provide the centerline deflections for this test, with the previously mentioned end conditions still applicable.

Figure 3.29 Static Test #2 Load vs. Centerpoint Deflection

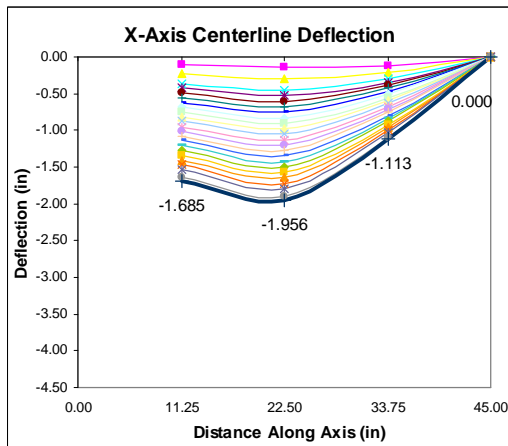
Figure 3.30 X-Axis Deflection

Figure 3.31 Y-Axis Deflection

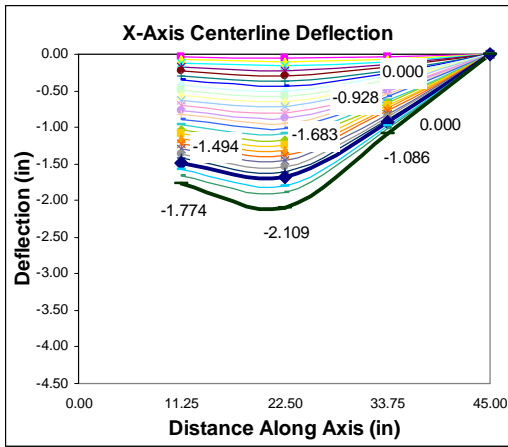
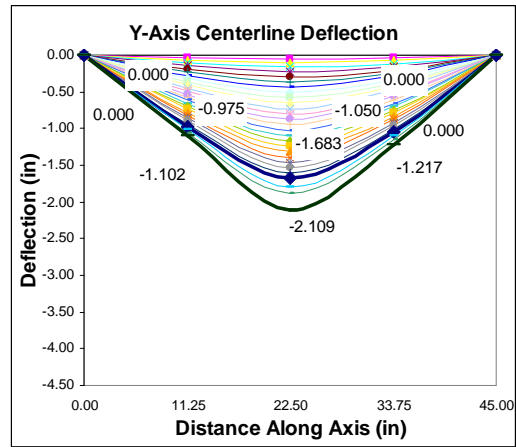
Figure 3.33 X-Axis Deflection

Figure 3.34 Y-Axis Deflection

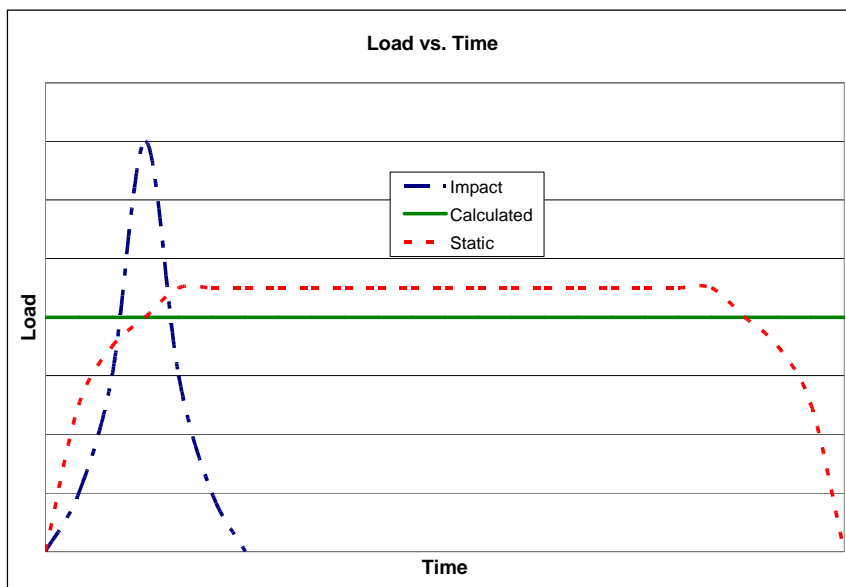
Impact tests also provided useful and significant information to understand how the specimens responded under very short duration loads. First, the loads resisted during 90° impact tests were not considerably larger than the loads at the elastic limit during static loading when comparing the loads resisted in the impact tests in Table 3.5 and the static tests in Tables 3.6-8. There are two reasons that this occurs. First, the impulse momentum relationship assumes a constant load on the specimen, but this is unlikely to be the case. In reality, the force on the specimen under impact loading is spiked, while the static load plateaus. Figure 4.1 illustrates the fact that the average value for the impact load and the static load may be similar, but the actual maximum loads may be drastically different. The maximum values were not able to be calculated.

Figure 4.1 Load vs. Time for Impact, Static, and Calculated Loadings

This is more likely to do with the flexible supports absorbing energy and energy being transferred back to the missile (causing it to bounce off the specimen) than rejecting the conclusions of ultimate strength increase of Elmendorf, Liska, and Wood. It is interesting to see that, despite the difference in response in the static testing, the load at failure was similar and it would be interesting to do future studies to model the stress distributions and deflection patterns in the impact tests compared with the static load tests. Such an impact load model would necessitate incorporating physical knowledge of wood properties under extremely rapid impact loading. Figures 4.2 (Energy vs. Velocity) and 5.3 (Energy vs. Load Duration) show that the energy absorbed during the impact tests is 3.7 to 7.0 times that of the energy stored during static loading. The durations of load for Figure 4.3 were determined from high speed video for the impact tests and were calculated as the deflection (inches) (mm) divided by the loading rate (inches/sec) (mm/sec). These figures also provide the impact energies for 90, 92.5, and 95 mph (145, 149, and 153

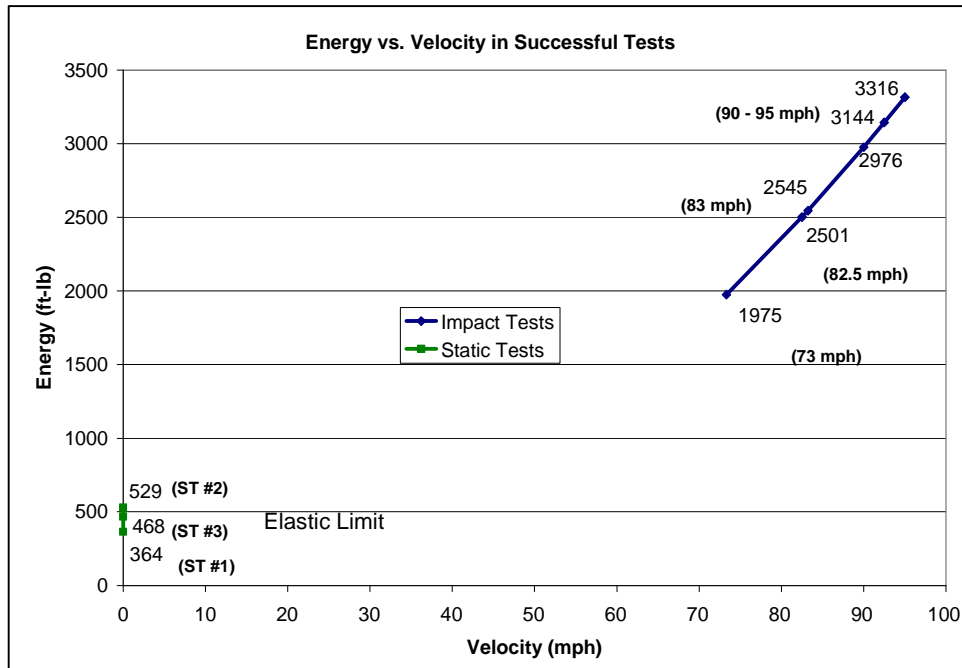
km/h) impact velocities that were estimated, not tested, to be in the range of maximum allowable test velocities for flexibly supported specimens. In addition, the nature of the tests provided useful insight as to how composite specimens - designed to act like netting - distributed loads throughout the specimen. It was also of interest to compare the energy absorbed by the specimens at failure. Figure 4.4 compares the energy stored in the specimen at ultimate failure in Static Tests #1 and #3 (Test #2 was not loaded to failure) to the kinetic impact energy for Tests #52 and #53, which failed the impact test but only allowed a small amount of penetration. Figure 4.4 also includes the kinetic impact energies for 90, 92.5, and 95 mph (145, 149, and 153 km/h), which were estimated to be the threshold velocities for success for this specimen configuration. The important observation from this chart is the impact tests withstanding 2.5 to 5.7 times the amount of kinetic impact energy over the energy absorbed by the statically loaded specimens.

Figure 4.2 Energy vs. Velocity for Passing Specimens

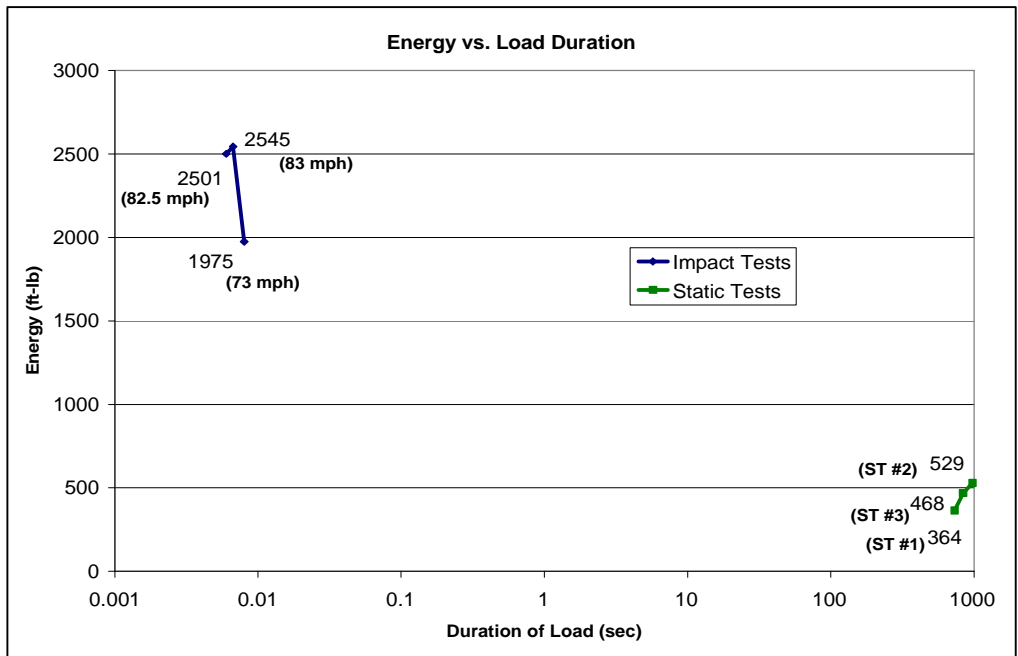
Figure 4.3 Energy vs. Load Duration for Passing Specimens

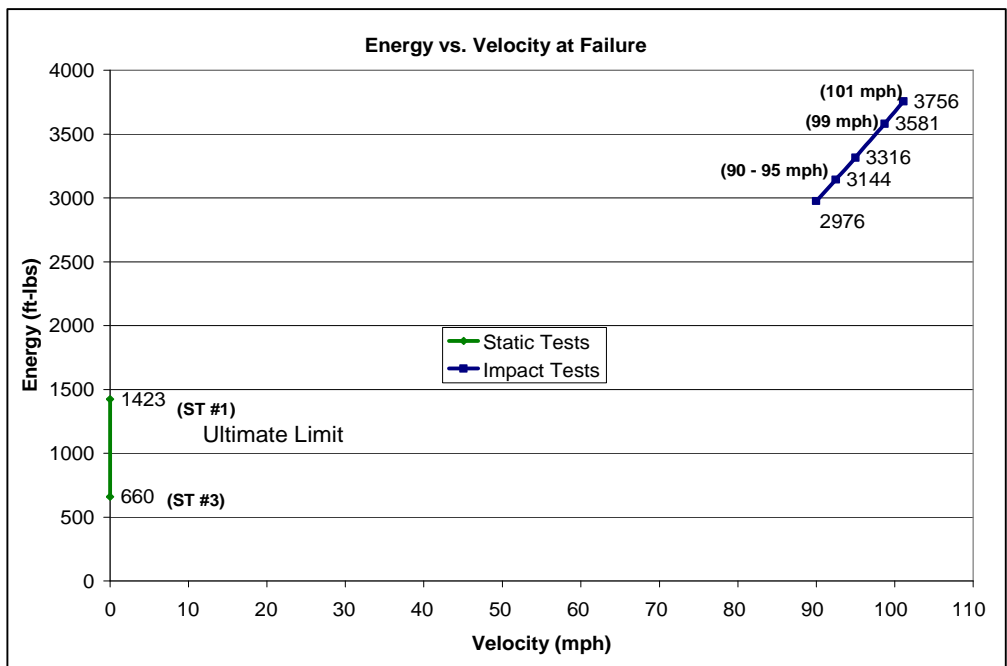
Figure 4.4 Energy vs. Velocity for Specimens at Failure
