| 4. Title and Subtitle<br>Performance Evaluation of JRCP with Stabilized Open-Graded Drainage Course | | 5. Report Date<br>August 2009 | |

**Project Title: Performance Evaluation of JRCP with Stabilized Open  
Graded Drainage Course**

Final Report

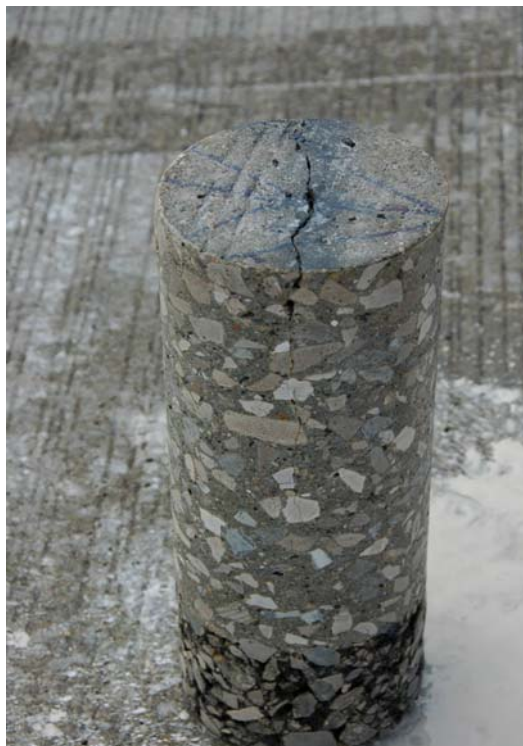
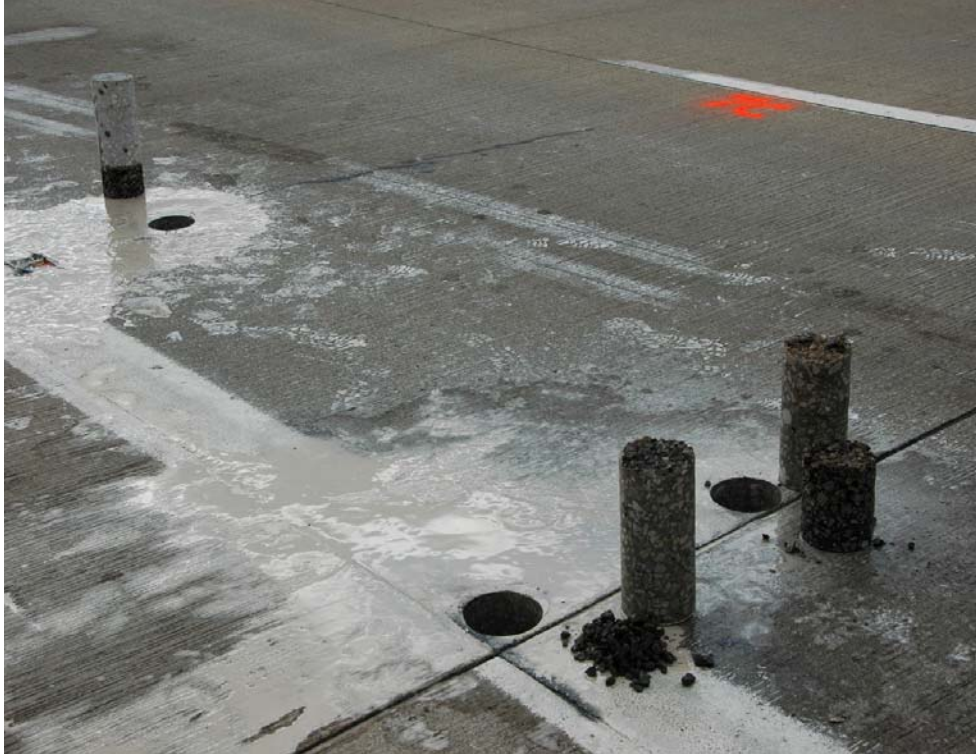
**Figure 4.6 a, b. Photograph is from Michigan Section 2, NB US-23.**

Two JRCP projects on treated OGDC were found to be in the beginning stages of mid-slab transverse cracking caused by joint settlement. The close-up photo (6a) of a mid-slab core in Figure 6b for Michigan Test Section 2 illustrates that top-down cracking is developing. Top-down cracking is normally associated with loss of joint support from an upward curl/warp condition. In this case, a permanent concave downward slab condition exists as seen from Dipstick Profilometer results in Figure 4.7. The magnitude is much larger than any curl/warp condition, and is due to joint settlement and base erosion. The joint settlement causes opposite slab rotation between the mid-slab and each transverse joint. Joint settlement and associated slab downward bending over time with a magnitude of 0.1 in. to 0.2 in. is promoting top-down mid-slab cracking.
