Use of Electrical Resistivity to Detect Underground Mine Voids in Ohio

Water-Resources Investigations Report 02-4041

By Rodney A. Sheets

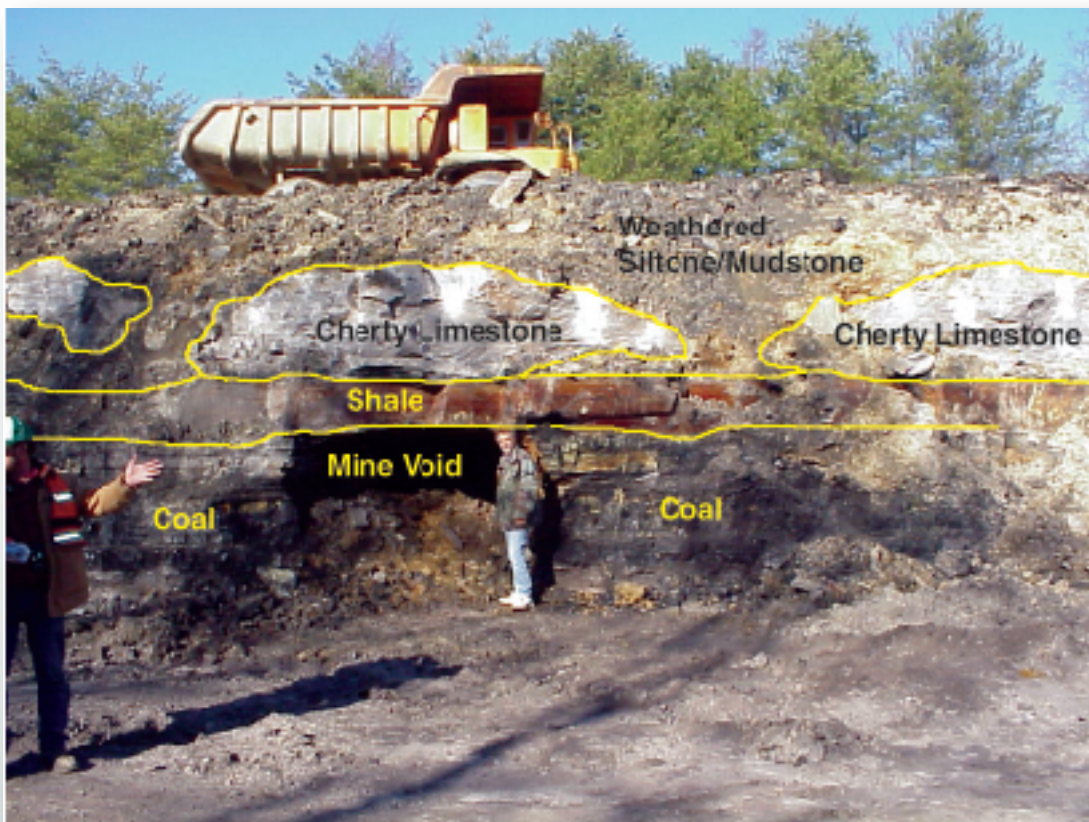
Cover photo: Excavation of site in Jackson County, Ohio, showing abandoned underground coal mine.
(Photo by L. Rick Ruesegger, Ohio Department of Transportation.)

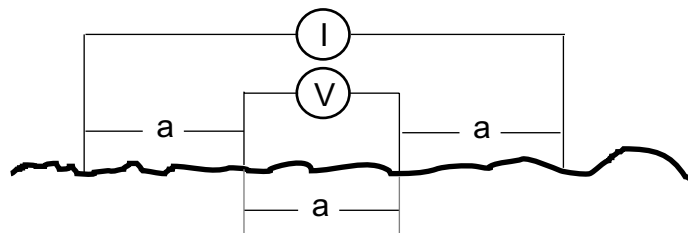
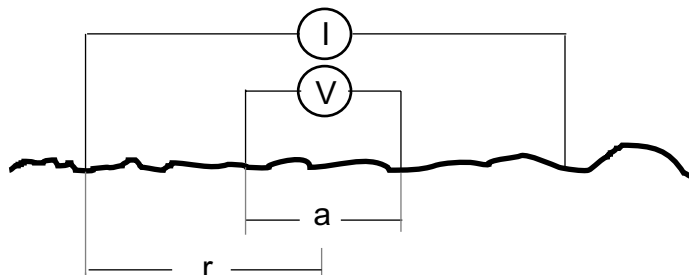
Three types of arrays—dipole-dipole, Wenner, and Schlumberger—were employed for this study (Zohdy and others, 1974). The configuration of current and potential electrodes for these arrays is shown in figure 2. For the surveys done in this study, 28 electrodes were placed either 2 or 3 m apart along survey lines, and the elevation of each electrode was determined. The automated system allowed data collection for all three survey arrays and various electrode spacings with static placement of electrodes.

Figure 2. Electrode configurations for resistivity surveys: (A) axial dipole-dipole array (B) Wenner array, and (C) Schlumberger array. For the Schlumberger array, the potential electrode spacing is kept small relative to r , which is increased during the survey.

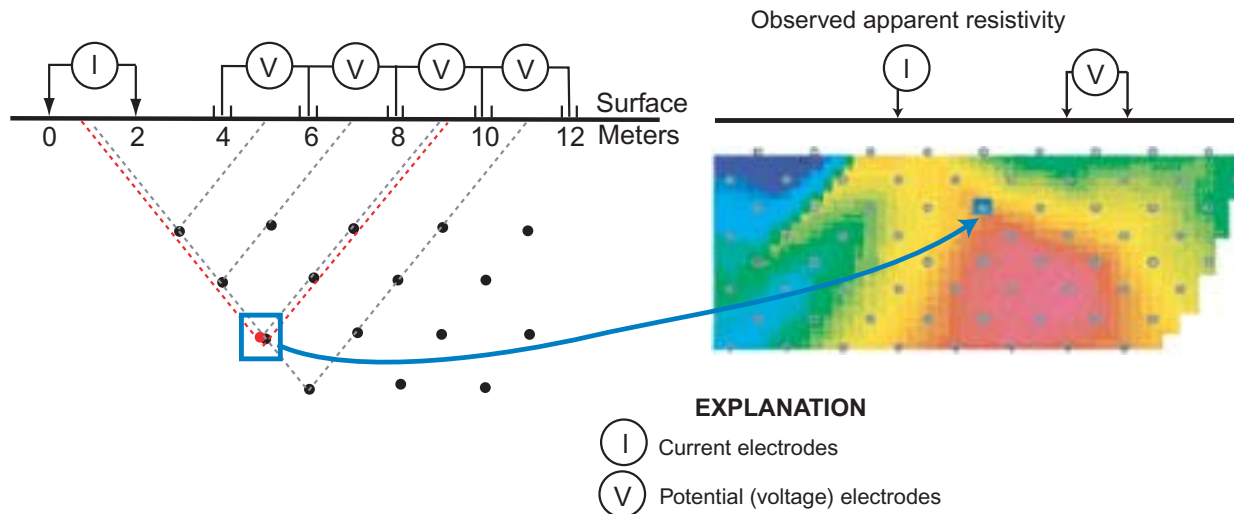
Results were plotted in the field to verify proper collection of data. Pseudosections (fig. 3) were used to plot the data; in pseudosections, values of apparent resistivity are plotted against electrode geometry. Because pseudosections are difficult to interpret, an inversion of the data was done to determine the electrical properties that give rise to the measured (apparent) electrical resistivity. Inversion of a geophysical data set results in a model of the resistivity characteristics of the subsurface; in this case, a model of the electrical properties of the subsurface. The inversion routine is based on the smoothness-constrained least-squares method (Sasaki, 1992) and can be used for many electrode configurations, including those used in this study. The inversion program used (RES2DINV; Loke and Barker, 1996; Loke, 1998) requires electrode spacing to be held constant and divides the subsurface into rectangular blocks; therefore, the inversion of resistivity data is not affected by the geometry of subsurface resistivity anomalies. The purpose of the program is to determine a resistivity of each

Figure 3. Pseudosection by use of axial dipole-dipole array configuration (Oldenburg and Jones, 1998). The resistivities in the pseudosection are contoured; in many cases, pseudosections are color contoured so that high resistivities are “hot” colors (red) and low resistivities are “cold” colors (blue).

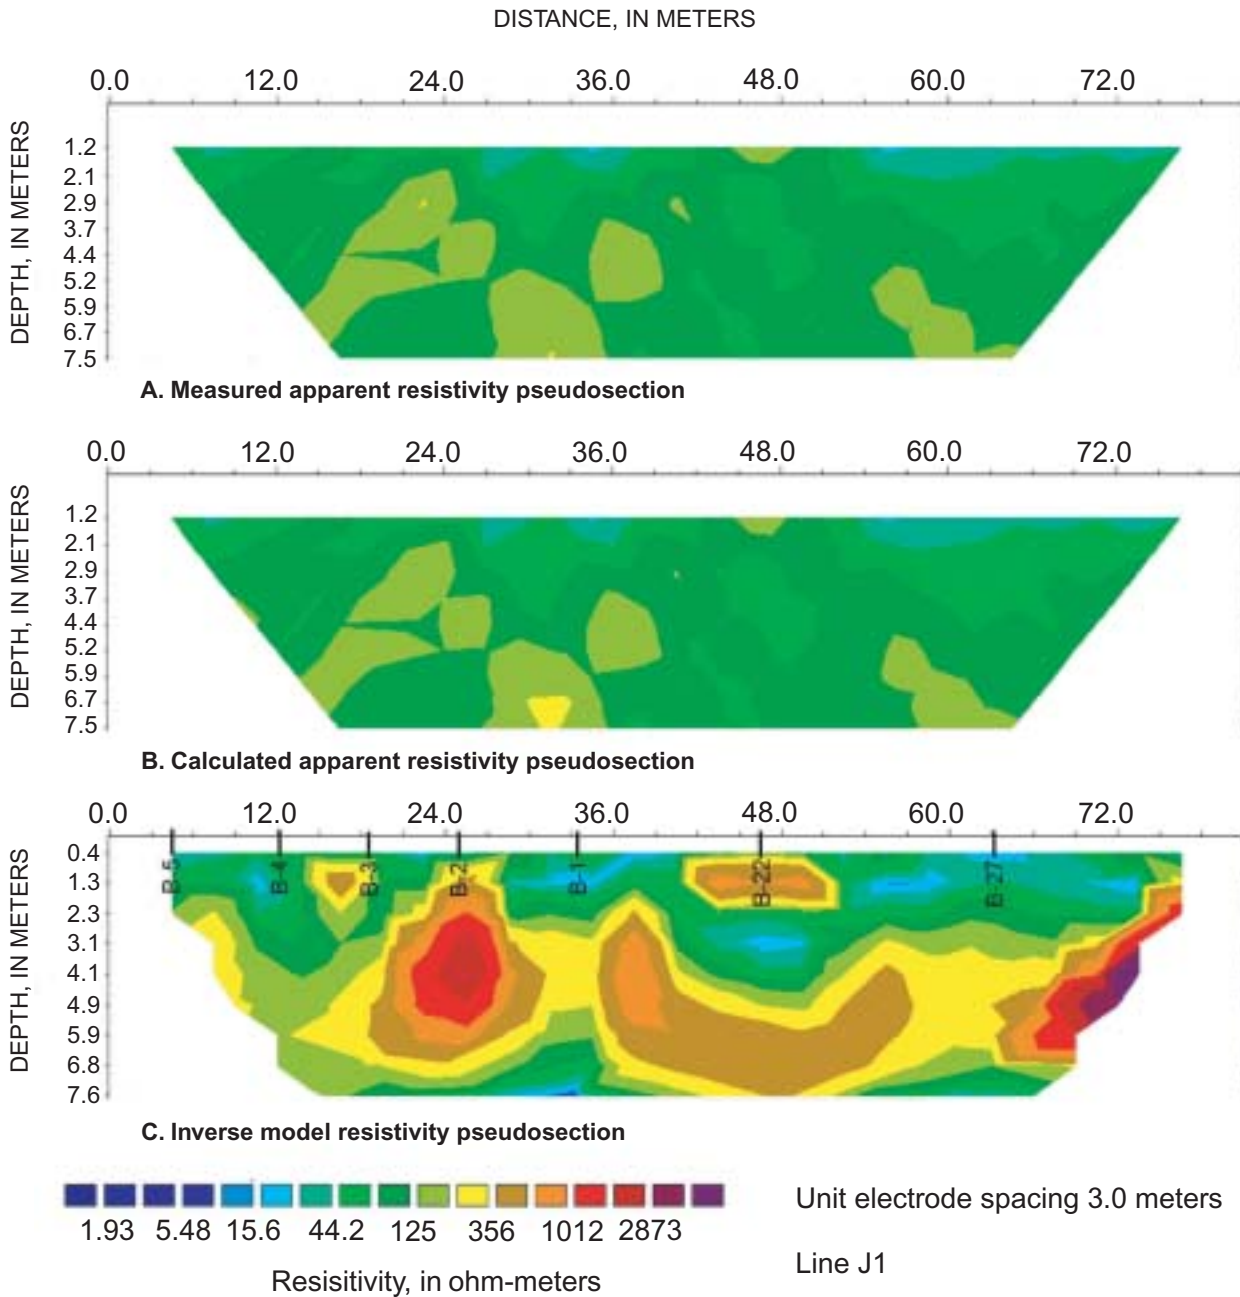
The results of a 3-m axial dipole-dipole resistivity survey, completed in late August 1998, along the northern edge of the roadway (line J1, fig. 1) are shown as a pseudosection in figure 4. The pseudosection shows the measured apparent resistivities plotted as a function of depth (fig. 4A) and the calculated resistivities from inversion of the field data (fig. 4B). The resulting model from the inversion (fig. 4C) shows three distinct areas of very high apparent resistivity (> 1,000 $\Omega\cdot\text{m}$) at approximately 26, 38, and

72 m (horizontal distance). These anomalous areas are about 3 m deep. The very high apparent resistivity is probably not related to natural geologic materials and is instead interpreted to be air-filled voids (abandoned coal mine tunnels). The somewhat continuous subhorizontal high-resistivity anomaly that spans the very high-resistivity anomalies from 38 to 72 m (horizontal) likely is a series of mine voids (tunnels) separated by sections of unmined coal. Drillers' descriptions of borings completed along the survey line are

Figure 4. Dipole-dipole resistivity survey results along State Route 32 in Jackson County, Ohio. High-resistivity anomalies ($>1,000 \Omega\cdot\text{m}$ (ohm-meters); for example, at approximately 26 meters horizontal and 3.5 meters vertical in the inverse section (C)) are interpreted to be air-filled mine voids. Locations of borings also are shown on the inverse model section.

After the resistivity surveys were completed, ODOT drilled boreholes in the roadway to determine the possible presence and extent of mine voids (Sept.-Dec. 1998; table 1). Boring B-2 was completed at the major anomaly at 25 m on line J1 (figs. 1, 4, 5; table 1); a mine void was encountered from a depth of 2.3 to 3.1 m (L.R. Ruesegger, Ohio Department of Transportation, written commun., 1999). The roadway and network of underlying mine voids was subsequently excavated and numerous tunnels were located. Three tunnels converged at or very near the anomaly at 25 m (figs. 1, 4, and 5). This finding may illustrate that although the resistivity arrays used were linear, the current and potential pathways in the subsurface may be affected by features outside the survey line, especially in areas of air-filled voids.

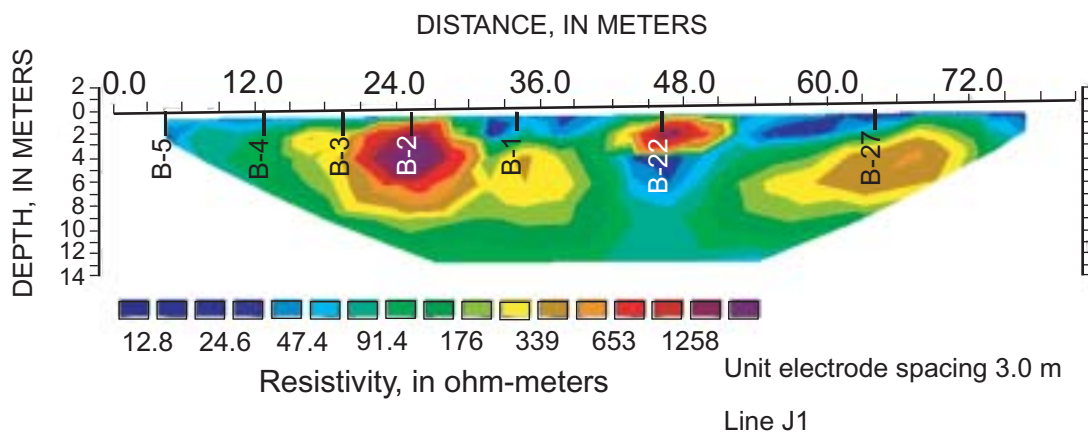
The results of a 3-m Wenner resistivity survey inversion for line J1 are shown in figure 5. These results also show the three highly resistive areas recognized in the axial dipole-dipole array results and the shallow anomaly at 48 m (horizontal), but they are generally not as detailed as the axial dipole-dipole results. Forward modeling of similar areas has shown that the axial dipole-dipole array is more appropriate than the Wenner array for detection of anomalously high-resistivity areas due to voids (Munk and Sheets, 1997). A subsequent 2-m axial dipole-dipole resistivity survey centered on the large anomaly at 26 m horizontal confirmed location and horizontal extent of that anomaly.

Figure 5. Wenner resistivity survey results, including topography, along State Route 32 in Jackson County, Ohio. This calculated inverse model section shows a high-resistivity anomaly at the same location as an axial dipole-dipole survey along the same line (fig. 4). Locations of borings also are shown above.

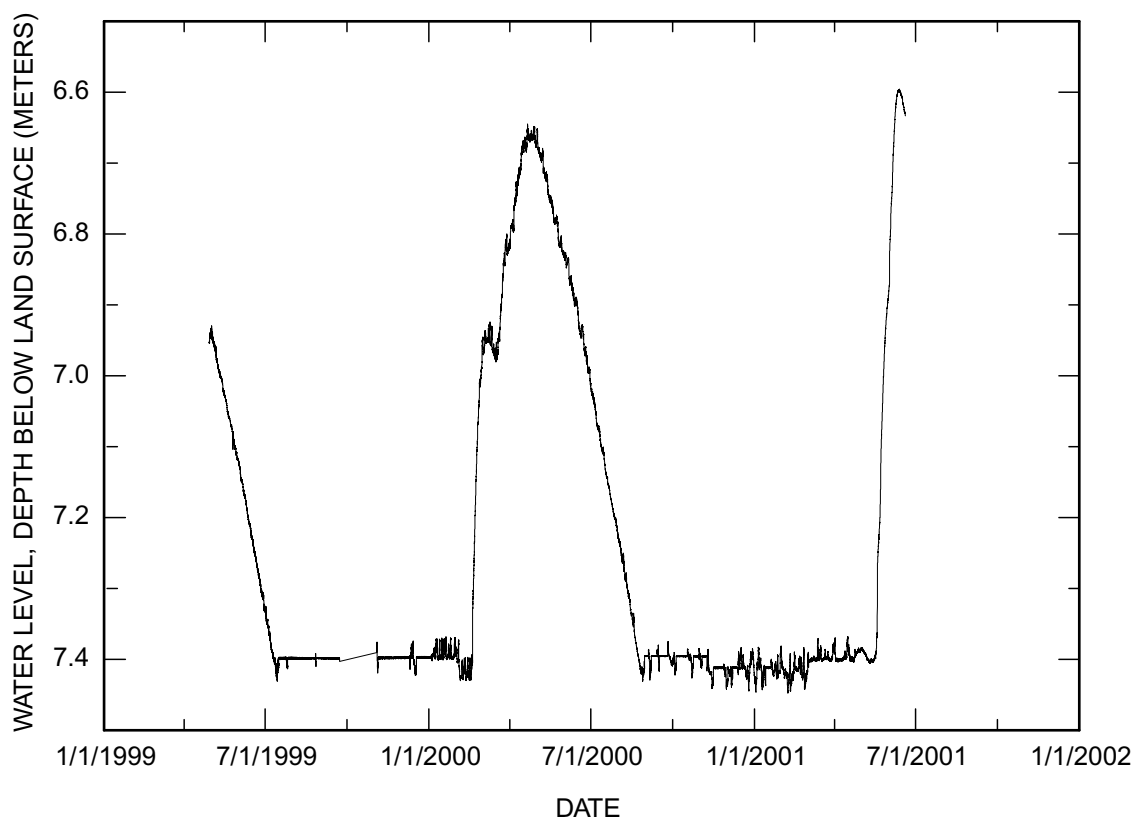
At the time the borings were made at the site (November 1997), no appreciable ground water was found (L.R. Ruesegger, Ohio Department of Transportation, written commun., 1998); however, for the purposes of this study, boring B-1 was instrumented with a submersible pressure transducer to measure water levels. As evident in figure 6, ground water partially filled the void from spring or early summer (March-June 2000), until midsummer (July-August 2000). The specific conductance of ground water in the void was 632 $\mu\text{S}/\text{cm}$ (June 2000).

Figure 6. Depth to water at boring B-1, Vinton County, Ohio. The bottom of the pressure transducer was set on debris in the mine void at approximately 7.4 meters.

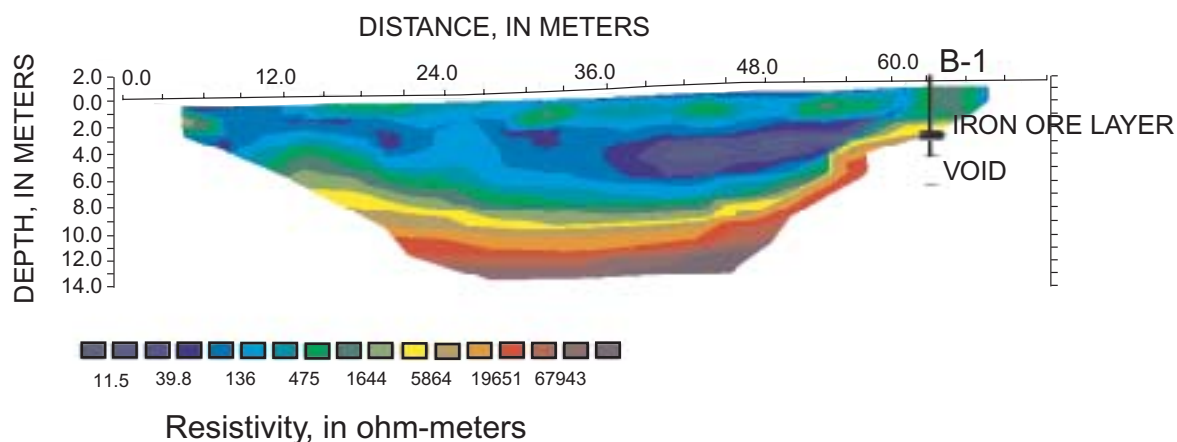
A 3-m axial dipole-dipole resistivity survey was performed along the westbound shoulder, parallel to the roadway and adjacent to boring B-1 (line V1, fig. 1). The results of that survey are shown in figure 7. The survey was 81 m long, but electrical interference from overhead high-tension powerlines resulted in loss of approximately 20 m of data at the east end of the survey line (fig. 7). A low-resistivity (high-electrical-conductivity) anomaly spans the section at 2–4 m depth, which approximately corresponds to the layer of iron ore reported in the boring logs (fig. 7; table 2). Just below this abnormally low-resistivity zone is a very high-resistivity anomaly that may be attributed to far-field effects of electrical interference from the powerline or effects from the very low-resistivity anomaly. The concept of approximate depth for the pseudosection is inappropriate below the abnormally low-resistivity anomaly because pseudosections are predicated on reasonable resistivity ranges. An axial dipole-dipole resistivity survey along the median strip of the highway yielded similar results.

Figure 7. Three-meter axial dipole-dipole resistivity survey results, along State Route 32 in Vinton County, Ohio. This calculated inverse model section shows a low-resistivity anomaly spanning the section at a depth of approximately 2–4 meters; this anomaly corresponds to a layer of iron ore.

As a result of a nearby underground mining permit process, a known underground mine was investigated by drilling along State Route 32 in Vinton County, Ohio. A well was completed in an underground mine void, and water levels were monitored. During a period of high water in the void, a 3-m axial dipole-dipole survey was completed over the void. A thin layer of iron ore above the mined coal dominated the electrical resistivity survey results. Interference from overhead powerlines also may have affected the survey results.
