**Report No. CDOT-2010-8
Final Report**

OPTIMIZATION OF STABILIZATION OF HIGHWAY EMBANKMENT SLOPES USING DRIVEN PILES – PHASE I

December 2010

**COLORADO DEPARTMENT OF TRANSPORTATION
DTD APPLIED RESEARCH AND INNOVATION BRANCH**

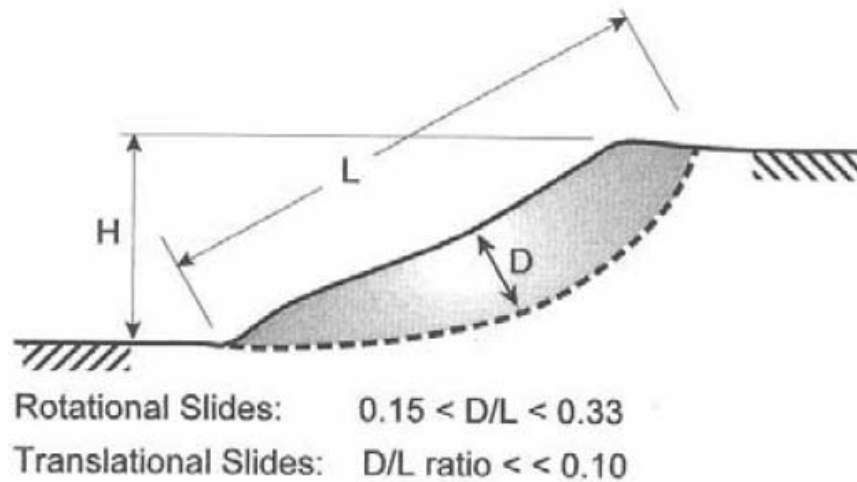
The aspect ratio of a slide or failure generally is used to classify the slope failure type. As presented in Figure 1, a rotational slide produces a failure surface with an aspect ratio in the range of $0.15 < D/L < 0.33$ where D is the depth of the sliding surface perpendicular to the slope face, and L is the length of the sliding surface, Abramson et al. [1].

Figure 1. Aspect ratio of failure mass (Abramson et al., 2002).

based on case histories, but all studies indicated the shallow nature of surficial failures. The aspect ratio of the failure can be used to categorize whether the slide is shallow or not. In Figure 1, when the aspect ratio, $D/L < 15\%$, or failure surface depth is less than 10 ft, the slide is characterized as shallow, Abramson et al. [1].

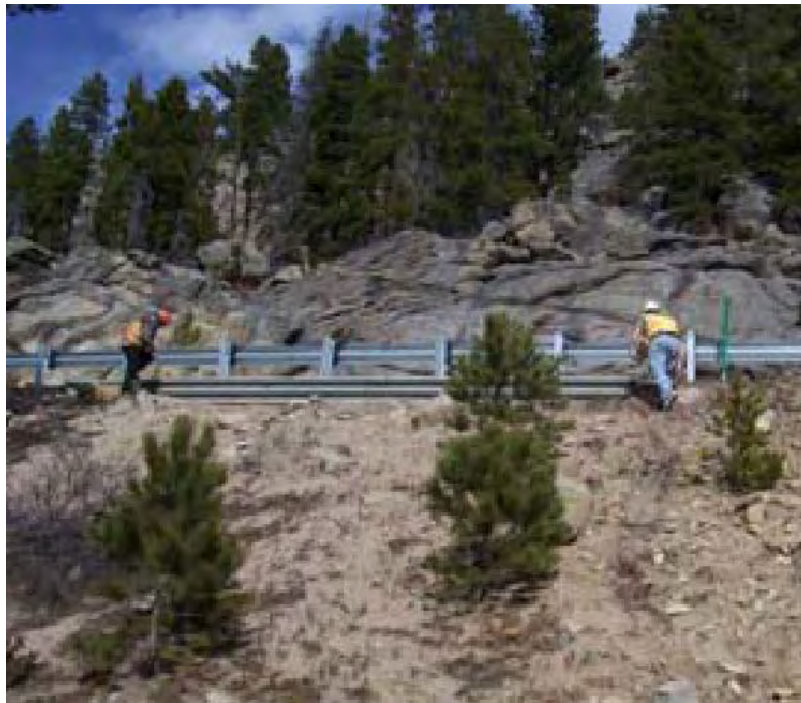
Figure 6. Guardrail stabilization system along SH-72.

The site visit was performed March 6, 2009 near mile marker 25 along State Highway 72 (Steve Laudeman, Aziz Khan, Russel Cox, Alan Lisowy, John Hart, Panos D. Kioussis, Jared Stewart). The slide had been previously stabilized using steel guard rail sections. Type 3 guardrail posts were used as piles spaced at six ft and three inches in this case, a typical section is shown in Figure 5. Additionally, guardrail railing was used to provide lagging between the piles, Figure 6. This slide did not show any signs of recent movement.

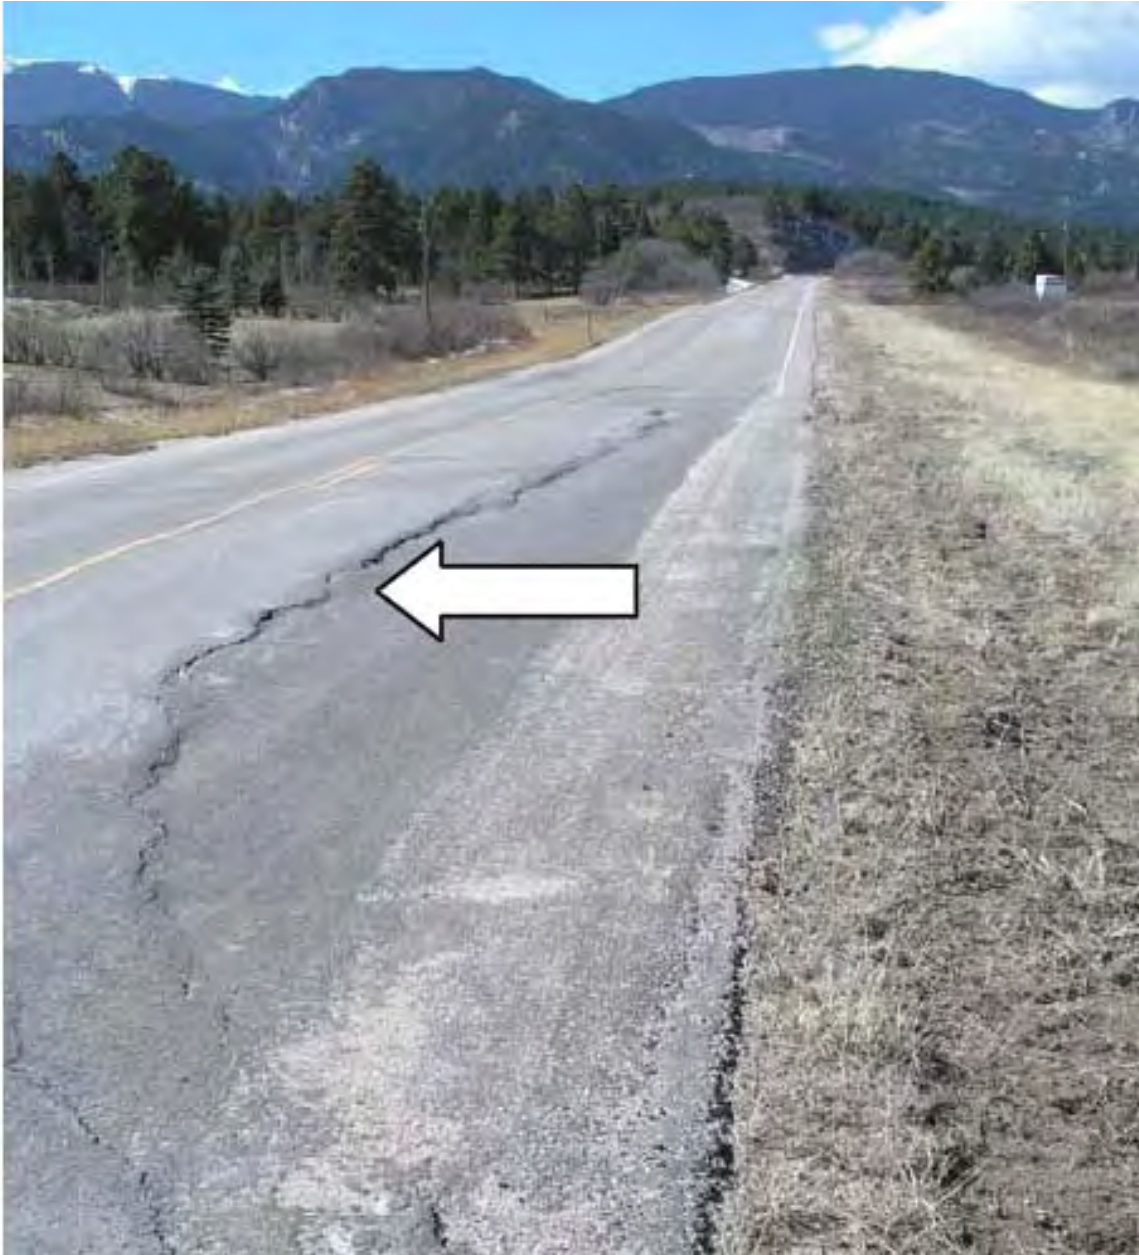
Figure 7. Pavement distress at Rye (2006).

Two main areas of distress were identified at the Rye slide (State Highway 165, mile marker 26) during the visit (Aziz Khan and Panos D. Kioussis) on May 11, 2009. The first area is identified in the 2006 report (Figure 7) and again during the May 11, 2009 visit (Figure 7 white arrow). This distress appears to be the result of a deep seated slip failure, which, according to the 2006 report, had its toe 50 to 100 ft within the private property that borders the northern “right-of-way” boundary. This is verified by close examination of Figures 1 and 4 of the 2006 “Rye Slide Interim Report” [14] and the inclinometer data of borehole I103 (up to 3-4-2008) provided by Mr. Laudeman, where a shear band at a depth between 34 and 36 ft (at the interface of clay and claystone layers) has been developed.

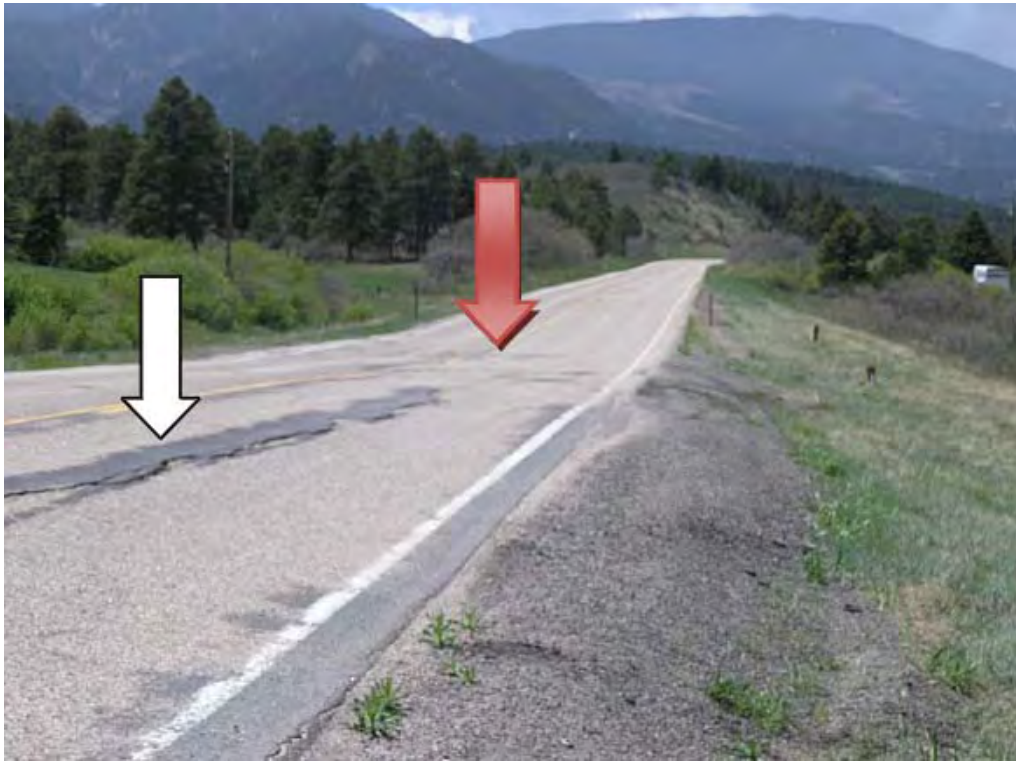
Figure 8. Pavement distress at Rye (2009).

The second area of distress is approximately 100 ft west of the aforementioned area (Figure 8 – red arrow) and it appears to be one where the predominant movement is settlement. Directly underneath this area, at the base of the embankment, there is a 24 inch diameter culvert which clearly sags approximately 9 inches in the area under the pavement (Figure 9 – the opening at the opposite end is barely visible due to sag). This indicates that a significant part of the settlement occurs below the fill, into the organic clay and/or clay layer beneath it. The inclinometers of boreholes I101 and I104 are located in this area, on the south and north sides of the road respectively. No shear failure is indicated in these inclinometers. Instead, a gradual displacement, almost linearly outwards (with respect to the road) in the case of I104 is observed. It is not clear if the displacements recorded by the inclinometer in borehole I101 are inward or outward with respect to the road.

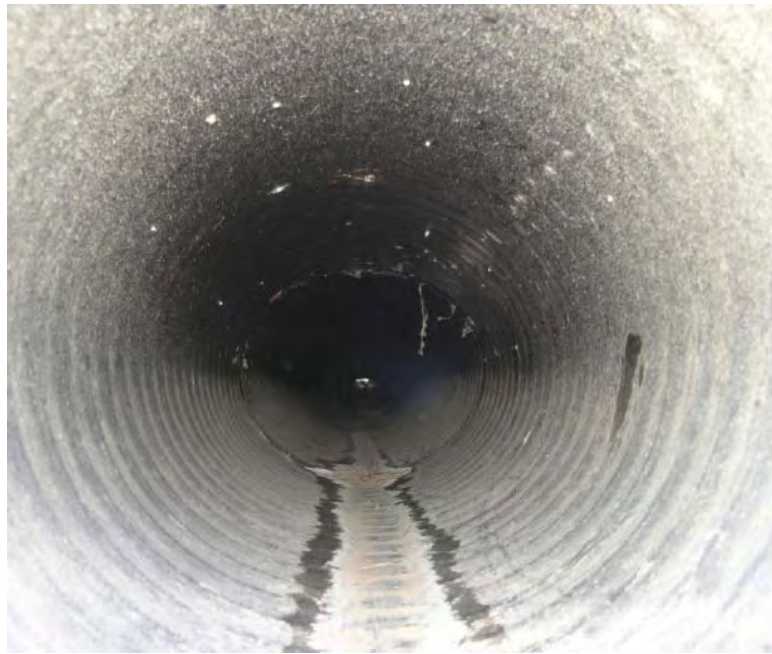
Figure 9. Photo through culvert showing sag.

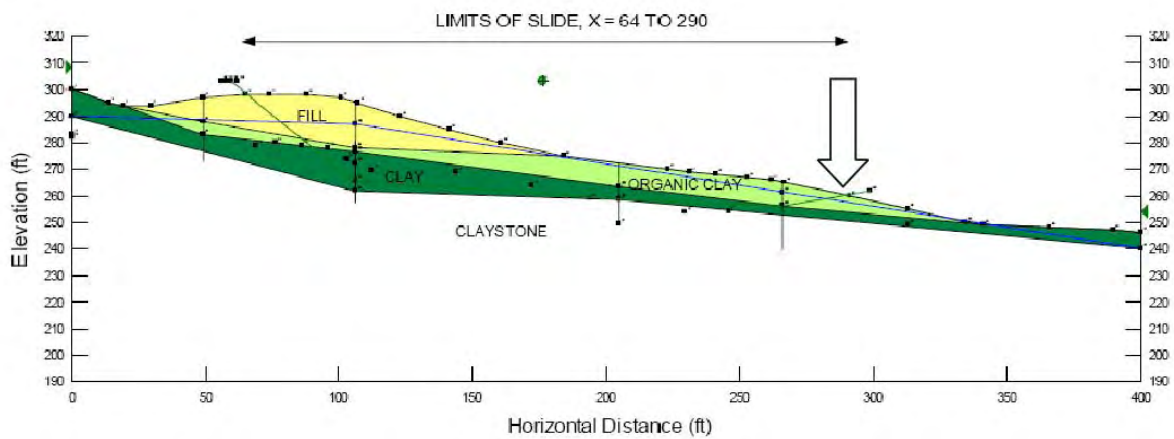
Figure 10. Soil stratification of the Rye slide area.

Based on the stratification of Figure 10 (from 2006 report- arrow indicates approximate location of right-of-way border), the effectiveness of driven piles to mitigate this site cannot be decided without further study. Piles driven next to the road may need to be longer than 30 ft to capture

the deep seated instability of this problem. Stabilization of the slope failure close to the toe (at the northern boundary of the right-of-way) using driven piles requires lengths in the order of 15 ft. Nevertheless, the Rye slide may be a good test site due to the three dimensional characteristics of the observed progressive slide as will be discussed in recommendations. The drains that were installed in the past (only two work currently) could aid in the mitigation of the problem. It appears that the currently installed drains were designed to predominately aid the drainage of the sandy clay fill material. Whereas this is necessary, drainage and/or other techniques to stabilize the organic clay and clay layers, especially under the fill may also prove to be necessary.

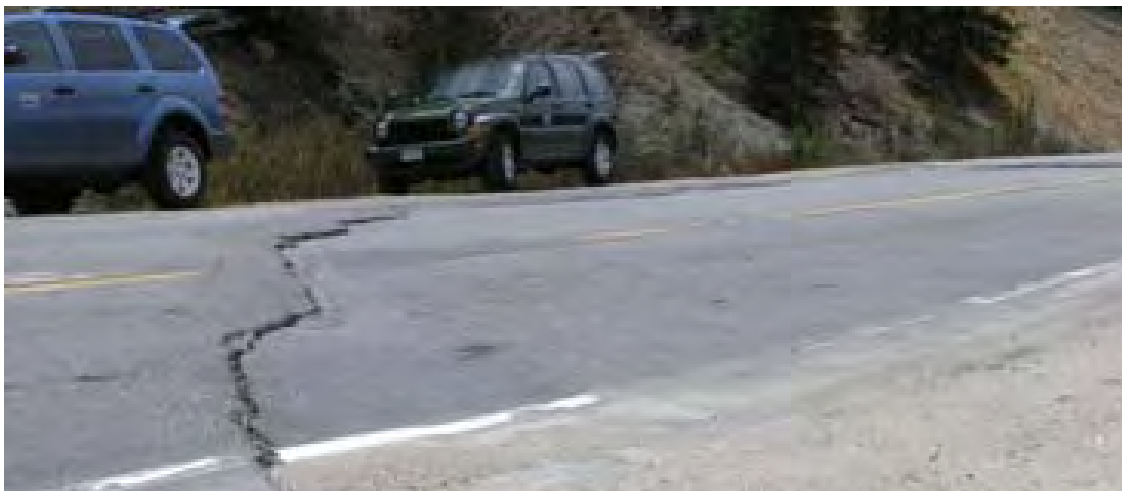
Figure 11. Pavement distress at Hoosier Pass.

A slide occurring at Hoosier Pass on State Highway 9 at mile marker 74.8 was inspected June 8, 2009 (Steve Laudeman, Aziz Khan, Alan Lisowy, John Hart, D. V. Griffiths, Panos D. Kiouisis, Xiaoxia Zhou, Jared Stewart). The tension cracks at this slide cross the entire width of the roadway and the toe was found approximately 250 ft below the crest of the slope as shown in Figure 11. This slide presented a deep failure over a sloped underlying base.

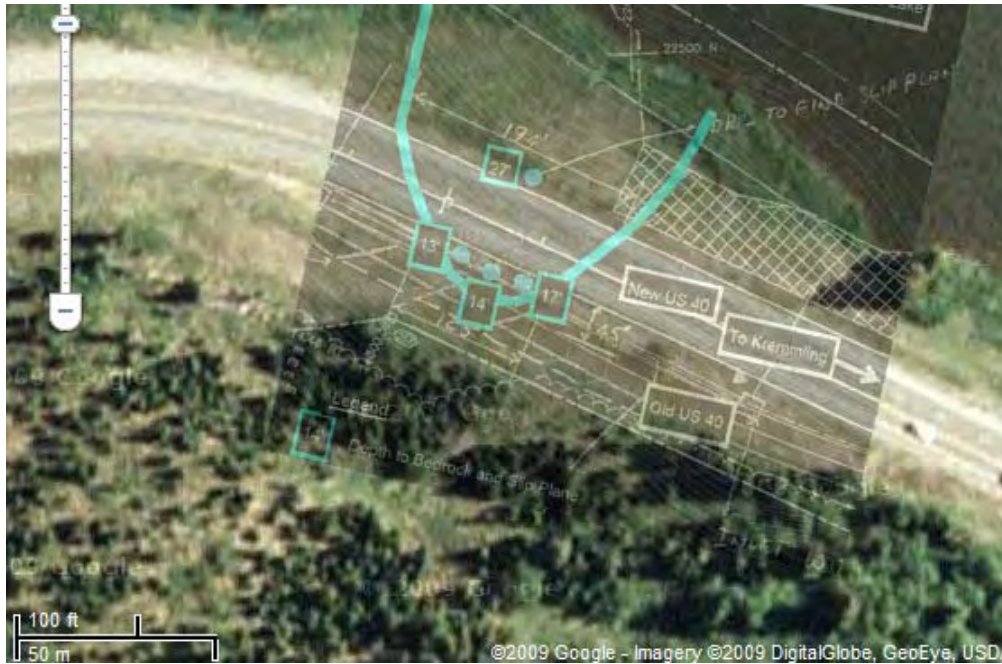
Figure 12. Aerial extents of the Muddy Pass slide.

shoulder, as shown in Figure 12. The toe is not apparent; it is believed to be near, or in, Muddy Pass Lake. Signs of distress were observed on the north side of the highway where the ground appears to have sunken as much as two ft in some locations. Tension cracks were found surrounding the slide mass and descending towards the lake.

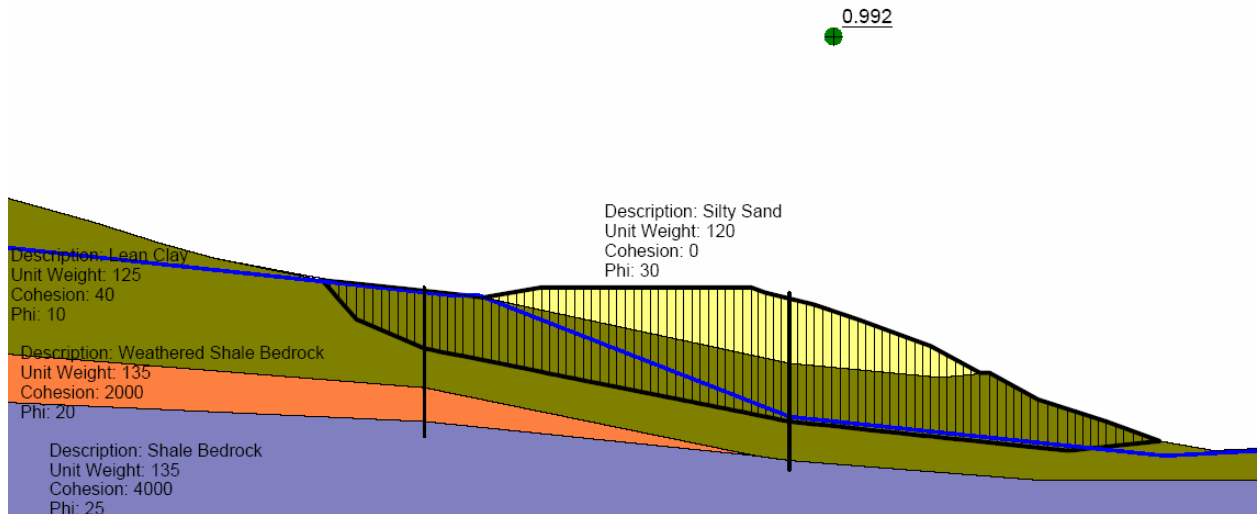
Figure 13. Soil stratification of the Muddy Pass slide.

highway; and 12 ft of medium dense, silty sand were found over 27 ft of the native clay overlying the shale bedrock on the north. Figure 13 provides a generalized cross section of the slide. Two inclinometers were also installed at this time. The data from the inclinometer shows the slip surface largely parallel to the bedrock. The slip surface, as calculated by the CDOT Geotechnical Program, is shown in Figure 13.

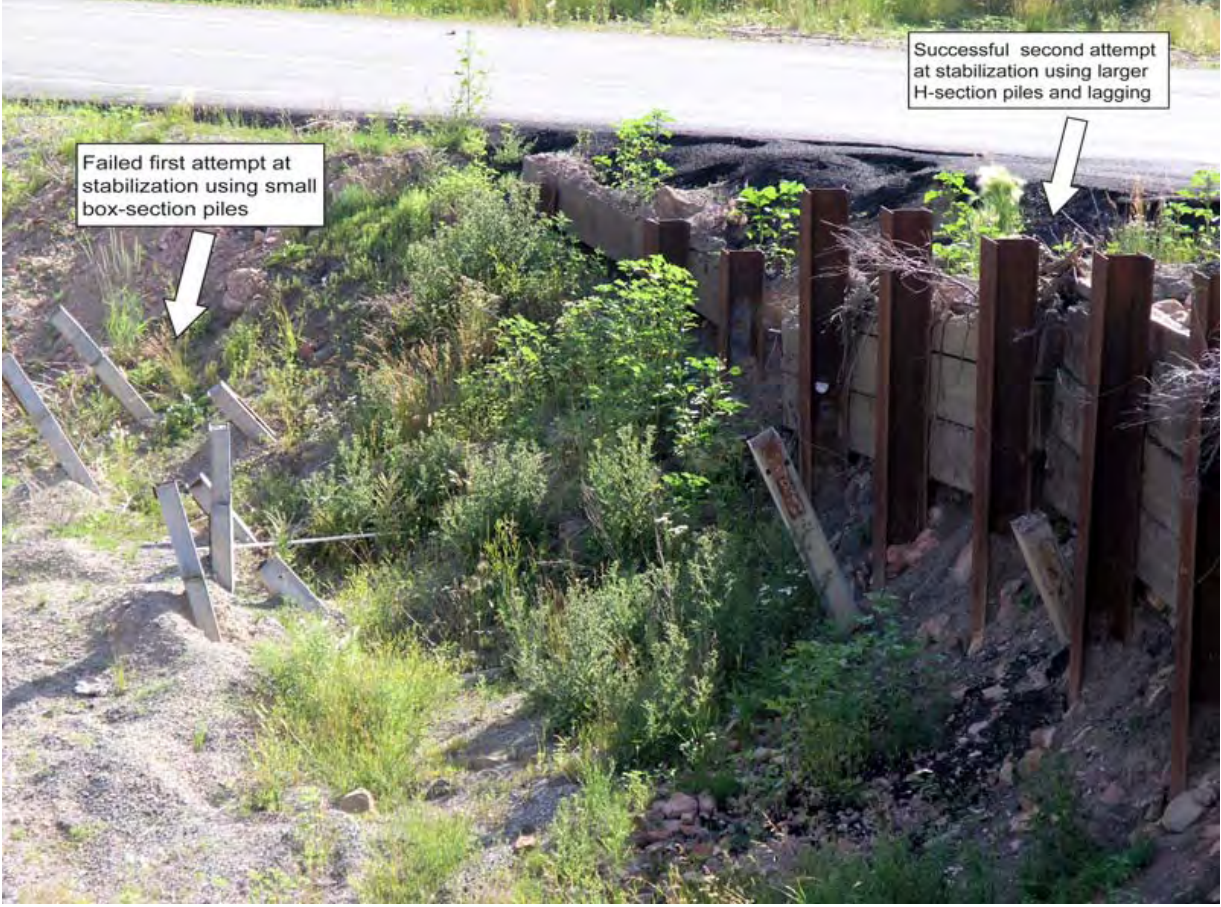
Figure 14. Stabilized site at Douglas Pass, showing failed first attempt.

Three sites were visited along State Highway 139 going south from Rangely towards Grand Junction. The first site visited here (located at approximately mile marker 36) had previously been stabilized unsuccessfully before using driven piles. The first attempt used small box-section piles that were driven into the failing slope, but later failed (Figure 14). The second attempt made use of 12 inch deep H-Piles spaced at 6 ft. Lagging, composed of guardrail posts, was also

installed to a depth of 10 ft as shown in the same figure. The piles were installed in 2004 and appear to be working well. The stiffness of the lagging is sufficient to provide support even at 12 foot spacing as is shown in Figure 15 where it is clear that the lagging support by the H-piles does not occur at the intended 6 foot interval. Nevertheless, it appears that the runoff has caused significant washout behind the lagging and piles, and may soon become a problem at this site.
