FINAL
CONTRACT REPORT
VTRC 10-CR7

METHODS FOR ASSESSING THE POLISHING CHARACTERISTICS OF COARSE AGGREGATES FOR USE IN PAVEMENT SURFACE LAYERS

LINBING WANG, Ph.D., P.E.
Director
Center for Smart Infrastructure
Virginia Tech Transportation Institute

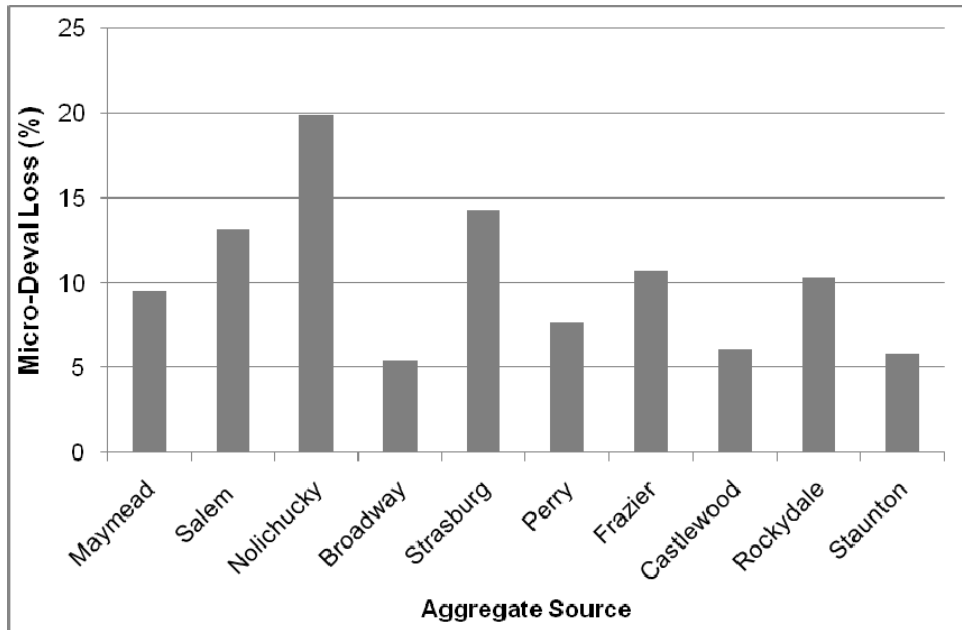
Figure 2. Micro-Deval Test Results (AASHTO T 327)

The results of the standard MD tests and the A/P MD tests are presented in Tables 4 and 5, respectively, and plotted in Figures 2 and 3. With two exceptions (Carmeuse limestone and Nolichucky sandstone) the aggregates can be considered as “suitable” aggregates for surface courses since they exhibited loss values of less than 15% as suggested by White et al. (2006) (Figure 2). Values ranged from a low of 5.4% (Mundy) to a high of 19.9% (Nolichucky). Salem quartzite could be considered “questionable” as its loss value (13.2%) is closer to the 15% limit. Previous tests of Nolichucky and Salem (unpublished data) were conducted at the request of the district materials engineers in response to concerns about the quality of the material being supplied yielded values of 23.1% and 19.1%, respectively. In general, the Nolichucky material is somewhat friable with the component sand grains easily loosened from the cementing matrix. With the Salem material, the previous sample was obtained when field personnel suspected that the supply was being produced from a more weathered area of the deposit where the matrix had become weakened. The Salem material included in this study was of better quality than that previously tested.

For the carbonate rocks tested, the standard MD test results can be separated into two groups: those “less wear-resistant” (LWR) with losses in excess of 10% (i.e., Strasburg, Frazier, and Rockydale) and those “more wear-resistant” (MWR) (i.e., Broadway, Castlewood, Perry, and Staunton). Comparing these groupings with those of Table 3, the lithologic polishing tendency, it is noted that the Strasburg and Frazier were grouped together as readily polishing, with the others split between moderate-to-readily and moderate. The obvious non-conformant in these groupings is Rockydale, which was included in the moderate group in Table 3 but falls into the LWR group based on MD loss. An explanation for the apparent aberrant behavior of the Rockydale is that some particles are showed signs of weathering, resulting in localized softening and splitting along fracture or bedding planes within the particles (see Figure 1). The MD procedure has been shown to be an effective tool in identifying reduction in material quality resulting from weathering (Hossain et al., 2007). Additional samples of the material should be obtained and tested to verify this explanation and assess the implications regarding sampling, testing and acceptance of materials for specific applications.

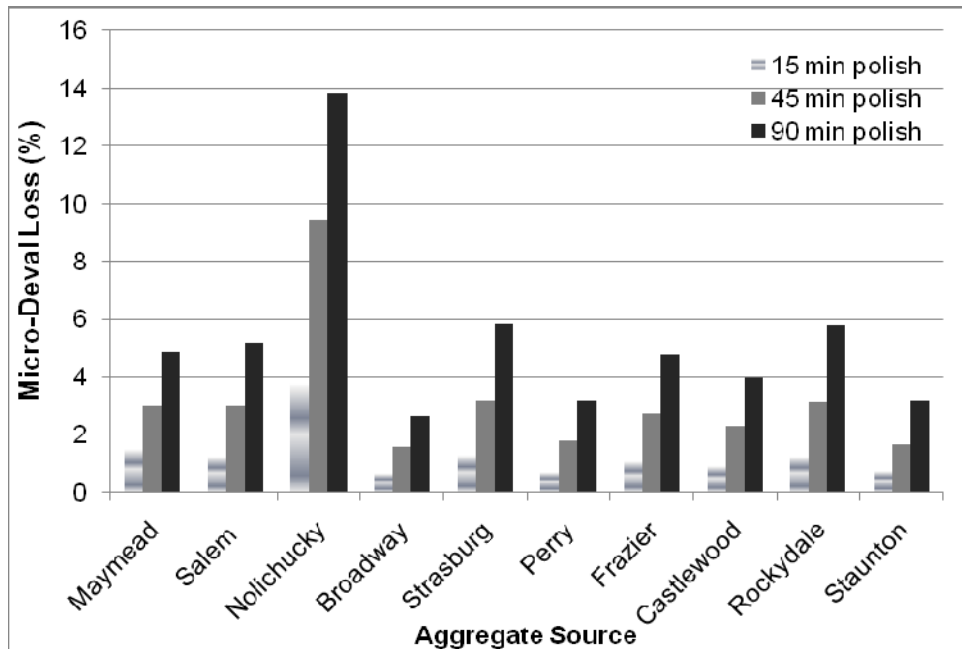
Figure 3. Micro-Deval Test Results (Non-Standard Procedure)

Examining the results of the A/P MD tests, the carbonate rocks separate into two groups based on loss that remain the same through the progression of wearing cycles. Using loss values of 1.0% at 15 min, 2.5% at 45 min, and 4.5% at 90 min, the carbonate aggregates can again be grouped into LWR (>x), i.e., Strasburg, Frazier, and Rockydale, and MWR (<x), i.e., Broadway, Castlewood, Perry, and Staunton.

Figure 3 presents the loss data for the same aggregate sources, but with the non-standard A/P procedure. It can be observed that the abrasion loss followed the same pattern as for the standard procedure. This indicates that the non-standard procedure did not alter the basic wear relationships between aggregates in the MD apparatus. Aggregates were grouped based on their lithologic characterization in Table 2.

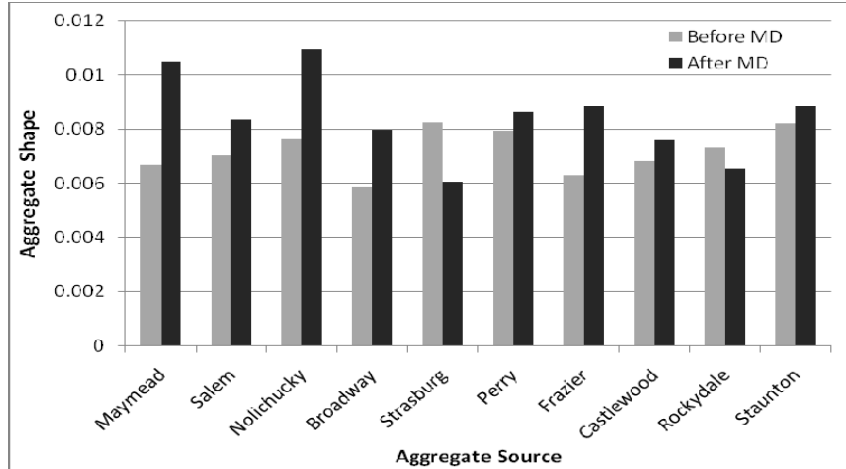
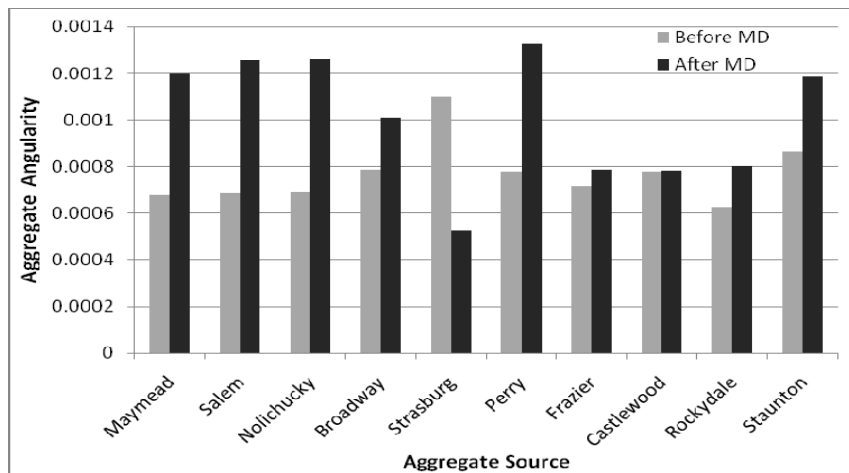
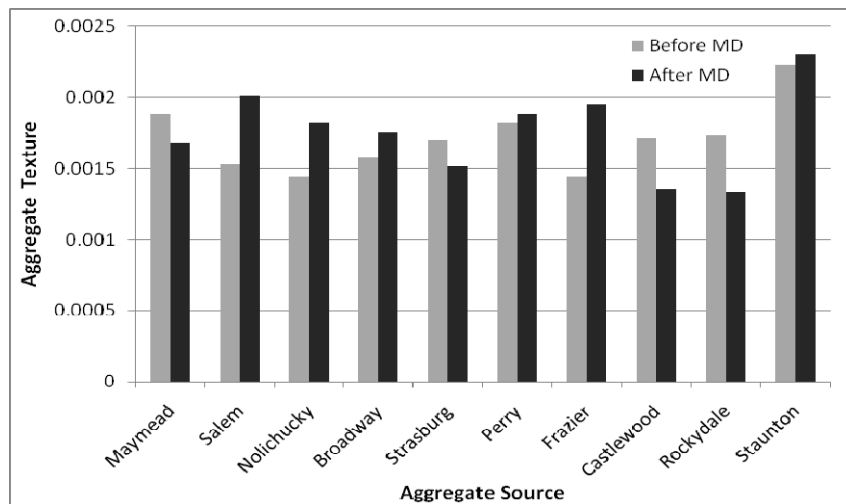
Figure 4. Aggregate Parameters Evaluation (AASHTO T 327 Procedure)

polishing. Statistical analysis results, mean and standard deviation, are presented in Tables 6 and 7. Figures 4 and 5 illustrate the mean values for the aggregates' characteristics before and after MD abrasion testing for the standard and A/P (non-standard) procedures respectively. Aggregate sources were grouped according to their lithologic description in Table 2.

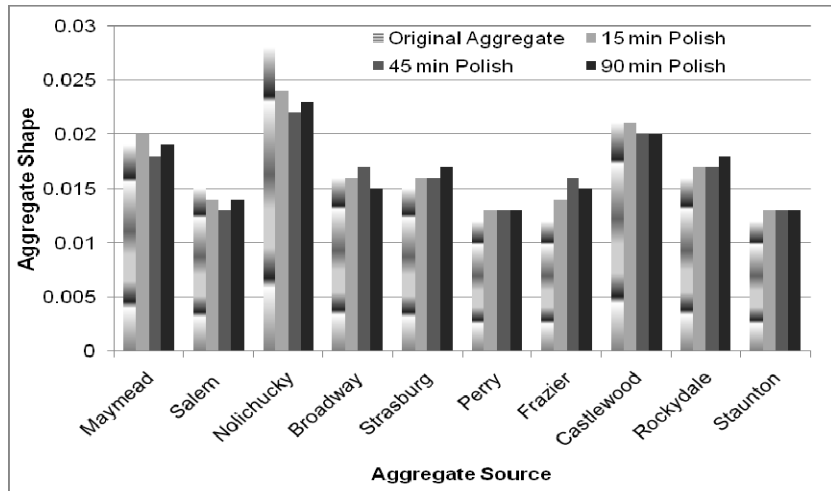
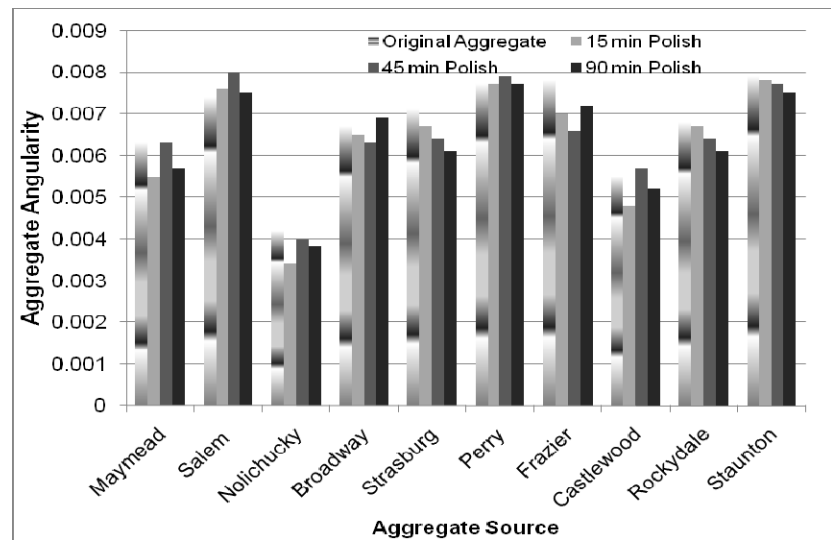
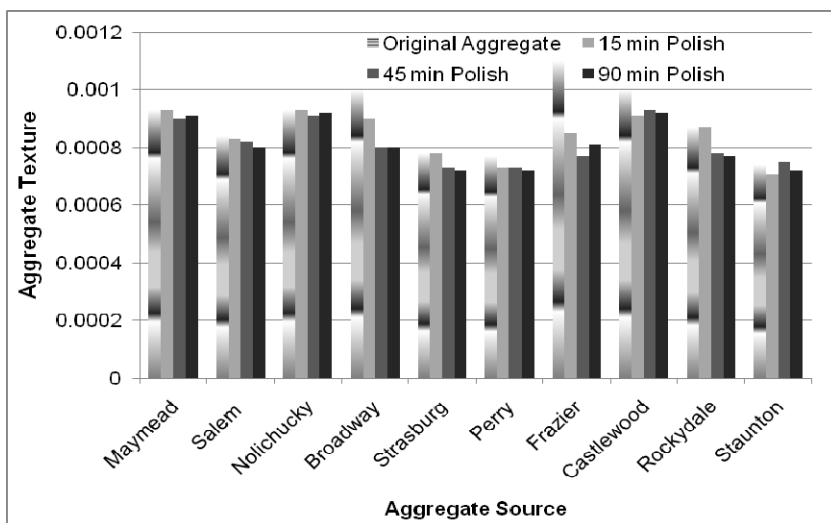
Figure 5. Aggregate Parameters Evaluation (Non-Standard Procedure)

Examining the image analysis data for the A/P procedure in Figure 5, the two aggregates with the steepest progressive loss of angularity through two cycles fell into the LWR category based on simple mass loss and were those classified as readily polishing by lithologic characteristics. The third steepest loss in angularity was shared by two sources, one of which was the third aggregate to fall into the LWR group. Similarly, the same four aggregates, Strasburg, Frazier, Rockydale, and Mundy, are four of the five showing the steepest progressive loss in texture through two cycles.

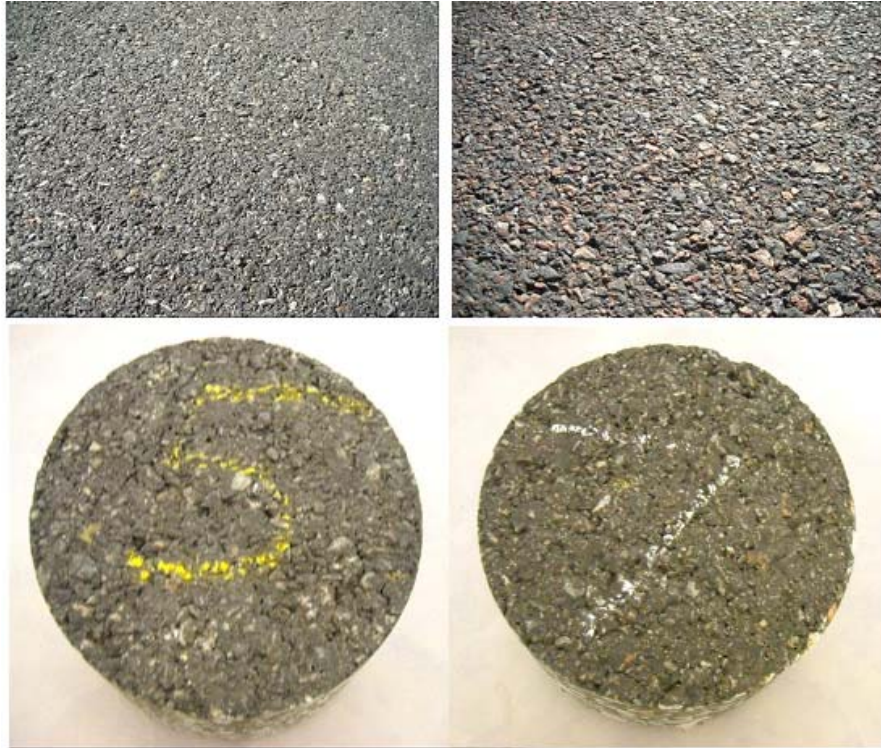
Figure 6. Buchanan County Pavement Sections and Specimens

Previous to this study, in 2007, pavement specimens had been collected for examination of aggregate surface wear a year after the pavements were placed. Pictures of pavement sections as they exist currently in service and of the specimens previously removed were taken for comparison purposes. They are presented in Figures 6 through 8, respectively.

From the specimens' pictures it can be inferred that the pavements did not suffer a tremendous amount of wear in the first year as most of the aggregates are still covered by asphalt. However, although some portions of the pavements still do not show serious signs of traffic wear (left picture) some portions started to wear off as aggregates started to be exposed (right picture). Aggregate exposure is more pronounced on the Buchanan and Tazewell sections (right picture).

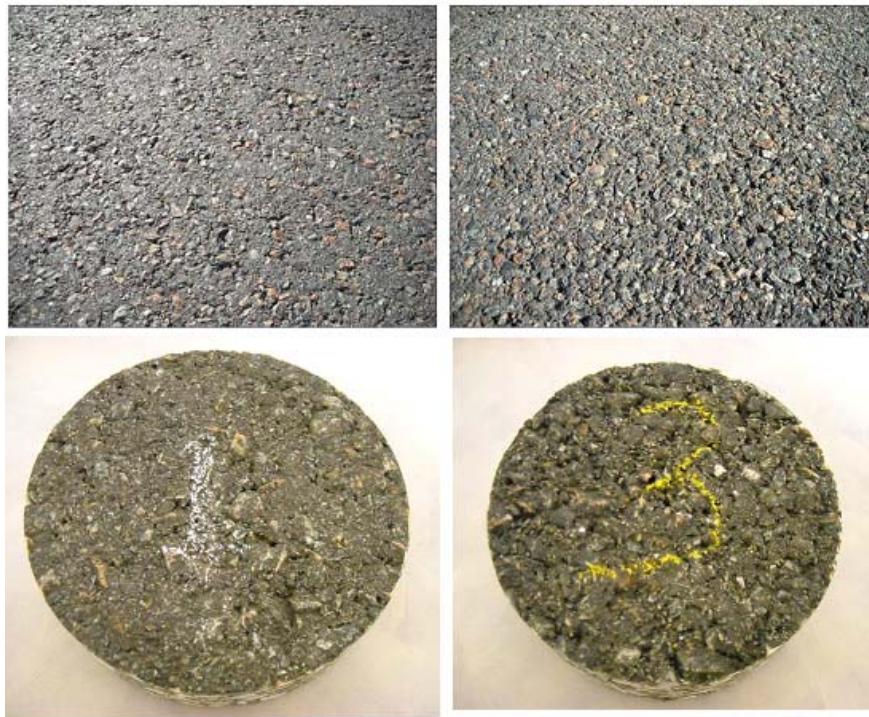
Figure 7. Russell County Pavement Sections and Specimens

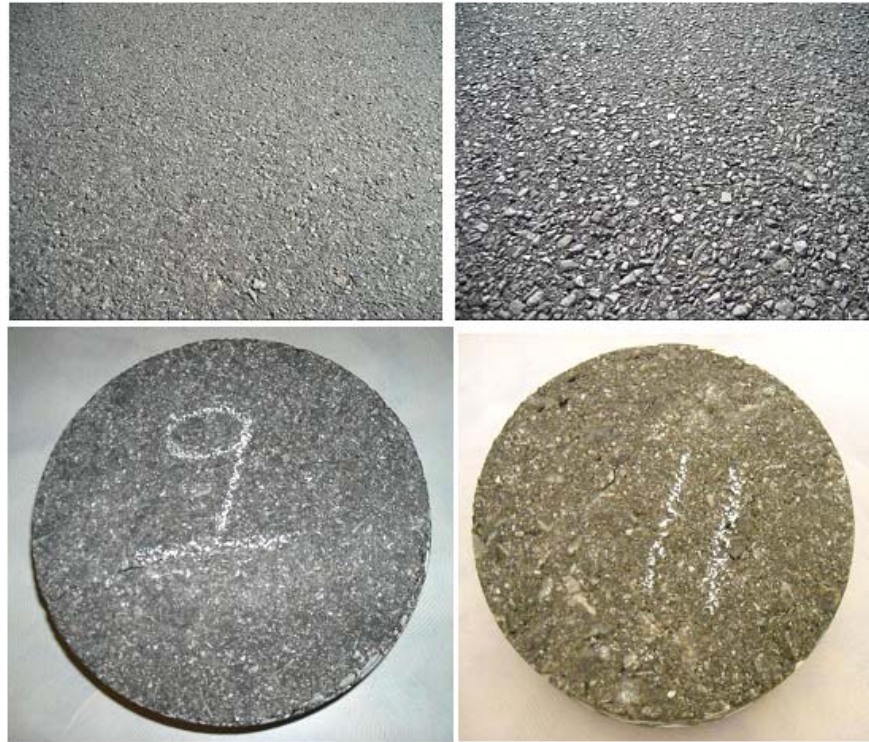
Figure 8. Tazewell County Pavement Sections and Specimens
