Final Report  
FHWA/NC/2007-17

**MONITORING THE EFFECTS OF HIGHWAY CONSTRUCTION  
IN THE SEDGEFIELD LAKES WATERSHED**

**September 4, 2007**

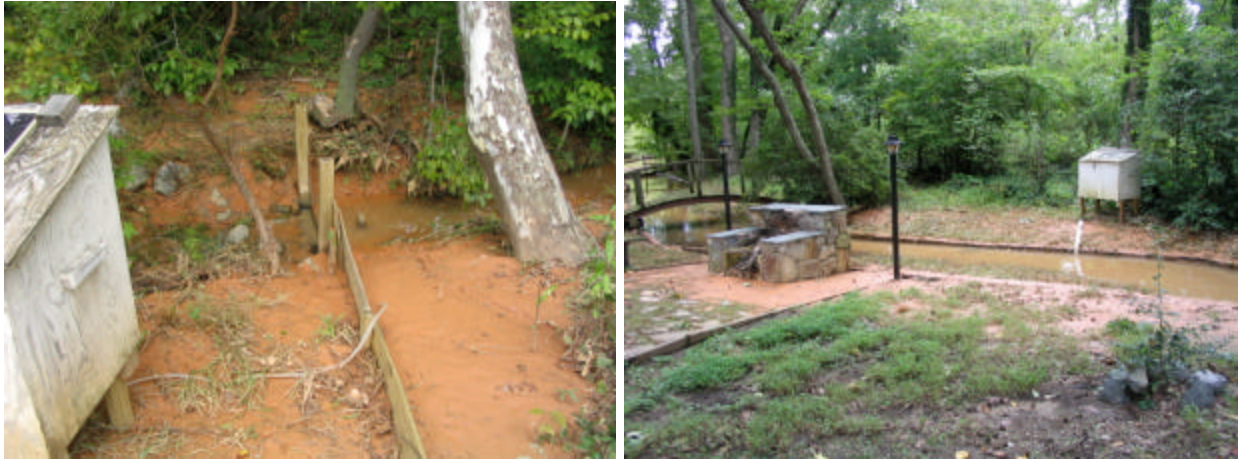
**Figure 3. Tilly-up weir (left) and Tilly-down monitoring site (right).**

All 6 samplers were programmed to collect samples on a flow-proportional basis. Flow or discharge monitoring was accomplished via the use of weirs (fig. 3) or stage-discharge rating tables related to a permanent stream staff gage (fig. 4 and 5). The frequency of sampling was continually evaluated to insure that enough samples were collected to adequately characterize the water, while making sure the capacity of the sampler was adequate to sample all the discharge during the 2-week period before the sampler became full. An equal volume of sample was taken from each bottle that was collected during the 2-week monitoring period and placed in a laboratory container for analysis. All samples were analyzed for total suspended solids (TSS), total solids (TS), and turbidity. Selected samples will also be analyzed for total Kjeldahl nitrogen (TKN), nitrate nitrogen (NO<sub>3</sub>-N), ammonia nitrogen (NH<sub>3</sub>-N), and total phosphorus (TP) by the NC State University Biological and Agricultural Engineering Departmental laboratory. Samples were analyzed using standard methods (APHA, AWWA, WPCF. 1998). Selected samples were analyzed for TSS by two labs to assess the repeatability of the results.

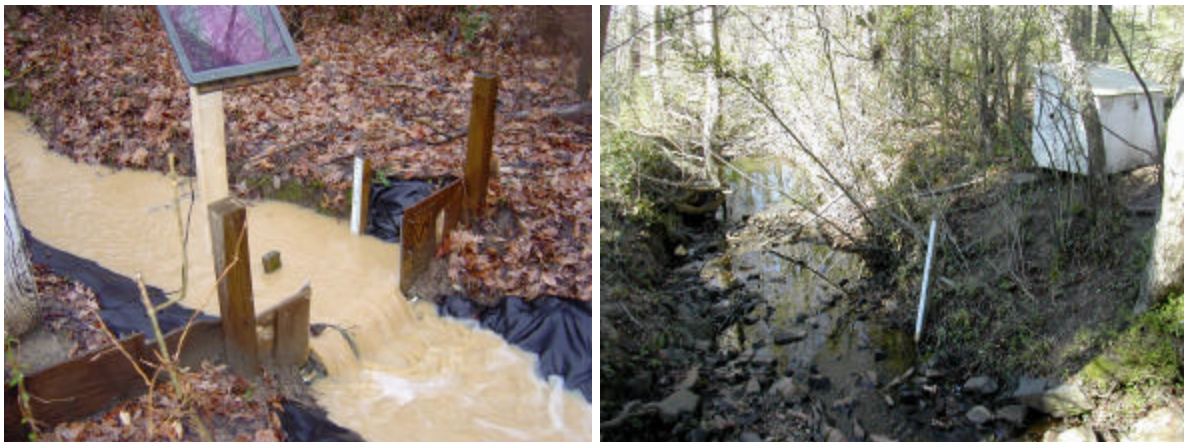
**Figure 4. Ellery-up (left) and Ellery-down (right) monitoring sites.**

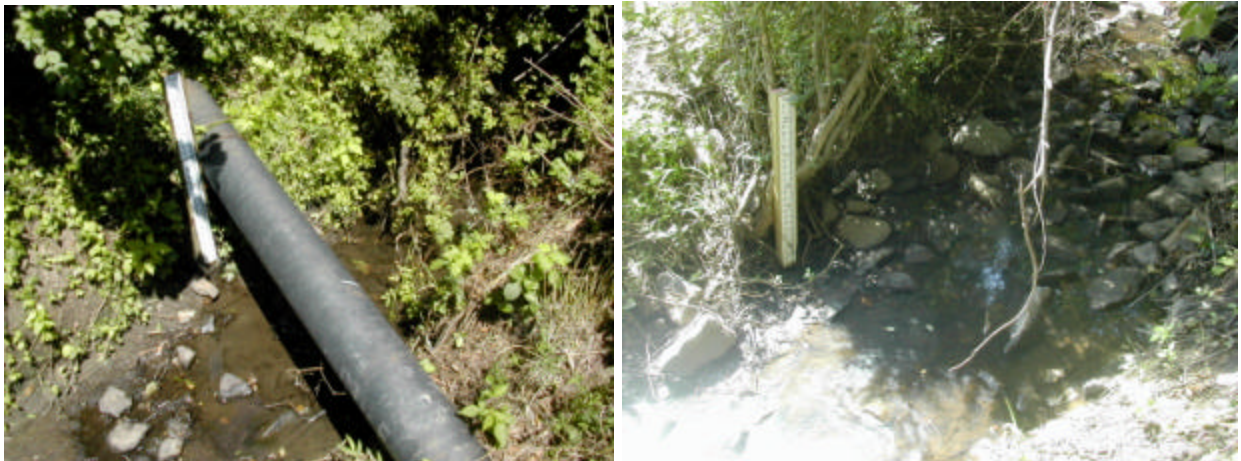
**Figure 5. King's Mill up (left) and down (right) monitoring sites.**

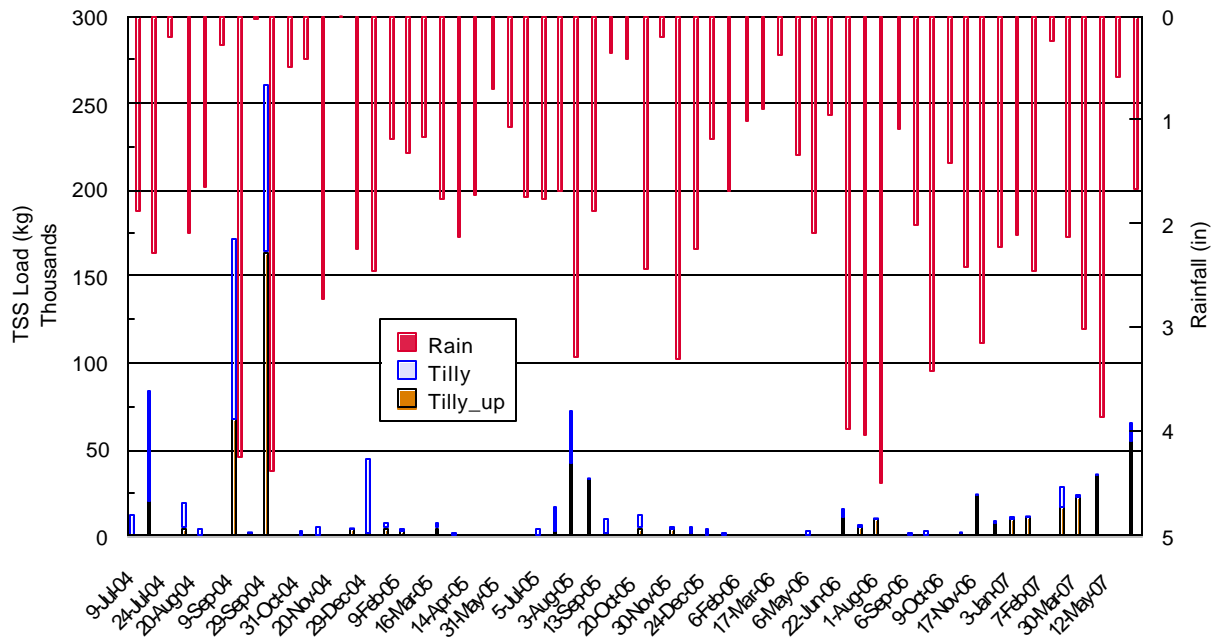
**Figure 6. Sediment export at Tilly-up and Tilly-down during construction.**
