Post-Earthquake Bridge Inspection Guidelines

Jerome S. O'Connor, P.E.¹
Principal Investigator
October 2010

Final Report for NYSDOT SPR Project # C-06-14
Development of Post-Earthquake Bridge Inspection Guidelines
Cornell Transportation Infrastructure Research Consortium (TIRC) Subcontract 53740-8411

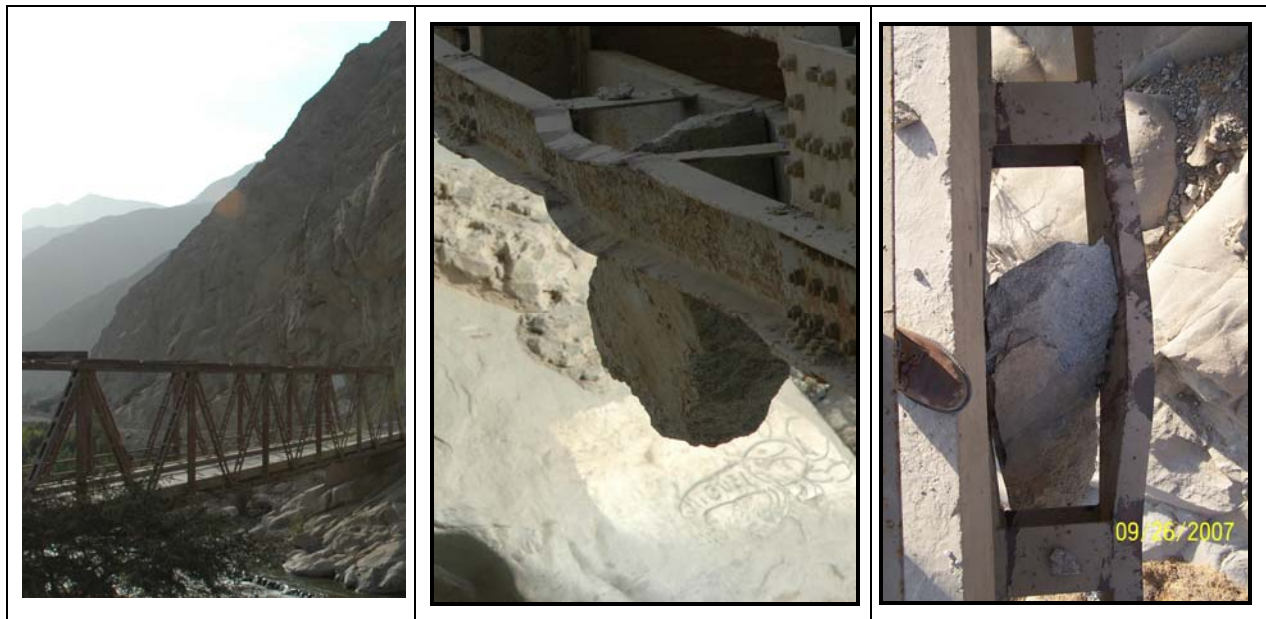
Figure 1. Damage from Rockfall in Peru. (O'Connor)

An earthquake caused rocks to fall from the mountain that was looming over this truss bridge in Peru, causing impact damage to the bottom chord, a primary structural member. In addition to the obvious deformation, cracked welds were discovered.

- Rockfall: boulders can become loosened crash onto a bridge, causing structural damage. (See Figures 1 and 2)
- Debris Flow, Mud Flow, Huaico: This is an uncommon occurrence but can develop after heavy rainfall or rapid snowmelt. A flowing river of mud can initiate and travel miles, picking up rocks, boulders, and trees along the way.

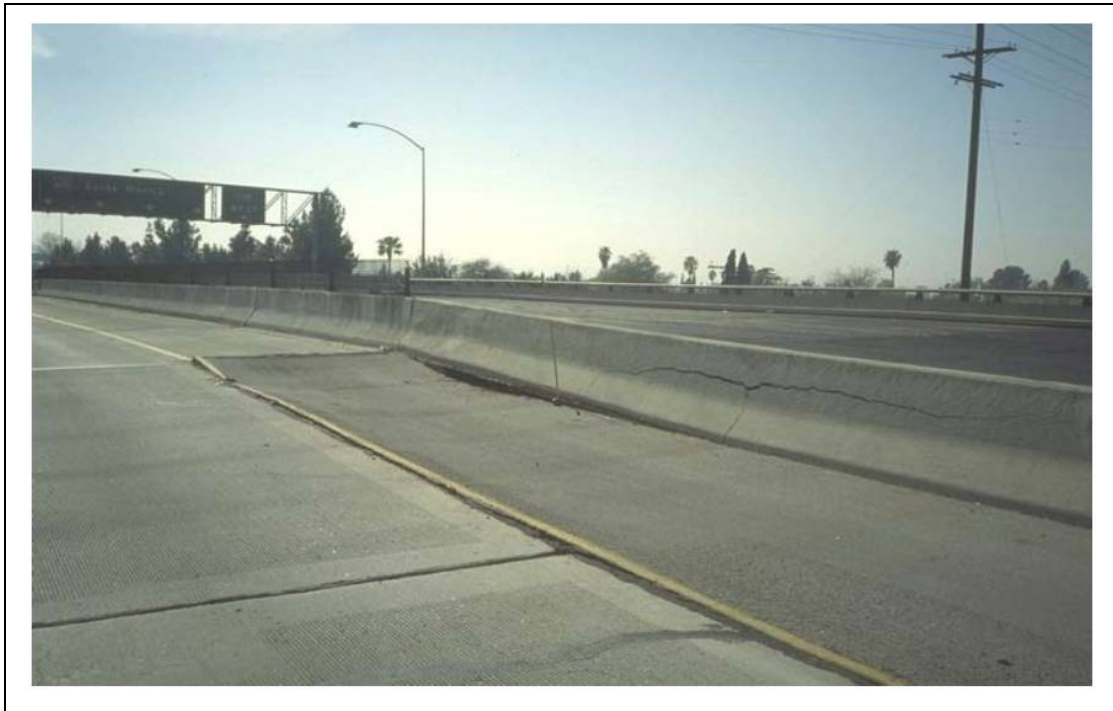
Figure 14. Moderate Damage: Approach slab settlement (Sardo, A. G., et al., 2006). Note the cracking of the concrete barrier as well.

Settlement of the approach slab is often a result of soil movement around the abutments (lateral spread or liquefaction) so if the approach has settled, particular attention should be given to evaluating the condition of the foundation and substructure.

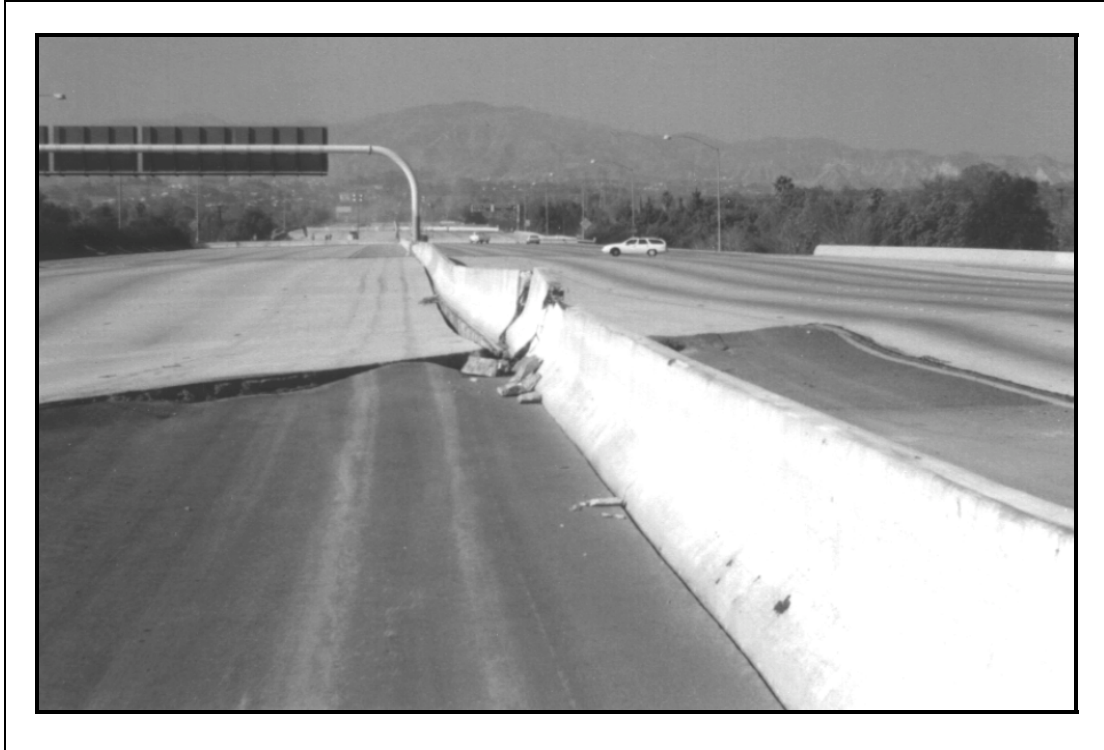
Figure 15. Approach damage considered Moderate to Major (Northridge Earthquake) (PEQIT)

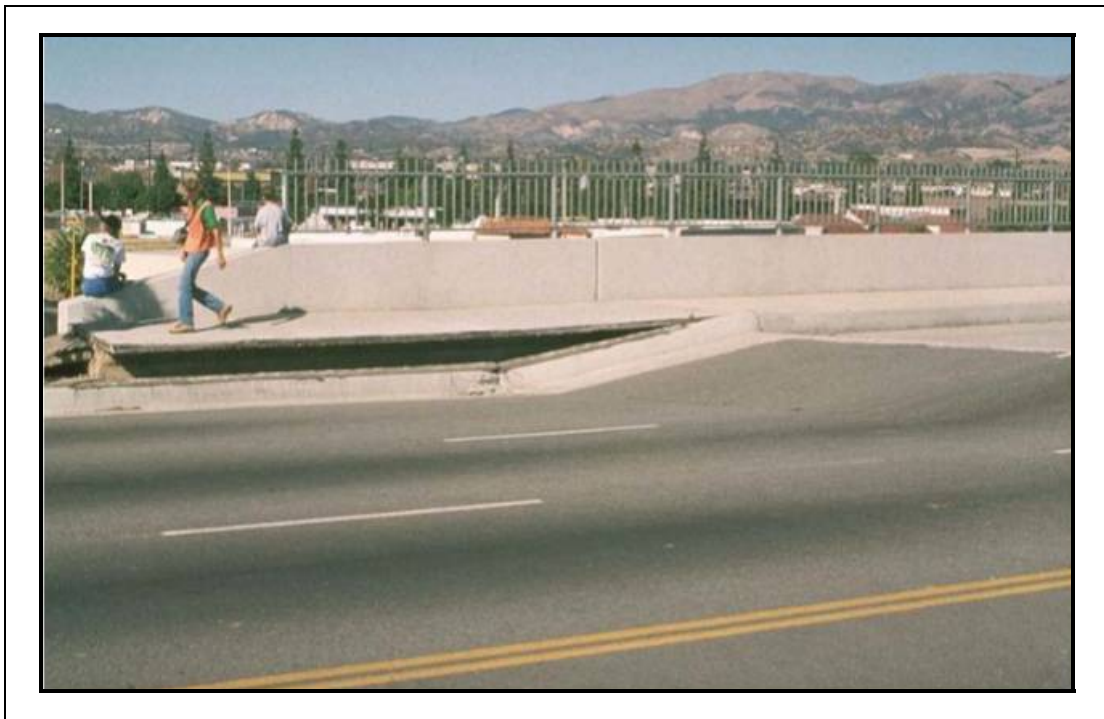
Figure 16. Settlement of bridge approach, considered Major damage (KTC)

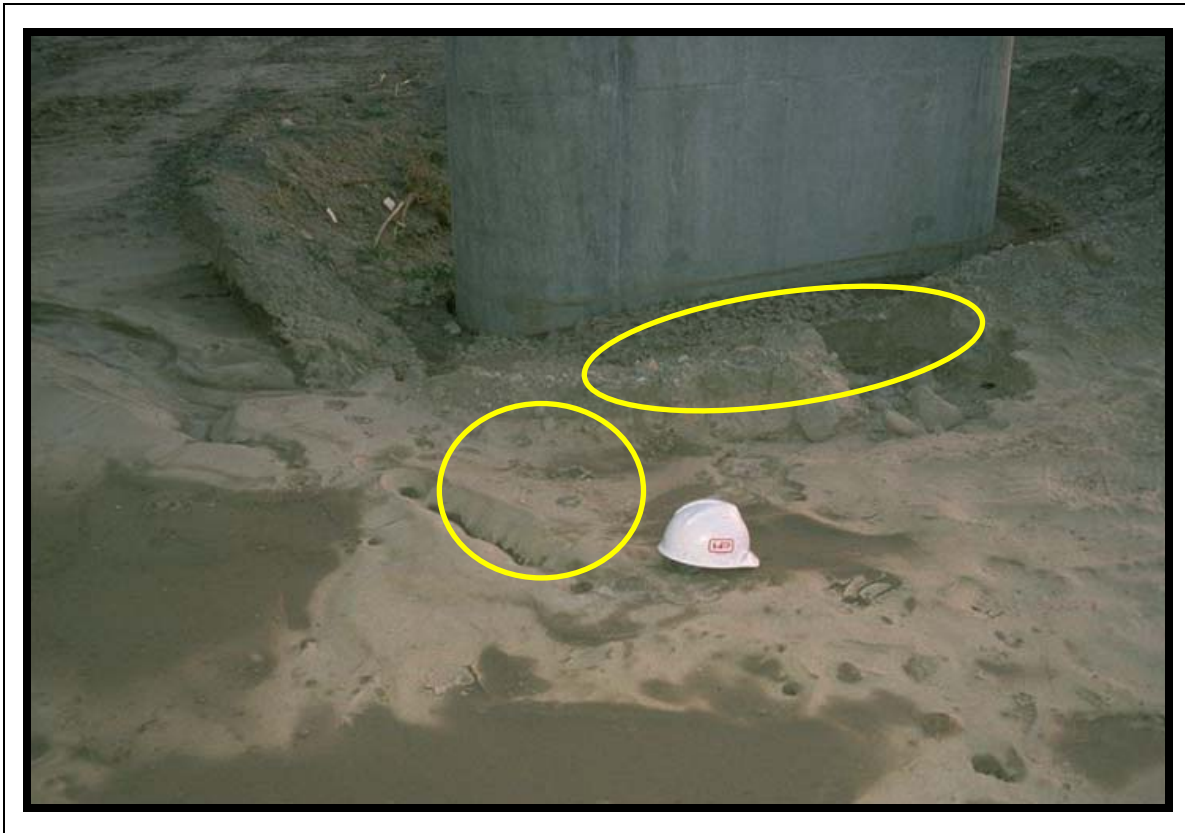
Figure 17. Evidence of liquefaction near a pier (NISEE)

All bridges (except floating bridges) are founded on soil or rock and any bridge is only as strong as its foundation. Earthquakes create ground shaking that can damage the substructure and superstructure, but can also cause soil problems. For instance, a seismic event can result in a loss of shear strength in loose, cohesionless soil when the water table is high – called liquefaction. Soil liquefaction and lateral spread are ground failures common in large earthquakes. A loss of bearing capacity caused by soil liquefaction can cause foundation failure, settlement, or tilting of abutments and piers. Settlement can result in a discontinuity in the superstructure between spans or between the bridge deck and the approach slab. Although liquefaction would only be expected in NYS if the magnitude was M6.0 or greater, an inspector should be aware and be able to identify unusual geotechnical conditions. This type of damage can be observed in Figure 17. Figure 18 is a condition that should prompt an investigation of the supporting embankment material.

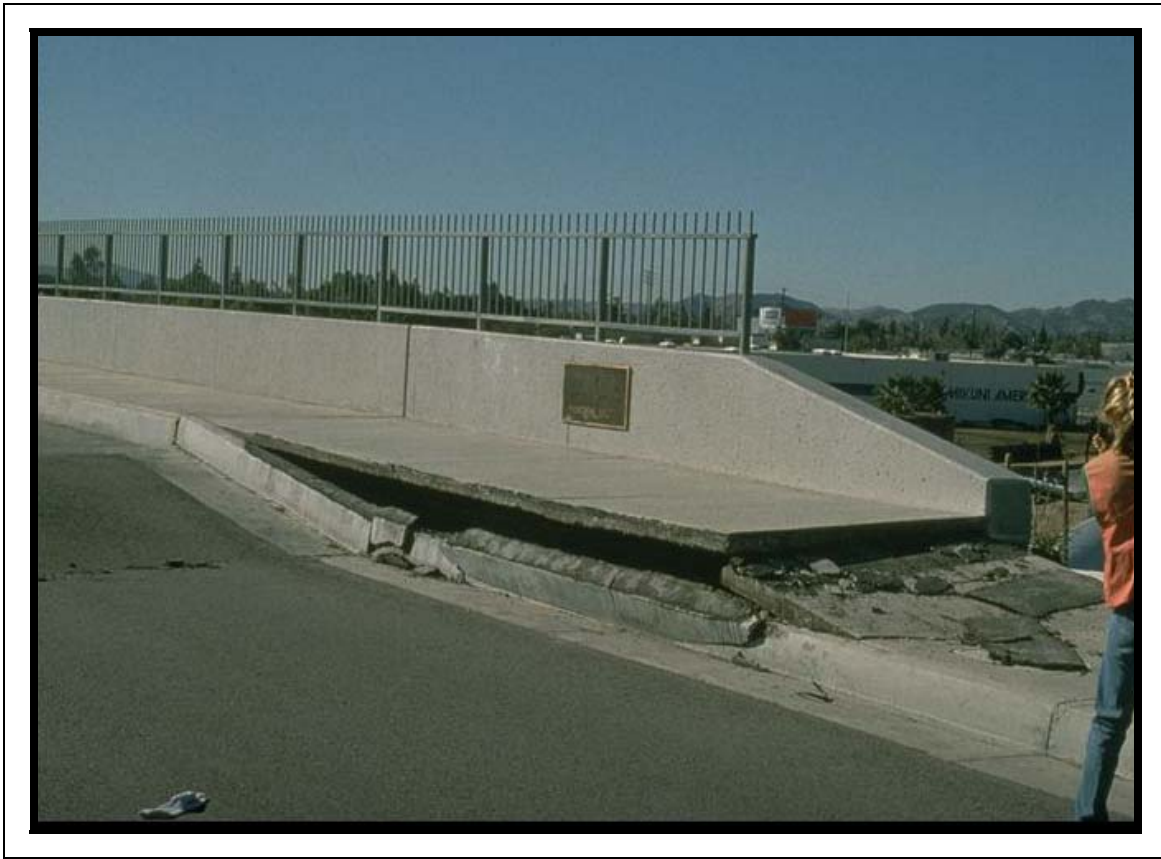
Figure 18. Settlement at the bridge approach, likely caused by soil settlement around the abutment (Northridge EQ) (NISEE)

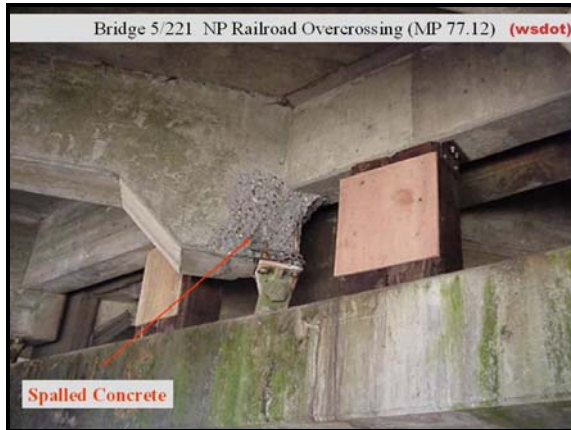
Figure 19. Moderate Damage: Spalled concrete (WSDOT)

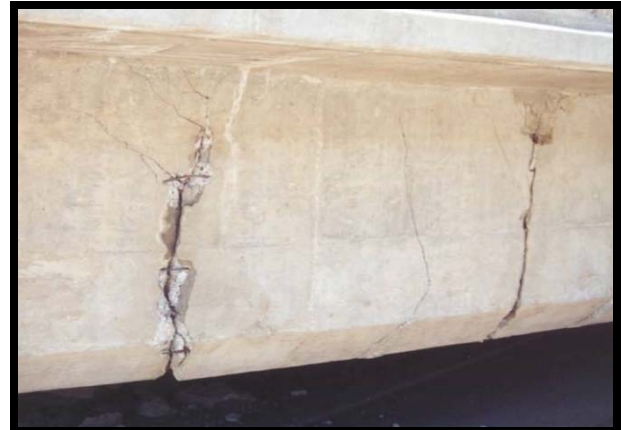
Figure 20. Moderate Damage: Flexural cracking of concrete girder (KTC)

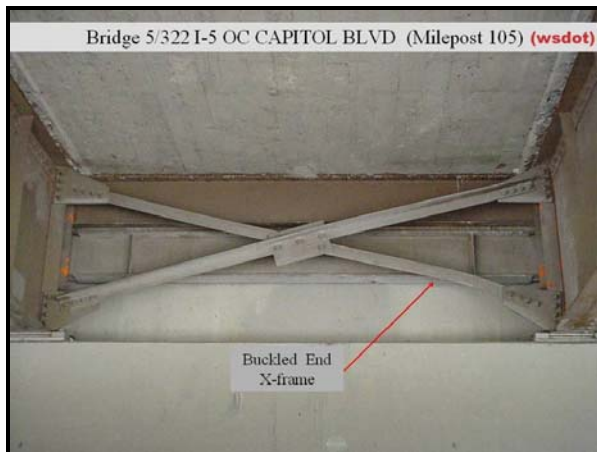
Figure 21. Minor Damage: Buckled bracing element. (WSDOT)

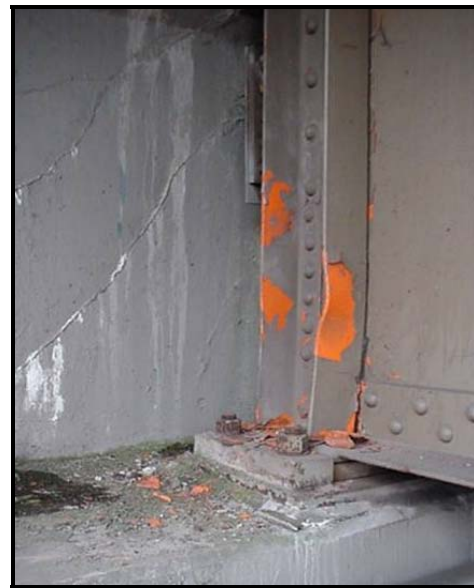
Figure 22. Minor Damage: Web stiffener damage. Note that the paint has flaked off recently. (MCEER)

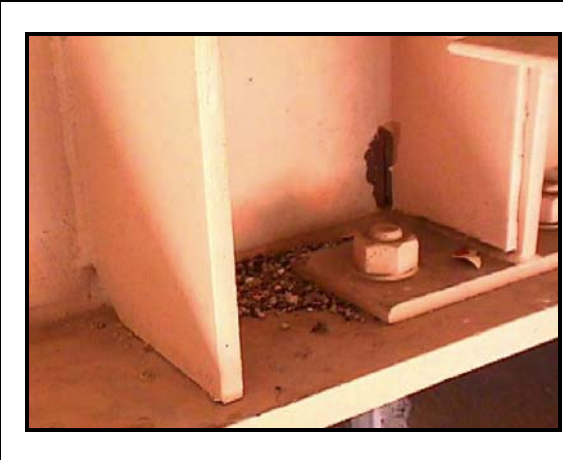
Figure 23. Moderate Damage: Crack in web of steel girder. Note that this may be a red flag condition if it is in the primary member. (CPHMR)

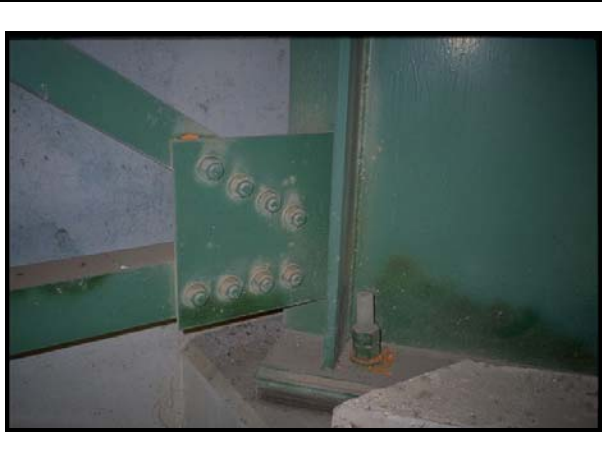
Figure 24. Minor Damage: Damage to anchor bolts (MCEER)

nuts tight (Figure 24). The girders should be inspected for any misalignment, cracking or cracked welds (Figures 25-26), especially fatigue sensitive details. Especially crucial are the “pin and hangers” used to support suspended spans of a steel girder bridge. This detail is considered a seismic vulnerability since damage or displacement can lead to complete loss of span support.

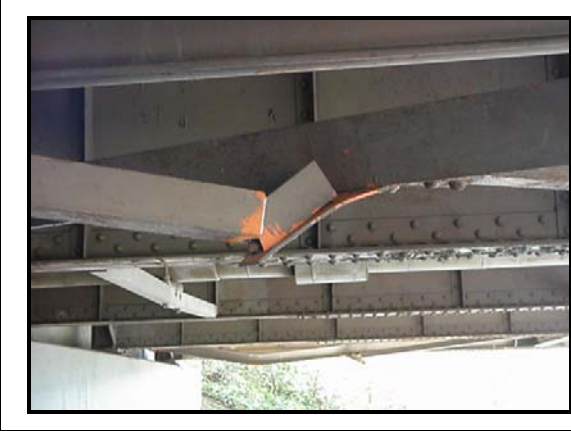
Figure 25. Moderate Damage: Fracture of lower lateral bracing (MCEER)

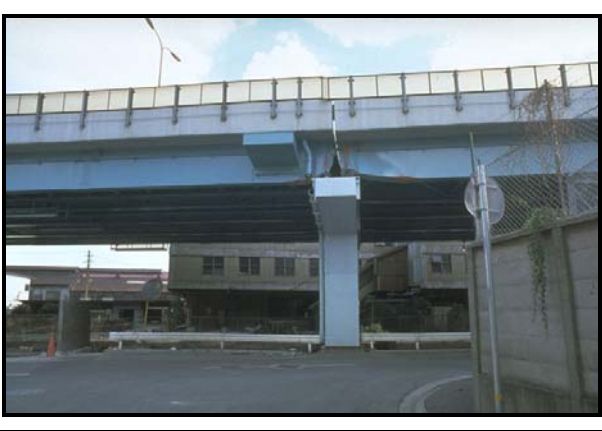
Figure 26. Severe Damage: Steel girder buckling (MCEER)

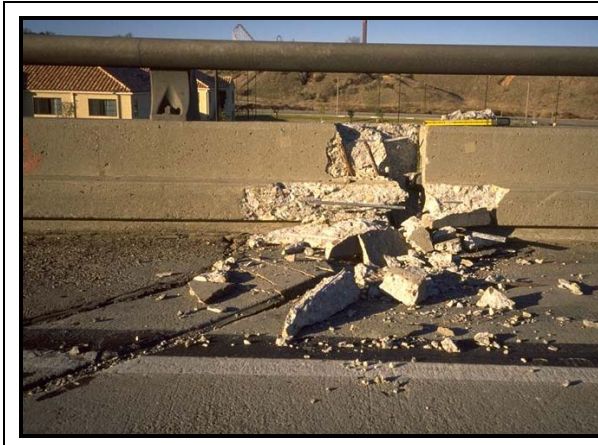
Figure 27. Minor Damage: Parapet crushing / spalling (NISEE)

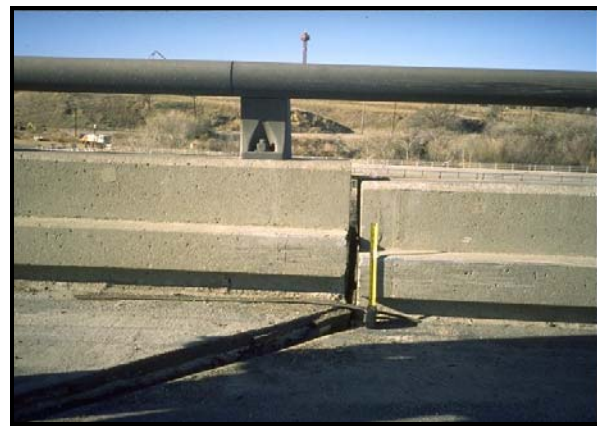
Figure 28. Minor to Moderate Damage: Vertical and horizontal movement at joint (NISEE)

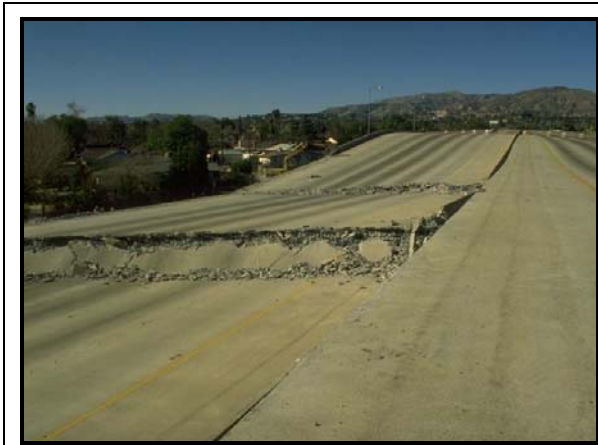
Figure 29. Severe Damage: Deck collapse (KTC)

misalignment in the pavement striping. Longitudinal motion may cause *pounding* of one span against an adjacent span, which can cause spalling of the deck, barrier and/or curb concrete. Sometimes this type of damage does not represent a structural problem itself, but the debris may jeopardize the safety of the traveling public (Figure 27). A slight drop of the deck at a joint illustrated in Figure 28, may be classified as moderate. Determination of the cause requires more investigation. There may be additional damage visible from below. Figures 29-31 illustrate severe failures.

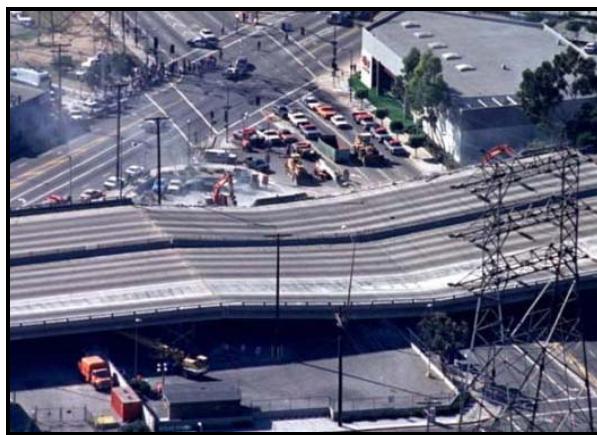
Figure 30. Severe Damage: Deck collapse (WSDOT)
I-10 and SR 118 Damage from Northridge EQ
http://itsdocs.fhwa.dot.gov/jpodocs/repts_te/13775.html

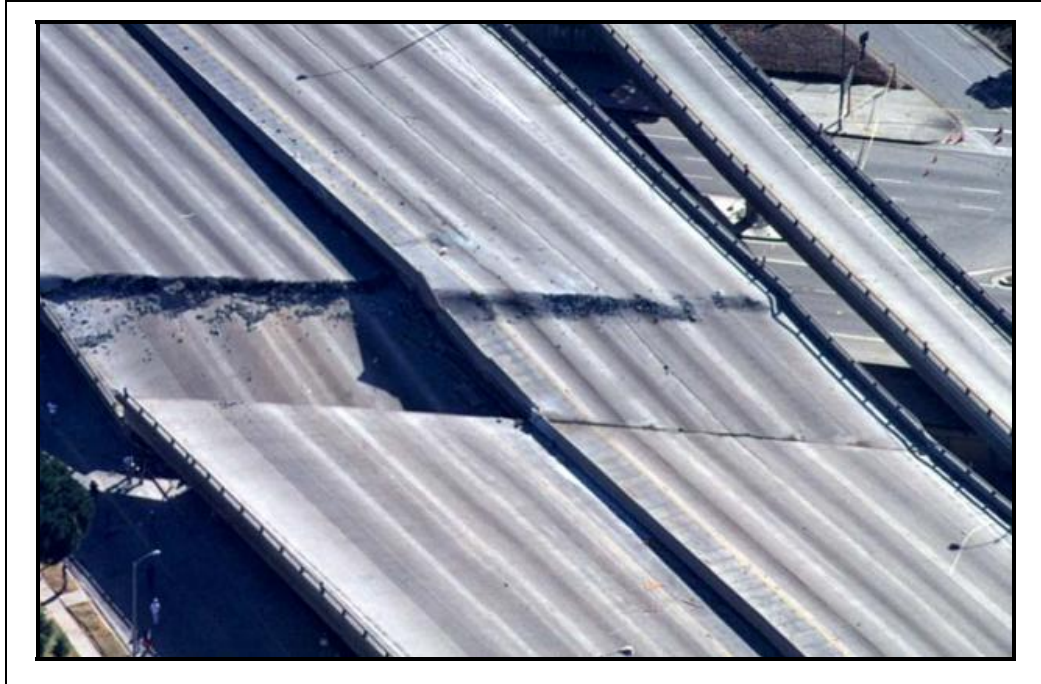
Figure 31. Severe Damage: Deck collapse (USDOT)
(I-10 and SR 118 Damage from Northridge EQ
http://itsdocs.fhwa.dot.gov/jpodocs/repts_te/13775.html)

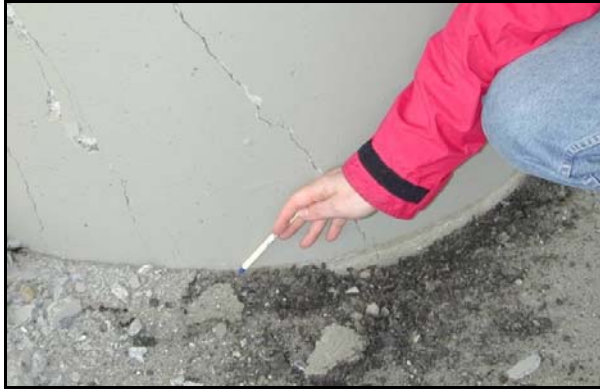
Figure 32. Ground movement indicating possible foundation problem (MCEER)

Concrete piers or columns may show flexural and/or shear cracks after an earthquake. If the cracks are superficial and if the concrete cover spalls over a limited area, the damage is minor but must still be noted on the PBDA. If the concrete cover spalls over a large area and the cracks penetrate into the core of the column (defined by the area within the limits of the lateral confining steel, such as hoops, ties or spirals), the damage should be considered moderate or severe and this should be noted on the form. There is not much room for judgment between the categories of moderate and severe. If a majority of the cracks are diagonal (indicating shear failure), the condition should be assessed as severe, until further inspection can be completed. Buckled or fractured reinforcement is also indicative of severe damage. More often than not, the noted damage will be at the top or bottom of the columns or piers. The top of the columns should be investigated for damage to the concrete and bearing. The bottom of the columns should be investigated for damage to the concrete and reinforcement but also for dislocated soil, liquefaction, fissures, and differential settlements as an indication of foundation movement and possible damage to the footings. (Figures 17 and 32) If there is settlement along with the pier damage, a “Yes” should be entered in column #5 as well. Figures 13, 32-42, and 60 show columns in various damage states.

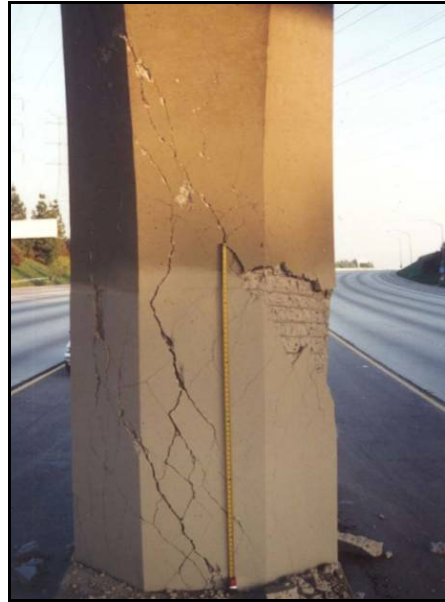
Figure 33. Minor Damage: Cracking and spalling of the concrete cover at the column base (KTC)

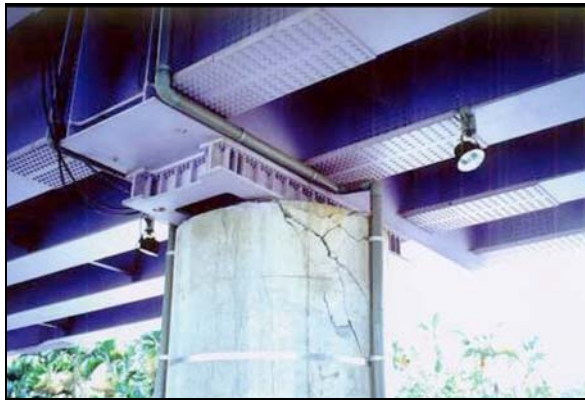
Figure 34. Moderate Damage: Compression failure at top of concrete column (INDOT)

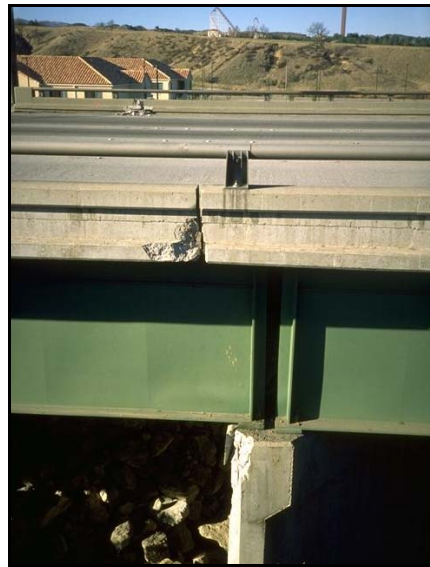
Figure 35. Moderate Damage: Support damage at top of pier. Minor Damage: Fascia concrete (MCEER)

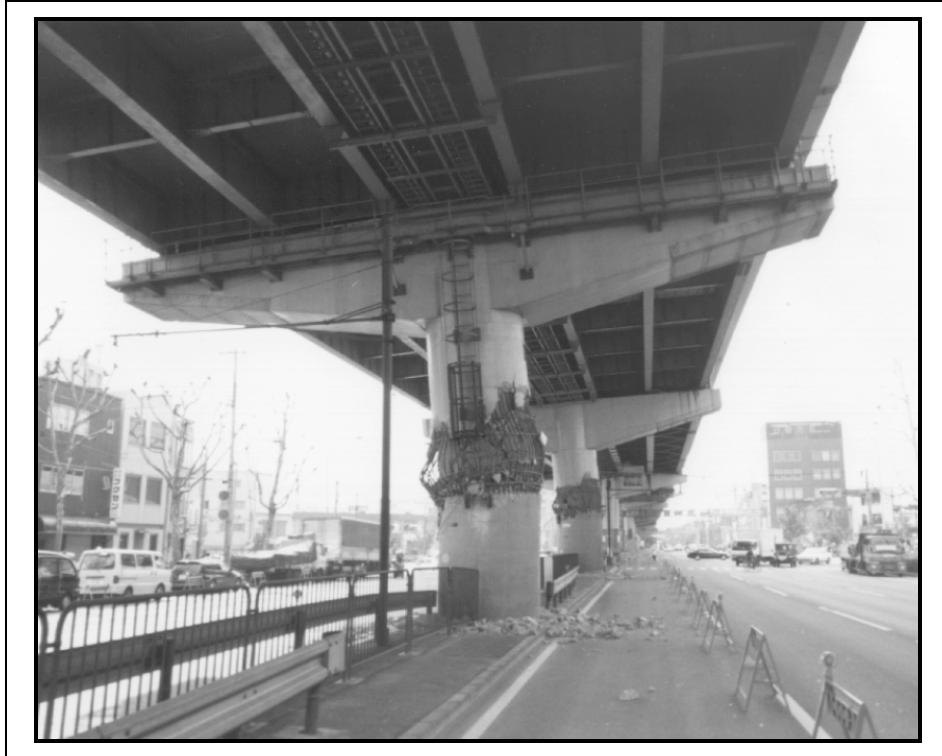
Figure 36. Severe Damage: Mid-height flexural damage (PEQIT)

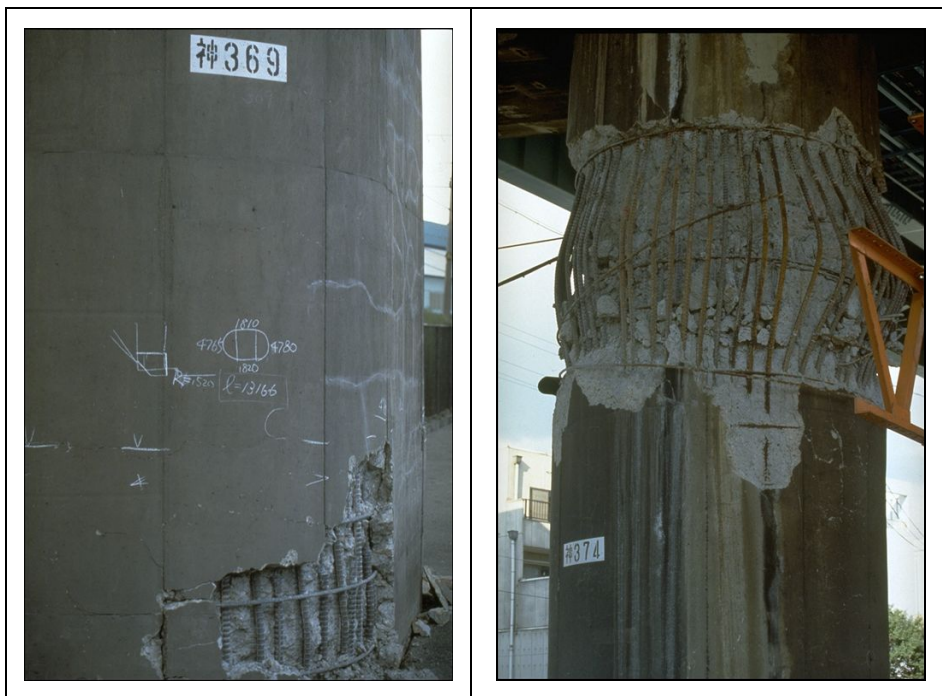
Figure 37.
Moderate to Severe Damage: Spalled column; buckling of primary reinforcement (MCEER)

Figure 38.
Severe Damage: Confinement failure (MCEER)

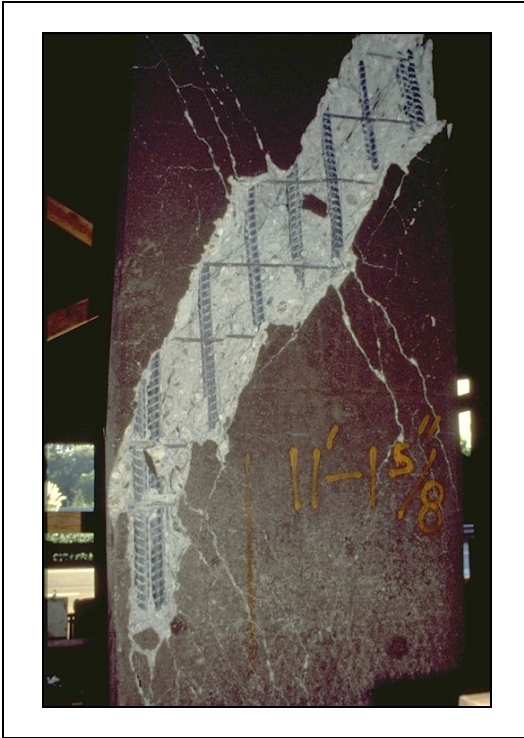
Figure 39.
Moderate Damage: Column shear (NISEE)

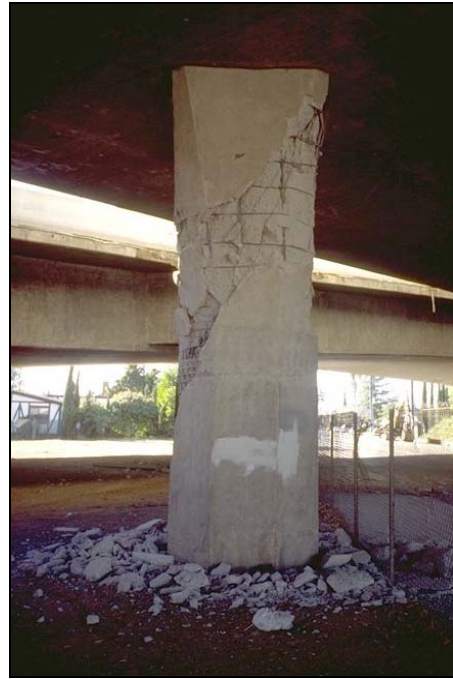
Figure 40.
Severe Damage: Brittle shear failure (NISEE)

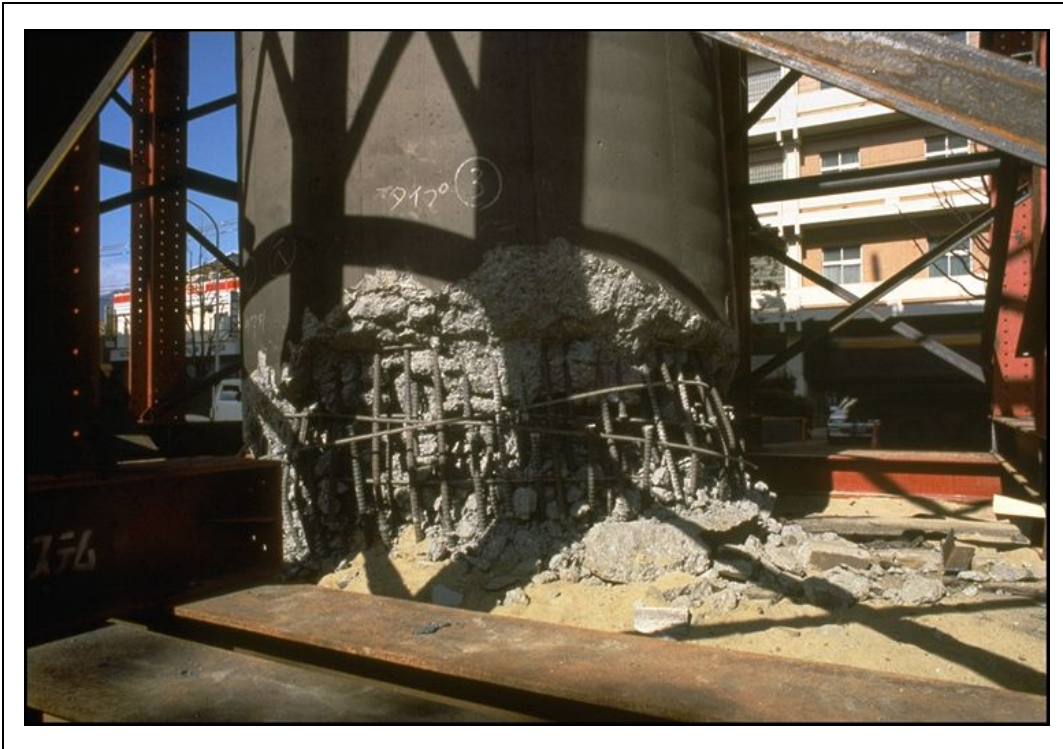
Figure 41. Severe Damage: Weld failure of column longitudinal reinforcement (MCEER)

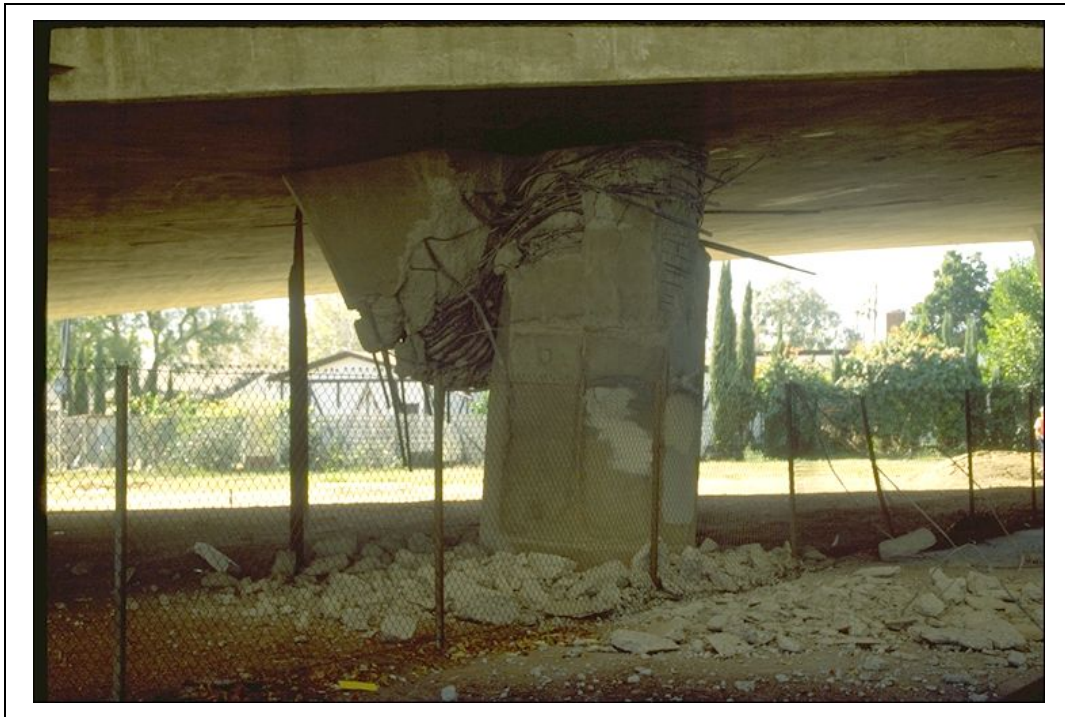
Figure 42. Severe Damage: Shear failure (1971 San Fernando Earthquake) (MCEER)

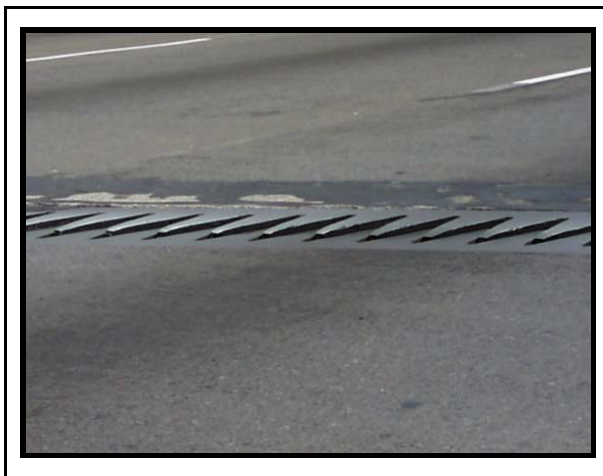
Figure 43: Minor Damage: Misaligned finger joint (MO)

Relative displacement of spans is often evident at joints. (Figures 43-45) This can result in joints that do not function as intended but may also mean that there is more serious damage underneath. For instance, a vertical displacement at the joint may mean that a bearing has toppled been damaged. To know conclusively, the area must be examined from below the deck.

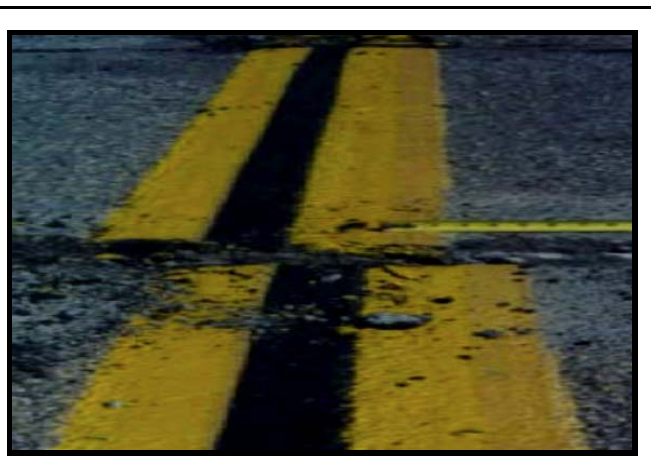
Figure 44: Minor Damage: Transverse movement along the centerline (COHMR)

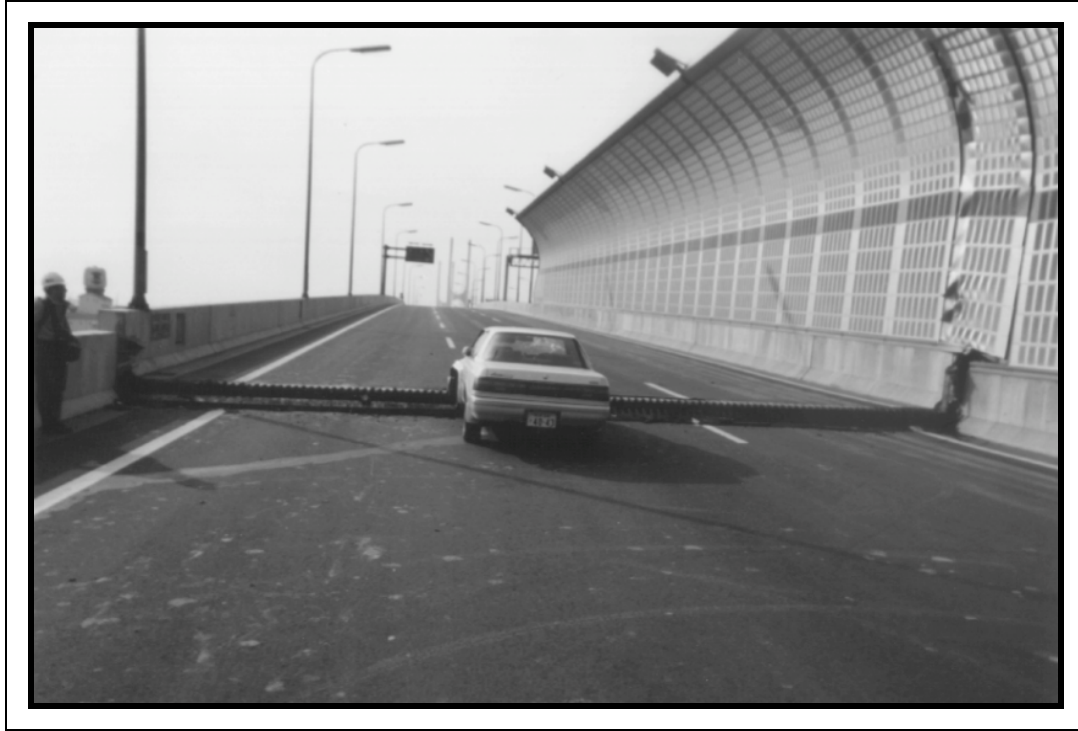
Figure 45: Moderate Damage: Differential settlement and expansion joint damage (PEQIT)

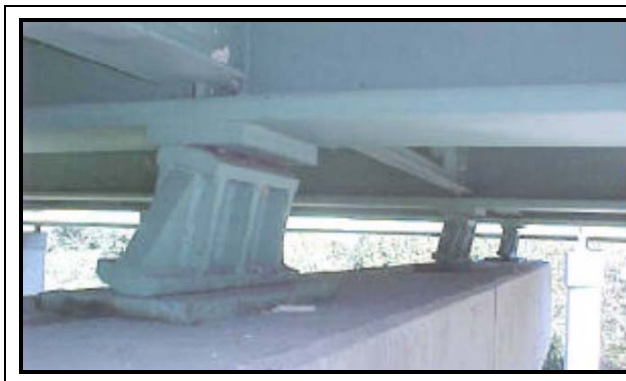
Figure 46. No Damage: Tilted rocker bearings, movement due to thermal loads (INDOT)

Bearings at the abutments and piers should be inspected for toppled assemblies, sheared or loosened bolts, sheared keeper plates and movement. Spans supported by tall rocker bearings such as those shown in Figure 46 are subject to large vertical drops. Cracked or spalled concrete at pedestals may also indicate damage to bearing assemblies (Figure 47). In addition, the bridge seats should be checked for adequate seat width to support the adjoining spans. If there is a changed condition such that less than 4 inches is available, this should be noted. Figures 48-51 show situations with severe damage to bearings.

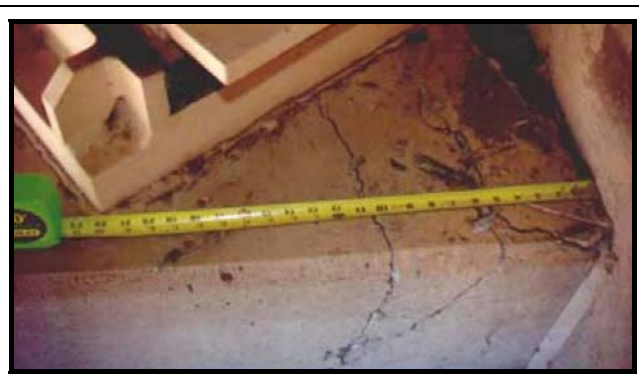
Figure 47. Minor Damage – Cracks induced by steel bearing (CPHMR)

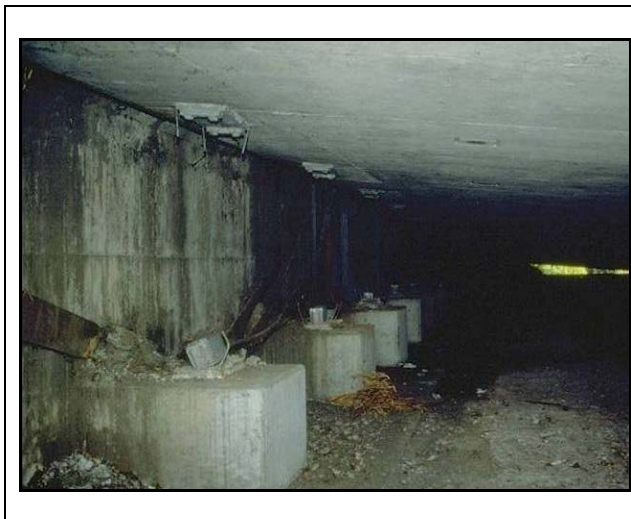
Figure 48. Moderate Damage: Abutment rocker bearings. (MCEE)

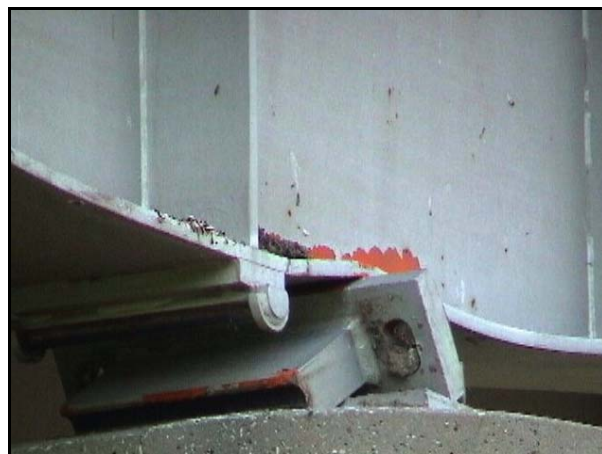
Figure 49. Severe Damage: Toppled rocker bearing (MO)

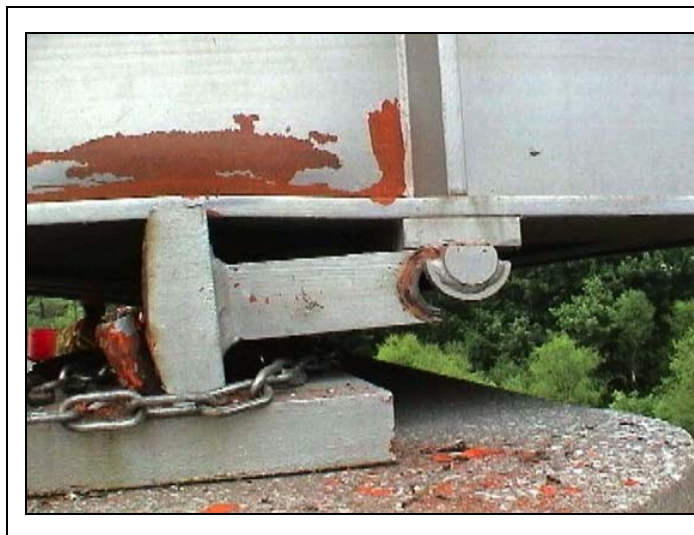
Figure 50. Severe Damage: Rocker bearing failure (MO)

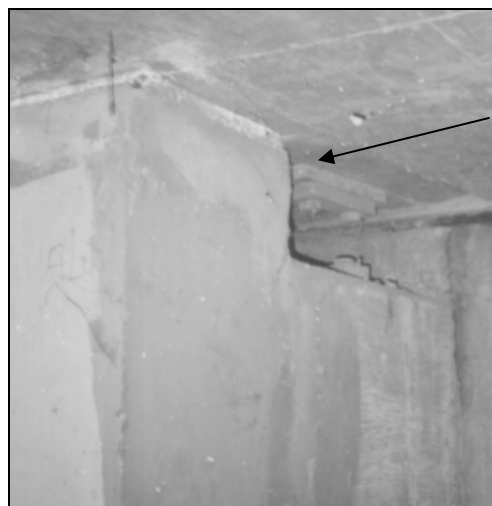
Figure 51. Severe Damage: Missing abutment bearing after Northridge (PEQIT)

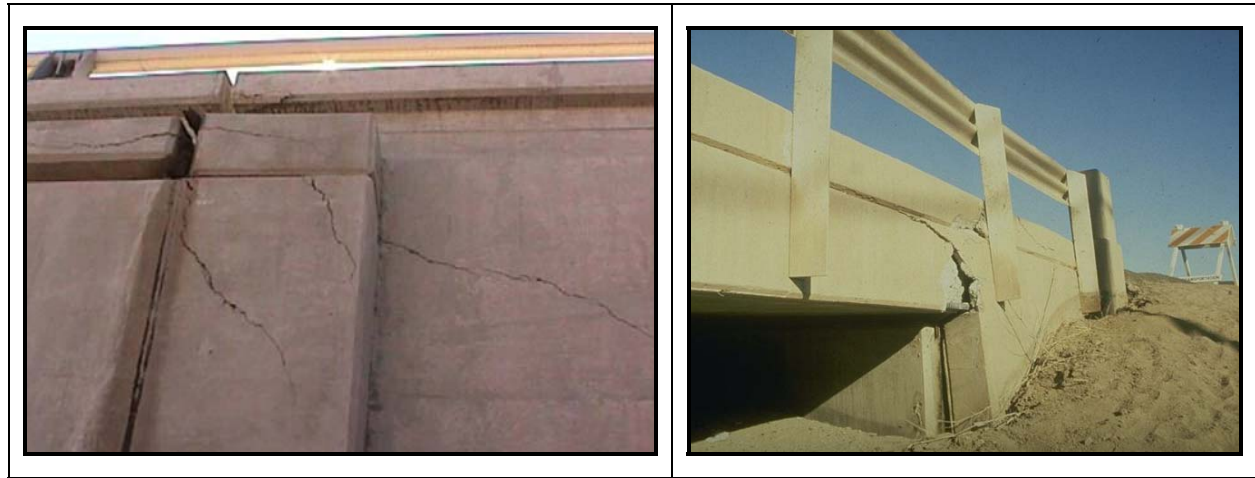
Figure 52. Minor Damage: Shear cracking at the abutment wing-wall (KTC)

Figure 53. Moderate Damage: Abutment slumping and rotation failure (NISEE)

Transverse movement may displace or crack the cheek-walls, wing-walls (Figures 52-53) and any abutment shear blocks. Longitudinal movement during an earthquake may damage the abutment stem and/or backwall (Figure 54). Examine abutment backwall and wing-walls for flexural or shear cracks, which may be less obvious than abutment movement. Loose or settled fill, slope failures, liquefaction, fissures and differential settlements at the base of the abutments may be observed as evidence of foundation movement and possible damage. If any evidence of cracking or displacement is observed, be sure to note it on the PBDA form and specify the location in the 'Comments' field.

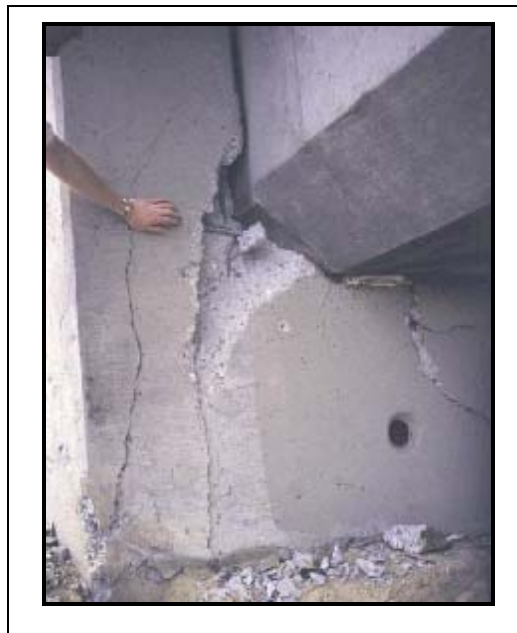
Figure 54. Moderate Damage: Spalling and cracking of abutment, movement at ground level (MO)
Note that the rebar is not rusting, an indication that damage is recent.

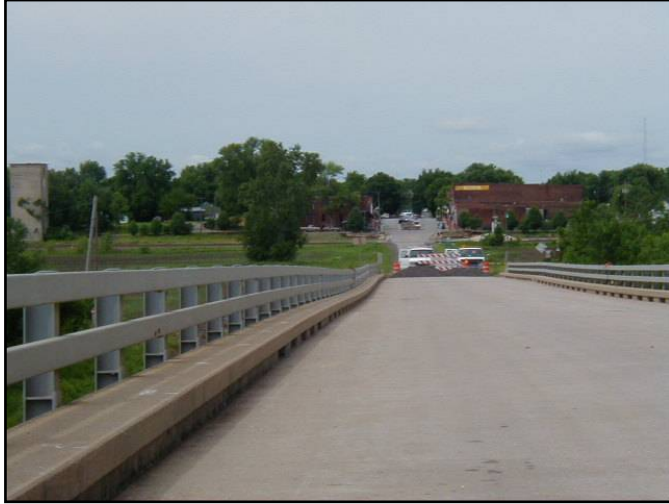
Figure 55. Moderate Damage: Bowing of parapet and railing (MO)

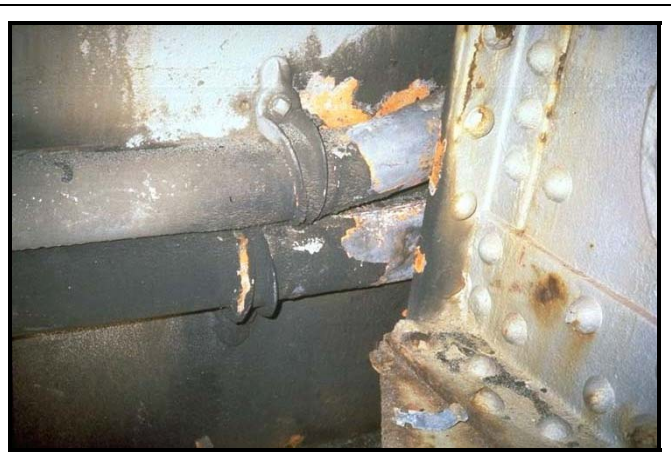
Figure 57. Movement of Trusses at Pier 23 of the San Francisco Oakland Bay Bridge during the Loma Prieta Earthquake. The shoe (at the right) hit two pipes that carried electric wires and dented them. These dents indicated that there was at least 3 to 4 inches of movement. (NISEE)

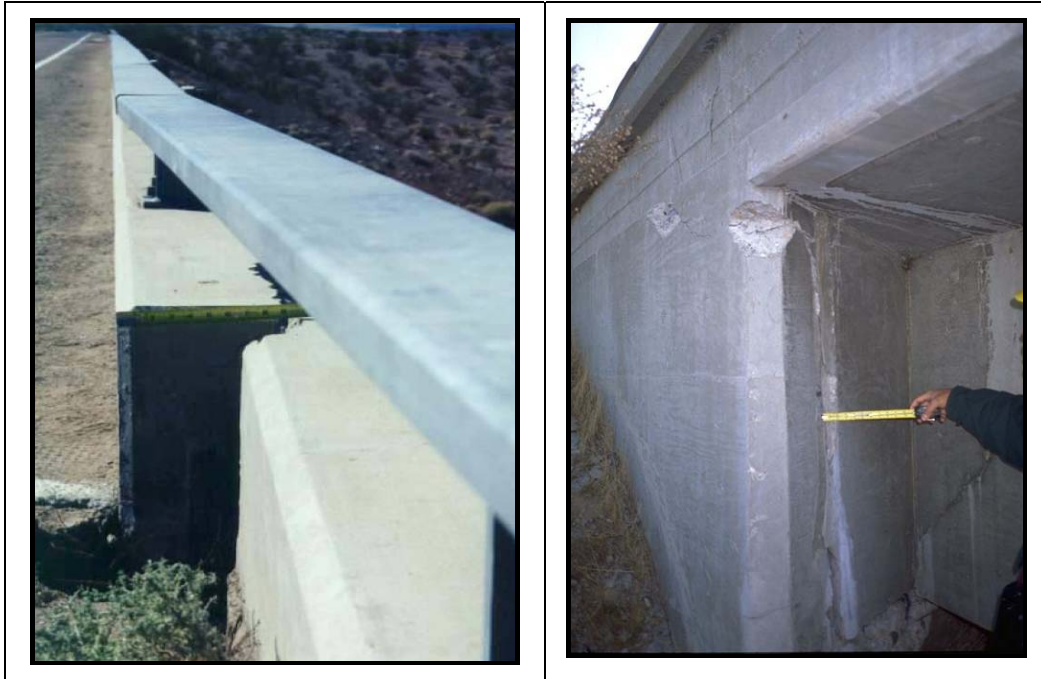
Figure 58. Moderate Damage: Transverse movement of the abutment wing-wall (CPHMR)

Figures 58-59 further illustrate conditions that may be encountered. While these changed conditions may not be cause for alarm, they should be noted in the inspector's report.

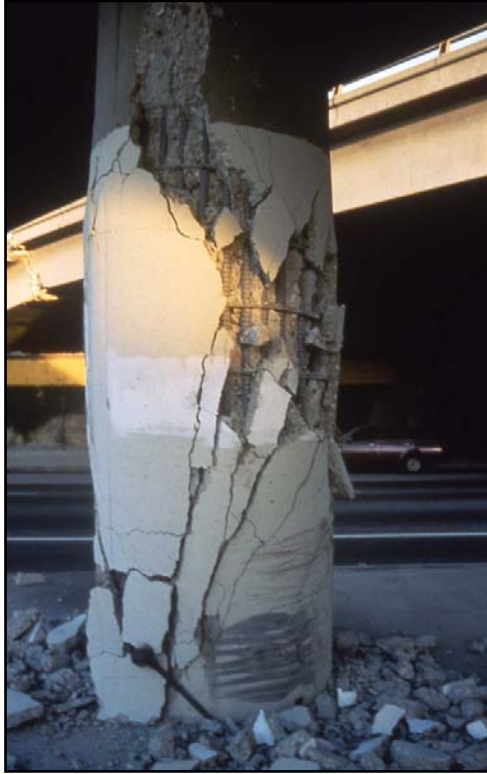
Figure 60. Earthquake damage to reinforced concrete bridge column (Aboutaha)

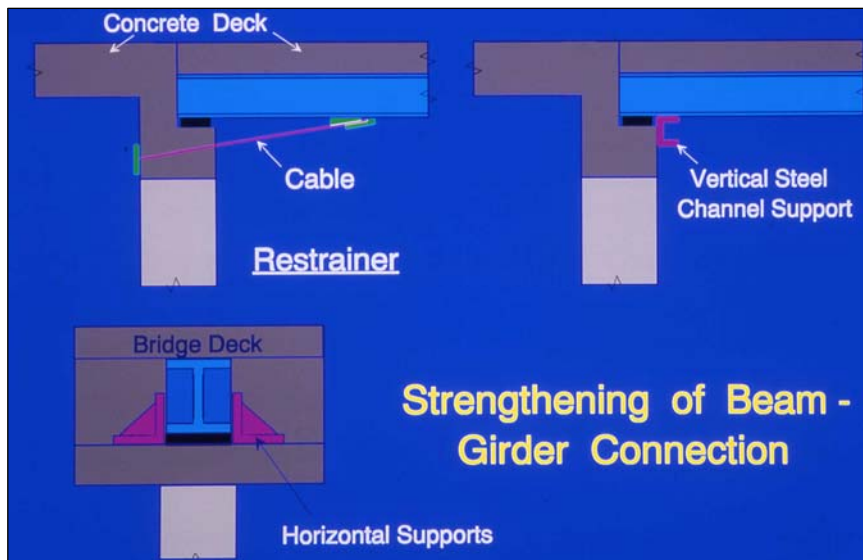
Figure 62. Use of structural shapes for seismic retrofit of bridge superstructure (Aboutaha, 1993)
