Post-Earthquake Bridge Inspection Guidelines

Jerome S. O'Connor, P.E.¹
Principal Investigator
October 2010

Final Report for NYSDOT SPR Project # C-06-14
Development of Post-Earthquake Bridge Inspection Guidelines
Cornell Transportation Infrastructure Research Consortium (TIRC) Subcontract 53740-8411

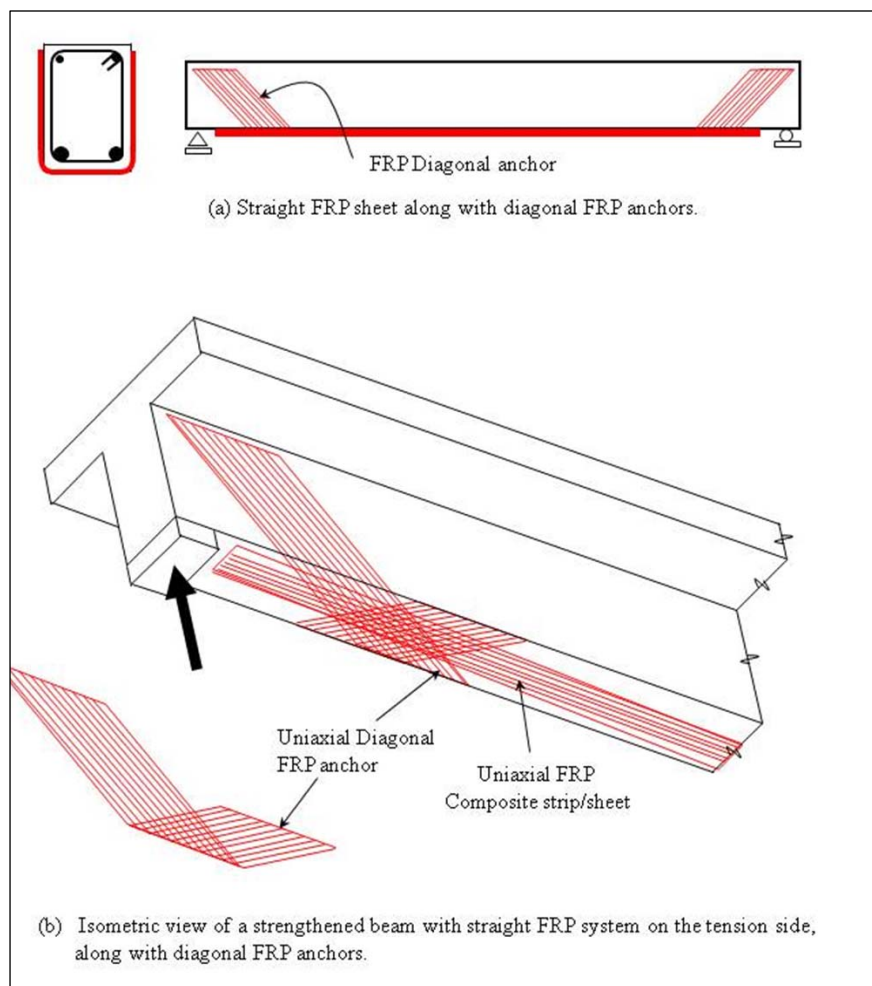
Figure 63. Retrofit of bridge girder with FRP composite sheets (Aboutaha, 2004)

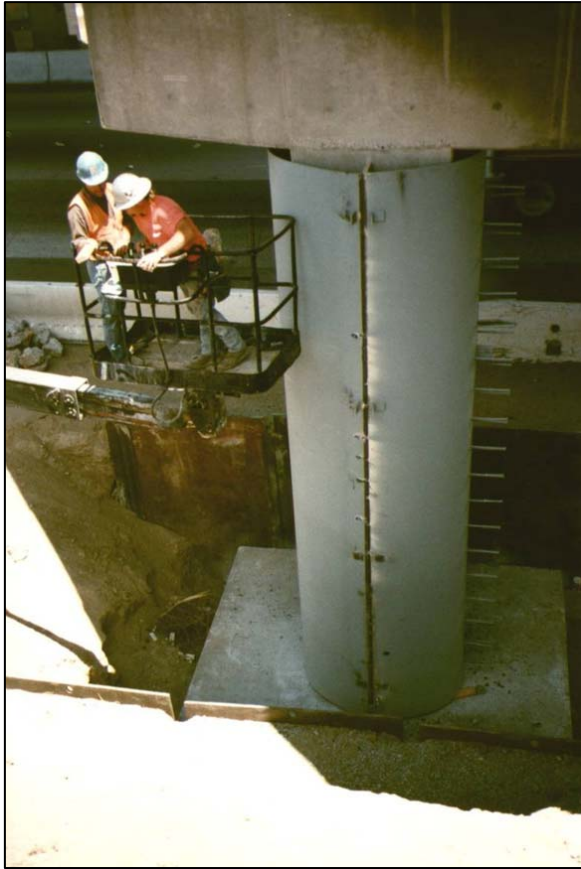
Figure 64. Seismic retrofit of a bridge column using a steel jacket (Aboutaha, 1994)

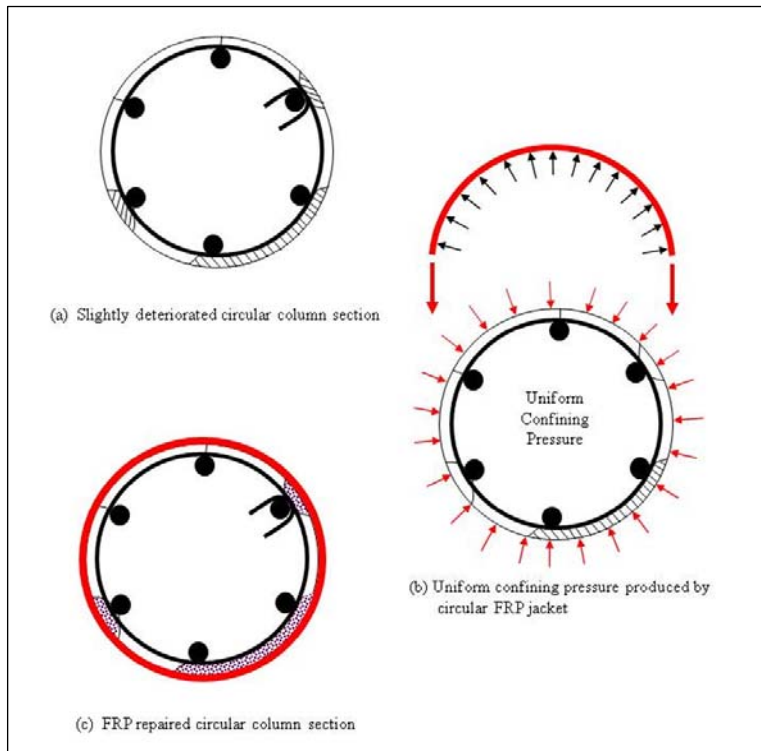
Figure 65. Seismic retrofit of bridge column with FRP composites (Aboutaha, 2004)

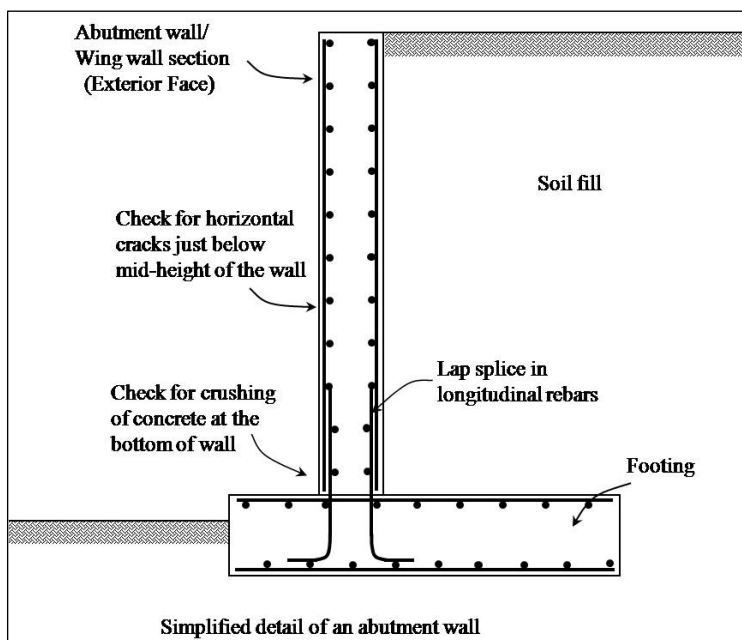
Figure 66. Typical cross section of an abutment/wing-wall, (Aboutaha, 2004)

case, the wall should be braced with diagonal structural members as an immediate and short-term retrofit. For long-term retrofit, the wall might need welding of the lap splice in the longitudinal bars at the base of the wingwall, and the damaged concrete might need replacement.

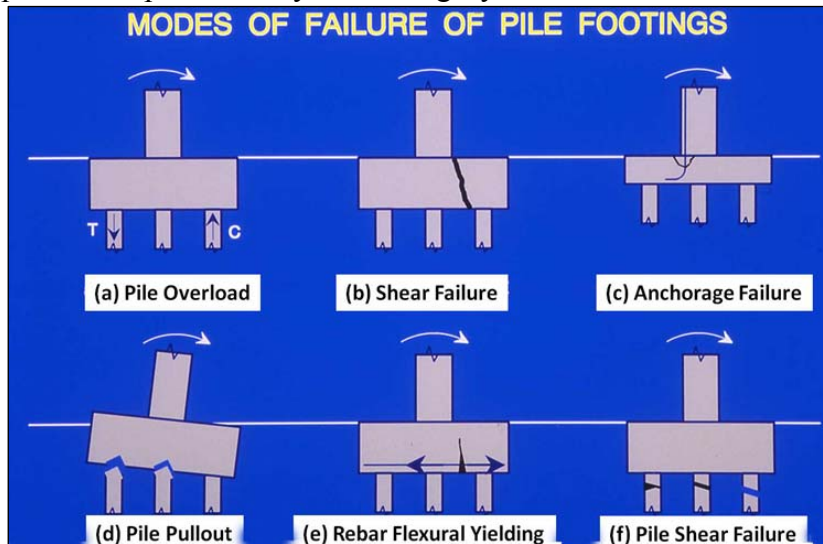
Figure 67. Modes of failure of pile footings, (Aboutaha, 1993)

Tilting of a pier, flexural cracking of the column, sloughing of the fill around a footing, pulling away of the fill from a footing, etc. are indications of foundation distress or possible failure. To assess thoroughly the extent of damage, it may be necessary to excavate along the footing and/or piles to inspect visually their integrity. Structural cracks in either the footing or piles would be

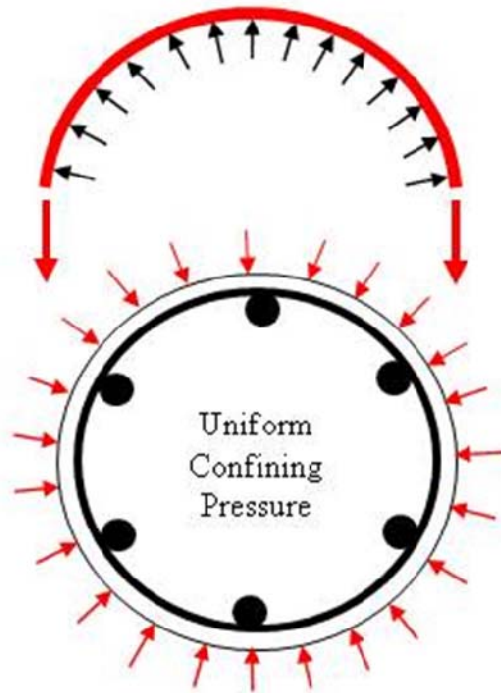
(a) Uniform confining pressure produced by circular steel jacket

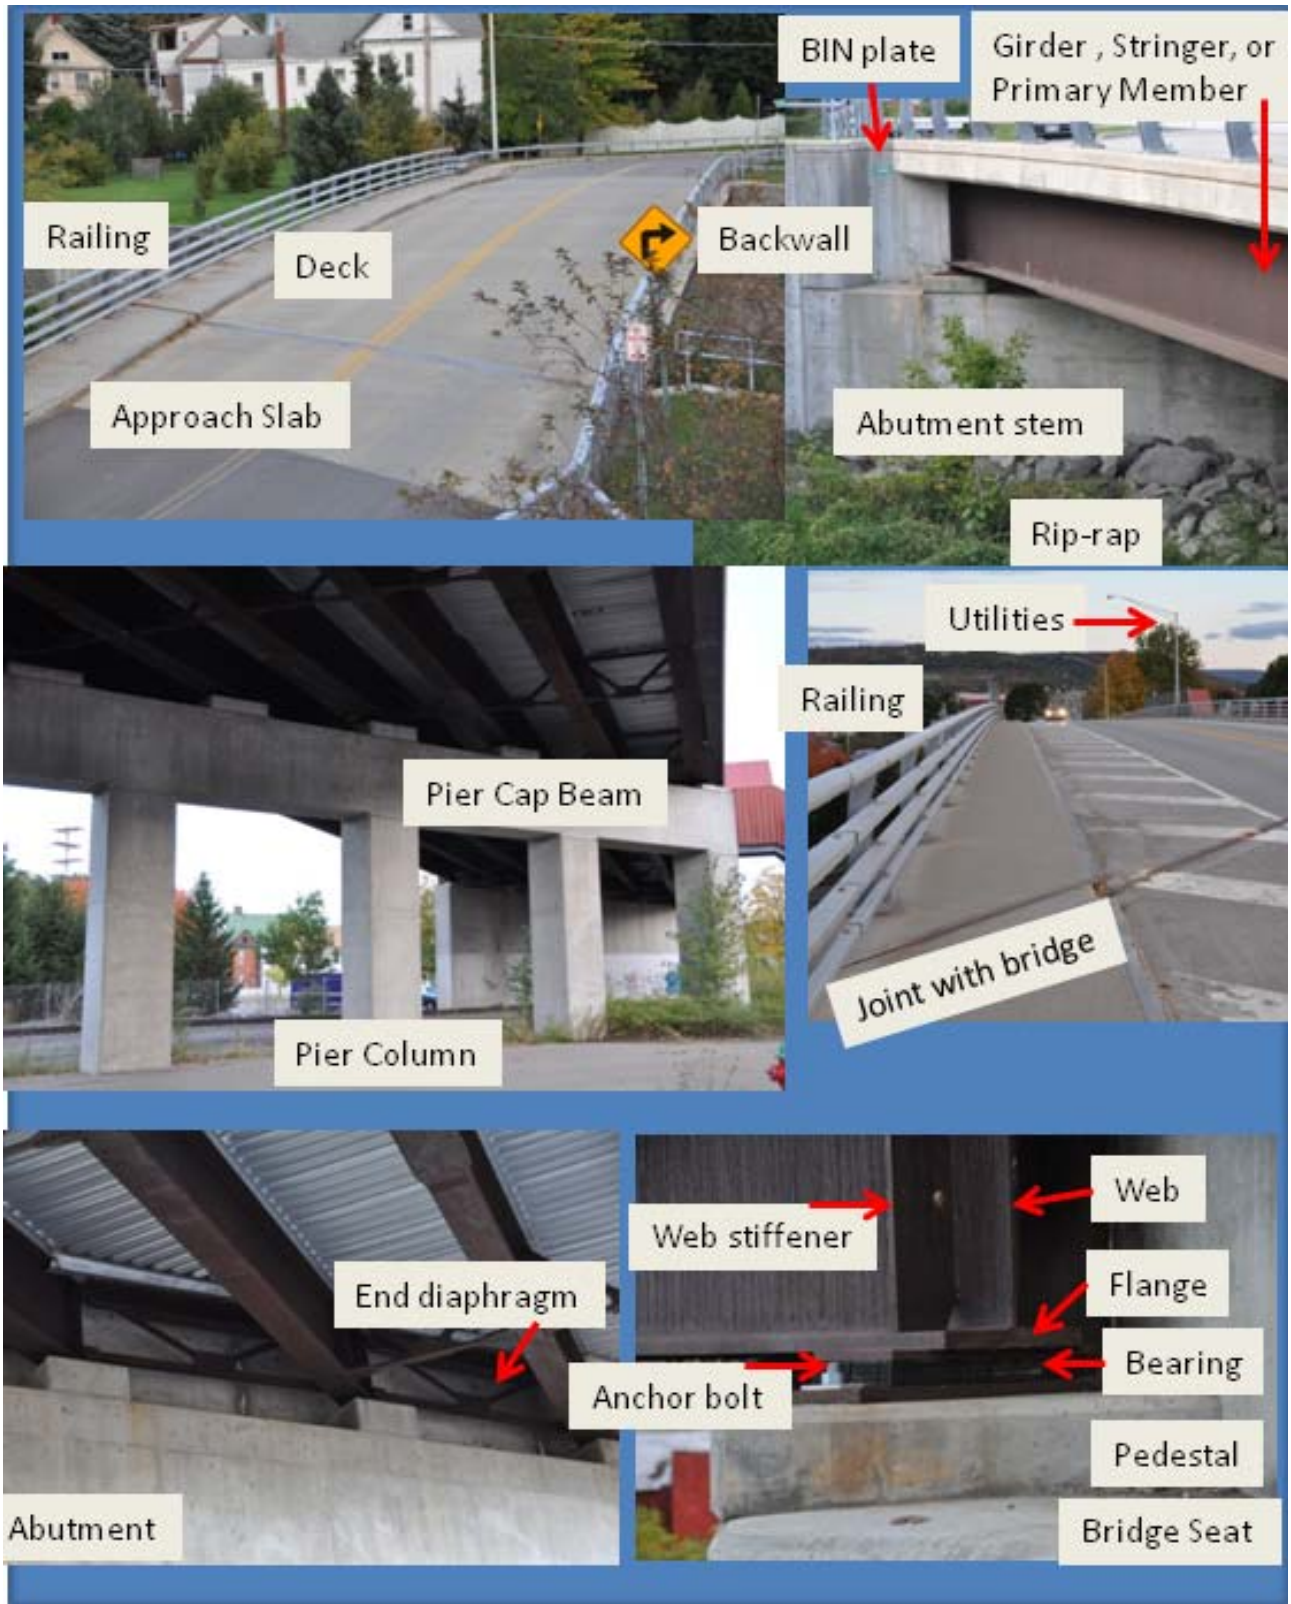
Figure 71. Bridge Terminology Reference Sheet
