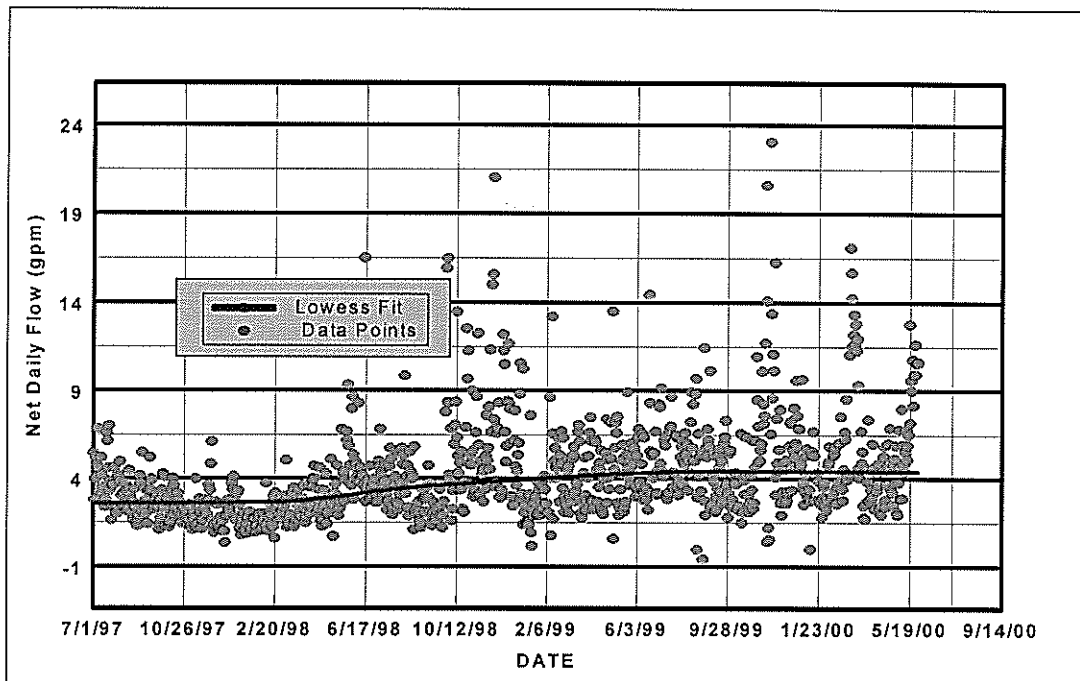
Figure 2
Daily water usage

Each morning at 5 o'clock, rest area personnel record the cumulative water volume from a totalizing flow meter in the well discharge. By subtracting sequential values, the volume of water used in the previous 24 hour period is obtained. During holiday periods, readings are taken every hour. An accurate data base has existed since July 1, 1997. Figure 2 is simply a plot of daily water use expressed in gallons per minute (gpm) vs time. The solid curve is a local regression plot meant to show trends in the data. It shows that the daily flow has increased since 1998. Day-to-day variations in water use can be caused by a large number of factors in addition to variation in the number of cars using the facility. Some of these are: watering of

greenery during the summer, water use at the picnic facilities, general cleaning and maintenance, as well as leaks in the water distribution system. Because of this “noise,” little can be gained in the way of useful design information from figure 2.

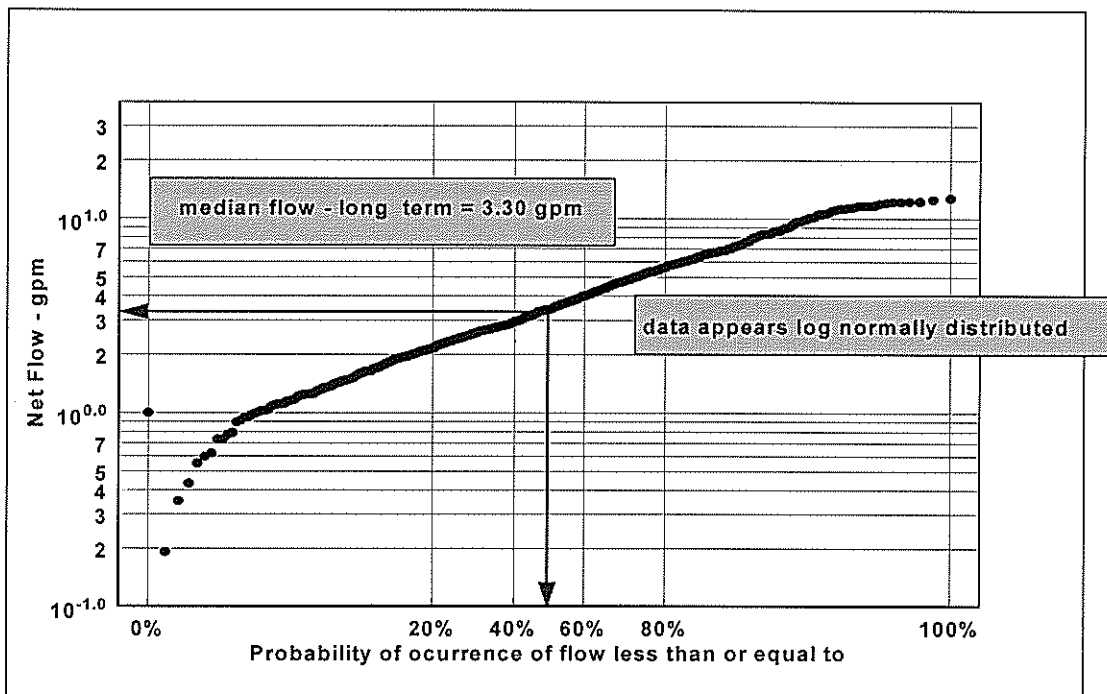
Figure 3
Probability plot daily water usage

Most recently, a water meter with the capability to transmit a signal to a data logger has been installed on the well. The average flow rate is logged every two minutes. Data is downloaded every two weeks. We have compared the daily flow volumes obtained to those from the manual procedure described previously and found the agreement to be within five percent. The equipment is easy to use, provides an abundance of data which can be downloaded to other software applications for manipulation, and does not require an individual to read the water meter. In figure 3, the same data is presented as a log-probability plot. The details of developing probability plots can be found in a variety of sources [4], [5]. Simply stated, figure 3

gives the probability (on the x axis) of daily water use being less than or equal to the corresponding value on the y axis. Using figure 3, we see that the water use rate is expected to be less than or equal to 3.3 gpm fifty percent of the time. Thus, the usage rate will be greater than 3.3 gpm fifty percent of the time. This is the median flow at the facility. It was somewhat surprising to find that the data plots as nearly a straight line. This indicates that it is possible to develop a statistical model of daily water use at this facility based on a log normal distribution.

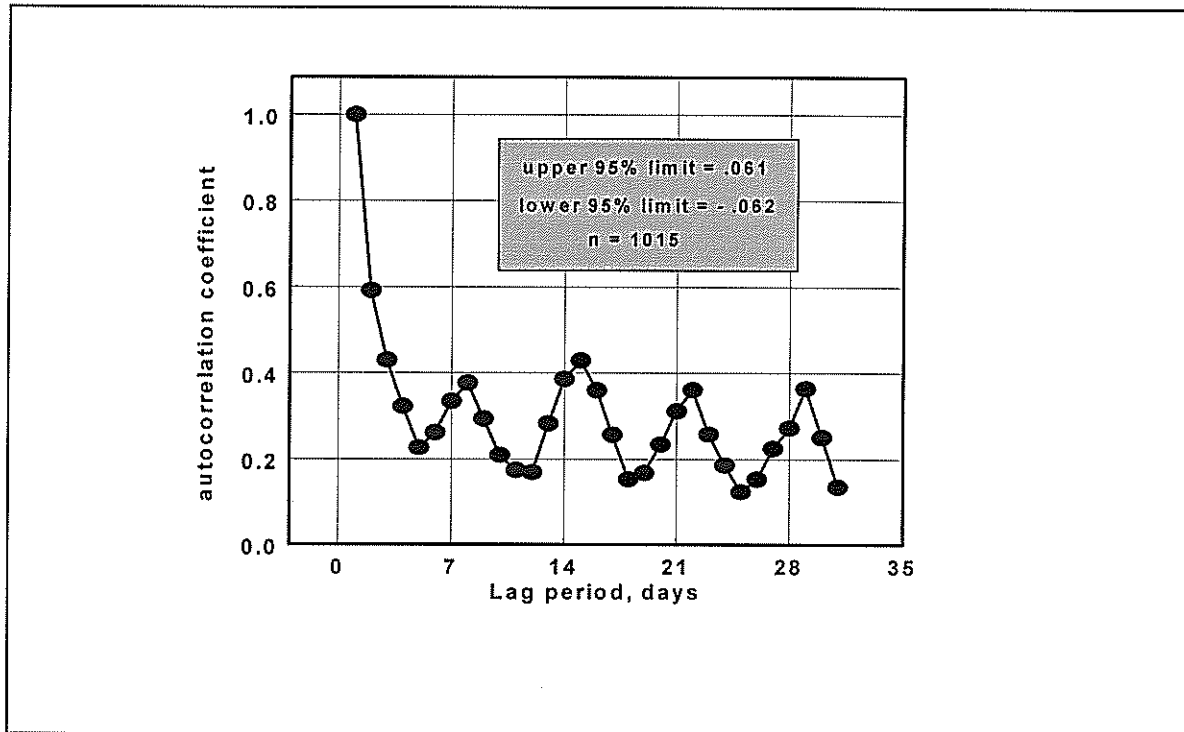
Figure 4
Autocorrelation analysis

Figure 4 is often referred to as a correlogram. To obtain it, the correlation coefficients for water use values, separated by varying times, referred to as “lags” are computed and plotted vs the lag period. The 95 percent confidence limits on these coefficients indicate that all of them are statistically significant. This correlogram

exhibits a regular cyclic pattern within a seven day period. This indicates that water usage is strongly cyclic, with a seven day period. The highest water use occurs on Sunday, 5.2 gpm, while the lowest occurs on Tuesday, 3.29 gpm.

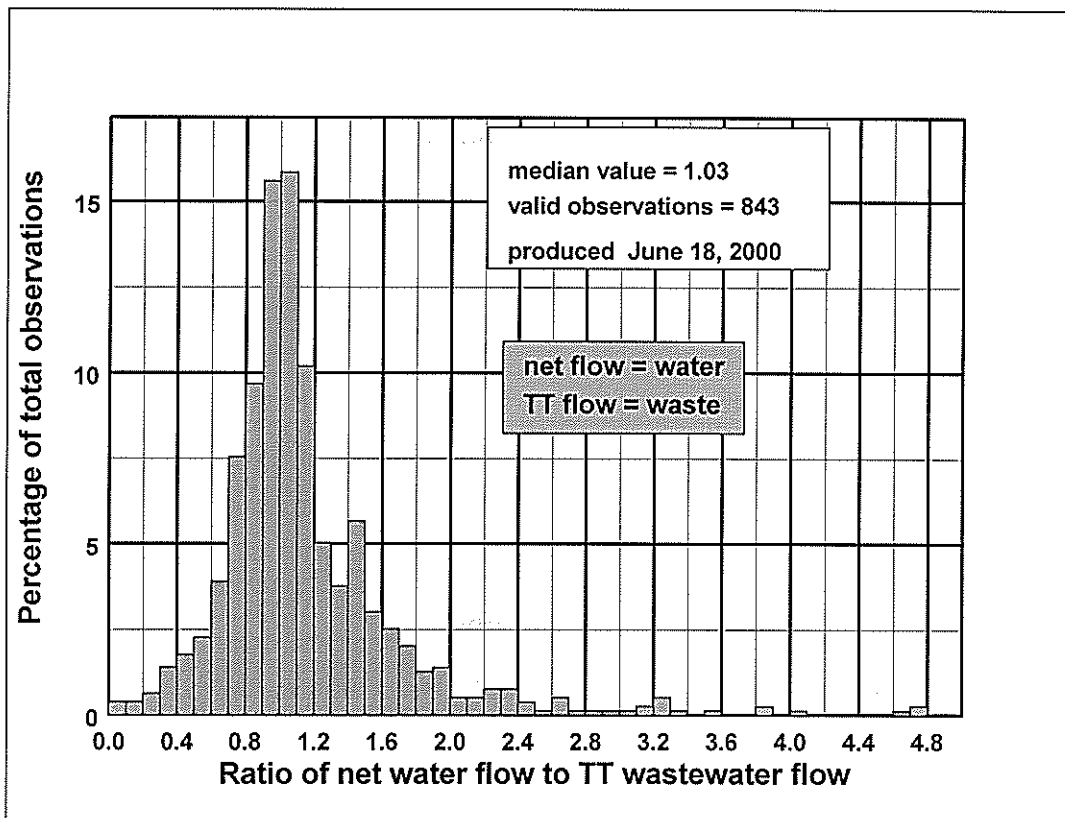
Figure 5
Comparison of water and wastewater flow rates

If we desire to predict the waste flow rate from a rest area, one very simple way would be to simply use water usage as a surrogate measurement. This however assumes that the two flows are nearly the same over time. For short time periods, this would not be the case, since a variety of factors can affect water use and/or waste flow, independently. However, it may be a reasonable assumption for longer averaging periods. Waste flow at Grand Prairie is measured independently of water use by transit

time flow meters at the treatment facility. One of these flow meters is located at the “main splitter box” as shown in figure 1. All of the waste generated passes through this box. Figure 5 is a histogram of the ratio of daily water use to daily waste flow, measured at the splitter box. The histogram peaks around one and the median ratio is 1.03. Additional analysis (not shown) confirms that monthly waste flow and water use are very nearly equal, within 10 percent. This results in a hydraulic loading of 2.4 cm/day. The mean hydraulic loading for 102 aquatic treatment systems is 3.4 cm/day [6].

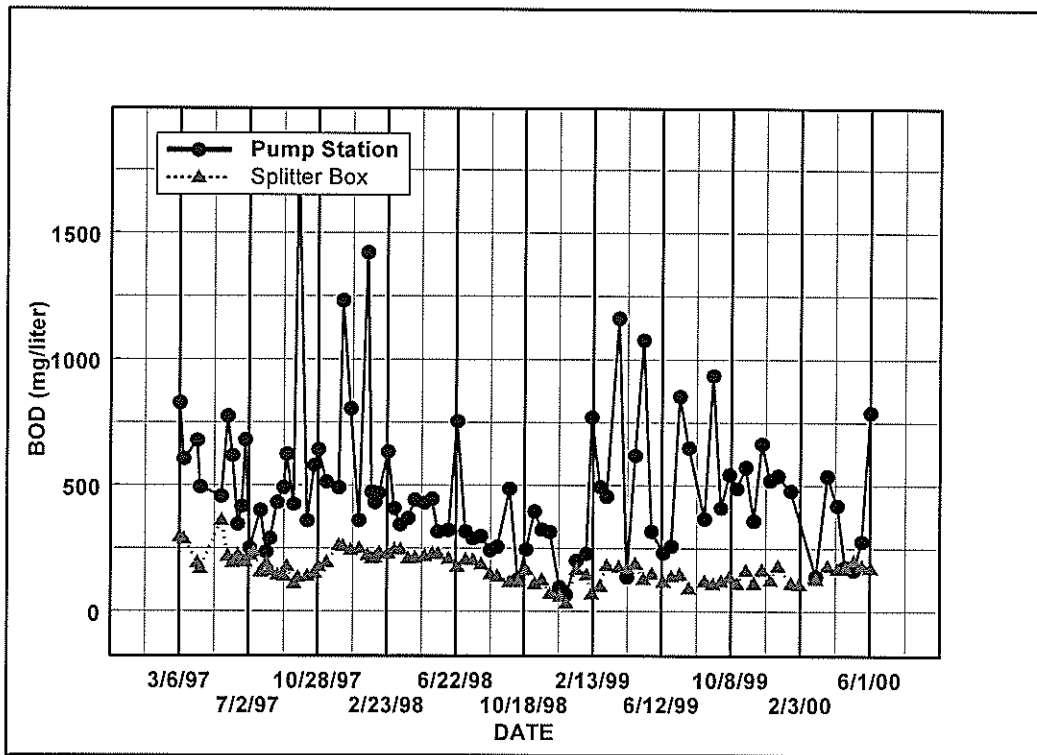
Figure 6
BOD at pump station and splitter box

Figure 6 shows the BOD of the pump station discharge and the BOD at the main splitter box.

As shown in figure 6, the BOD of the waste is highly variable (mean = 491 mg/liter, s.d.= 309 mg/liter) and strong, on occasion exceeding 1500 mg/liter. The probability plot in figure 7 indicates a median BOD at the pump station discharge of approximately 450 mg/liter. However, the BOD at the splitter box, after the waste has passed through the septic tanks, exhibits much less variation (mean = 172 mg/liter, s.d. = 56 mg/liter) and the strength has decreased substantially.

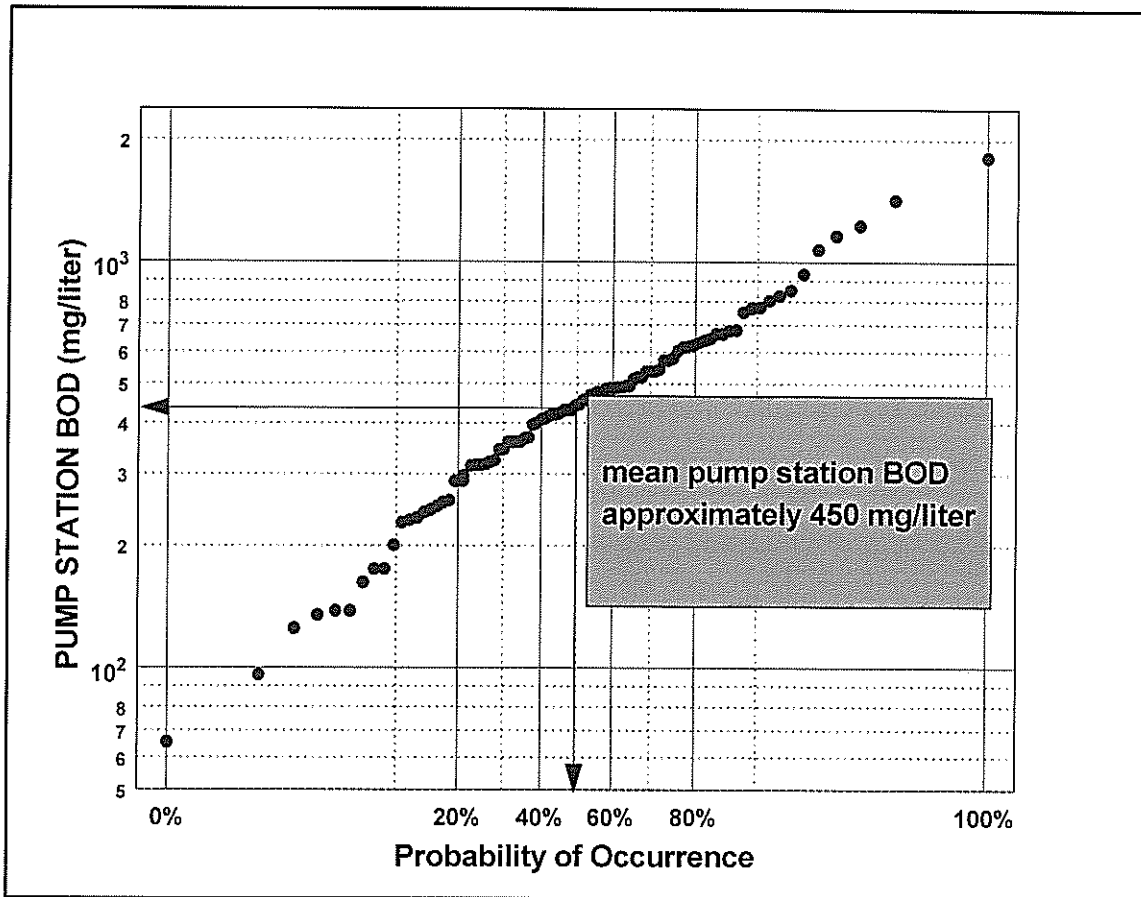
Figure 7
Probability Plot - Pump Station BOD

Figure 7 is a log-probability plot of the BOD of the waste at the pump discharge.

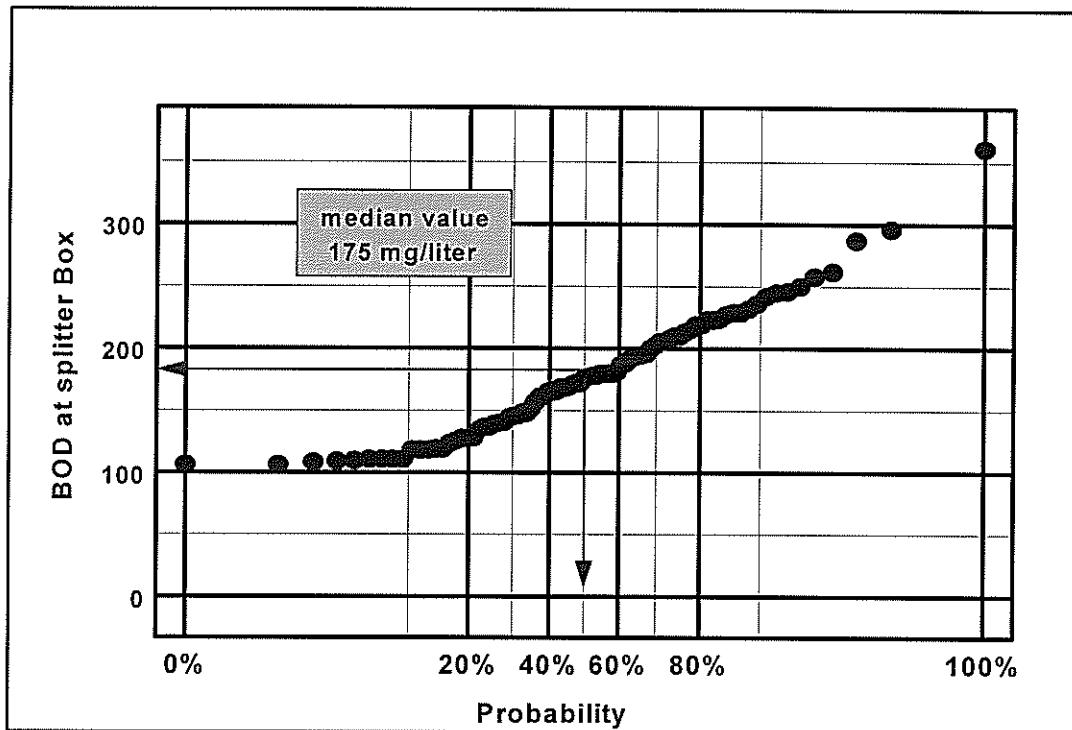
Figure 8
Probability plot - splitter box

Figure 8 shows a median BOD entering cell 1 of 175 mg/liter. The resulting median BOD loading for cell 1 is 67.2 lb/acre*day. Several points are of interest here. First, the waste generated at this facility is significantly stronger than domestic wastewater, which has a BOD of 200-300 mg/liter [7]. Second, the septic tanks act to dramatically reduce the BOD₅ and BOD₅ variation. Finally, the BOD₅ of the waste entering cell 1 is much higher than at any other facility in Louisiana of which we are aware. Kadlec and Knight, 1996, report an average BOD loading of 26 lb/acre*day (29.2 kg/ha*day) for North American subsurface flow treatment systems.

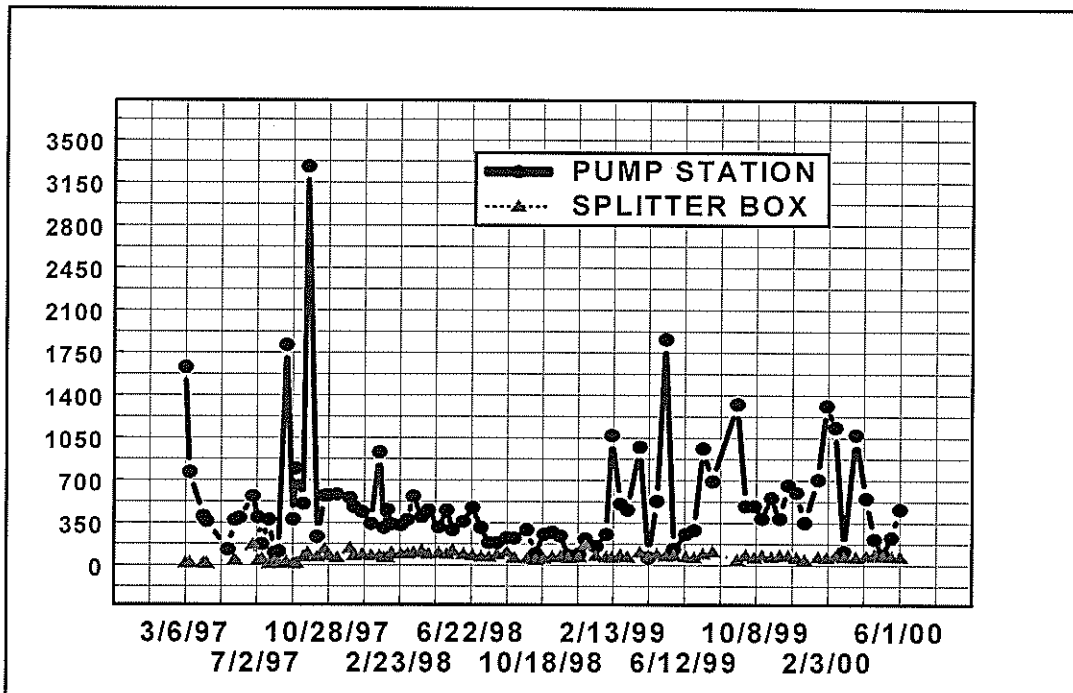
Figure 9
Suspended solids pump station and splitter box

Figures 9 and 10 are analogous plots for TSS at the pump station discharge and the main splitter box.

The mean and standard deviation at the pump station discharge are 523 and 480 mg/liter; corresponding values at the splitter box are 71 and 32 mg/liter. Thus, a similar phenomenon to that occurring for BOD occurs with TSS. Since much of the BOD in this wastewater is present as TSS, it appears that the primary mechanism for waste strength reduction prior to the RPF is the settling of solids in the septic tanks. The TSS concentration going to cell 1 is approximately 71 mg/liter (27.2 lb/acre*day, 30.5 kg/ha*day). RPFs treating domestic wastewater in Louisiana usually receive the effluent from a pond or lagoon. Waste strength is rarely greater than 30 mg/liter for BOD and TSS and is substantially less in many cases. The mean TSS loading for

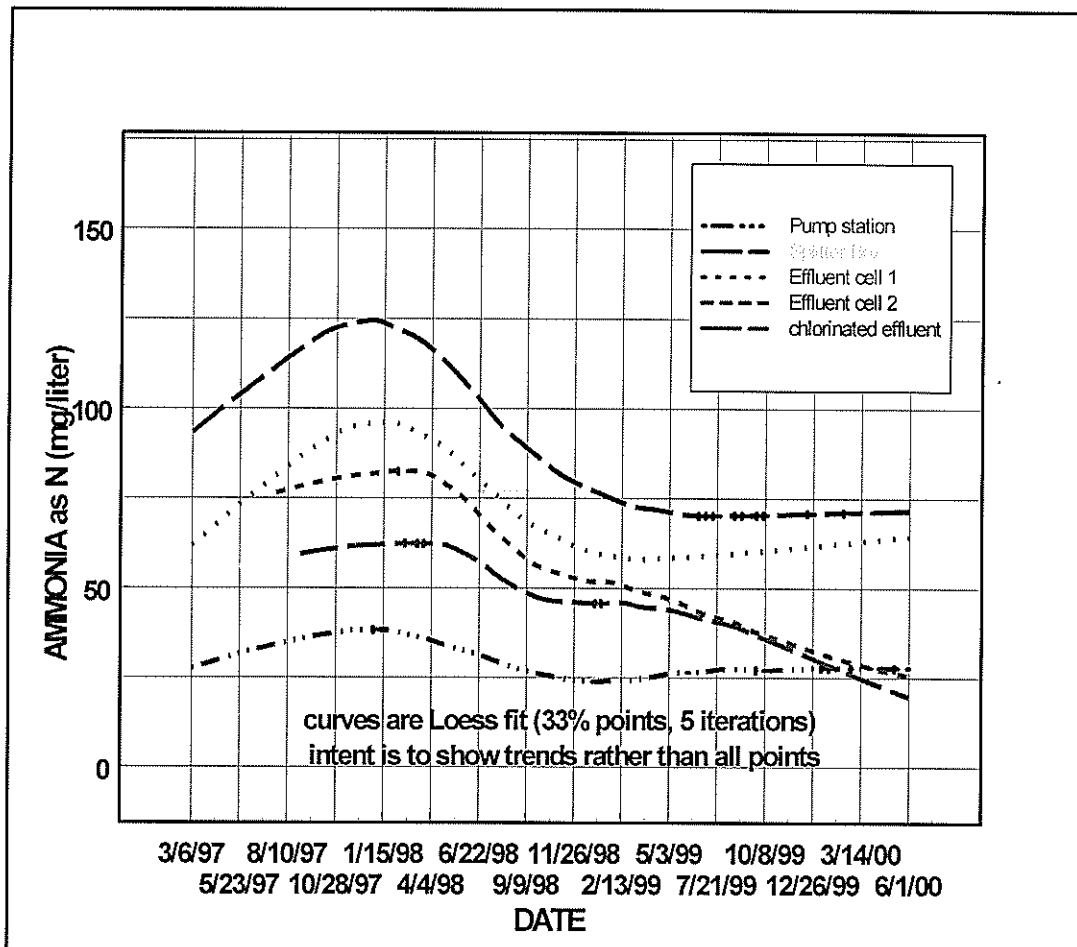
Figure 11
Ammonia-N at various locations

Depending on the pH of the waste, ammonia in wastewater exists in two forms, NH_3 and NH_4^+ . Unionized ammonia (NH_3) is toxic to higher aquatic life forms at concentrations far below 1 mg/liter [8]. Figure 11 shows the ammonia concentration at various points in the Grand Prairie treatment system. In order to minimize clutter caused by the data, local regression (lowess) curves are presented for each location, rather than individual data points. The ammonia concentration in the raw waste at this facility is not excessively high. The mean is 40.1 mg/liter. Ammonia concentrations in strong, untreated domestic wastewater may reach as high as 50 mg/liter-N [7]. However, at this point, only about $\frac{1}{2}$ of the incoming nitrogen is in the ammonia-N form. The mean TKN concentration is high, 111 mg/liter, as compared to 85 mg/liter for strong domestic waste [7].

However, by the time the waste leaves the septic tanks, essentially all of the nitrogen has been converted to ammonia-N. The range of values in the waste at the splitter box is between 37 and 161 mg/liter. The mean and standard deviation are 94 and 30.3 mg/liter, respectively, resulting an ammonia loading to cell 1 of 40.3 kg/ha*day. This compares to an average ammonia loading for subsurface flow

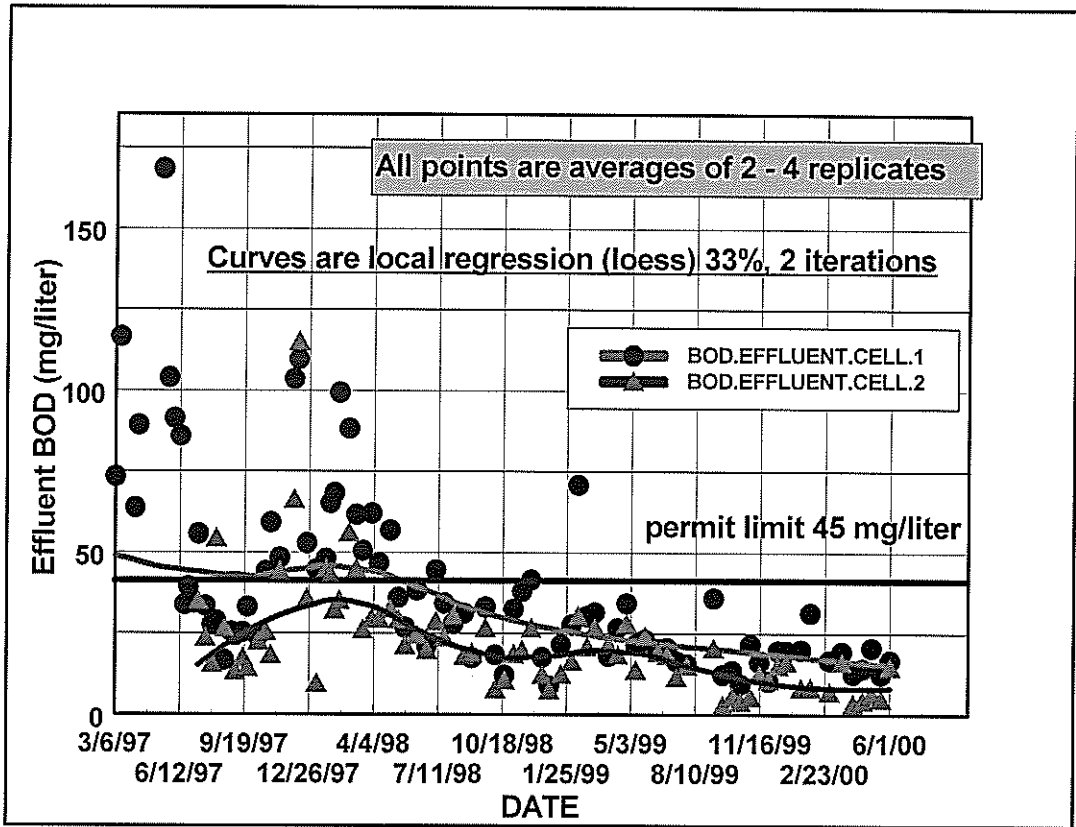
Figure 14
Effluent BOD cells 1 and 2

Figure 14 shows the variation over time in BOD₅ from cells 1 and 2. In general, the system seems to perform reliably. The last violation of the facility's discharge permit occurred near the beginning of 1998.

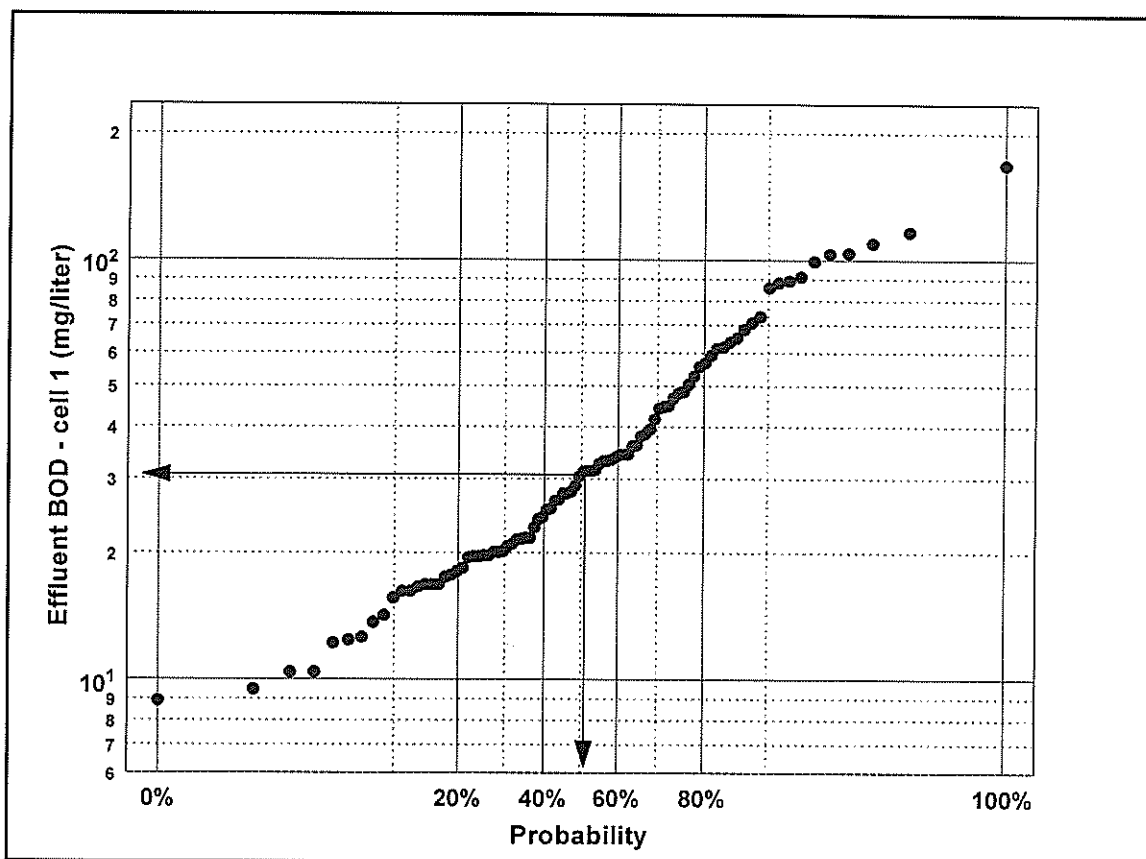
Figure 15
Probability plot - effluent BOD cell 1

Figure 15 is a log probability plot of the BOD in the effluent from cell 1. As shown, the median value is 30 mg/liter.

The plot suggests that cell 1 alone could produce an effluent meeting the current permit requirement (45 mg/liter) nearly seventy percent of the time. Griffin, Bhattarai and Xiang have shown that the BOD from cell 1 varied with the temperature of the waste in the splitter box, this variation could be described reasonably well using an exponential model [12]. Figure 16 is a similar plot for cell 2, showing a median effluent BOD of 20 mg/liter. Based on this figure, the treatment facility, using cells 1 and 2 in series, has met its permit limit over ninety percent of the time. This compares to roughly seventy five percent for other RPF systems in Louisiana [2].

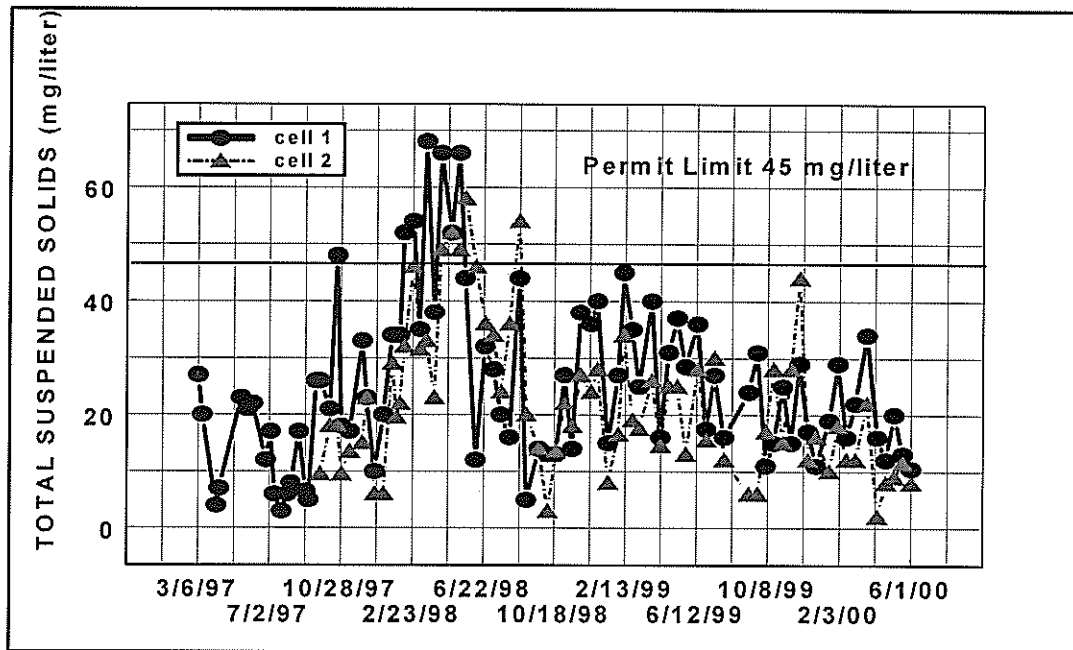
Figure 17
Effluent TSS cells 1 and 2

Figure 17 is a plot of the effluent TSS concentrations from cells 1 and 2 with time.

The system seems to be functioning reliably with respect to TSS. The last permit violation occurred in August of 1998. This probably occurred as a result of disturbance in cell 2 because plants were being placed during that time. The probability plot in figure 18 indicates a median effluent concentration of 24 mg/liter and that cell 1 produced an effluent acceptable for discharge approximately eighty five percent of the time. Figure 19 shows a median TSS concentration of 15 mg/liter.

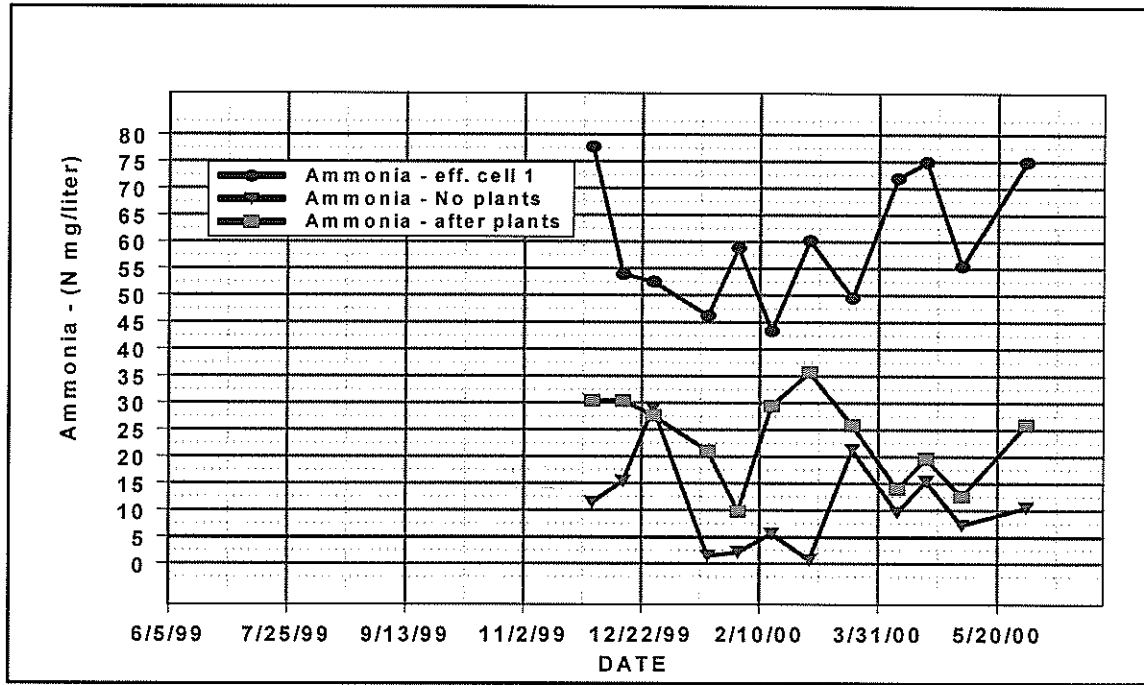
Figure 20
Ammonia variation - cell 2

1. The ammonia concentration has been reduced from 50-80 mg/liter to 5-15 mg/liter.
2. The ammonia concentration increases as the liquid passes through the planted section of cell 2, presumably due to plant decay.

3. The primary ammonia removal mechanism appears to be nitrification. Some of the nitrate is then taken up by the plants.

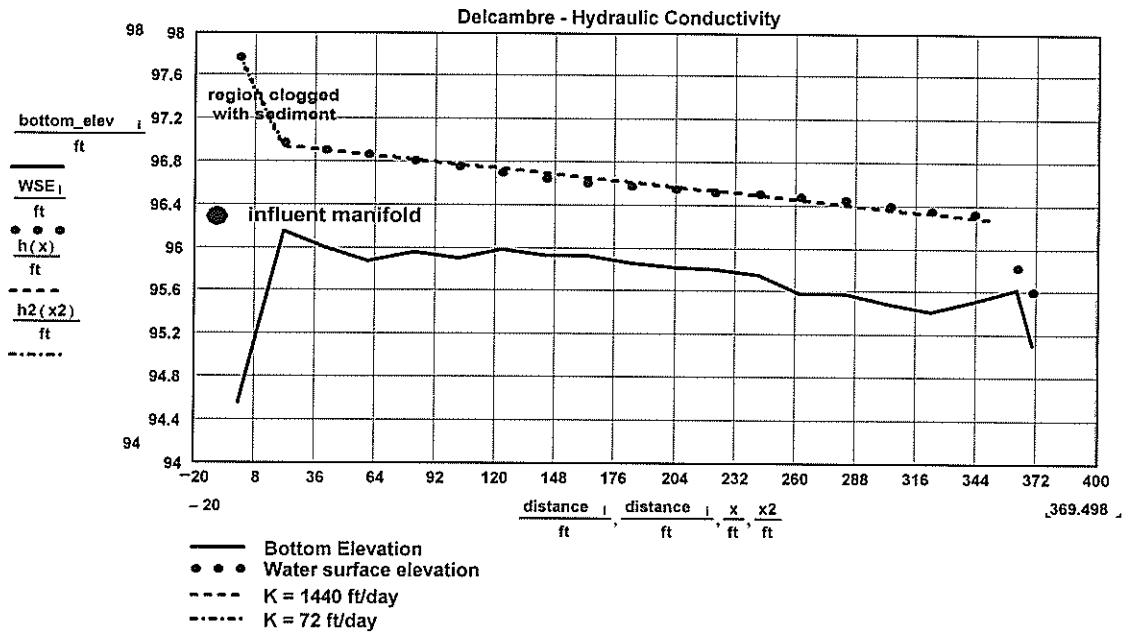
Figure 22
Water surface profile - Delcambre, LA

media porosity in all four cells resulted in values of around thirty nine percent. More recent measurements (1998) in cell 1 indicate that this value has changed very little. Perhaps the best evidence we have to present describing a mechanism for media clogging comes from a RPF serving the town of Delcambre, Louisiana. Delacmbre has two RPF cells each 400 feet by 150 feet . They are preceded by a lagoon and surface flow wetland. As a result, the BOD₅ at the inlet is low. These cells had been in operation approximately seven years when one of them began to exhibit surface flow near the inlet manifold. In order to investigate this problem, we placed observation ports at 20 foot intervals down the center of the cell. We then determined and plotted the water surface elevation along the centerline of the cell. In addition, we dug a number of holes in the rock. We visually observed that the media did appear clogged in the vicinity of the inlet manifold as well as along the sides of the filter. There was little or no apparent clogging elsewhere. Samples of the interstitial material were collected and analyzed. It was found that the material was largely inorganic in nature (VSS <20%); it was basically sediment. A plot of the filter bottom and water surface elevation in the filter are shown in figure 22.

Based on the water surface elevations collected, we were able to determine the hydraulic conductivity from Darcy's Law. In the region of the cell near the manifold, it was found to be 72 ft/day, a very low value. However, as flow moved downstream from the inlet manifold (away from the clogged section), the hydraulic conductivity achieved a constant value of 1440 ft/day, a textbook value for "gravel" or "well sorted gravel" such as that used in RPFs. A second test conducted in January of 2000 resulted in a value of 576 ft/day, suggesting that the clogging is becoming worse. Based on these results we postulated the failure mechanism as being due to the migration, over time, of sediment from the berms around the sides of the cell into the cell, producing progressive clogging. The influent manifold in this system lies parallel to one of the berms, about 10 feet away. This 10 foot strip was not a part of the operating filter, per se, and clogging which occurred behind the influent manifold had no effect on the

operation of the system. However, once the clogging reached the influent manifold, the flow was forced to the surface. At this point, substantial algal growth began to occur on the surface of the media, exacerbating the problem. We concluded that the problem was caused by the lack of a lining along the sides of the cell to prevent soil migration into the filter. We also concluded that while the growth of biological slime on the media was the first visible sign of clogged media, it was NOT the cause of the problem.
