**Louisiana Transportation Research
Technical Assistance Report
Report No. 19**

***Evaluation of the Use of Shredded
Tires Around Buried Pipes***

Technical Assistance Report Number 19

May 1999

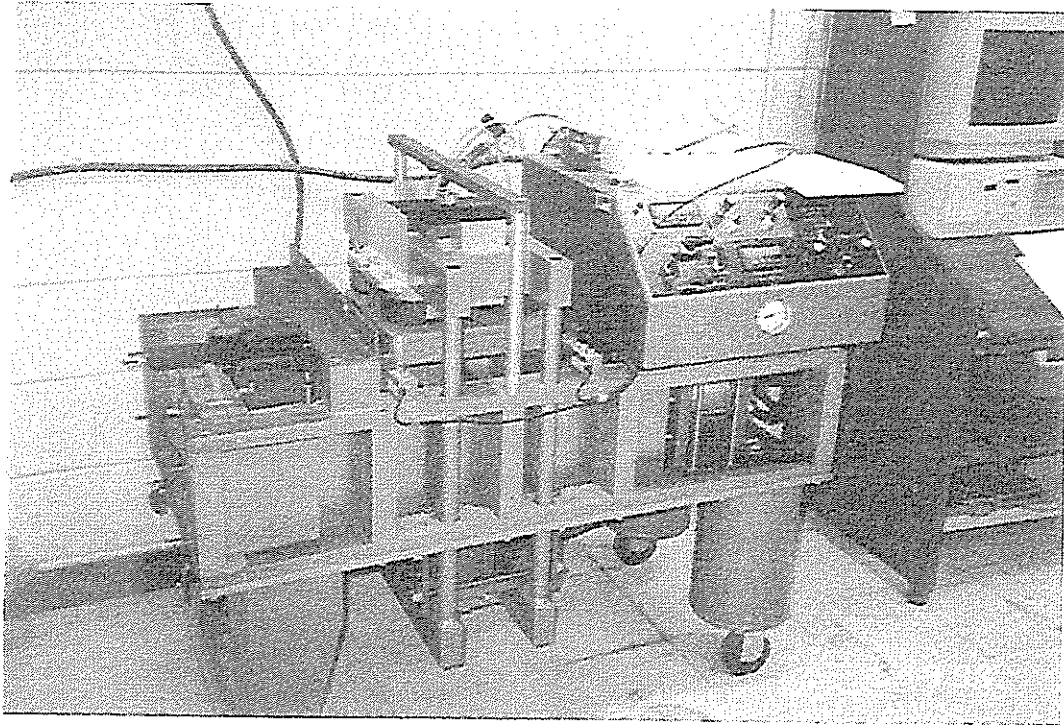
Figure 1. View of the large direct shear testing apparatus

Shear strength is the design parameter that characterizes the tire chips when used as fill in embankments and slopes. In order to determine the shear strength properties of the tire chips, direct shear tests were conducted in a large direct shear box. The direct shear test apparatus consisted of two boxes, each with a 300 mm (12 inches) by 300 mm interface shear area. The boxes were 75 mm (3 inches) high with the lower box connected to the shear loading system. Figure 1 shows a view of the large direct shear testing equipment. The vertical pressure and the shear load were applied on the specimen by means of controlled hydraulic system. Tests were performed on the specimen at a shearing rate of .25 mm/min (0.01 in./min).

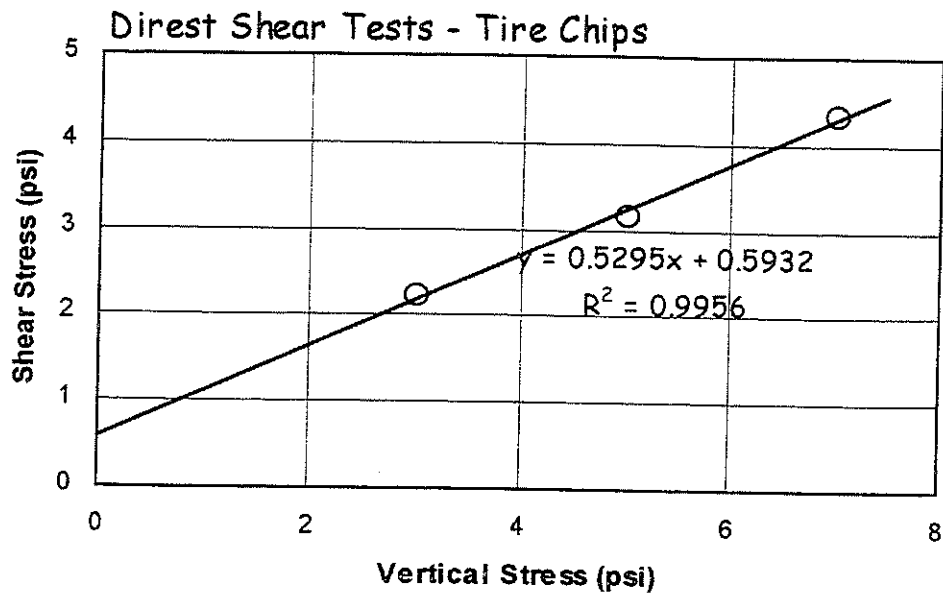
The results of direct shear tests on the tire chips are shown in figure 2. Detailed figures of the direct shear test results are shown in appendix A. The results show a friction angle of about 28 degrees and a cohesion intercept of about 4.2 kPa (0.6 psi) for the tire chips alone. These results compare with results reported in the range of 19 to 25 degrees with cohesion intercepts between 8 and 11 kPa (1.1 to 1.6 psi) [5].

Figure 2. Direct shear test results on the tire chips

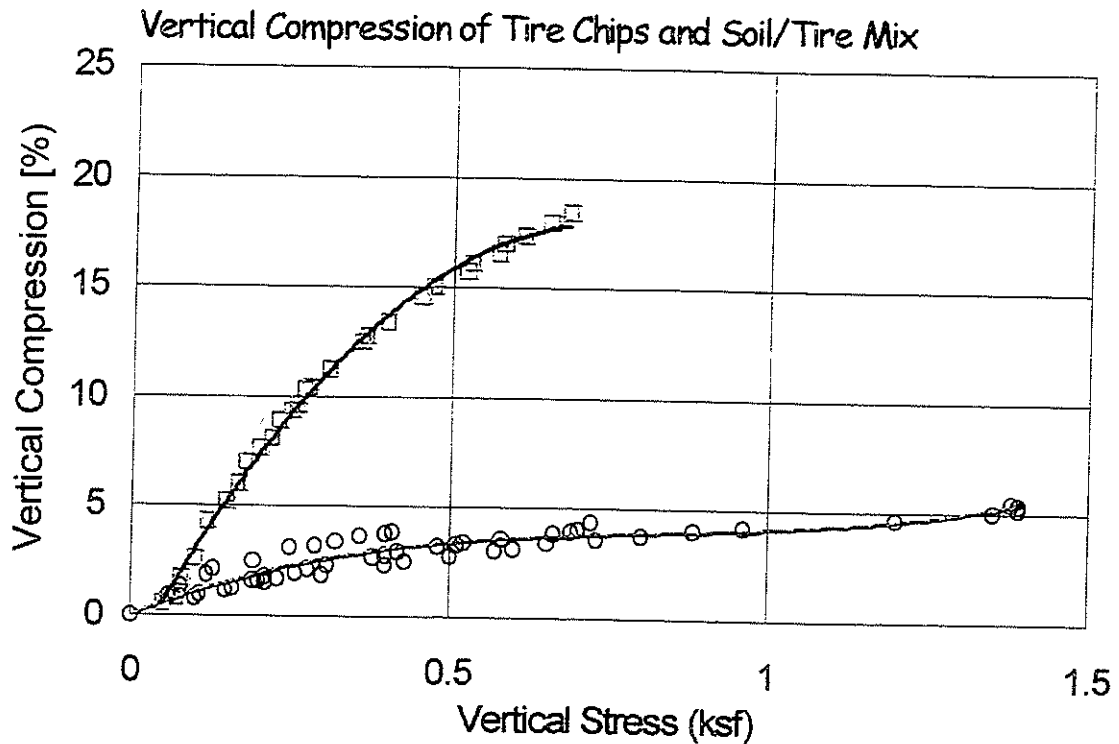
Figure 3 shows that a vertical compression of about 20 percent was measured when the applied vertical pressure was 34 kPa (5 psi). Such decrease in the specimen thickness required re-adjusting the specimen height to attain similar densities in all the tests regardless to the amount of confining pressure.

Figure 3. Compressibility of tire chips and soil-tire mix

An evaluation of the compressibility of the tire chips was investigated while applying the confining pressure in the direct shear box. A quasi-static vertical loading was applied at several intervals during a relatively short period of time (about 15 minutes). The measurement of the vertical compression of the tire chips alone and the mix of soil-tire chips is shown in figure 3. The mix had a 50 percent soil to 50 percent tires by volume. The results show the relatively high compressibility of the tire chips alone.

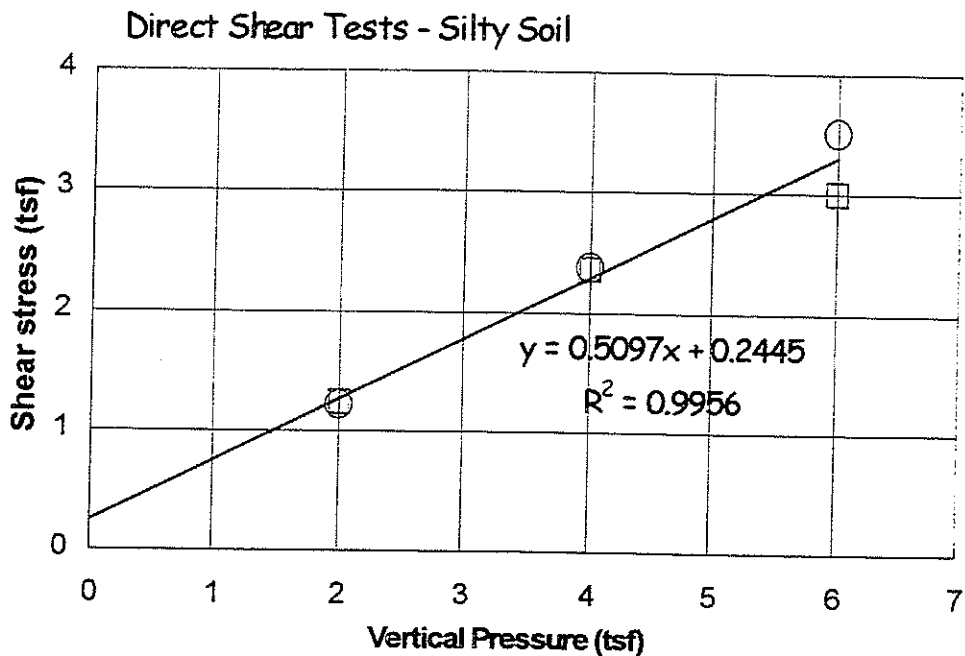
Silty-clay soil was used in the mixture with the tire-chips in the field. The soil was about 55 percent sand, 33 percent silt and 10 percent clay, with a medium plasticity index of 15. Direct shear tests on the soil were conducted in a small direct shear box of two-inch diameter interface area. The results are shown in figure 4. The results show a soil friction angle of about 27 degrees and a cohesion intercept of about 20 kPa (0.24 tsf).

Figure 4. Direct shear test results on the silty-clay soil

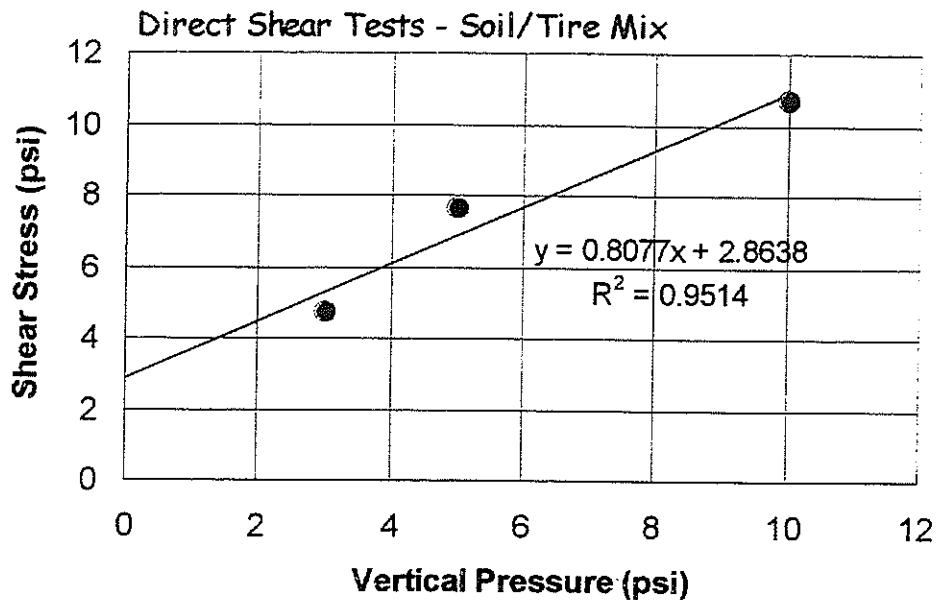
The results of direct shear test on the soil-tire mix are shown in figure 5. The results show an increase in the frictional angle to 39 degrees with a cohesion intercept of 19.5 kN/m² (2.85 psi). The results of the direct shear tests at various confining pressures are shown in Appendix A. It should be noted that there were no defined peak shear stress values at these tests. Maximum shear stress was defined at 10 percent shear strain level.

Figure 5. Direct shear test results on the soil-tire mix

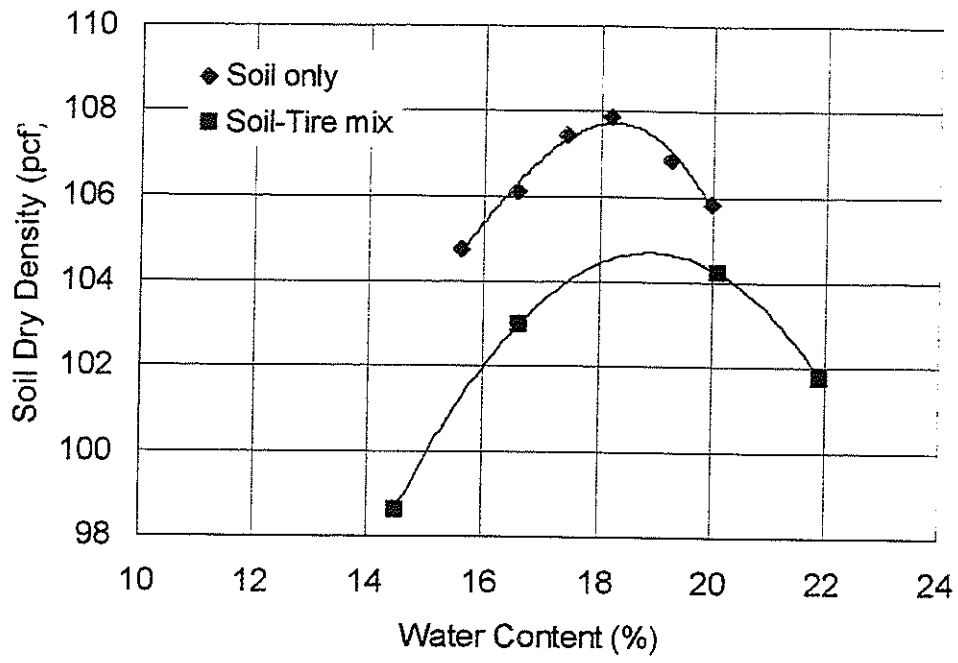
The compaction characteristics of the tire chips and the soil-tire mix govern the in-place density and the shear strength properties of the material. Tire chips material is highly elastic and it absorbs the energy induced by the compaction effort. Moisture-density relationship of the soil-tire mix was investigated using 150-mm (6-inch) diameter compaction mold according to the ASTM -D 1557. Previous studies on compaction characteristics of tire and soil-tire mix has shown that moisture content and mold size have no significant effect on the compaction properties [3]. The procedure was modified to accommodate the large particle size of the tire chips. Tire chips of maximum size of 75 mm (3 inches) were used in the mix with soil specimen of maximum particle size of 4.75 mm (passing sieve No. 4). Equal volumes of the soil and the tire chips were dry mixed first. Water was added to the mix as percentage by weight. The mix was compacted in three layers in a mould. Each layer was compacted 56 times using the modified Proctor hammer. The top portion of the mold was removed and top of the sample was leveled. The density of the sample in the mold was noted and the water content measured. Figure 6 shows the moisture-density relationship of the soil-tire mix and the soil only.

Figure 6. Moisture-Density relationship of the soil and the soil-tire mix

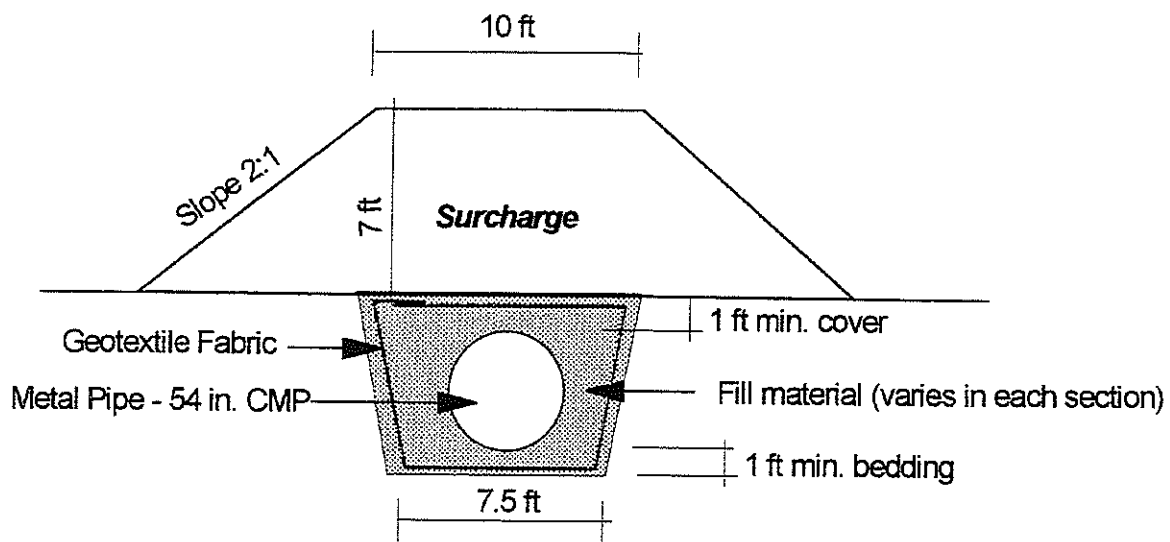
Three test sections were constructed to investigate the performance of the tire chips and the soil-tire mix as pipe backfill and bedding. Each section had a metal pipe placed in a trench 12 m (40 ft) long and 2 m (7 ft) deep. The base of the trench was about 2.5 m (7.5 ft) with vertical cuts to the ground surface. A geotextile wrap for separation was installed and a corrugated metal pipe of length 12 m (40 ft) was placed in each section on top of one foot of bedding material. The pipes had a diameter of 1.35 m (54 in.), a 16-gage thickness, and a 76 mm (3 in.) x 25 mm (1 in.) corrugation. Figure 7 shows a typical cross section.

Figure 7. Typical cross section of the test embankment

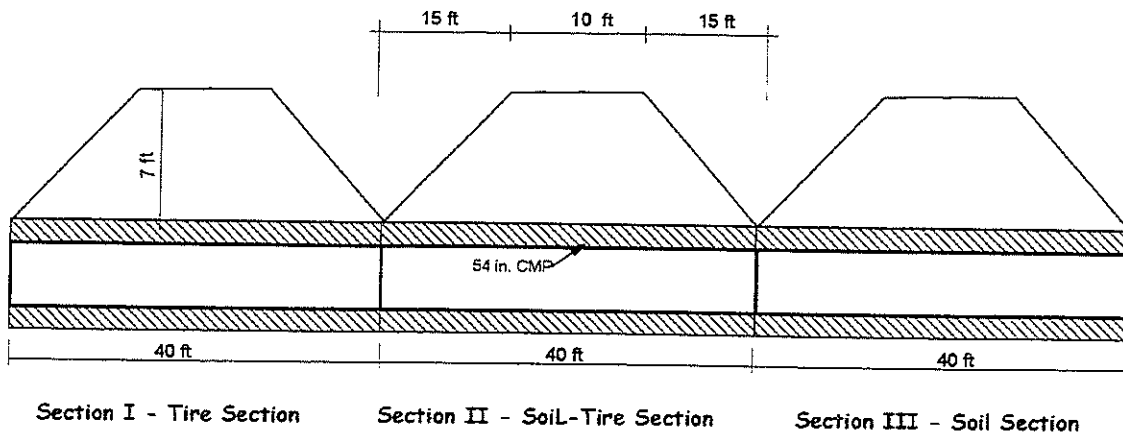
The first section was filled with tire chips, the second section was filled with a mix of one silty-clay soil to one tire chips by volume. The third section was filled using silty-clay soil as a control section. A surcharge of about two meters (7 ft) high was initially placed on the top of each section. The embankment height was raised to about four meters (14 ft) three months after construction. A longitudinal cross section of the test embankment is shown in figure 8.

Figure 8. Longitudinal cross section of the test embankment

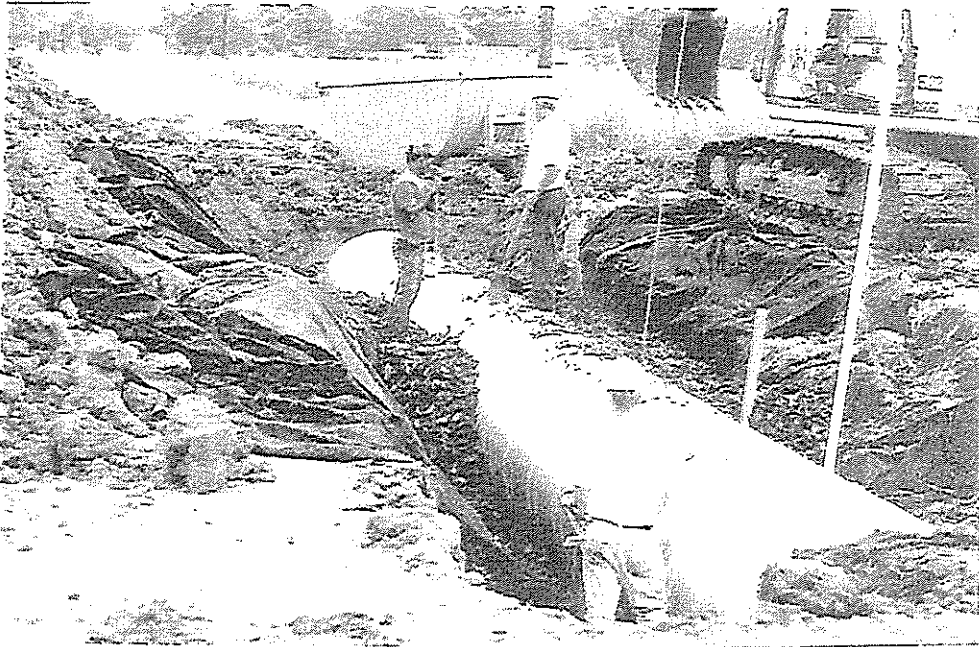
Tire chips were placed in about 30 cm (12 in.) lifts in the first section and they were manually spread around the pipe. Figure 9 shows the placement of the tire chips. Soil and tire chips were mixed in a large container in the field, using the bucket of a backhoe. The mixing ratio was one-to-one by volume. The mix was placed in its respective section using the bucket.

Figure 9. Placement of tire chips around the pipe

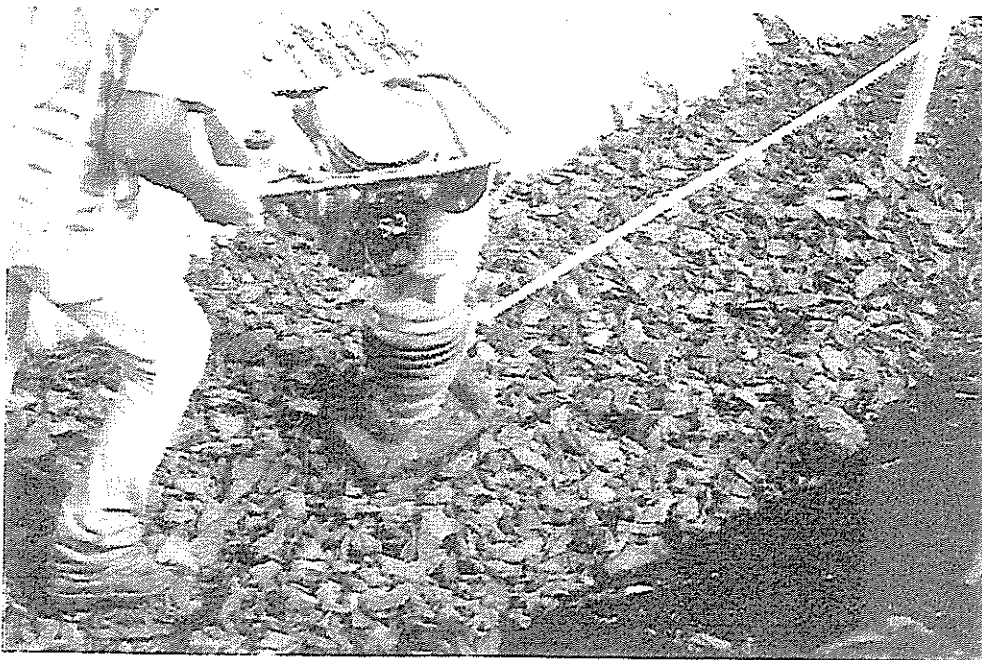
Compaction was performed using a hand-held vibrating compactor. Soil and soil-tire mix were compacted to about 90 percent of their maximum dry density using the vibrating compactor. Density was measured in the field using a nuclear density gage. Compaction of the tire chips was applied to reduce the voids between the dispersed plate-like tire chips. The attempt to compact the tires proved to be very difficult and labor intensive. The hand compactor would sink into the loose tire fill. A rope was attached to the compactor in an effort to pull it over the surface. As a conclusion, very little improvement in density was observed after compaction due to the elastic behavior of the tires. Figure 10 shows a view of the compaction of tire chips around the pipe.

Figure 10. Compaction of the tire chips around the pipe

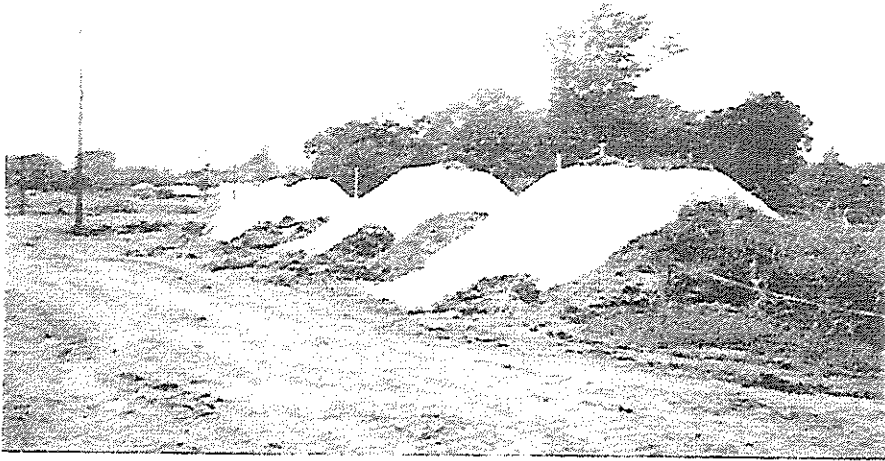
Embankments were constructed on the top of each section to apply overburden pressure. The embankment had a slope of 1.5-to-1 on each side. The slopes were covered with fabric to reduce surface erosion. Figure 11 shows a view of the test embankments.

Figure 11. View of the test sections

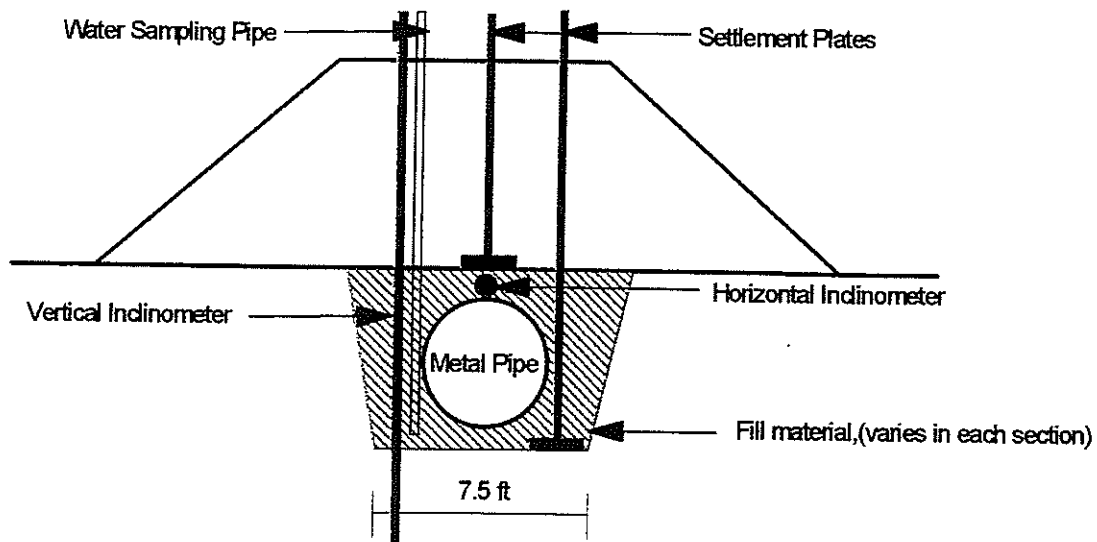
The three test embankments were instrumented to monitor the performance of the metal pipe in the three types of backfill materials. The instrumentation consisted of placing two settlement plates; one at the top and one at the bottom of the fill in order to determine the compression of each fill type under embankment weight. Settlements of the tire chips and soil-tire mix sections were monitored at the top of the metal pipe using a horizontal inclinometer that extended across both sections. Vertical inclinometers were installed in each section to measure the horizontal deformation of the fill near the metal pipe. Figure 12 shows a schematic of the instrumentation layout in a typical cross section of the pipe. A view of the inclinometer pipe in the field is shown in figure 13.

Figure 12. Layout of the field instrumentation

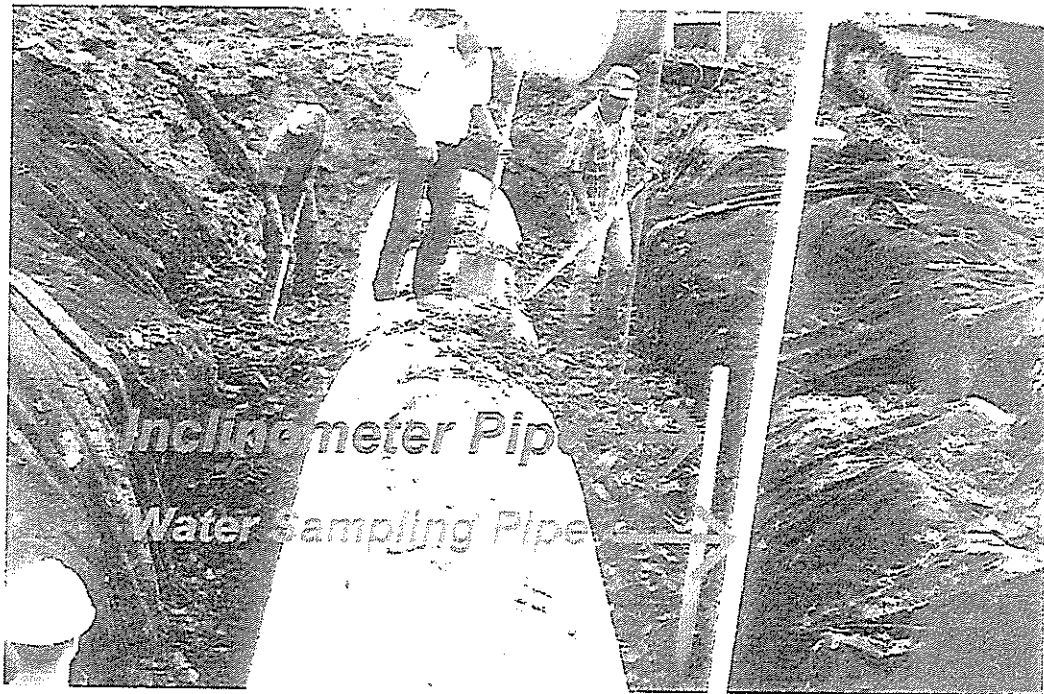
Figure 13. Installation of the vertical inclinometer in the field

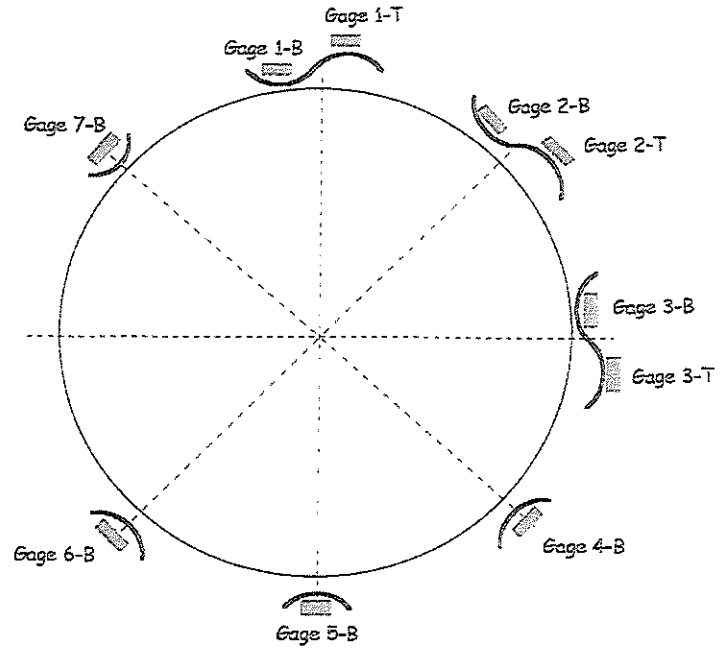
The strains of the pipe in the three fill sections were compared using strain gages installed around the pipe cross section. A total of ten strain gages in each section were installed in the configuration shown in figure 14. Seven of the gages were installed in the hollow of the corrugation while the other three gages were installed on the hump. The strain gages were of Micro-Measurements type EP-40-250BF-350. Figures 15 and 16 show the installation of the strain gages on the metal pipe.

Figure 14. Schematic of the locations of strain gages in the Field

The compression and tension forces at the bottom and top of the corrugation can be estimated from the measured strains and the modulus of elasticity of the metal pipe. However, the estimation of the forces and stresses on the pipe surface were not in the scope of this study. Measurements of the strains were taken using a field read out box and they were compared in the three sections. Figure 17 shows the initial reading of the strain gages after pipe installation in the field.

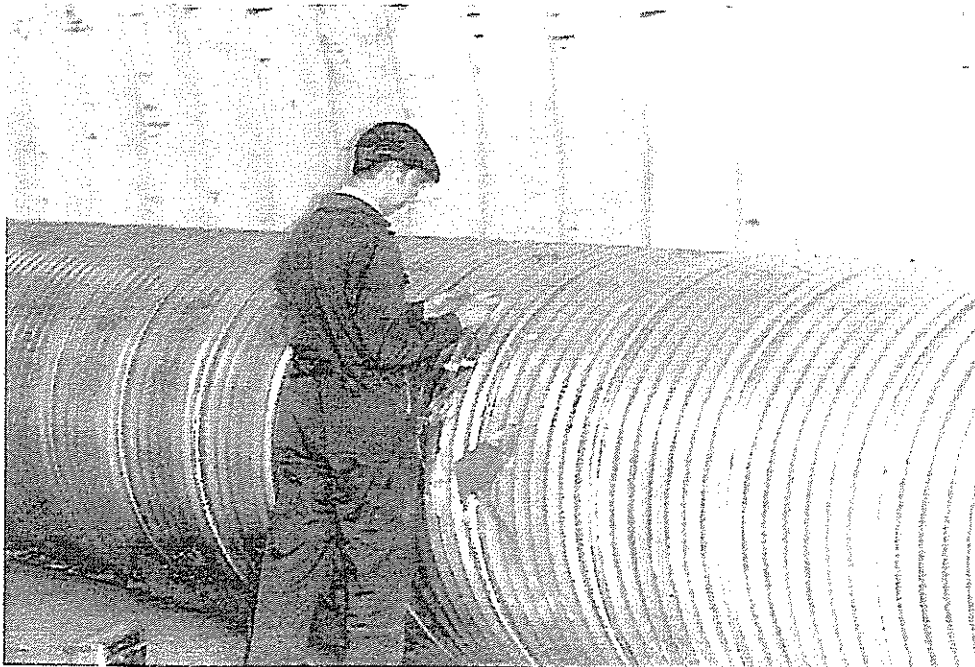
Figure 15. View of the inclinometer installation in the field

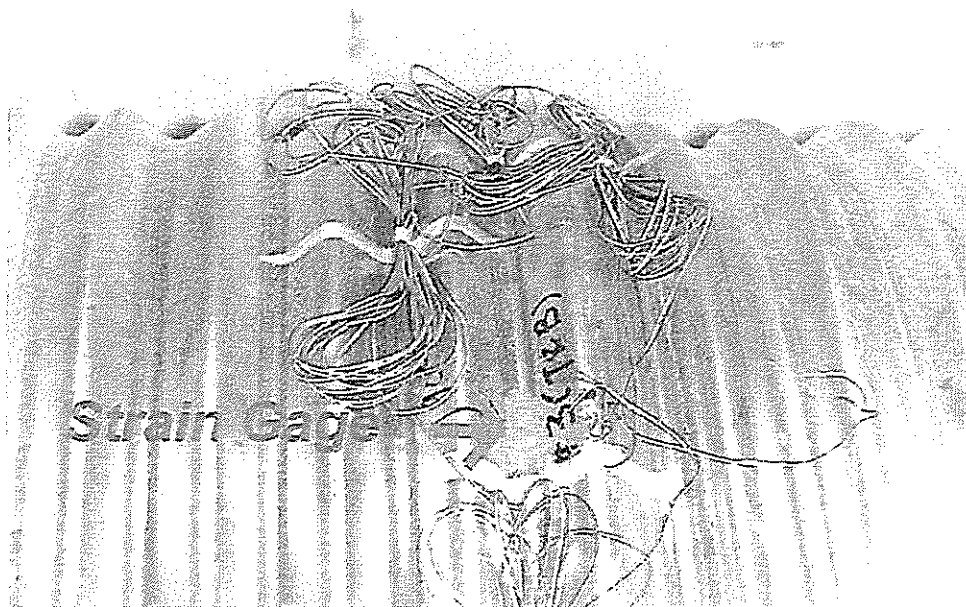
Figure 16. View of the strain gages on the pipe

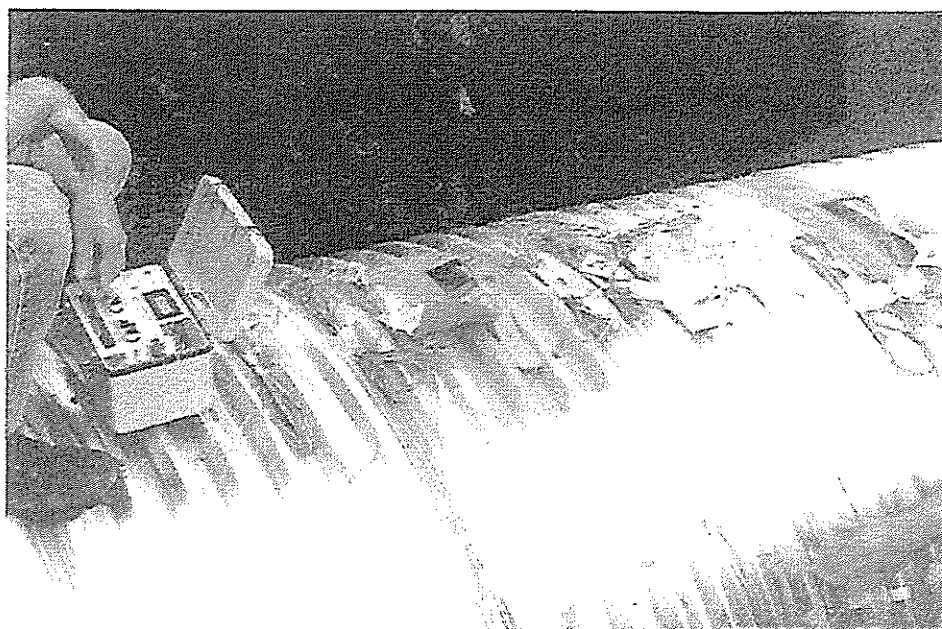
Figure 17. Initial reading of the strain gages in the field

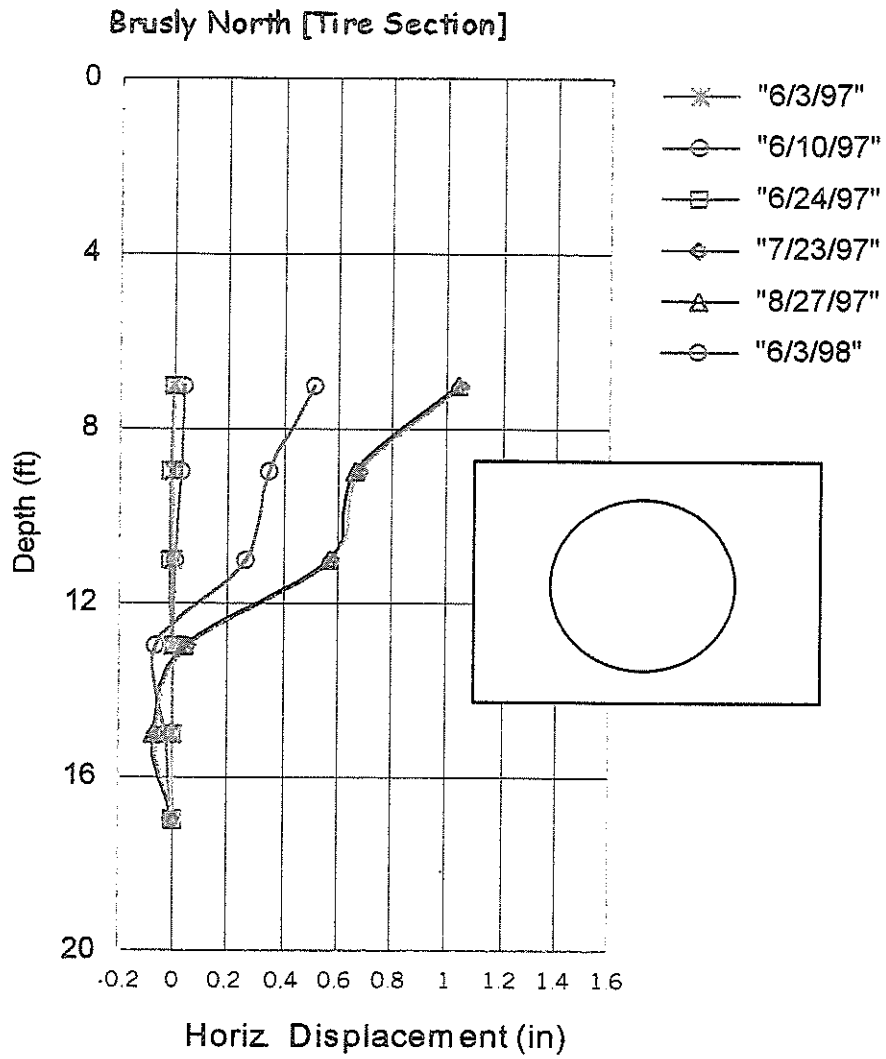
The vertical inclinometer readings are plotted in figures 18, 19, and 20 for the tire section, the soil-tire mix section, and the soil section, respectively. The plots show the horizontal soil displacement near the metal pipe with the positive direction indicating soil movement away from the pipe. It should be noted that the plots show only the readings up to the top of the backfill material below the embankment. The readings of the vertical inclinometers in the embankment above the backfill are irrelevant to this evaluation study. However, for the sake of completeness, the total plots of the inclinometer readings are presented in appendix B.

The maximum horizontal displacement (at the center height of the metal pipe) in the tire section was 16.5 mm (0.65 in.). Displacements of 7.5 mm (0.30 in.) and 3 mm (0.12 in.) were monitored in the soil section, and the soil-tire section, respectively. Figure 21 shows a comparison of the maximum displacements in the three sections near the metal pipe. The figure demonstrates the significant increase of soil deformation around the pipe in the tire section in comparison with the other two sections.

Figure 18. Horizontal soil displacement near the pipe in the tire section

The initial readings during construction were taken on May 31, 1997. The plots show the accumulated horizontal displacements at the dates shown in figures. The first three readings after construction, namely on 6/3/97, 6/10/97 and 6/24/97 were taken when embankment height was two meters (7 ft). Small horizontal displacements in the order of 1.5 mm (0.05 in.) were monitored in the three sections at this height. In order to investigate pipe deformation at higher loads, embankment height was increased to about four meters (14 ft). The readings beginning on 7/23/97 represent the horizontal displacement at this embankment height.

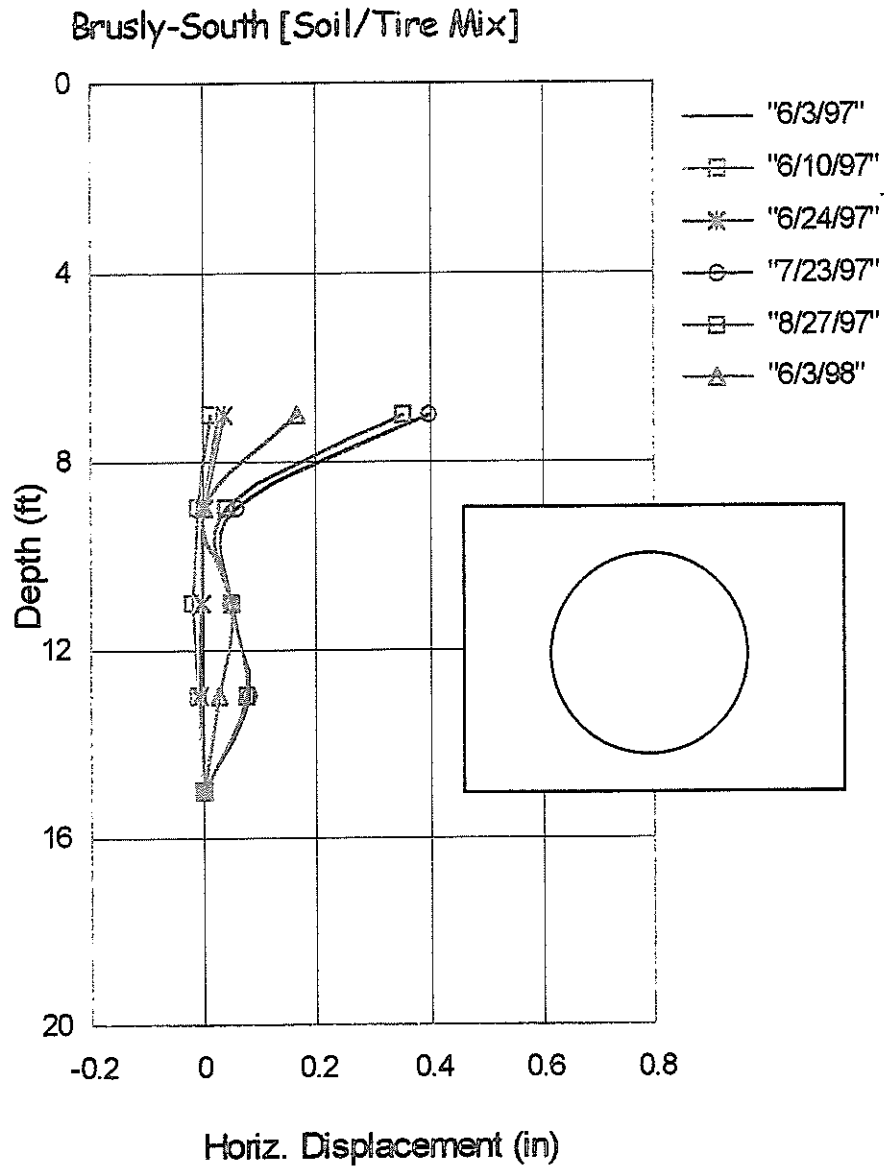
Figure 19. Horizontal soil displacement near the pipe in the soil-tire section

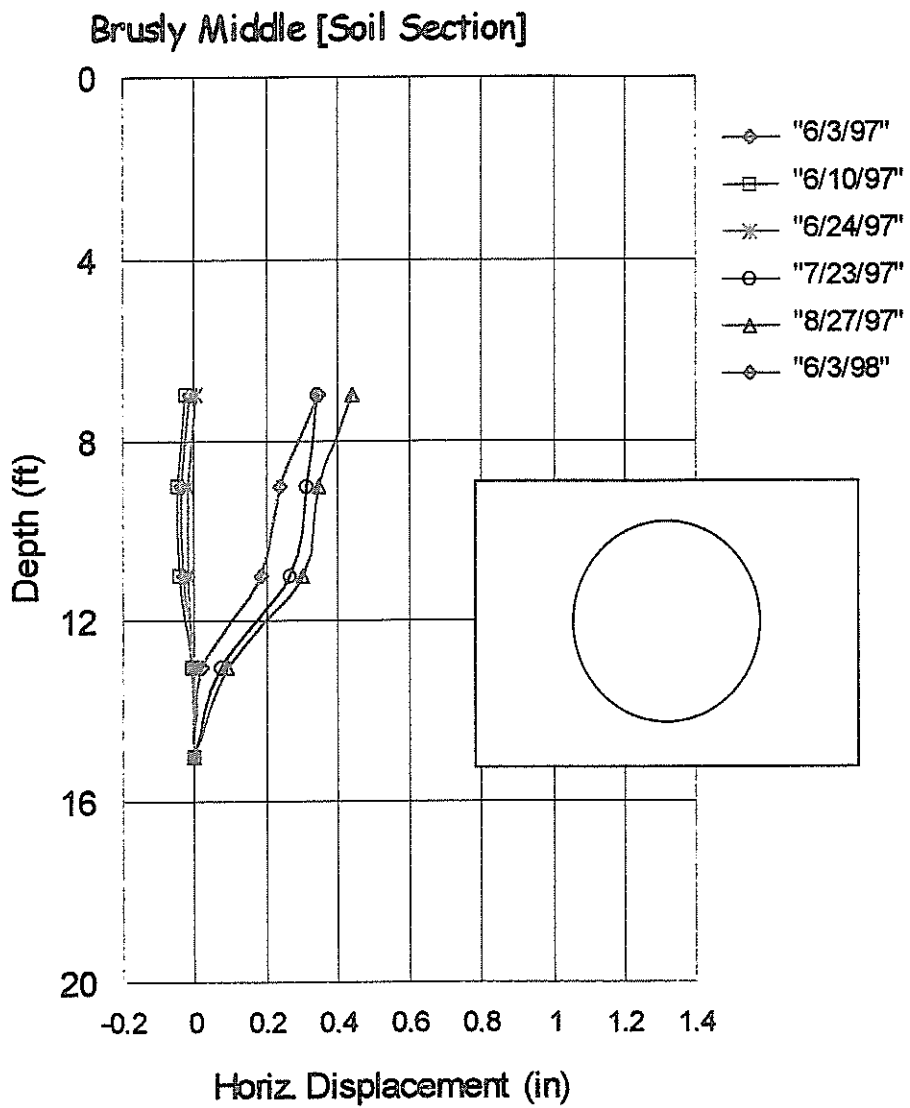
Figure 20. Horizontal soil displacement near the pipe in the soil section

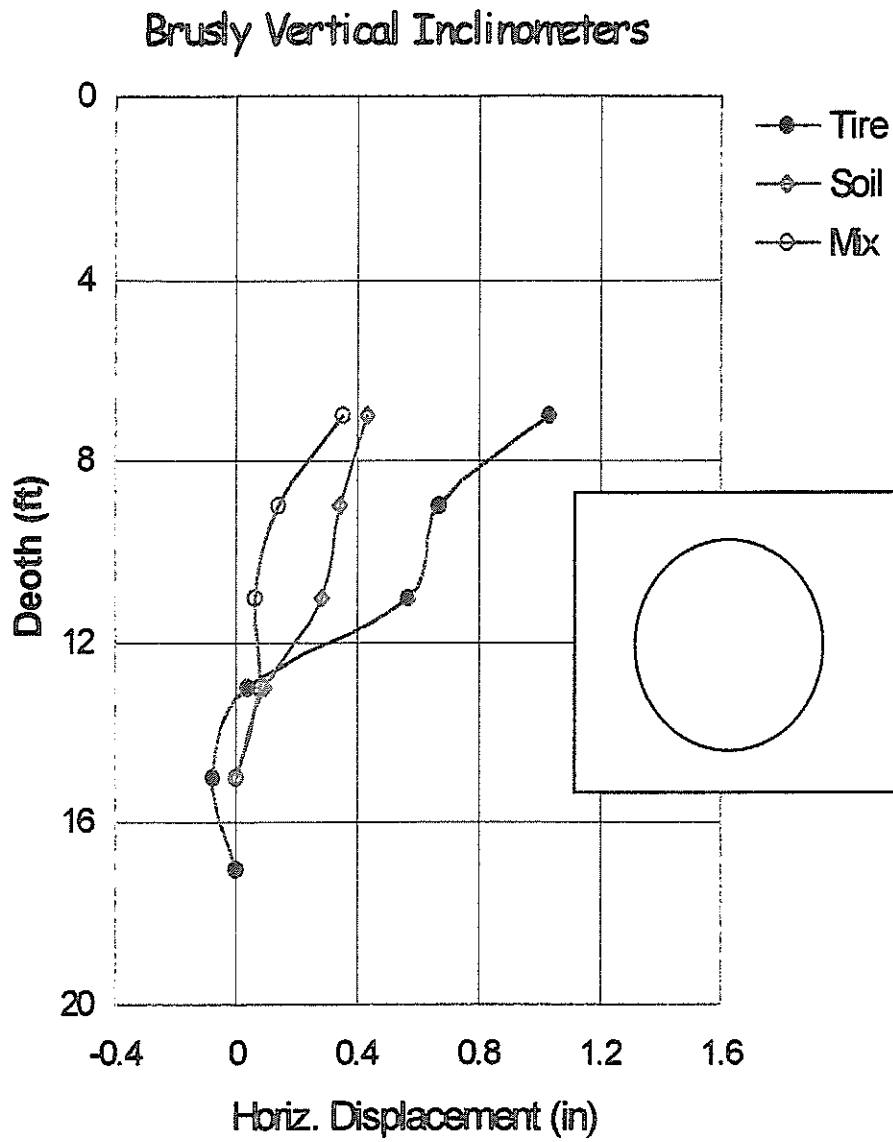
Figure 21. Comparison of horizontal soil movement in the three sections

The results of the vertical and horizontal inclinometers show that the tire fill did not provide comparable horizontal stresses around the metal pipe to restrain pipe deformation. It can also be concluded that the horizontal deformation in the soil-tire mix fill was comparable to the one in the soil section. Further investigation of the deformation of the pipe was carried out through monitoring the strains in the pipe in the three sections.

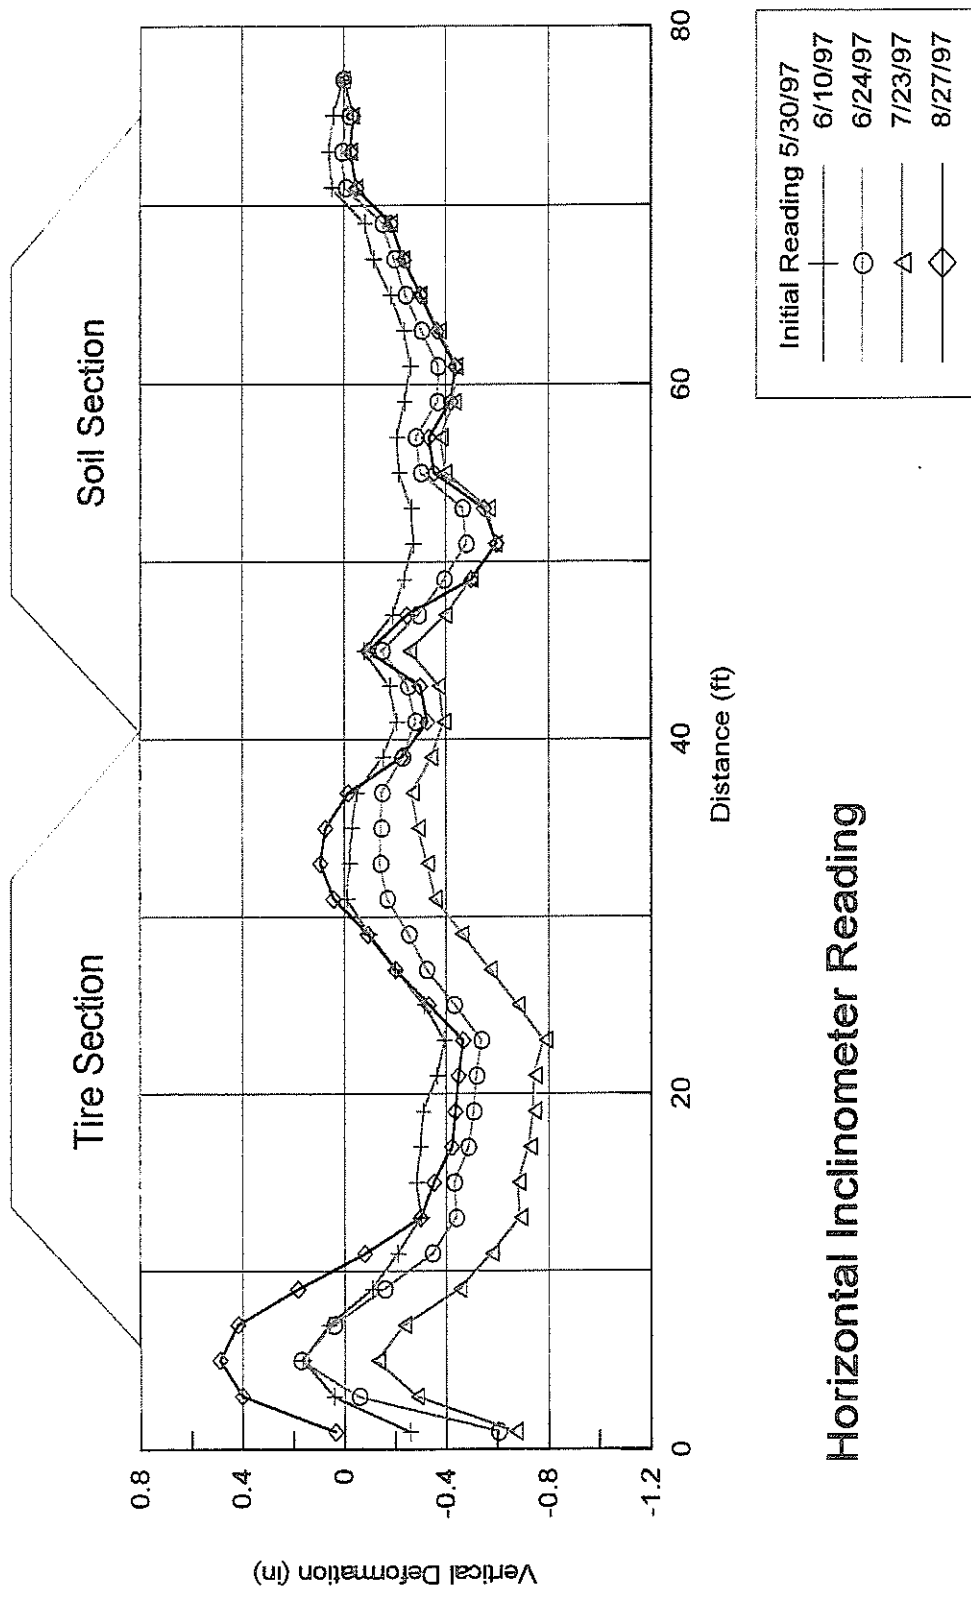
Figure 22.

The horizontal inclinometer was placed in both the tire section and the soil section. The inclinometer was placed directly on the top of the metal pipe as shown in figure 12. The measurements of the horizontal inclinometer are shown in figure 22. The results show that the vertical deformation of the metal pipe in the tire section was higher than that in the soil section. The higher vertical displacement in the tire section can be attributed to the compressibility of the part of the tire section underneath the metal pipe and to the higher deformation of the pipe in the tire section.

Horizontal Inclinator Reading

- d) The vertical deformation at the top of the metal pipe was monitored using the horizontal inclinometer. Measurements at the end of 4 months period after construction showed a vertical settlement of 0.8 inches in the tire section in comparison to an average of 0.45 inches in the soil section. The

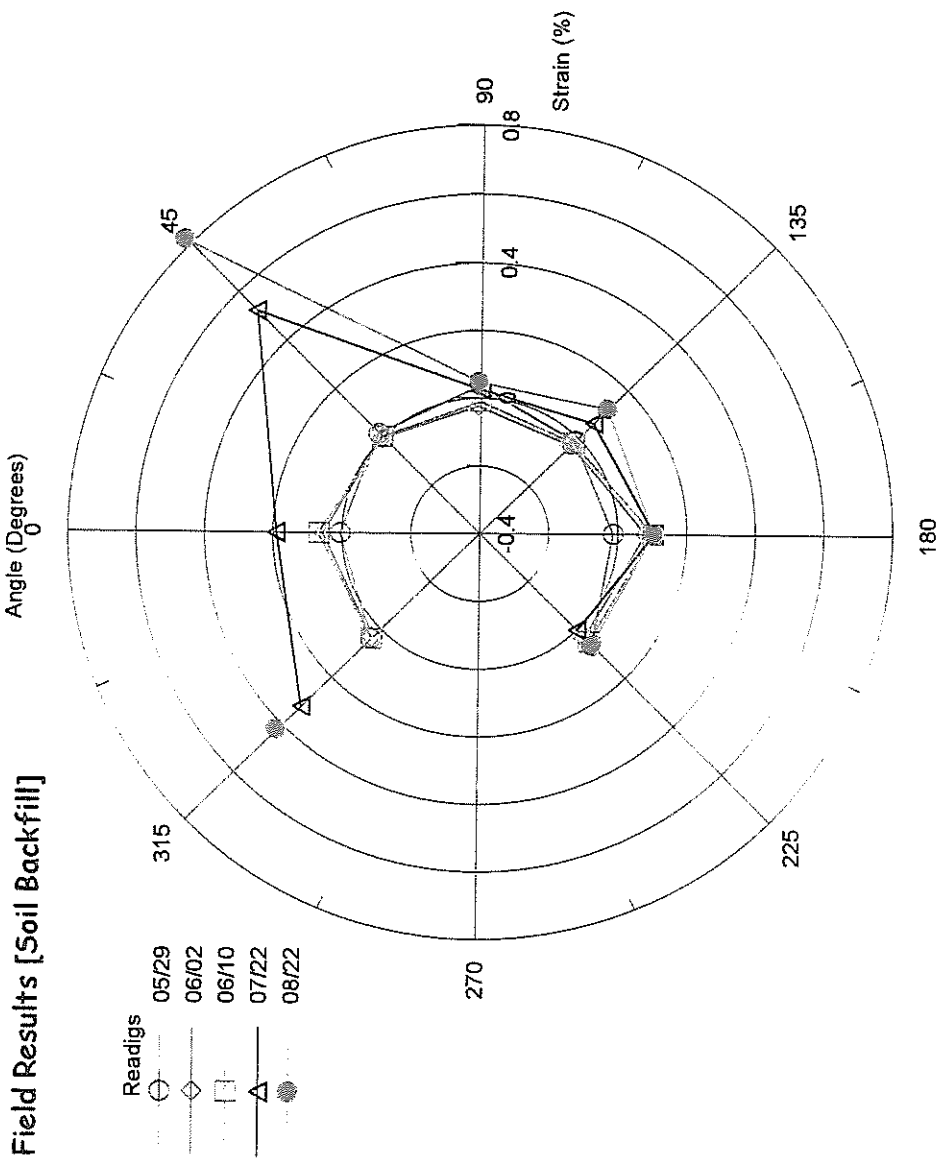
The results of the pipe strains in the soil section are shown in figures 23 and 24 for the gages at the bottom and the top of corrugation, respectively. The strains in these figures are plotted in polar coordinates to represent the state of deformation around the circular pipe. The plots illustrate the development of strains after construction, when the readings on 07/22 and 8/22 were at embankment height of four meters (14 ft). The results of the strain gages readings in the soil-tire mix section and the tire section are shown in a similar fashion in figures 25 to 28. The plots of strains against the gage numbers are also shown in appendix B.

Figure 23. Strain measurements of bottom gages in the soil section

The results in these figures show that the profile of strains in the soil section and the soil-tire section were comparable. In both sections, maximum positive strains were in the range of 0.8 percent at the 45-degree angle, and minimum strains accrued at the bottom of the pipe. On the other hand, the profile of strains in the tire section was significantly different. In this section, maximum positive strains occurred at the top and bottom of the pipe while negative strains were measured at the middle height of the pipe at the 90-degree angle.

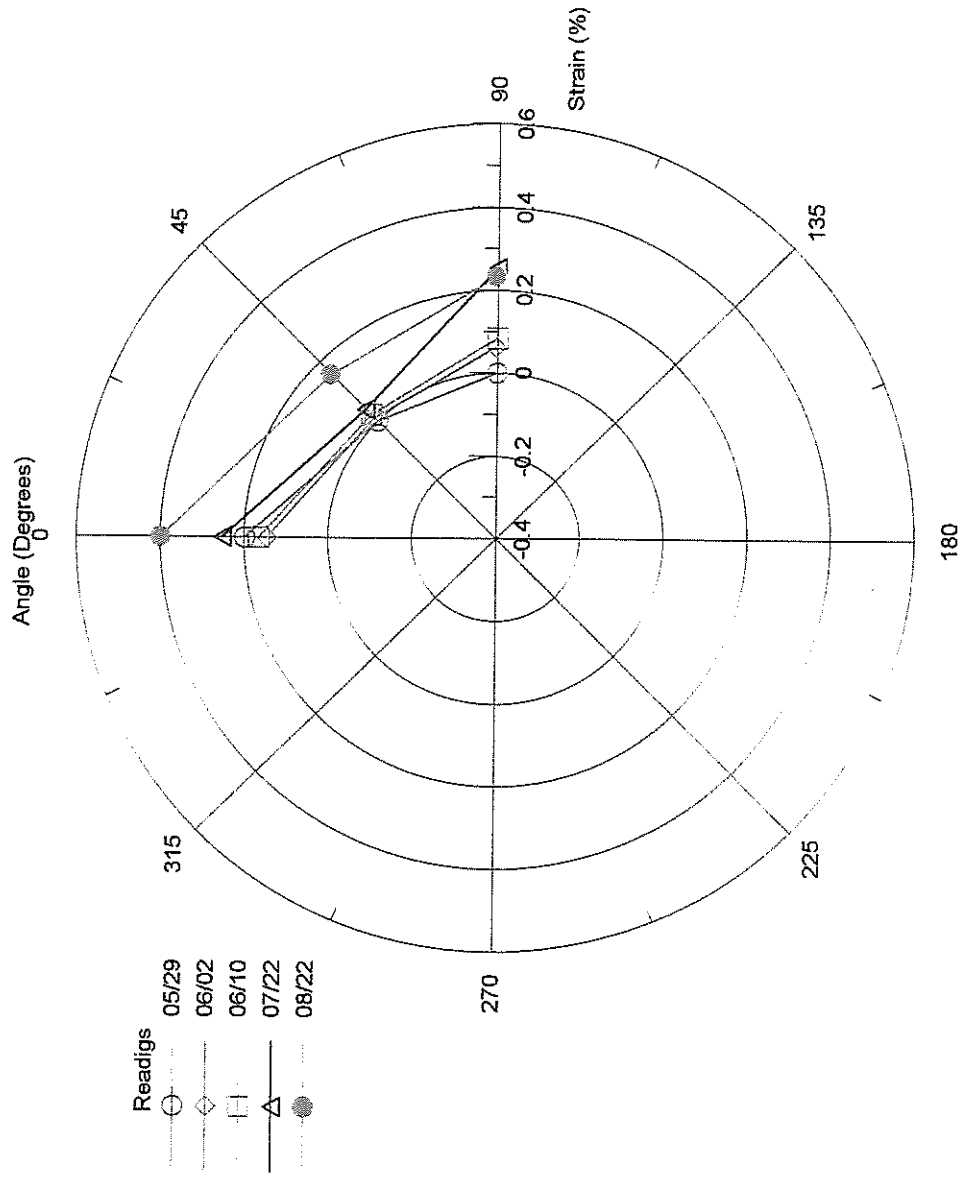
Figure 24. Strain measurements of top gages in the soil section
