**Louisiana Transportation Research
Technical Assistance Report
Report No. 19**

***Evaluation of the Use of Shredded
Tires Around Buried Pipes***

Technical Assistance Report Number 19

May 1999

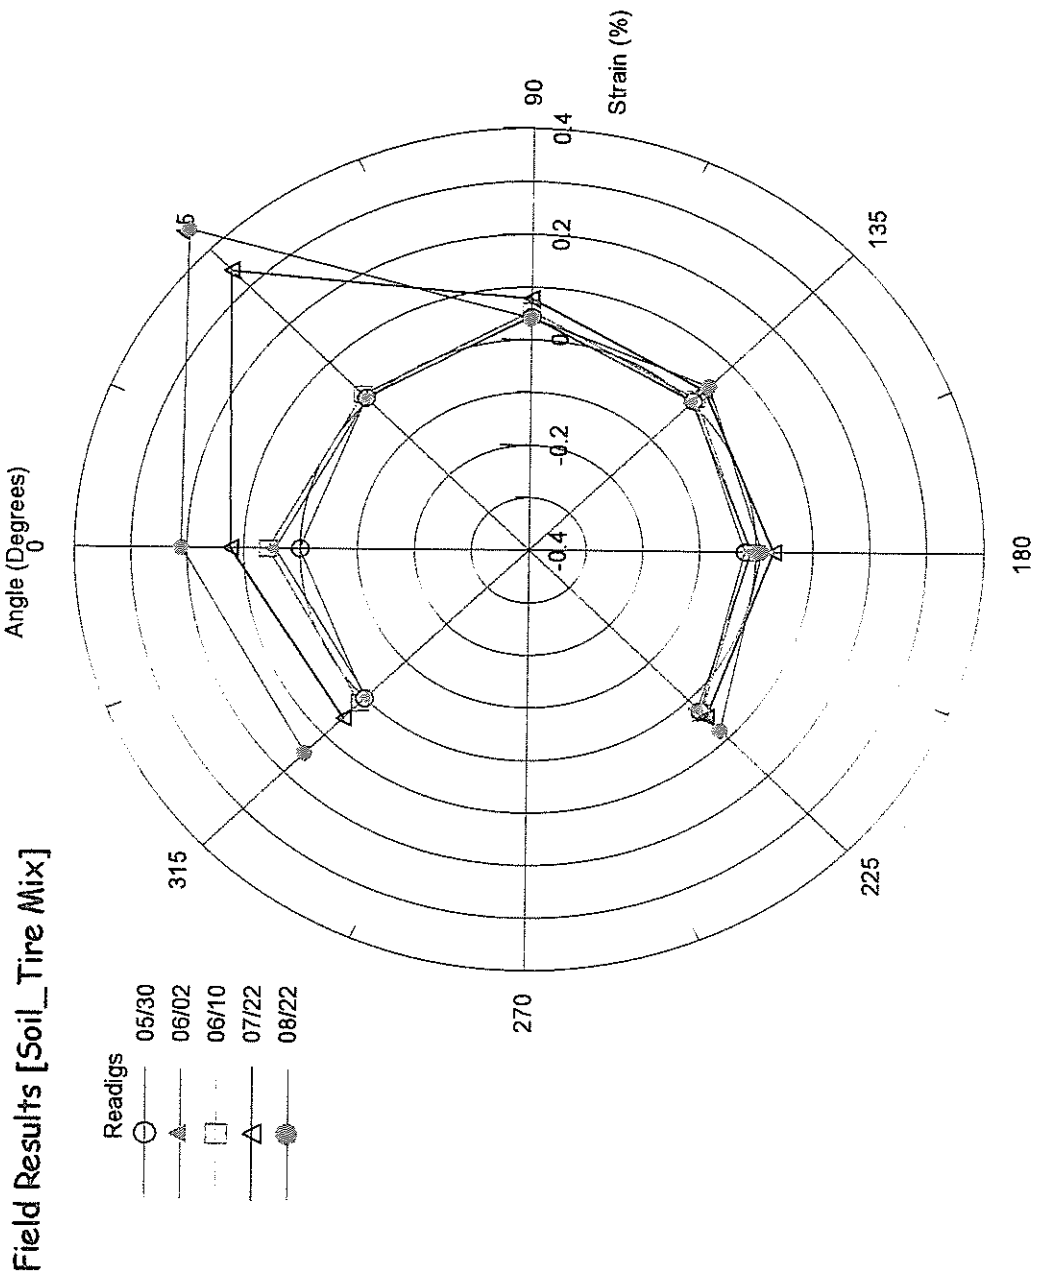
Figure 25. Strain distribution of bottom gages in the soil-tire section

The results in these figures show that the profile of strains in the soil section and the soil-tire section were comparable. In both sections, maximum positive strains were in the range of 0.8 percent at the 45-degree angle, and minimum strains accrued at the bottom of the pipe. On the other hand, the profile of strains in the tire section was significantly different. In this section, maximum positive strains occurred at the top and bottom of the pipe while negative strains were measured at the middle height of the pipe at the 90-degree angle.

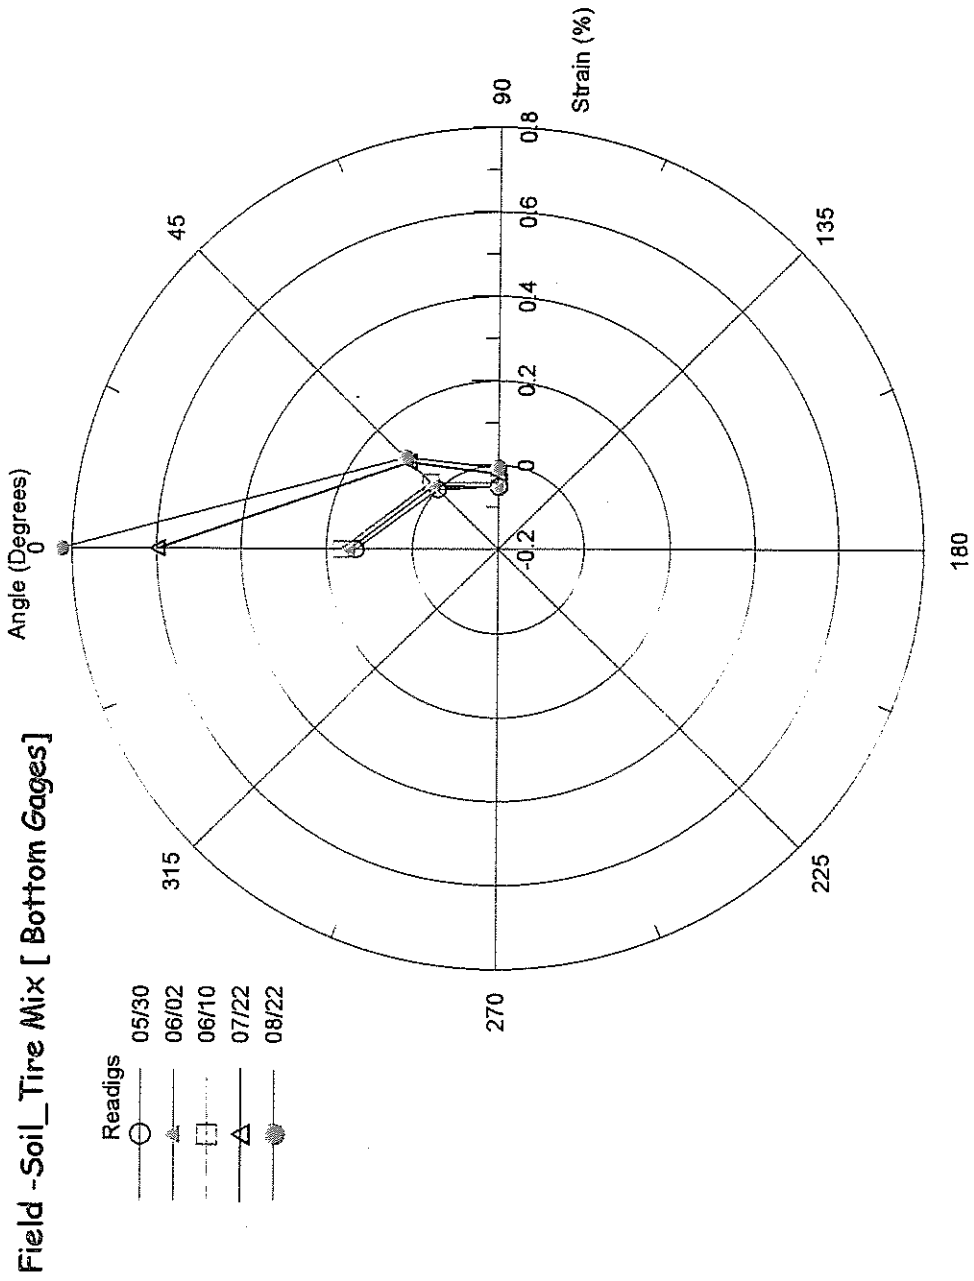
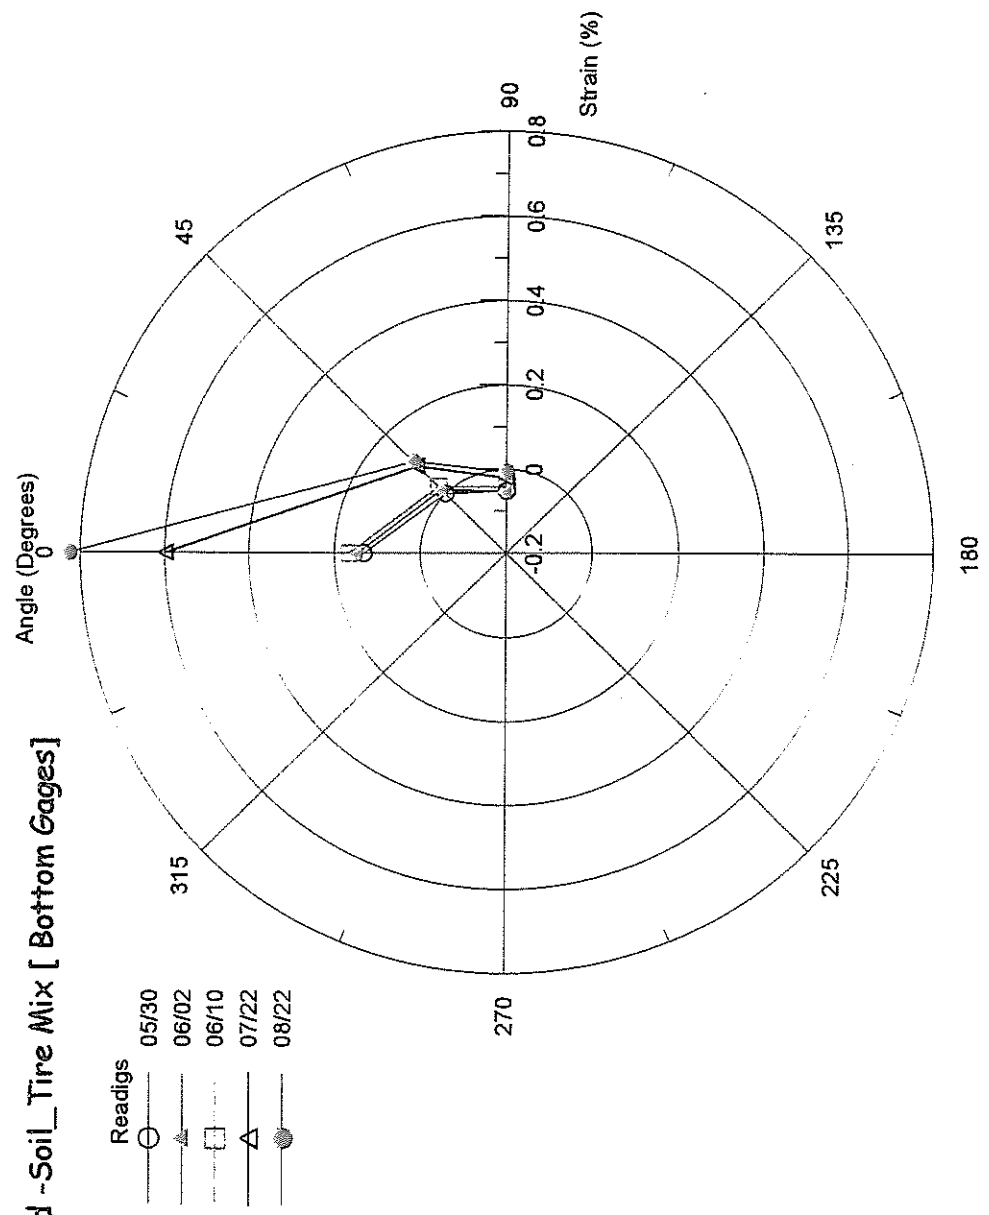
Figure 26. Strain measurements of top gages in the soil-tire section

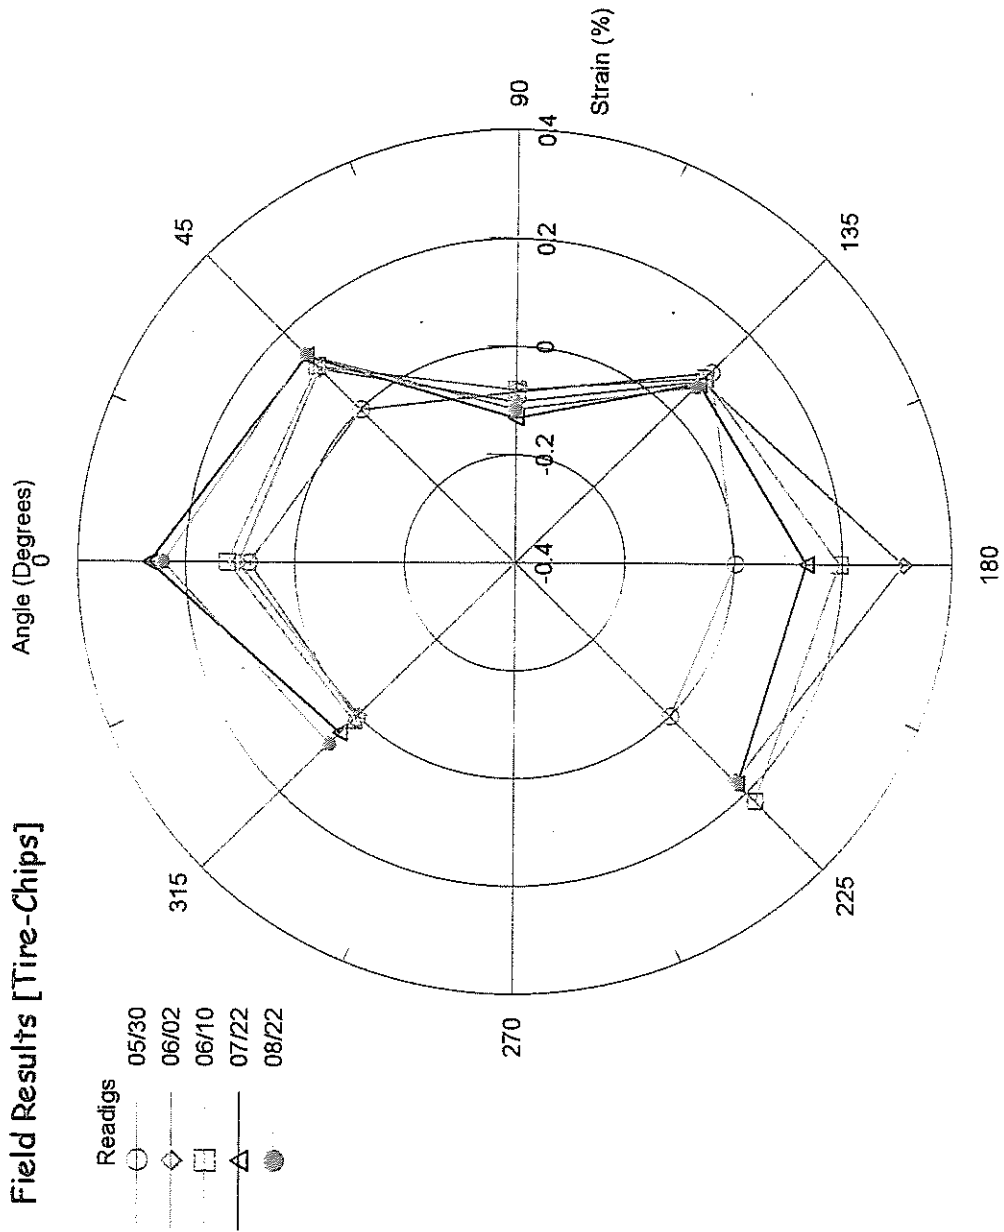
Figure 27. Strain measurements of bottom gages in the tire section

It can be concluded from the previous figures that the deformation behavior of the metal pipe in the tire section is fundamentally different than that of the other two sections and that the strains in the soil-tire section had values closer to the ones in the soil section. In order to further investigate pipe deformation in the tire backfill, a laboratory testing program was developed to compare pipe strains in tire backfill with the strains when the pipe is tested unconfined in the air.

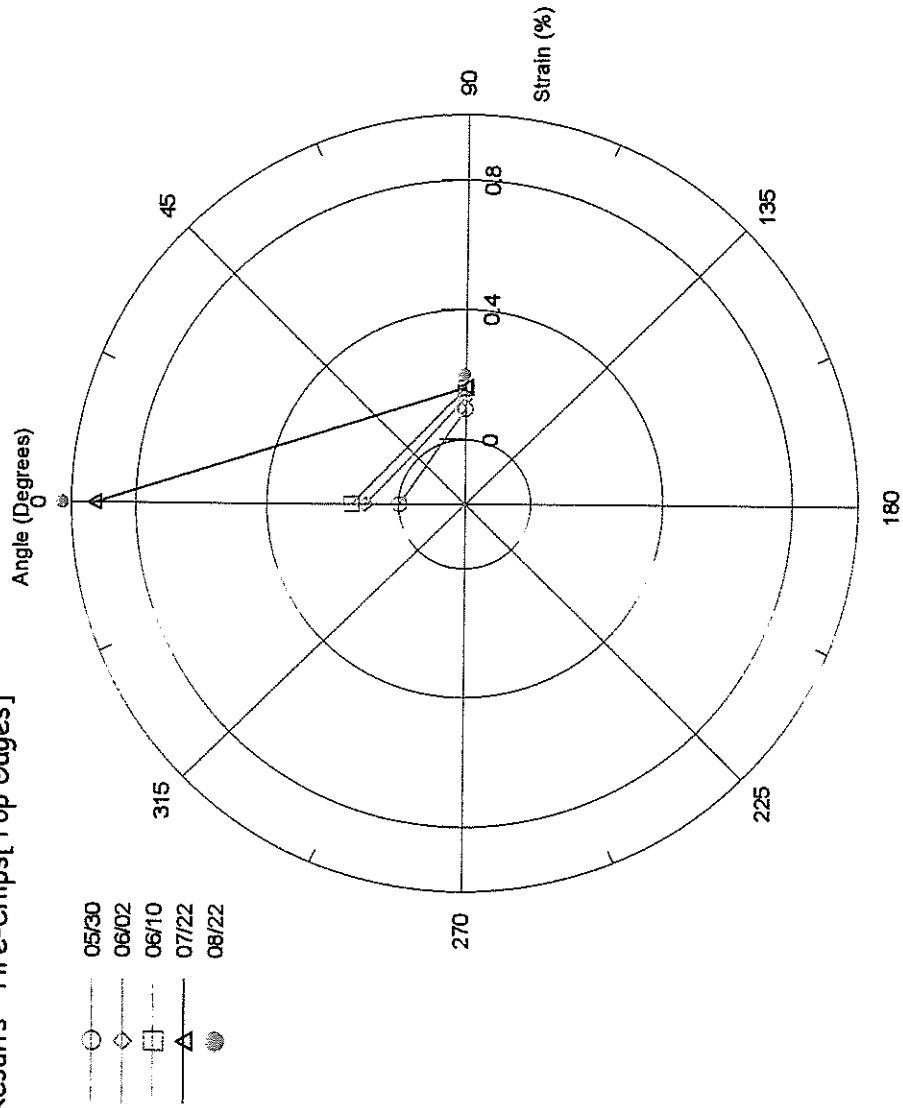
Figure 28. Strain measurements of top gages in the tire section

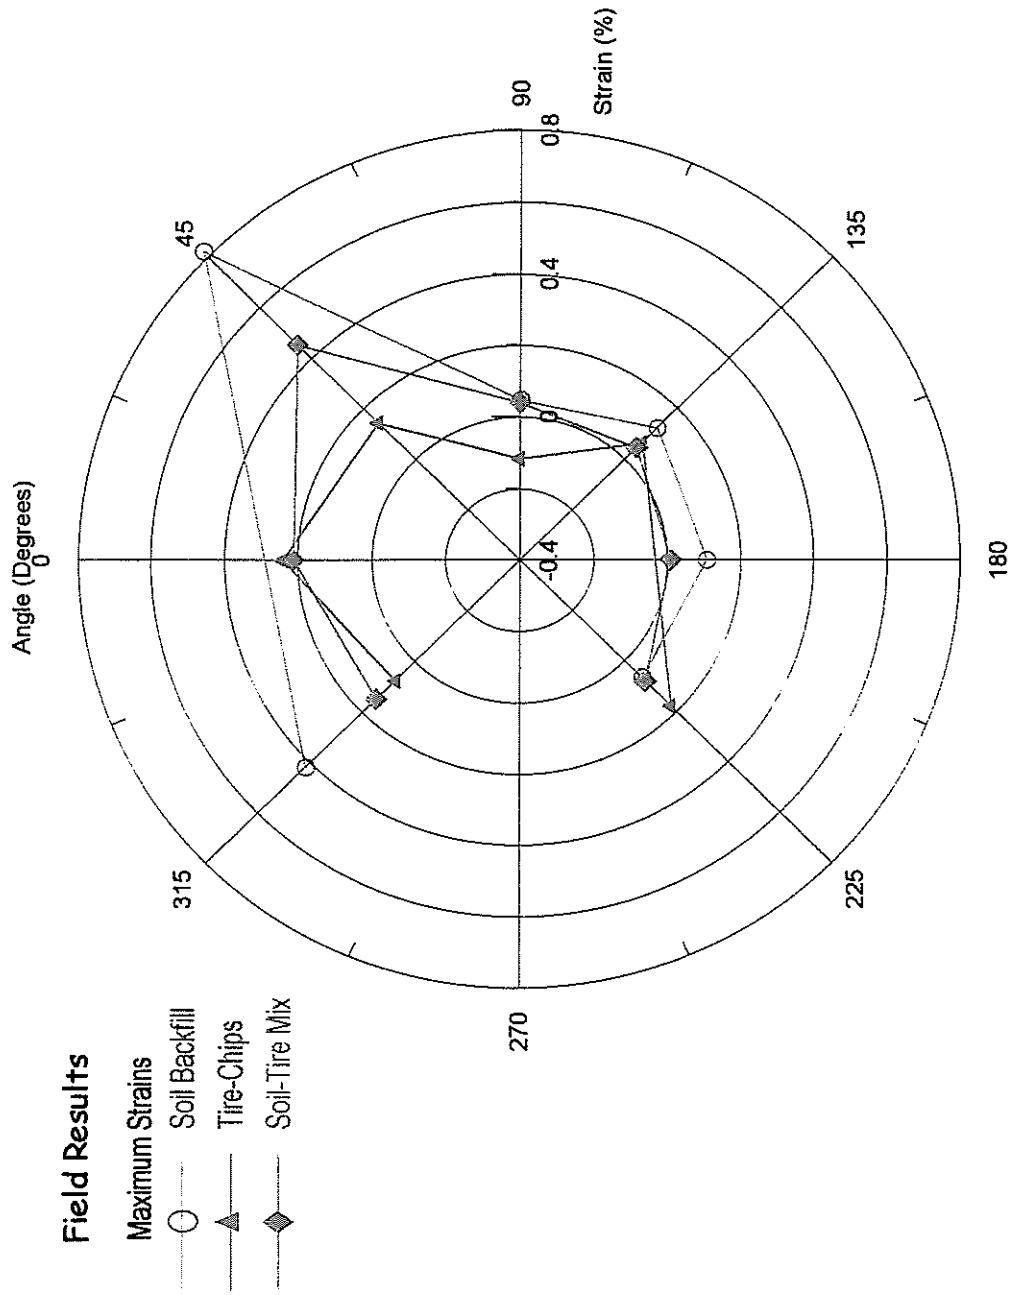
Maximum strains in the pipe in the three test sections are plotted in figures 29 and 30 for the strain gages at the bottom and the top of the corrugation, respectively. The figures show the state of strain in the metal pipe for the three types of fill.

Figure 29. Comparison of strains in bottom gages in the three sections

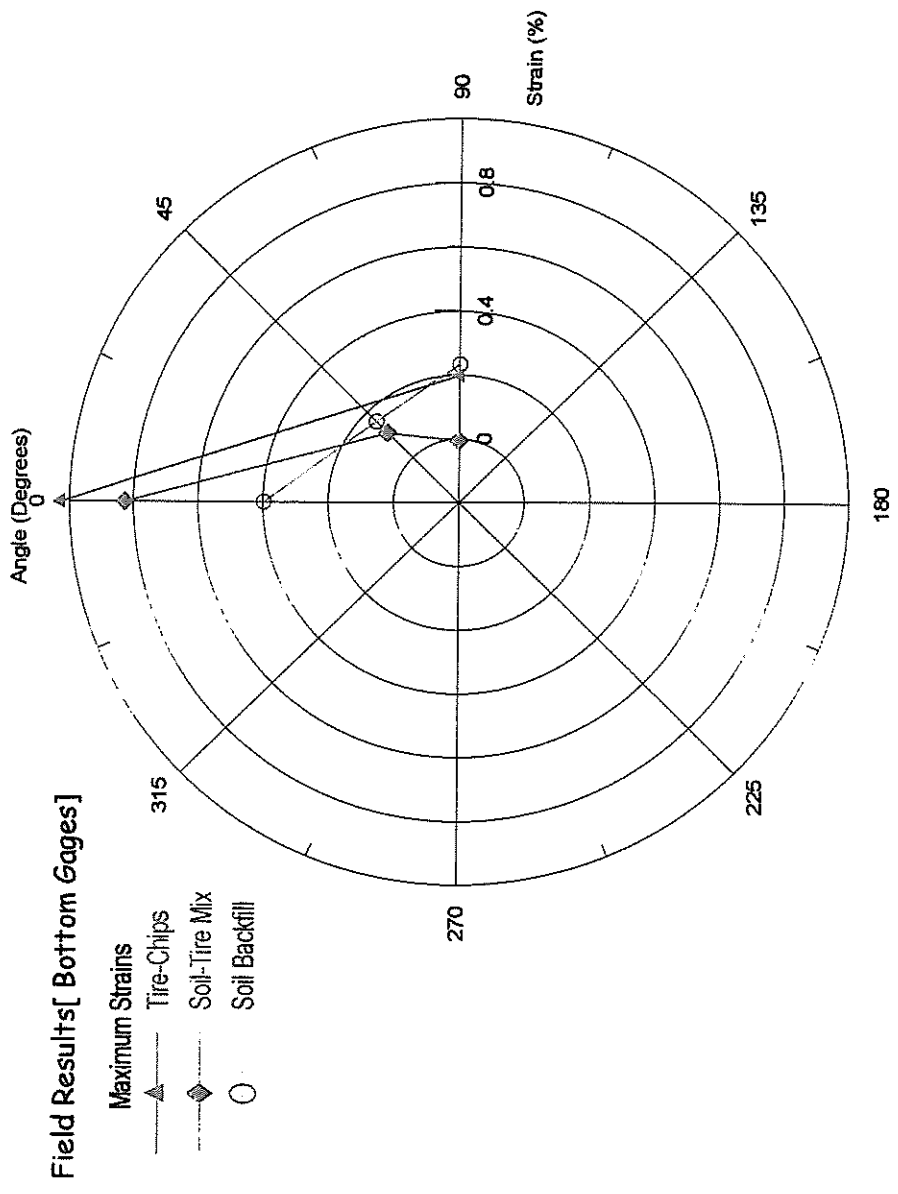
Figure 30. Comparison of strain in top gages in the three sections

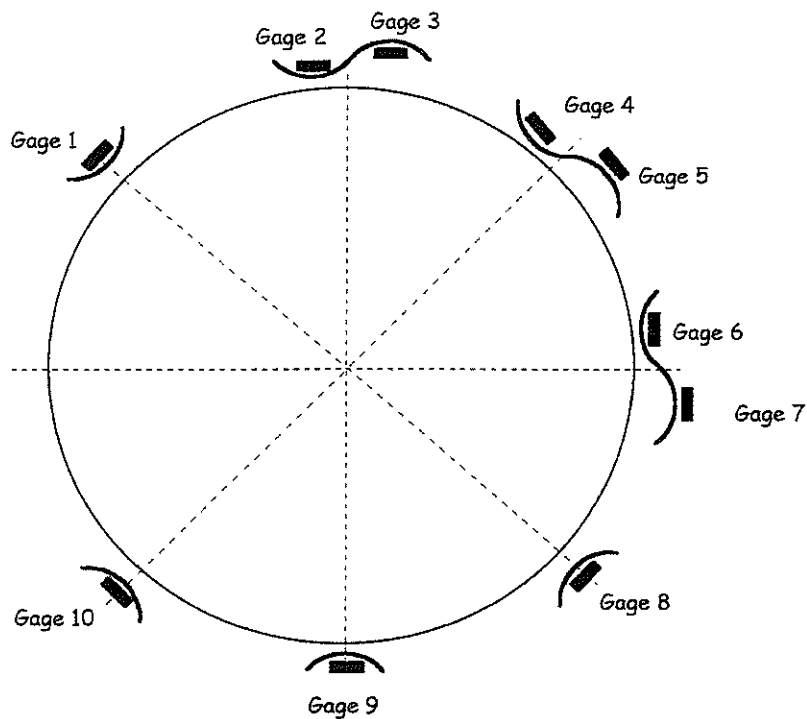
Figure 31. Schematic of the strain gages locations in the lab

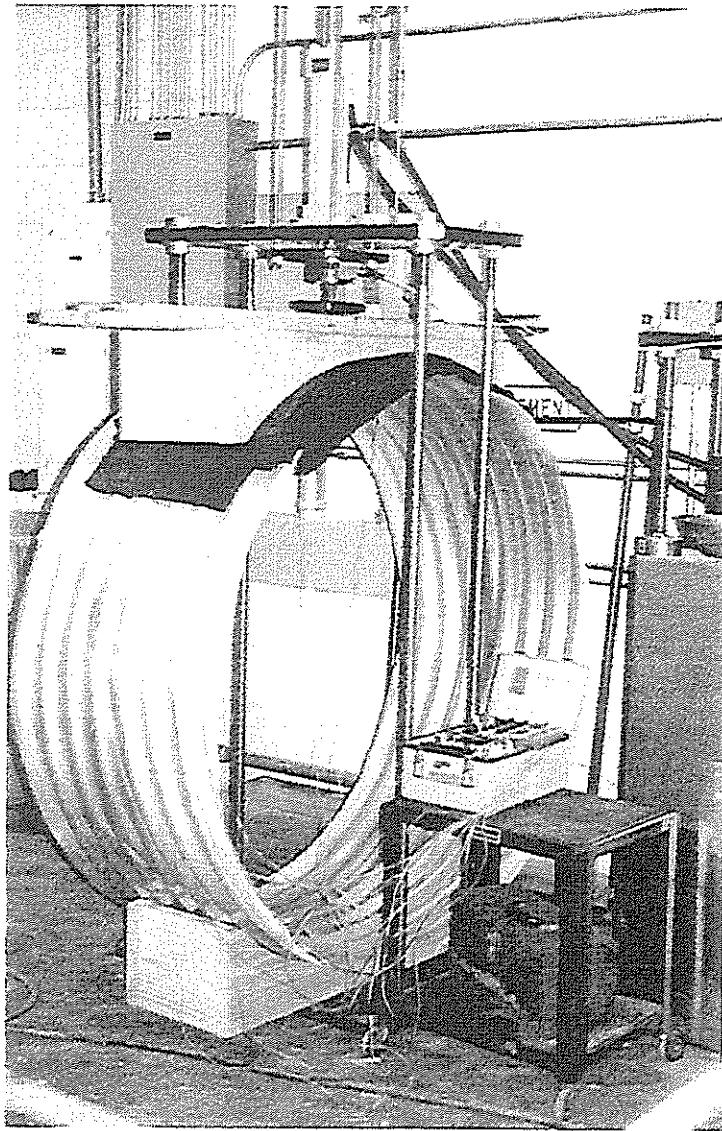
The metal pipe was tested in the air at vertical incremental loads up to 11 kN (2.5 kips) on top of the metal plate. Vertical deformation and strains were monitored with the incremental loads at intervals of two kN (400 lb). The results of the strain gage measurements are plotted in appendix C. Figure 32 shows a view of the metal pipe tested in the air.

Figure 32. View of the in-air testing of the metal pipe

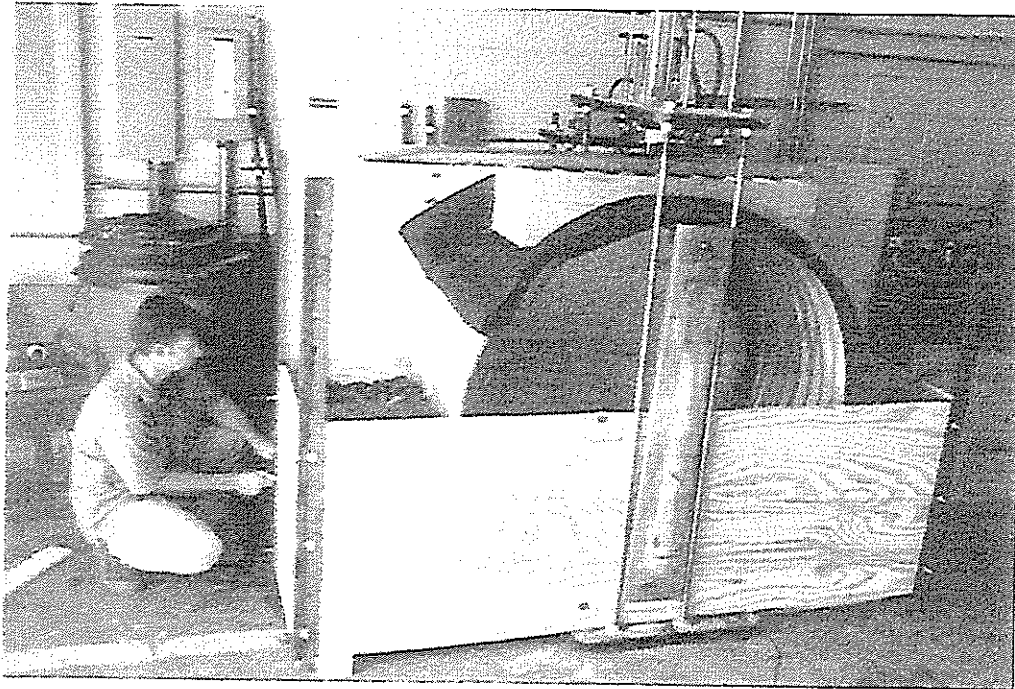
Confined tests in tire-chips and in soil-tire mix backfill were performed at similar increments of vertical loads. In these tests, the backfill was manually placed and lightly compacted in the large box. Figure 33 shows a view of the placement of the backfill around the metal pipe in the large box. The results of the strain gage measurements in these tests are plotted in appendix C.

Figure 33. Placement of the tire chips around the pipe in the lab

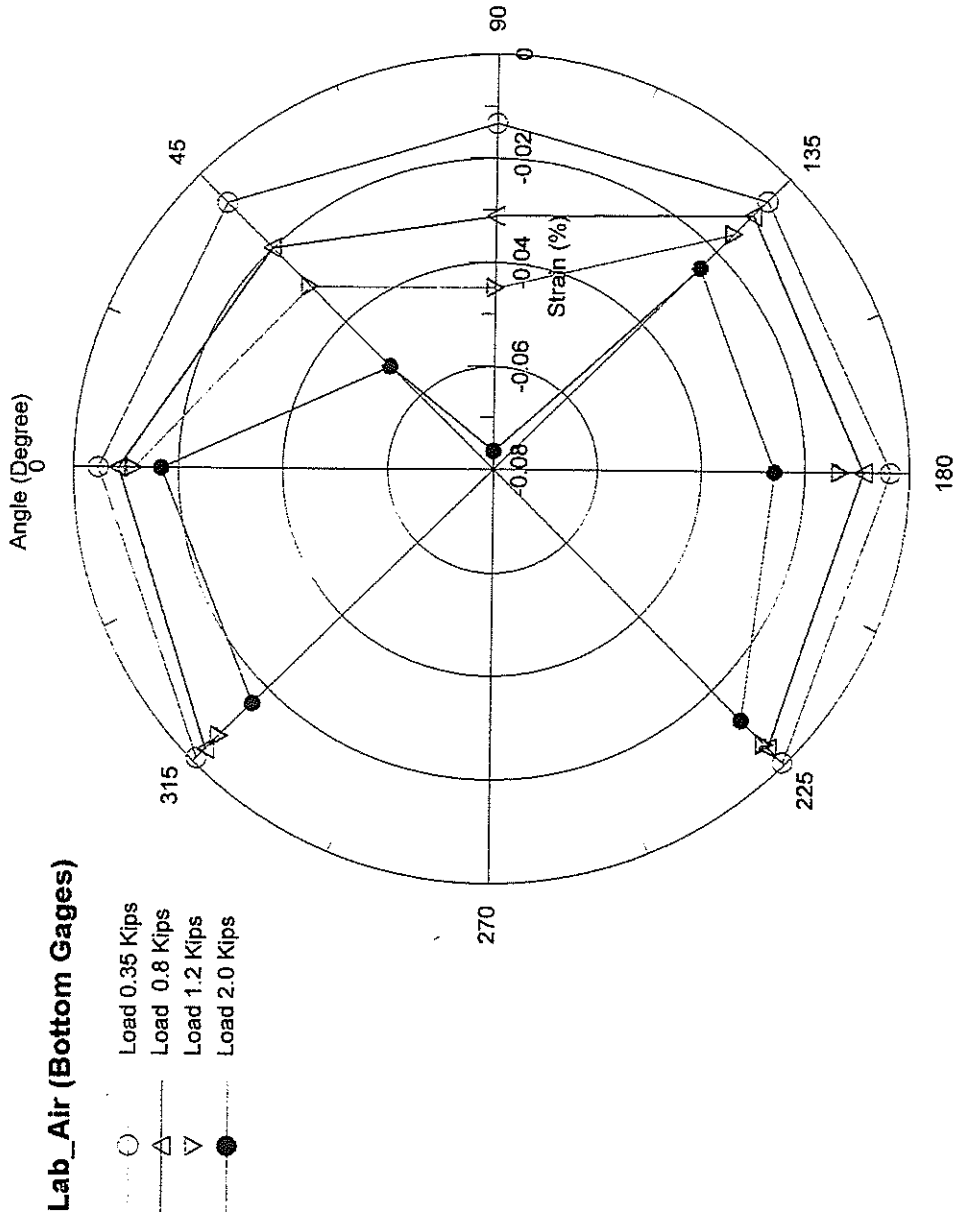
Plots of the measurements of the strain gages around the pipe cross sections are shown in figures 34 and 35 for the in-air test. The results show the measurements of the bottom and top strain gages separately. Similarly, the results of the tests in tire chips and soil-tire mix are shown in figures 36 to 39.

Figure 34. Strain measurements in bottom gages in in-air test

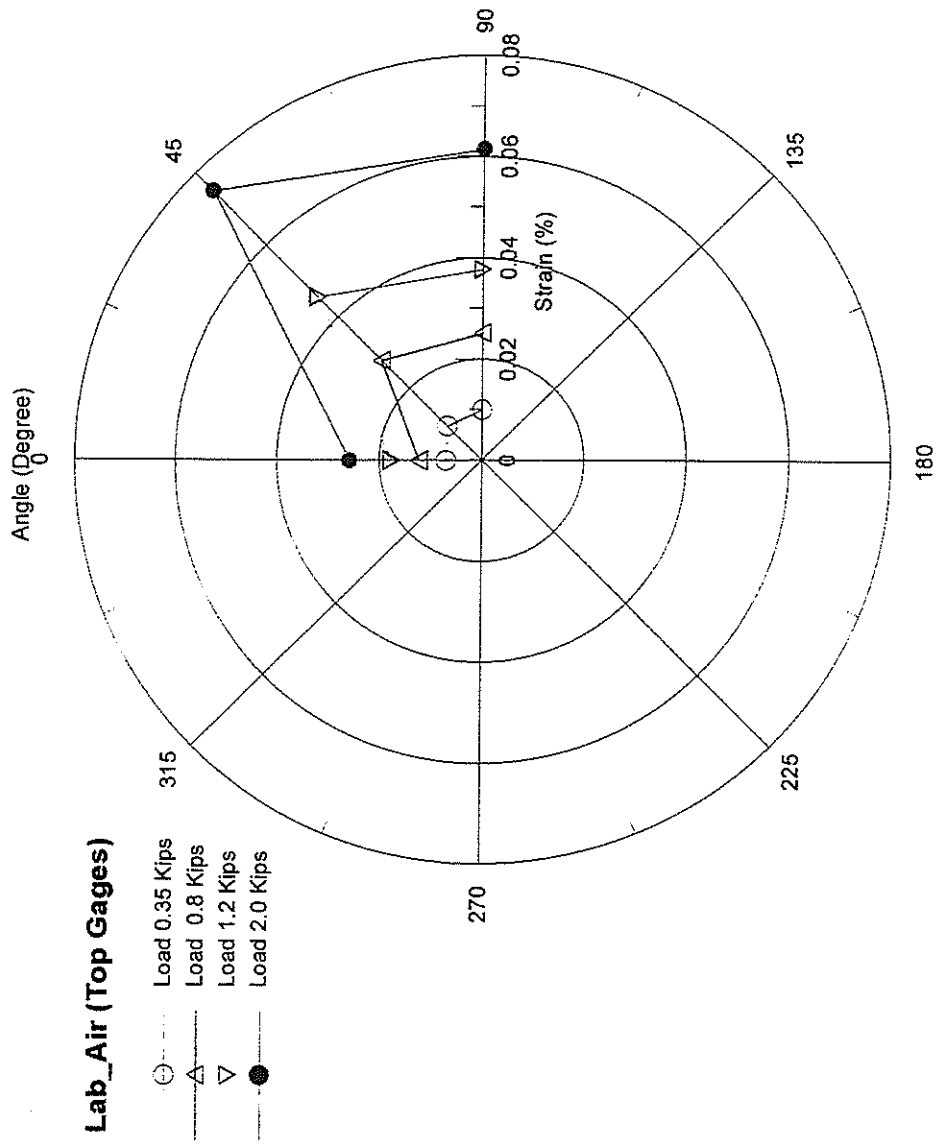
Figure 35. Strain measurements of top gages in in-air test

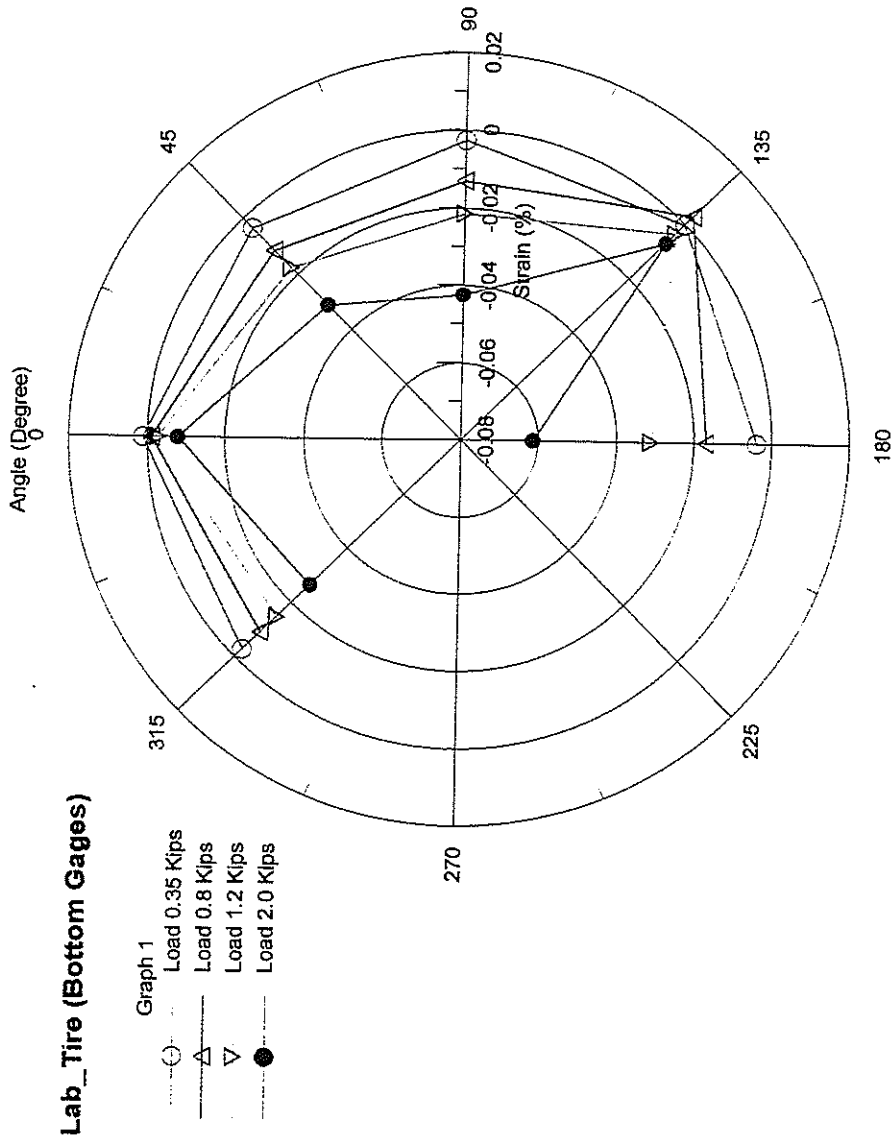
Figure 36. Strain measurements of bottom gages in tire fill

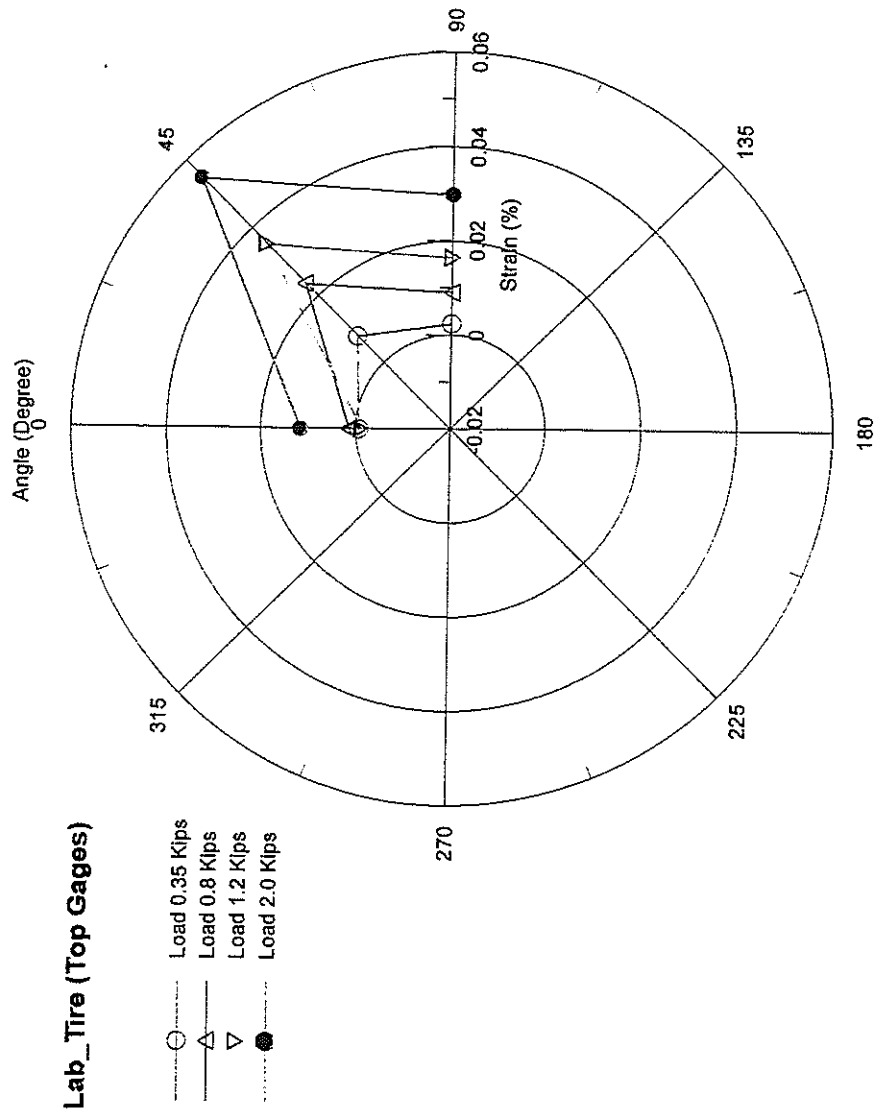
Figure 37. Strain measurements of top gages in tire fill

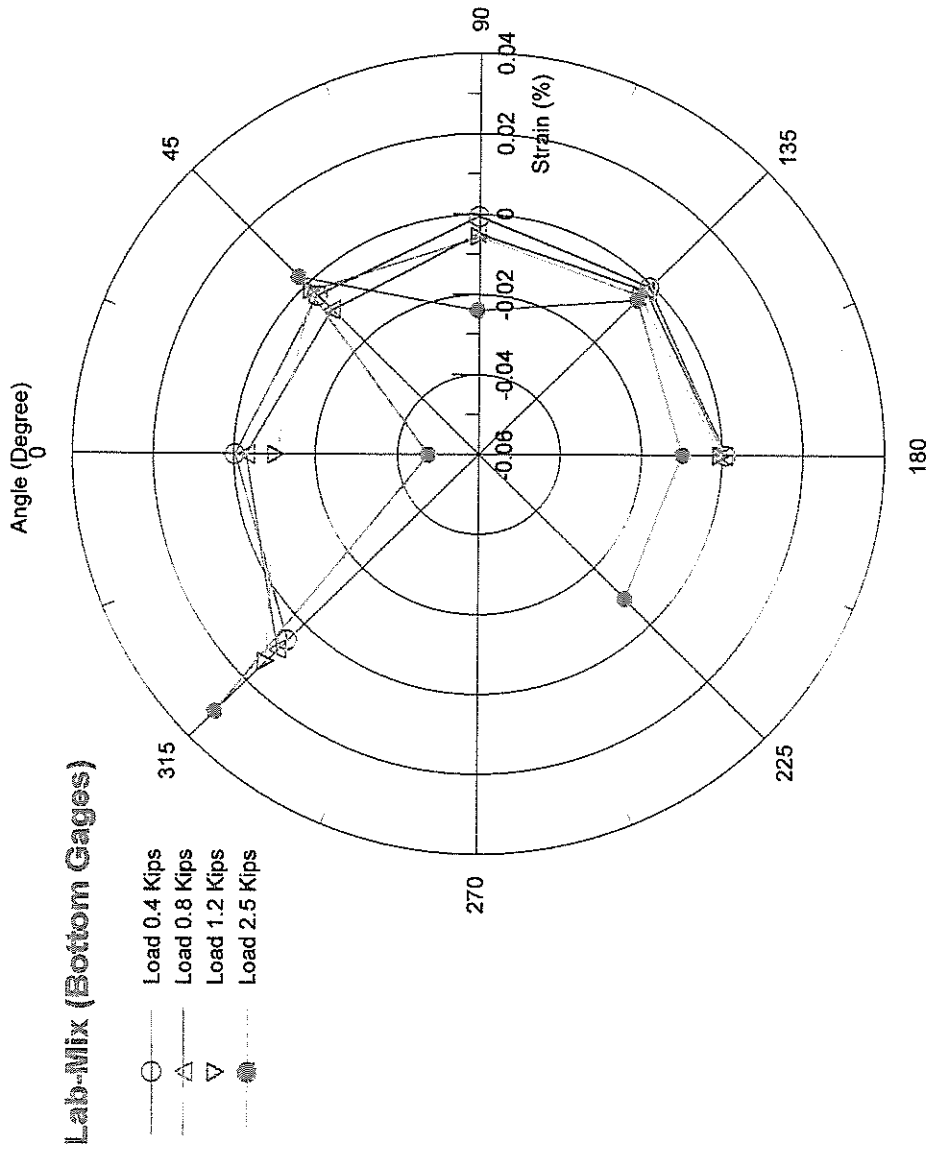
Figure 38. Strain measurements of bottom gages in soil-fire mix

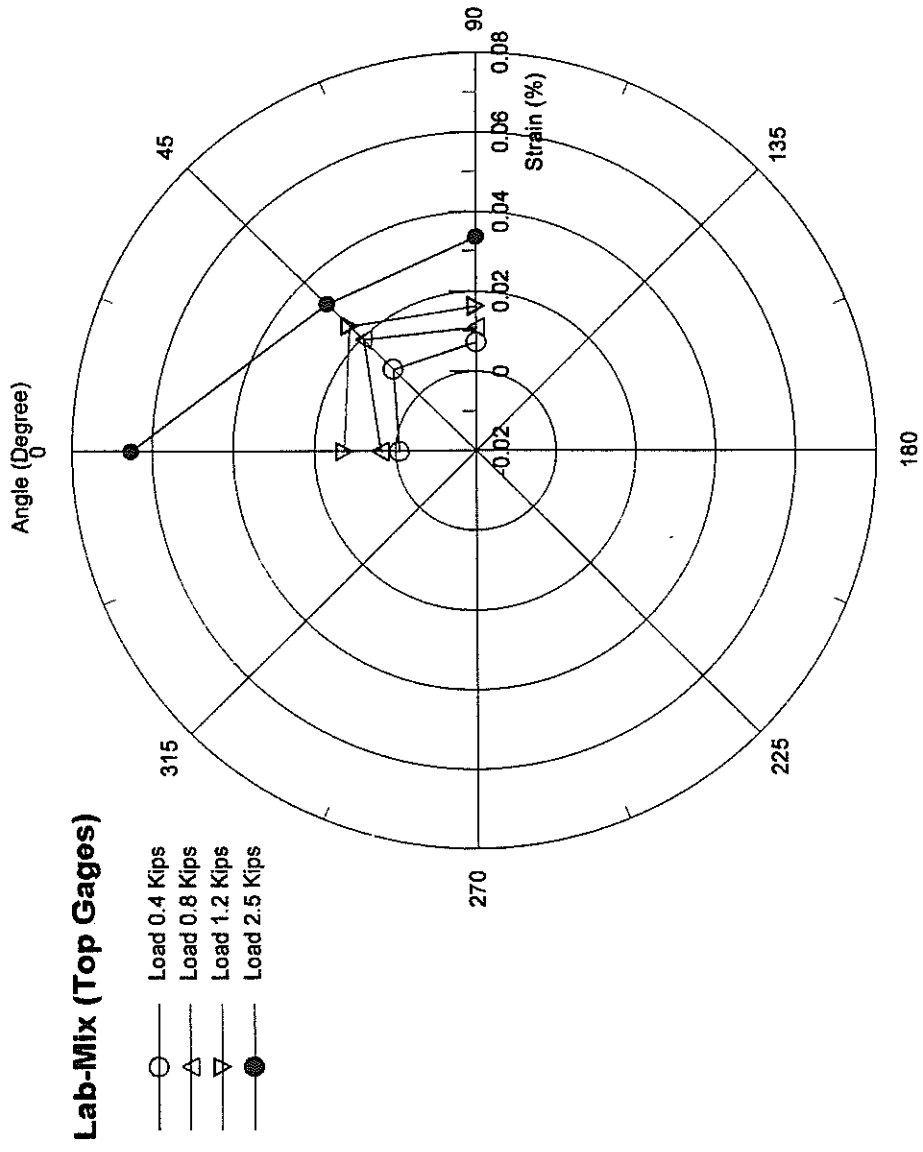
Figure 39. Strain measurements of top gages in soil-tire mix

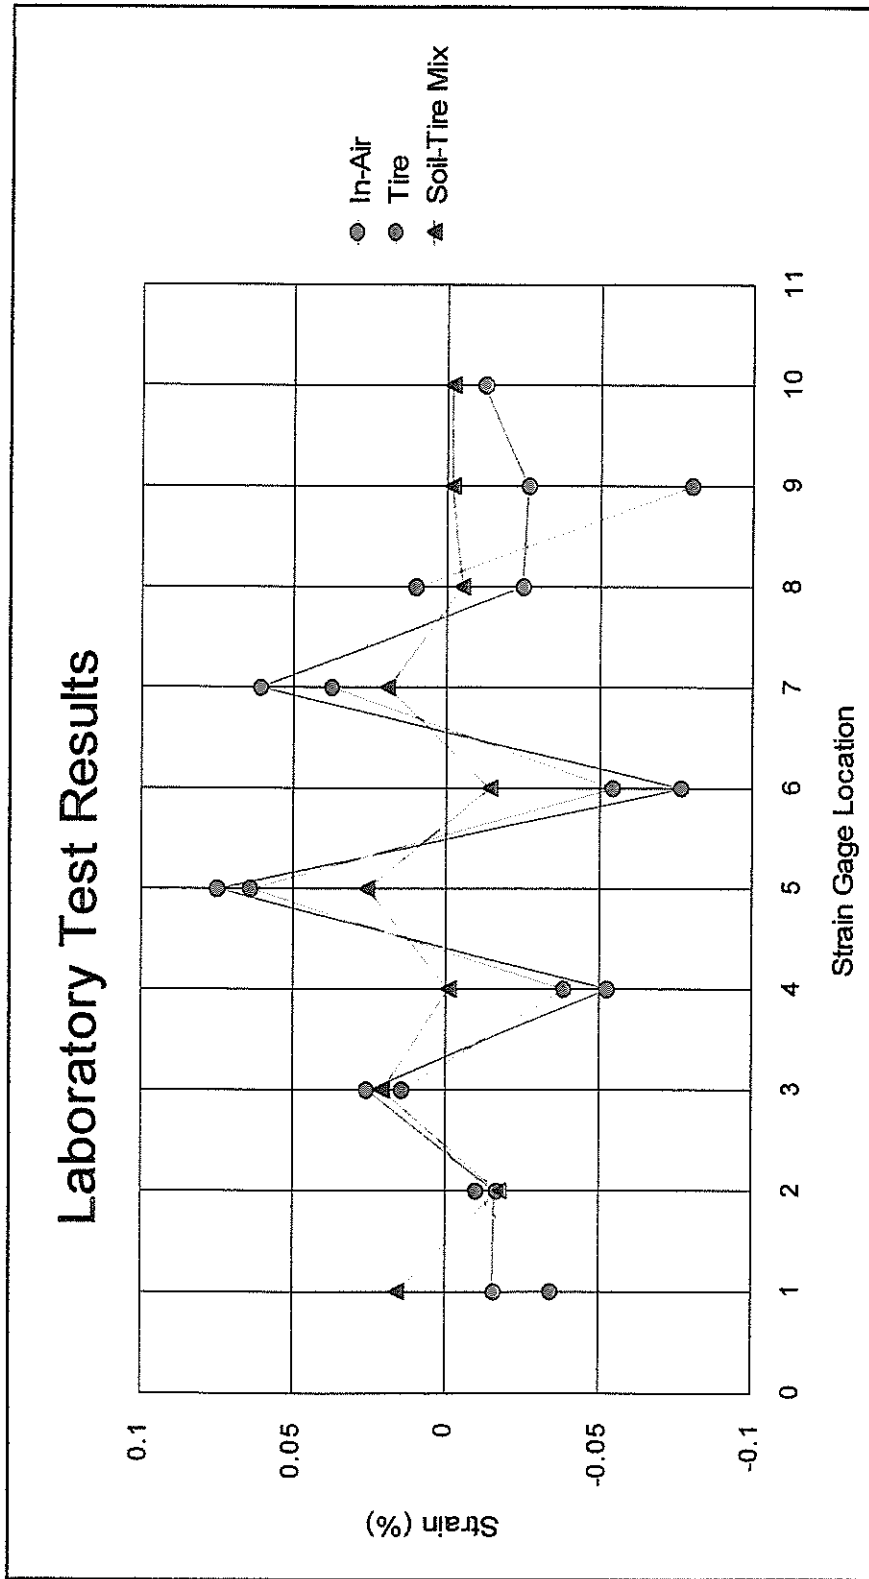
A comparison of the measurements of the strain gages in the laboratory tests is shown in figure 40. The figure shows the strain gages measurements at each gage location. The LVDT's measurements of the vertical deformation at the top of the pipe are shown in figure 41. The results of the laboratory tests show that pipe deformation in tire chips backfill is comparable to its deformation in the air. Furthermore, field tests demonstrated that the state of stresses in the pipe cross-section in tire chips is fundamentally different than those in soil and in soil-tire mix.

Figure 40. Comparison of strain gages measurements in the laboratory

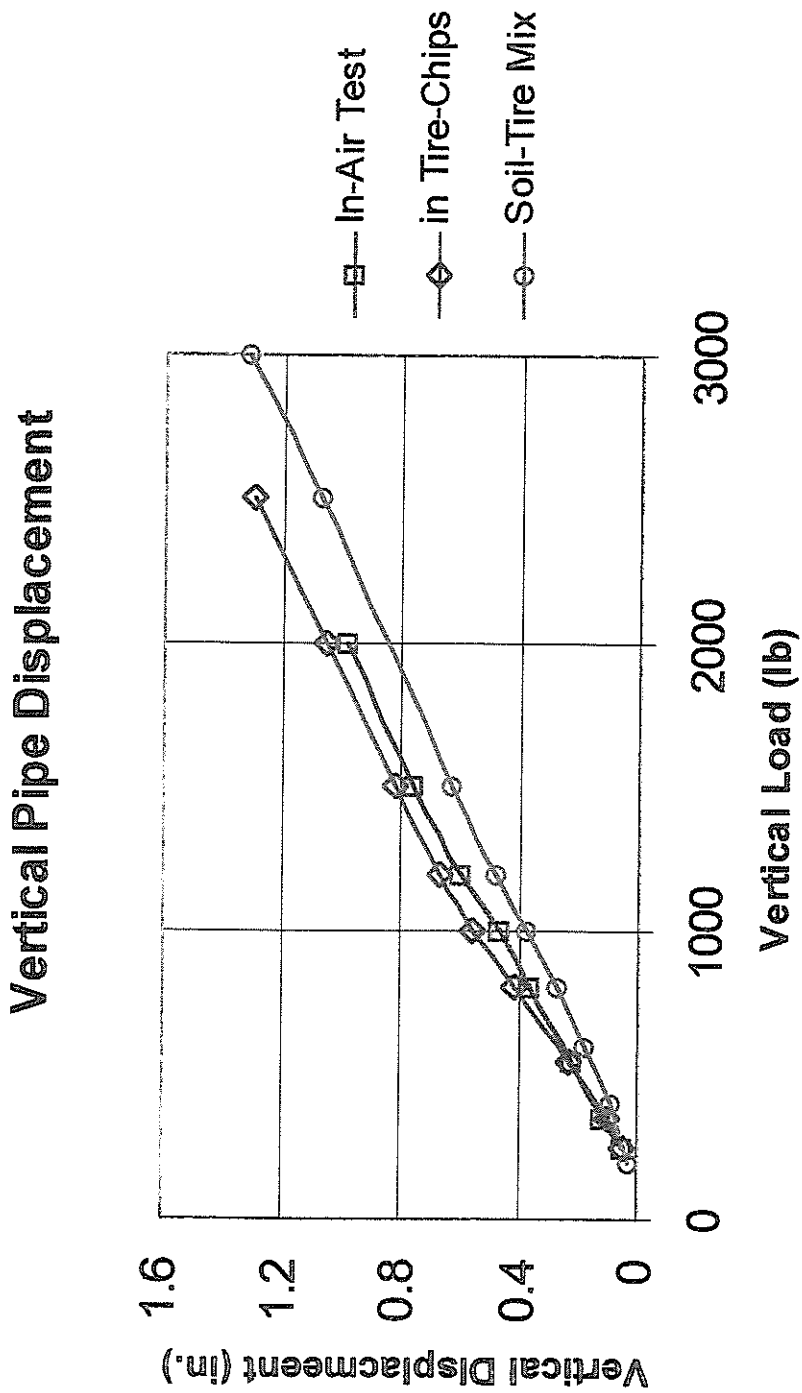
Figure 41. Measurements of vertical pipe displacement by the LVDT

The hydraulic loading frame applied the incremental vertical loads on a steel plate placed with a wooden cushion on the top of the pipe. The cushion applied the load on a distributed area of 1 m (3 ft) long and 0.6 m (2 ft) wide. A linear Variable Differential Transducer (LVDT) was installed on the loading frame to monitor the vertical pipe deformation. Strain gages were installed on the metal pipe in similar locations to the ones in the field. Figure 31 shows a schematic diagram of the locations of the strain gages in the pipe. It should be noted that the loading mechanism and the boundary conditions of the setup in the laboratory are different than the conditions associated with the tests in the field. For this reason, no comparison was attempted to relate the deformation measurements in the lab to the ones in the field.

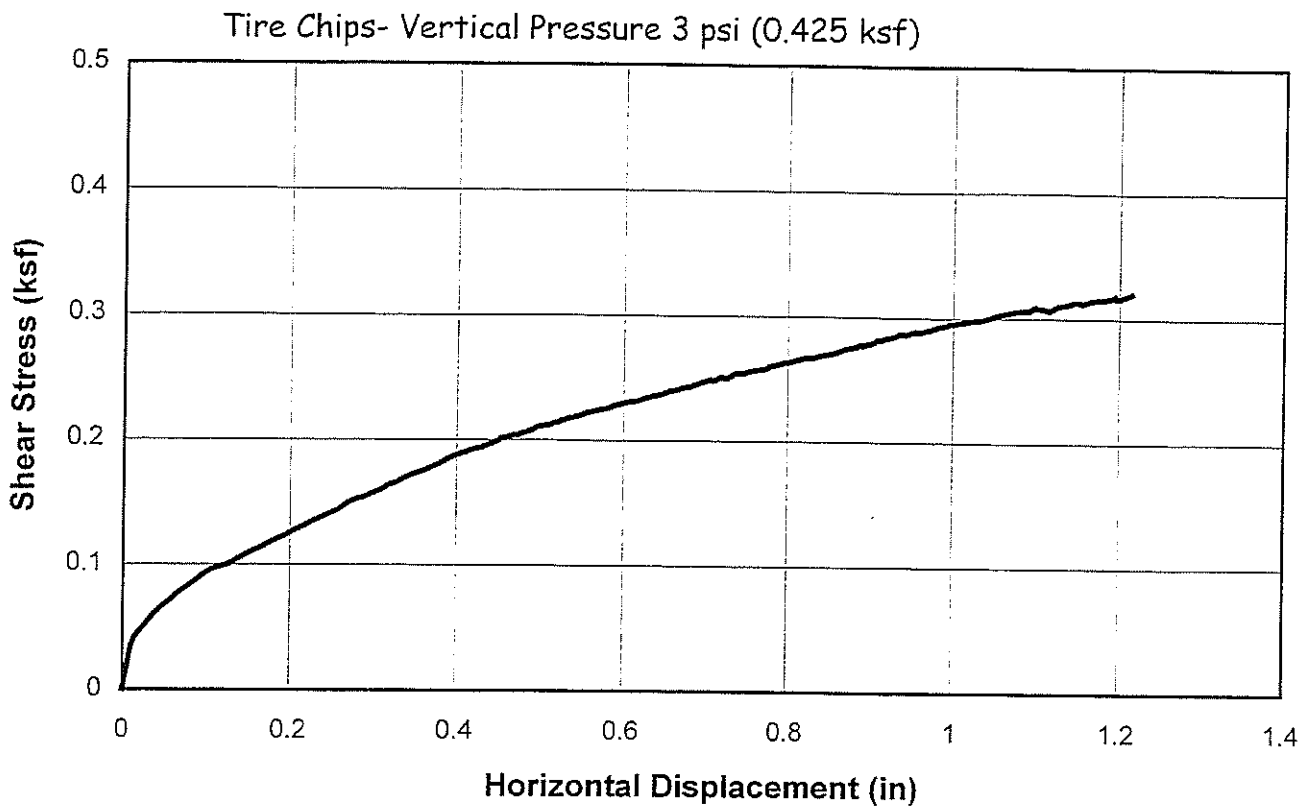
Figure A-1 Direct shear test on tire chips

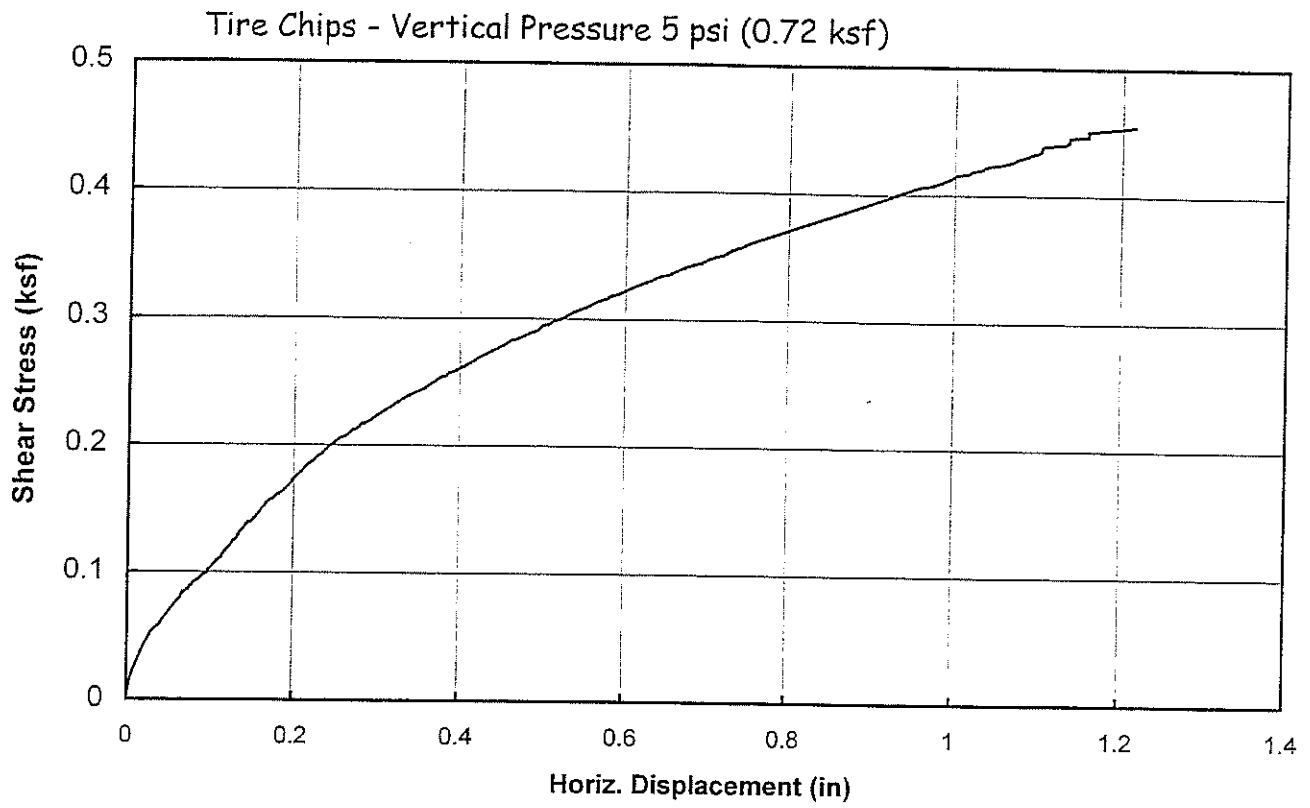
Figure A-2 Direct shear tests on tire chips
