**Louisiana Transportation Research
Technical Assistance Report
Report No. 19**

***Evaluation of the Use of Shredded
Tires Around Buried Pipes***

Technical Assistance Report Number 19

May 1999

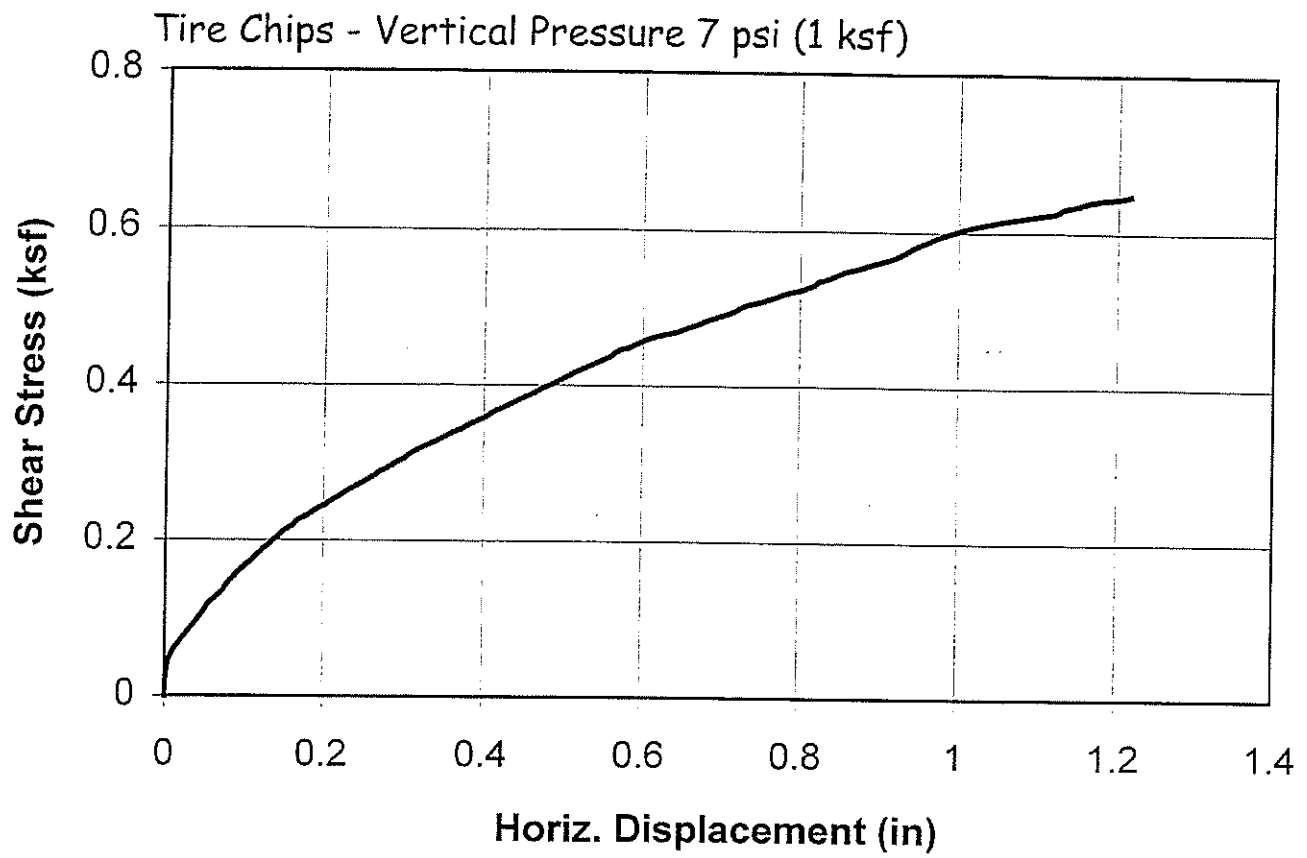
Figure A-3 Direct shear test on tire chips

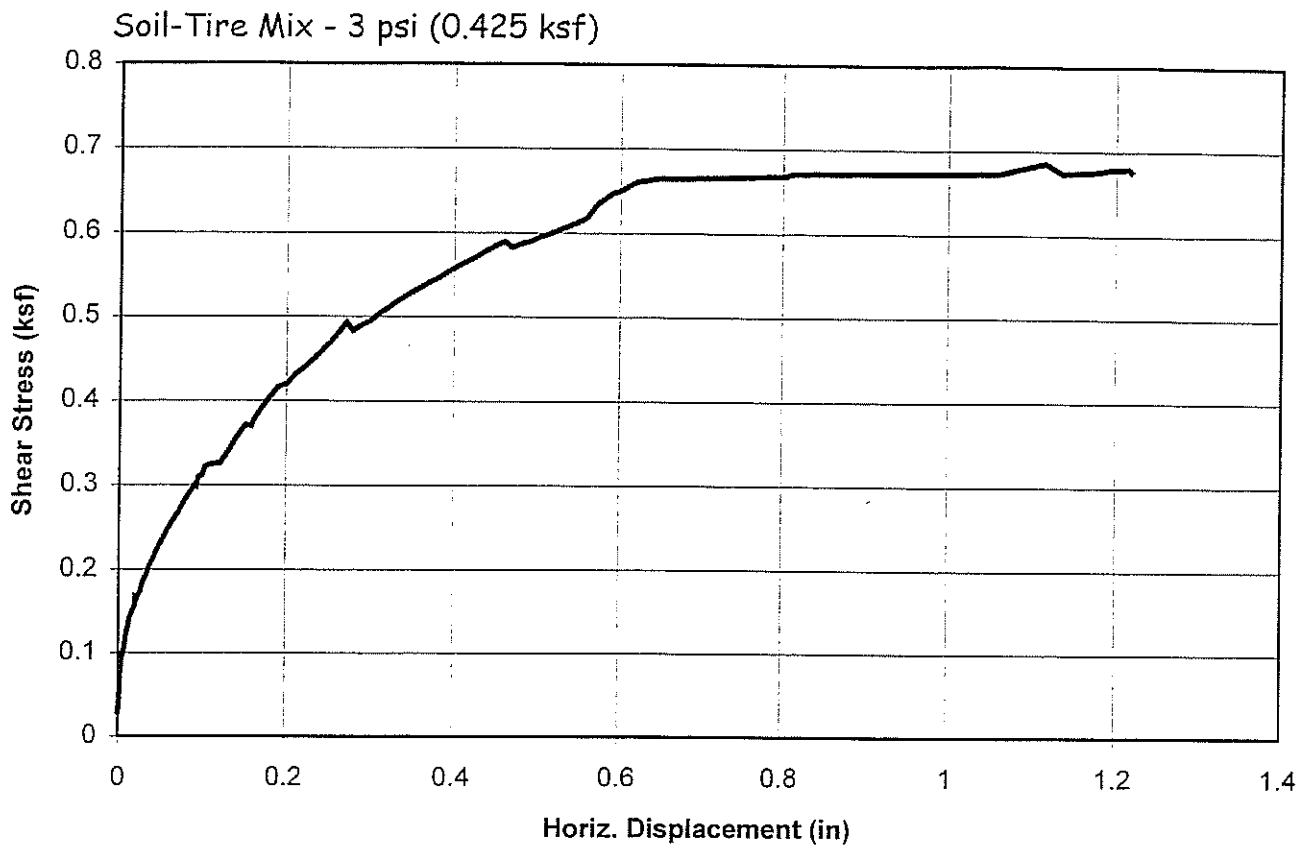
Figure A-4 Direct shear test on soil-tire mix

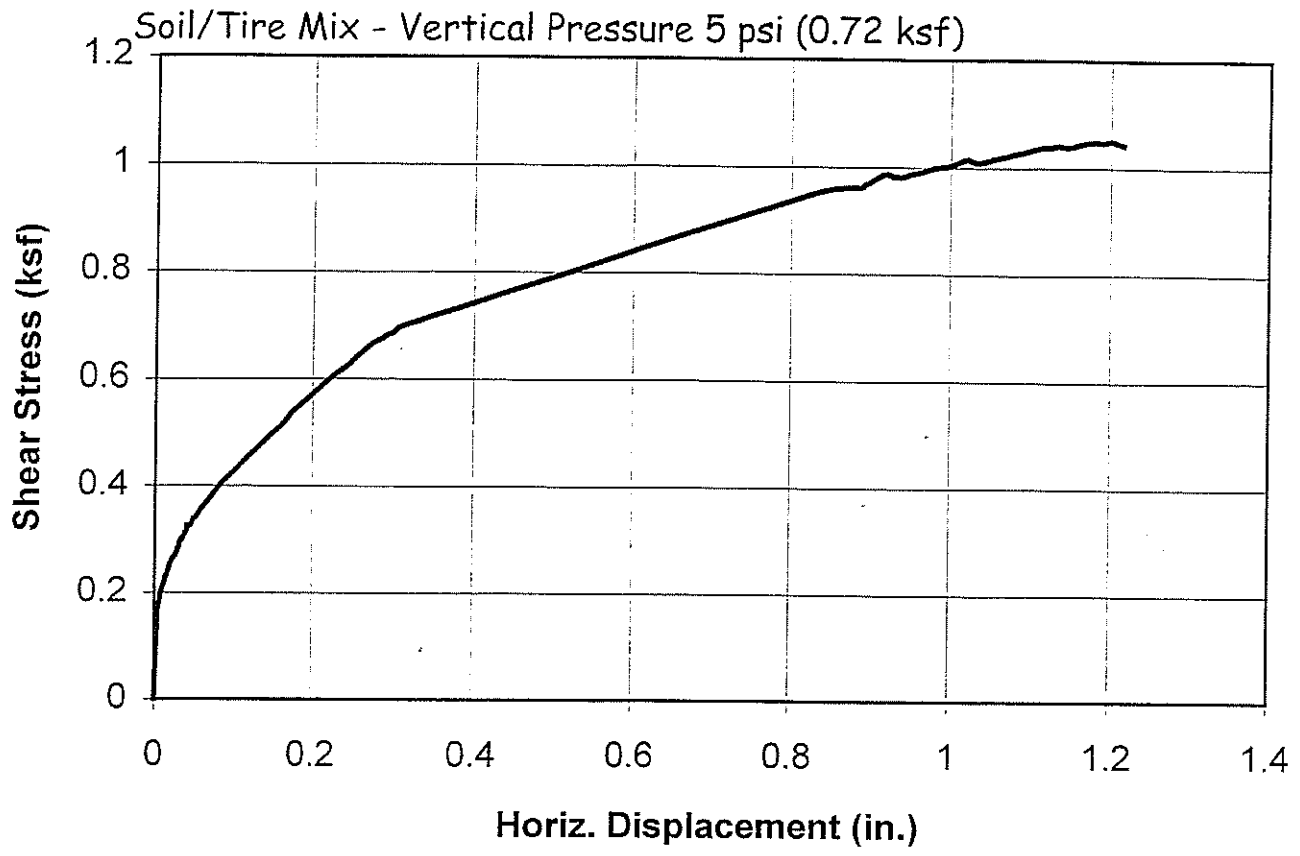
Figure A-5 Direct shear test on soil-tire mix

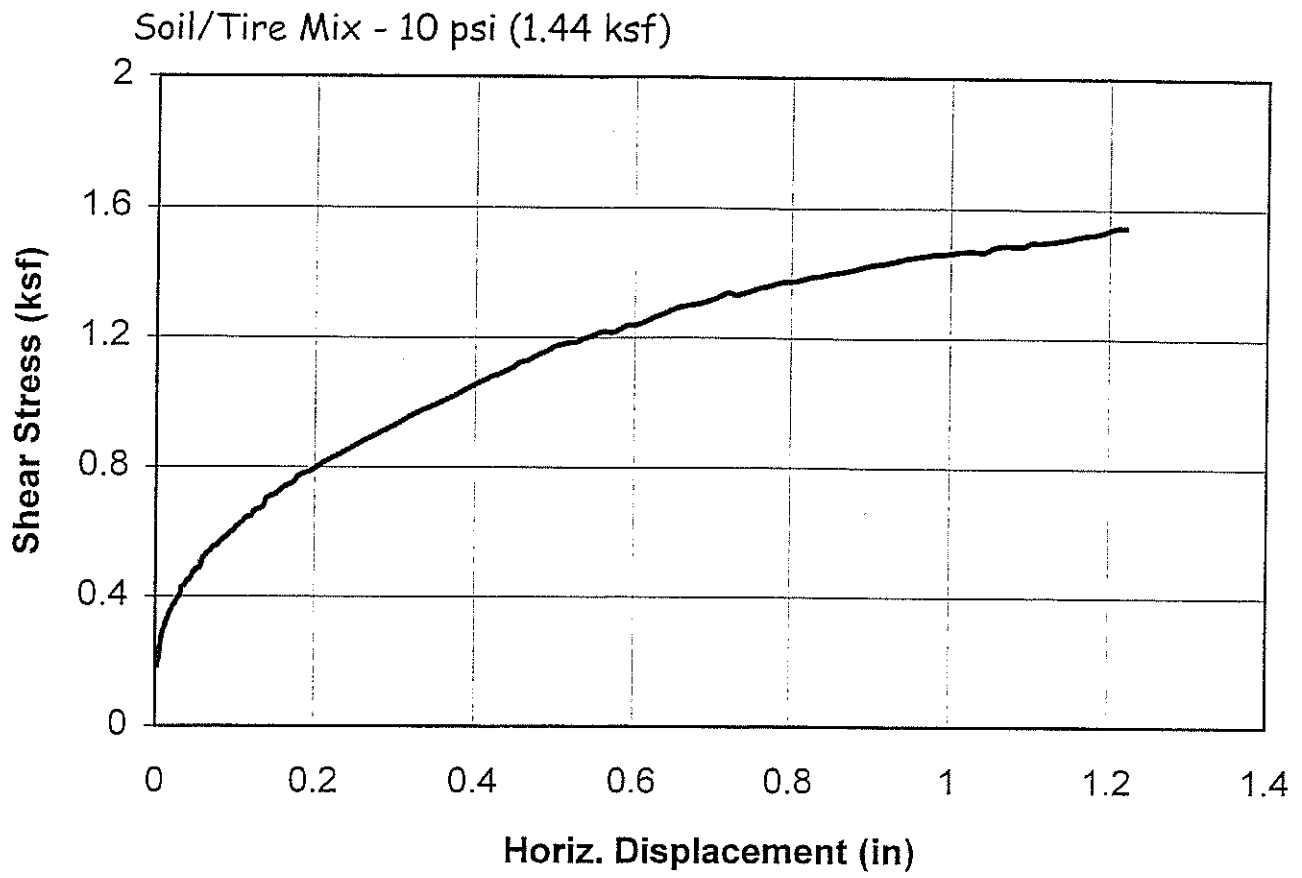
Figure A-6 Direct shear test on soil-tire mix

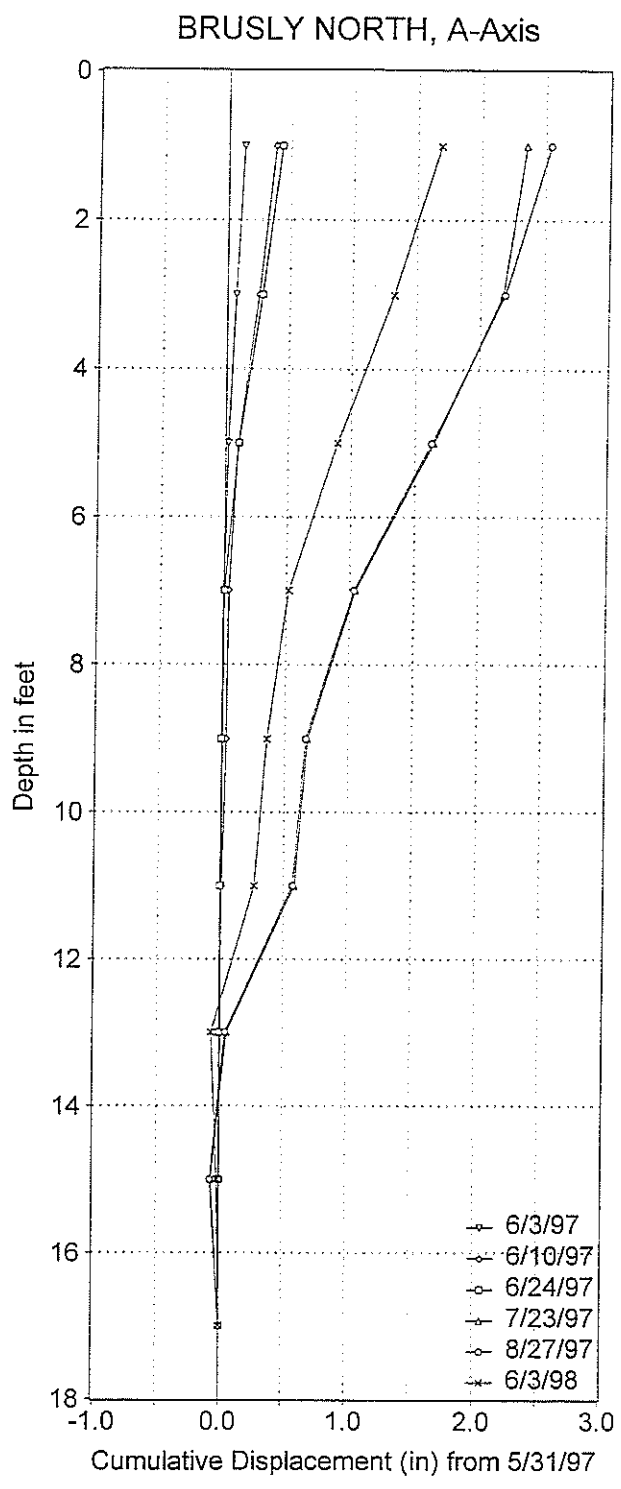
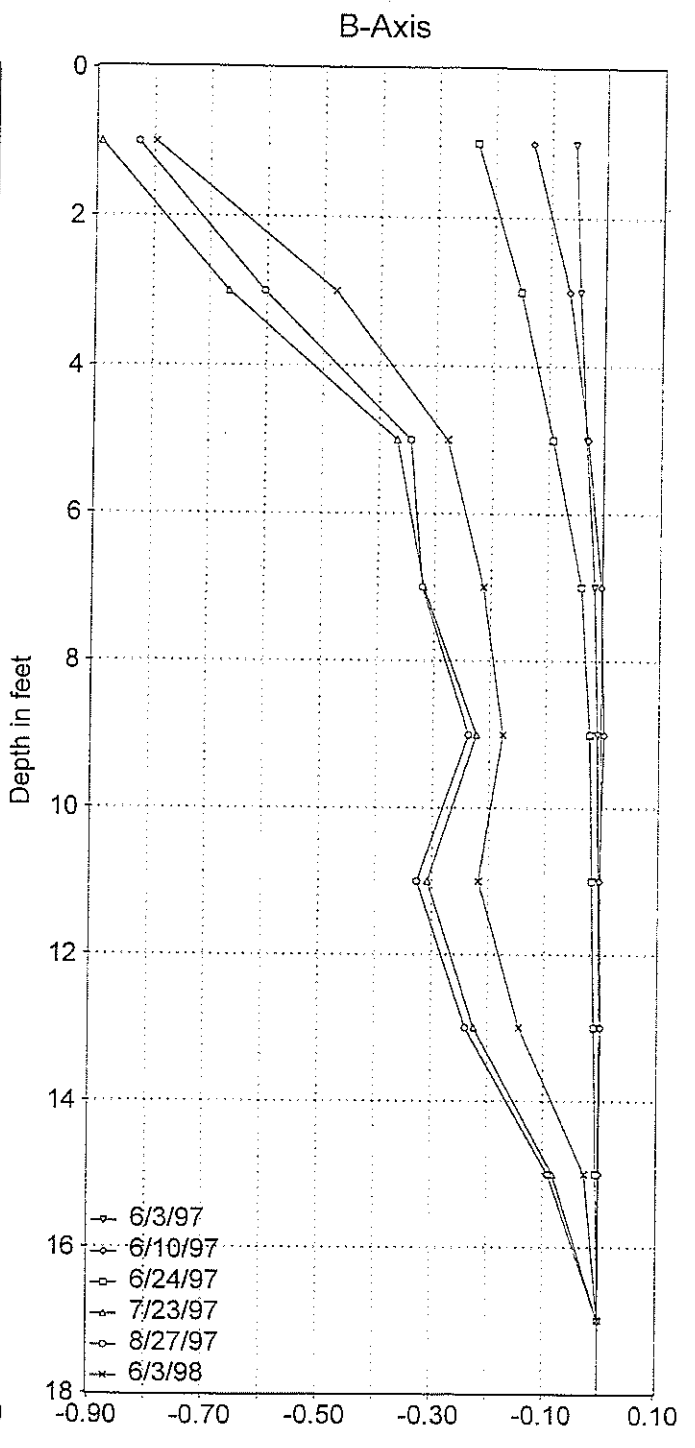
Figure B-1 Vertical inclinometer readings in tire-section

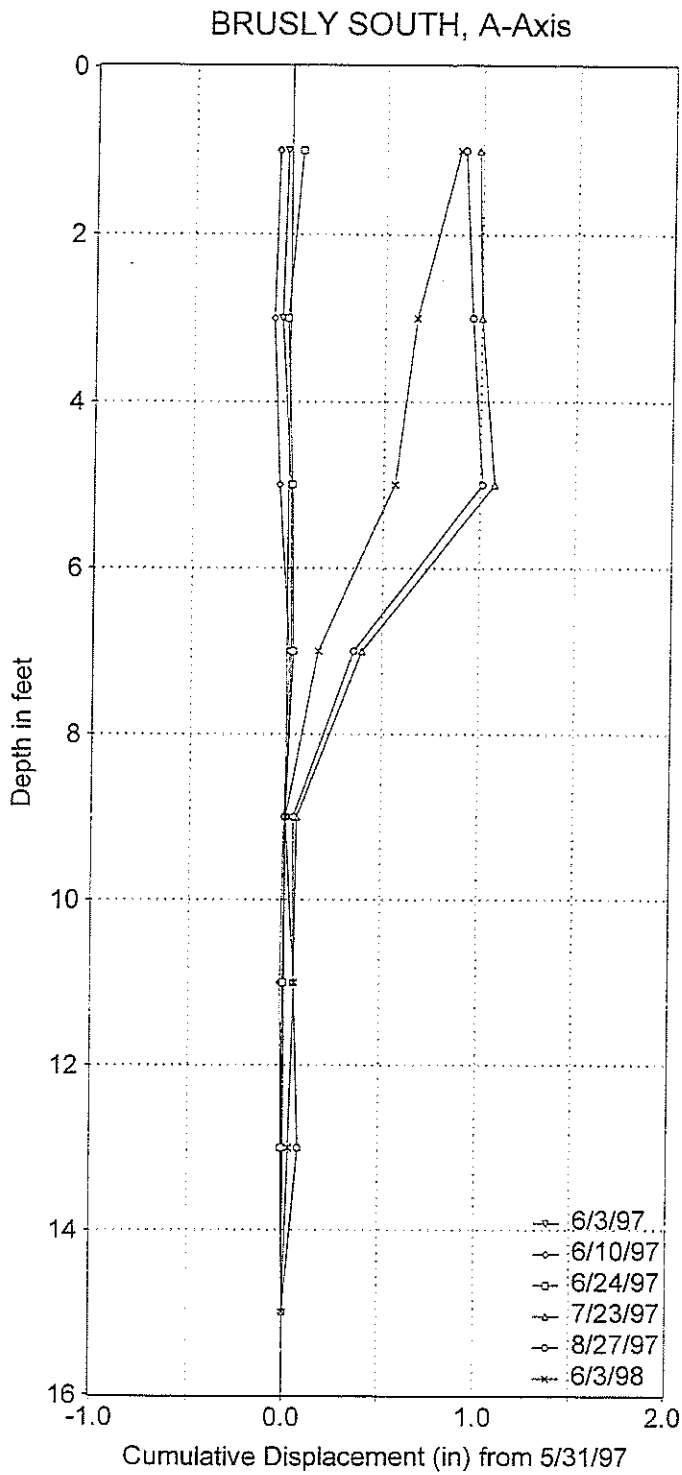
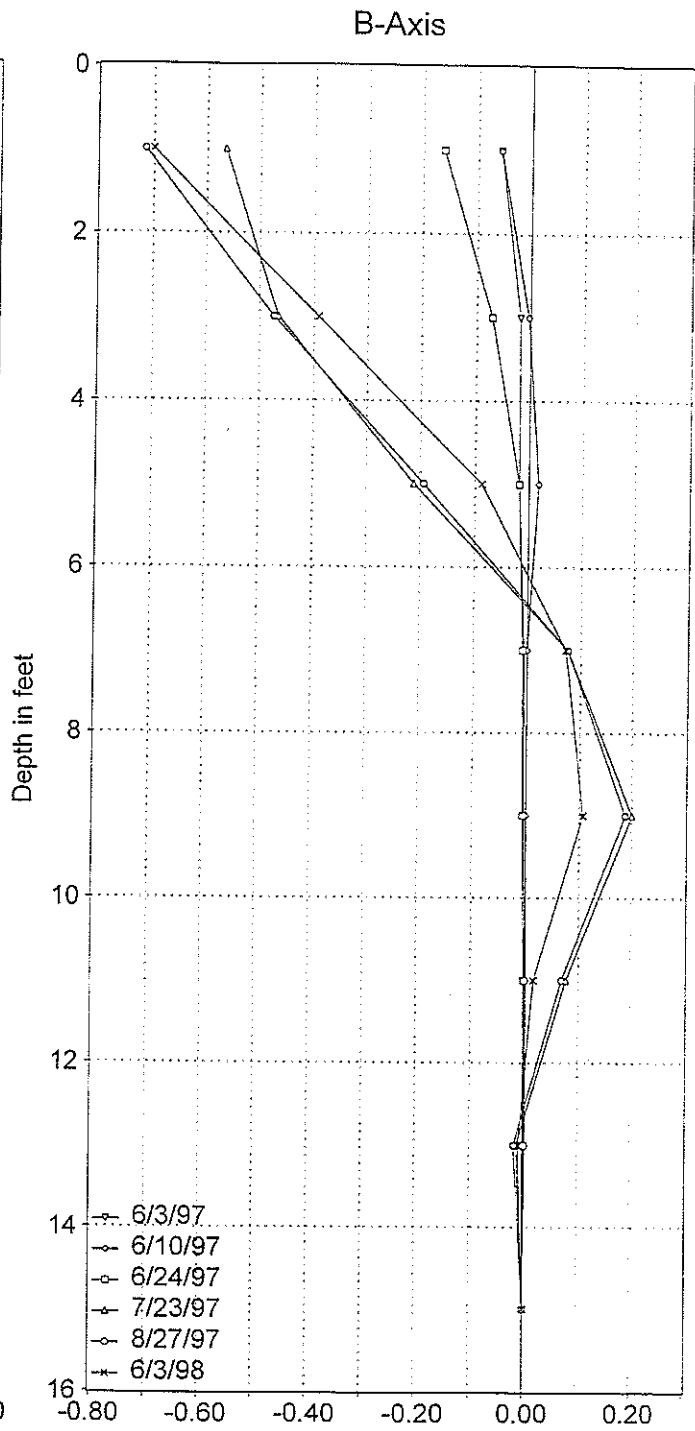
Figure B-2 Vertical inclinometer readings in soil-tire section

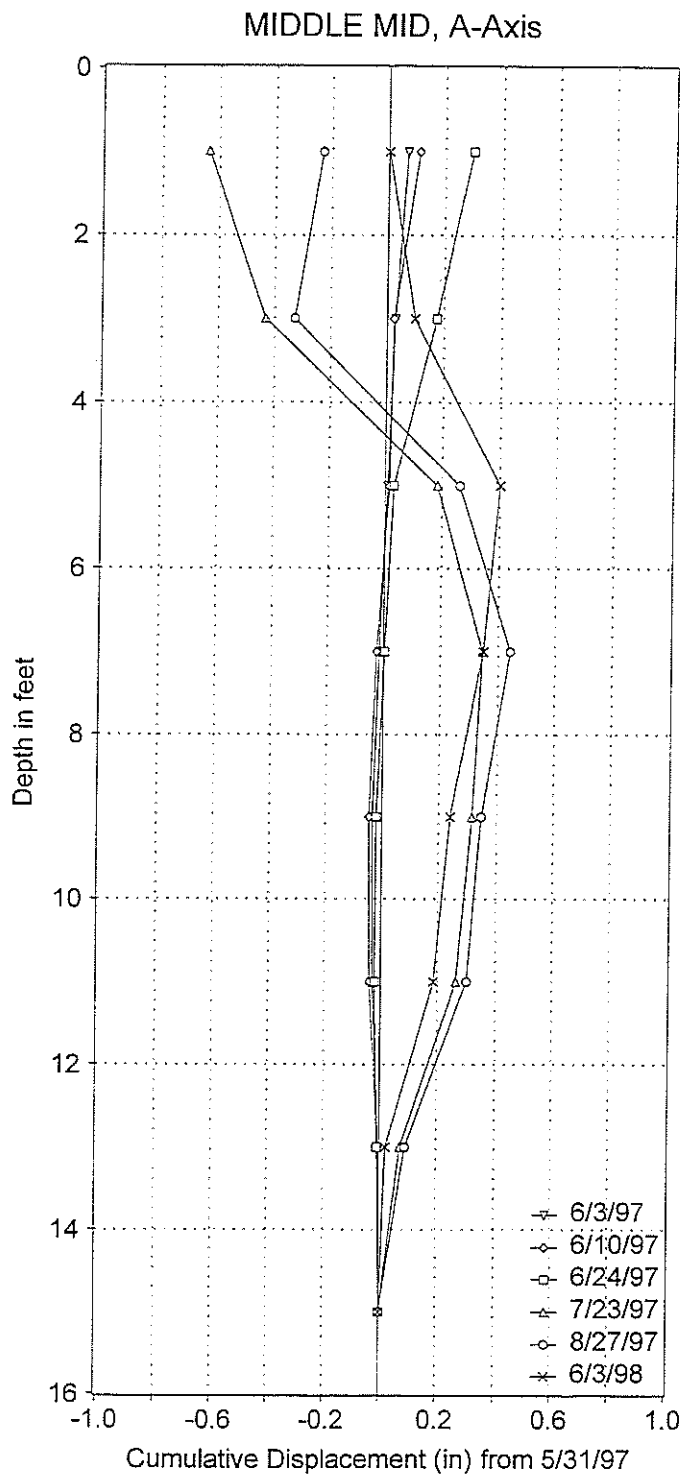
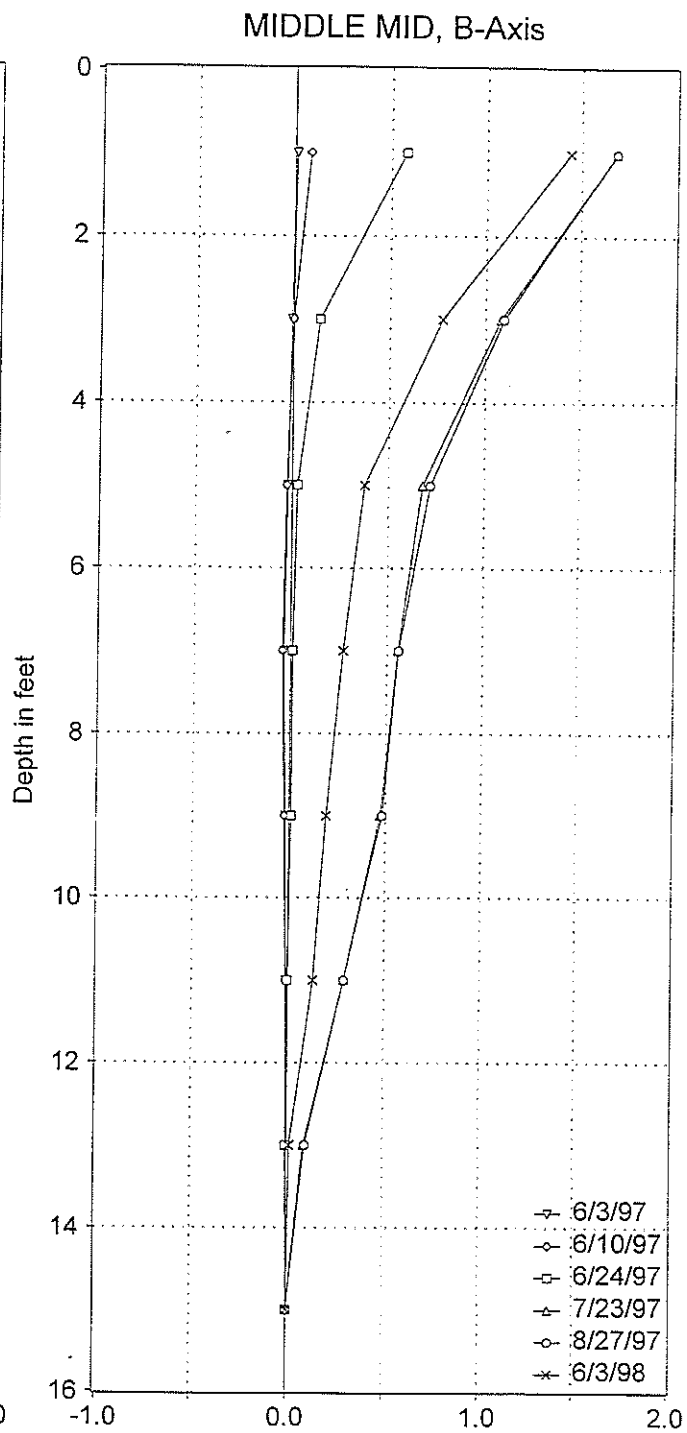
Figure B-3 Vertical Inclinometer readings in soil section

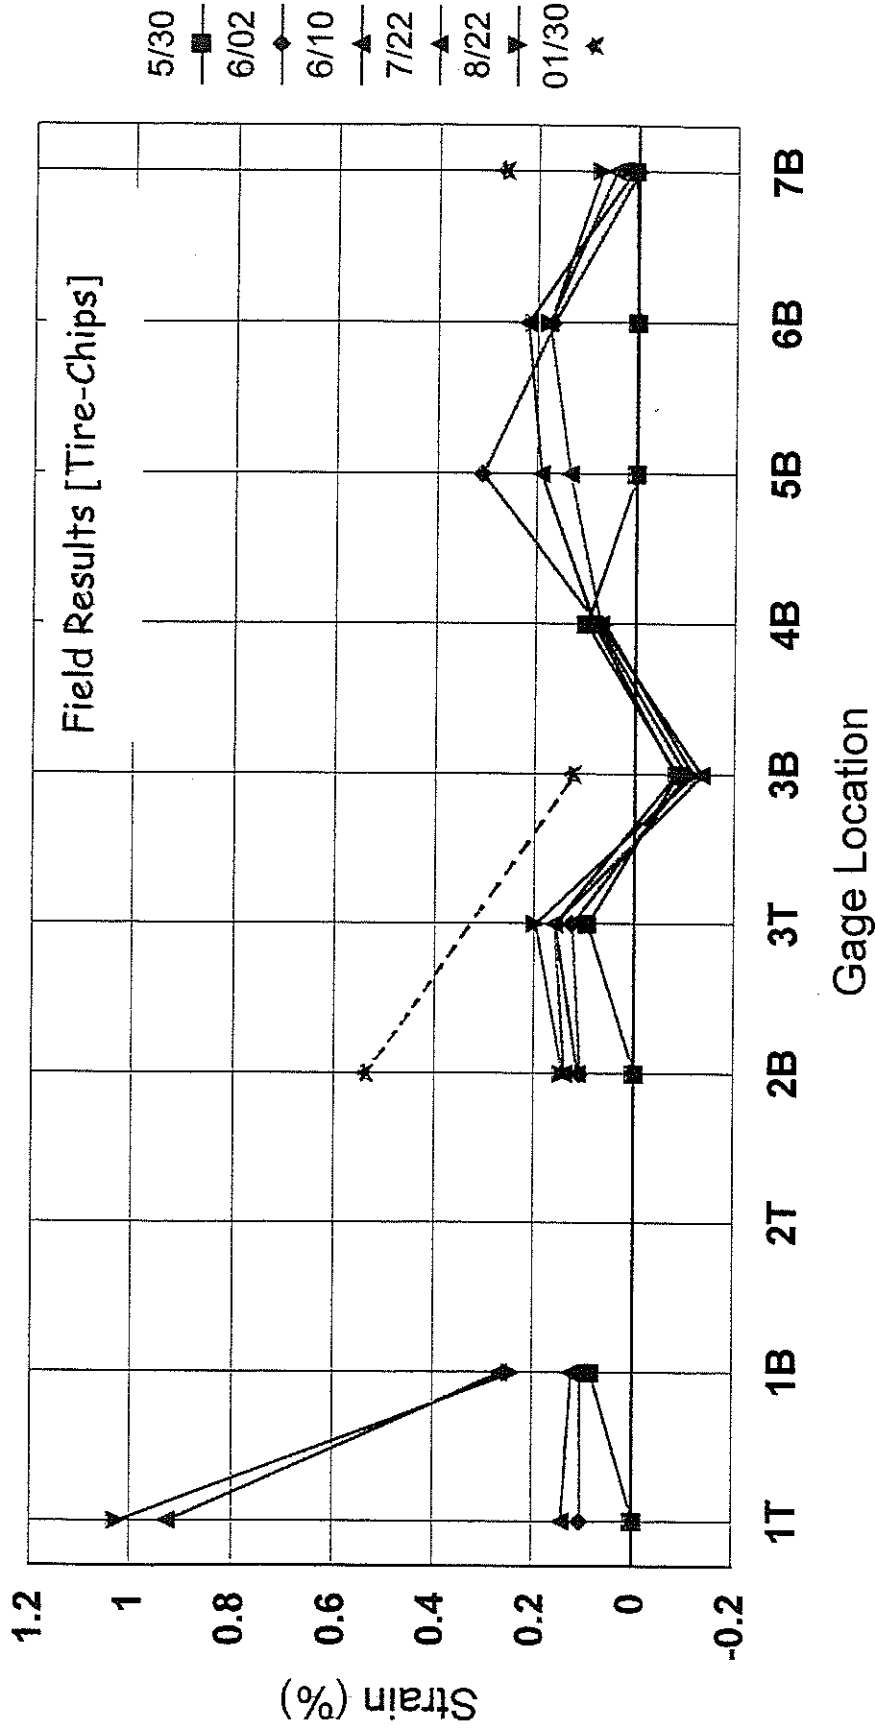
Figure B-4 Strain gage readings in tire section [see figure 14 for gage locations]

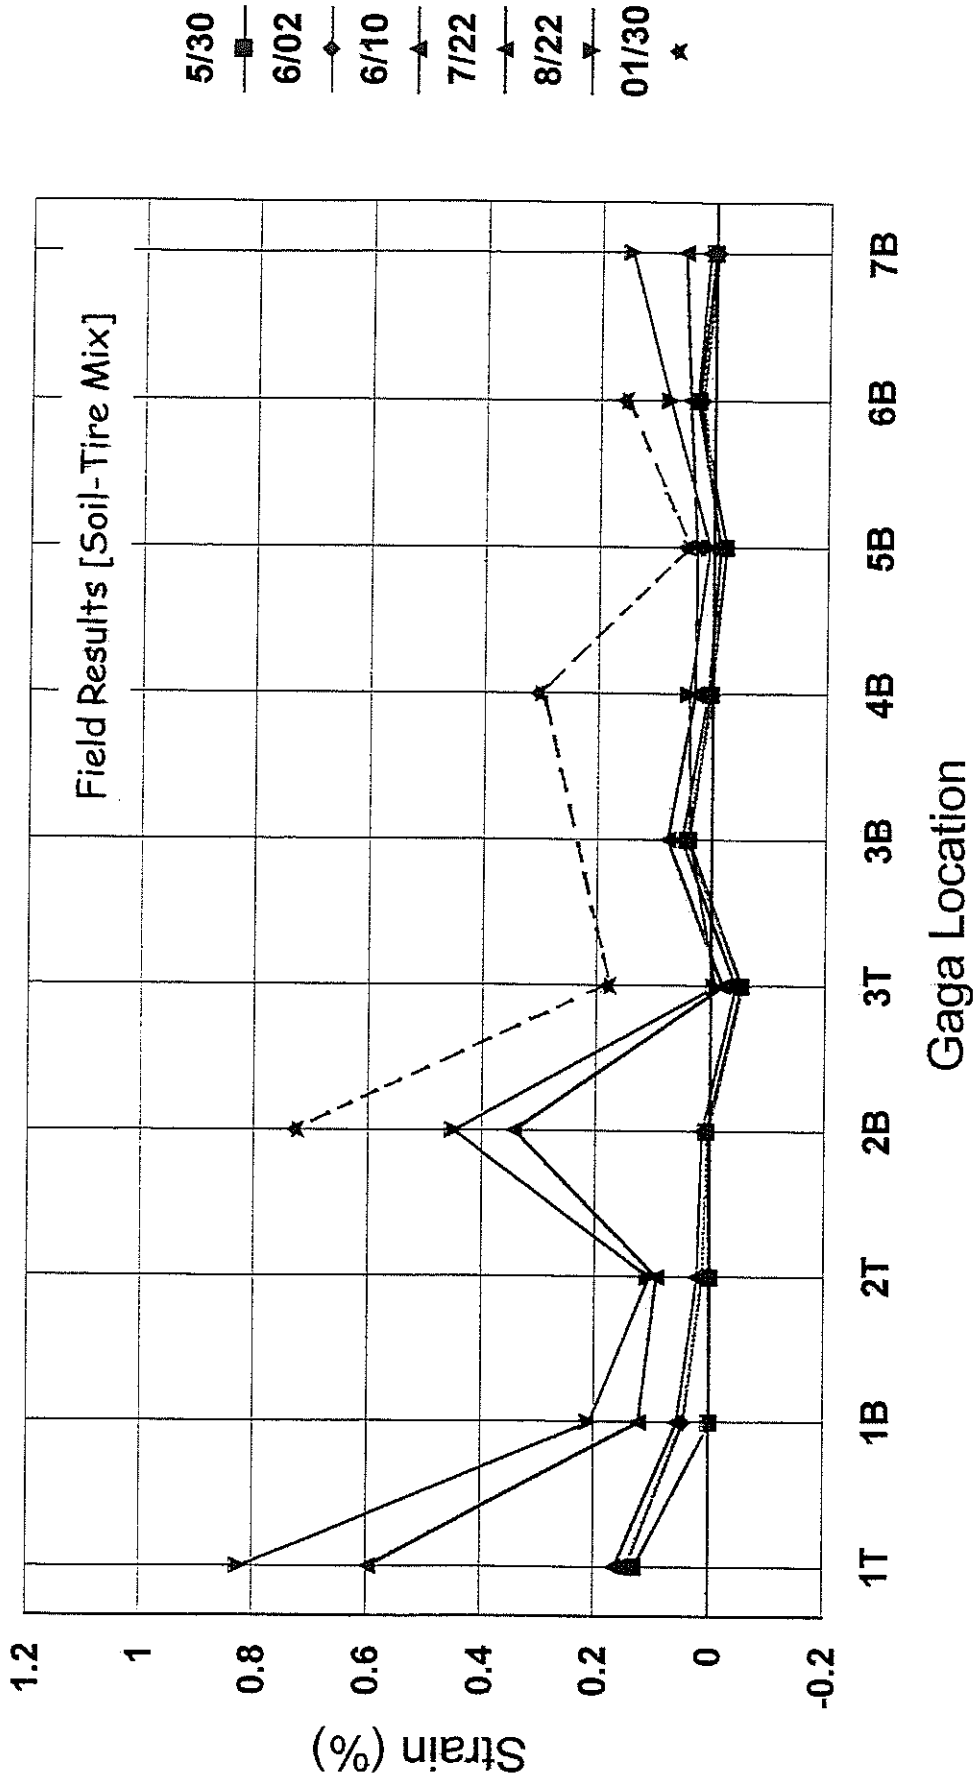
Figure B-5 Strain gage readings in soil-tire section

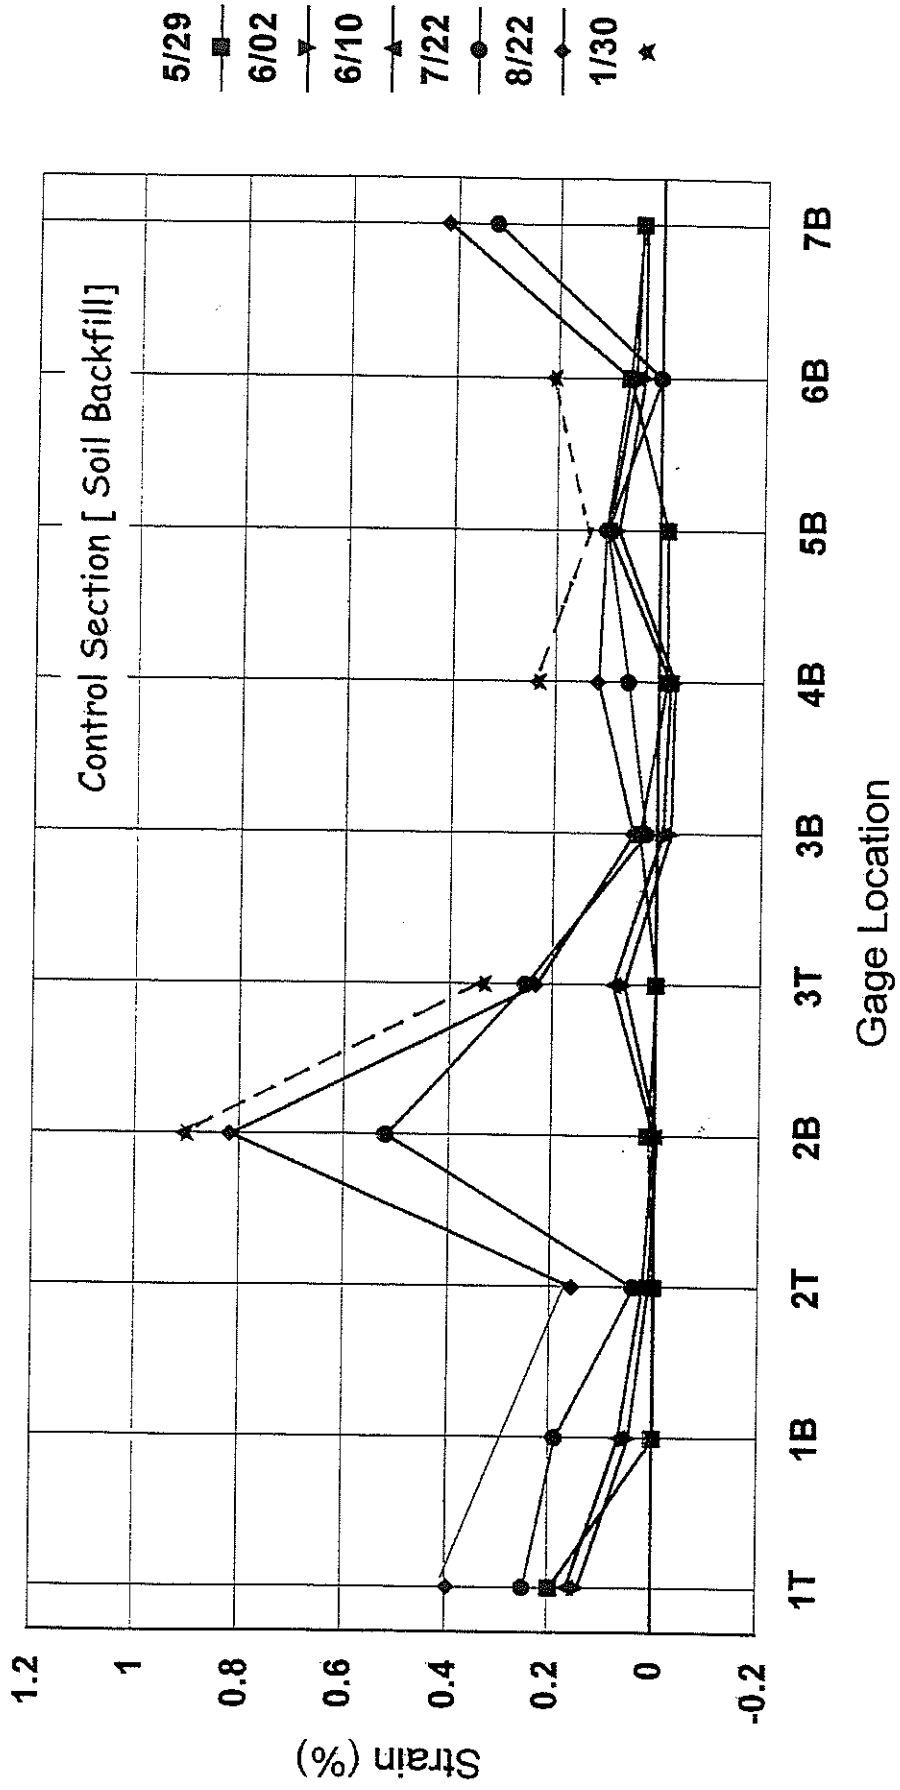
Figure B-6 Strain gage readings in soil section
