# Latex Modified Fibrous Concrete Sundial - Sandy River Section

## Interim Report

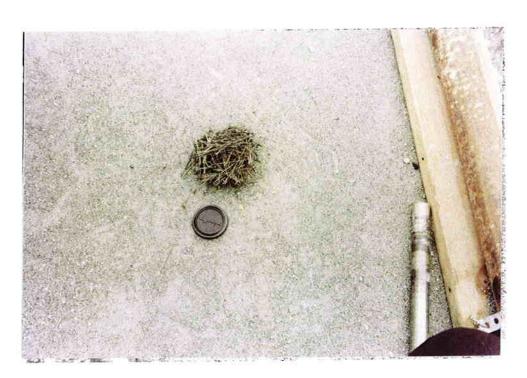
Figure 2
Close-up of steel fibers in ball.

The balling of the steel fibers was a continuous problem on all four bridge overlays but it appeared to be worst with drier mixes. Small balls of fibers and aggregate were removed from the concrete after it was deposited on the deck. In some cases the fiber balls were four inches in diameter.
