## Utility Cut Repair Research Continues

### **RESEARCH**news

**Iowa Department of Transportation**

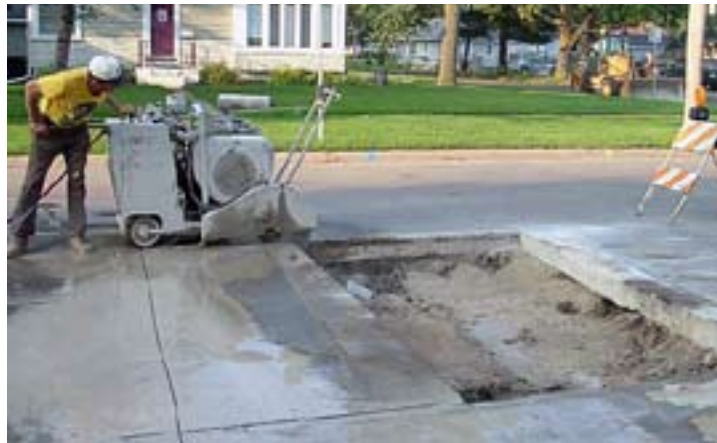
*Concrete pavement cut being made*

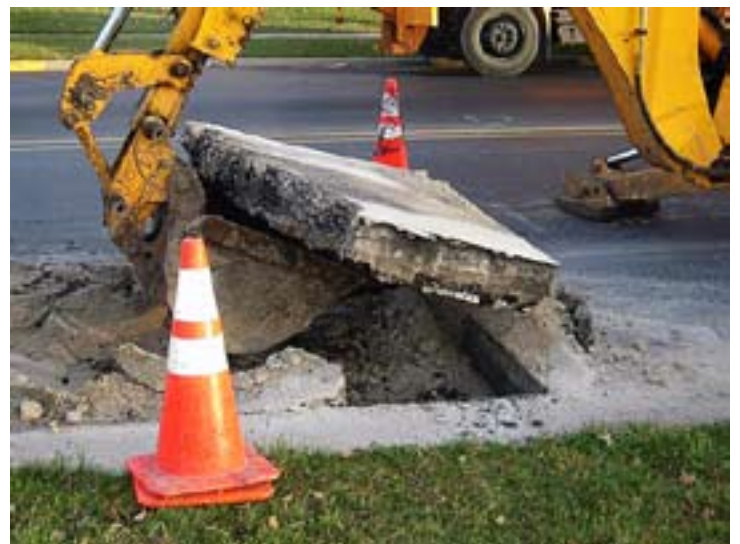
*Pavement removal*

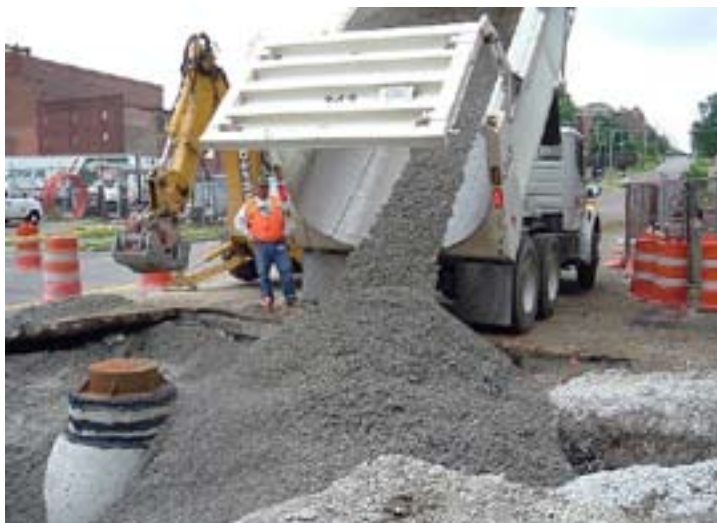
**Large backfill lift being placed**

Phase I of utility cut repair research, funded through the Iowa Highway Research Board (IHRB), consisted of both a survey of municipal authorities and field and laboratory investigations to identify factors contributing to the settlement of utility cut restorations in pavement sections. Responses received from seven cities across Iowa indicated that utility cut restorations often last less than two years. Observations made during site inspections showed that backfill material varies from one city to another, backfill-lift thickness often exceeds 12 inches and backfill material is often placed at
