| 1. Report No. FHWA/TX-12/5-4577-05-1 | 2. Government Accession No. | 3. Recipient's Catalog No. | | |
|---|---|--|--|--|
| 4. Title and Subtitle STATEWIDE IMPLEMENTATION OF PAVE-IR IN THE TEXAS DEPARTMENT OF TRANSPORTATION | | 5. Report Date September 2011 Published: February 2012 6. Performing Organization Code | | |

Project Title: State-Wide Implementation of Pave-IR into HMA QC/QA

Report 5-4577-05-1 Project 5-4577-05 Project Title: State-Wide Implementation of Pave-IR into HMA QC/QA

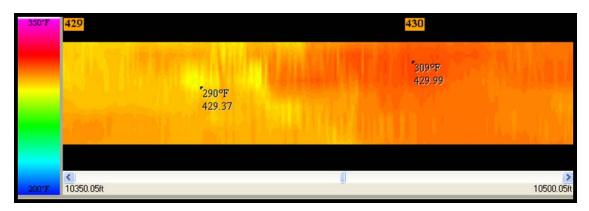
Figure 2. Typical Profile without Thermal Segregation on IH 35 SBIL.

Note: Profile 70 shown.

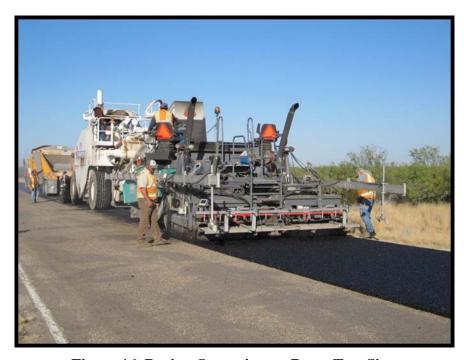
The contractor used tarped belly dump trucks to haul the mix from Midland to the job site, resulting in a haul distance of approximately 100 miles. At the job site, a Roadtec Shuttle Buggy SB 2500D transferred the windrows to a Vogele Vision 5203 paver. Figure 16 shows the paving operation.

Figure 16. Paving Operation on Pecos Test Sites.

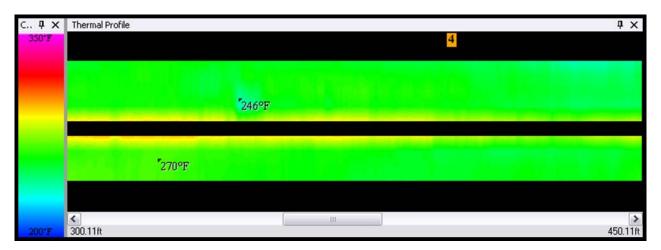
Figure 17 shows a representative profile from the SMA with Hoban aggregate where the temperature differential barely exceeds the 25°F threshold. Figure 18 presents an example profile from the SMA with Eastland aggregate, which typically did not exhibit any thermal segregation. In both of these figures, the black horizontal line surrounded by red feathering near the center of the plots is due to sensor 7; that sensor received damage in transit to the job site and was providing bad data; sensor 7 was therefore ignored from the profile analyses.

Figure 17. Example Thermal Profile from SMA with Hoban Aggregate.

Note: profile 3 shown.

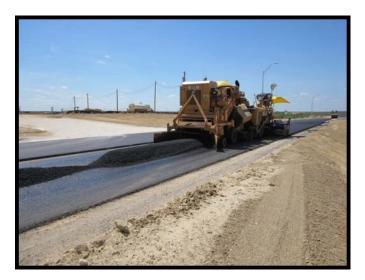
Figure 33. Paving TY C Mix on SL 20.

Belly dump trucks transported the mix from the plant to the job site, resulting in a haul distance of approximately 20 miles. A Lincoln 660 AXL windrow elevator transferred the mix into a Cat AP 1000D paving machine. The planned compacted thickness was 2 in., and the mat width was approximately 15 ft. Figure 33 shows the paving operation with Pave-IR data collection taking place.

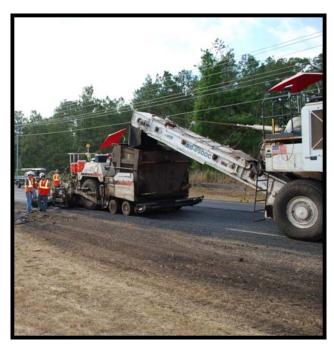
Figure 41. Paving on FM 2854 with Pave-IR Data Being Collected.

The mix was produced with PG 64-22 binder and transported approximately 12 miles from the plant to the project site. No RAP and RAS was used. At the job site, a Roadtec SB-2500C transferred the mix to a Cedarapids 452 paver. The planned compacted thickness was 2 inches. Figure 41 shows the paving operation with Pave-IR data collection taking place.

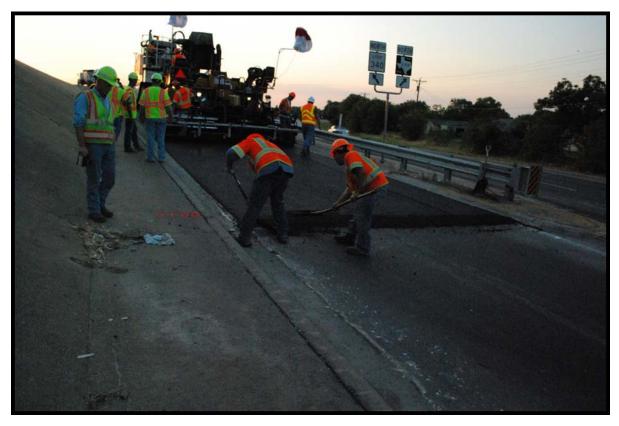
Figure 45. Paving on Loop 340 with Pave-IR Data Being Collected.

The mix was produced with PG 64-22 binder and transported approximately 6 miles with belly-dump trucks from the plant to the project site. RAP and RAS was not used. At the job site, a Roadtec SB-2500D transferred the mix to a Cat AP1000 paver. The planned compacted thickness was 2 inches. Figure 45 shows the paving operation with Pave-IR data collection taking place.
