JOINT TRANSPORTATION RESEARCH PROGRAM

SPR-3472

EVALUATION OF EFFECTS OF SUPER-HEAVY LOADING ON THE US-41 BRIDGE OVER THE WHITE RIVER

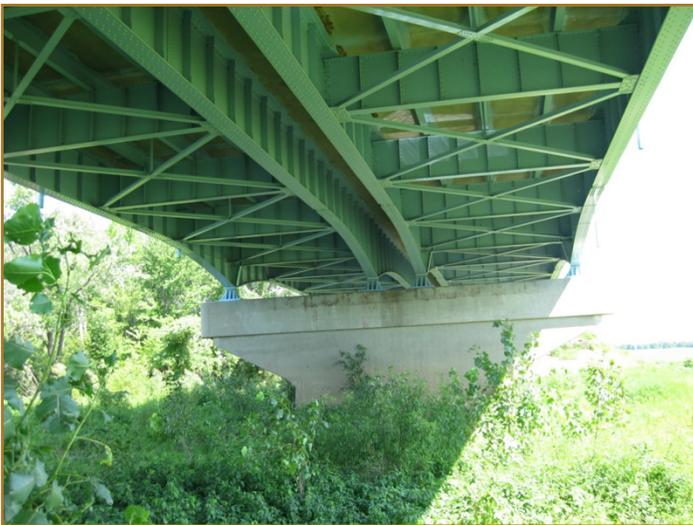
US-41 White River Bridge twin structures

Built in 1958, the US-41 White River Bridge is a two-girder, riveted steel structure located near Hazelton, IN. The bridge is comprised of two, sixteen span superstructures sharing a common substructure. Each superstructure also contains four pin and hanger expansion joint assemblies.

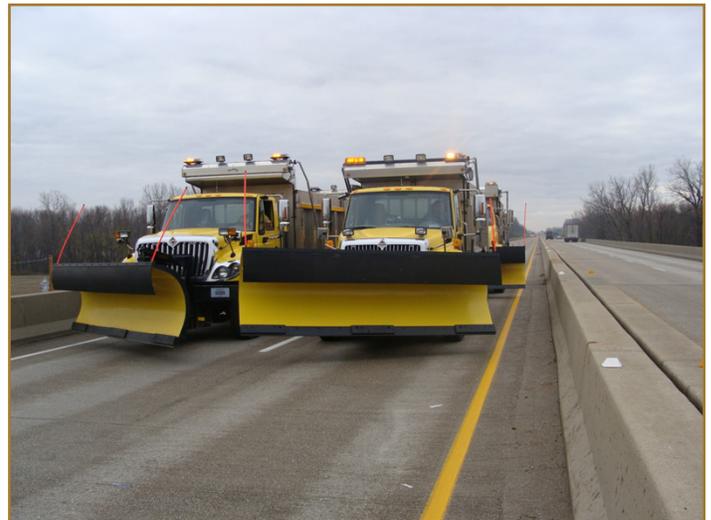
Static test configuration

1. Perform controlled load testing to gain insight on the typical behavior of the bridge.

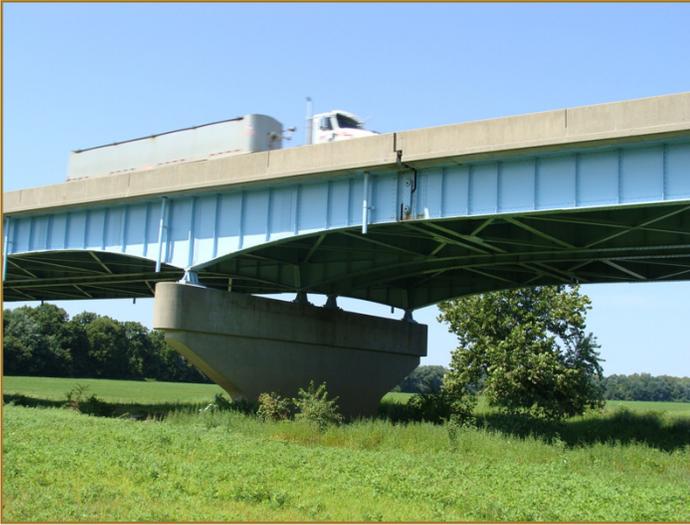
Pin and hanger

Based on the results of the study, only two actions items were suggested: 1.) Perform an in-depth inspection of the pin and hanger assemblies; and 2.) Lubricate all pin and hanger expansion joints. This study was not able to evaluate the pins of these joints directly; therefore, an in-depth inspection of the pins by a qualified inspector is advisable in response to this series of super-heavy loadings. Also, during the long-term monitoring, bending was measured in the four hangers instrumented; thus, lubricating the joints should allow for better movement and in turn less bending.

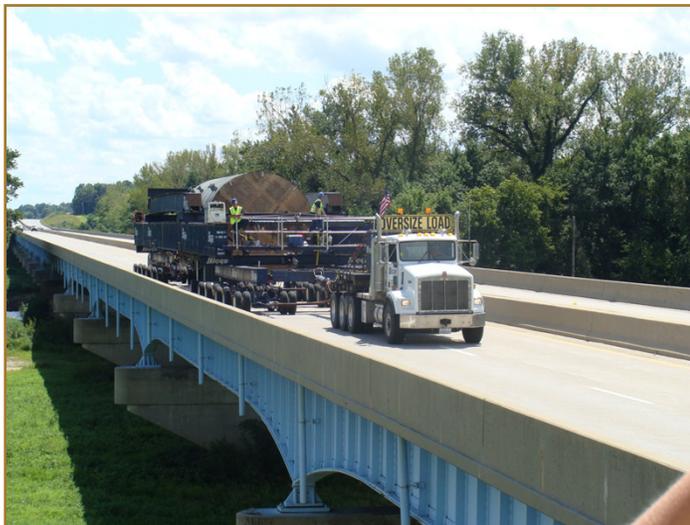
Beam and dolly transporter for superload test

Over a period from August 2009 to August 2010 a series of nearly one hundred super-heavy loads ranging in weight from 200,000 lbs to up over 1,000,000 lbs crossed the northbound superstructure of the bridge. The loads were moved to support the construction of a new power plant facility located in Edwardsport, IN. It was unknown what effect this number of super-heavy loading events, over a relatively short period, would have on the long-term performance of the US-41 White River Bridge. Therefore, long-term remote monitoring was used to quantify any negative effects due to the series of superloads. Five primary tasks were undertaken as part of this study:
