**FINAL REPORT ~ FHWA-OK-08-08**

# **RATING PRECAST PRESTRESSED CONCRETE BRIDGE FOR SHEAR**

**ODOT SPR ITEM NUMBER 2186**

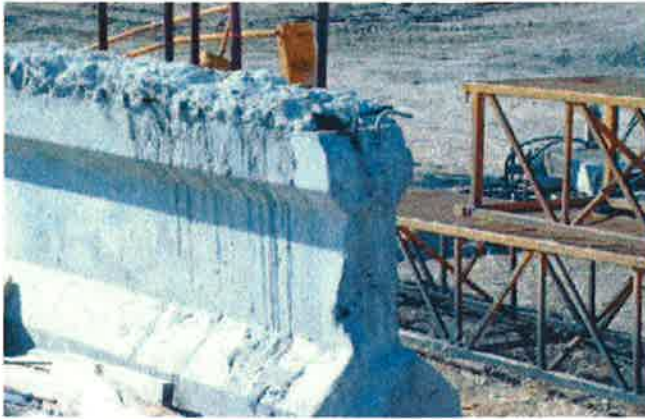
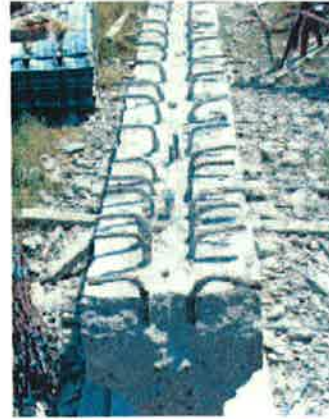
**Figure 3: The I-244 Bridge girder (a) before (taken by Mr. Richard Moon) and (b) after the slab was removed by Concrete Services Corporation.**

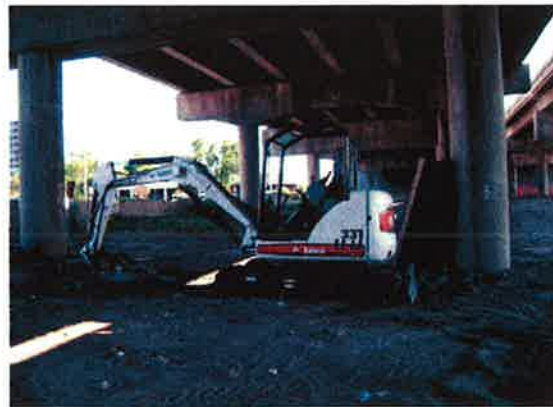
**Figure 4: Track hoe used to demolish the girder from the I-244 Bridge.**

As shown in Figure 10, numerous locations along the girder were visibly damaged once the girder was unloaded at Fears lab. Some damages are assumed to be from the removal of the girder from service. The slab was removed using a track hoe (see Figure 4) so the girder was more mobile. Some longitudinal cracks that propagate from the area of missing concrete suggest a large shear force similar to the hydraulic ram on the track hoe that removed the concrete. An inverse analysis in Chapter 4 will explore the effect of visible and invisible damages caused to the flexural stiffness of the girder for a more accurate estimation of the

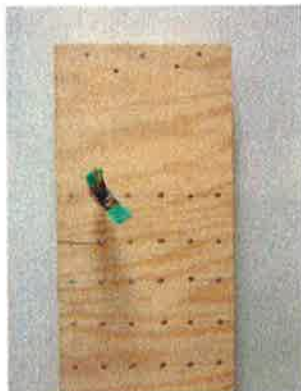
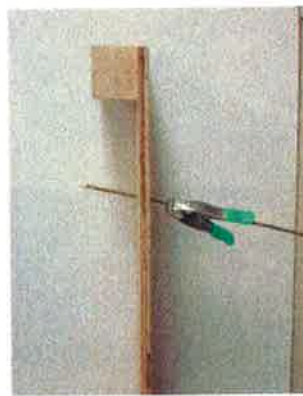
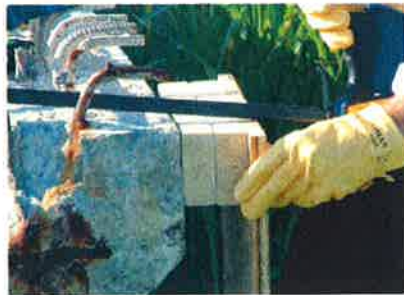
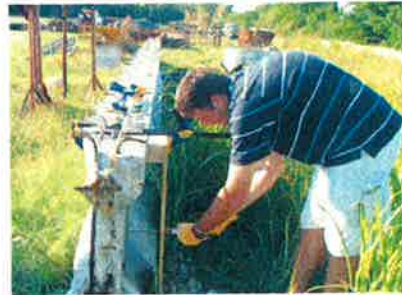
**Figure 6: (a1) Front view, and (a2) side view of the depth gage. (b1) The depth gage being installed, and (b2) the depth gage being used.**

In light of the existing damages the girder had had, a proposal was made to ODOT to (1) retrofit the corroded end with the same materials and method that were used to retrofit the other girders on the I-244 Bridge, (2) test the retrofitted end, and (3) compare the result with of the non-retrofitted end to study the contribution of the retrofitting material. For all visible damages, proper documentations would be required to ensure the accuracy of theoretical and numerical studies of this girder. The second field trip took place in June 2006 spanning about a week so that Concrete Services Corporation could retrofit the corroded end following what they had done to the other girders on the I-244 Bridge. Before the retrofitting started, a depth gage developed by Dr. Jin-Song Pei and Mr. Colby Sandburg, shown in Figure 6, was used to document some damage details to be covered by the external reinforcement in a cost effective manner on site. In short, the depth gage allowed the distance from the concrete to be known. From this information the amount of concrete that spalled off could be determined.

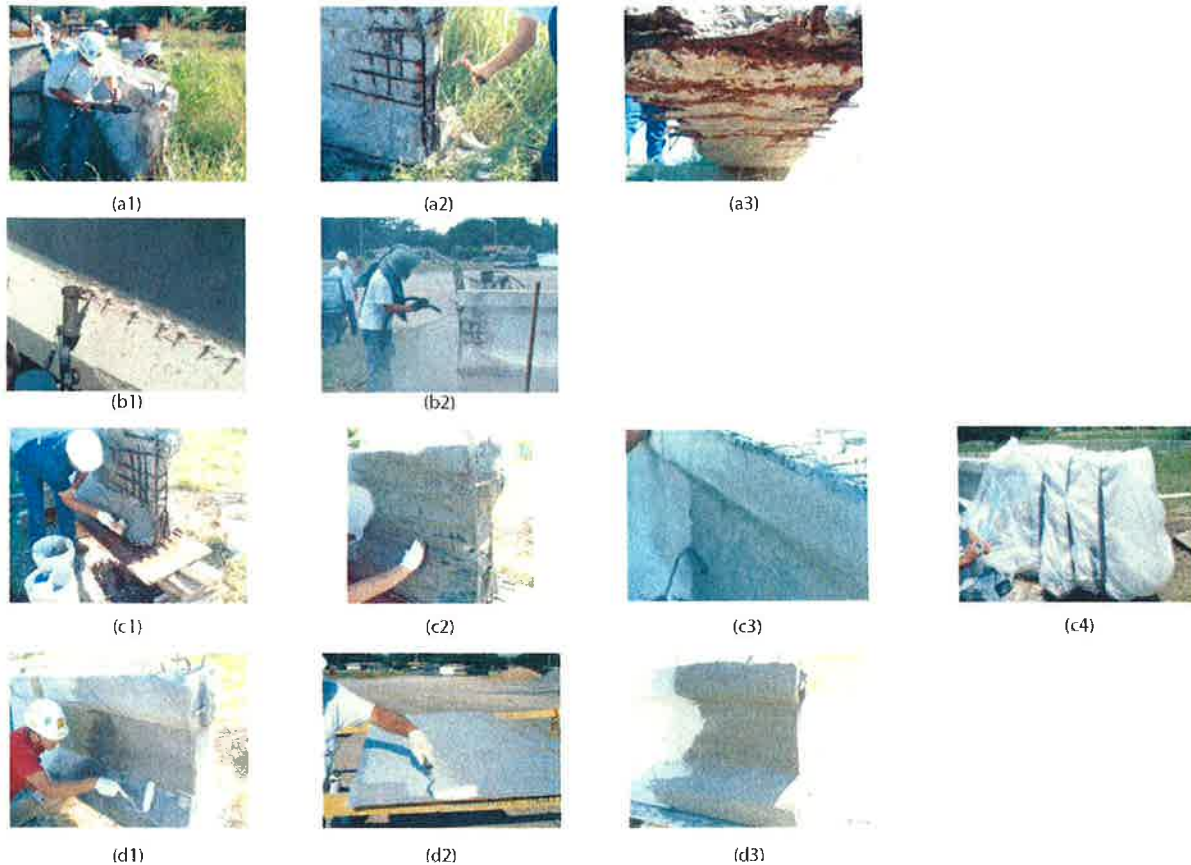
**Figure 7: Retrofitting process documented by Mr. Christopher Davis: (a1) using a pneumatic drill to remove unsound concrete; (a2) using a standard hammer to remove unsound concrete so that more damage was not done; (a3) original view of damage to the bottom of the girder; (b1) sandblasting the surface; (b2) using a pressure injection epoxy to repair existing cracks; (c1) applying the initial coat of the wet mortar; (c2) applying the second coat of the intermediate mortar; (c3) the final mortar being the thickest and the repaired end finally shaped; (c4) the burlap sack that was used during curing; (d1) rolling on the epoxy to the girder prior to install the FRP wrap; (d2) impregnating the three-layer FRP wrap prior to installing it, and (d3) rolling the FRP wrap onto the girder to avoid air voids in the finished product.**

The retrofitting process was documented in detail (Sandburg [2007]). Figure 7 shows a step-by-step view of the retrofitting process carried out by Concrete Services Corporation. The material was cured for 24 hours before the burlap was removed. To protect the retrofitted girder a UV coating was applied. When the contractor had finally finished the retrofitting the girder, transportation of the girder was organized.

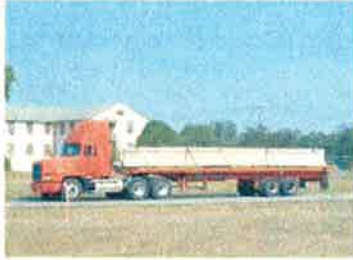
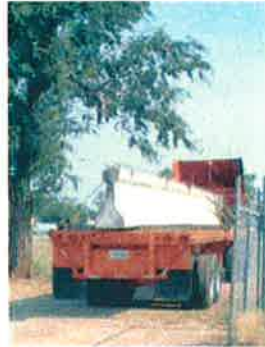
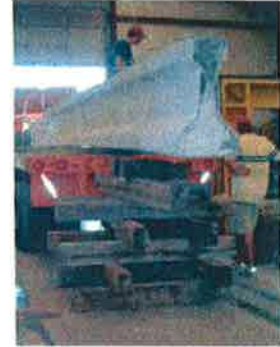
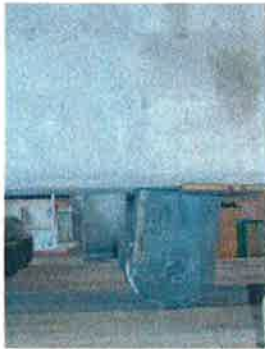
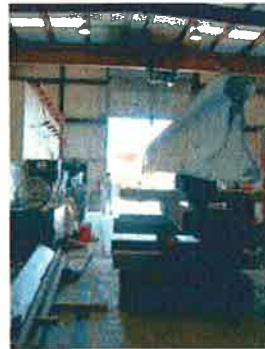
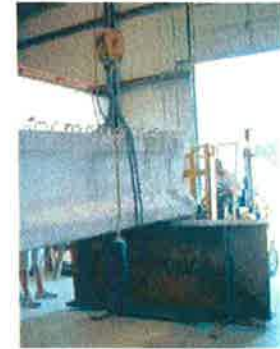
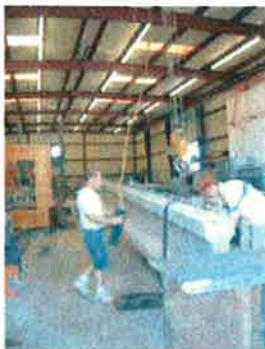
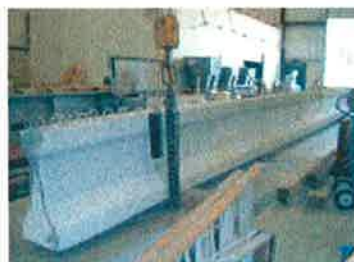
**Figure 8: Girder unloading at Fears Lab: (a1) The girder on the delivery truck; (a2) the delivery truck backing into Fears lab; (a3) the cribbing built to support the girder while the truck left; (b1) the roller the girder was rolled on; (b2) the girder supported by the crane and the cribbing; (b3) the steel support the girder rested on after the truck left; (c1) the girder being lowered to the ground, and (c2) the girder being placed into the final location.**

Schmitz, the lab manager. See Figure 8 for the snapshots of the process.

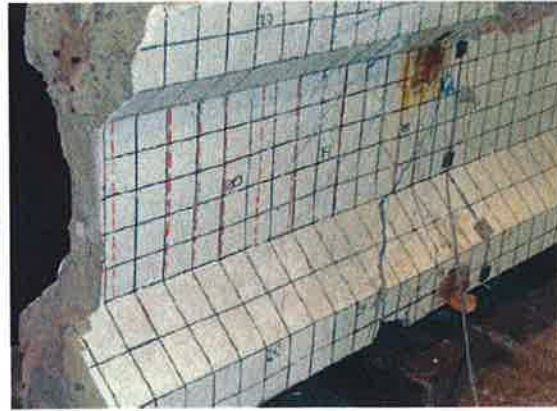
**Figure 12: Grid system placed on the I-244 Bridge girder, where (a) shows the origin, i.e., the hole pointing to the diaphragm's location (circled), and (b) shows the grid system drawn by Mr. Aaron Landrum using Sharpie markers and the stirrups located by Mr. Krisda Piyawat using a pacometer borrowed from ODOT.**

Once the girder was under the loading frame and out of the main traffic areas at Fears lab, visible damages on the girder, shown in Figure 10, were patched with a commercial repair concrete. When the repairs were complete and dry, the girder was painted white for further testing. Following the decision of the origin, other testing preparations include drawing grid lines of 3" by 3" onto the two sides of the girder throughout the span by Mr. Aaron Landrum using Sharpie markers and using a pacometer borrowed from the ODOT to scan the location of some stirrups and bend-up locations of the draped strands by Mr. Krisda Piyawat. Figure 12 contains photos of the grid system placed on the girder, which enables an efficient documentation of cracks in further testing.

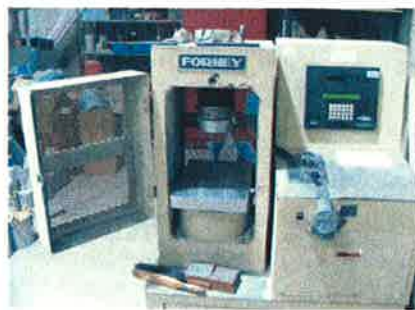
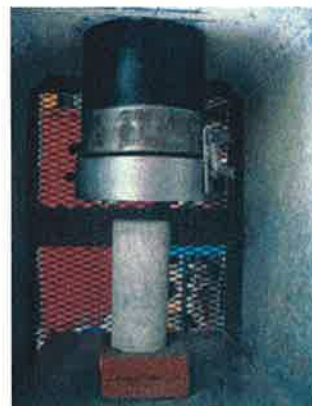
Figure 22: (a) Forney LC-1 testing machine (For [2005]) used for material testing, and (b) a view into the Forney machine with a concrete cylinder.

When the I-244 Bridge girder was cut after the completion of the above-mentioned four shear tests, cylindrical specimens were cored from the cut-off non-retrofitted end. These cores were 6" deep and 2.7" in diameter. The former followed the web thickness, while latter was dictated by the blade used. Three specimens were tested in compression using a Forney LC-1 testing machine (For [2005]) following ASTM [2001]. See Figure 22 for the test setup, while other details can be found in Sandburg [2007].
