Florida Department of Transportation Research

Evaluation of Shared Lane Markings in Miami Beach, Florida

BDM10 977-01

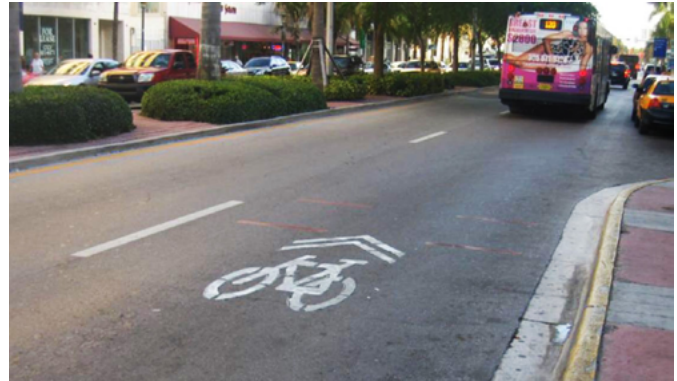
In this pilot study, the bike-and-chevron marking was placed in the center of the outside lane to encourage bicyclists to take over the lane.

in many categories; a sampling follows. Before marking, about 10 percent of bicyclists rode near the center of the lane, but after marking, this increased to nearly 30 percent. Women were more likely than men to ride near the center of the lane both before and after marking. There was also a slight increase in the number of cyclists riding in the narrow space between traffic and parked cars. Marking decreased bicyclists’ use of empty parking spaces. Women used empty parking spaces less often than men, both before and after marking. Potential dooring incidents were reduced, first, by bicyclists riding further from parked cars – outside the “door zone” – and second, because the number of open parked vehicle doors was reduced by half. Bicyclists yielded to motorists much less after marking than before.
