## **STATE HIGHWAY ADMINISTRATION**

### **RESEARCH REPORT**

# **LOW COST STRUCTURAL HEALTH MONITORING OF BRIDGES USING WIRELESS SENSPOT SENSORS**

**FINAL REPORT**

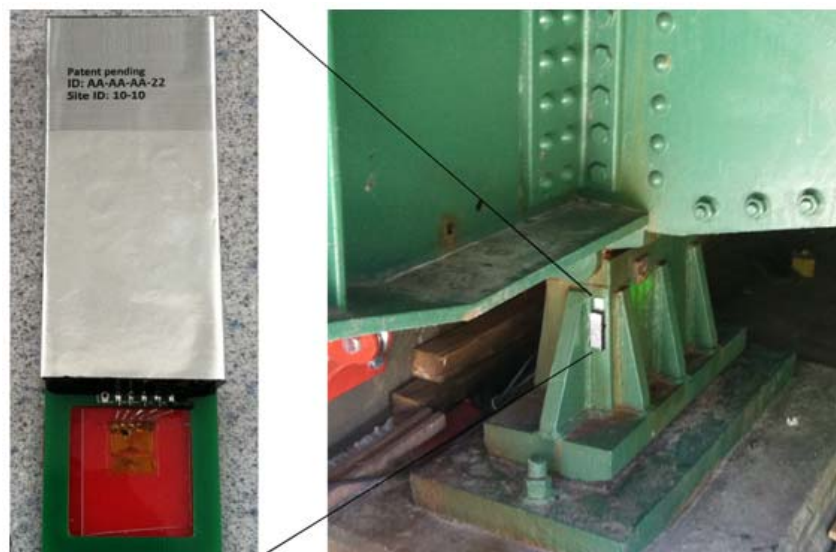
Figure 1: A SenSpot (left) and installed sensor on a bridge bearing (right) for tilt and loading monitoring.

Figure 1 shows a SenSpot sensor. This device is powered using a built-in prime lithium-ion battery which is designed to supply the energy needed by the device for 30 years. The device uses sensing, synchronization, and ultra-low-power wireless communication technology. A picture of a SenSpot installed on a bridge bearing is also shown in Figure 1. In this installation, the sensor monitors the tilt of the bearing as well as the load on the bearing through strain measurement. In addition, the sensor monitors changes in these parameters as the bridge expands or contracts as a result of temperature variations (please see the case studies in Section 5 for more details).

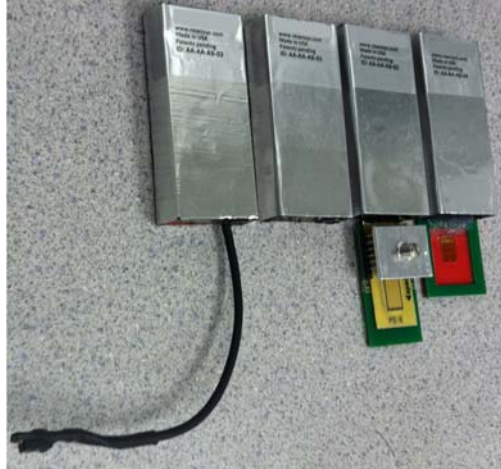
**Figure 2: Left to right: SenSpots for humidity, tilt, crack, and strain monitoring.**

Currently, SenSpot sensors offer a variety of features that meet the needs for monitoring bridges: strain, tilt, moisture and humidity, temperature, pressure, and crack width. A number of these SenSpot sensors are shown in Figure 2:

- The SenSpot on the left, which monitors relative humidity, has a special probe that is connected to the main body of the sensor through a variable-length cable.

- The second device monitors tilt (inclination) with a resolution of 0.1 degrees.
- The next device is a special SenSpot that measures crack activity (or crack-meter with a resolution of 0.1 mm (0.004 inches). When installed on an existing crack, it will monitor the activity and growth of that crack. The device can also be installed at locations where the development of a crack is a possibility (e.g., at welds, attachment points, etc.).

- The device on the far right offers the combined strain and tilt measurement, with accuracies of 0.1 degree and 2 microstrains for tilt and strain, respectively. A special application of this device is the combined monitoring of loading and tilt on bridge rocker bearings (please see case study 1 in the Appendix).

In addition to the aforementioned capabilities, all of the devices pictured have built-in temperature sensing capability with 0.1°C resolution.

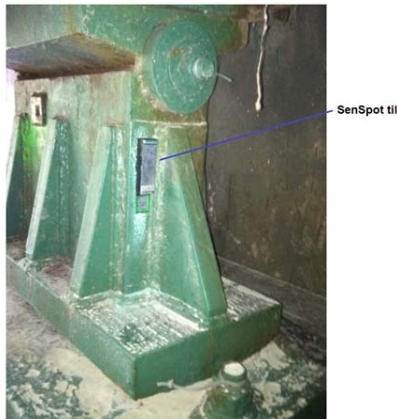
SenSpot tilt sensors can gather changes in the tilt of the bearing by angles as small as 12 arc seconds (or approximately 0.003 degrees). Tilt changes happen as a result of daily temperature variations. Such changes can be monitored by the installed tilt sensors. The installed tilt sensor on a rocker bearing is shown in Figure 8.

**Figure 8: Wireless tilt sensor on a rocker bearing of Northwest Branch Bridge on I-495**

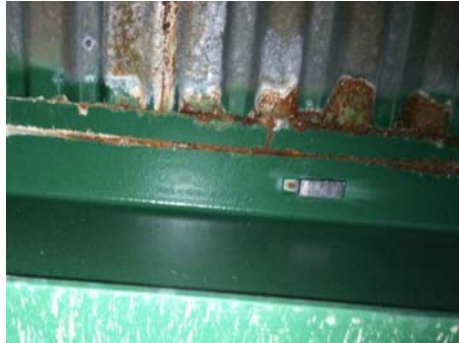
To evaluate the performance of SenSpot for monitoring strain, a sensor was installed on the deck of Northwest Branch Overpass on I-495. The installed SenSpot is shown in Figure 13.

Figure 13: Installed SenSpot strain under the deck of Northwest Branch Bridge on I-495.
