FINAL REPORT

FHWA-WY-09/02F

PRACTICAL OPERATIONAL IMPLEMENTATION OF TETON PASS AVALANCHE MONITORING INFRASOUND SYSTEM

**Inter-Mountain Laboratories, Inc.
555 Absaraka Street
Sheridan, WY 82801**

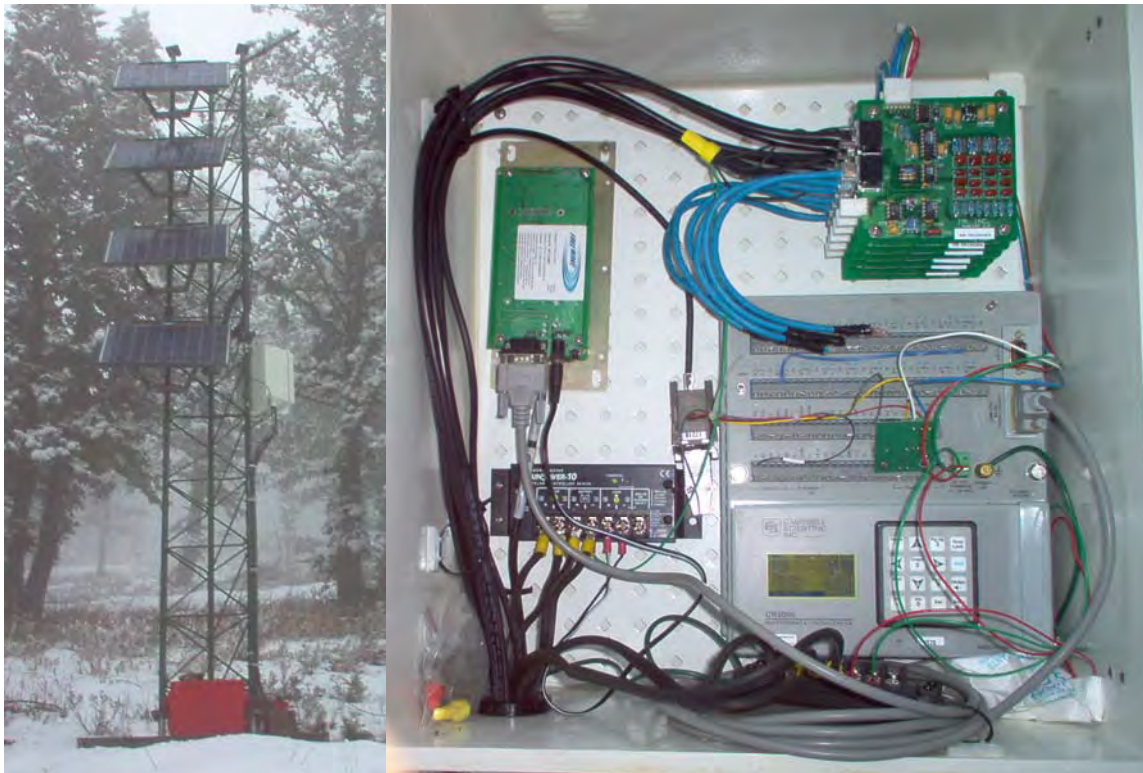
Figure 2. Twin Slide RSAMN Tower and Outdoor Instrument Enclosure

Even though installation of RSAMN instrumentation was delayed due to the tower construction set backs, preparatory activities for this task began in August, 2006. RSAMN instrumentation that was retrieved in June, 2006 was put through quality control checks and refurbishment to ensure proper operation upon subsequent re-deployment. In an effort to prevent animal damage and unintentional installation caused damage, previously utilized infrasound sensor cables were replaced using a type of signal cable that provides a more durable outer casing and less memory.

After the tower installations were completed, necessary instrumentation was installed in a similar manner at each RSAMN and made operational during the inclement winter weather conditions of the first week of November, 2006. Figure 2 shows critical components of the fully installed and operational Twin Slides RSAMN, which is analogous to the Glory Bowl RSAMN.

According to practical and necessary requirements, appropriate installation plans were designed and specified to deploy 20 ft (6.1 m) tall mounting towers at the RSAMN sites. The ability for the towers to withstand snow glide, snow creep, and solar panel wind loading were critical design parameters. Since it is desirable to prevent tower failure for a worst case scenario, hefty steel towers with sturdy bases were specified. A new tower was purchased for the Twin Slides RSAMN site, and an existing Teton Pass WYDOT tower was salvaged for the Glory Bowl RSAMN site.

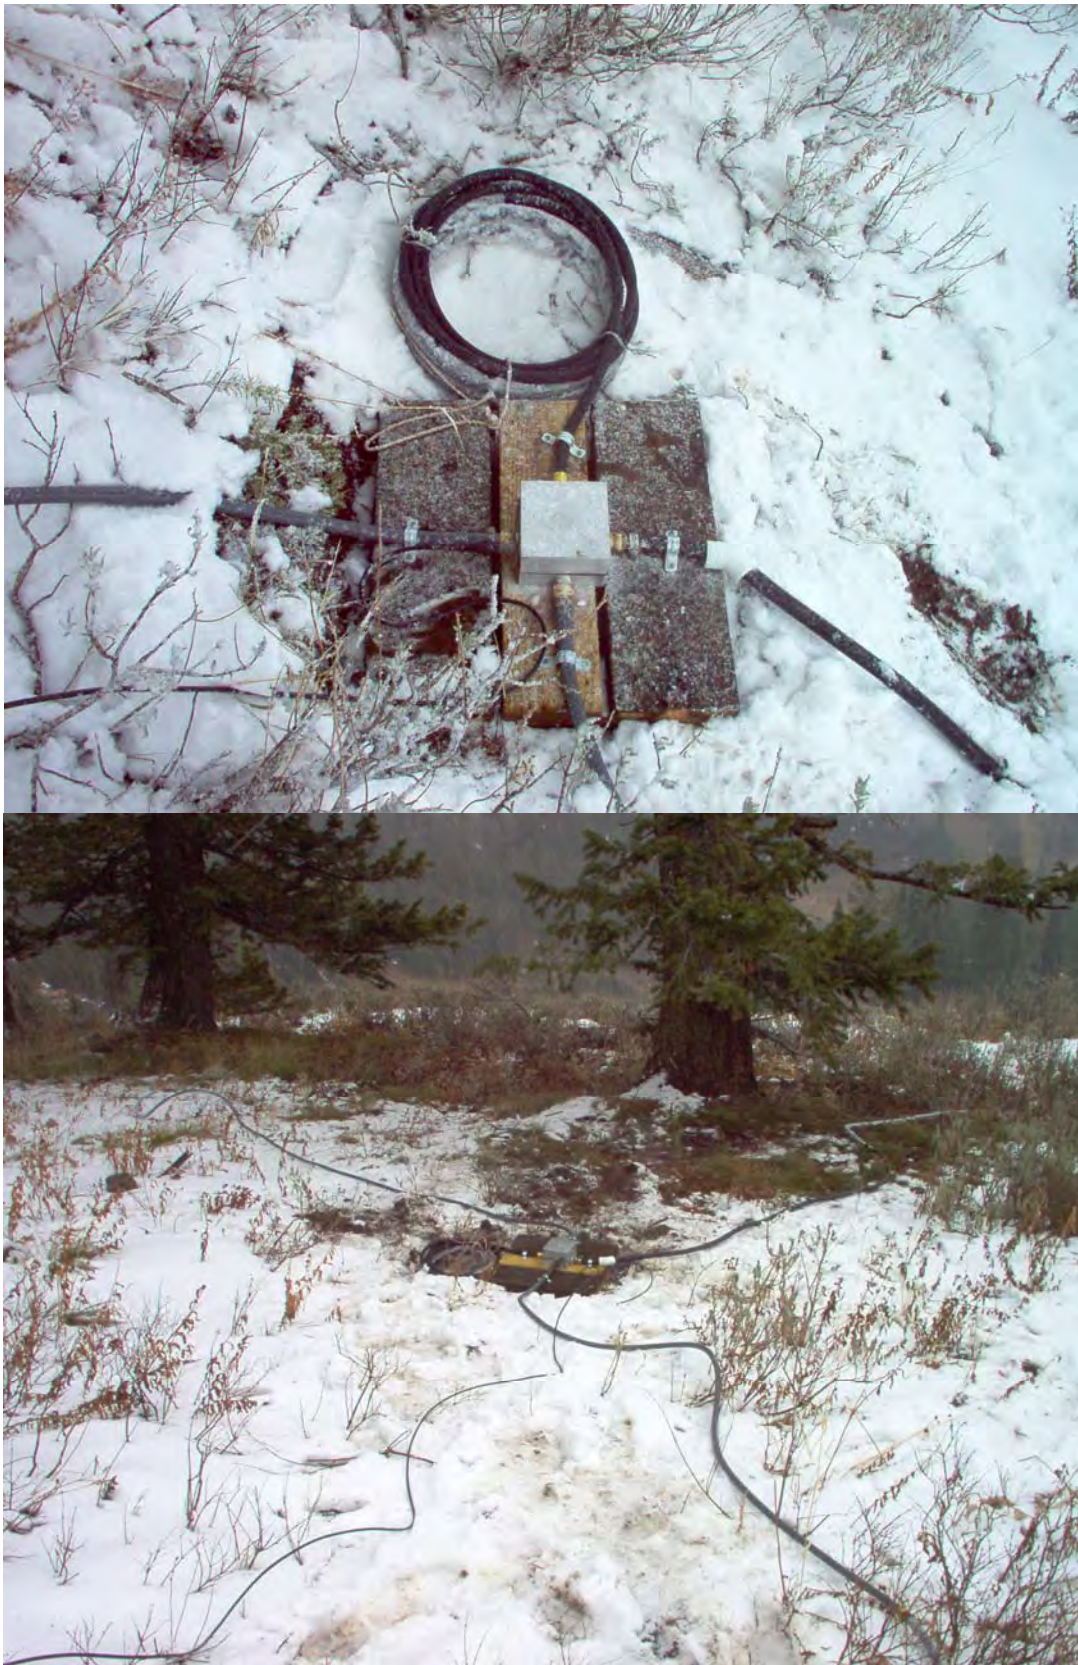
Figure 3. Deployed Infrasound Sensors

Each infrasound sensor was placed on an elevated platform to protect electronics from potential water intrusion damage. Electronic infrasound sensor gain settings were increased in an effort to mitigate the infrasound signal degradation issues that were previously encountered during operation of the prototype system. Also attempted as mitigation to the infrasound signal degradation issues was altering how the solid and porous hose sections of the infrasound sensors pneumatic spatial wind noise reducing filters were deployed

As is shown in Figure 3, the configuration of the hoses connected to each of the four infrasound sensor ports differs. The infrasound sensor port connected directly to the single section of coiled porous hose was done as an attempt to provide a failsafe infrasound signal path, since it was speculated that the extra rigidity provided by stacking coils of the porous hose could mitigate the potential of the porous hose being crushed or flattened. It is suspected that the porous hose material itself encourages the formation of ice, which impedes the infrasound signal. In an effort to prevent ice from forming, various sections of the porous hoses were wrapped in poly tubing with the idea that the infrasound signal would penetrate the poly tubing while the poly tubing itself will provide a barrier for the bonding of ice to the porous hose material. Another alteration was the use of durable, light weight, and flexible PVC conduit material to facilitate crush and kink proof solid hose sections.

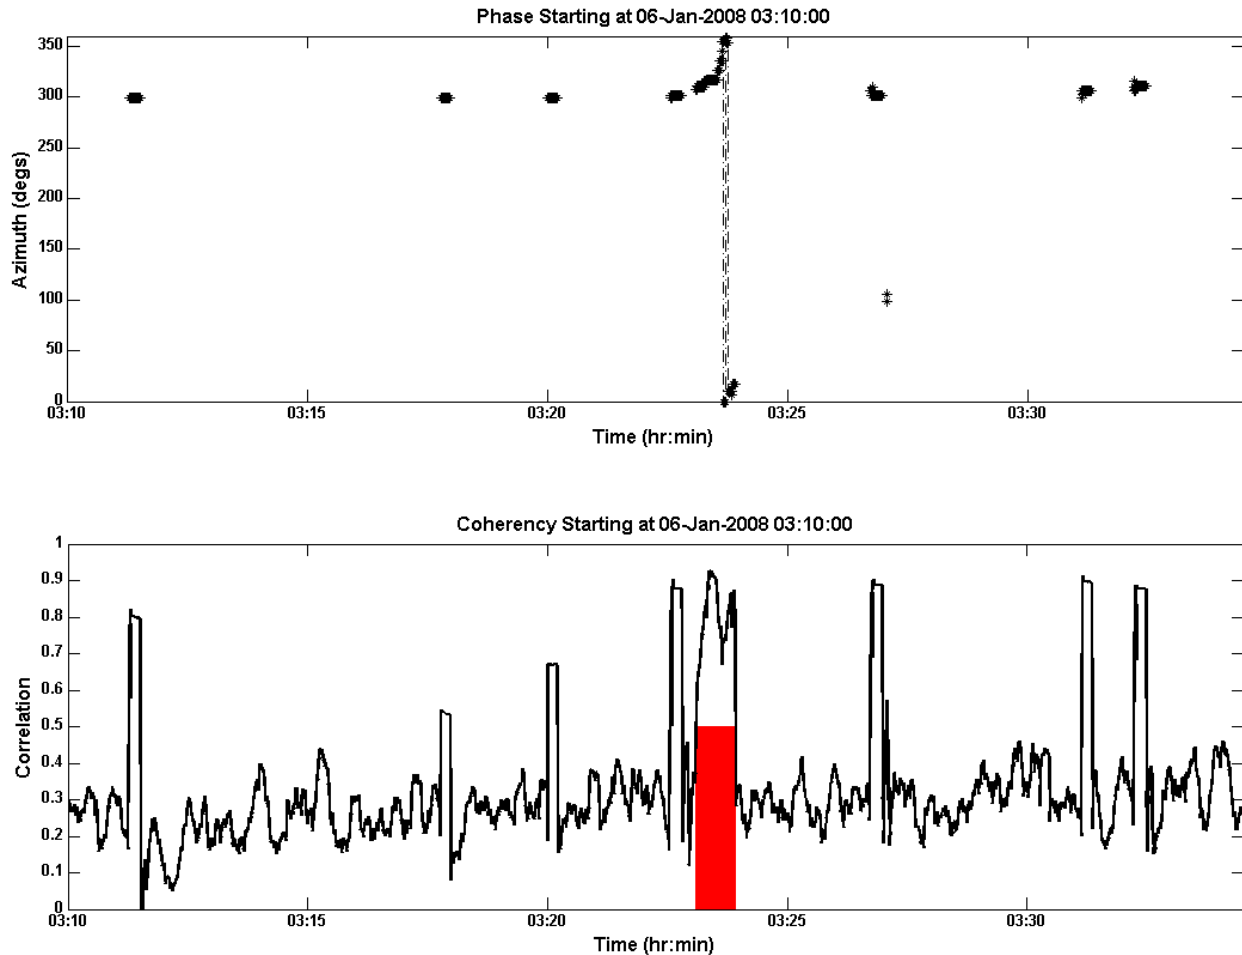
Figure 4. Teton Pass Avalanche Mitigation Glory Bowl RSAMN Results

The executed CPU GUI software signal analyses were shown effective, even though data recorded at only a single RSAMN site near the targeted slide path (Twin Slides or Glory Bowl) is utilized by each signal analysis. Shown in Figure 4 are Glory Bowl RSAMN signal analysis results obtained during a WYDOT Teton Pass avalanche hazard mitigation mission. Evident via the elevated correlation levels are a series of stationary interfering explosive infrasound signal events with the positive identification (designated by the red bar) of one released moving Glory Bowl avalanche event that stopped well short of WY-22, which was valuable information to have in near real-time as these operations were carried out by WYDOT personnel.

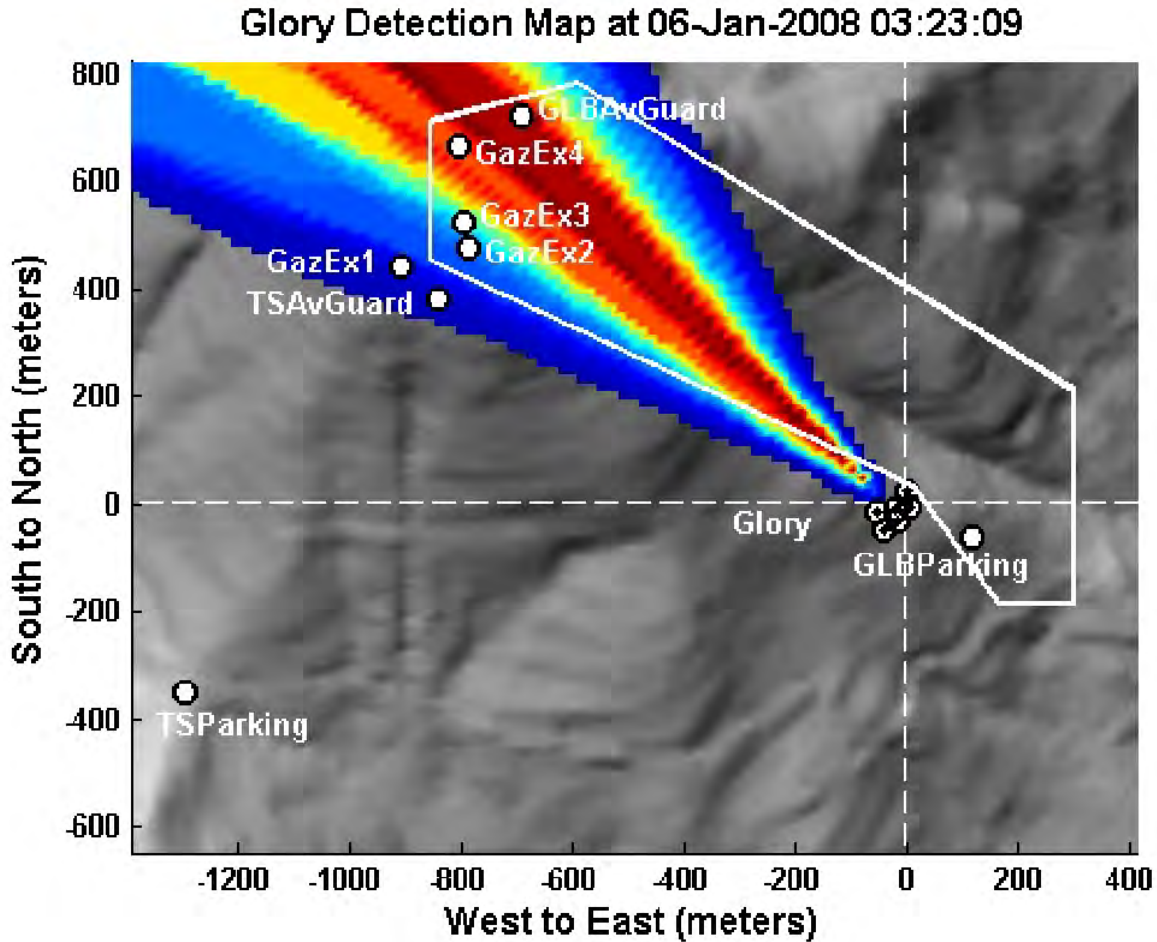
Figure 4. Teton Pass Geographic Glory Bowl Avalanche Detection

Figure 5 shows a complimentary geographic detection image of a time instance during the identified Glory Bowl avalanche event. Blue to red colors indicate the intensity of the infrasound signals detected at the RSAMN. Evident is that the only reliable signal source location information is the azimuth angle of arrival for the detected infrasound signal. This location information could be extended to be reliable in three dimensions, if data recorded at distributed RSAMN sites were utilized by the signal analysis (Yount, et al., 2008).

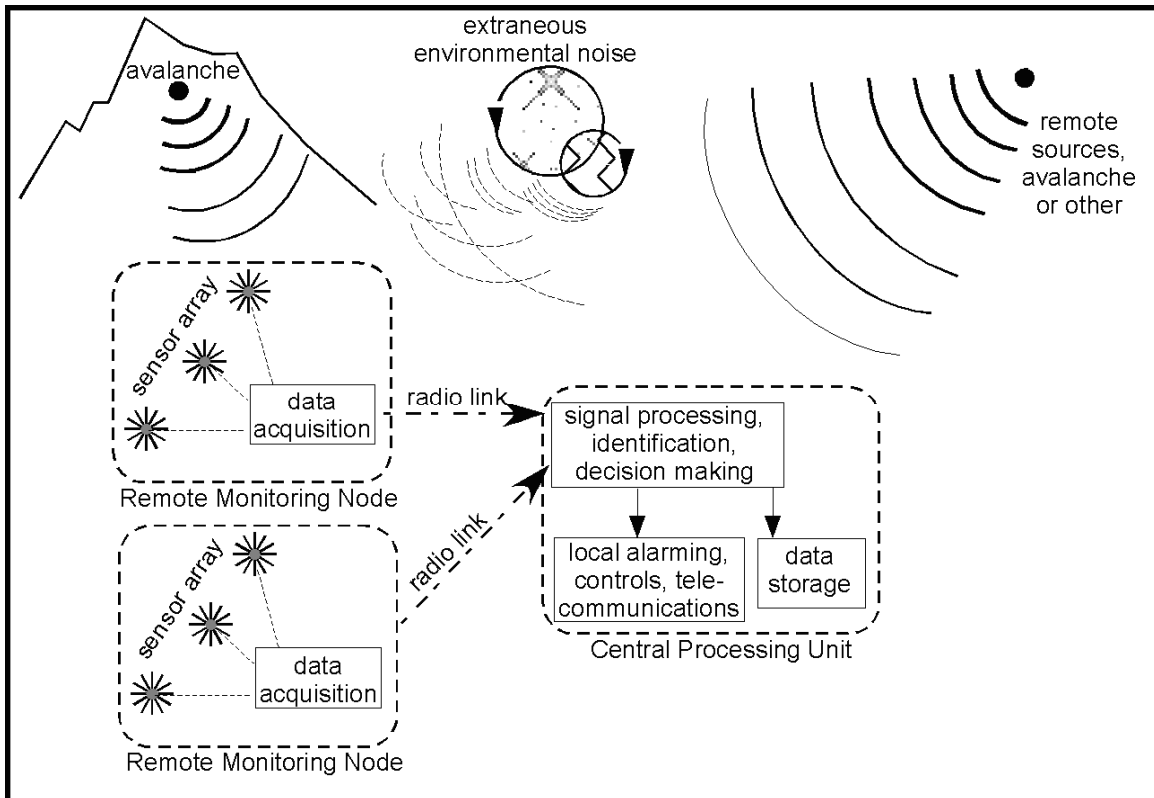
Figure 6. Avalanche Infrasound Monitoring Concept

Snow avalanches generate low frequency acoustic energy as they occur. The resultant airborne signals propagate away from their source and occupy a relatively low noise band of the sub-audible infrasonic frequency spectrum, which provides a functional basis for avalanche event detection by sensing equipment that is not placed in the slide path. Since avalanche infrasound signal detection does not require the sensing equipment to be physically harmed, monitoring can occur in a continuous automated fashion without the need to reset measurement components. However, in addition to problematic ambient noise and interfering signals, both the atmosphere and snow are inherently variable media, which complicates the ability to deploy a reliable and stable infrasound monitoring solution targeting avalanche activity. For the often encountered non-ideal signal and noise environment, utilization of multiple, spatially separated infrasound sensors allows for beamforming signal processing that effectively confirms detection of coherent signals and estimates their geographic source location.

As is conceptually depicted in Figure 6, infrasound measurements are facilitated via remote sensor array monitoring nodes, which are deployed in mountainous environments that contain avalanche-generated infrasound signals in addition to problematic interfering infrasound signals and ambient noise. On a continuous near real-time interval (e.g. every 1 minute), measurement data are automatically transferred via wireless communications to a centrally located processing
