1. Report No. FHWA/TX-12/0-6496-1		2. Government Accession No.		3. Recipient's Catalog No.	
4. Title and Subtitle PERFORMANCE COMPARISON OF VARIOUS SEAL COAT GRADES USED IN TEXAS				5. Report Date January 2012 Published: July 2012

# **PERFORMANCE COMPARISON OF VARIOUS SEAL COAT GRADES USED IN TEXAS**

Report 0-6496-1  
Project 0-6496

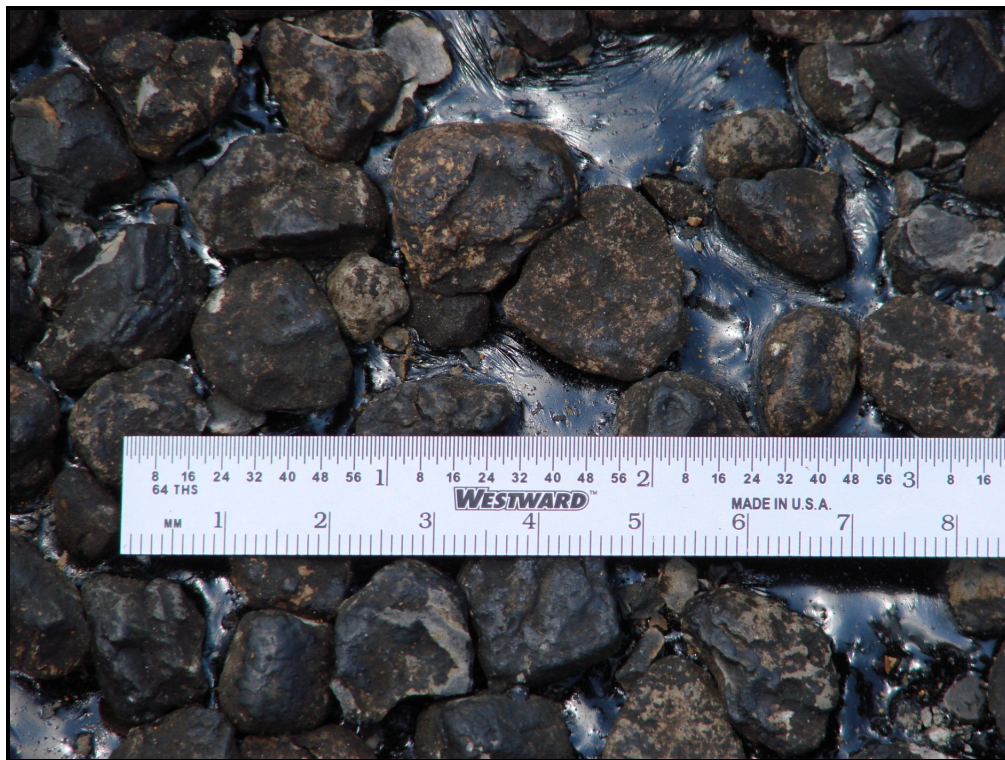
**Figure 1. Grade 3 Lightweight Aggregate Seal Coat.**

The Lufkin District constructed end-to-end test sections of Grades 3, 4, and 5 seal coats during their 2010 district seal coat program. The aggregate for each grade was rotary kiln expanded shale and clay lightweight material produced by Texas Industries, Incorporated. The aggregate grades were precoated with asphalt prior to delivery to the construction site. The seal coat asphalt cement was AC-15P, with application rates averaging 0.42, 0.31, and 0.22 gallons/SY for the three grades of aggregate, respectively. These test sections are located southwest of Nacogdoches on SH 7. Figures 1, 2, and 3 show photographs of the three seal coat grades soon after construction.

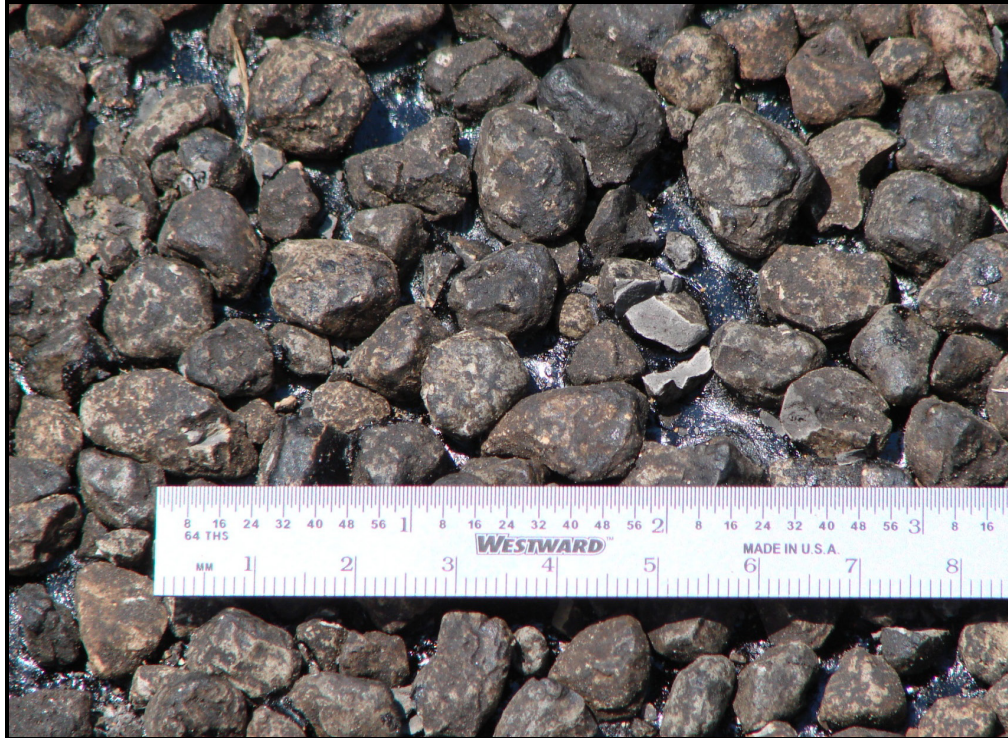
**Figure 2. Grade 4 Lightweight Aggregate Seal Coat.**

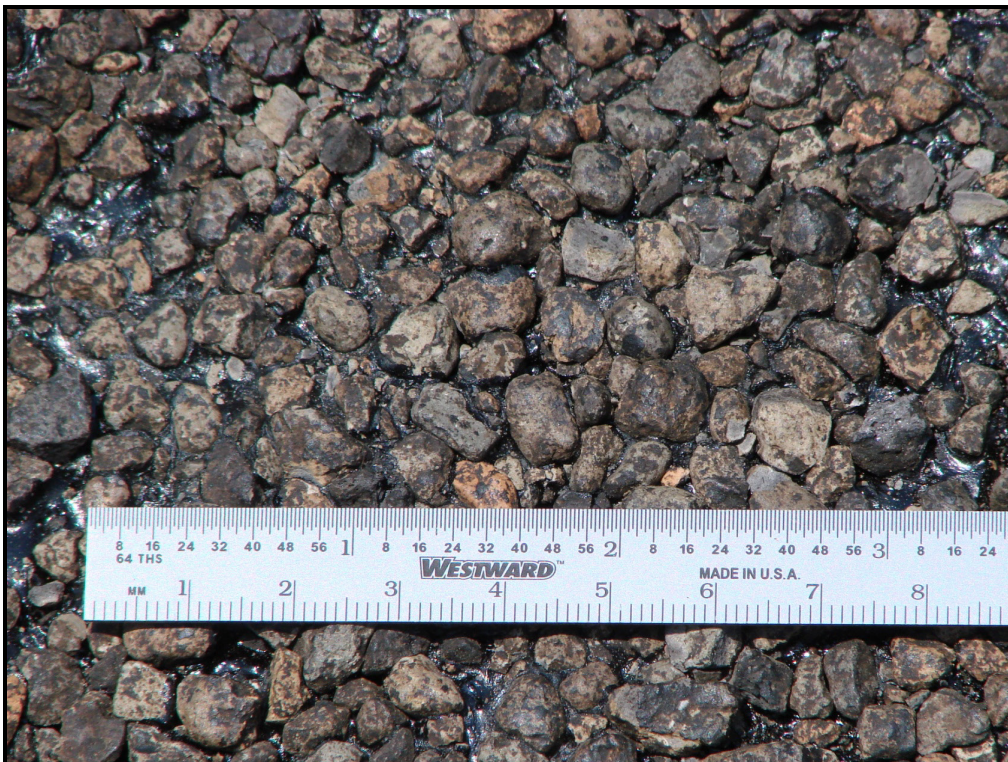
**Figure 3. Grade 5 Lightweight Aggregate Seal Coat.**

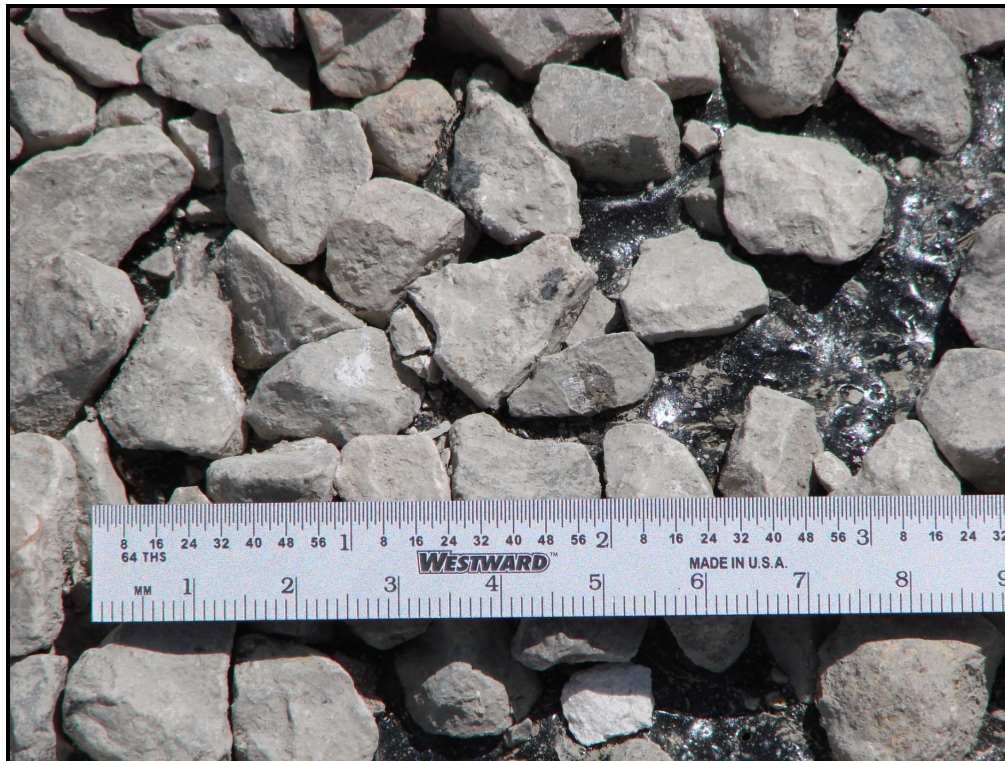
**Figure 4. Grade 3 Limestone Aggregate Seal Coat (1CY/85SY).**

The Brownwood District provided end-to-end test sections of limestone aggregate Grades 3, 4, and 5 seal coats during their 2010 district seal coat program. The seal coat asphalt was an emulsion, CRS-2H. The asphalt application rates averaged 0.48, 0.35, and 0.19 gallons/ SY for the three grades of aggregate, respectively. In addition, the Brownwood District placed two test sections where the Grade 3 and 4 aggregate application rates were reduced slightly, allowing determination of whether small changes in aggregate application rate have a measurable effect on tire-pavement interface generated noise level. The Grade 3 aggregate coverage rates were 1CY/85SY and 1CY/90SY. For the Grade 4 the two aggregate coverage rates were 1CY/120SY and 1CY/125SY. The reduced aggregate coverage rates were placed in climbing lanes immediately adjacent to the standard aggregate coverage rates, so when comparing aggregate application rates over time, traffic levels cannot be assumed to be equal. The Brownwood District test sections are located between May and Rising Star on US 183 north of Brownwood. Figures 4, 5, and 6 show photographs of the seal coats soon after construction.

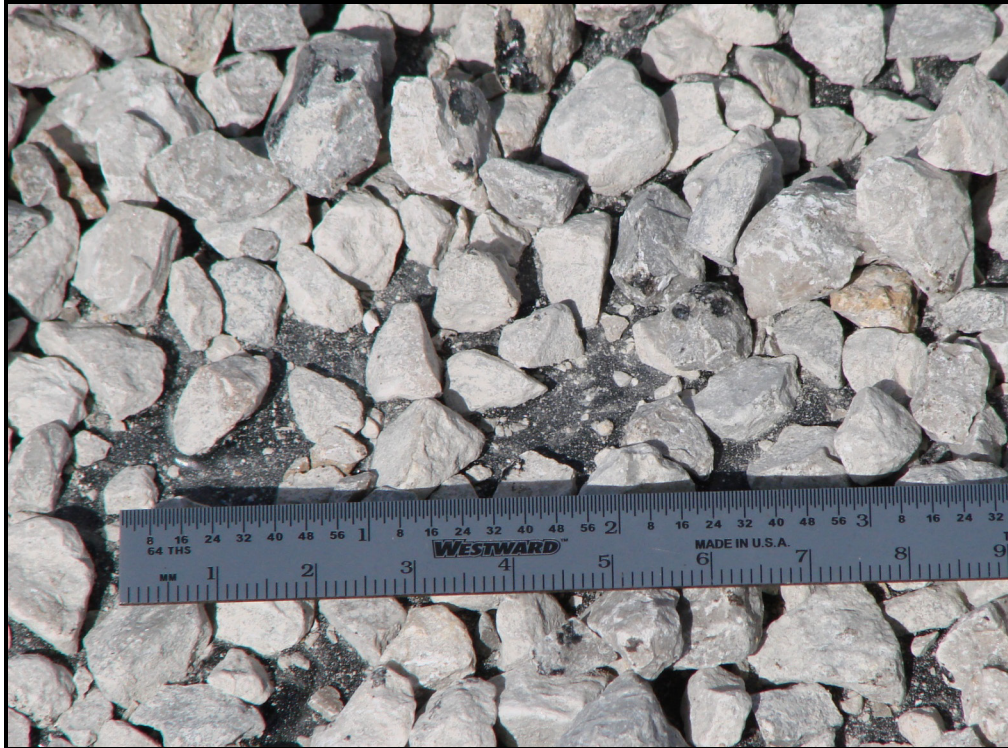
**Figure 5. Grade 4 Limestone Aggregate Seal Coat (1CY/120SY).**

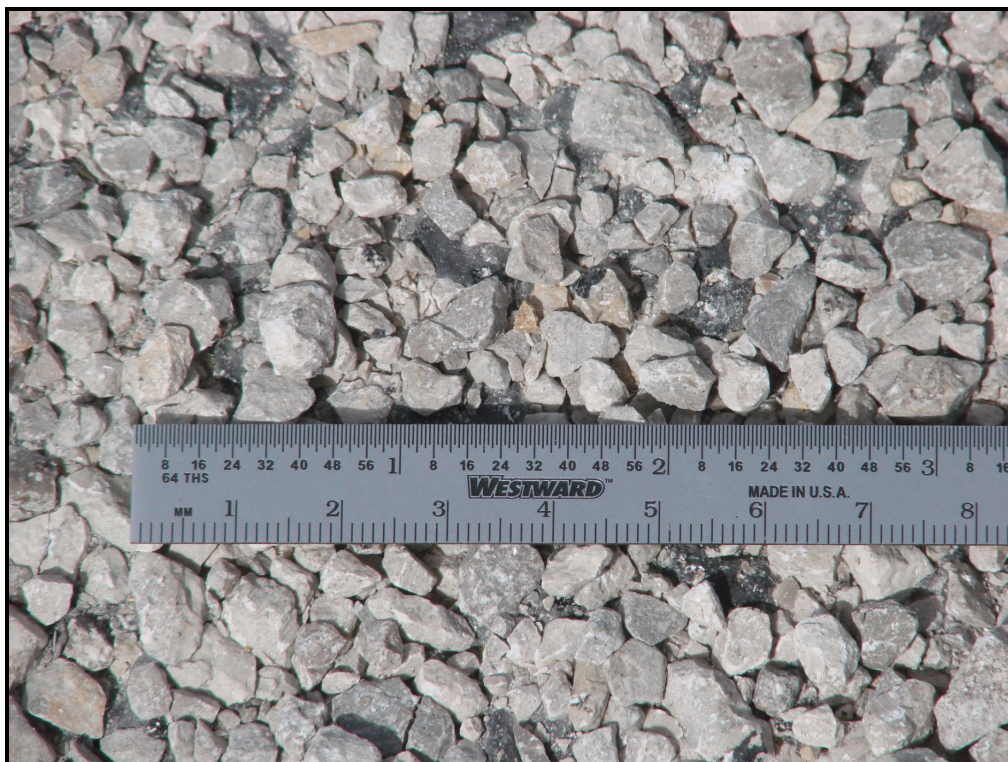
**Figure 6. Grade 5 Limestone Aggregate Seal Coat.**

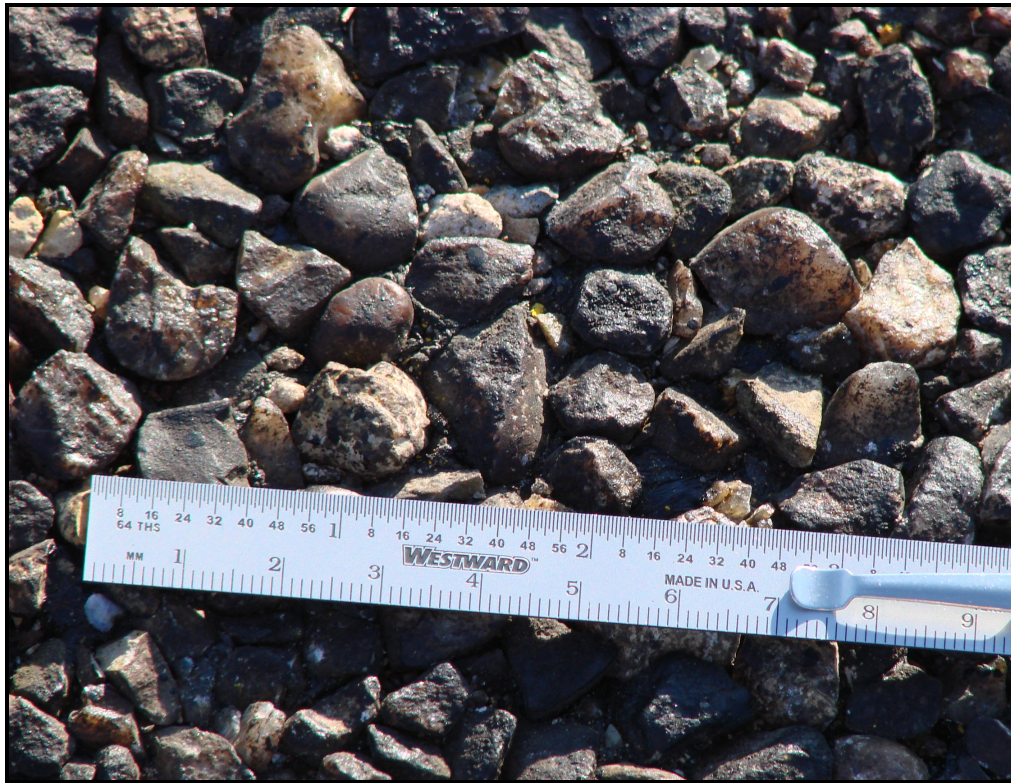
**Figure 7. Grade 4 Crushed Siliceous Aggregate Seal Coat.**

The Amarillo District constructed end-to-end test sections of Grades 4 and 4S seal coats during their 2011 district seal coat program. These test sections sought to determine the difference in performance and noise generation between the standard gradation for Grade 4 and the near single-sized Grade 4S aggregate. This comparison was thwarted when the contractor was unable to obtain both aggregate grades from the same quarry. The Grade 4 aggregate is crushed siliceous gravel, and the Grade 4S aggregate is a lightweight scoria material. These test sections are located in the northeast quadrant of Loop 335 around Amarillo. As these test section were placed in the second summer of this research project, OBSI testing was performed only once, soon after construction. Figures 7 and 8 are photographs of the seal coats soon after construction.

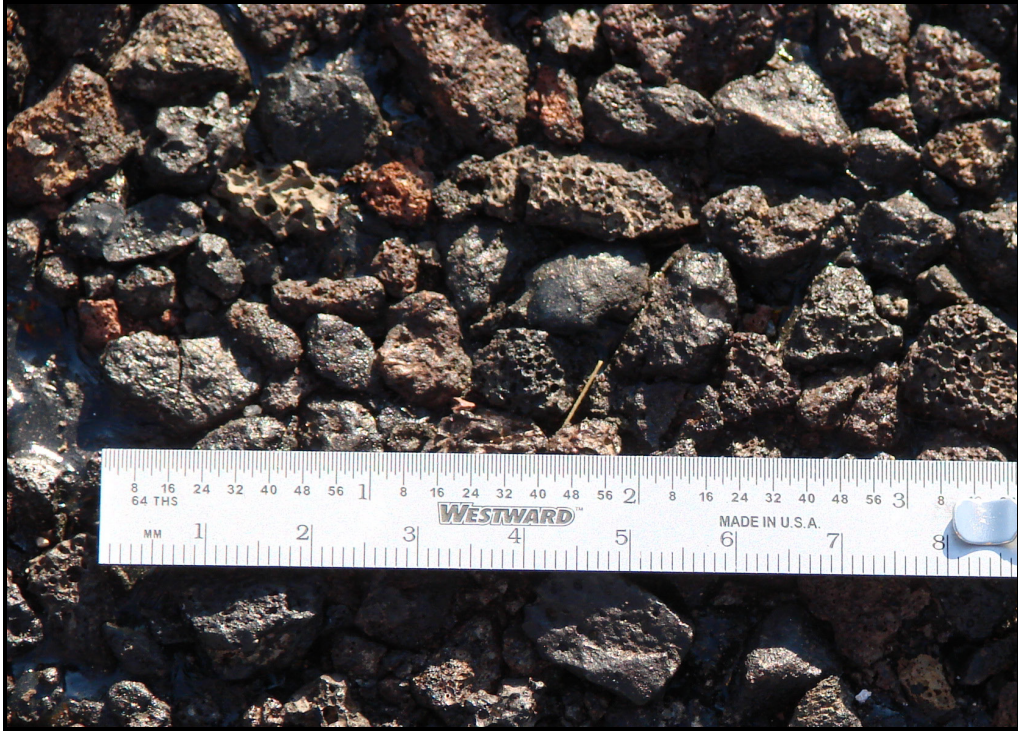
**Figure 8. Grade 4S Scoria Aggregate Seal Coat.**

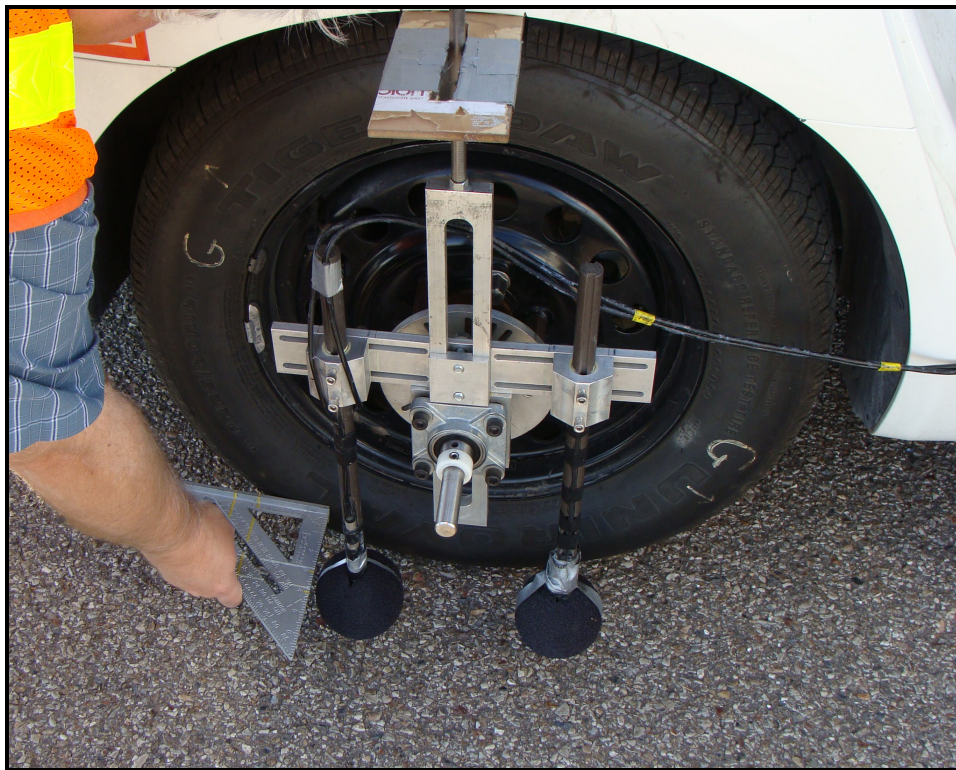
**Figure 9. Mounted TxDOT OBSI Noise Testing Equipment.**

The level of noise heard on the side of the road as a vehicle passes is a compilation of noise levels generated from several sources. The primary sources are from the engine compartment, from the exhaust system, and the noise generated at the tire-pavement interface as the vehicle passes. For a given vehicle passing over two differing pavement surfaces at the same speed, the first two noise sources can be considered constants. It is the third component of total roadside noise, the component generated at the tire-pavement interface, which varies based on the type of pavement surface. For this reason, OBSI noise testing was selected to compare sound levels associated with the various types and grades of seal coats. Figure 9 shows OBSI test equipment mounted on the passenger side rear tire of a test vehicle. The OBSI method of test was AASHTO TP 76-09, “Measurement of Tire/Pavement Noise Using the On-Board Sound Intensity (OBSI) Method.” TxDOT’s OBSI equipment was used for all testing, and TxDOT’s noise test specialist, John Wirth, participated in all noise testing on the project.

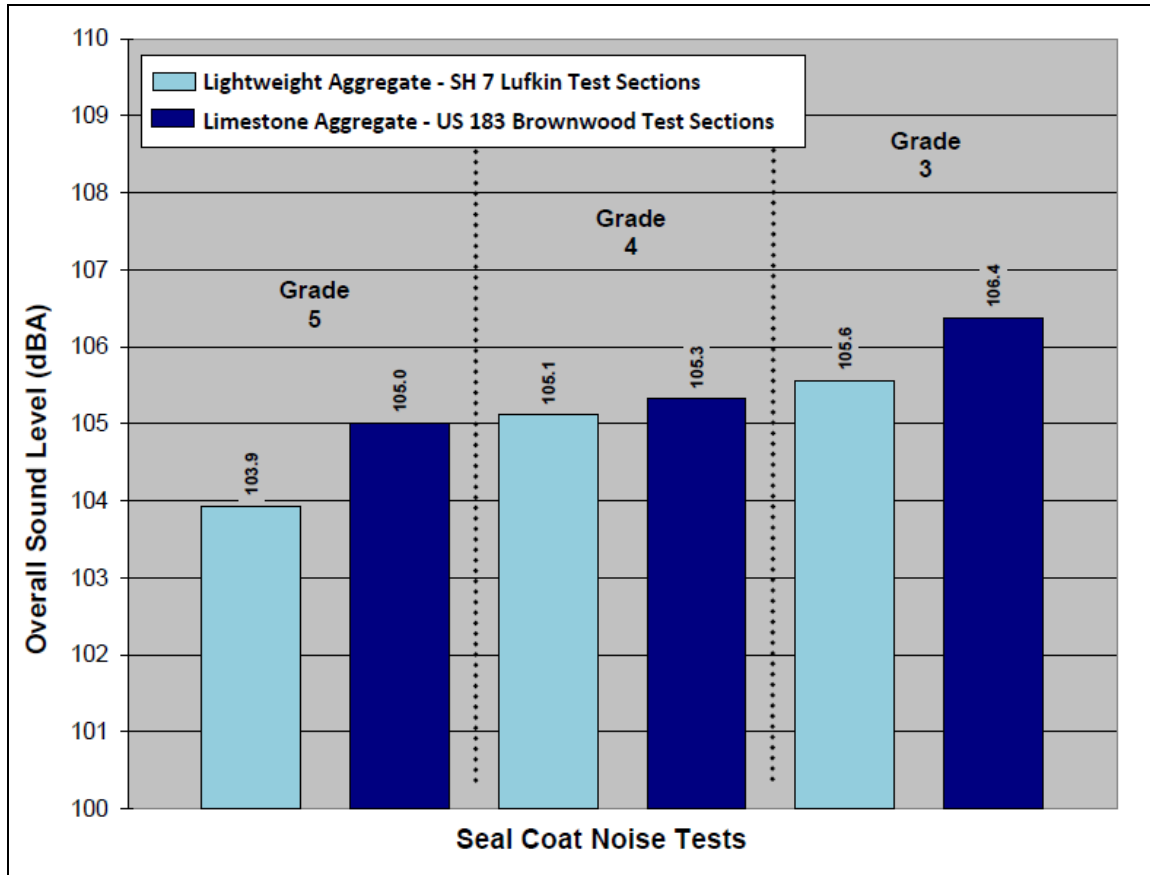
**Figure 11. Noise Level Comparison of Grades 3, 4, and 5 Lightweight and Limestone Seal Coat Test Sections Less Than 1 Week under Traffic.**

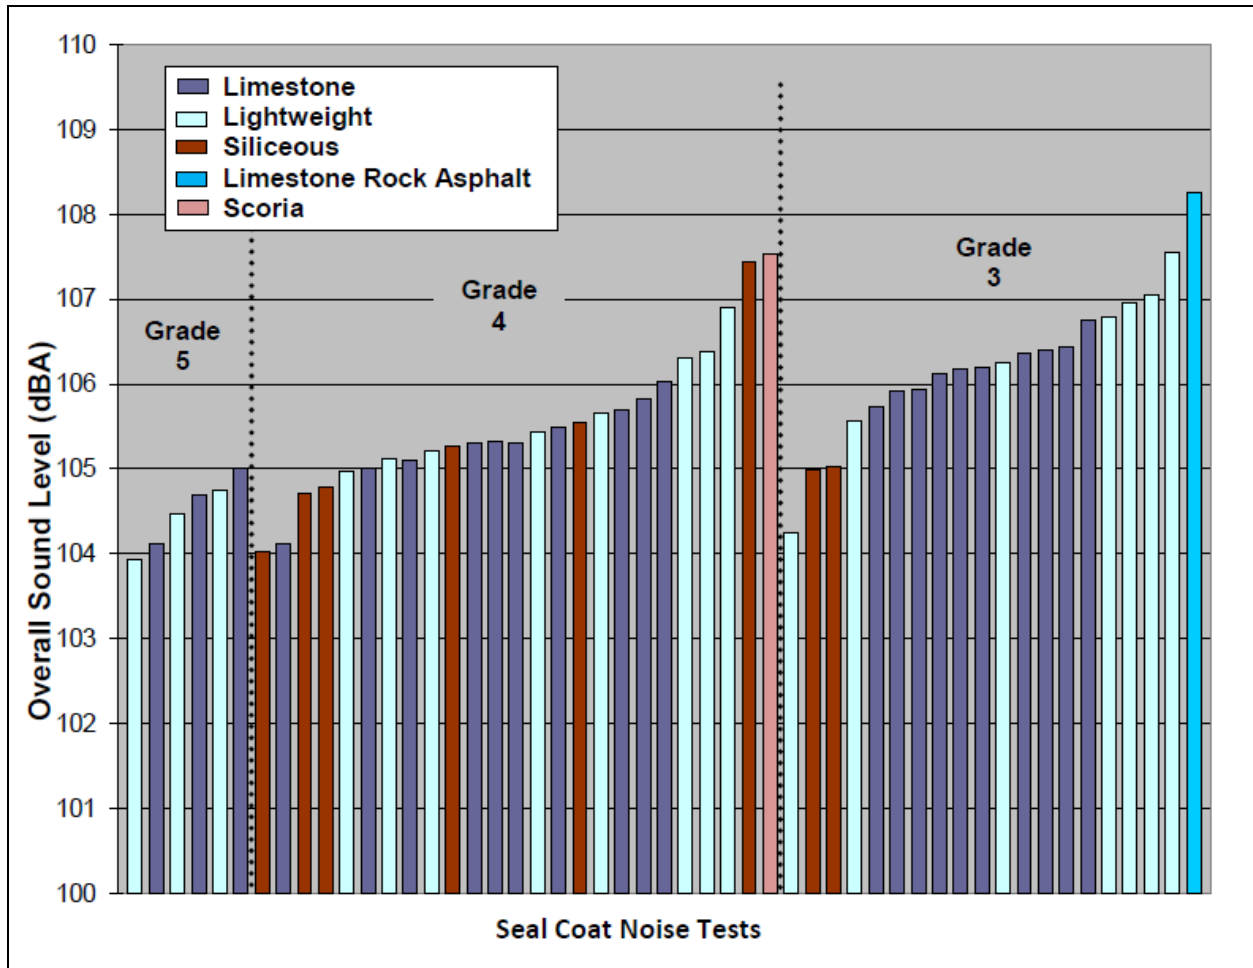
Average noise intensity levels were determined for all Grades 3, 4, and 5 seal coats tested. The average noise intensity level averages were 106.2 dBA, 105.5 dBA, and 104.5 dBA, respectively, for Grades 3, 4, and 5 seal coats.

**Figure 12. Comprehensive Noise Level Comparison of Seal Coat Grades 3, 4, and 5 – All Ages.**

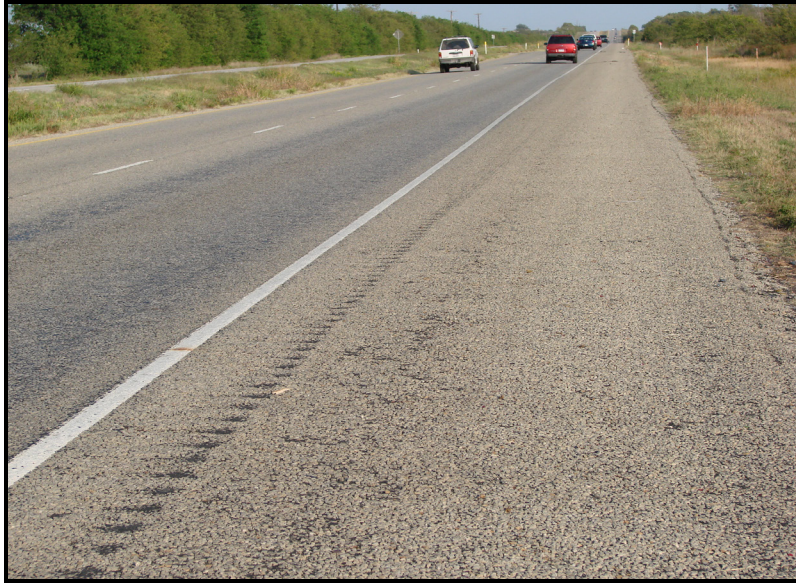
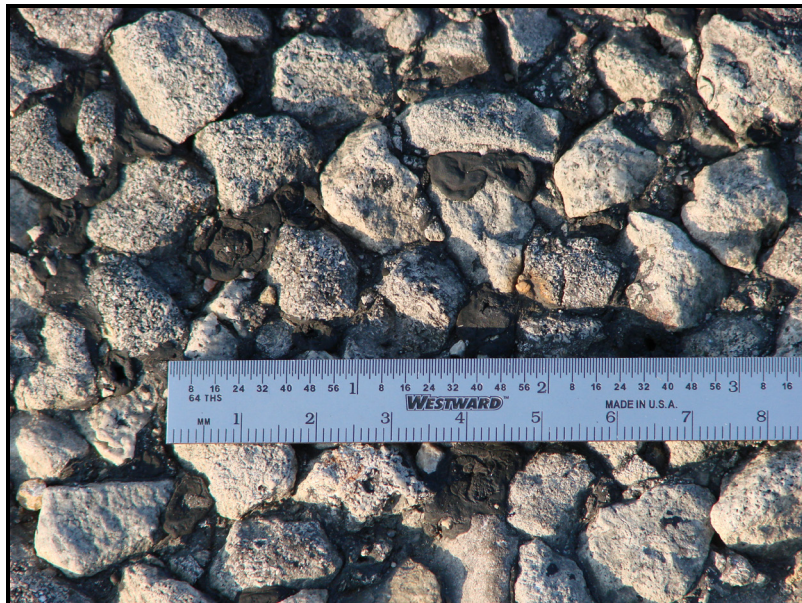
The single limestone rock asphalt seal coat included in the noise test study was selected for testing because the local district considered it particularly loud. This seal coat was approximately 10 years old when noise tested, and it was still in very good condition. The district had not yet scheduled it for resealing. This pavement was found to be the loudest seal coat included in project testing, at 108.3 dBA. Figures 13 and 14 show the appearance and texture of

**Figure 13. US 80 Limestone Rock Asphalt Grade 3 Seal Coat Appearance.**

**Figure 14. US 80 Limestone Rock Asphalt Grade 3 Seal Coat Texture.**

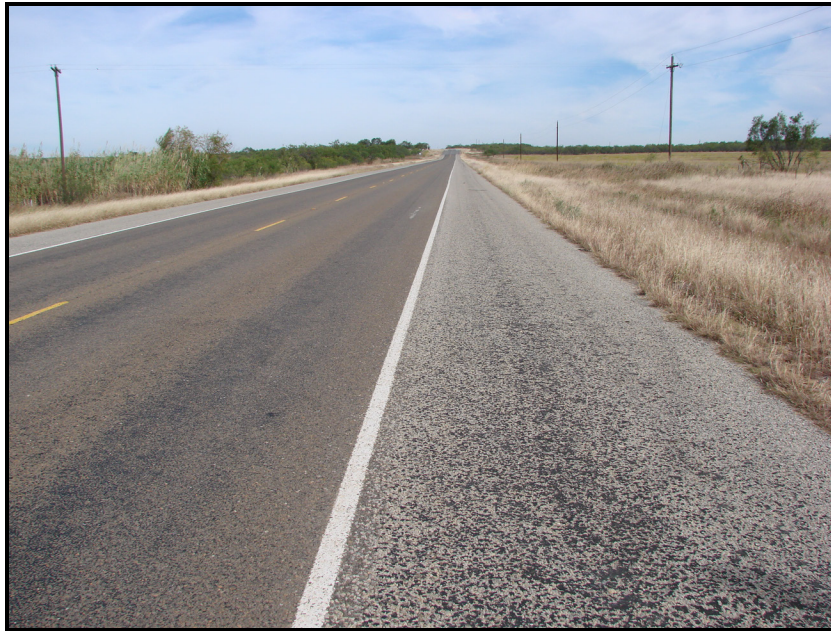
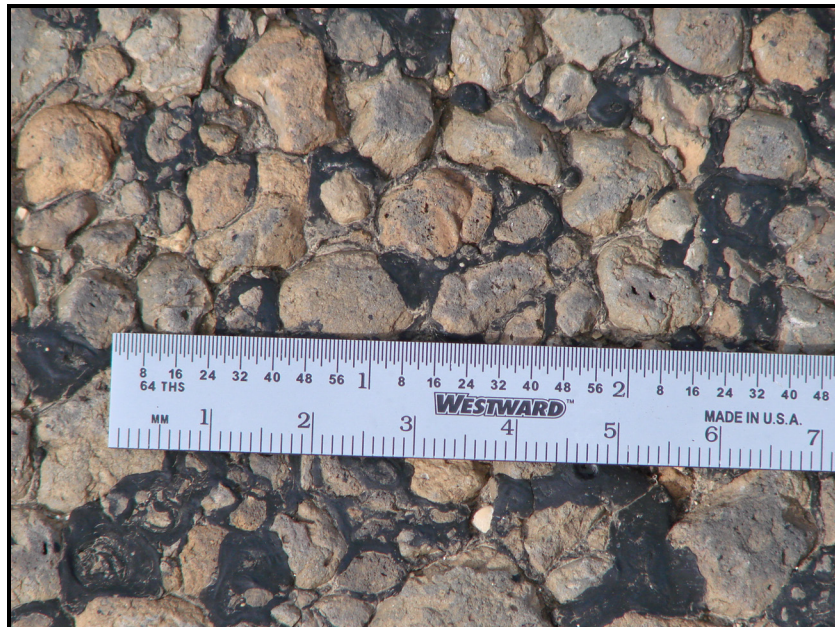
this pavement. On the other extreme among Grade 3 seal coats, an eight-year-old lightweight Grade 3 was found to have a noise level of 104.3 dBA, which is well within the noise level range found for Grade 5 seal coats. Figures 15 and 16 show the appearance and texture of this particularly quiet Grade 3 seal coat. The texture photo shows a distinct lack of macro-texture, which may be a factor in the lower noise level being emitted.

**Figure 15. FM 503 Lightweight Grade 3 Seal Coat Appearance.**

**Figure 16. FM 503 Lightweight Grade 3 Seal Coat Texture.**

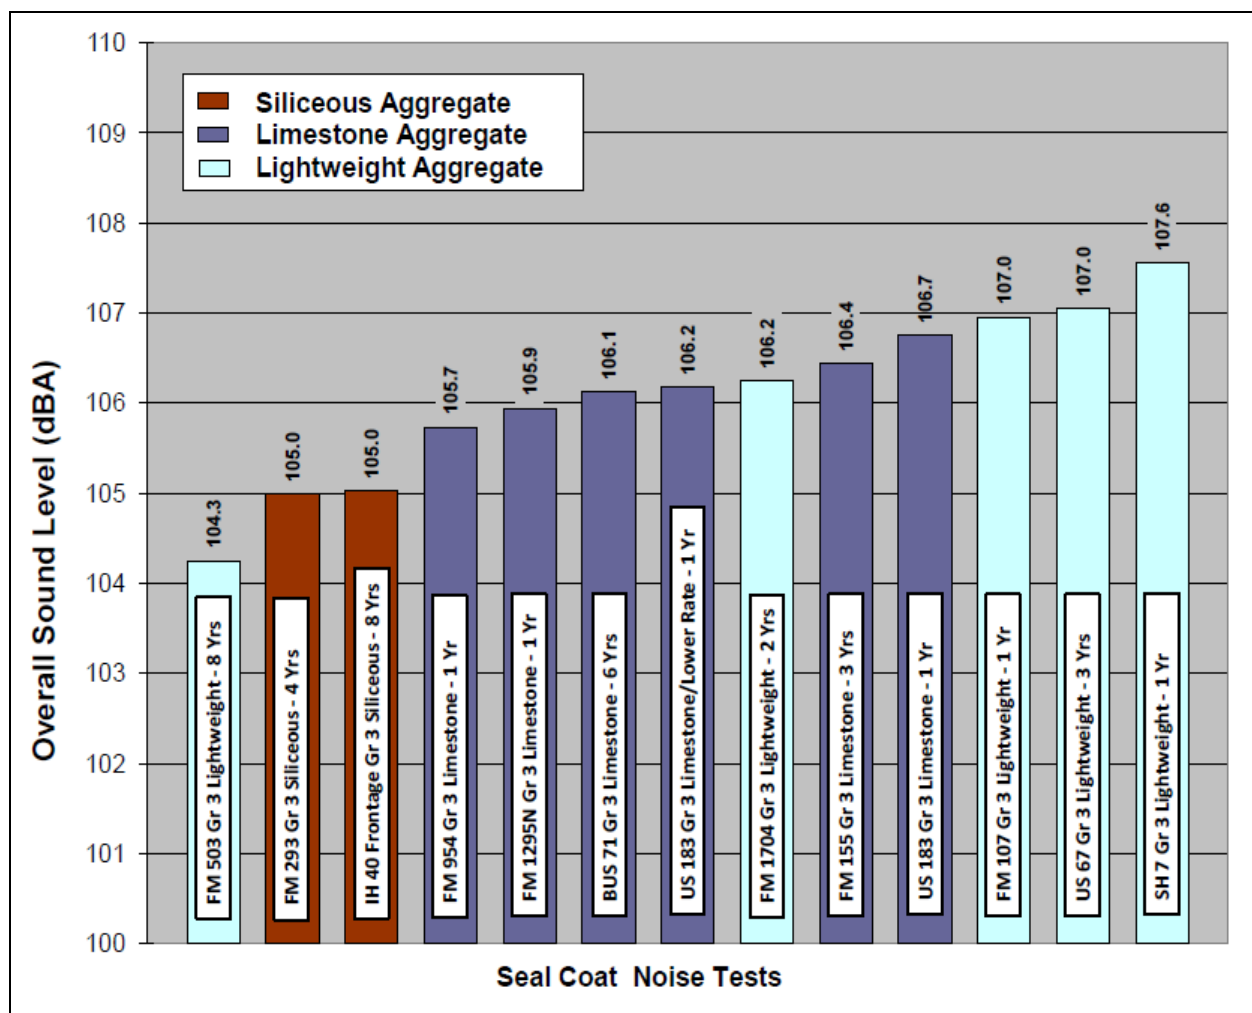
Testing included seal coats composed of limestone, siliceous, lightweight, limestone rock asphalt, and scoria mineral types. Figure 17 displays the range of noise levels found in siliceous,

limestone, and lightweight aggregate Grade 3 seal coats after at least one year under traffic. The single limestone rock asphalt Grade 3 seal coat noise level of 108.3 dBA is not included in the figure for comparison since this pavement was selected for testing due to its particular loudness. Figure 18 shows the range of noise levels found in Grade 4 seal coats of varying mineral types after at least one year under traffic. The single noise test of scoria seal coat aggregate is also not displayed as this test was performed after one week of traffic. A noise intensity of 107.5 dBA was determined.

**Figure 17. Noise Level Comparison of Various Grade 3 Mineral Aggregate Types after 1 or More Years under Traffic.**

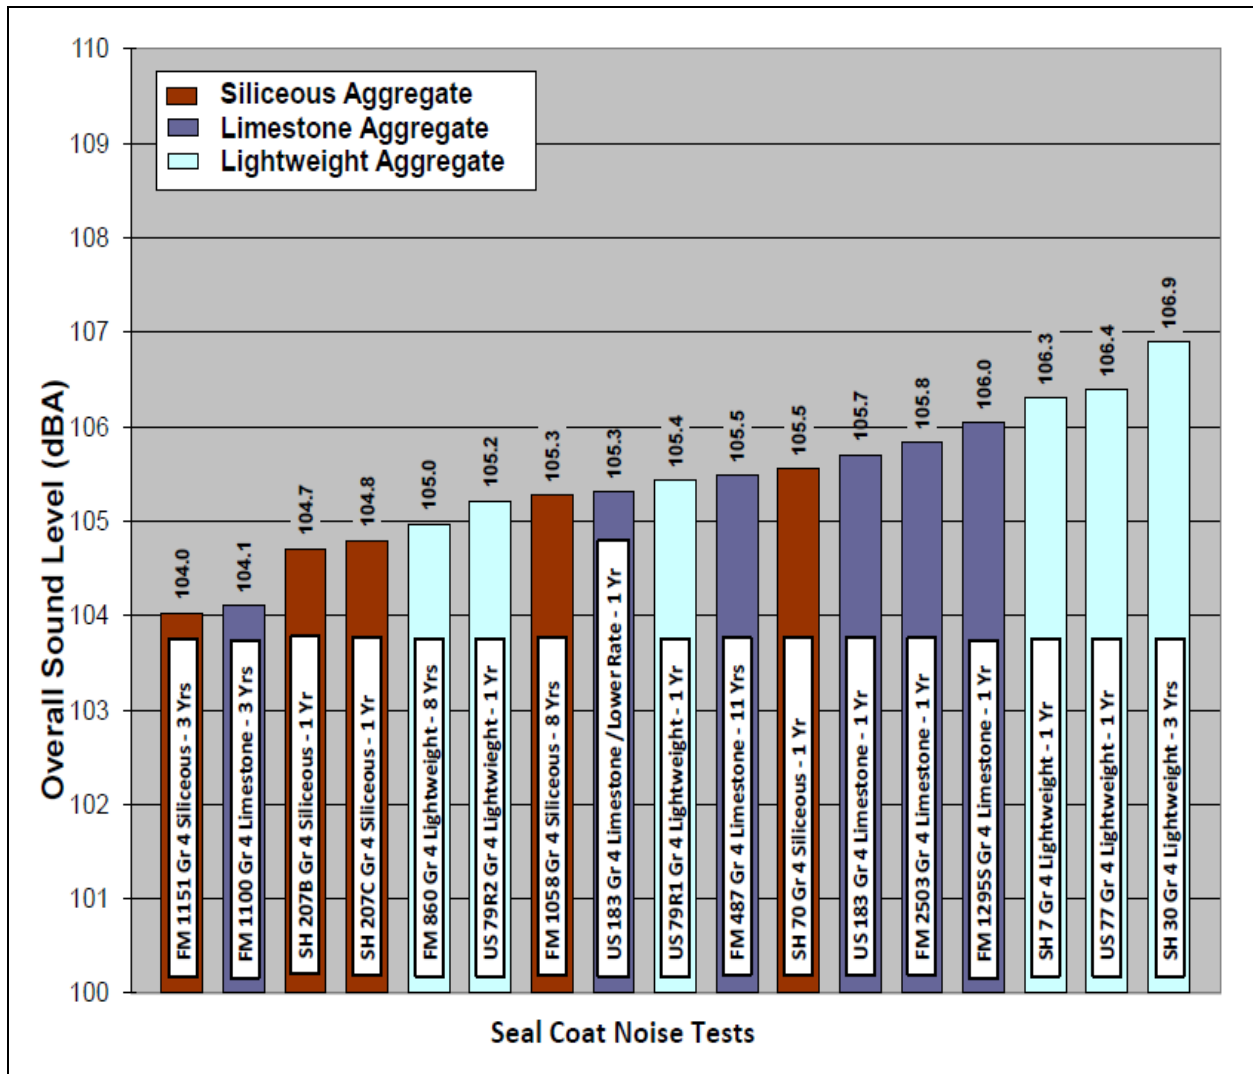
**Figure 18. Noise Level Comparison of Various Grade 4 Mineral Aggregate Types after 1 or More Years under Traffic.**

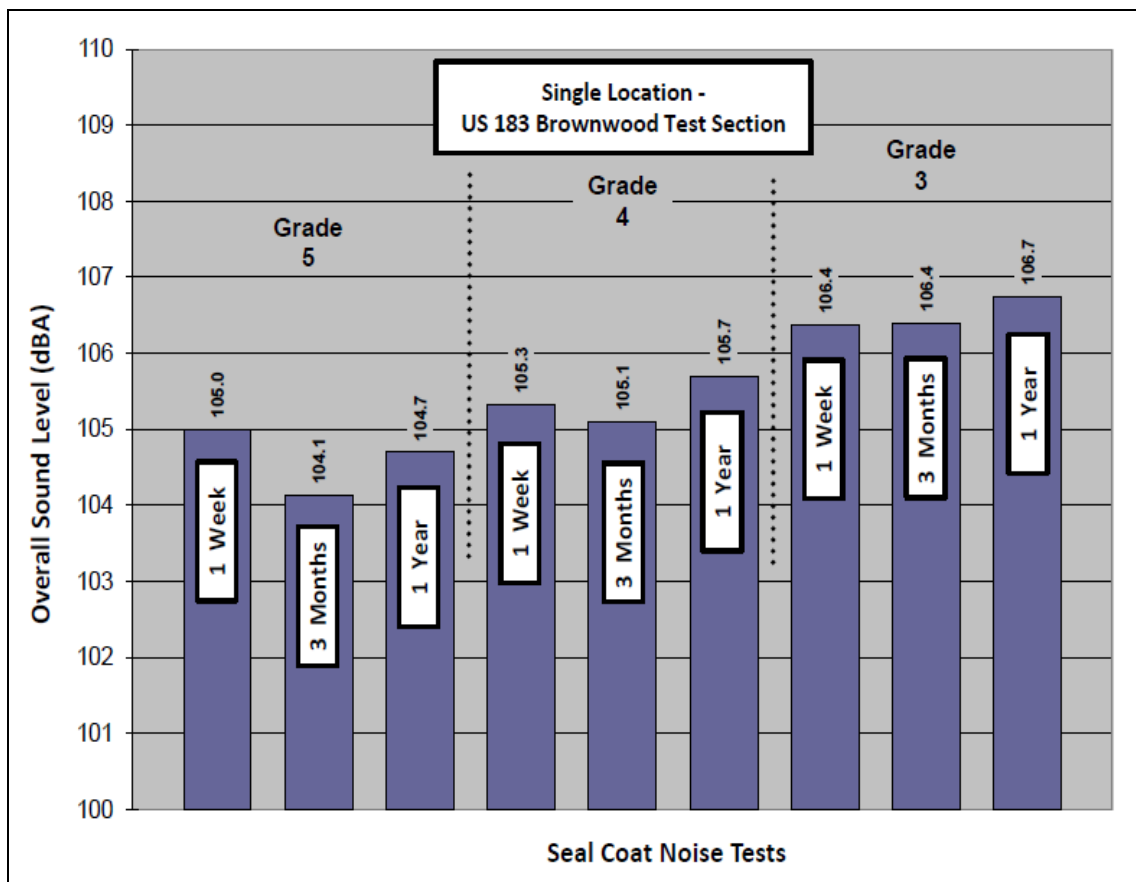
Seal coats of varying ages were tested during the project. The test sections constructed for this study were OBSI tested within a week after construction, after approximately three months under traffic, and after one year under traffic. Existing seal-coated pavements noise tested ranged from one year to 11 years old. Figures 19 and 20 display noise test results obtained from the limestone and lightweight aggregate seal coat test sections constructed for this project. During the first year under traffic, a mild increase in tire-pavement interface noise is noted in two of the three limestone aggregate test sections and in all three of the lightweight aggregate test sections. However, the degree of increase in noise level is so small as to be indiscernible to the human ear.

Figure 19. Noise Level Comparison of Limestone Seal Coats at Early Ages.

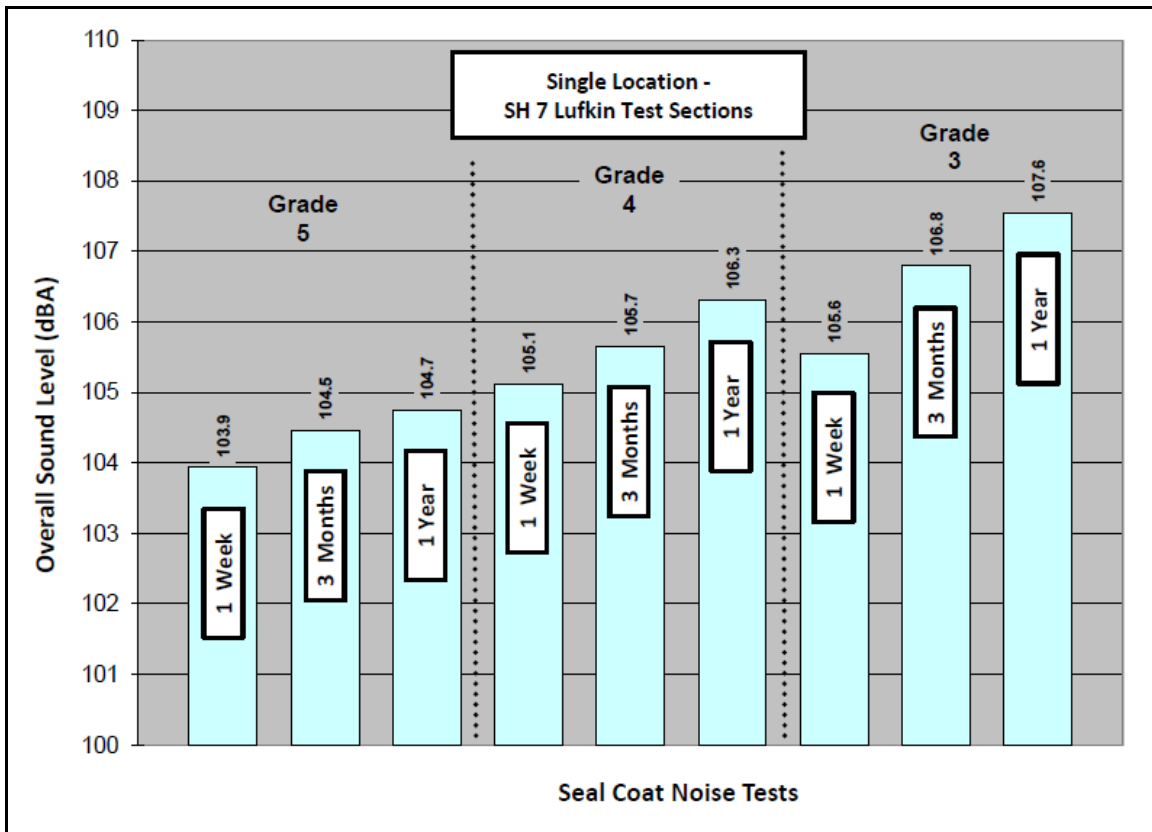
**Figure 20. Noise Level Comparison of Lightweight Seal Coats at Early Ages.**

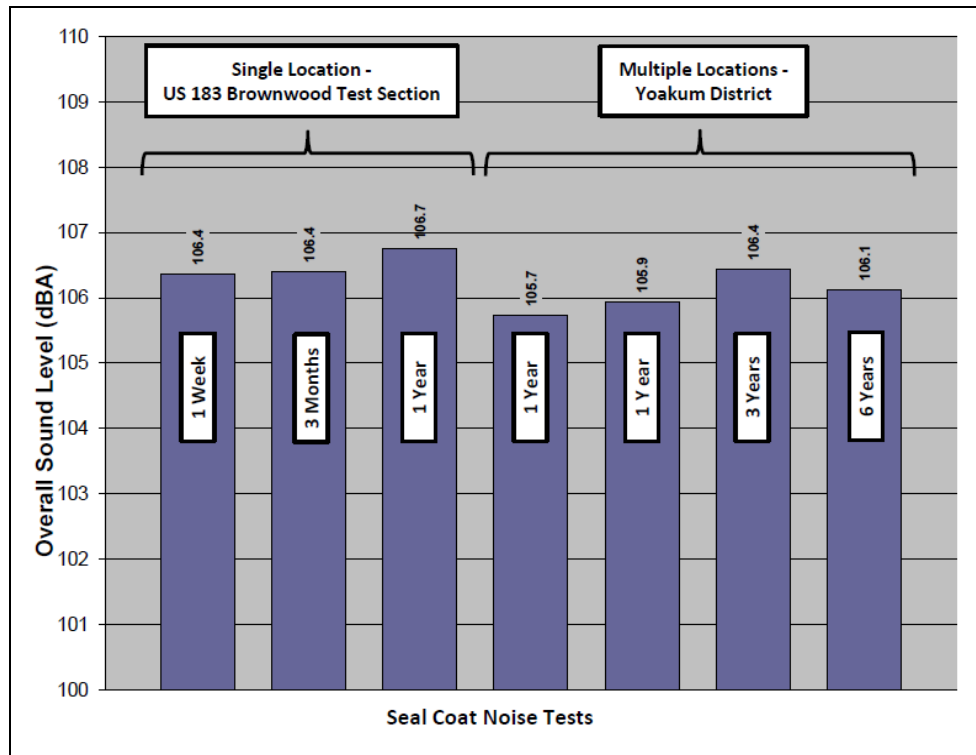
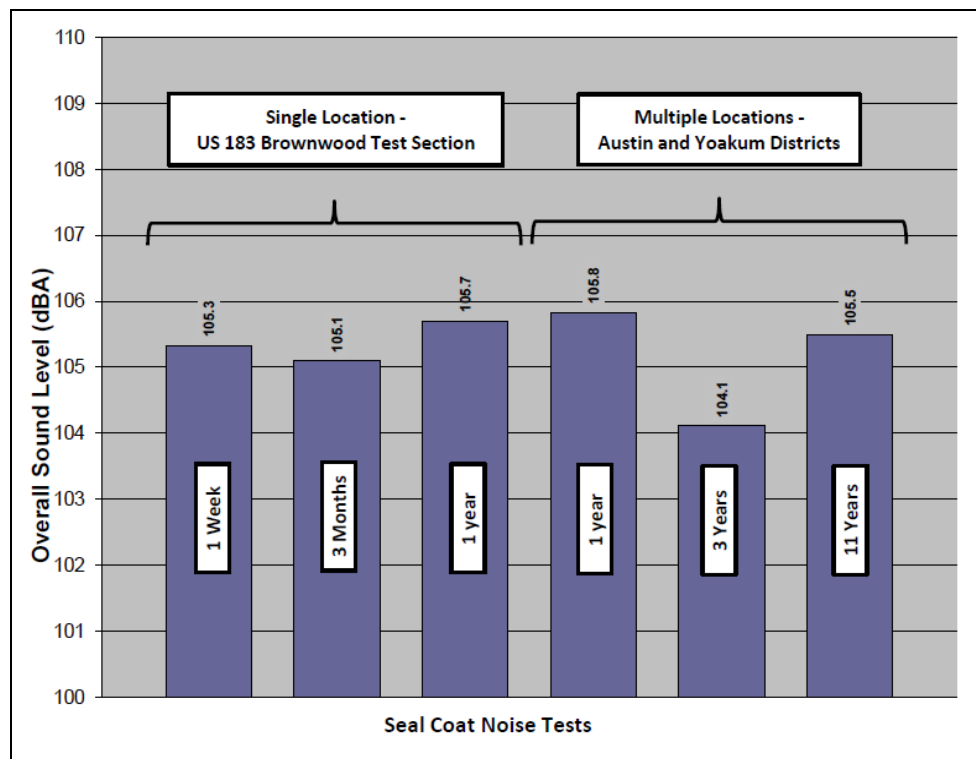
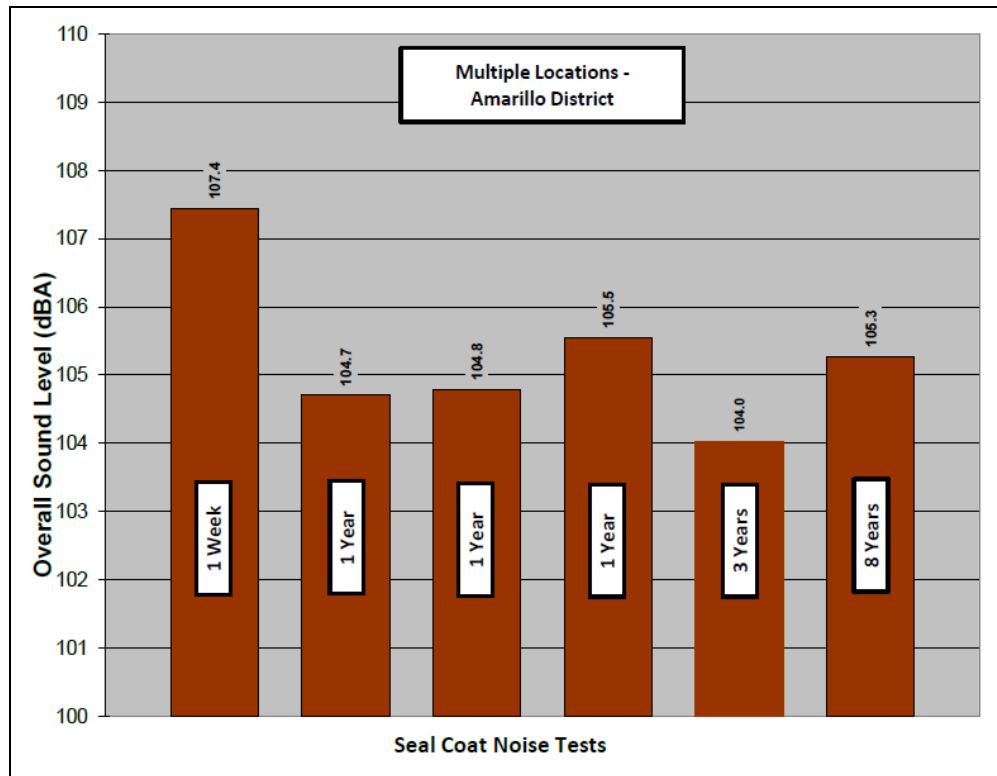
Figures 21 through 25 display noise test results from multiple locations, including both the constructed test sections and the existing pavements tested at various later ages. As such, they show the range of noise levels found for the full range of seal coat ages included in the study. The test results are grouped by age at the time of noise testing.

As shown in these five figures, no obvious trend between age and noise level being generated at the tire-pavement interface was observed. A possible trend is noted for the lightweight aggregate to become slightly louder with age. When interpreting these results, one should keep in mind the process of selecting existing pavements for testing. If a pavement was found to have notable flushing in the wheel path, it was not included in the set of pavements to be tested. A number of pavements did exhibit a degree of flushing deemed normal for aged seal coats. Although mild, differences in degree of flushing between pavements may have had an effect on noise test results. Appendix E contains photographs of the roadway and the pavement wheel path texture representative of each noise test location.

Figure 21. Noise Level Comparison of Limestone Grade 3 Seal Coats at All Ages.

Figure 22. Noise Level Comparison of Limestone Grade 4 Seal Coats at All Ages.

Figure 23. Noise Level Comparison of Grade 3 Lightweight Seal Coats at All Ages.

Figure 24. Noise Level Comparison of Grade 4 Lightweight Seal Coats at All Ages.

**Figure 25. Noise Level Comparison of Grade 4 Siliceous Aggregate Seal Coats at All Ages.**

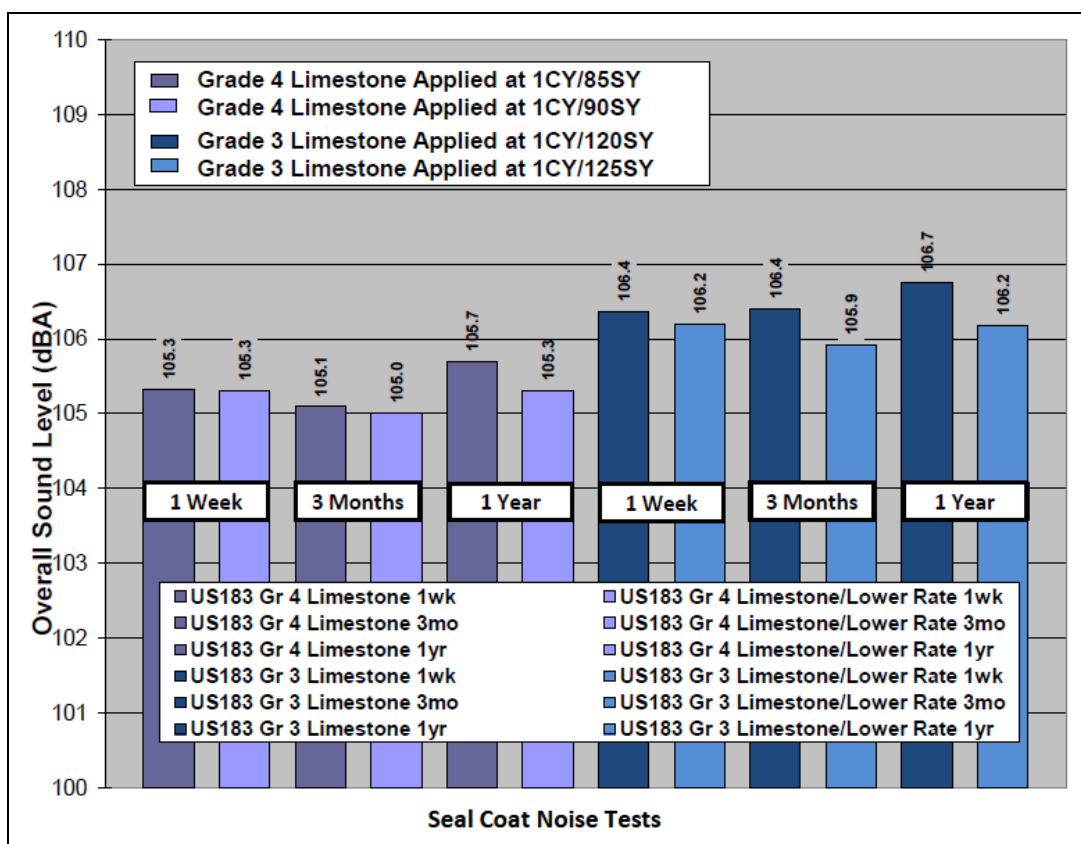
A reduction in tire-pavement interface noise intensity resulted from lowering the aggregate application rate for both Grade 3 and Grade 4 limestone aggregates. However, the degree of reduction is so small that the human ear would not be able to detect this difference.

**Figure 26. Noise Level Comparison of Varied Aggregate Application Rates.**

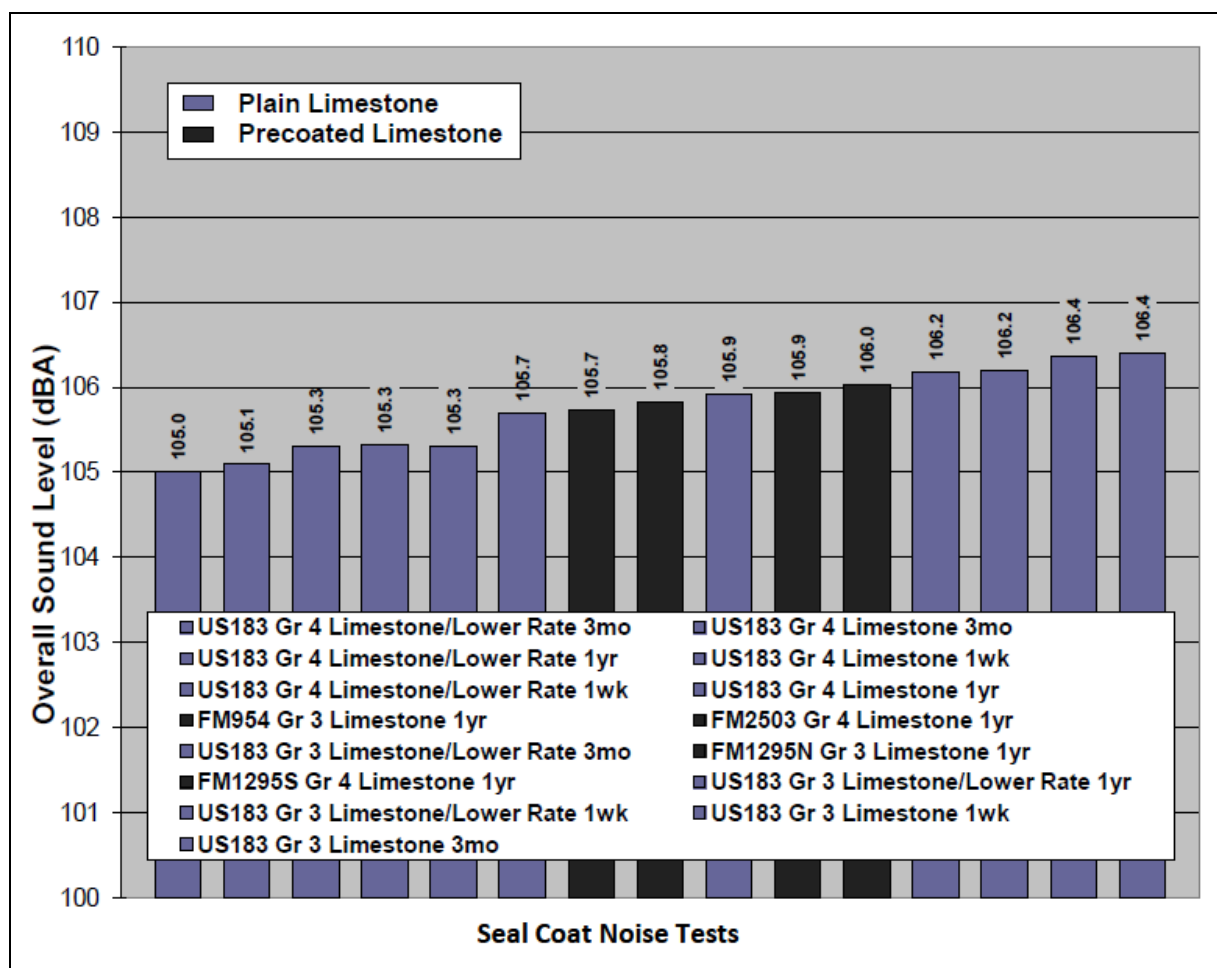
It is common practice in certain situations for construction plans to require the contractor to precoat the seal coat aggregate with asphalt prior to placement of the aggregate during seal coat paving. Noise test results from all limestone seal coats having been under traffic for one year or less are displayed in Figure 27. The results show no clear indication of effect on tire-pavement interface noise intensity level resulting from whether or not the aggregate had been precoated with asphalt prior to construction.

**Figure 27. Noise Level Comparison of Plain and Precoated Limestone Aggregate.**
