1. Report No. FHWA/TX-12/0-6496-1		2. Government Accession No.		3. Recipient's Catalog No.	
4. Title and Subtitle PERFORMANCE COMPARISON OF VARIOUS SEAL COAT GRADES USED IN TEXAS				5. Report Date January 2012 Published: July 2012

# **PERFORMANCE COMPARISON OF VARIOUS SEAL COAT GRADES USED IN TEXAS**

Report 0-6496-1  
Project 0-6496

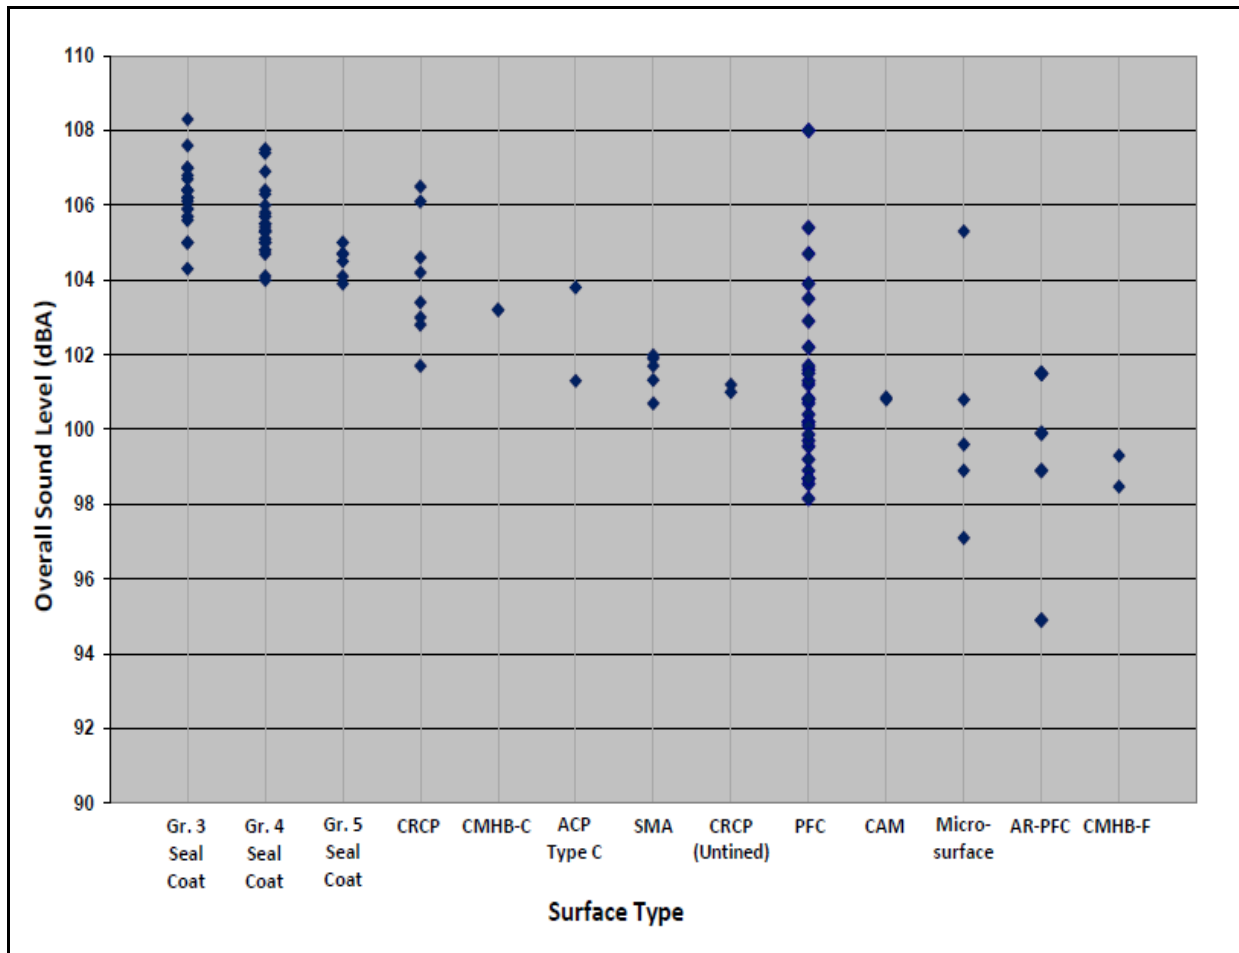
It is apparent from Figure 28 that seal coat pavement surfaces are generally the loudest pavement surface options, followed closely by continuously reinforced concrete pavement (CRCP). Permeable friction course (PFC) surfaces tend to be noticeably quieter, on average, but it is possible to have a PFC just as loud as any of the seal coat grades or CRCP.

**Figure 28. Noise Level Comparison of Various Pavement Types.**

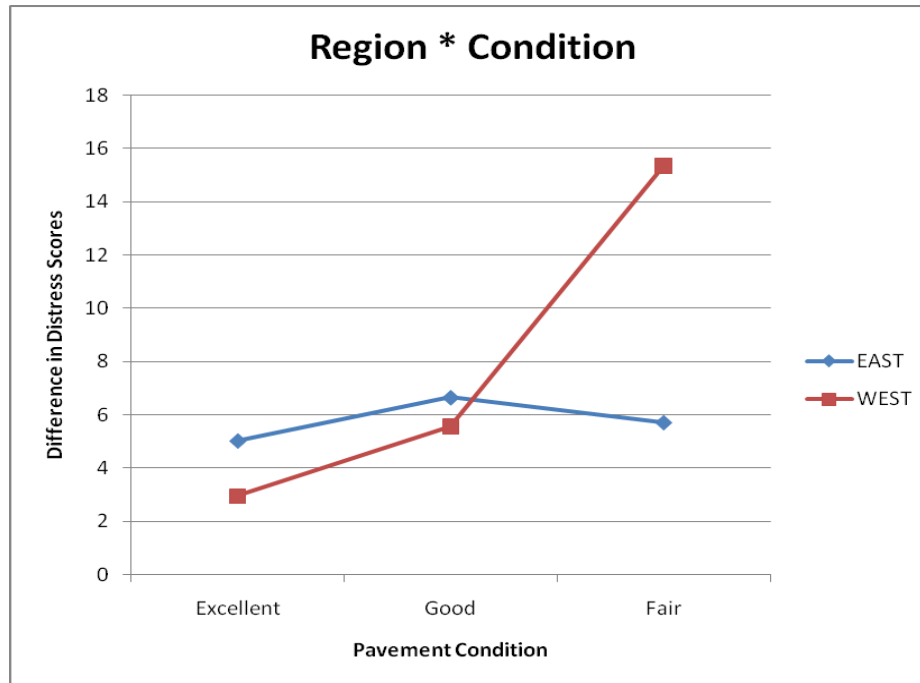
Distress scores decline much more rapidly for fair to poor pre-construction pavement condition sections in the western region than for those in the eastern region (see Table 14 and Figure 29). A different situation applies for excellent and good pavement conditions, where distress scores decline less in the western region.

**Figure 29. Interaction Plot for 1998 Region and Pre-Construction Pavement Condition.**

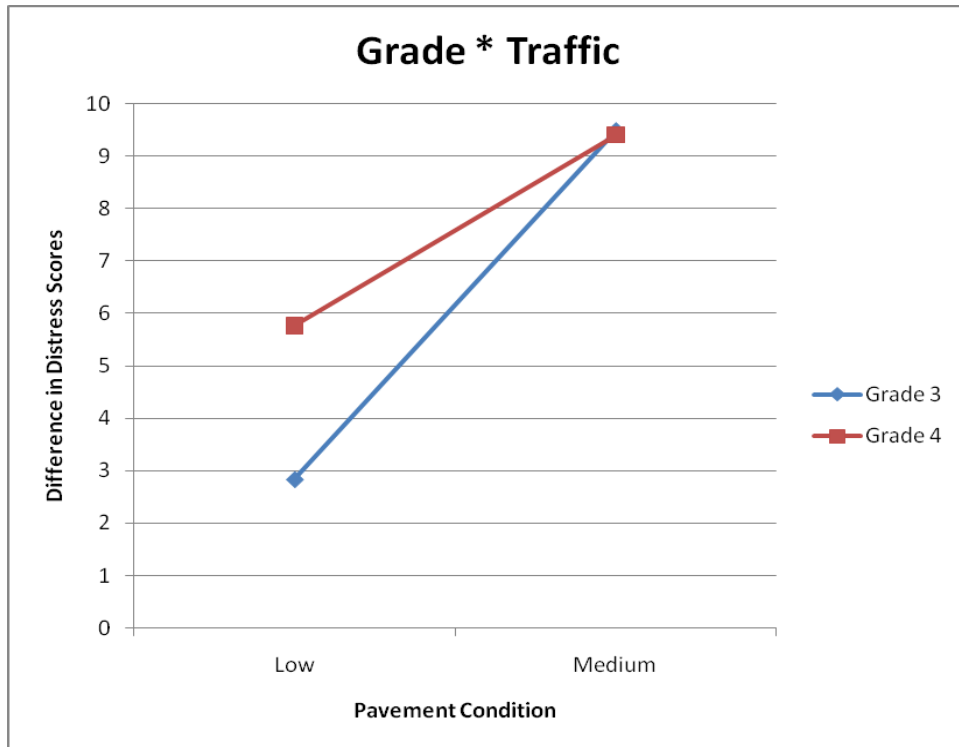
**Figure 30. Interaction Plot for 1998 Seal Coat Grade and Traffic Level.**

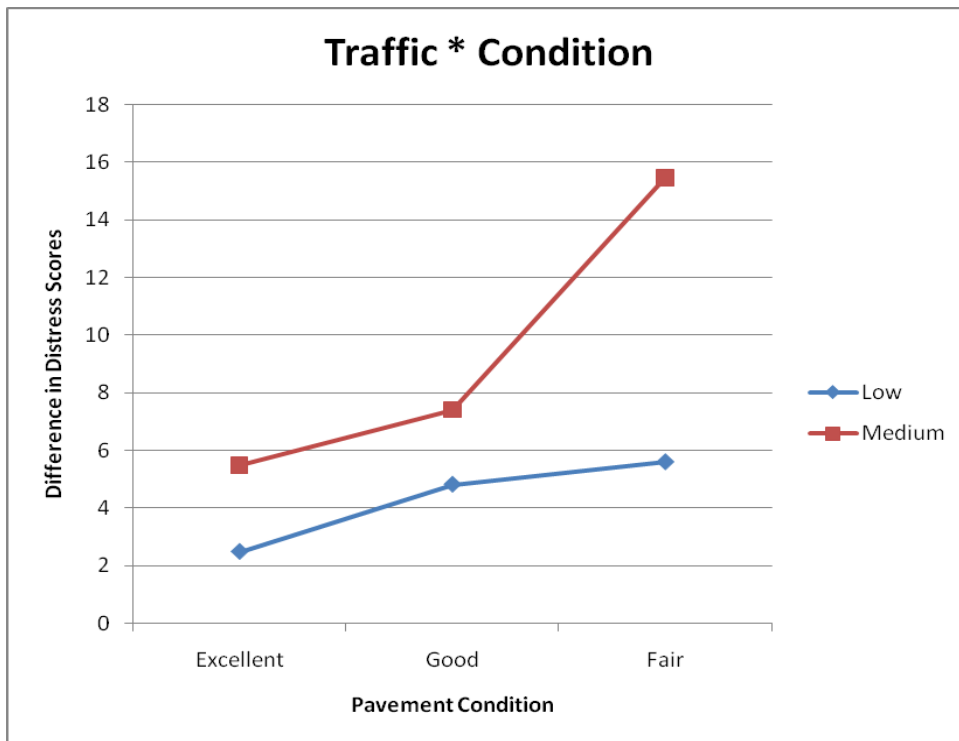
**Figure 31. Interaction Plot for 1998 Traffic Level and Pre-Construction Pavement Condition.**

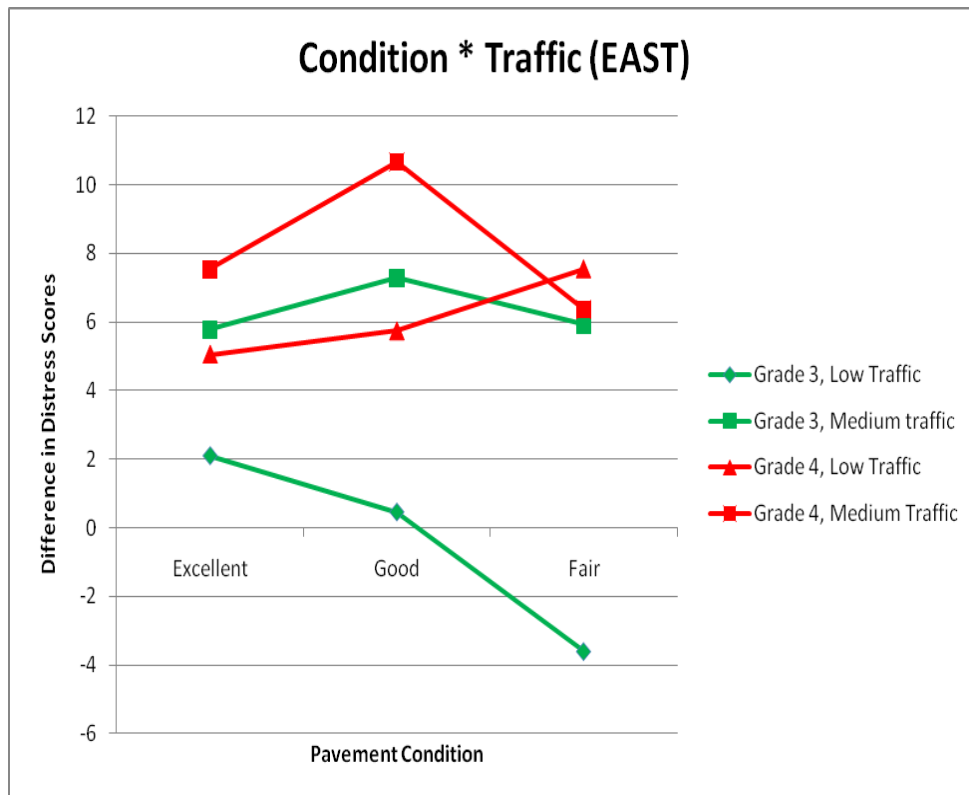
**Figure 32. Interaction Plot for 1998 Pre-Construction Pavement Condition and Traffic Level by Grade, Eastern Region.**

Declines in distress scores are much more unpredictable when seal coats are applied to roadways in only fair condition. In the Eastern region, Grade 4 seal coats on fair condition segments experience roughly the same decline in distress scores for low and medium traffic levels (see Figure 32). The same cannot be said for the western region, where traffic level appears to have a disproportionately large effect on distress scores for sections in fair condition, (see Figure 33), with medium traffic sections exhibiting a fourfold to sixfold decline in distress scores compared to the declines seen in low traffic sections.

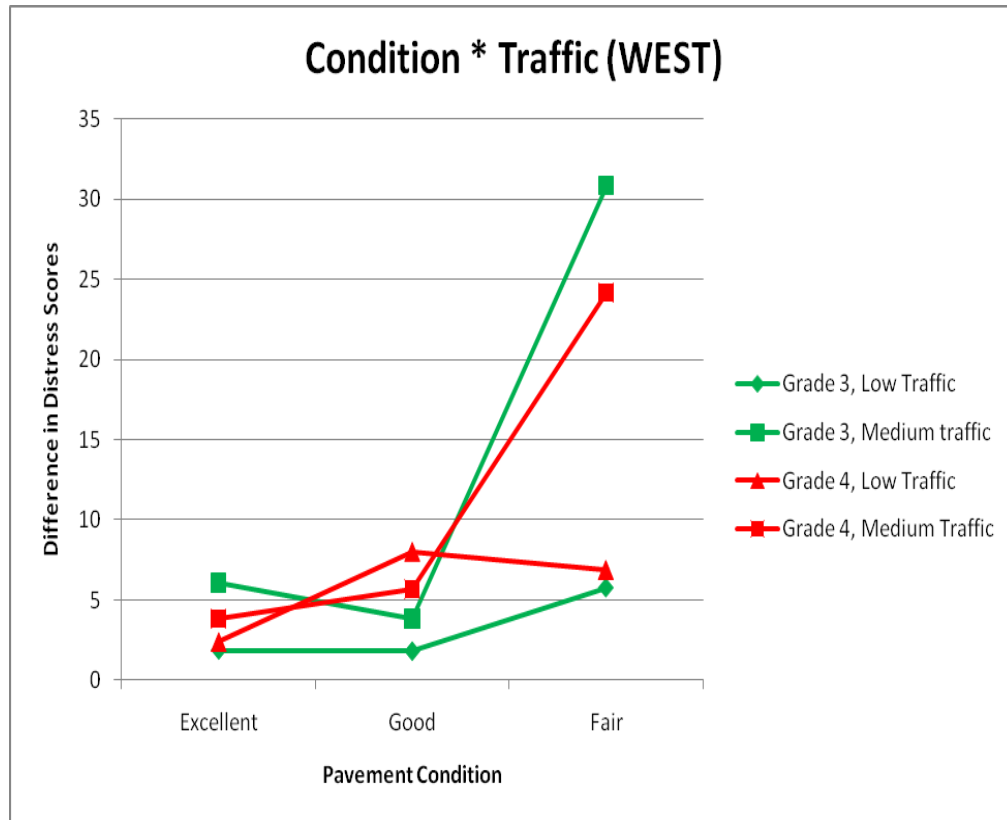
**Figure 33. Interaction Plot for 1998 Pre-Construction Pavement Condition and Traffic Level by Grade, Western Region.**

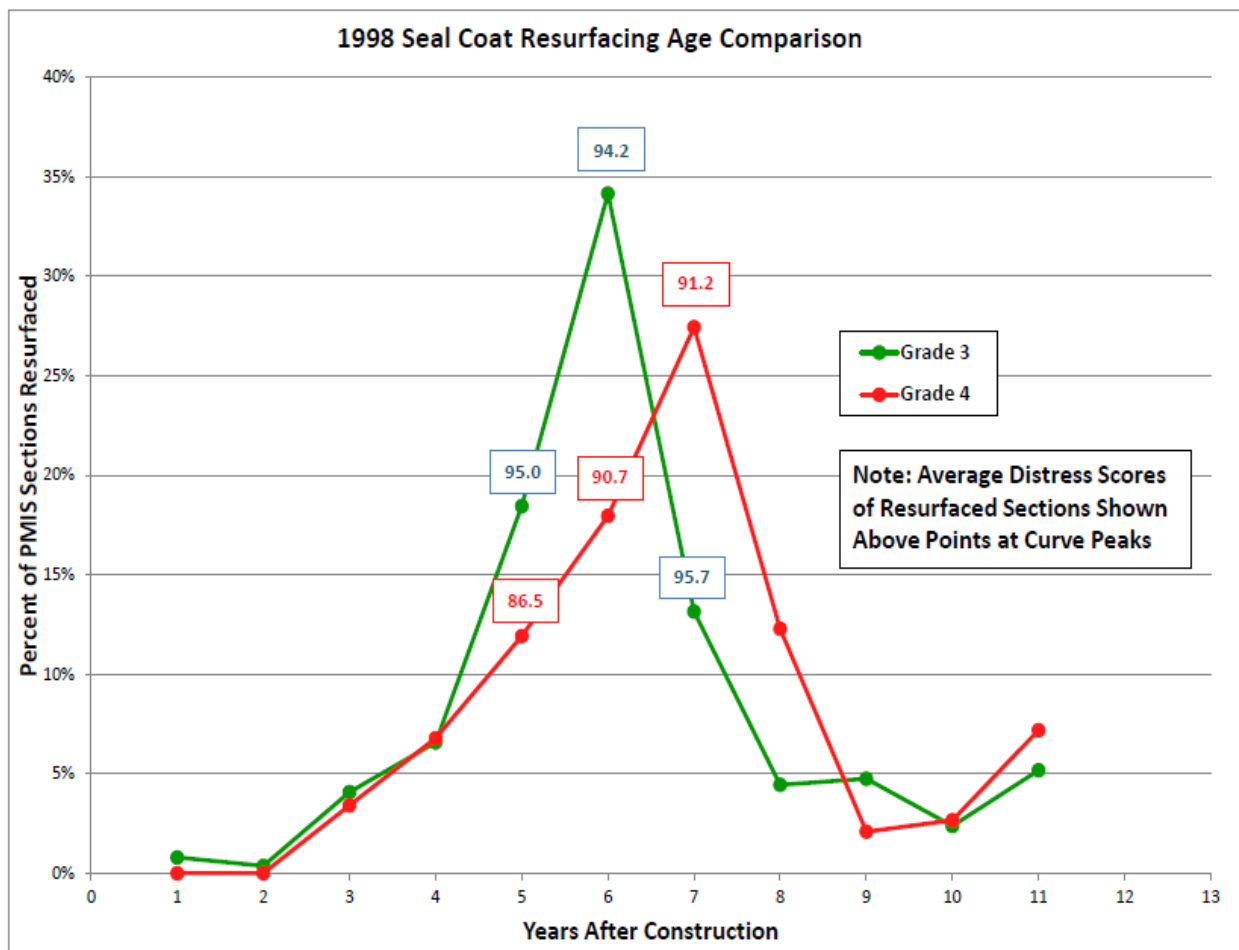
The curves clearly reveal two things. First, the six districts tended to replace Grade 3 seal coats more quickly than Grade 4 seal coats. The most frequently occurring resurfacing ages for Grade 3 and Grade 4 seal coats were after six years and seven years, respectively. Second, the Grade 3 seal coats selected for replacement each year consistently had higher distress scores (less distress observed) than the Grade 4 seal coats selected for resealing in the same year. No explanations for these tendencies were determined, and these findings were a surprise to those contacted in the districts as well. Certainly, something in addition to visually observable distresses noted during annual PMIS inspections triggered selection for resurfacing of seal coats constructed in these six districts in 1998.

**Figure 34. Annual Percentages of 1998 Seal Coats Resurfaced.**

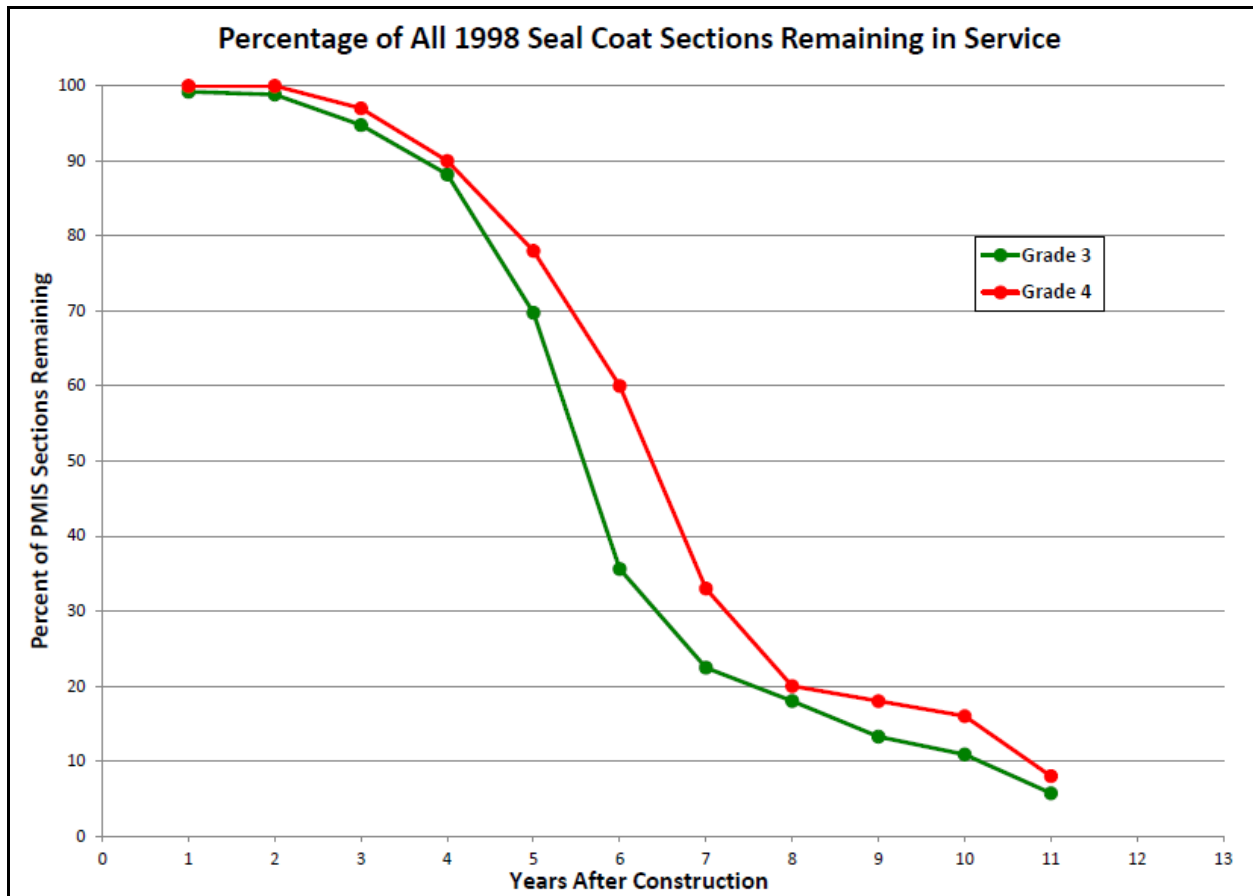
Figure 35 shows another method of comparing seal coat grade survival, where the declines in sections remaining in service can be seen. As in earlier comparisons of Grade 3 and Grade 4 performance, both groups of seal coats being compared include both precoated and plain aggregate.

**Figure 35. Survival Grade Comparison for All 1998 Seal Coats.**

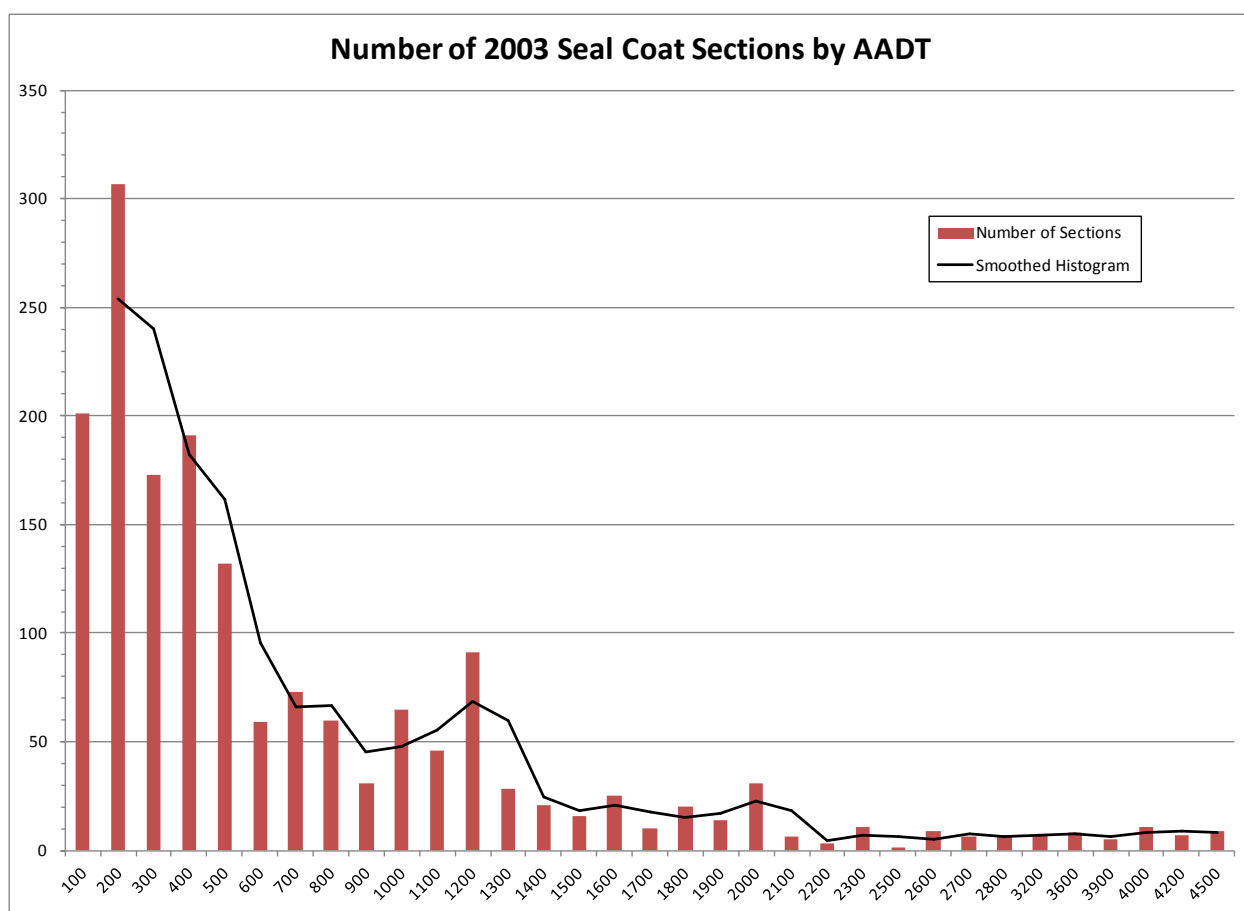
The range of annual average daily traffic (AADT) on these pavement sections ranged from extremely low to approximately 4,500. As might be expected for pavements selected for seal coat surfacing, the bulk of the pavements are carrying between 100 and 500 vehicles per day. The histogram displayed in Figure 36 shows additional detail about the AADT distribution in the data set used in this Grade 3 and Grade 4 seal coat performance comparison.

**Figure 36. Histogram of Seal Coat Sections by AADT.**

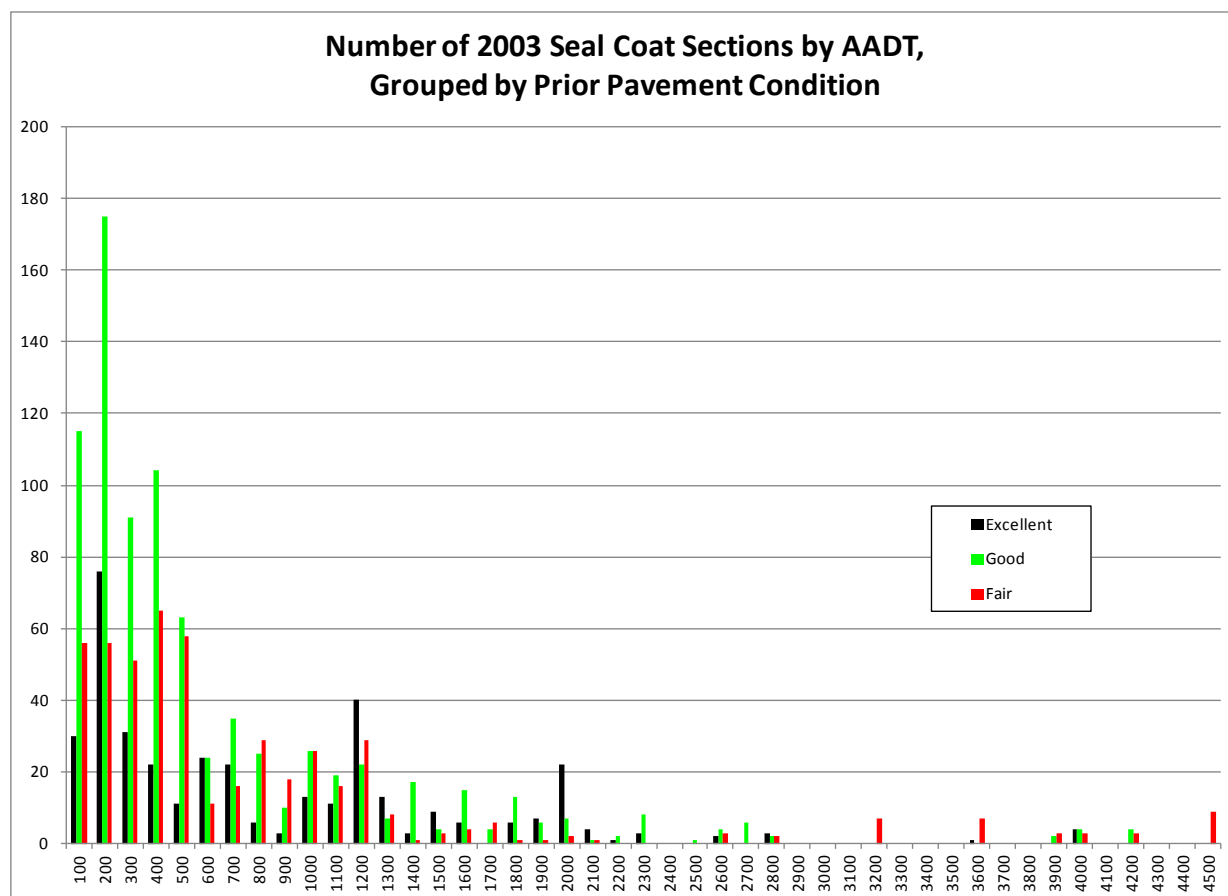
between 70 and 98, and Fair if the distress score is below 70. The traffic level is considered in the Low traffic category if AADT is below 1,000, the Moderate traffic category if the AADT is between 1,000 and 5,000, and any roadway with traffic above 5,000 is considered in the High traffic category.

**Figure 37. Histogram of Seal Coat Sections by AADT, Grouped by Condition.**

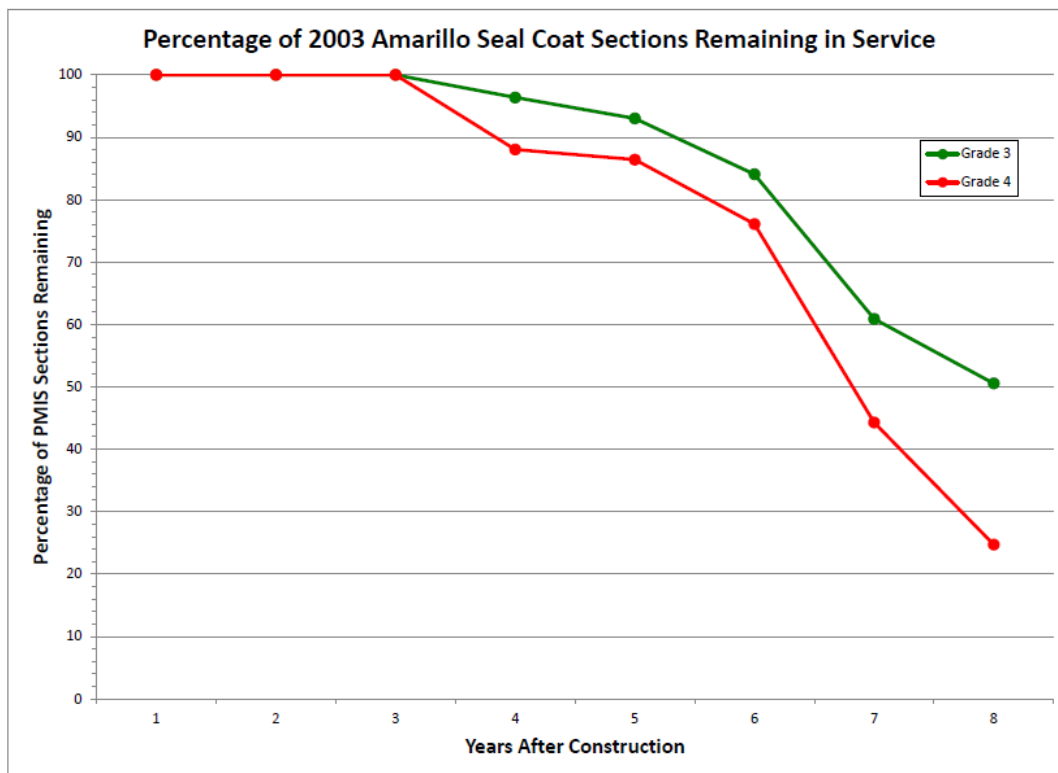
**Figure 38. Percent PMIS Sections Remaining in Service – Amarillo District.**

Preliminary data exploration indicated possible differences in distress score behavior over time, among the three districts. This led the research team to prepare separate analyses for each district. Figures 38, 39, and 40 show percentages of Grade 3 and Grade 4 seal coats remaining in service in the Amarillo, Paris, and Yoakum Districts, over time, following construction in 2003. Each of the three districts, on average, have left their Grade 3 seal coats in service longer than their Grade 4 seal coats. This is a reversal from the findings from the earlier analysis of seal coats that the six districts placed in 1998. No reason for this shift was evident, though only Amarillo District data were included in both the 1998 and 2003 seal coat analyses. This lack of geographic and management overlap could be a factor involved in this difference.

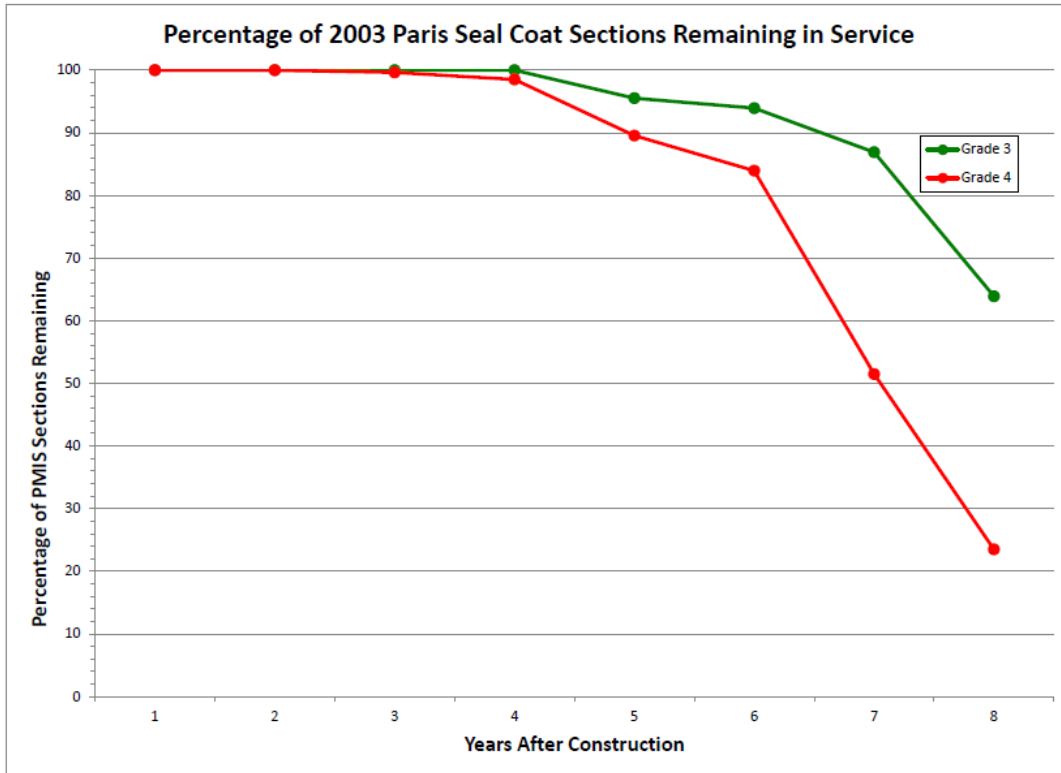
**Figure 39. Percent PMIS Sections Remaining in Service – Paris District.**

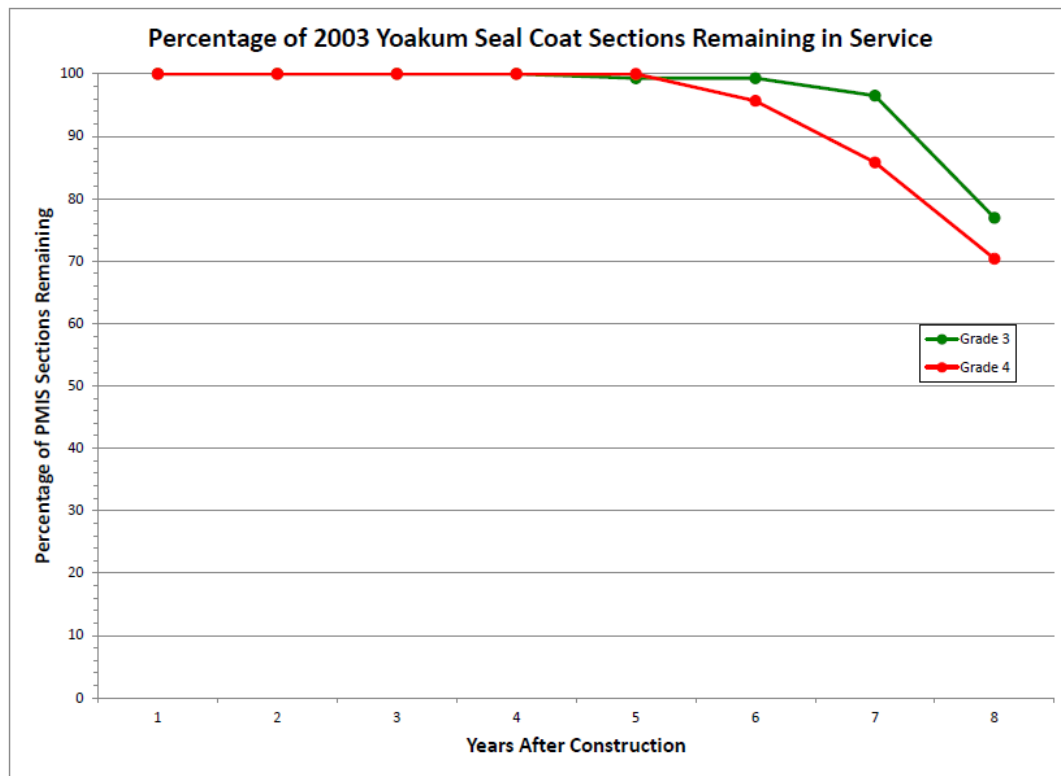
**Figure 40. Percent PMIS Sections Remaining in Service – Yoakum District.**

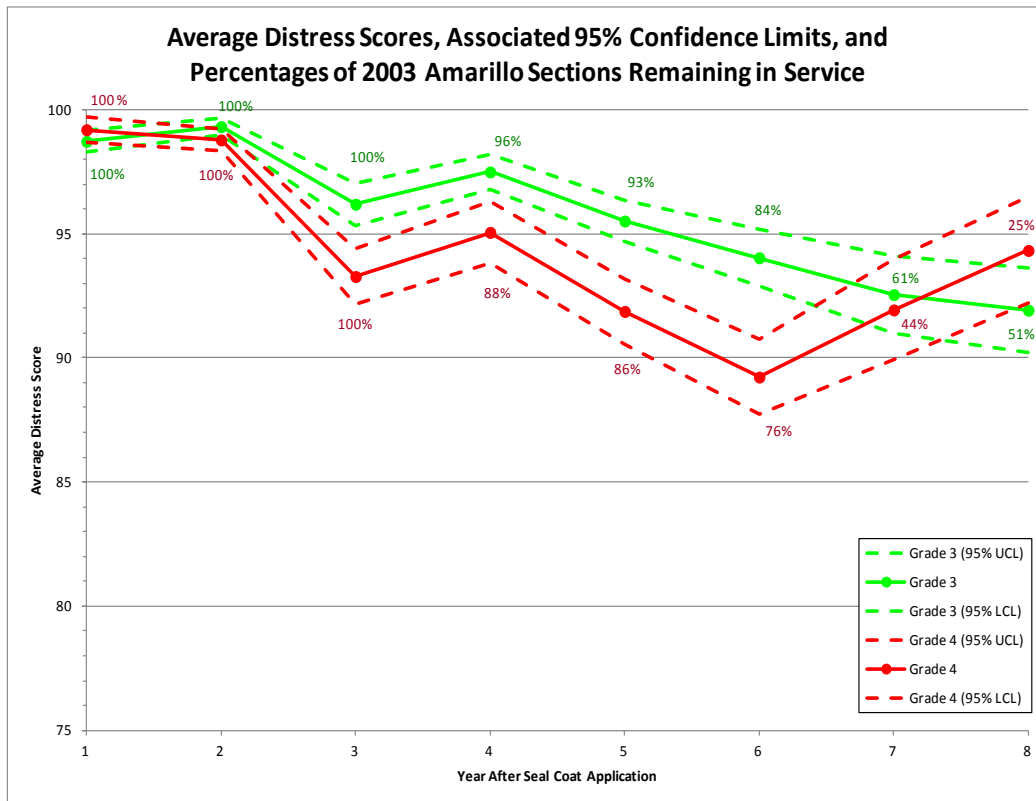
Despite the counteracting factors involved, a significant finding is provided in Figure 41. The average distress scores plotted in Figure 41 for years 1, 2, and 3 are true deterioration curves as none of the pavements had been resurfaced until year 4 after construction. The 95-percent confidence limits at year 3 in Figure 41 do not overlap, thereby indicating a highly significant difference in performance being obtained from Grade 3 and Grade 4 seal coats at this time in their service lives. The average distress score for all Grade 3 seal coats after three years was 96.19 while the average distress score for all Grade 4 seal coats was 93.28. This group of Grade 4 seal coats in the Amarillo District averaged approximately 75 percent more distress than the Grade 3 seal coat group after three years of service.

**Figure 41. Average Distress Scores of Remaining Sections by Year – Amarillo District.**

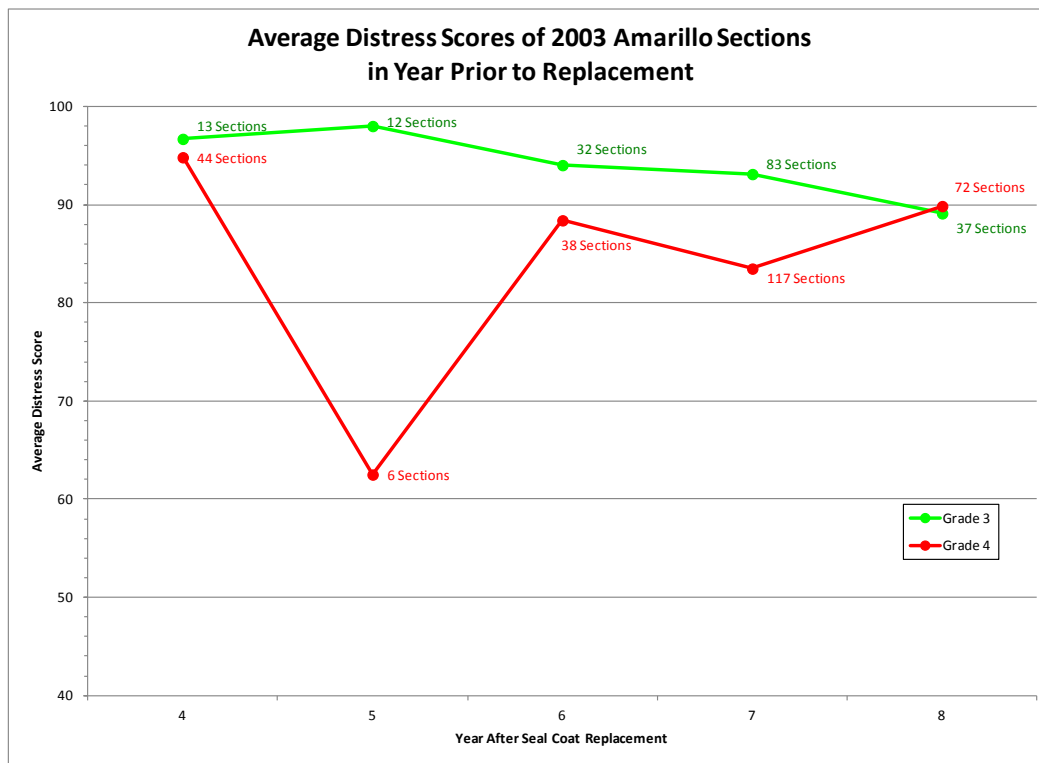
**Figure 42. Average Distress Scores of Resurfaced Sections by Year – Amarillo District.**

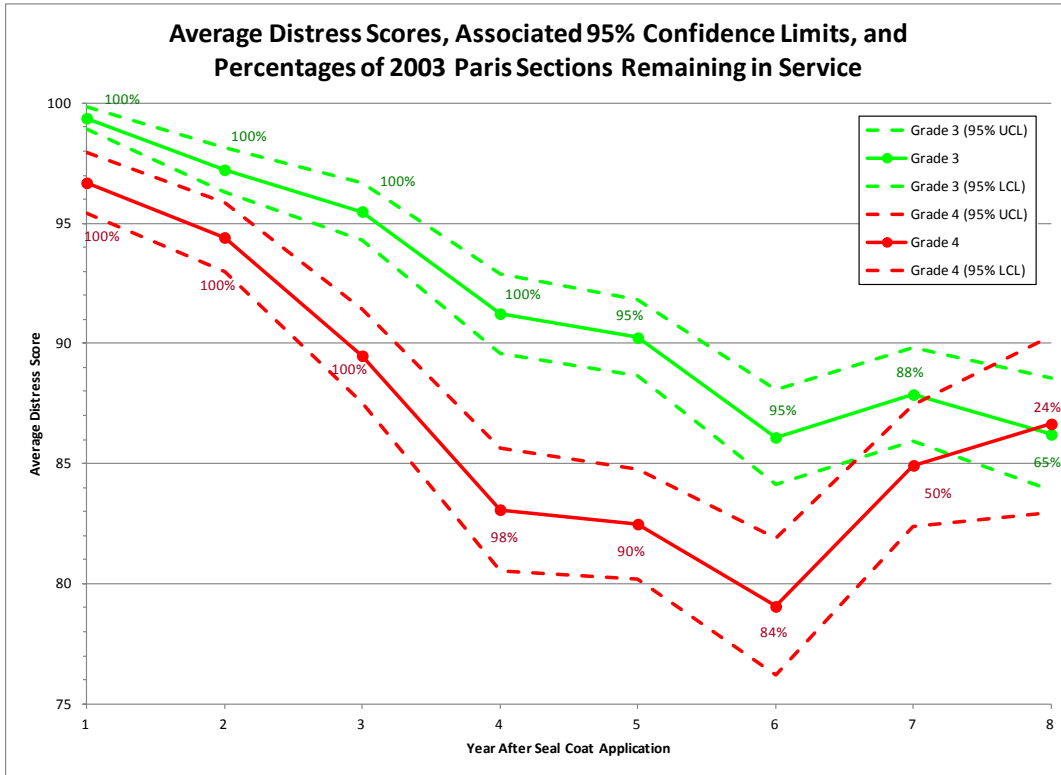
**Figure 43. Average Distress Scores of Remaining Sections by Year – Paris District.**

The results of the inverse regression of Paris District data in Table 20 show more comparable performance expectations between Grade 3 and Grade 4 seal coats when the pre-existing pavement condition is Good or Fair than with the Amarillo District data. If the pavement condition prior to placing the seal coat is Excellent, however, the Grade 4 seal coats are projected to reach given distress levels approximately twice as quickly as Grade 3 seal coats will. This latter finding is similar to the findings of the analysis of the Amarillo District data.

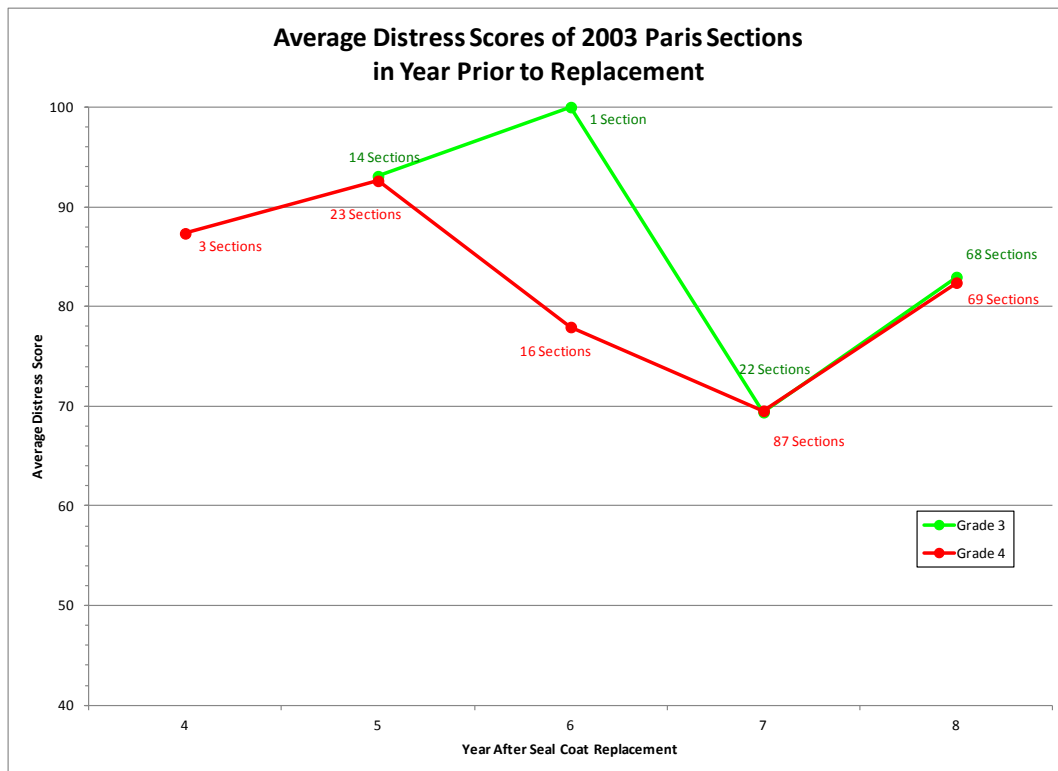
**Figure 44. Average Distress Scores of Resurfaced Sections by Year – Paris District.**

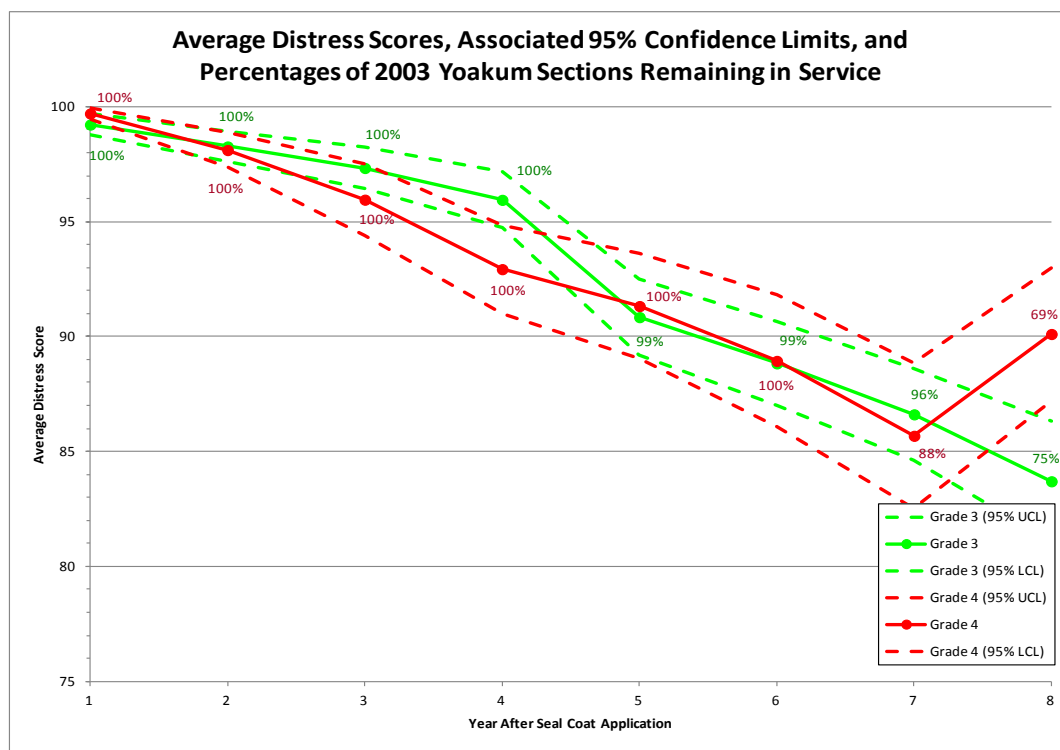
Another distinct difference between the seal coat performances in Yoakum and the other two districts is that the true deterioration curves for Grade 3 and Grade 4, observable with Yoakum data through year 6, were very similar. If the trend for Grade 3 to outperform Grade 4 is to continue in Yoakum, it will occur at later ages. The data show an indication of this beginning to occur in that somewhat higher percentages of Grade 4 seal coats were resurfaced in years 7 and 8 than were the district's Grade 3 seal coats.

**Figure 45. Average Distress Scores of Remaining Sections by Year – Yoakum District.**

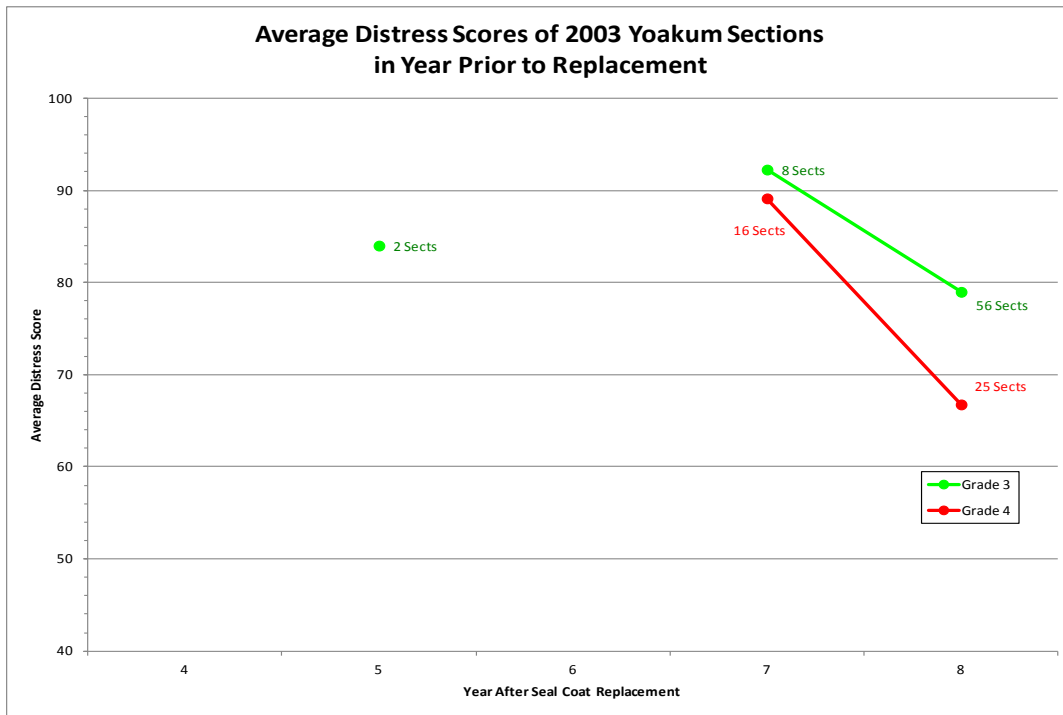
**Figure 46. Average Distress Scores of Resurfaced Sections by Year – Yoakum District.**

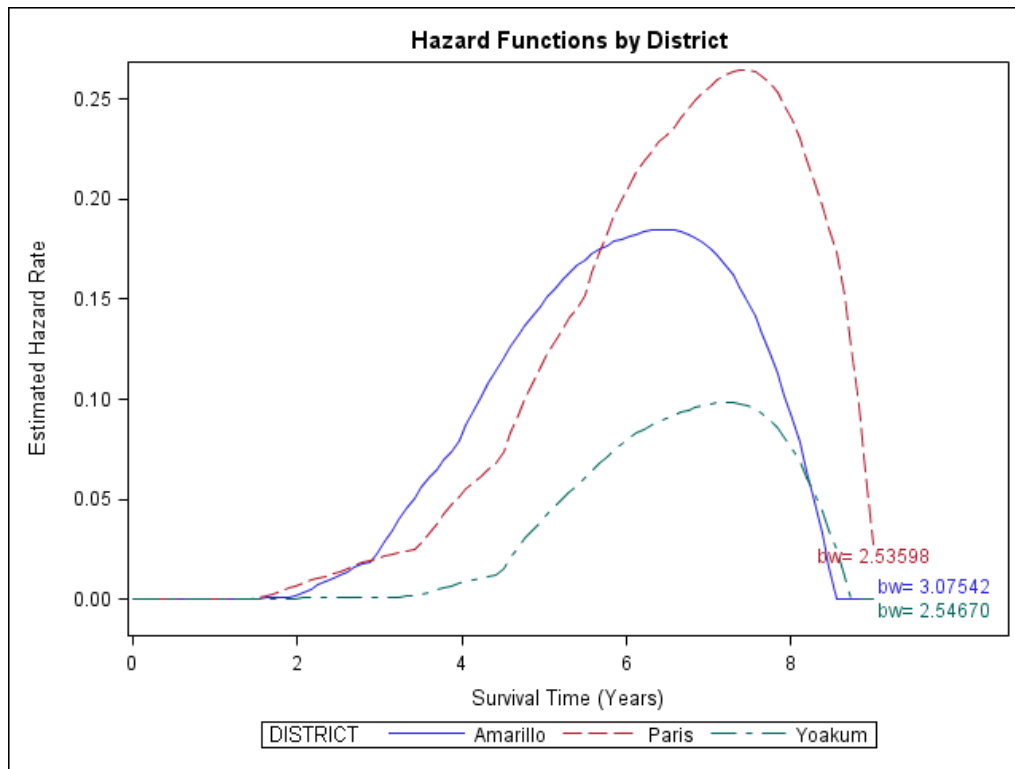
The hazard function specifies the instantaneous rate of failure at time  $t$ , given survival up until  $t$ . The shape or distribution of the hazard function determines the class of the data set. The set of hazard function results developed for the 2003 PMIS data are displayed graphically in Figure 47. One can see that the hazard functions for all three districts increase at an accelerating rate until between 6 years (Amarillo) and 8 years (Yoakum), followed by swift declines after 8 years. This latter feature is most probably caused by the high degree of censoring in the data (i.e., many PMIS sections with Grade 3 seal coats were still in service at the end of the observation period). Such hazard functions suggest something other than a pure deterioration process is at work. Under a pure deterioration process, the hazard rate is typically non-decreasing with respect to time.

**Figure 47. Hazard Functions for Seal Coat Sections – All Districts.**

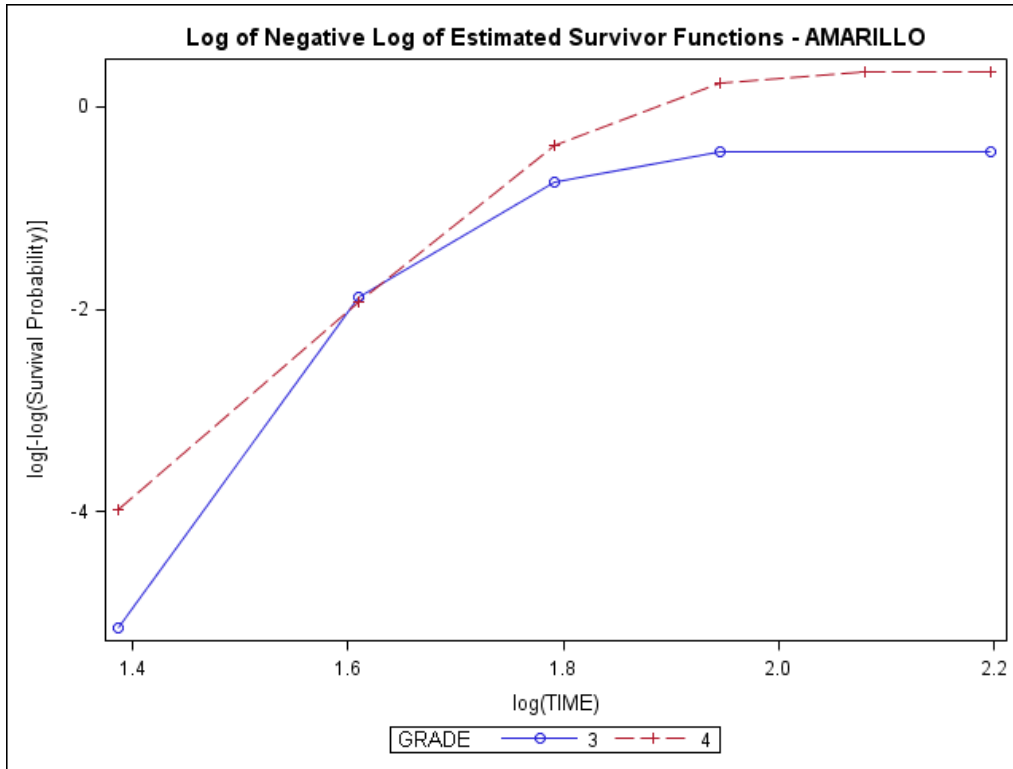
time model (AFT model) is a parametric model that provides an alternative to the commonly used proportional hazards models. Whereas a proportional hazards model assumes that the effect of a covariate is to multiply the hazard by some constant, an AFT model assumes that the effect of a covariate is to multiply the predicted event time by some constant. AFT models can therefore be framed as linear models for the logarithm of the survival time.

**Figure 48. Log of Negative Log Functions – Amarillo District.**

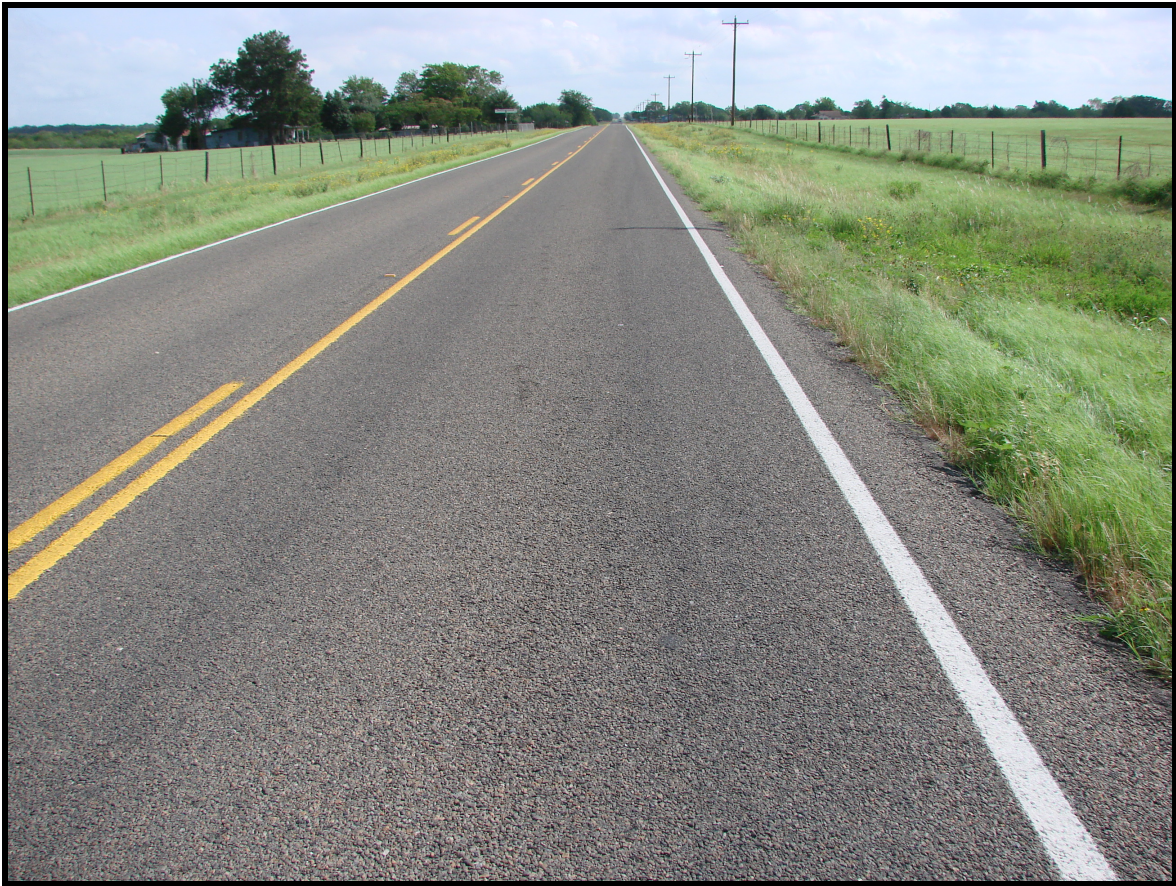
The noise test location on FM 1704 is seen in Figure E1. Figure E2 is a close up photograph of the wheel path condition at the same location. Similar photography of all roadways included in OBSI noise testing is provided in the CD-ROM enclosed in a jacket inside the cover of this report. Photography is courtesy of John Wirth, TxDOT.

**Figure E1. FM 1704 Roadway Noise Test Location.**

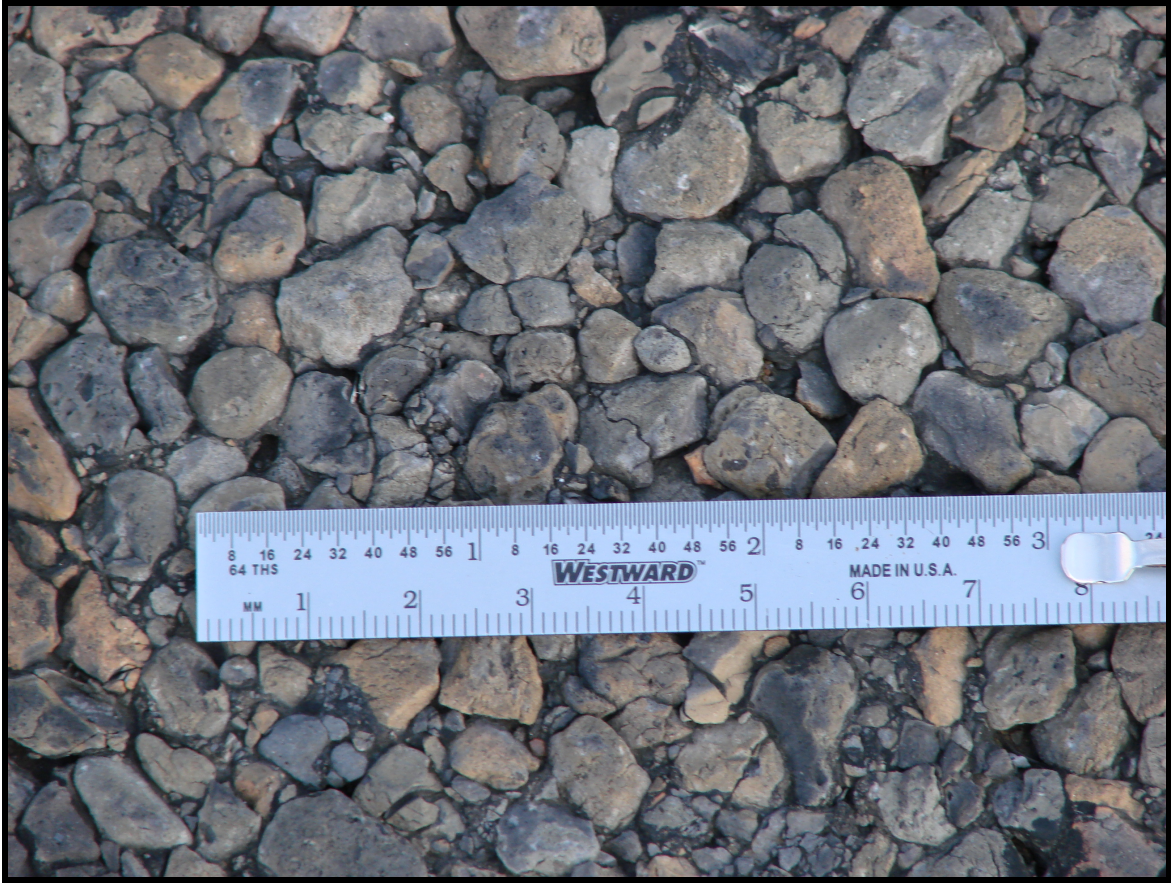
**Figure E2. FM 1704 Wheel Path.**
