Report # SPR-P1 (11) M305

Final Report

## Effectiveness Study on Temporary Pavement Marking Removals Methods

June 2011

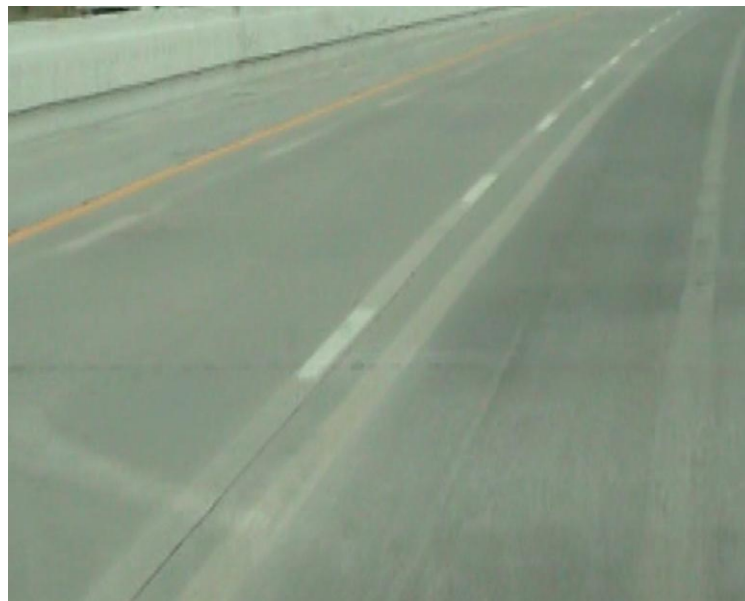
**Figure 2.1** Scars on I-80 that can confuse drivers

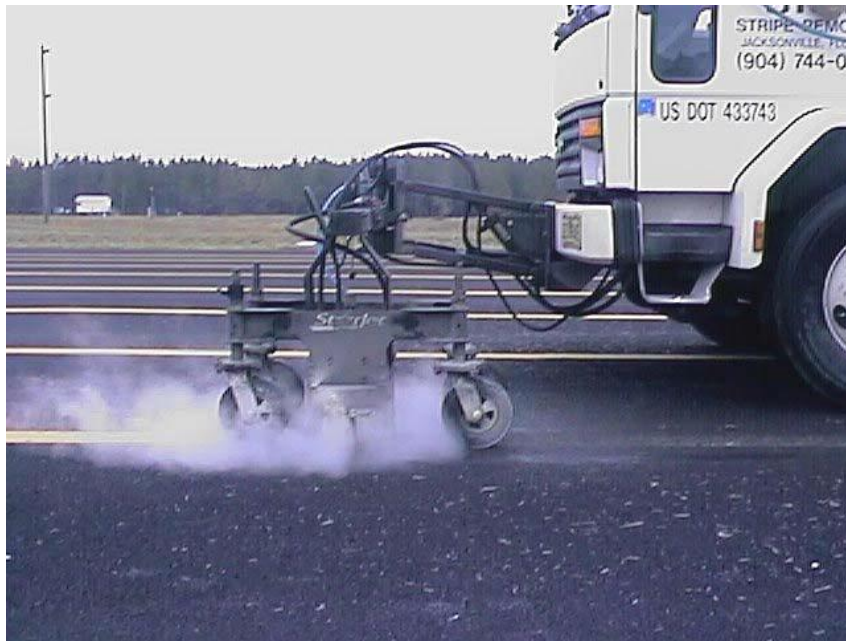
Water blasting is a process of using a high pressurized water jet—usually greater than 10,000 psi depending on the thickness of the paint and/or type of pavement surface—to remove markings from pavements. This method is effective in removing the markings, but can also leave scars on the pavement and leave the site messy. Water blasting costs can be high depending on the amount of water needed to remove the markings. Removal speed might also be a disadvantage as it requires added time to completely remove the markings. Figure 2.2, taken from a Florida Department of Transportation final report on the subject, shows a high pressure truck mounted water blaster unit being used on an asphalt surface (Ellis and al. 1999).

**Figure 2.2** High pressure water jet water blasting pavement marking

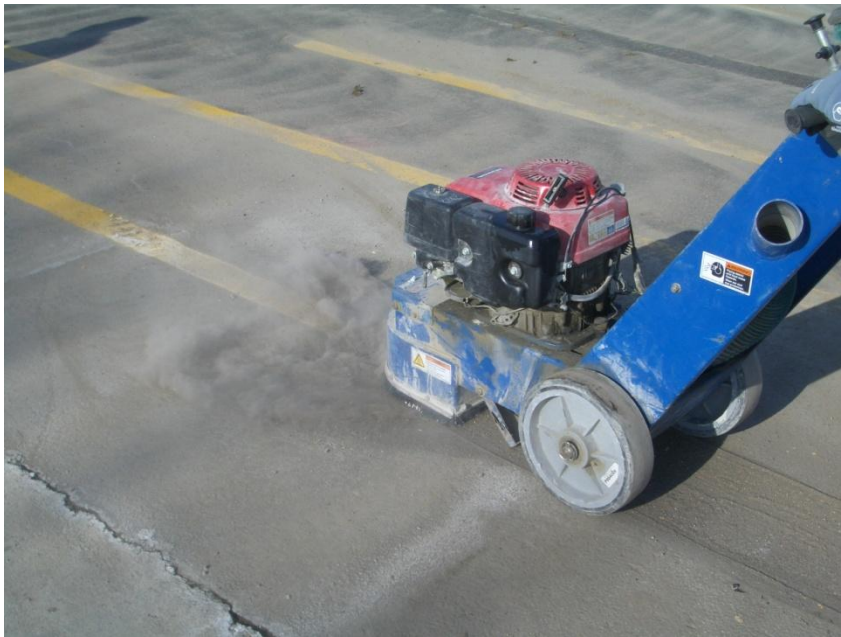
The method used most commonly, grinding, effectively removes markings. Depending on the cutting teeth applied on the grinder, it can be rapid by quickly cutting through the pavement. Interchangeable heads make grinding ideal for different pavement thicknesses and applications. The biggest disadvantage of grinding is scarring, which affects both the pavement texture and color since a deep scar will confuse motorists and lead to accidents. Figure 2.3 is an example of a grinder being used to remove paint on concrete.

**Figure 2.3** Grinder removing paint on asphalt pavement

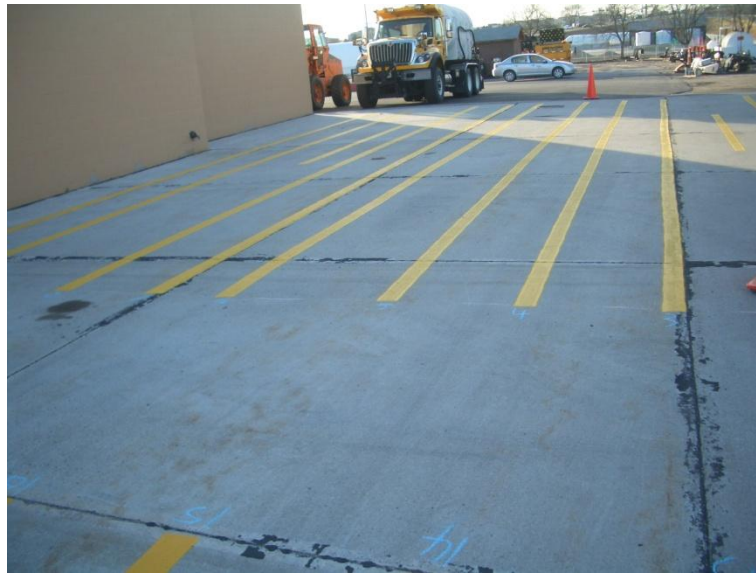
The research team used the NDOR District 1 office parking lot (Figure 4.1) and yard (Figure 4.2) to test onto concrete and asphalt sites. Marking lines were applied onto each site for testing. A total of 40 lines were made with yellow paint, each measuring about 50 ft in length. To test differences in paint types, 12 and 20 mils of water-based and oil based paint were used to make lines 6 in. wide on both the concrete and asphalt pavements. Additionally, 5 pre-formed foil-backed tape lines also measuring about 50 ft were installed on both sites.

**Figure 4.1** Concrete site used for testing

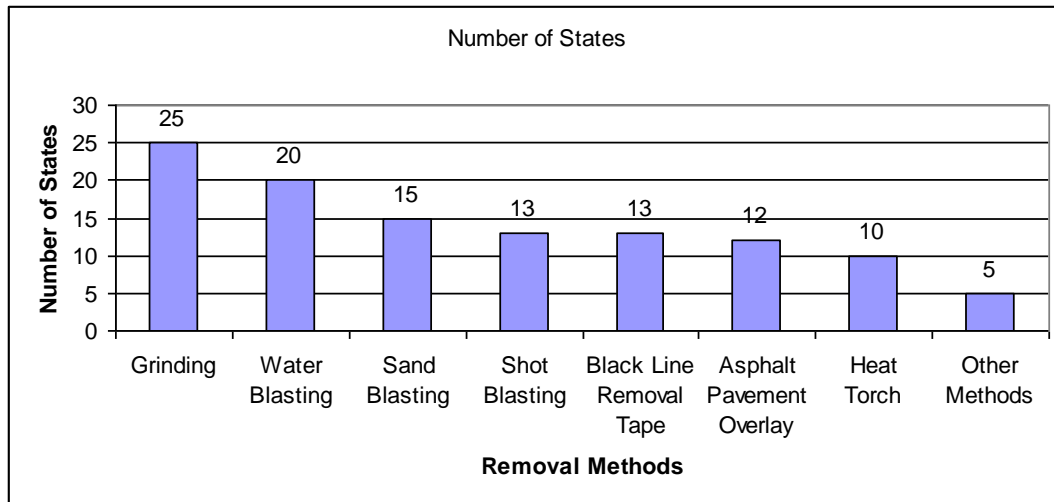
**Figure 5.1** Removal methods usage frequency in 25 states

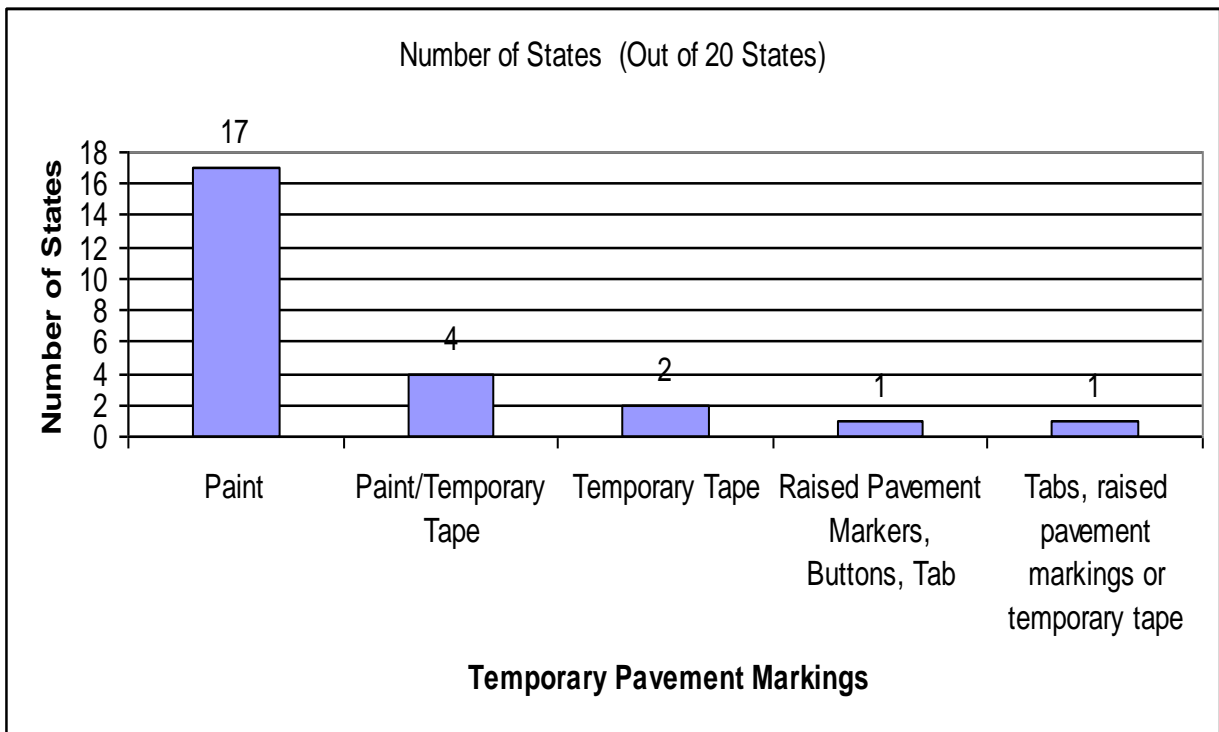
Finally, the responses concerning the types of pavement marking materials that are used often are summarized in figure 5.4, as well as tables 5.4 and 5.5.

**Figure 5.4** Most types of pavement markings frequency graph

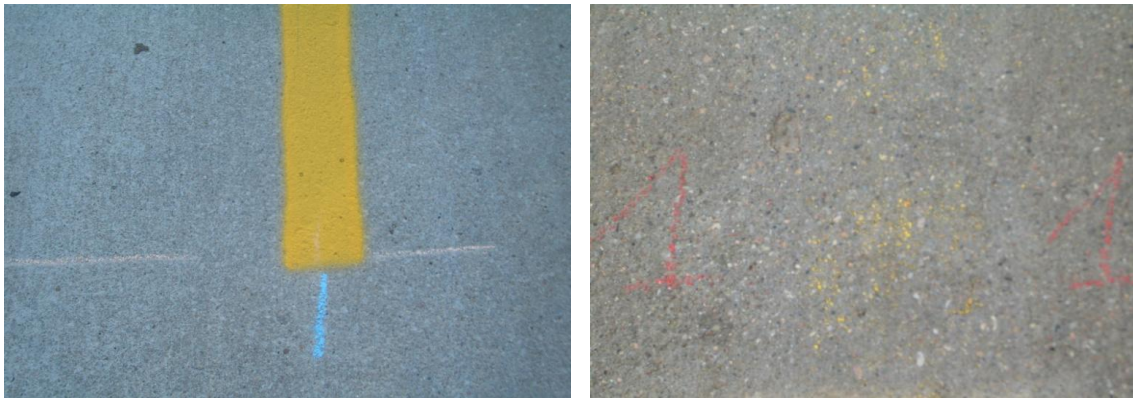
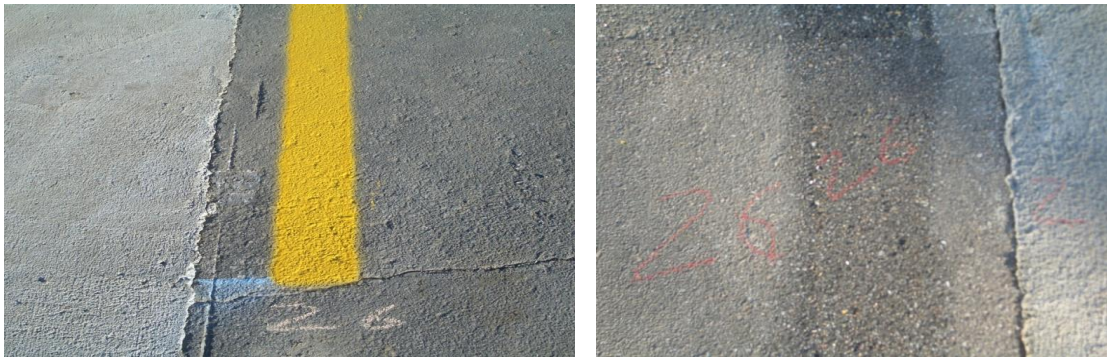
Water blasting removed the marking on all surfaces, but left a scar that could lead to confusion. Water blasting worked the best on concrete while removing water based paint of 12 mils (fig. 6.1). Figures 6.2 and 6.3 show the results of water blasting on oil-based paint concrete and water-based paint on asphalt, respectively.

**Figure 6.1** Concrete pavement condition before (left) and after (right) 12 mils water-based paint has been removed by water blasting

**Figure 6.2** Concrete pavement condition before (left) and after (right) 10 mils oil-based paint has been removed by water blasting

**Figure 6.3** Asphalt pavement condition before (left) and after (right) 10 mils water-based paint has been removed by water blasting

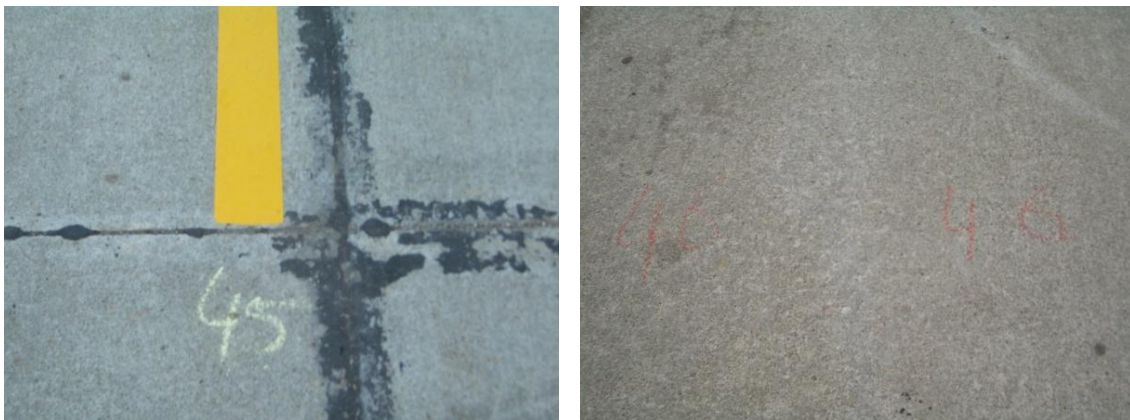
The process of water blasting was much slower compared to the other methods, but was very fast and effective on tape (fig. 6.4). It was relatively easier to remove the tape by water blasting. The surface was free of scars as shown in figure 6.4. It should be noted here that the tests were performed at non-favorable weather conditions for the tape. The temperature outside may not have allowed the tape to have properly set down before testing.

**Figure 6.4** Concrete pavement condition before (left) and after (right) tape has been removed by water blasting

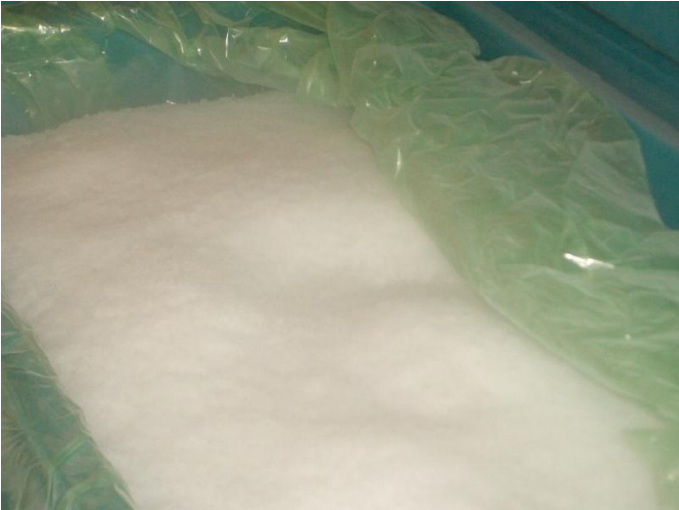
change after removal. As mentioned previously, a container of dry ice pellets (fig. 6.5) is attached to a hose that shoots the dry ice onto the pavement (fig. 6.6).

**Figure 6.5** Container full of dry ice

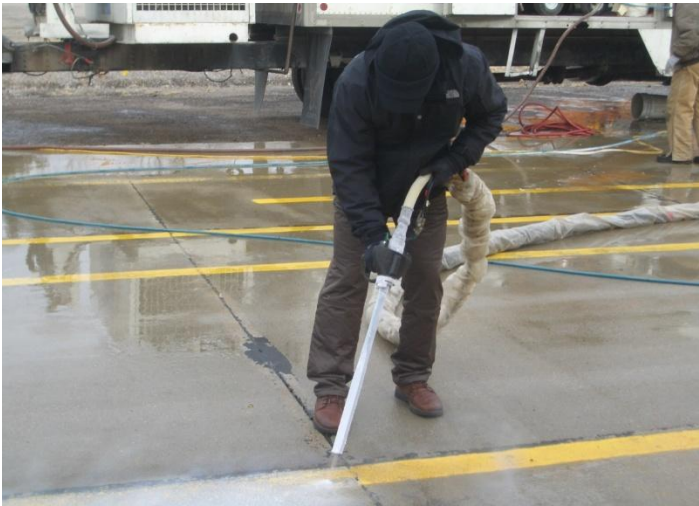
**Figure 6.6** Dry ice is shot onto the markings

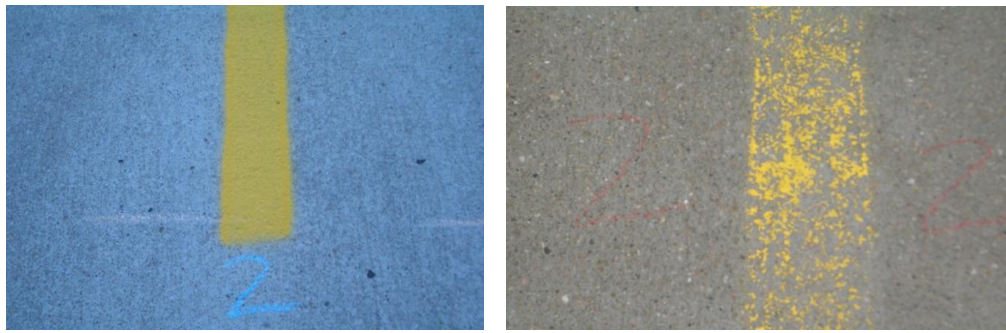
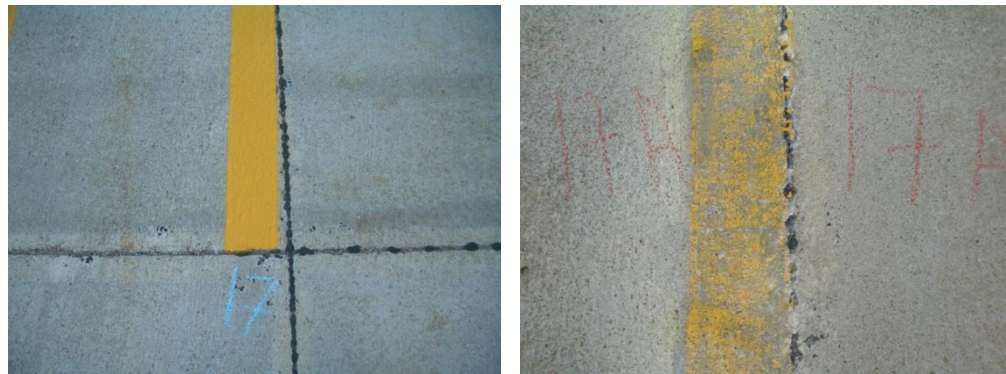
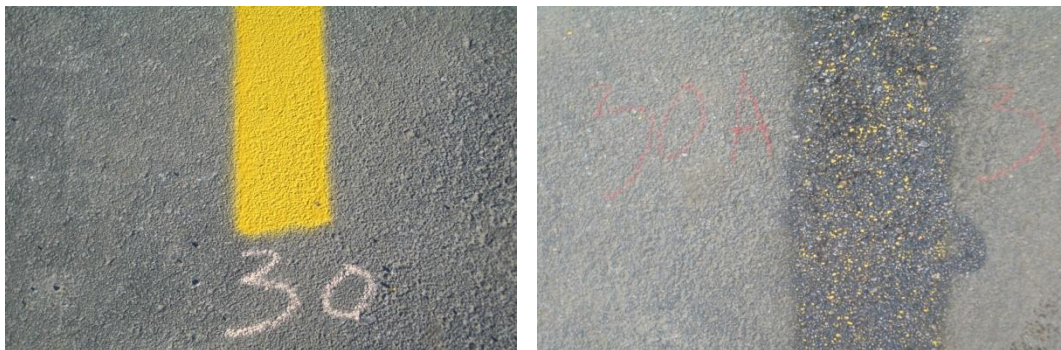
Dry ice blasting did not entirely remove the paint markings on the concrete surface, as shown in figures 6.7 and 6.8. On asphalt pavement, however, the removal was complete, but left a scar on the pavement (fig. 6.9). Dry ice blasting was the slowest method of removal. Results improved as the operator spent longer times on the markings. Both pavement surfaces were left with scars and texture

**Figure 6.7** Concrete pavement condition before (left) and after (right) 10 mils water-based paint has been removed by dry ice blasting

**Figure 6.8** Concrete pavement condition before (left) and after (right) 12 mils oil-based paint has been removed by dry ice blasting

**Figure 6.9** Asphalt pavement condition before (left) and after (right) paint has been removed by dry ice blasting

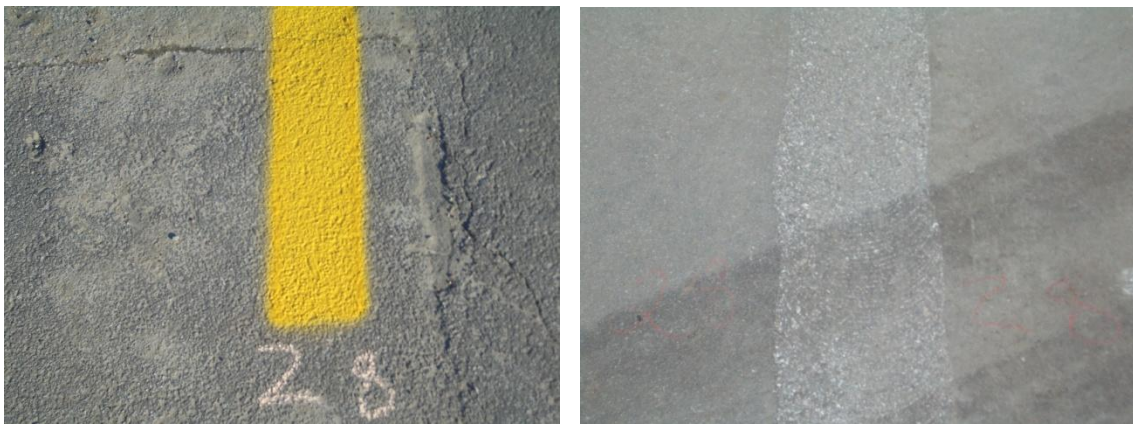
discrepancies. Regardless of the pavement type or marking material, the grinder did leave scars, as shown by figure 6.10 on concrete and figure 6.11 on asphalt.

**Figure 6.10** Concrete pavement condition before (left) and after (right) paint has been removed by grinding

**Figure 6.11** Asphalt pavement condition before (left) and after (right) paint has been removed by grinding

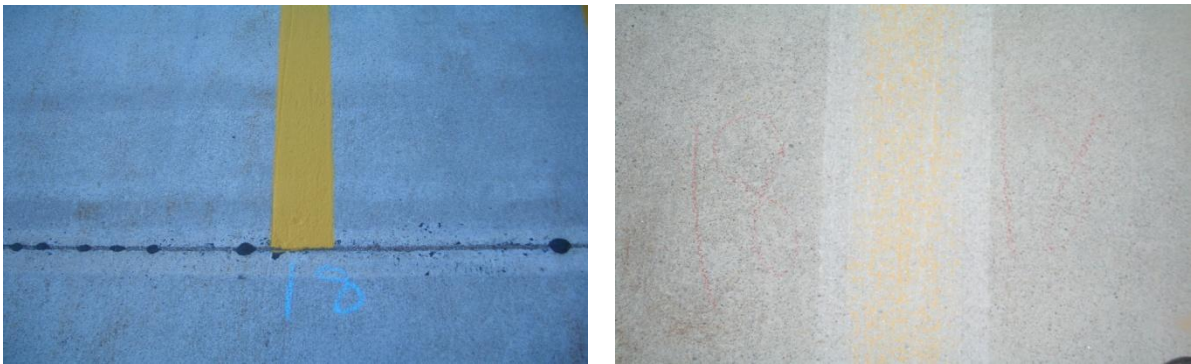
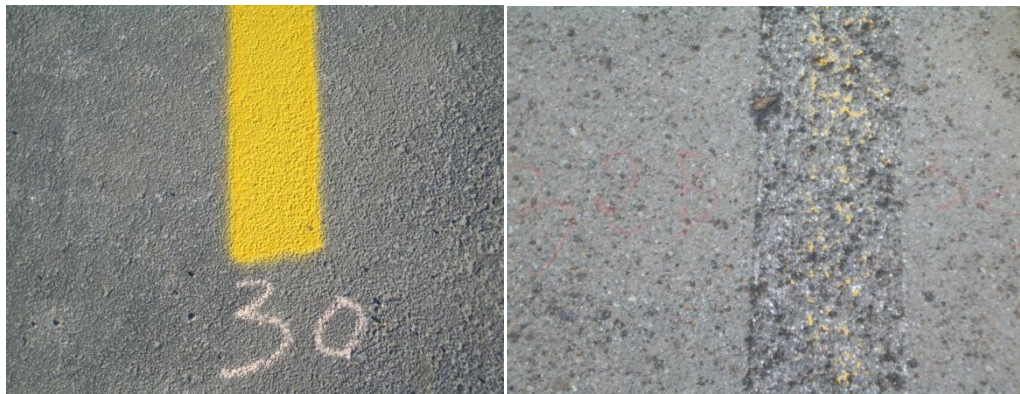
The scarifier is just like a grinder except the cutting blade heads never leave the surface while cutting in forward and reverse directions. While the scarifier is a fast process, it damages the pavement and does not completely remove the paint markings. The scarifier also left scars on the pavements. Figures 6.12 and 6.13 show the results of using a scarifier on concrete and asphalt pavements, respectively.

**Figure 6.12** Concrete pavement condition before (left) and after (right) paint has been removed with scarifier

**Figure 6.13** Asphalt pavement condition before (left) and after (right) paint has been removed with scarifier

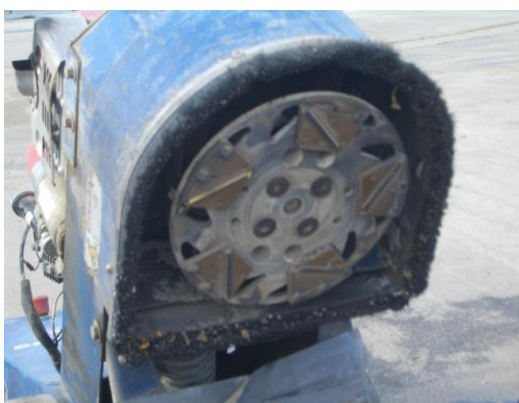
This method is also a form of grinding, but the only difference is that the cutter is made of polycrystalline diamond material, which generates less heat during the cutting process and increases grinding efficiency (fig. 6.14). The PCD scrapper allows the operators to decrease the intensity of labor while effectively removing the markings.

**Figure 6.14** PCD plate cutter

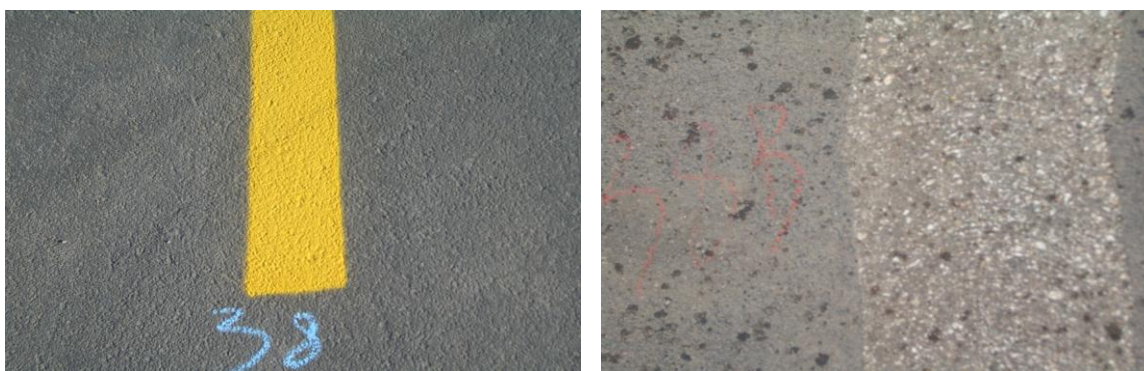
For evaluative purposes, the PCD was only used to remove one marking, and it displayed similar results as the grinder. Figure 6.15 shows the concrete pavement condition before and after the PCD was used.

**Figure 6.15** Concrete pavement condition before (left) and after (right) 12 mils paint has been removed by PCD grinder

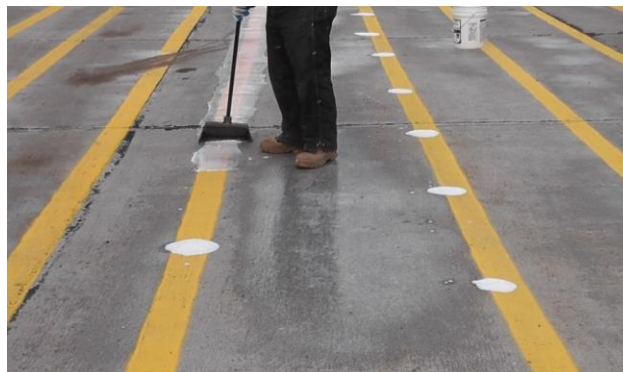
The research team tested the use of an environmentally friendly chemical stripper—it did not contain Methylene Chloride (MeCl)—to remove paint markings. First, the operator or worker needs to apply one pass of the chemical solution on the paint marking with a brush or roller (fig. 6.16) and let it set for approximately half an hour. The set time depends on the chemical stripper and marking material types. The material safety data sheet will have more details on setting time. The next step consists of power washing the solution from the pavement with a sprayer hose of about 400 to 1000 psi.

**Figure 6.16** Applying the chemicals on the markings

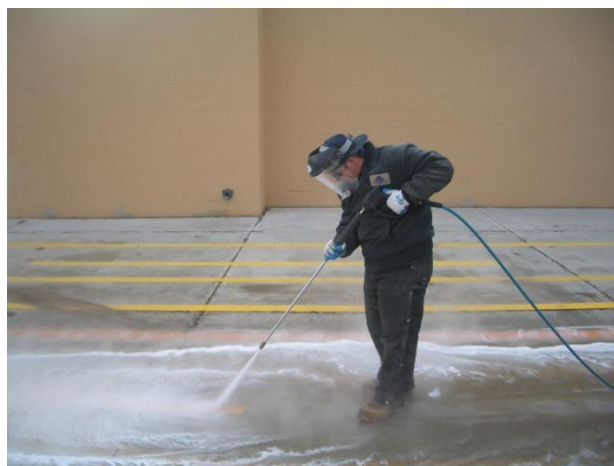
**Figure 6.17** Operator with proper protection while removing marking by chemical method

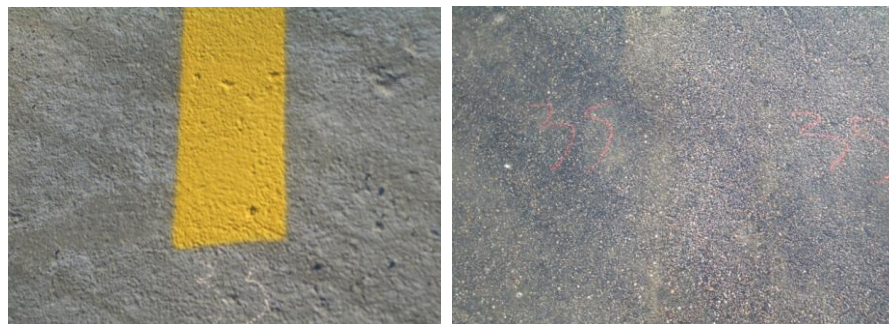
The chemical stripping method was the most effective during testing and left no or very little paint on both surfaces (fig. 6.18 and 6.19).

**Figure 6.18** Concrete pavement condition before (left) and after (right) paint has been removed by chemicals

**Figure 6.19** Asphalt pavement condition before (left) and after (right) paint has been removed by chemicals

There was no visible scar on the pavement after the use of chemical strippers. Table 6.1 below is a summary of some data that were recorded during testing. The complete data is shown in Appendix II. The completeness of removal rating shows whether or not there was paint left on the surface (5 represented little or no paint, and 1 was significant amount of paint left). The degree of scarring rating was used to classify how much damage and/or texture difference was/were left on the pavement (5 represented a lot of scarring, and 1 for little or no scarring). Please note that the set time of the chemicals was not used to calculate the rate of removal.

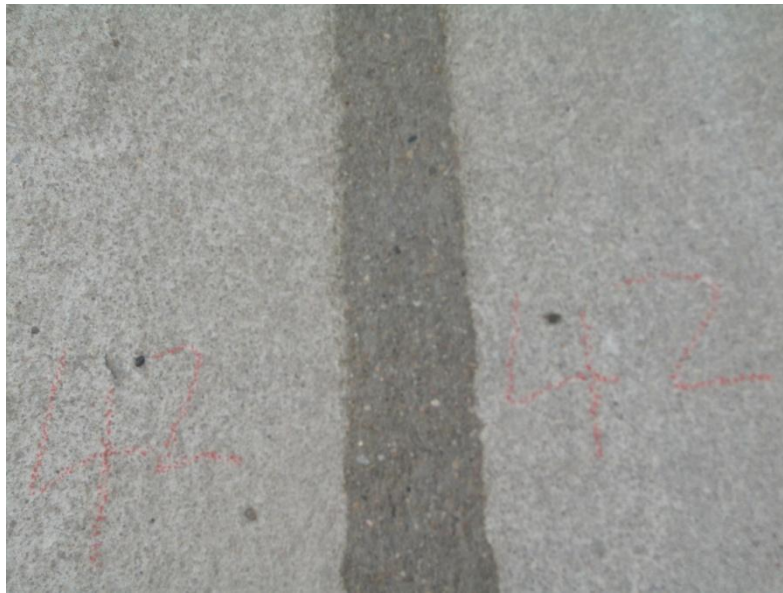
The chemical stripping method was the most efficient on both surfaces for paint, and was rather fast if one does not consider the setting time. There was also little or no scarring left on the pavement after using chemical strippers. The outside temperature was about 20°F when the tape was laid down on the pavements; therefore, most of the tape did not stick well to the surface, and some was not even entirely set. Almost every method used on tape was successful except for dry ice and heat torching which left some marks on the pavement. Figure 6.20 shows the result of the heat torch on concrete pavement.

**Figure 6.20** Condition of concrete pavement after heat torch applied on tape

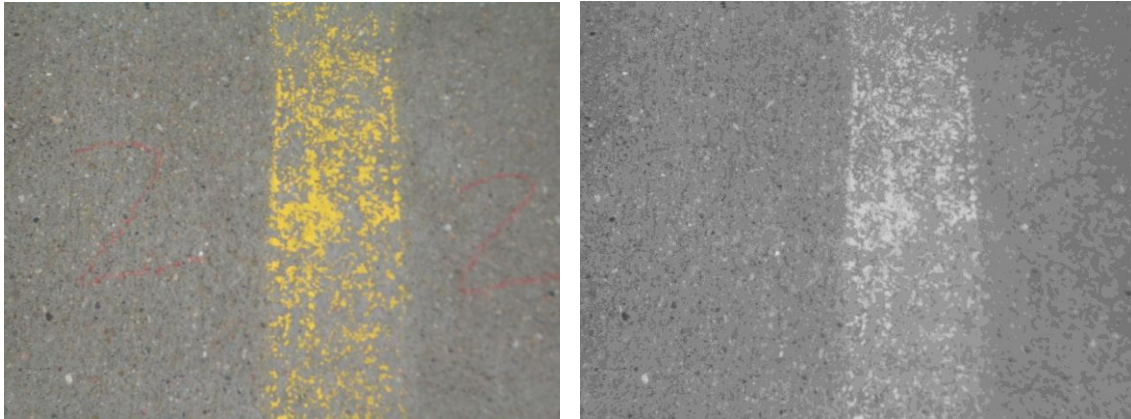
**Figure 7.1** Actual picture (on left) and grayscale image (on right) of pavement after marking has been removed
