TRANS **NOW**

Final Report
TNW2012-14

SEISMIC-RESISTANT CONNECTIONS BETWEEN PRECAST CONCRETE COLUMNS AND DRILLED SHAFTS.

June 2012

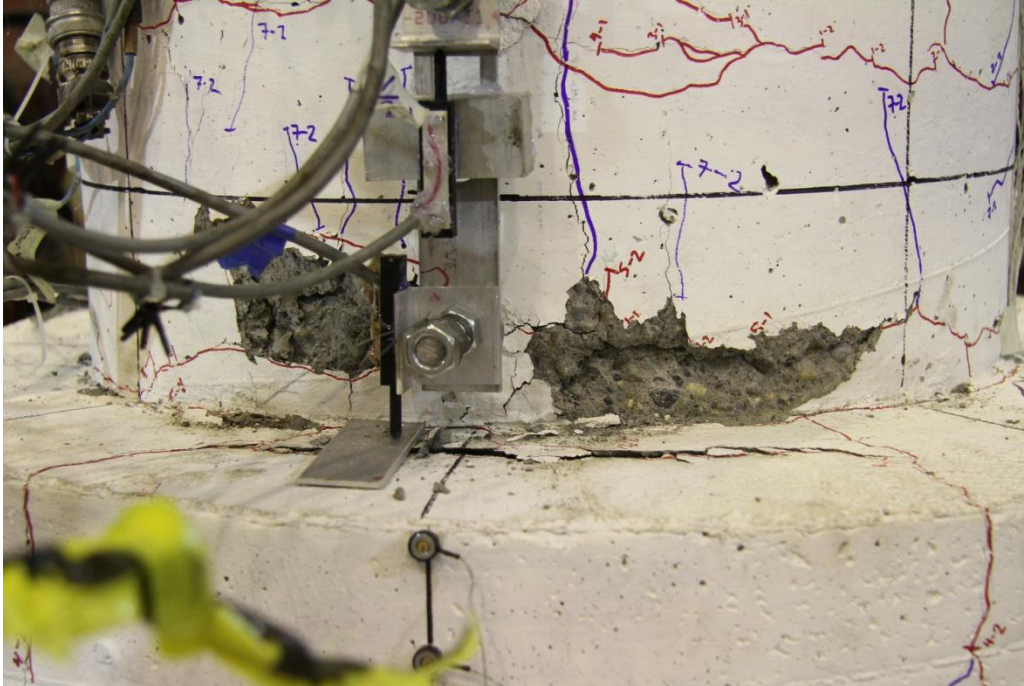
Figure C-0-2. DS-1 – First significant spalling occurred in the column in Cycle 7-2 (3.00/-3.14 percent drift)

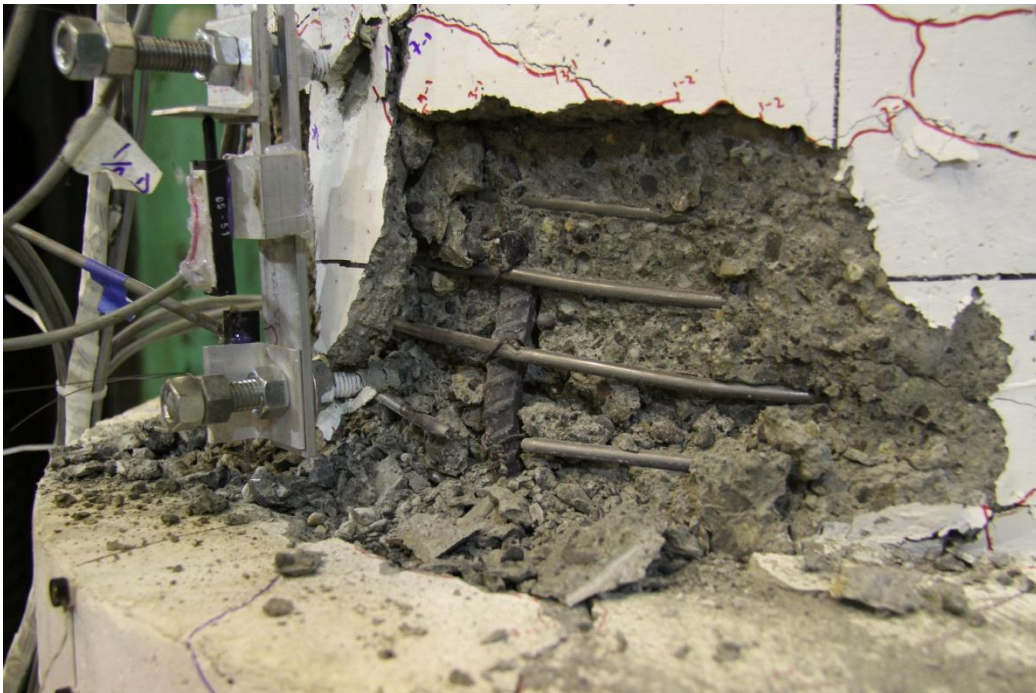
Figure C-0-5. DS-1 – First column spiral fractured in Cycle 10-1 (8.43/-8.27 percent drift)
