Continued Monitoring of Indiana's SPS9-A Site

JOINT TRANSPORTATION RESEARCH PROGRAM

INDIANA DEPARTMENT OF TRANSPORTATION
AND PURDUE UNIVERSITY

Report Number: FHWA/IN/JTRP-2012/19

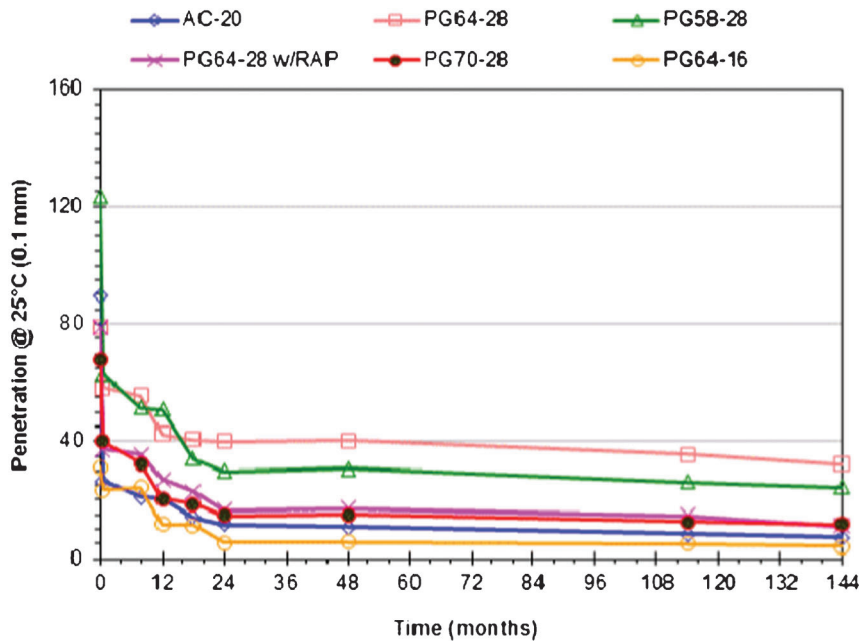
Figure 3.2 Change in penetration of recovered asphalt with age (25°C).

The penetration test was conducted at 25°C and 5°C according to AASHTO T49-89, and the data is presented in Figure 3.2 and Figure 3.3, respectively. No further hardening of the asphalt was observed, using this test method, after the second or fourth year after placement.

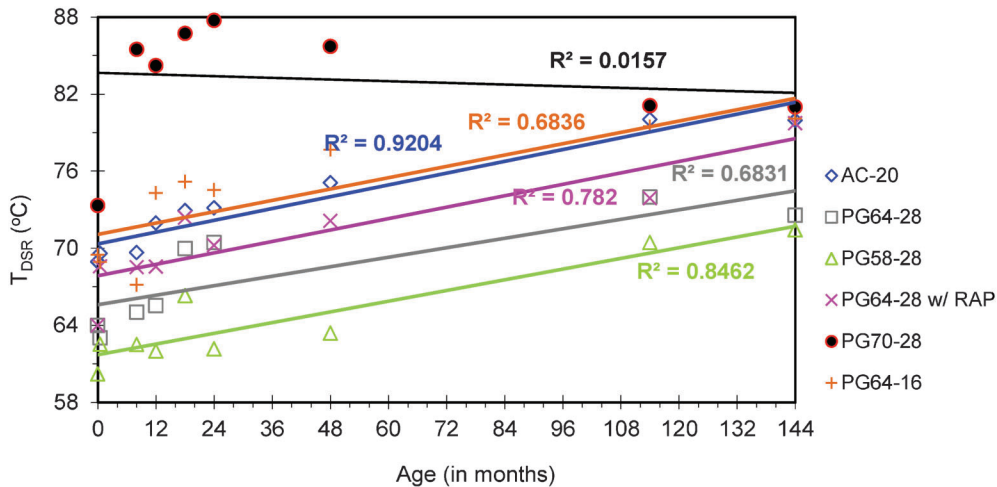
Figure 3.4 Change in T_{DSR} of recovered binders with time.

A Bohlin CVO-II dynamic shear rheometer was used to perform these tests. Two replicates of each sample were tested and the average is presented in the graph shown in Figure 3.4. Except for binder recovered from Section 5 (PG70-28), all the remaining binders showed an increase in T_{DSR} , indicating a stiffening effect with the age of the pavement. The similar slopes of the trend lines indicate similar rates of aging. It can also be observed that at the end of 12 years, the high-temperature binder grade was increased by one level (6-degree increment) with respect to the original, tank binder used. The binder recovered from Section 4 with

PG64-28 and RAP was consistently stiffer than the PG64-28 binder from Section 2 without RAP. Even in the case of binder from Section 5 that showed minimal aging, there was an increase in T_{DSR} with respect to the tank binder. If the tank binder data point for PG70-28 were to be omitted as an outlier, the R-squared value would increase to 73%. The binder used in Section 3 was of a softer grade and this is reflected in its lower stiffness all through the study period. Similarly, the stiffer binder used in Section 5 stayed consistently higher than the other binders in the study, during the whole study period.

respectively). Based on the observed trends, it can be seen that in situ aging of the binder continued beyond the initial four years until the end of this study period (12 years since construction). Although the changes between the 9.5- and 12-year data points do not appear to be visually significant, excluding the last data point did not improve the R-squared value of the trend lines.

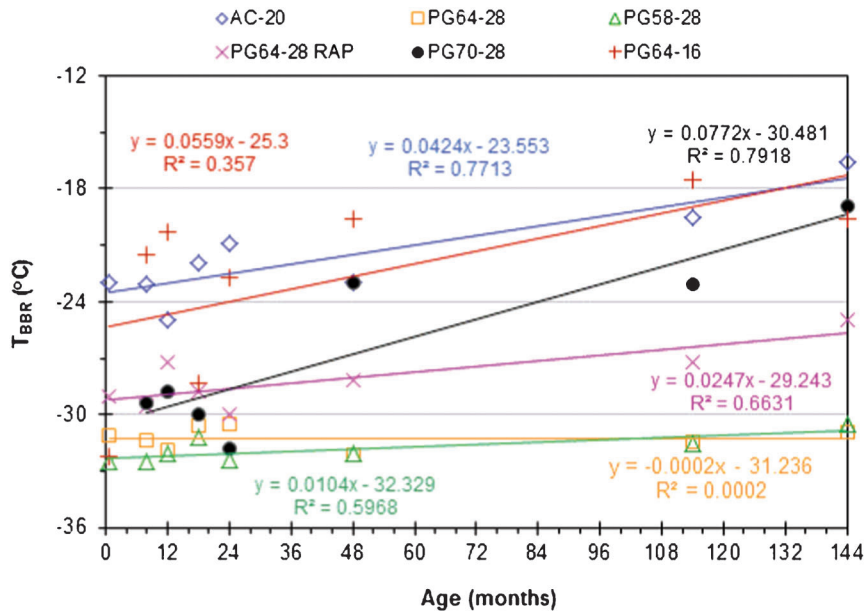
Figure 3.6 Trend in T_{BBR} as a function of age of the pavement.

The flatness of the lines for the PG58-28 and PG64-28 binders indicates that there was no perceptible increase in the low-temperature stiffness of these binders during the 12 years of the study period. A stronger linear trend was observed in the case of binders recovered from Section 1 (AC-20), Section 4 (PG64-28 w/RAP) and Section 5 (PG70-28). In particular, data from Section 5 showed the highest R-squared value and the steepest slope, indicating that this binder underwent the highest degree of aging (stiffening) as determined by the BBR at low temperatures. This is contrary to the trend observed at high temperatures where the shear modulus was measured using the DSR at high temperatures. In that case, Section 5 binder did not show any stiffening with age, whereas all the other binders showed similar stiffening behavior, as evidenced by their slopes in Figure 3.4.

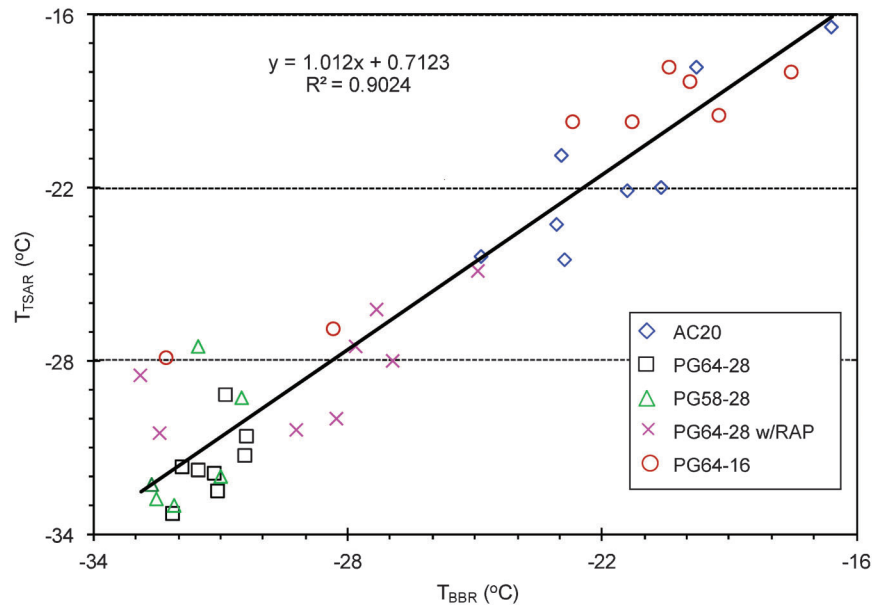
Figure 3.8 Comparison of T_{BBR} versus T_{TSAR}, excluding PG70-28 data.

Table 3.1 shows the critical temperature obtained from TSAR and BBR data from recovered binders at the end of 9.5 (G) and 12 (H) years. Neglecting the modified binder (PG70-28), good similarity can be observed between the two sets of data points. The critical temperature for binder recovered from the RAP section (S4) was warmer than that of the control section (S2) without RAP. This is indicative of binder stiffening and may be attributed to the contribution of the binder recovered from the RAP present in the mix. Sections 2 and 3 with the same low-temperature grade (PGxx-28, unmodified) had similar cracking temperatures. Recovered binder test data from these field cores indicate that they still satisfy the PG requirement at low temperature, for Sections 1, 2, 3 and 6, implying that thermal cracking may be expected only in Sections 4 and 5 at the end of 12 years.

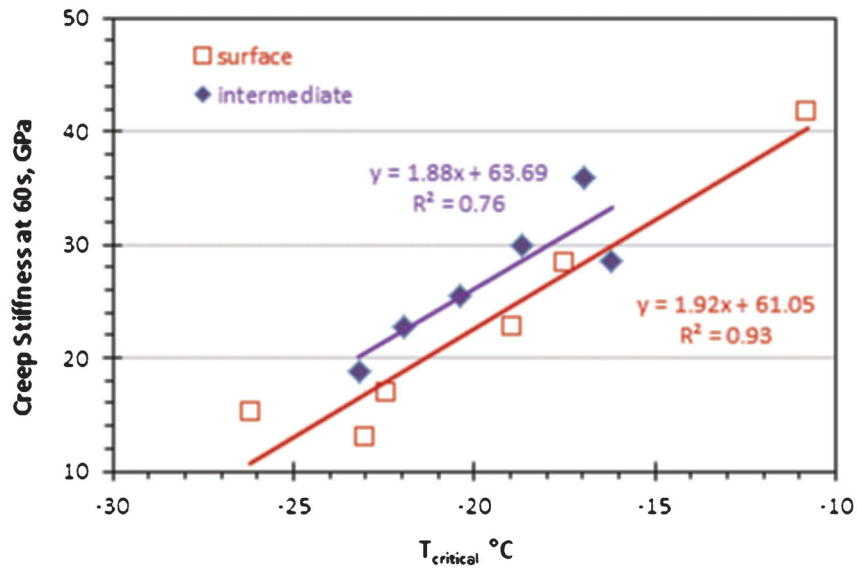
Figure 4.3 Relation between stiffness and critical cracking temperature.

To further emphasize the relationship between mixture stiffness at 60 s and the critical cracking temperature of the pavement (mix), a regression line between the two factors was fitted as illustrated in Figure 4.3. Both trend lines exhibited similar slopes, i.e., both mixes showed similar change in stiffness for a

given change in temperature. The intermediate mixes have a smaller range in temperature and stiffness data compared to the surface mixes, suggesting a lesser variability in the stiffness and cracking temperature of the intermediate mixes specific to this study.

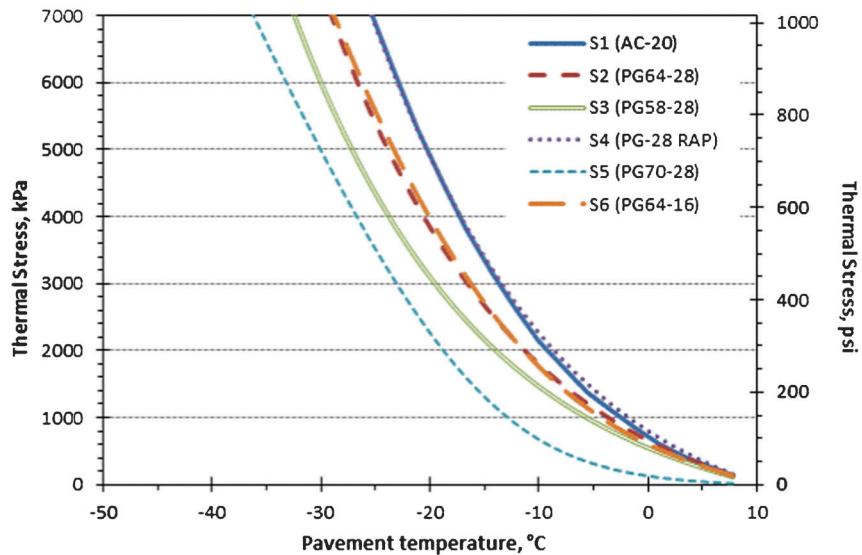
Figure 4.5 Thermal stress versus pavement temperature in the intermediate layer mixes.

The development of thermal stresses in the pavement as the temperature falls below freezing is shown in Figures 4.4 and 4.5, for the surface and intermediate mixes, respectively. Typical failure strength of hot mix asphalt at low temperature is in the range of 300 - 500 psi. Examining the behavior of mixes below 4000 kPa (~600 psi), it is clearly evident from Figure 4.4 that mix from Section 1 was the stiffest among all the mixes and the mix used in Section 5 (with the SBS-modified binder) was the most flexible. Initially, Sections 2 and 4 (control vs. RAP section) showed similar stress development, but as the temperature fell below -10°C the lines diverged, with the

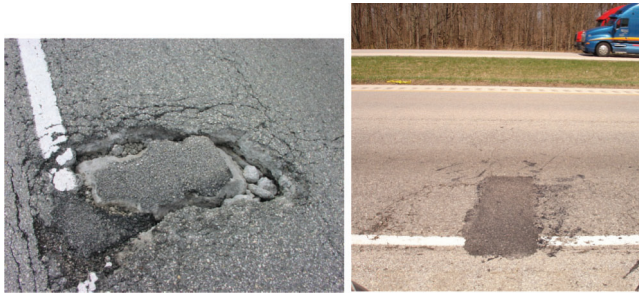
Figure 5.2 Punchout between Sections 5 and 6 (left) and subsequent patching (right).

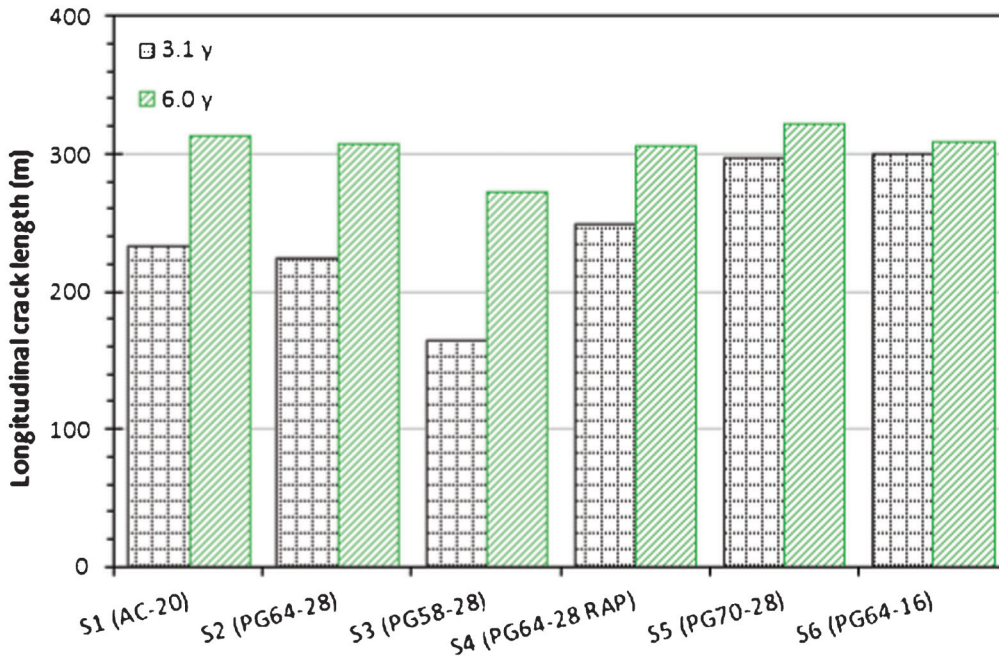
Figure 5.4 Longitudinal cracking outside the wheel path from photographic surveys.

While all the sections performed relatively well in withstanding low-temperature stresses at the end of three years, all sections showed longitudinal cracking outside the wheel path to various degrees. Trends similar to those observed in transverse cracking were also evident in longitudinal cracking, such as, S3 with the softest binder performed better than all the other sections, S4 showed more cracking than the control probably due to the presence of RAP, and S5 showed the highest amount of cracking comparable with S6, etc. At the end of six years, however, all sections showed similar amounts of cracking, with S5 still leading the ranking and S3 in the last position. A minimal amount of wheel path cracking (< 2 m

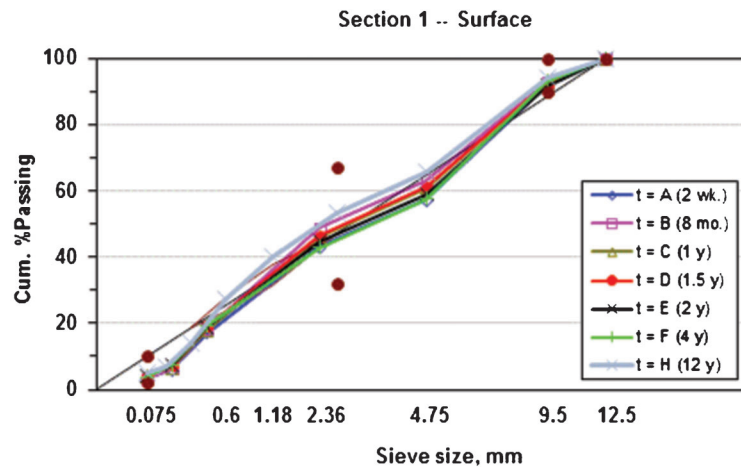
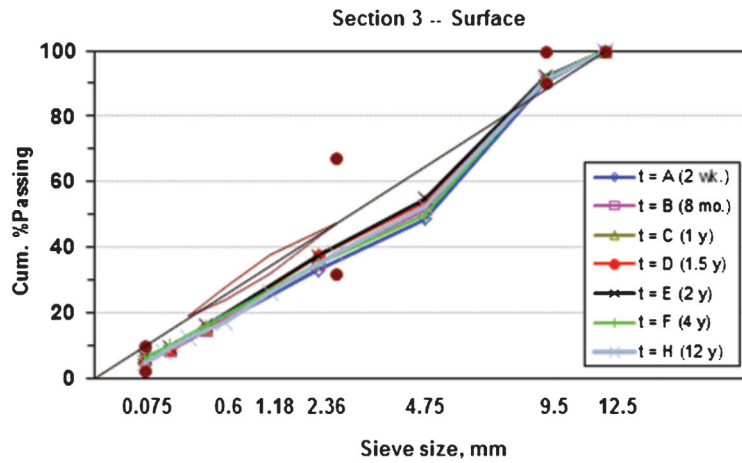
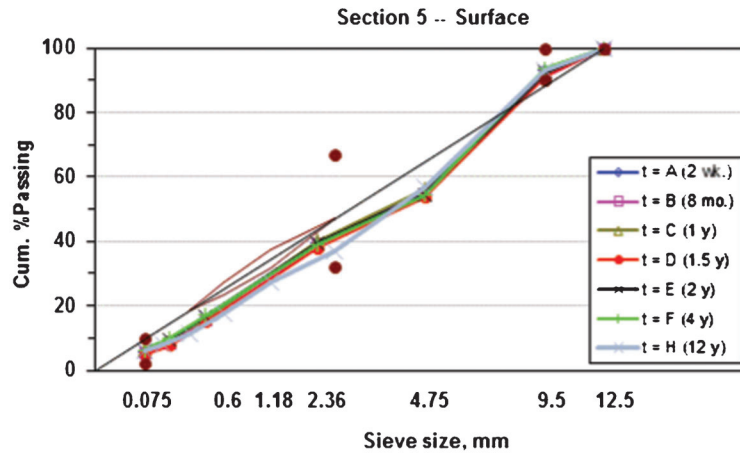
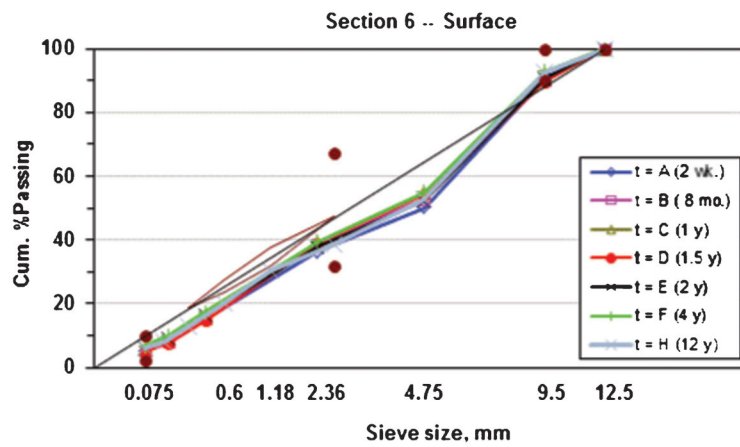
Figure A.1 Gradation of recovered aggregate from Section 1 (AC-20).

Figure A.2 Gradation of recovered aggregate from Section 2 (PG64-28).

Figure A.3 Gradation of recovered aggregate from Section 3 (PG58-28).

Figure A.4 Gradation of recovered aggregate from Section 4 (PG64-28 w/RAP).

Figure A.5 Gradation of recovered aggregate from Section 5 (PG70-28).

Figure A.6 Gradation of recovered aggregate from Section 6 (PG64-16).

After the binder extraction process, mechanical analysis of extracted aggregate was conducted to determine the particle size distribution of the aggregate in the surface mixes, according to AASHTO T30. Figures A.1 through A.6 in the appendix show the gradation plots for the six test sections at different ages. As these graphs indicate, all the plots from the different ages overlapped and formed a narrow band, indicating that there was no significant degradation of aggregate over time and that the mix placement was uniform (no segregation).
