Applying Safety Treatments To Rail-Highway
At-Grade Crossings

Douglas L. Cooper and David R. Ragland
SafeTREC

May 2012
RR-2012-2

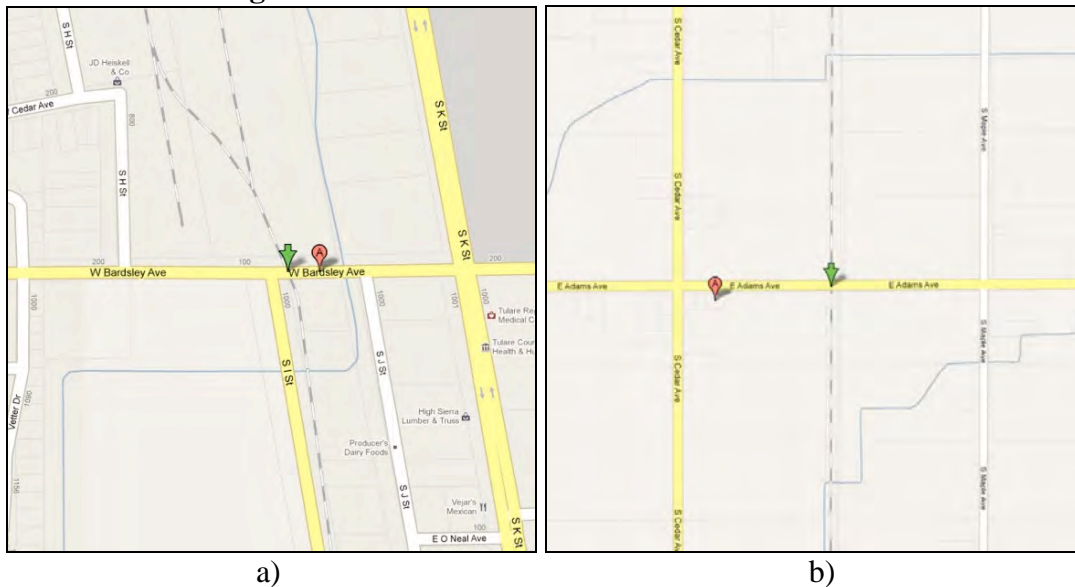
Figure 2: Train and Vehicle Direction of Travel

The crash records in the FRA database are often lacking in detail. While there is a narrative section that should describe the circumstances of the crash, for the most part this section appears to be constructed from checked boxes or short statements recorded elsewhere in the record. This makes interpreting the data difficult. For example, according to FORM FRA F 6180.57 (Highway-Rail Grade Crossing Accident/Incident Report), vehicles and trains only travel in one of four directions: north, south, east, or west. There are no other choices. Combined with inaccurate incident reporting, the results are often similar to those depicted in Figure 2, in which the car in a) was reported to have been traveling north on Bardsley Avenue, while in b) the train was reported to have been traveling east.

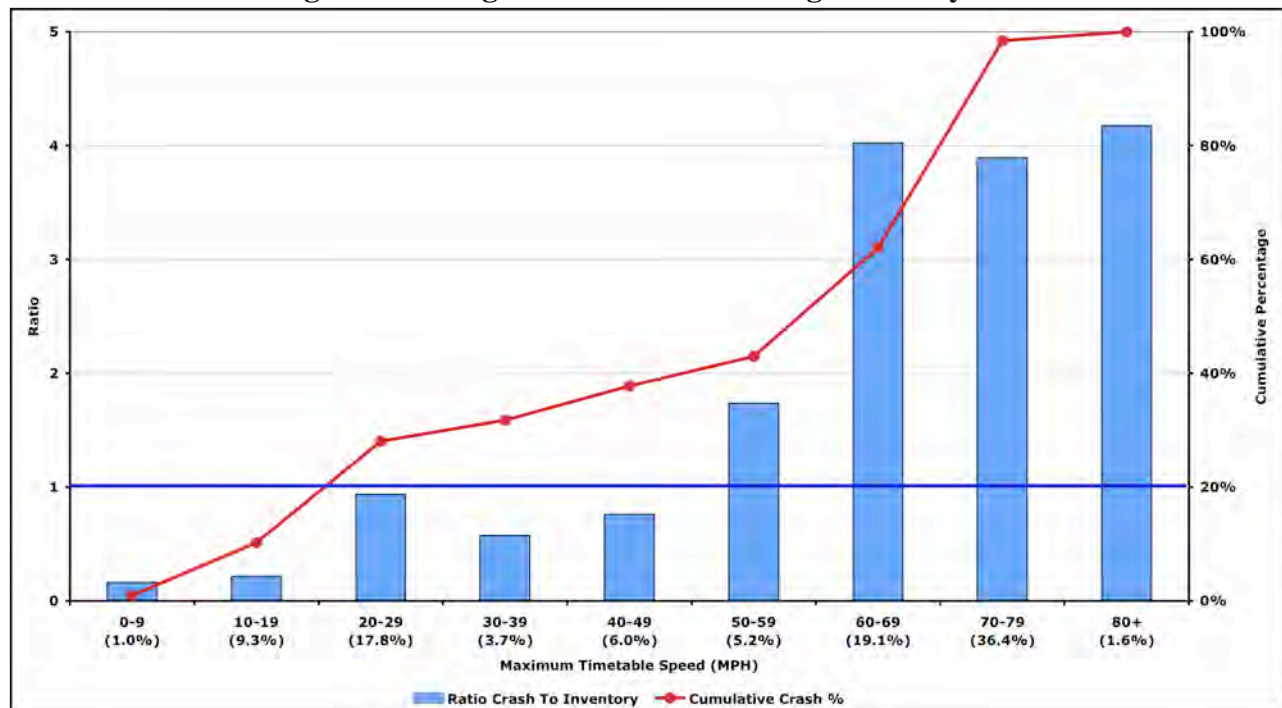
Figure 3: Ratio of Maximum Timetable Speed Percentages at Crash Crossing to Percentage of Crossings in California Crossing Inventory 2001-2010

Each point on the cumulative distribution line represents the percentage of total crashes that have occurred at that speed or less. For example, approximately 60% of total crashes occurred at crossings with a maximum timetable speed of 69 MPH or less.

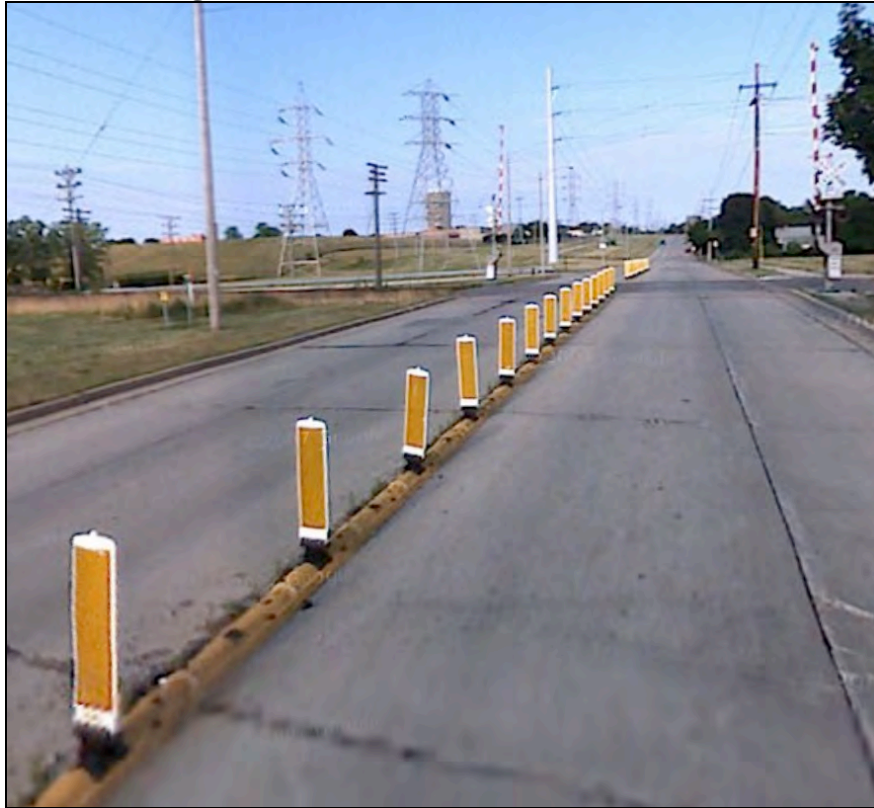
Figure 9: Street Mounted Channelization

The most widely used rail-crossing product at this time is Qwick Kurb, manufactured in Ruskin, Florida. An email from the company (2006) stated that “a typical crossing involves about \$10,500 of material...We do not install Qwick Kurb ourselves, but have noted that installation costs vary quite a bit from state to state. Perhaps \$1,500 give or take \$500 is a reasonable estimate.” Recent experience at North Carolina DOT leads them to estimate a cost of around \$10,000 for materials and \$3,000 for labor for a new installation in NC consisting of 200 linear feet total median length for two roadway approaches to a crossing.

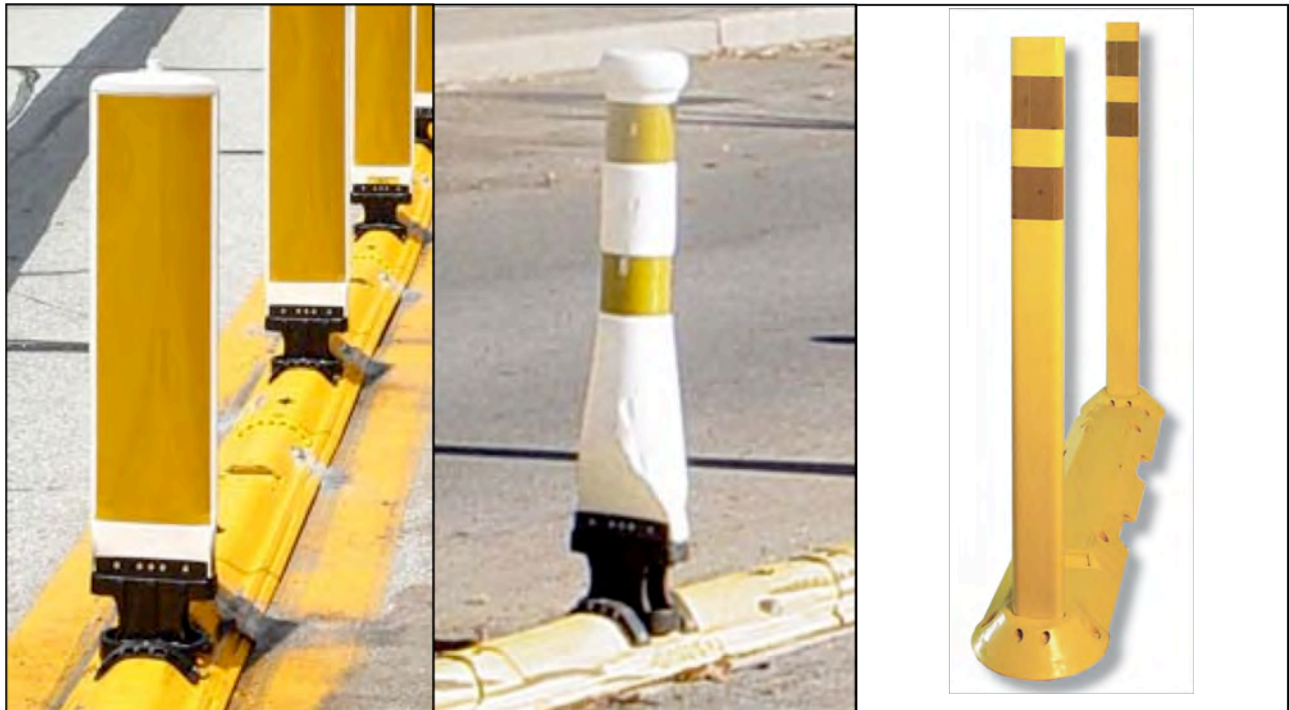
Figure 11:Channelization Examples

“Qwick Kurb [Figures 11a & 11b] was first available and was therefore first deployed by NCDOT. Qwick Kurb is somewhat higher in cost than its competitors; delineators are proprietary, as is delineator mounting system, driving higher costs (without significantly better durability) than more generic tubular markers that one of the

“The third product NCDOT installed was the FG 300 Curb System [Figure 11c] from Davidson Traffic Control Products (mfg. by Filtrona Extrusion). We installed this product at one crossing outside the Sealed Corridor, as it came to market later than the other two and our Sealed Corridor construction was complete with regard to modular medians. FG 300 is a more rigid plastic than the recycled rubber products. It is a molded product (as opposed to extruded) with internal radial rib construction (as opposed to solid), making it lighter in weight than the other two products. While I cannot provide evidence of such, we have concerns that this product may fracture more easily, given its rigidity. This product meets NCHRP 350 requirements.”

a: Qwick Kurb

b: Qwick Kurb

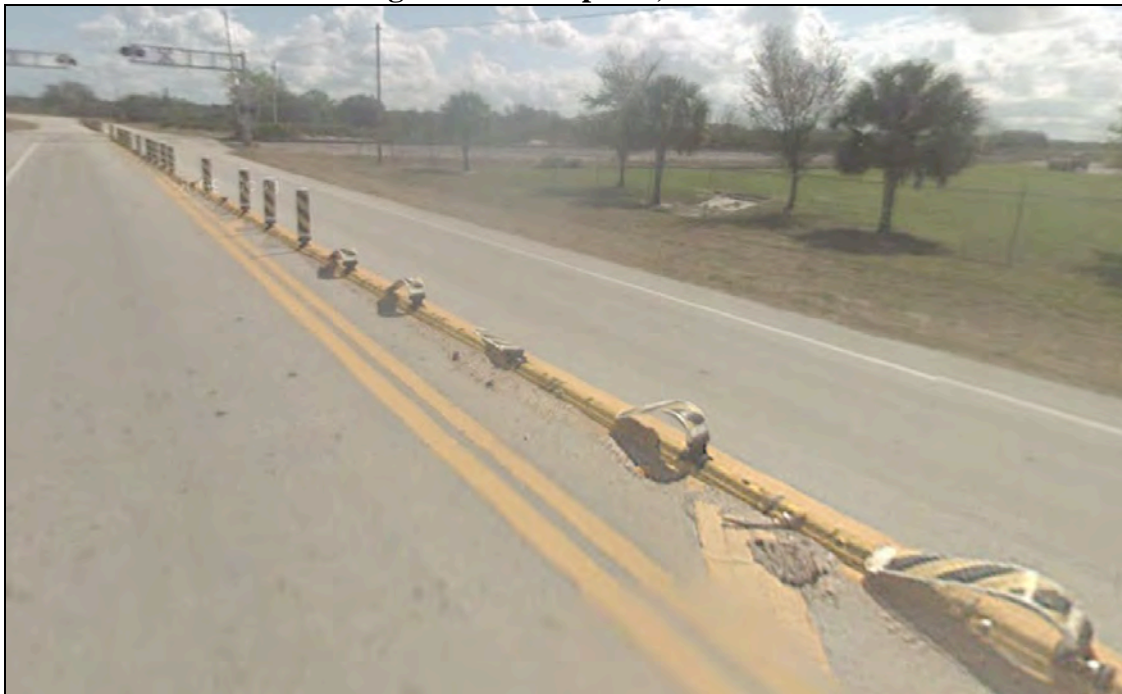
Figure 12: Frostproof, Florida

There was significant damage to a Qwick Kurb installation at the US 98 site in Frostproof, Florida. Nine consecutive markers were completely removed from the traffic separator, apparently by the impact of a large motor vehicle such as a semi-trailer. Factors that may have contributed to the collision include narrow lane width (9.2 feet) and the number of lanes (2). With additional lanes, motorists have the ability to compensate for the presence of the traffic separator and may be able to avoid collision with the markers (Ko et al. 2003). Nearby, on State Route 17, there was also substantial damage to another channelization device (Figure 12).

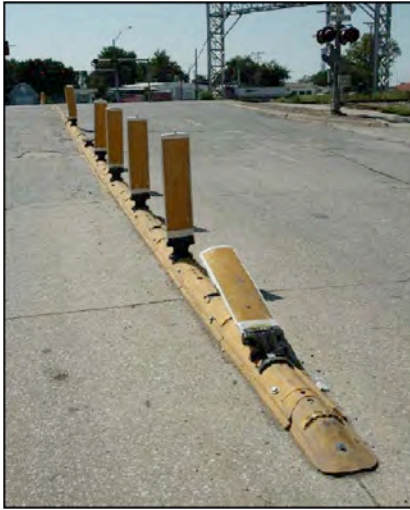
Figure 13: Flattened Curbing Caused by Trucks

“While the barriers installed at the two study locations were similar in construction material and installation, the observed maintenance needs were different due to differences in roadway traffic, geometry, and traffic composition. The barrier at Waverly received more abuse due to higher roadway traffic and higher percentage of

truck volume compared with the Fremont site. Also, the Waverly site involved a 90-degree turn from Highway 6 onto North 141St street, which exacerbated the situation with trucks frequently overrunning the end of the barrier [Figure 13]. Hence, maintenance needs were higher at the Waverly location. Since relatively little truck traffic volume and no significant turning traffic were involved at the Fremont site, the barrier was much less abused at that location. Nonetheless, the barrier at Fremont was overrun by roadway traffic and damaged as evident from tire tread and scuff marks [Figure 14], which required some maintenance.”

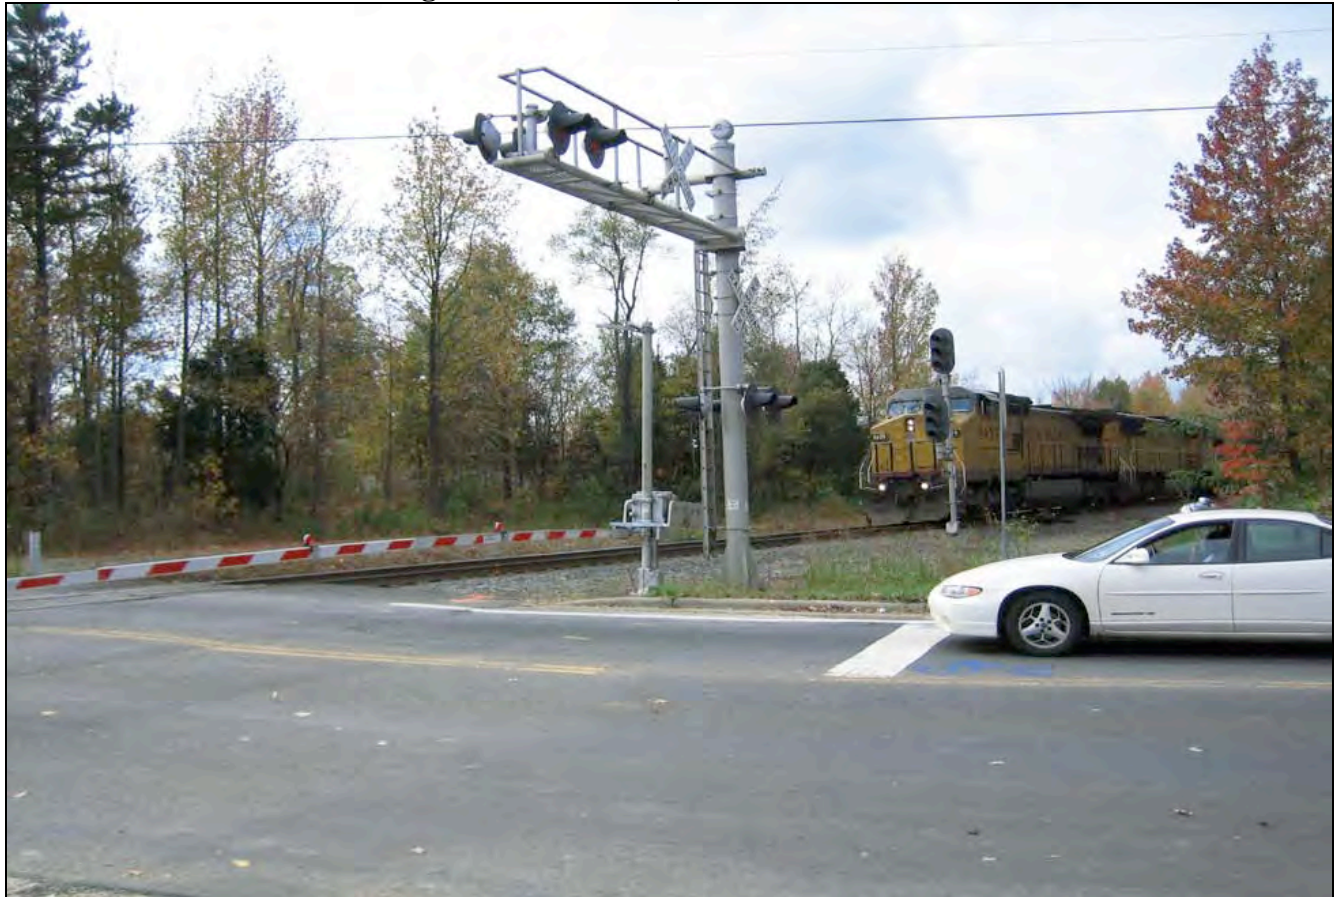
Figure 15: Orr Road, North Carolina

As reported in the North Carolina Sealed Corridor Phase I, II, and III Assessment study, the longer-arm gate systems must cover at least three quarters of the roadway. Tests at the Orr Road Crossing in Charlotte were conducted by the state’s DOT to evaluate the effectiveness of longer-arm gates to reduce drivers’ ability to drive around the gates (Figure 15). A total of three tests were conducted with the first gathering driver violation data before the gate was installed, the second test gathering post-treatment violation data which showed a 67 percent reduction in crossing violations, and a third test which gathered “after” data on long gate arms a year after the first test to determine whether long-arm gates retain their effectiveness. The results from the third test showed an even higher reduction in

crossing violations of 84 percent compared with pretreatment “before” numbers. Longer gate arms are used in conjunction with traffic channelization devices in some locations, but not where they would block a street or driveway intersection close to the crossing. The gates provide considerable discouragement to drivers who start to drive around and then realize how great the distance is.

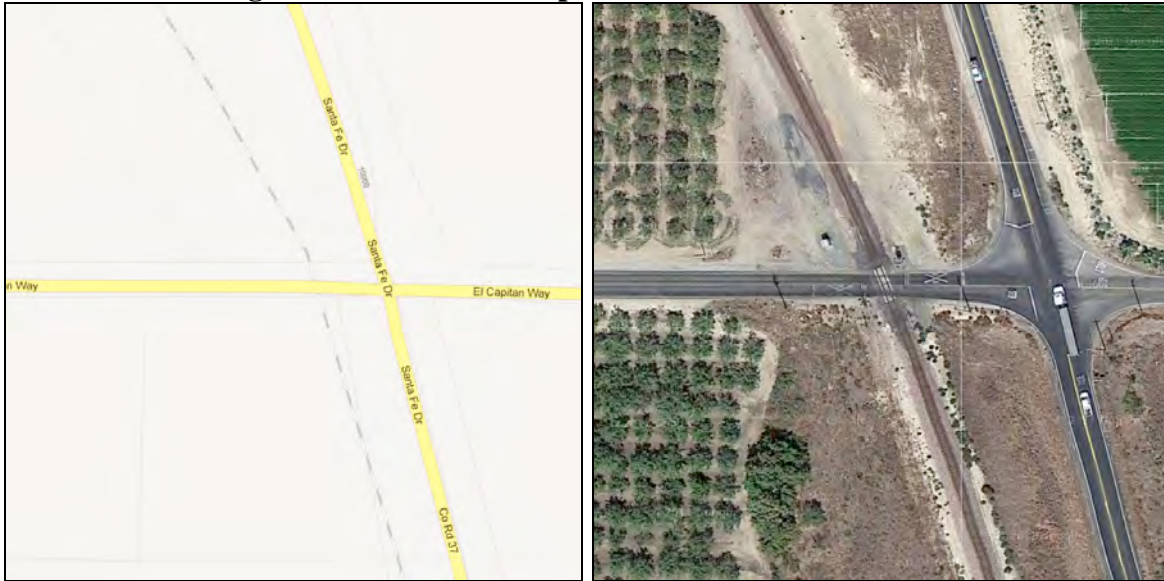
Figure 20: Overhead Map and Picture View 028714W

Using Google Maps, record the two views as shown in Figure 20. While these two views can be seen in the embedded viewer in the sample database, there may be times when an Internet connection is not available

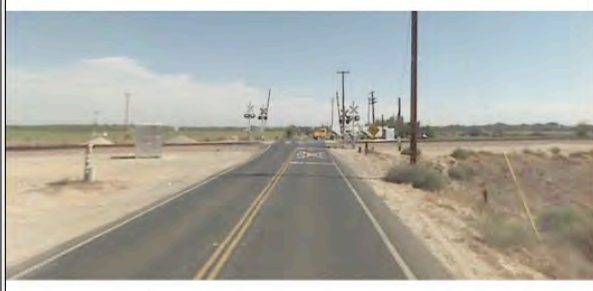
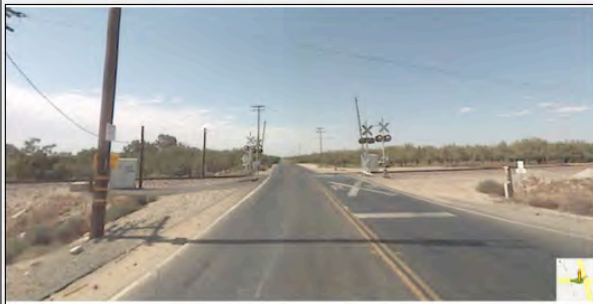
Approach View 1 Looking: East

Approach View 2 Looking: West

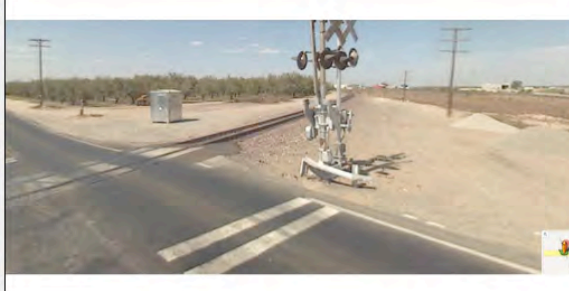
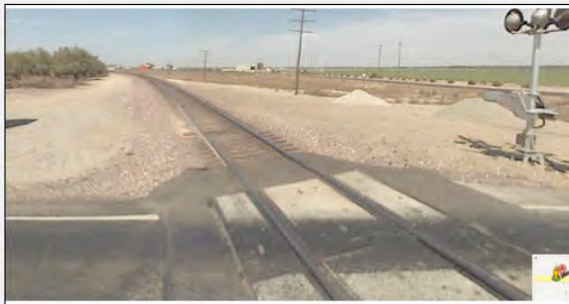
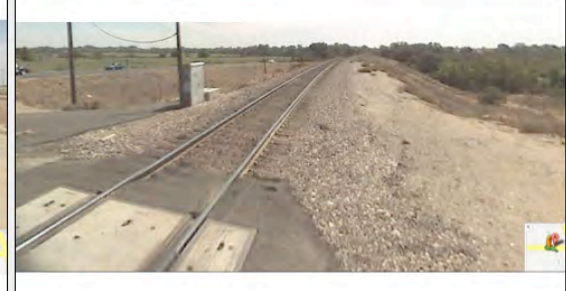
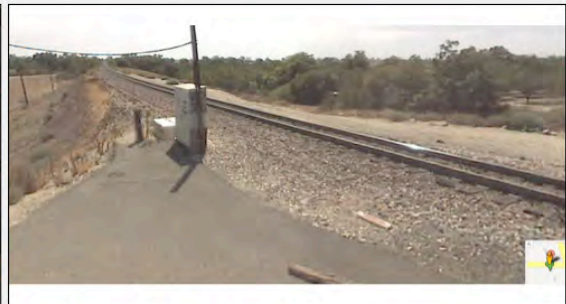
Track View 1: W of crossing, looking N

Track View 3: W of crossing, looking S

Track View 2: E of crossing, looking N

Track View 4: E of crossing, looking S
