Final Report

Testing & Evaluation of Close-Range SAR for Monitoring & Automatically Detecting Pavement Conditions

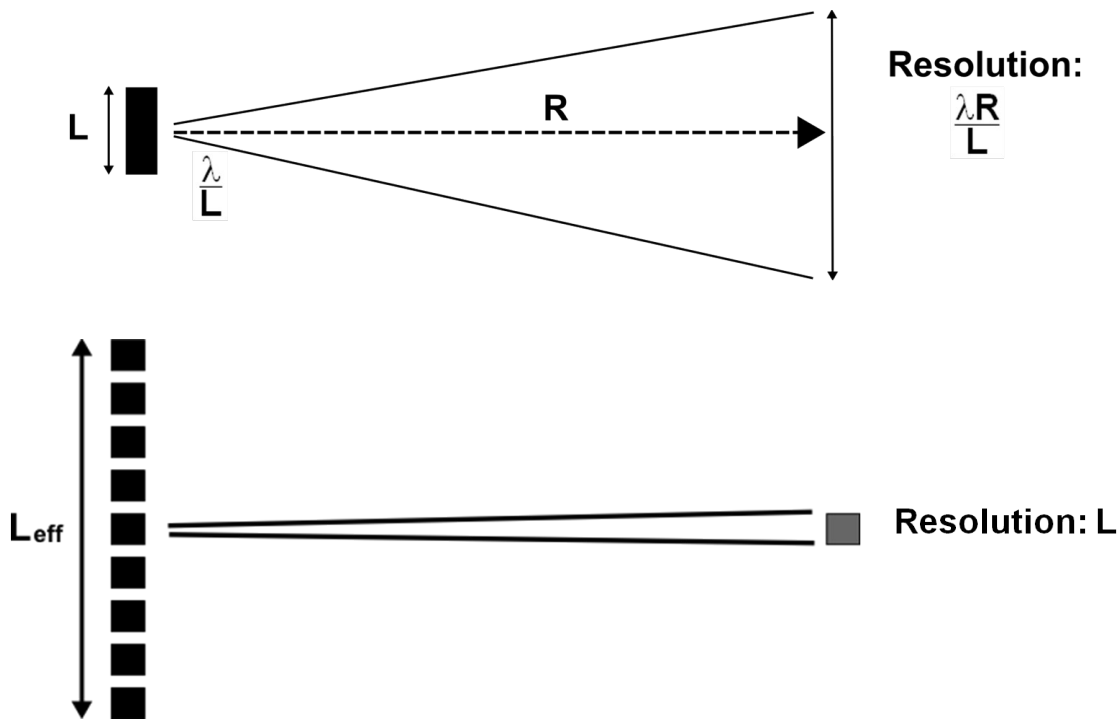
Figure 1. Whereas any optical system is governed by diffraction theory, the resolution can be improved through the use of a large antenna. The top schematic shows a real aperture radar, while the bottom schematic shows a SAR, in which a large effective antenna, L_{eff} , is achieved and the resultant resolution equals the actual physical size of the antenna, L .

An alternative, and more clever adaption of radar is to use a synthetic aperture. Such systems rely upon sensor motion (mounted on a satellite, plane, or vehicle) to create an effective, large antenna. By the previously mentioned Diffraction Equation, this extremely large synthetic aperture gives SAR systems extremely high resolution. Interestingly for SAR (as compared to real aperture radar), the smaller the antenna, the higher the spatial resolution. (See figure 1 for a schematic comparison between real aperture and synthetic aperture radars.) In the case of

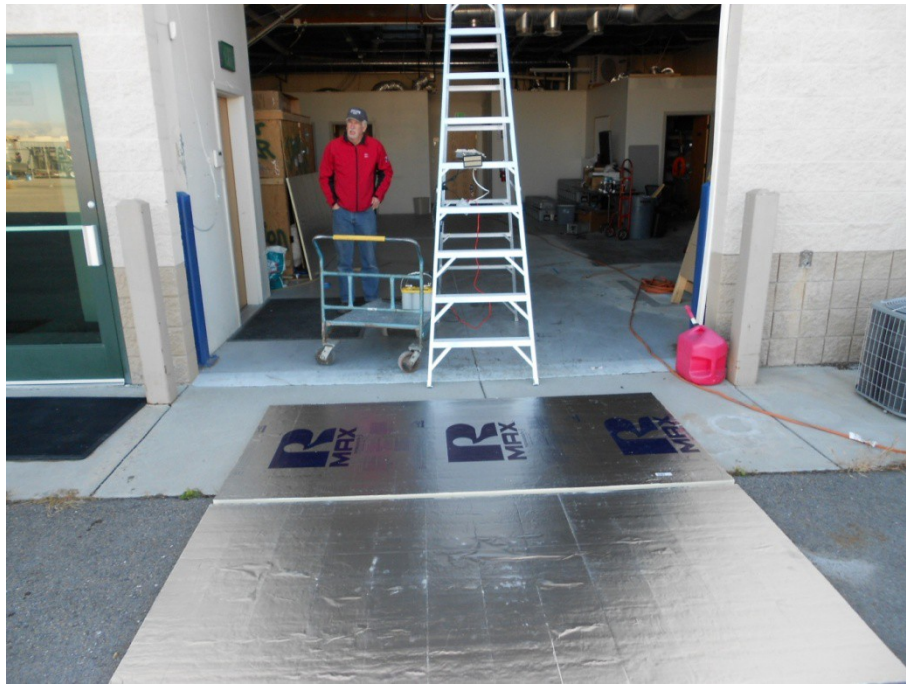
Figure 2. Configuration of preliminary experiments in which metallized foam sheets were illuminated by ladder-mounted X-band radar.

Preliminary Experiments Since the use of radar for crack detection had not been previously demonstrated, a set of controlled experiments was conducted using idealized cracks illuminated by the X-band radar mounted on a ladder. Specifically, a set of 4' x 8' insulation pads (used for home construction) were used to represent the roadway. These insulating pads are of 2" thickness and covered with a thin metallic veneer. Metallic tape was used to metalize the uncoated edges of the panels.

In these experiments, three panels were situated together on the ground, with variable spacing between the panels:

- No gaps
- 1" gap between 1st and 2nd panels
- Addition of 1" gap between 2nd and 3rd panels

- Increasing to 2" gap between 2nd and 3rd panels
- Increasing to 6" gap between 2nd and 3rd panels

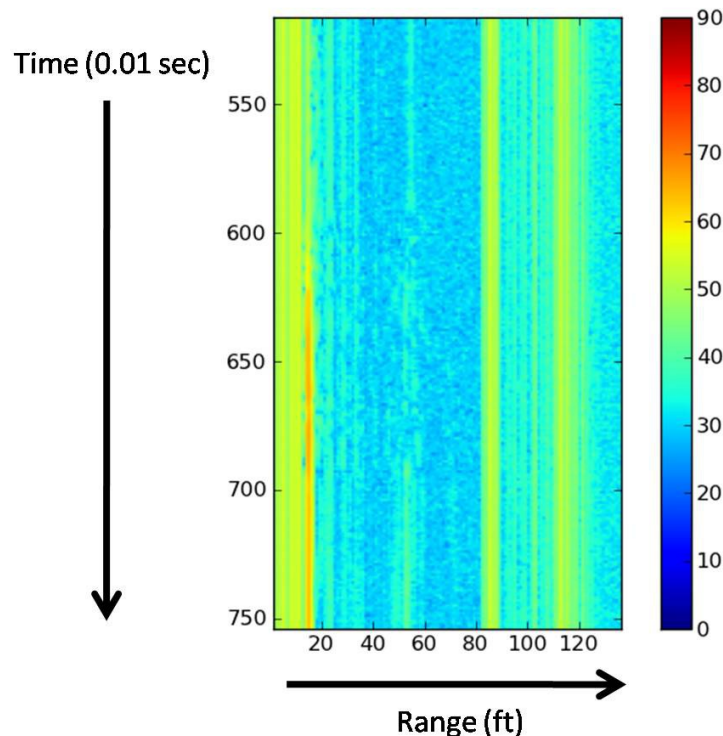
Figure 3. Waterfall plot for preliminary experiment in which gap between 2nd and 3rd panel is increased from 2" to 6". The strengthening return is seen in the vertical line that progresses from green to orange at the 15' range.

The solution used to address this problem is called a *water fall plot*, in which the strength of radar returns are plotted in range and time. To minimize processing time, only every 10th radar chirp is displayed in the image. For unmoving targets, as in this preliminary experiment, the cracks yield straight lines at a fixed range. For targets moving away from the sensor (e.g. if the sensor was moving), individual targets are expected to form lines that steadily increase in range with time. An example of this is shown below, for the preliminary experiment in which the second gap is being increased (by hand) from 2" to 6". The strength of the return (at about 15 on the range scale) is seen to steadily increase as the gap size grows.

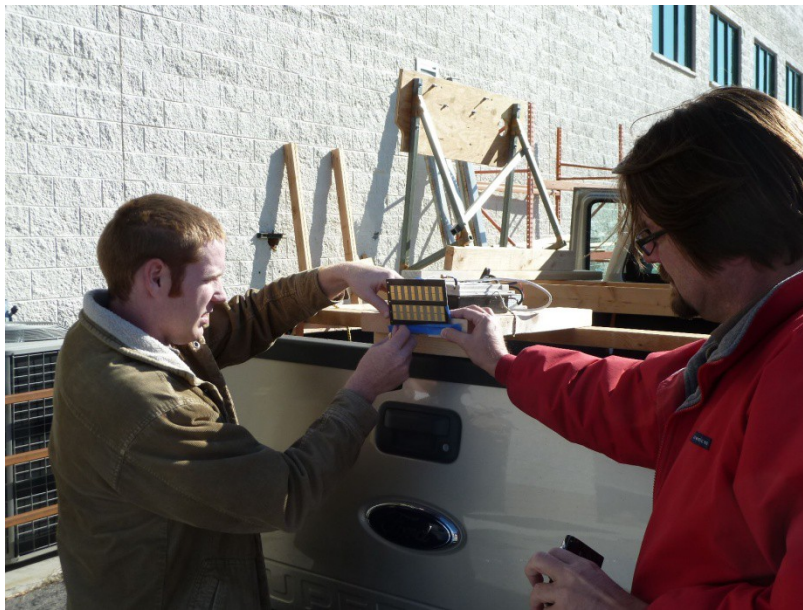
Figure 4. X-band radar mounted on tailgate of truck. Antenna is looking down at approximately 45 degrees.

Road Tests Upon completion of the controlled experiments with panels, a number of road tests were conducted over a variety of surface conditions. The X-band radar was mounted at a height of 5' on the tailgate of a truck, looking back down at the pavement at an angle of approximately 45 degrees. With this geometry, the illuminated footprint on the ground is approximately $0.3 \times \text{Range}$. In other words, at a distance of 10' from the radar, the width of the illumination is about 3', and broadens with increasing distance from the back of the truck. In optimized operation, the radar antenna would be tailored to provide illumination of the entire width of a road lane at a reasonable range. The set-up of the radar is shown in Figure 4.

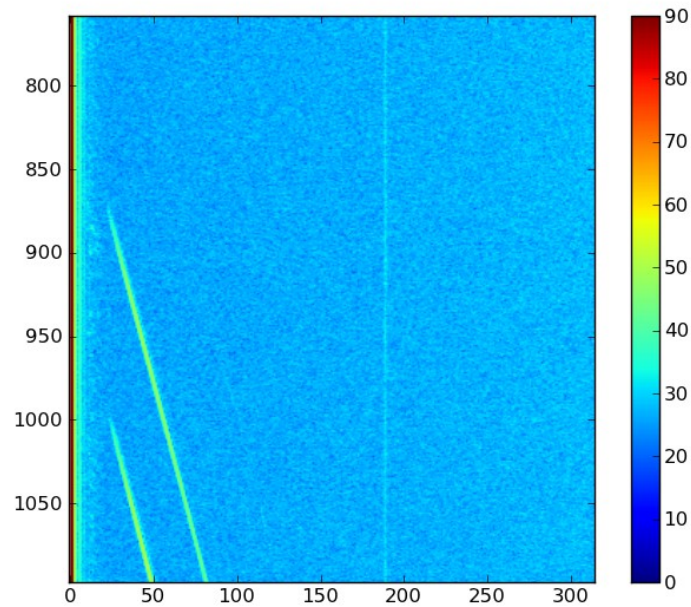
Figure 5. Two strong returns are seen as truck drives by two corner reflectors positioned along side of asphalt road. Random scatter from road features are seen at smaller ranges.

The impact of motion on the waterfall plots can be seen in Figure 5, where two corner reflectors were positioned at the edge of the asphalt road as the truck drove by. Reflectors are first seen at a range of approximately 25ft and increase in range as the vehicle drives past.

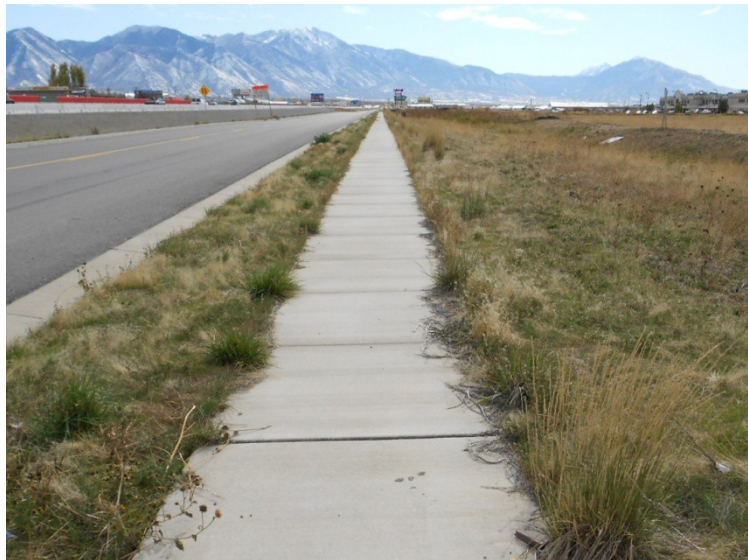
Figure 6. Sidewalk imaged by real aperture radar.

To investigate a consistent pattern of cracks in concrete, the sidewalk near ImSAR (Figure 6.) was imaged. The resulting waterfall plot is shown in Figure 7.

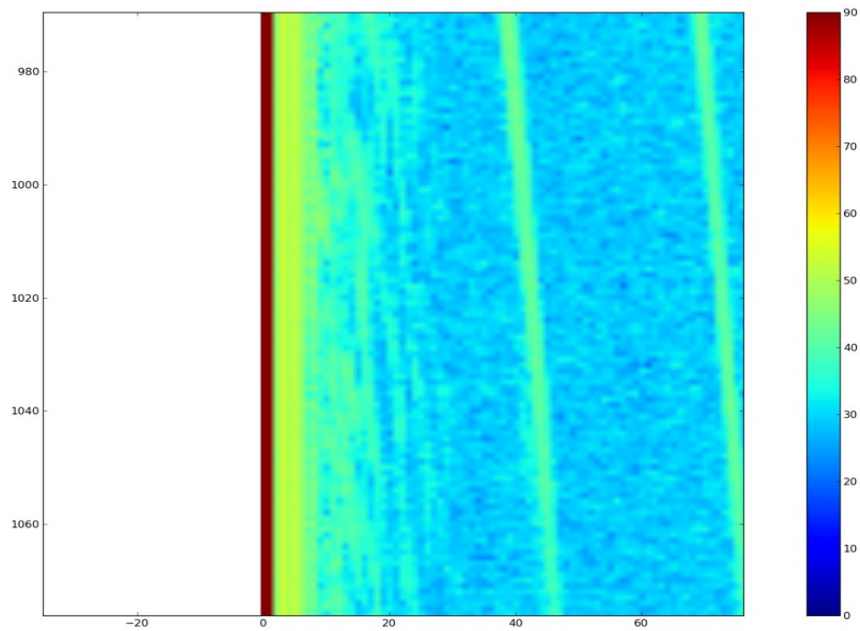
Figure 7. Concrete sidewalk cracks clearly seen in above waterfall plot as a succession of lines at the lower range scale (less than 30).

The results for cracks in concrete were very encouraging; yielding clear returns from the cracks and negligible return from the smooth surfaces. Unfortunately, the results were not so unequivocal for features in asphalt roads. Numerous experimental scenarios were explored at an airport, a parking lot, and on country roads. But the results can be best characterized by comparing two scenes: one for a pristine road with no discernible cracks and one for a road

Unlike the previous example in which concrete cracks were readily seen in Figure 7, there is no striking difference between the “good” and “bad” asphalt in Figure 8. The backscatter of microwaves from any surface depends on the roughness of the surface. A rule of thumb for roughness is that a surface is rough if the surface fluctuates by more than $\frac{1}{4}$ wavelength. For X-band radar, this is a mere 8 mm. Thus, asphalt surfaces look rough and produce random noise (or clutter) that masks the returns from the actual cracks. This poor signal-to-clutter issue is further exacerbated by the low signal from the cracks. Since asphalt cracks tend to be very rough (on a 8mm scale), the signal gets reflected in all directions; further limiting the strength of the microwaves reflected back to the detector. Based upon this outcome, X-band characterization of surface features in roads made of asphalt appears unlikely due to the comparable magnitudes of signal and clutter.

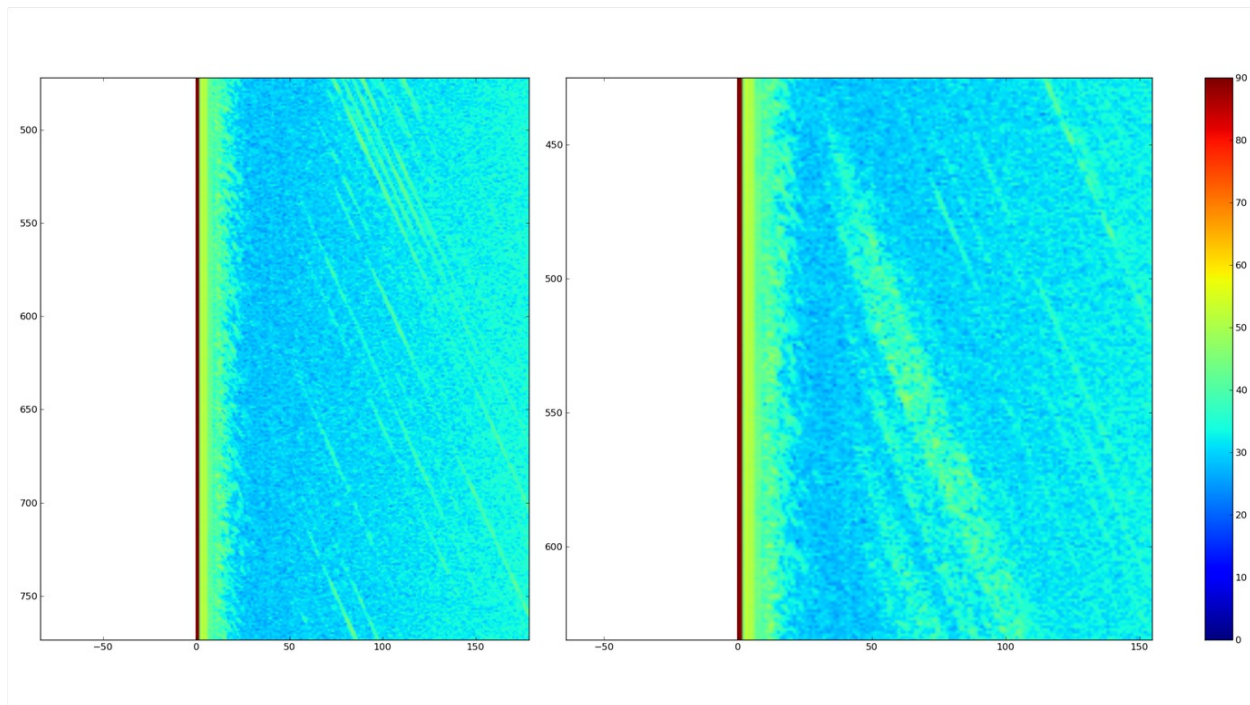
Figure 8. Waterfall images for asphalt pavement in case of pristine condition (left) and a maze of “spider” cracks (right). All road features are seen at ranges of less than 50. Fenceposts are seen at larger ranges in left image, and a passing car is seen at larger ranges in right image.

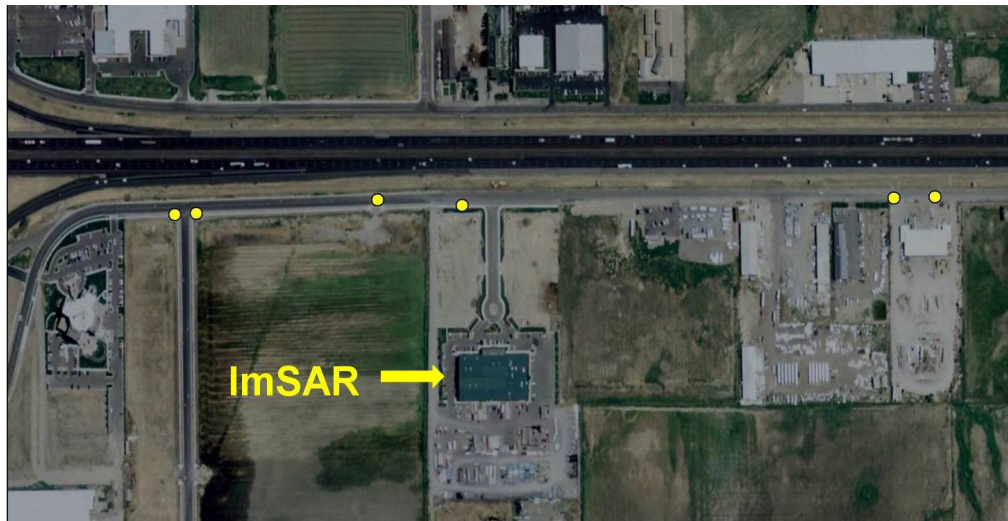
Figure 9. Google Earth image of the region around the ImSAR building, showing six identified concentrations of cracks in the asphalt service road.

To prepare for the flight tests, the service road in front of ImSAR was scanned for features of interest. As seen in Figures 9 and 10, a number of features were identified and geolocated with GPS. Of the six features identified in the service road, none were discernible in the Ku-band image. Moreover, all asphalt roadways are dark and appear to be dominated by noise. As observed with the X-band real aperture radar, Ku-band SAR seems incapable of discerning surface features in asphalt roadways.

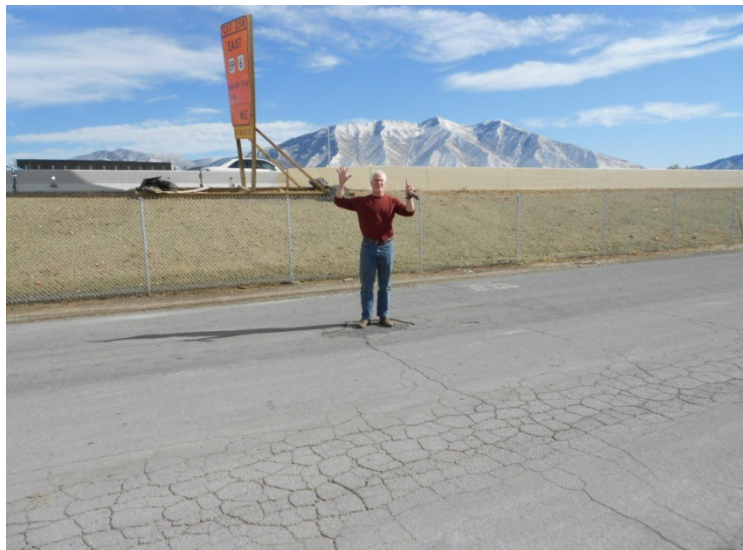
Figure 10. Photo showing cracks at one of the six locations in Figure 9.

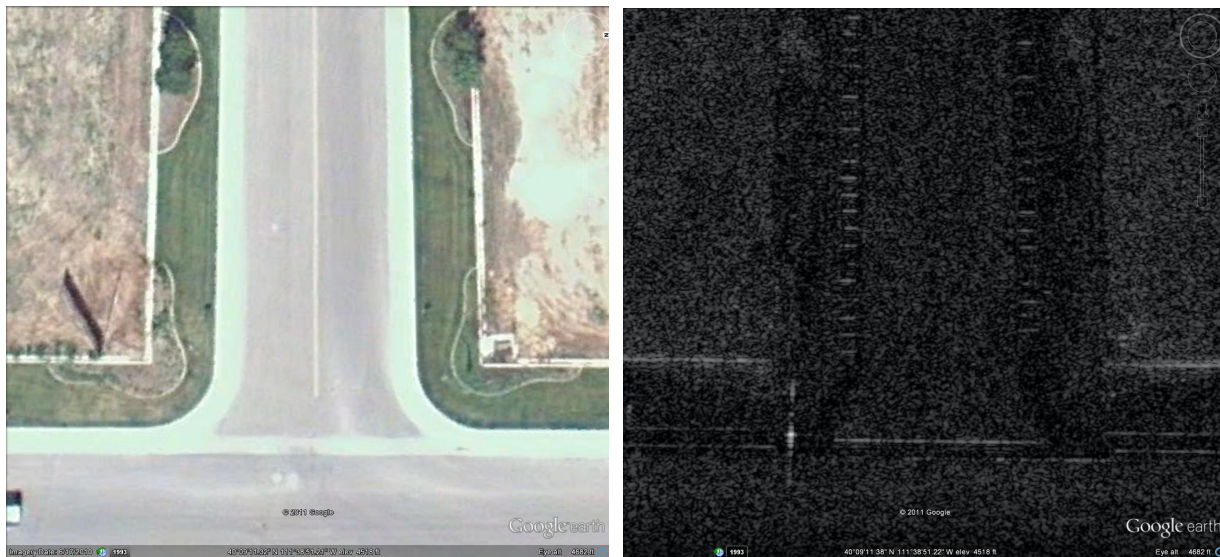
Figure 11. Google Earth image (left) and Ku-band SAR image (right) of roads and sidewalks in front of ImSAR. Cracks running left/right (the same direction as the flight direction) are readily seen.

Better results were found for features in the concrete. As in the case of the X-band radar, the Ku-band SAR could easily see sidewalk cracks in concrete. Figure 11 shows an optical image (from Google Earth) and the associated SAR image for the service road and sidewalk in front of ImSAR. Note that the SAR image was flown in a left/right direction. It should be noted that cracks that run parallel to the flight line are easily observed, while those sidewalk cracks running perpendicular to the flight direction are invisible.

The preference for seeing cracks parallel to the flight direction is not surprising. Those cracks present a reflective surface facing the plane and yield a strong return relative to the flat surface of the sidewalk. On the other hand, cracks perpendicular to the flight direction merely present a trough to the microwaves; offering no significant surface with which to reflect microwaves.
