NDOR Project No. SPR-P1(07) P596

PHASE I DEVELOPMENT OF AN AESTHETIC, PRECAST CONCRETE BRIDGE RAIL

MIDWEST ROADSIDE SAFETY FACILITY (MwRSF)

MwRSF Research Report No. TRP-03-239-12

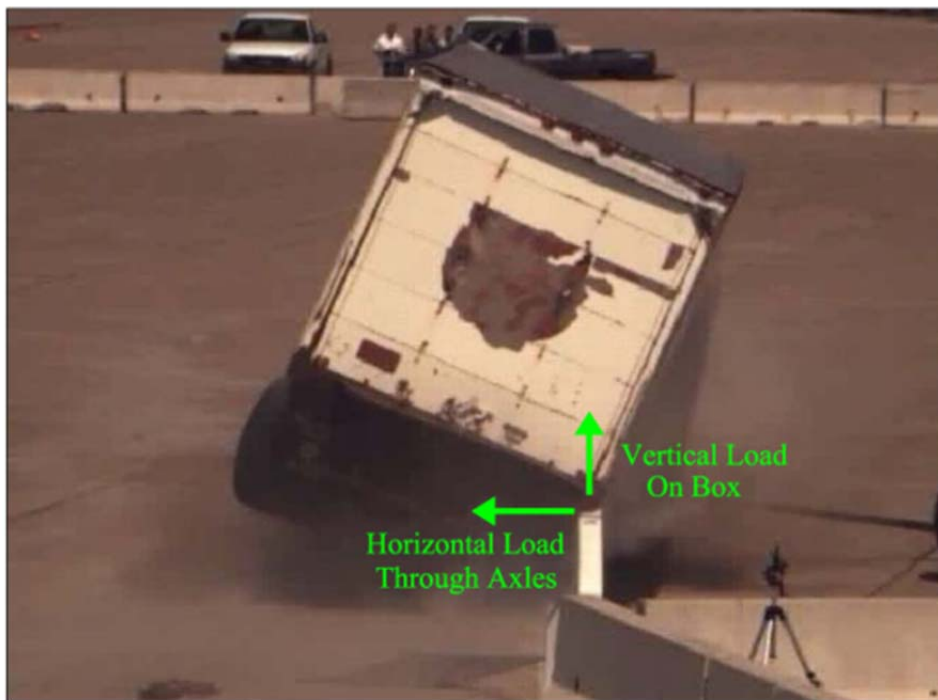
shorter barriers during impact events. For example, the MASH 10000S single-unit truck (SUT) has a ballast center of gravity (c.g.) height of 63 in. (1,600 mm). Thus, these heavier and taller vehicles, such as single-unit trucks, are redirected and prevented from rolling over the top of rigid barriers due to a combination of a vertical barrier load being applied to the outer underside of the cargo box and a lateral barrier resistance imparted to the wheels and axle assemblies, as shown in Figure 3.

Figure 3. Barrier Forces Acting on Single-Unit Truck During Impact

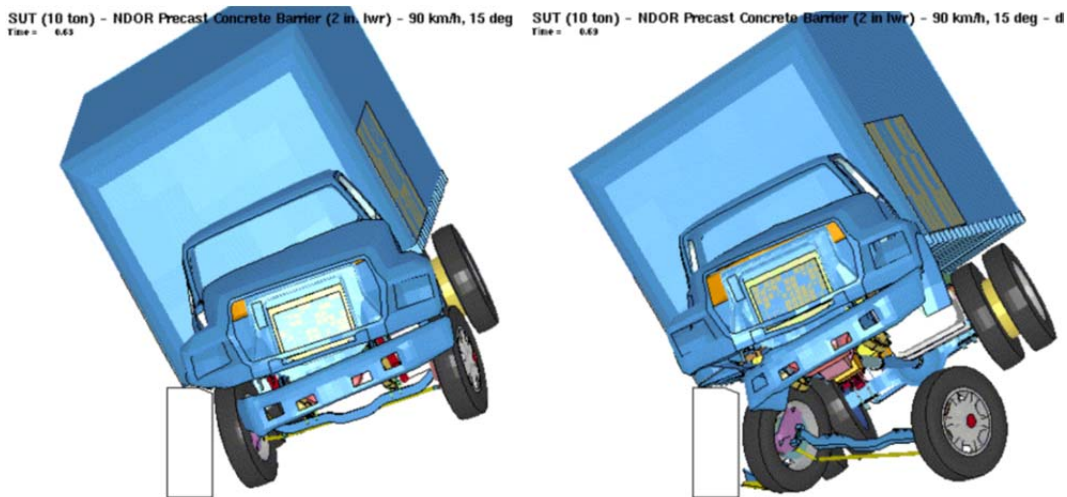
As such, an LS-DYNA computer simulation effort [18] was utilized to determine the barrier height necessary to prevent rollover. A 15-in. (381-mm) wide, rigid barrier was configured using a cross-sectional geometry conforming to the design limits shown in Figure 2. The barrier geometry was modeled such that the barrier height could be raised or lowered between simulation trials. A 10000S vehicle was modeled to impact the barrier under the TL-4 impact conditions of MASH. If the initial simulation provided satisfactory results (i.e., the vehicle was redirected without rolling over the barrier), then a second simulation was conducted at the same barrier height in which the suspension was disconnected from the front axle during impact. This type of vehicle damage has been commonly observed in previous TL-4 full-scale crash tests [15-16, 19-21], which can cause vehicle instabilities. LS-DYNA simulations demonstrated that a barrier height of 34½ in. (876 mm) was adequate for redirecting a single-unit truck and preventing the vehicle from rolling over the top of the barrier. Crash images depicting the vehicle's maximum roll angle when impacting a 34½-in. (876-mm) tall barrier are shown in **Error! Reference source not found.** for both the connected and deleted suspension simulations.

Connected Suspension Deleted Suspension @ 100 ms
Figure 4. Maximum Roll Angle of 1000S Vehicle Impacting 36½-in. Tall, Rigid Barrier

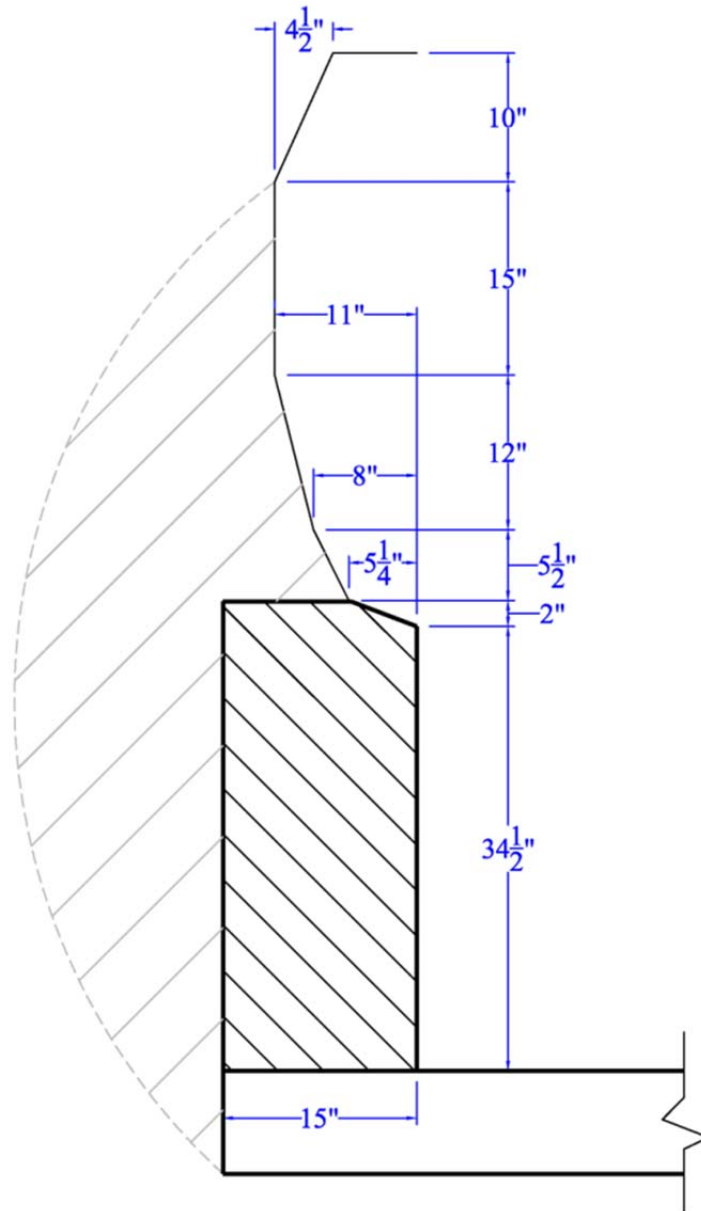
bridge deck surface in front of the parapet. Using the prior width and head ejection limits in combination with the noted rail height, the geometric bounds for the new bridge rail were determined, as shown in Figure 5. However, it was noted that additional features may be incorporated into the simple geometry shown in Figure 5 as long as the head ejection envelope or lateral rail width limits are not violated.

Figure 5. Bridge Rail Geometric Bounds

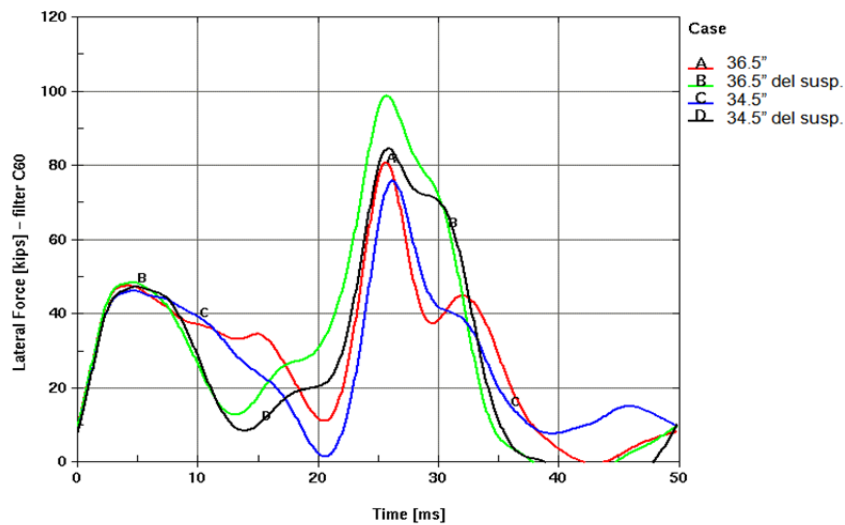
The third method for approximating the MASH TL-4 peak lateral impact loads consisted of LS-DYNA computer simulation. The computer simulations described in Section 3.1.3 were used to demonstrate that a 34½ in. (876 mm) tall, rigid barrier could successfully redirect a 10000S vehicle. These same simulations were also used to predict the peak lateral impact forces. Two simulations were conducted for each barrier height of 36½ and 34½ in. (927 and 876 mm). The front suspension was deleted at 100 ms for one simulation at each barrier height. Figure 6 contains force vs. time curves for all four simulations after an SAE C60 filter was applied. Table 2 contains the simulation results for the applicable TL-4 test condition.

Figure 6. LS-DYNA Impact Force vs. Time - MASH TL-4 Condition

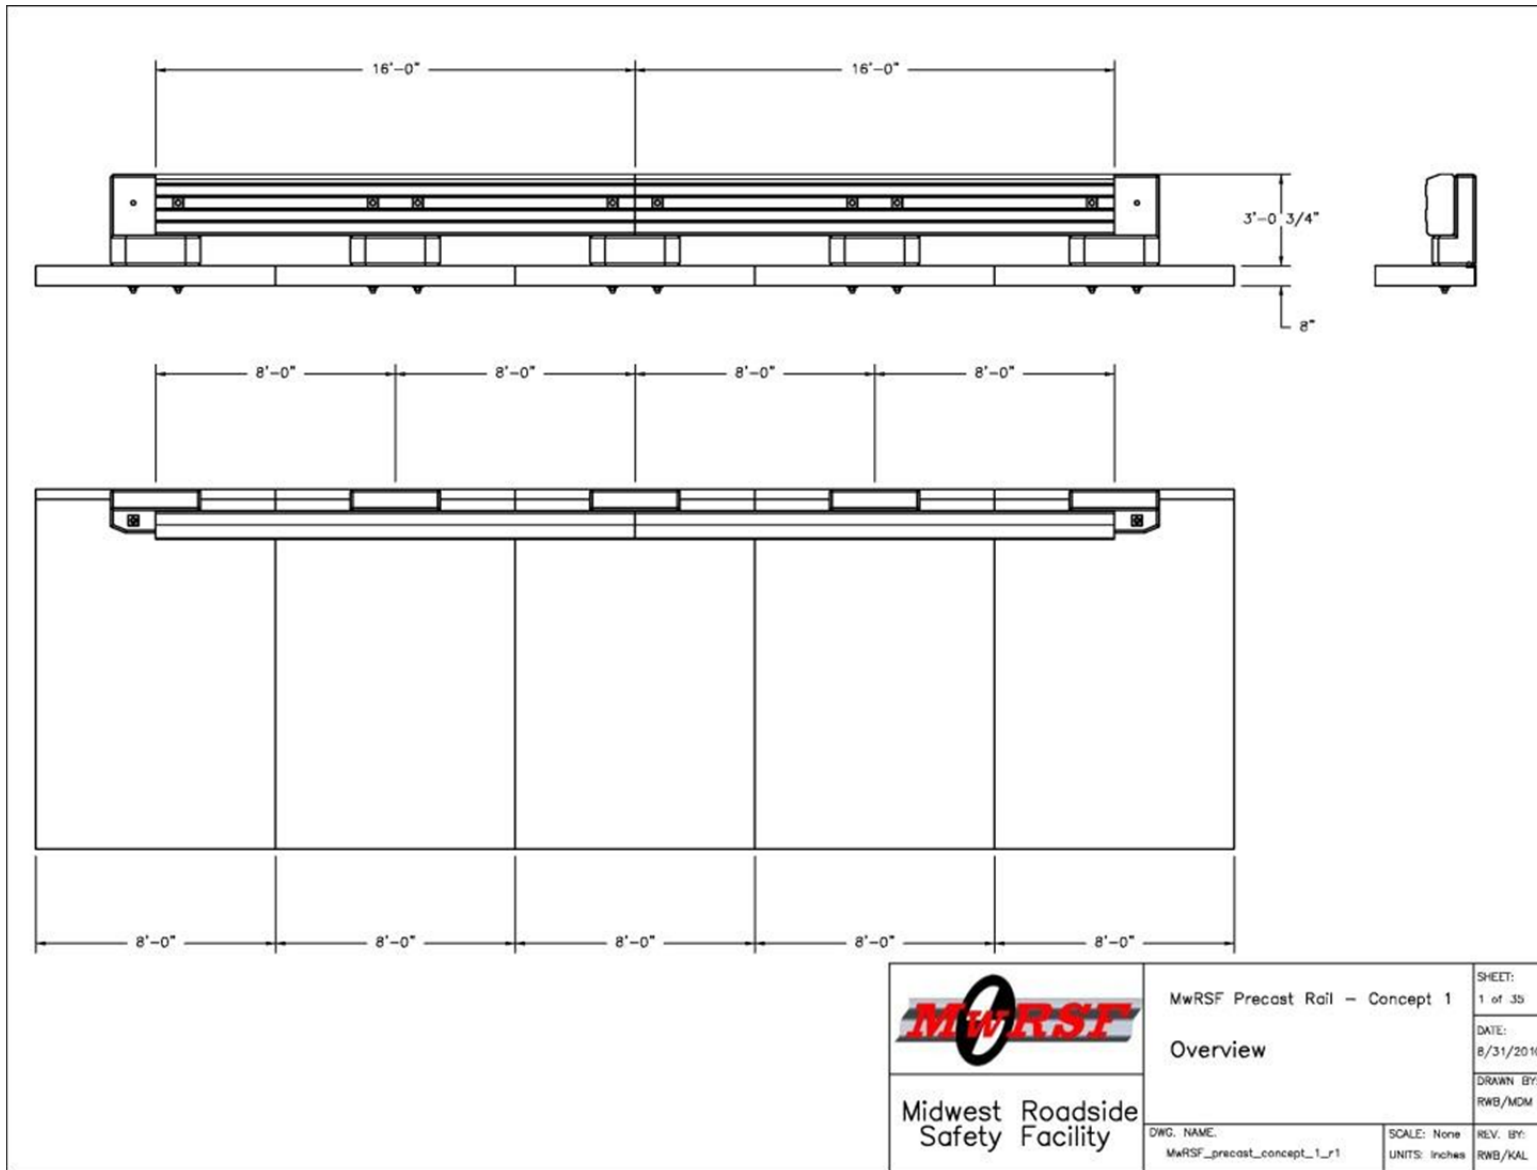
Figure 7. Concept A (L-Post) - Overview

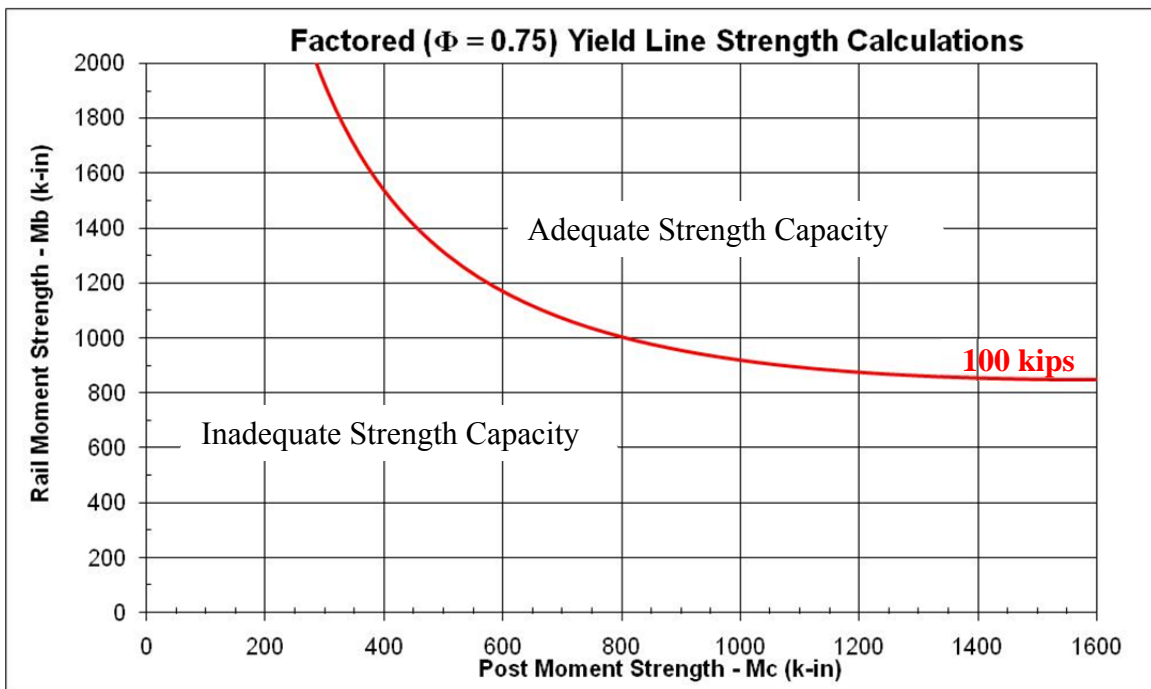
The plot shown in Figure 34 was used to analyze the effects rail strength had on post strength, and vice versa. A value of 1,000 k-in. (113 kN-m) was selected as the design moment for the rail beams, which corresponded to a post bending value equal to 800 k-in (90 kN-m). Note that this post bending value will be used to design the post to deck attachment hardware in Chapter 9. Again, the rail design moment was allocated accordingly between the upper and lower rails. Estimating that up to two-thirds of the impact load could be applied to a single rail, a design moment of 700 k-in (79 kN-m) was prescribed for each rail.

Figure 34. Factored Rail Moment Strength vs. Post Moment Strength

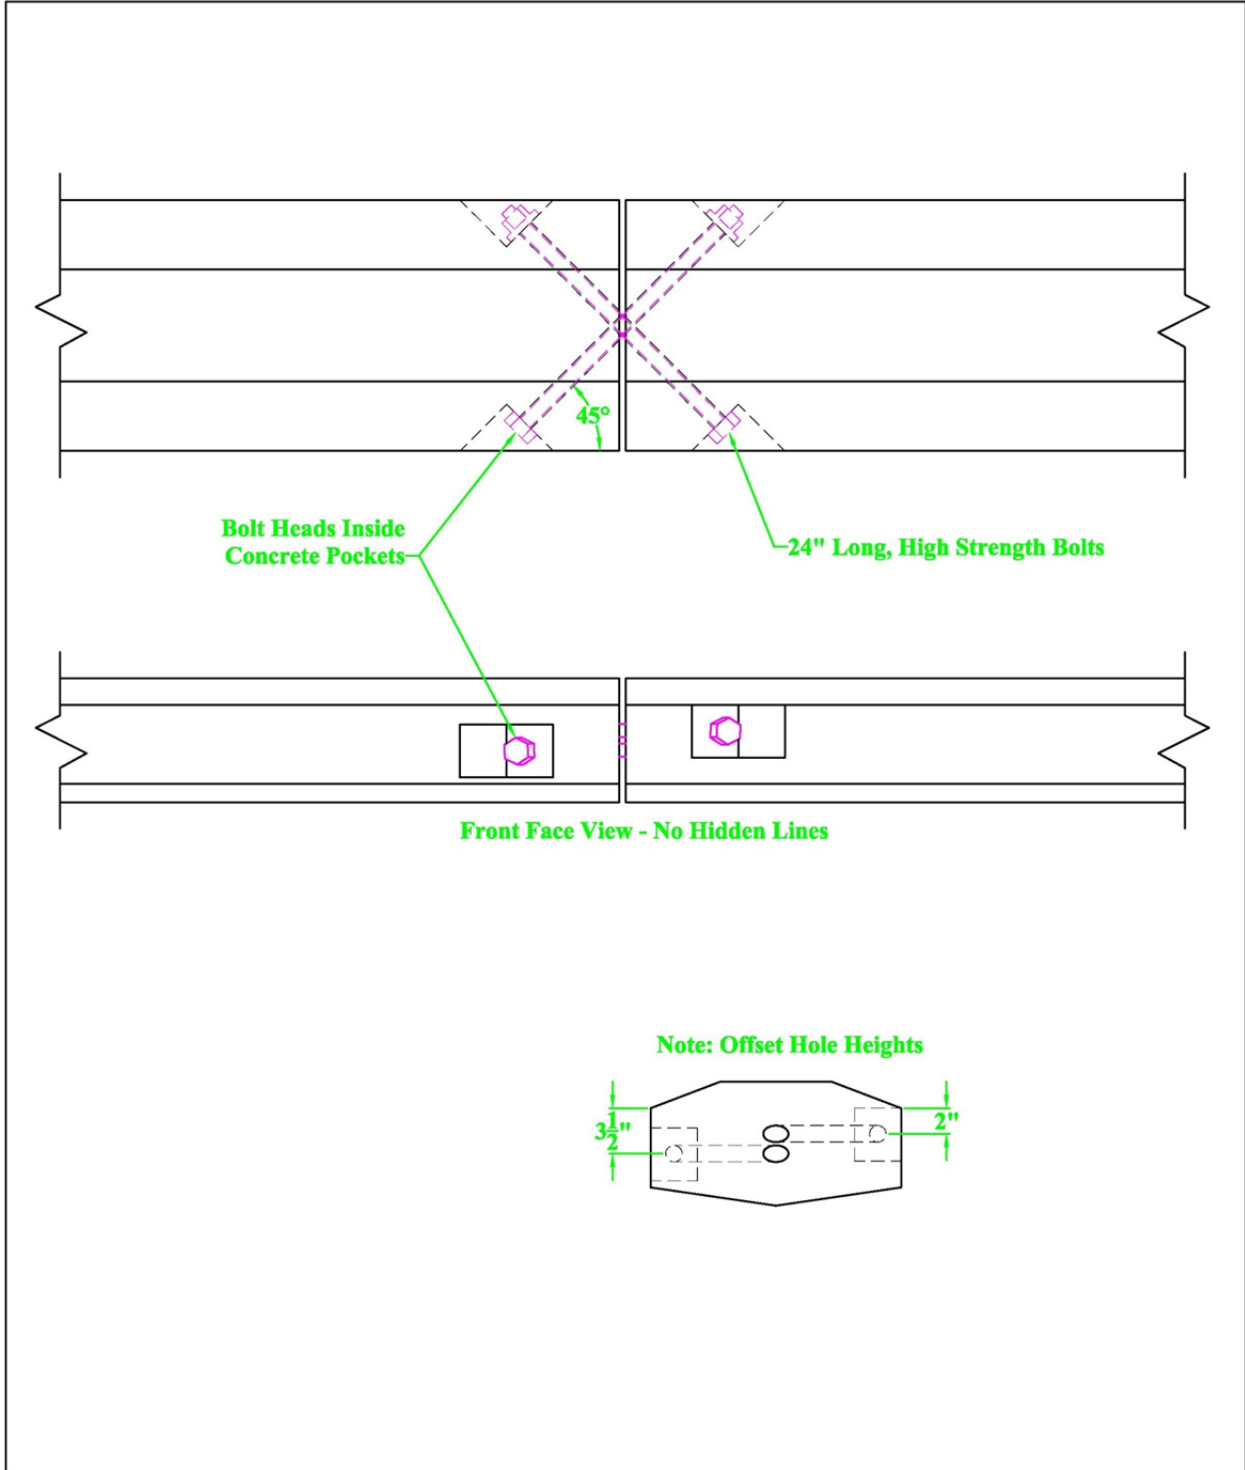
Unfortunately, a major issue developed upon further examination of the cross bolt joint: the size of the bolts needed to significantly increase. The original cross bolt joint design by TTI utilized $\frac{7}{8}$ -in. (22-mm) diameter bolts. However, the design criteria used in that study corresponded to a NCHRP Report No. 350 TL-3 barrier, whereas the design criteria for the proposed precast bridge rail in this project corresponds to a MASH TL-4 barrier. Consequently, impact loading conditions vary between the two designations. In fact, the proposed precast barrier is required to resist much higher force levels than the original TTI design. Thus, larger bolts and more anchorage in the rail segment ends were necessary. The task of increasing the size of the bolts while still providing adequate concrete cover proved to be too difficult.

Figure 36. Joint Design B – X-Bolts

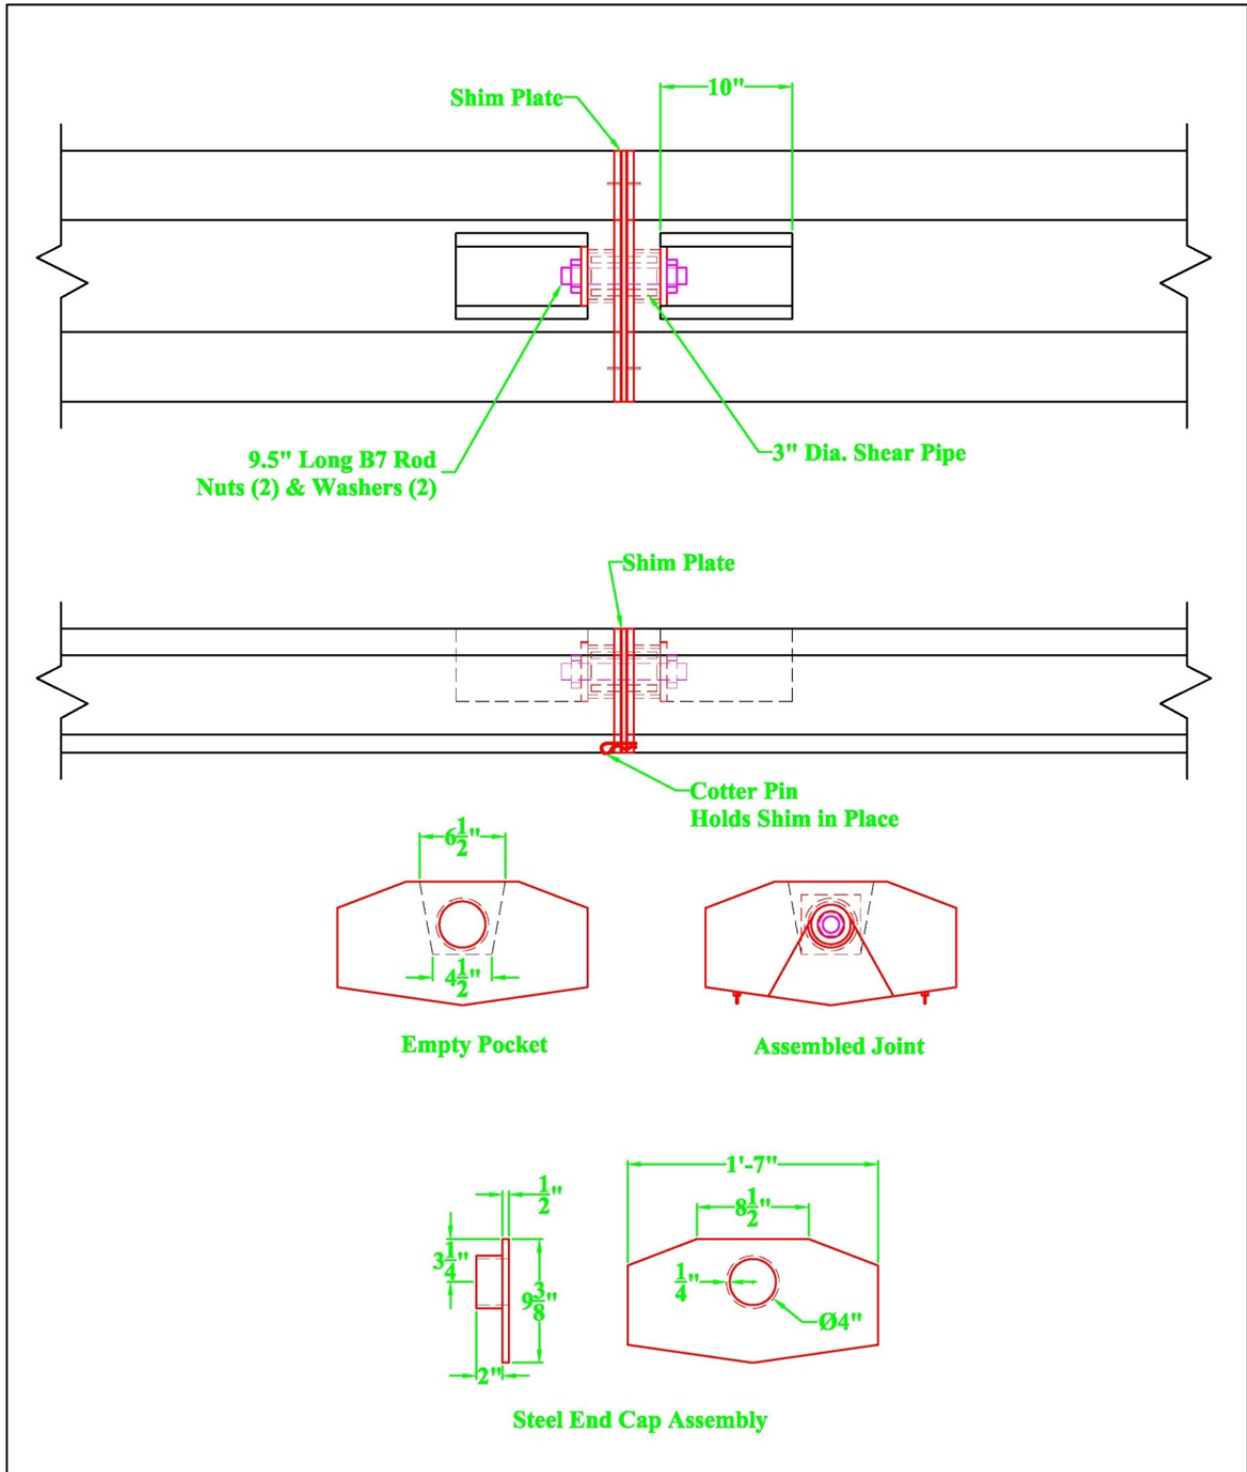
Although locating the joint hardware in the center of rail eliminated steel from the rail face and reduced the amount of parts necessary for installation, it did create other problems. Without a moment arm for bending transfer, the threaded rod had to be larger and of higher strength material than in other joint designs. Also, due to the hollow pocket for hardware in the center of the rail, a steel end cap assembly was necessary to distribute the loads and prevent concrete failure to the reduced rail section. Finally, since the shims covered the entire rail width and not individual sides, creating a tight joint in a curved bridge rail system would be difficult.

Figure 40. Joint Design E – Center Bolt and Shear Pipe

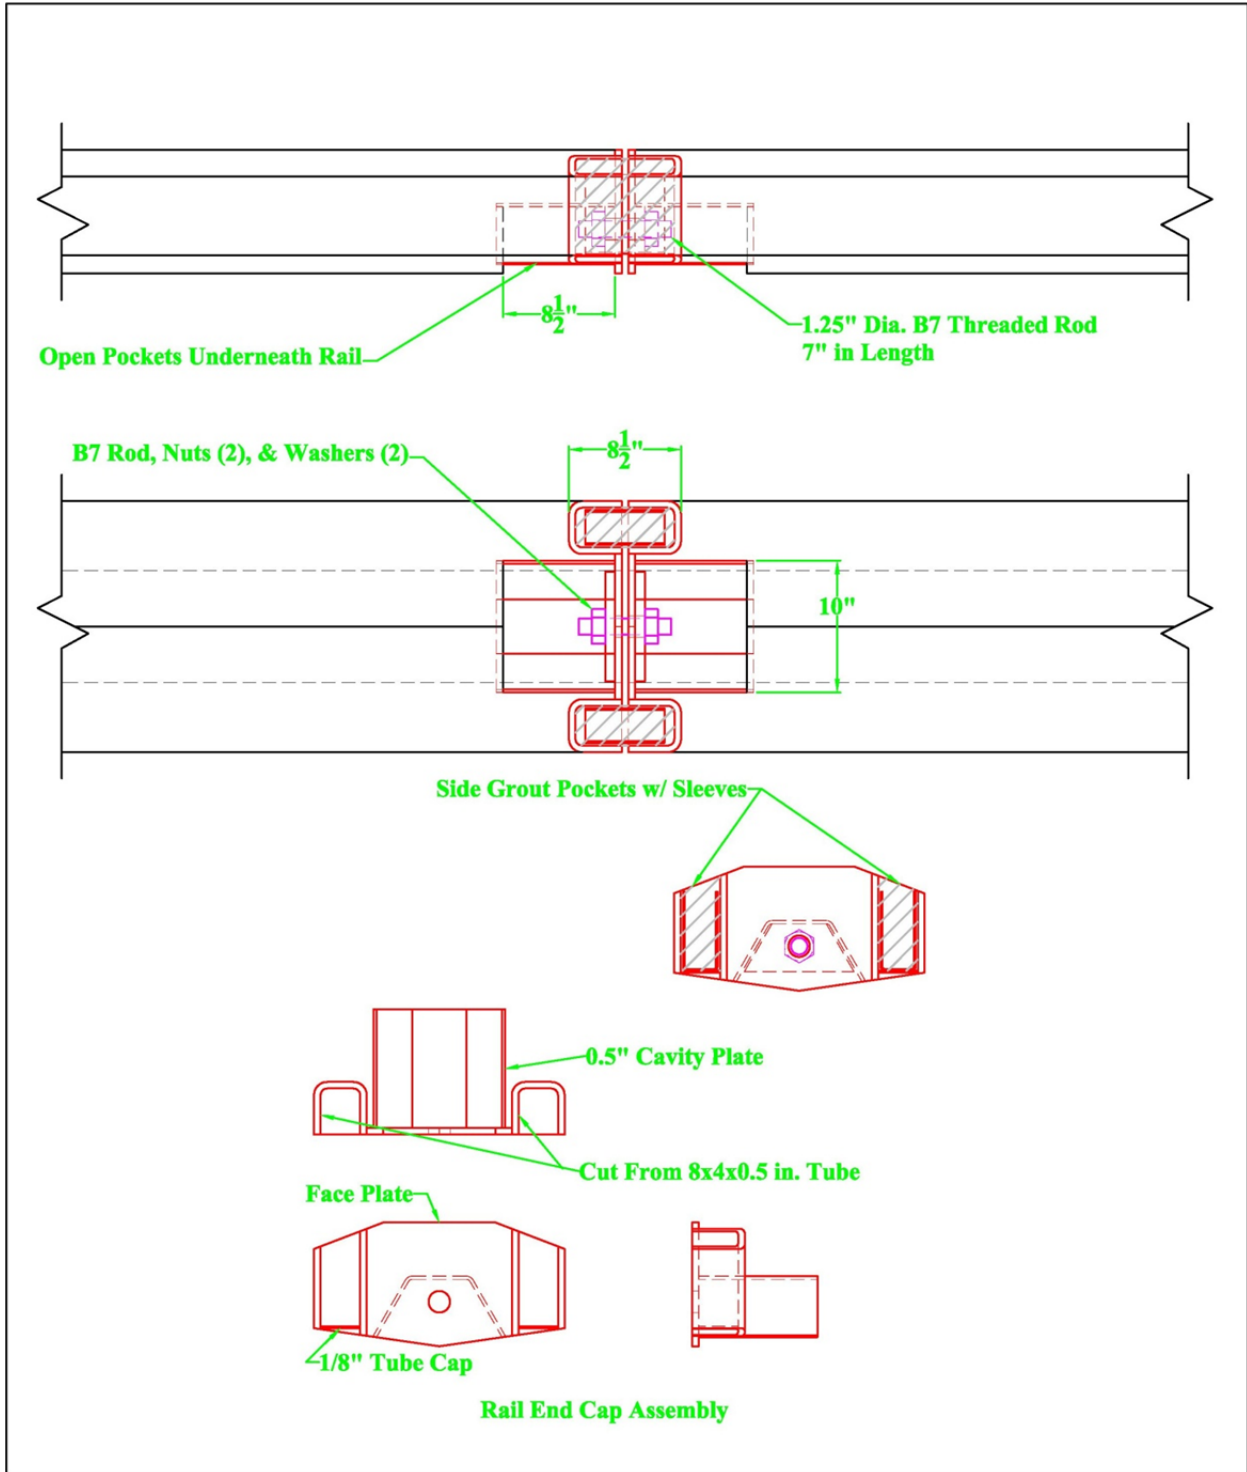
Joint Design G was one of the most robust of all joint designs described in this chapter. However, this strength and durability came at the expense of an elaborate rail end cap which required six different steel pieces to be fabricated and welded together. Also, installation on the joint required multiple steel hardware pieces and grout. Thus, this joint was considered one of the more expensive joint to fabricate and to install. Further, a reduction in the aesthetic appeal of the precast concrete bridge rail was another concern with the design. This joint contained both exposed steel to the rail faces and grout on the top surfaces of each rail. The entire bridge rail system may have to be painted to preserve the appeal of the precast bridge rail system.

Figure 44. Joint Design G – Center Bolt and Side Grout Pockets

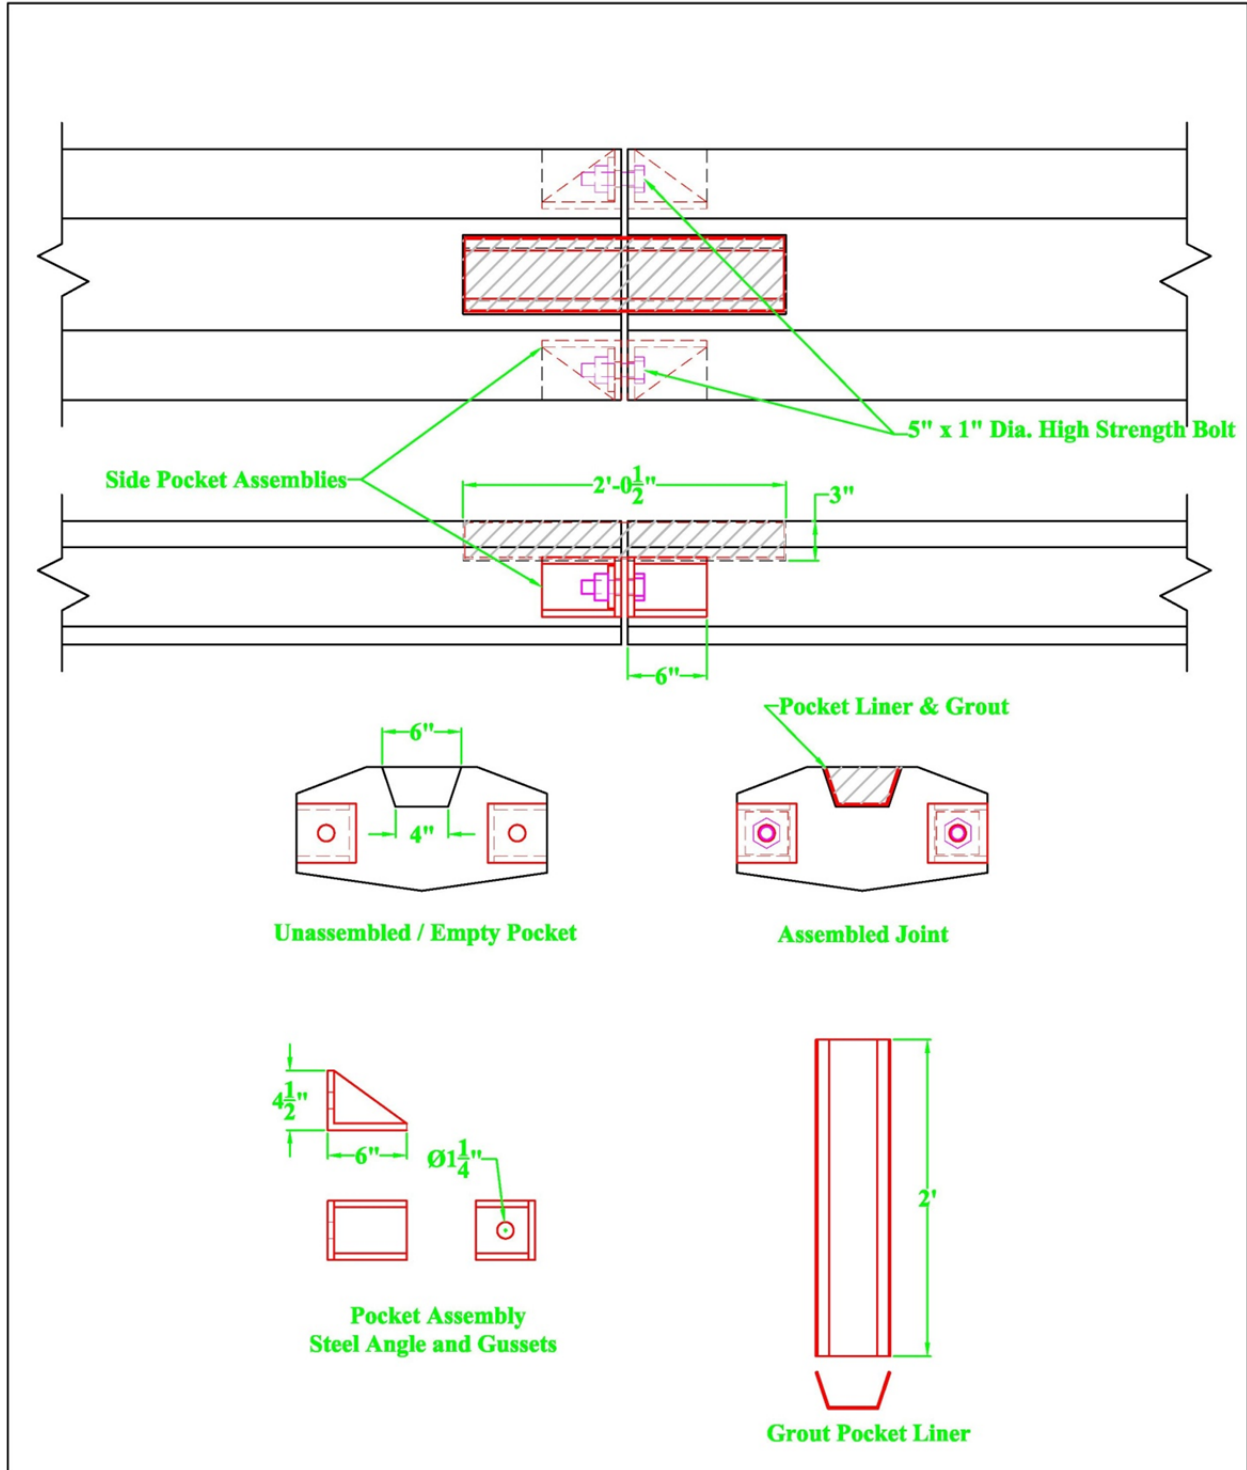
Separating the grout from the rest of the precast rail and connection hardware created a joint that could be assembled and disassembled quickly and easily. However, this ease in field labor was the result of pre-construction fabrication which required multiple steel pieces to complete the joint. Although the steel pocket assemblies were small, they required both cutting and welding to attach the gussets. Also, the grout pocket liner was not created from a standard steel shape, thus it required specific fabrication as well. Further, the side pockets may also be the source of future problems. Since the pockets were designed open to the sides, they increase the risk of vehicle snag on the joint during impacts. The pockets may also result in a reduction in aesthetic appeal to the precast concrete rail that painting could not cover up.

Figure 47. Joint Design I – Side Bolts and Center Grout Pocket

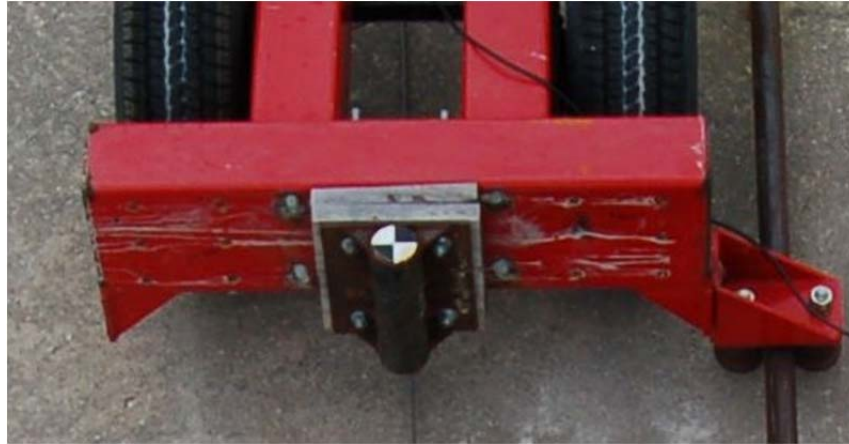
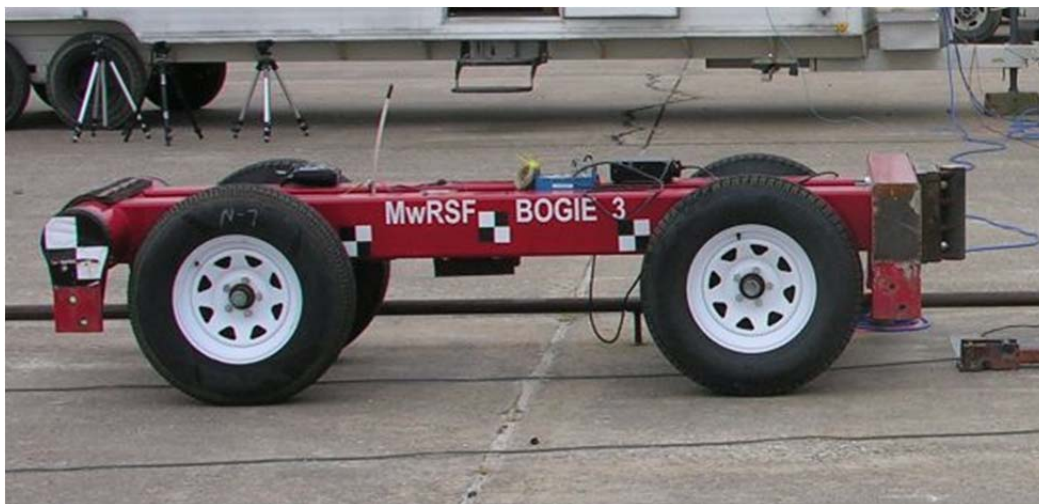
Figure 49. Bogie Vehicle (a) Impact Head and (b) on Guidance Track

A rigid frame bogie was used to impact the posts. A variable height, detachable impact head was constructed and used in the testing. The bogie head was constructed of 3-in. (76-mm) diameter steel pipe welded to a ½-in. (13-mm) thick steel plate using multiple gussets. Also, the steel tube was filled with concrete to prevent damage to the impact head. The impact head assembly was bolted to the bogie vehicle at a centered height of 21⅞ in. (537 mm) above the ground. The bogie with attached impact head is shown on the guidance track in Figure 49. The weight of the bogie with the addition of the mountable impact head was 1,616 lbs (733 kg).

A pickup truck with a reverse cable tow system was used to propel the bogie down the guidance track to a target impact speed of 22 mph (35 km/h). When the bogie reached the end of the guidance system, it was released from the tow cable, allowing it to be free rolling when it impacted the rail joint specimen. A remote braking system was installed on the bogie allowing it to be safely brought to rest after the test.

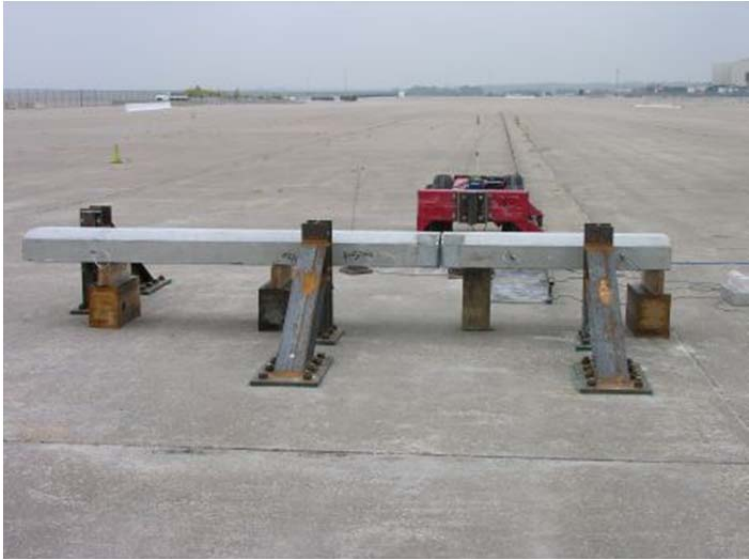
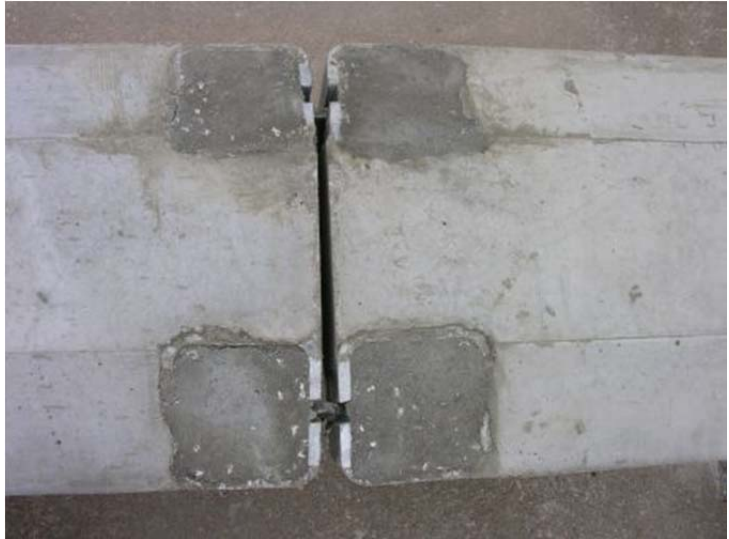
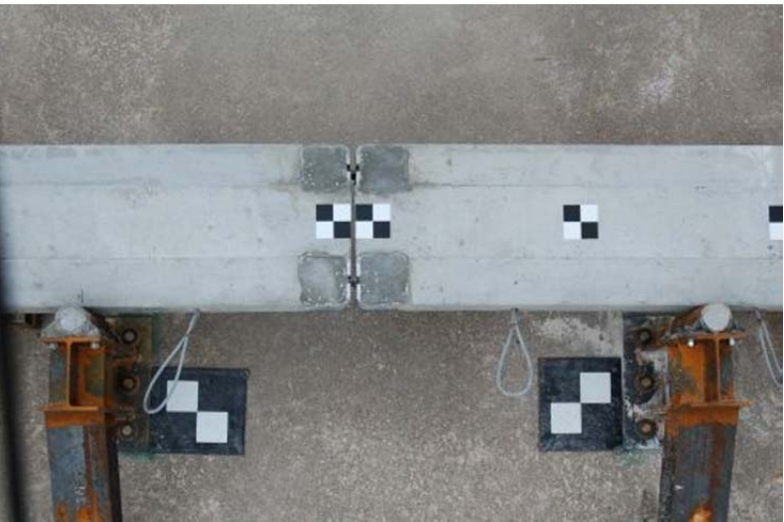
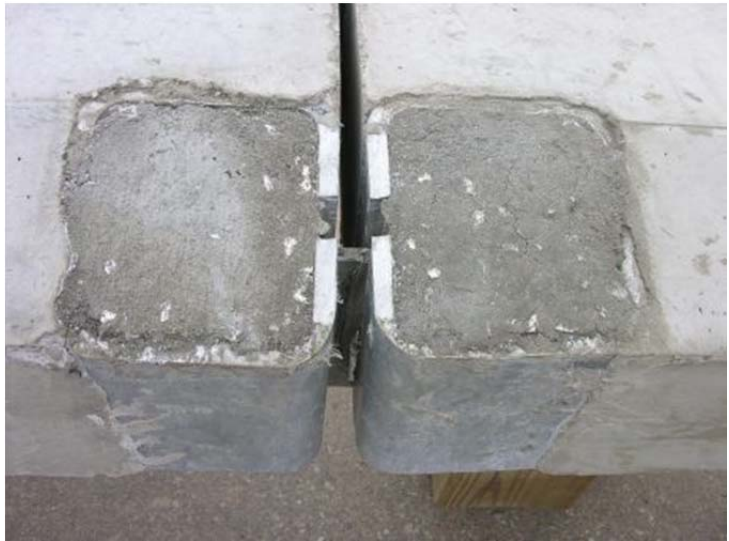
Figure 62. Rail Component Photographs, Test No. PCRB-1

The rail segments were placed on wooden support blocks and positioned as prescribed by Section 6.2 and Figure 48. To assemble the rail joint, two wide flange segments were dropped into the pockets with the web spanning across the $\frac{1}{2}$ -in. (13-mm) wide gap between rail ends. The steel segments were $5\frac{3}{8}$ -in. (137-mm) long S8x23 (S200x34) members. Once the segments were in place, L&M Crystex grout with a design strength of 10,000 psi (68.9 MPa) was used to fill the pockets and secure the steel sections. Photographs of the assembled joint specimen are shown in Figure 62.

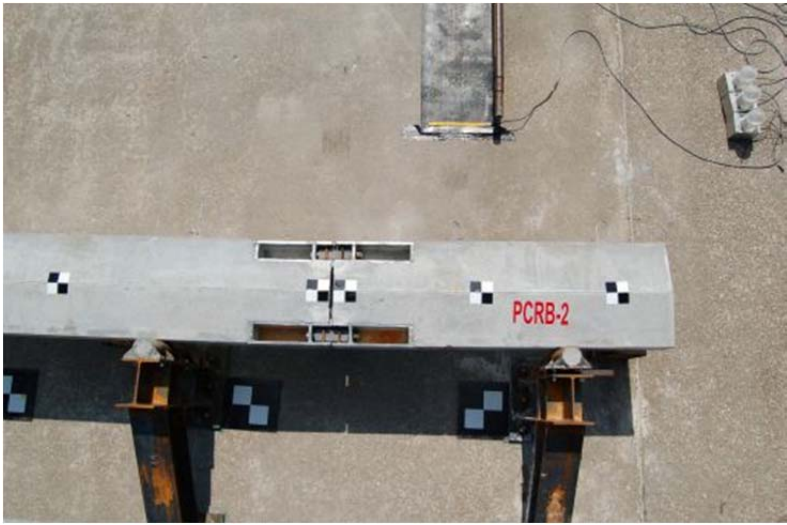
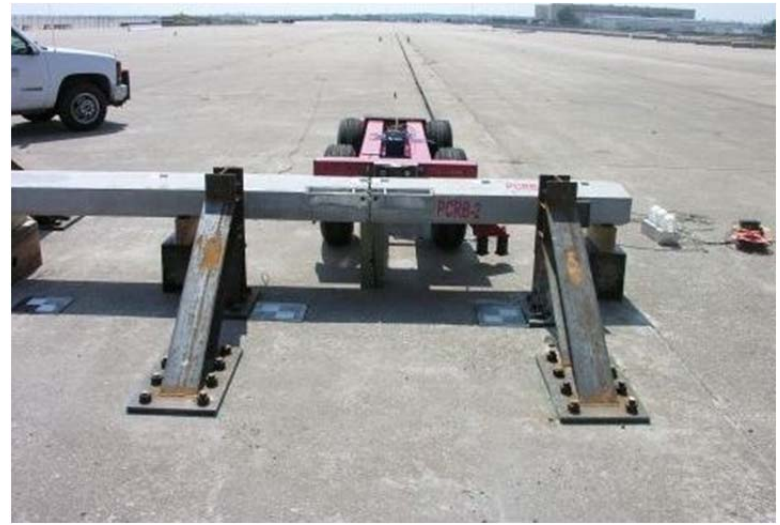
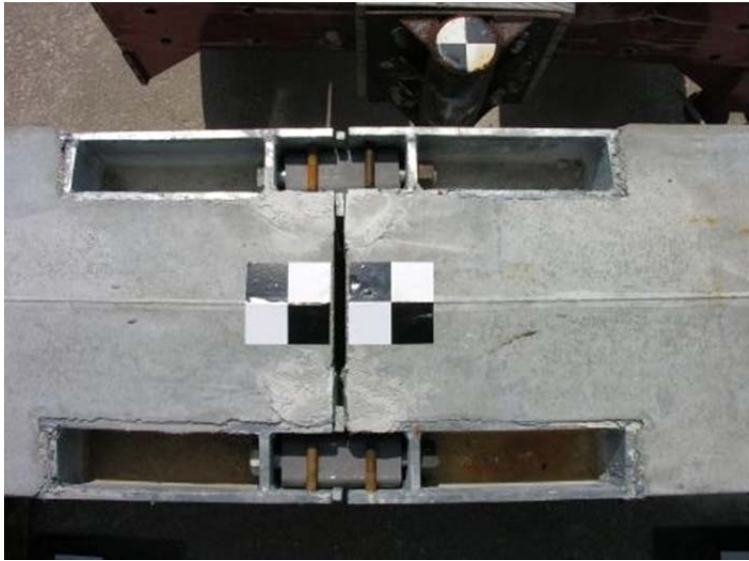
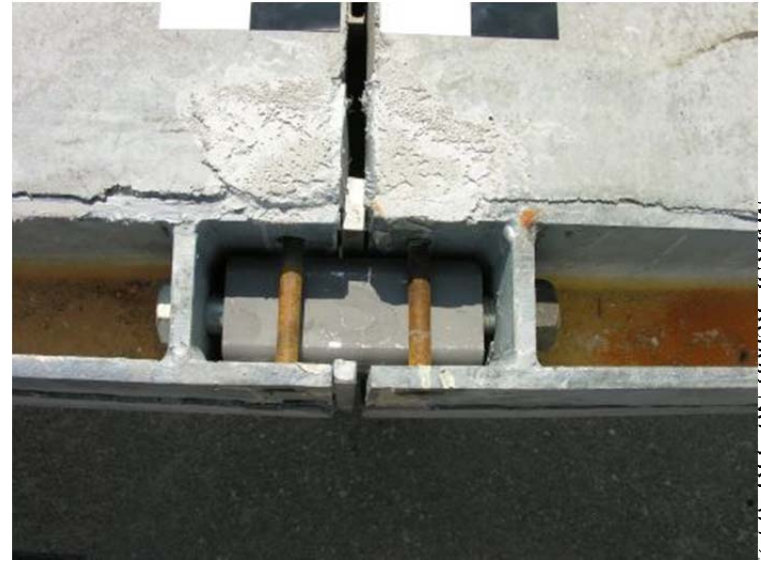
Figure 75. Rail Component Photographs, Test No. PCRB-2

The following hardware was necessary to assemble the joint between rail segments: two 1-in. (25-mm) diameter, 9-in. (229-mm) long Grade 5 bolts, four $\frac{1}{2}$ -in. (13-mm) diameter by 5-in. (127-mm) long Grade 5 bolts, two shear tubes made from $2\frac{1}{2} \times 2\frac{1}{2} \times \frac{1}{4}$ -in. (64 x 64 x 6-mm) A500 Grade C steel tubing, and two $\frac{1}{2}$ -in. (13-mm) thick shim plates. All of this hardware is shown in Figure 74. During assembly, first a shear tube was positioned inside adjacent pockets spanning the $\frac{1}{2}$ -in. (13-mm) gap between rail segments, as shown in Figure 64. Next, a 1-in. (25-mm) diameter bolt was inserted into a pocket between the gusset plates and slid through the gusset plate, shear tube, and gusset plate of the adjacent pocket. This process was repeated for the other side of the rail joint. Shims were then positioned in the gap between the rail segments and surrounding the shear tubes, as shown in Figure 64. The shim plates were intended to close the gap between rail ends left as a result of tolerance issues and provide a compression zone for bending resistance. The nuts and bolts were then tightened bringing the rail segments together

The segments were set in the same positions as the segments in test no. PCRB-1, only the rail system was flipped upside down so that the joint hardware could be viewed from the overhead video during the test. Photographs of the assembled joint specimen for test no. PCRB-2 are shown in Figure 75.

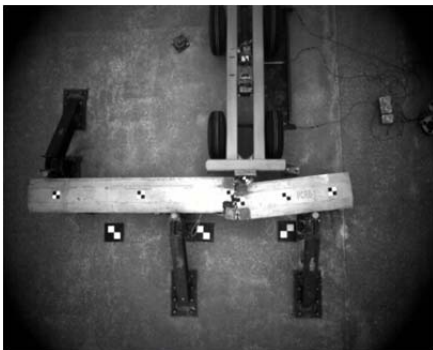
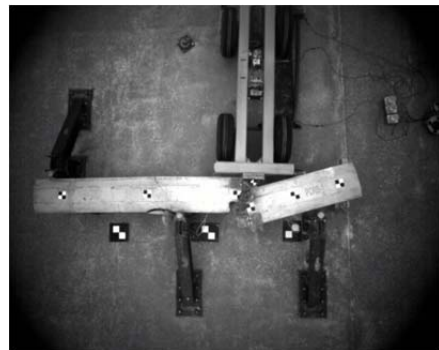
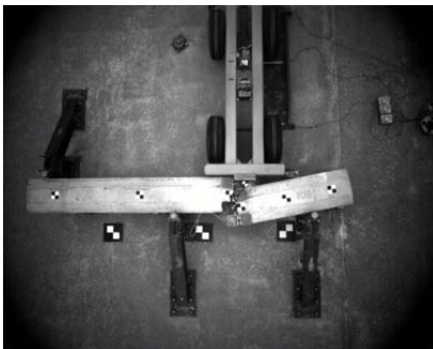
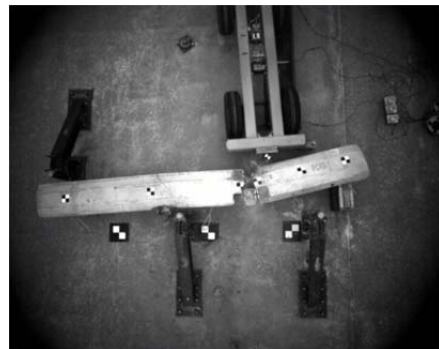
Figure 76. Sequential Photographs, Test No. PCRB-1

and began to redirect in the opposite direction. Sequential photographs of the impact event are shown in Figures 76 and 77.

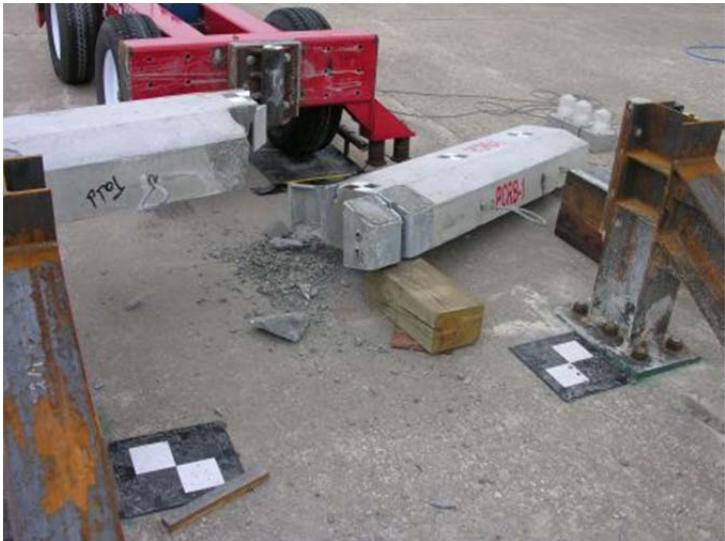
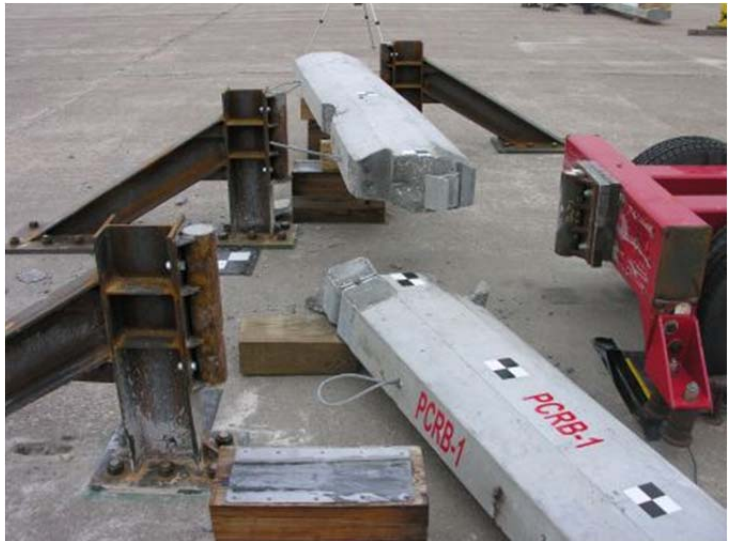
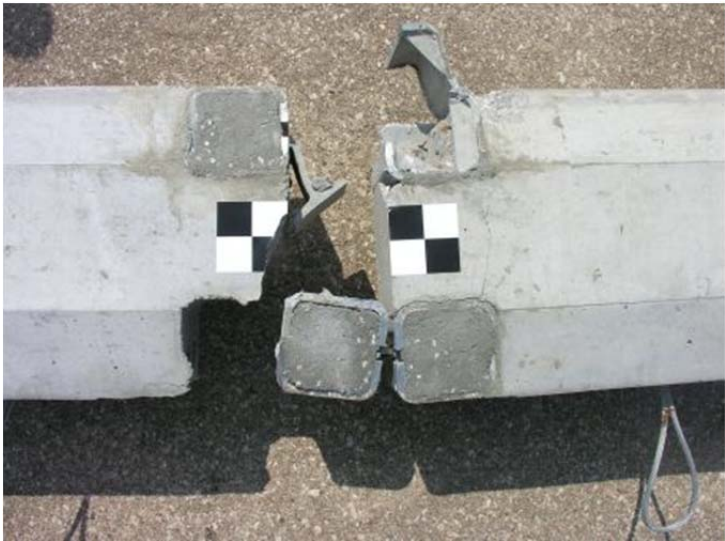
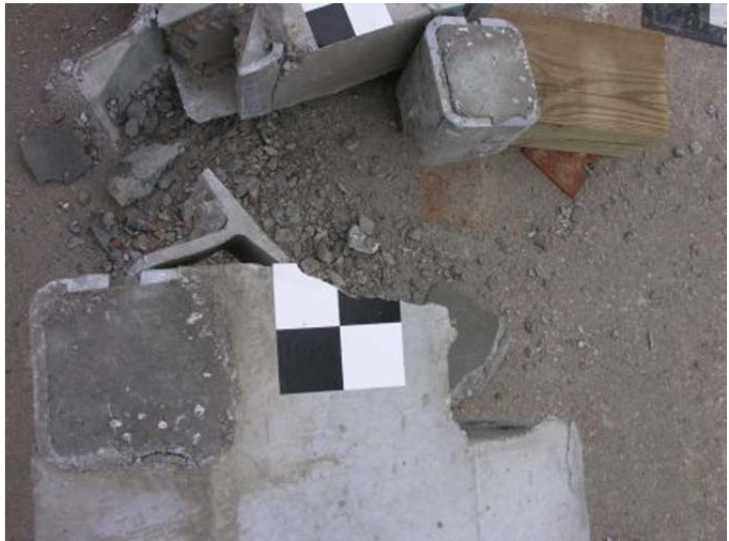
Figure 78. Component Damage, Test No. PCRB-1

During bogie test no. PCRB-1, the joint failed and the rail segments completely separated, as shown in Figure 78. After the joint failed, the short rail segment (e.g., impact side) spun off of the wood block supports and fell to the ground. The long rail segment (e.g., non-impact side) remained on top of its supports, but had rotated away from the anchor posts following the redirection of the bogie vehicle.
