NDOR Project No. SPR-P1(07) P596

PHASE I DEVELOPMENT OF AN AESTHETIC, PRECAST CONCRETE BRIDGE RAIL

MIDWEST ROADSIDE SAFETY FACILITY (MwRSF)

MwRSF Research Report No. TRP-03-239-12

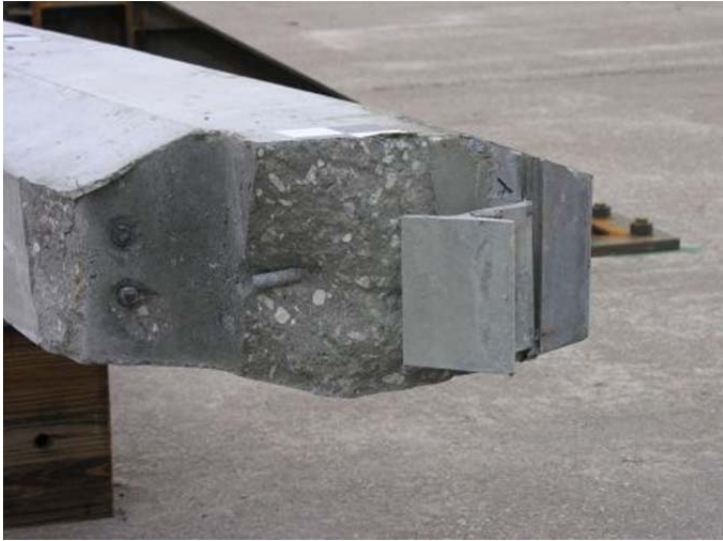
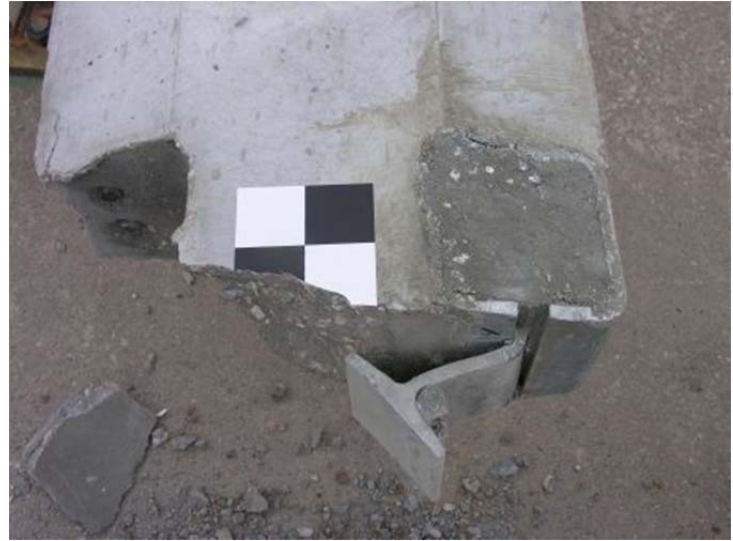
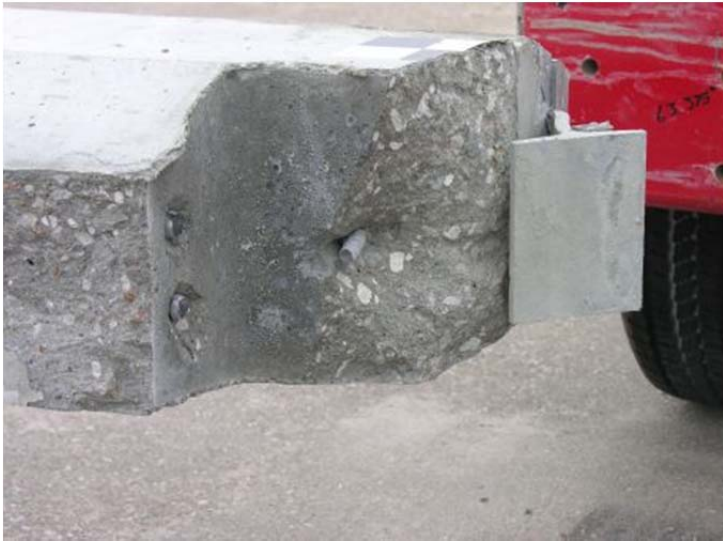
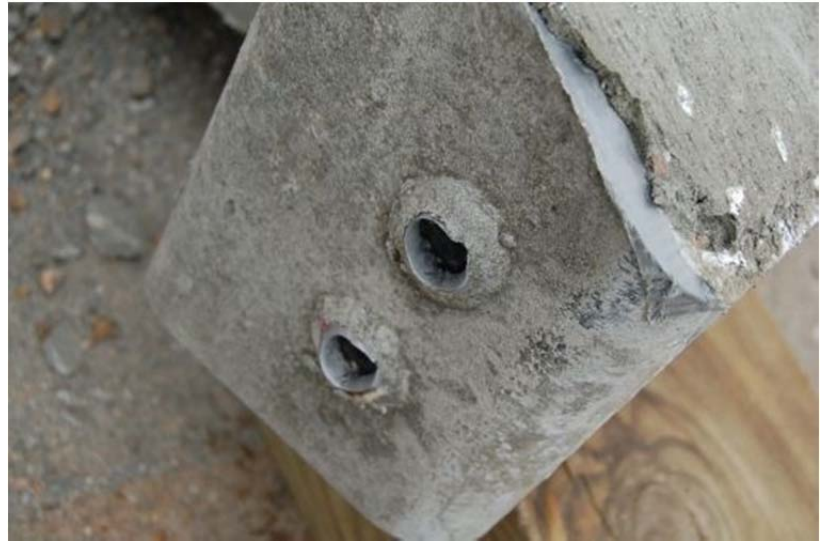
Figure 79. Component Damage – Long Rail Segment, Test No. PCRB-1

As shown in Figure 79, the I-shape connector used to connect the front grout pockets remained attached to the long rail segment. However, it was bent nearly 90 degrees toward the center of the rail. The back grout pocket of the long rail segment had completely broken away from the rest of the rail. Both of the butt welds attaching the pocket to the longitudinal reinforcement of the rail segment had failed. Also, the rebar running between the grout pockets was bent out toward the joint and the butt weld connecting the rebar to the back pocket had failed. Concrete spalling was located around the area in which the back grout pocket was originally positioned.

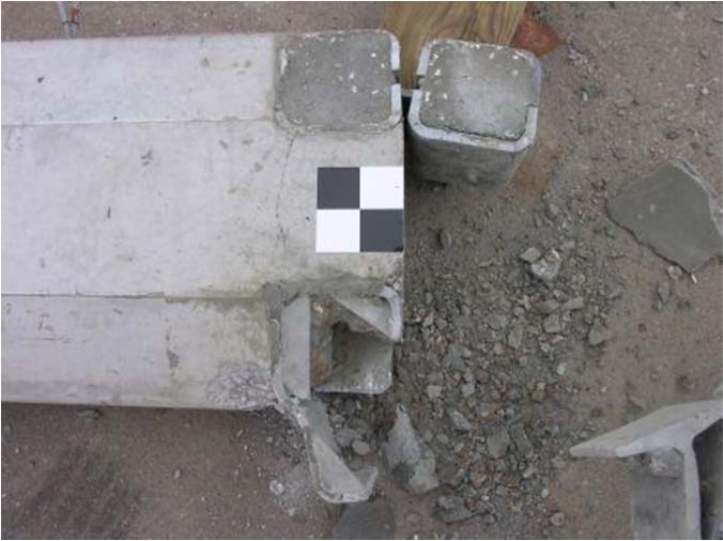
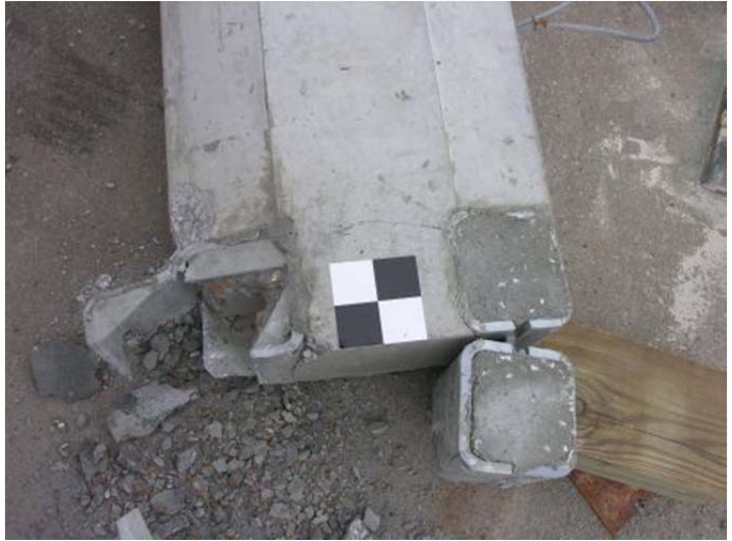
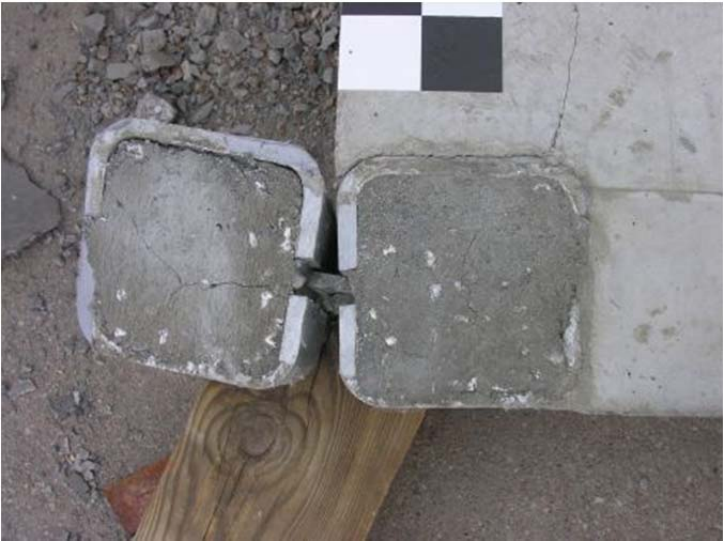
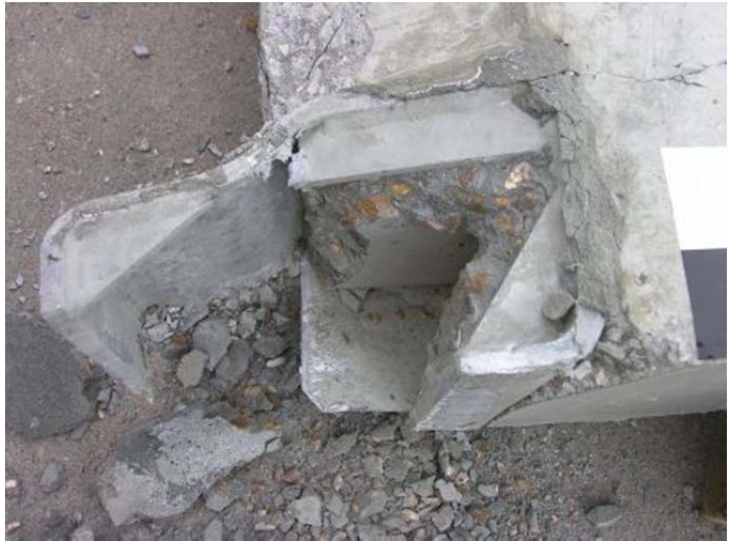
Figure 80. Component Damage – Short Rail Segment, Test No. PCRB-1

The front grout pocket on the short rail segment was pried open, as shown in Figure 80. Subsequently, the I-shape connector and fragments of grout had been pulled out of the pocket. Concrete shear cracks were found running from the front grout pocket to the back grout pocket. The back grout pocket remained intact. Only minor cracks had formed between the steel pocket and the surrounding concrete rail. The back grout pocket that had been removed from the long rail segment remained attached to the back grout pocket of the small rail segment via the steel I-

shape segment. Both pockets appeared to be in good condition with only minor cracking of the grout.

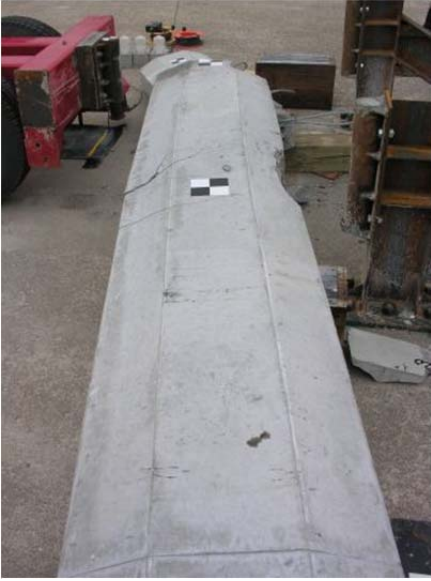
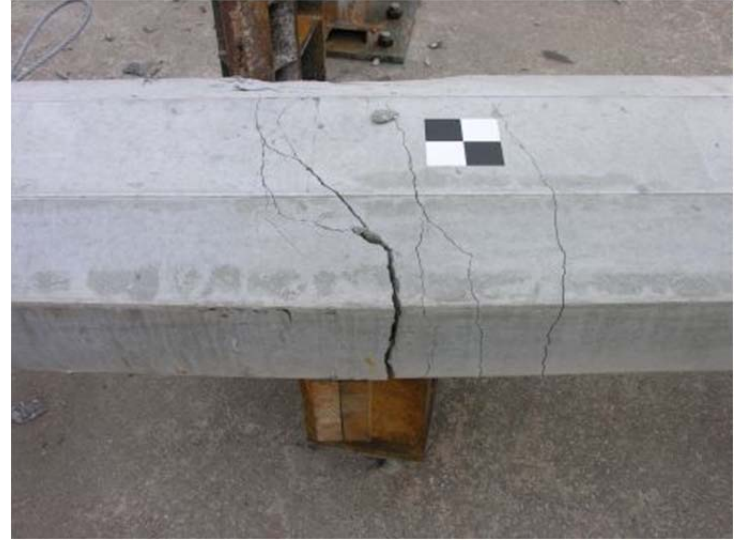
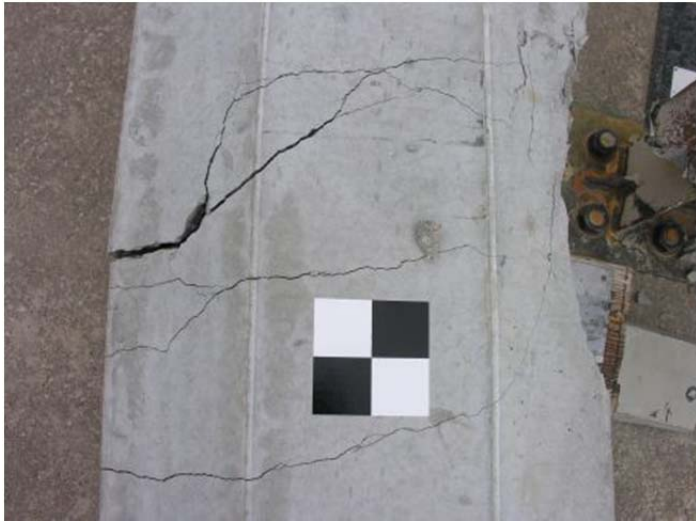
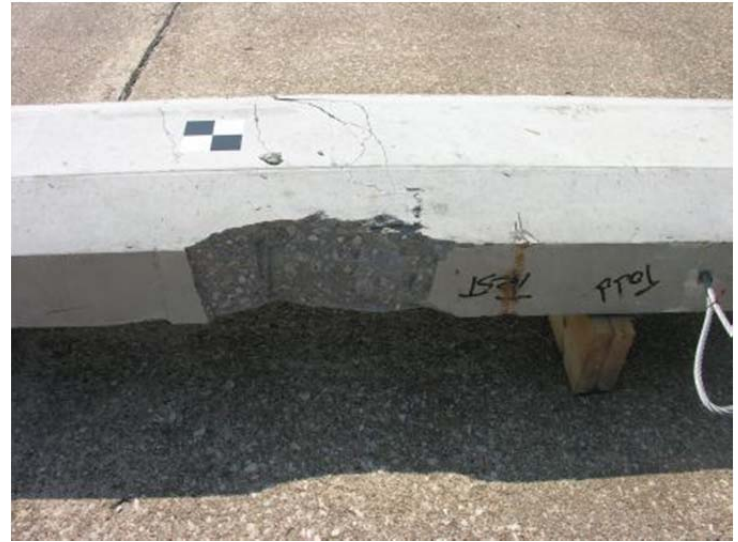
Figure 81. Bending Damage of Long Rail Segment, Test No. PCRB-1

Bending cracks were found in the long rail segment, as shown in Figure 81. Also, a large amount of spalling was observed on the back face of the rail segment. Both the spalling and the bending cracks were located near the middle anchor post and were caused by the bogie frame impacting the long rail segment after the joint had failed. Although this damage was not directly related to the strength of the joint, it was documented to demonstrate that the strength of the rail cross section was adequate to carry the design load with only minor damage.

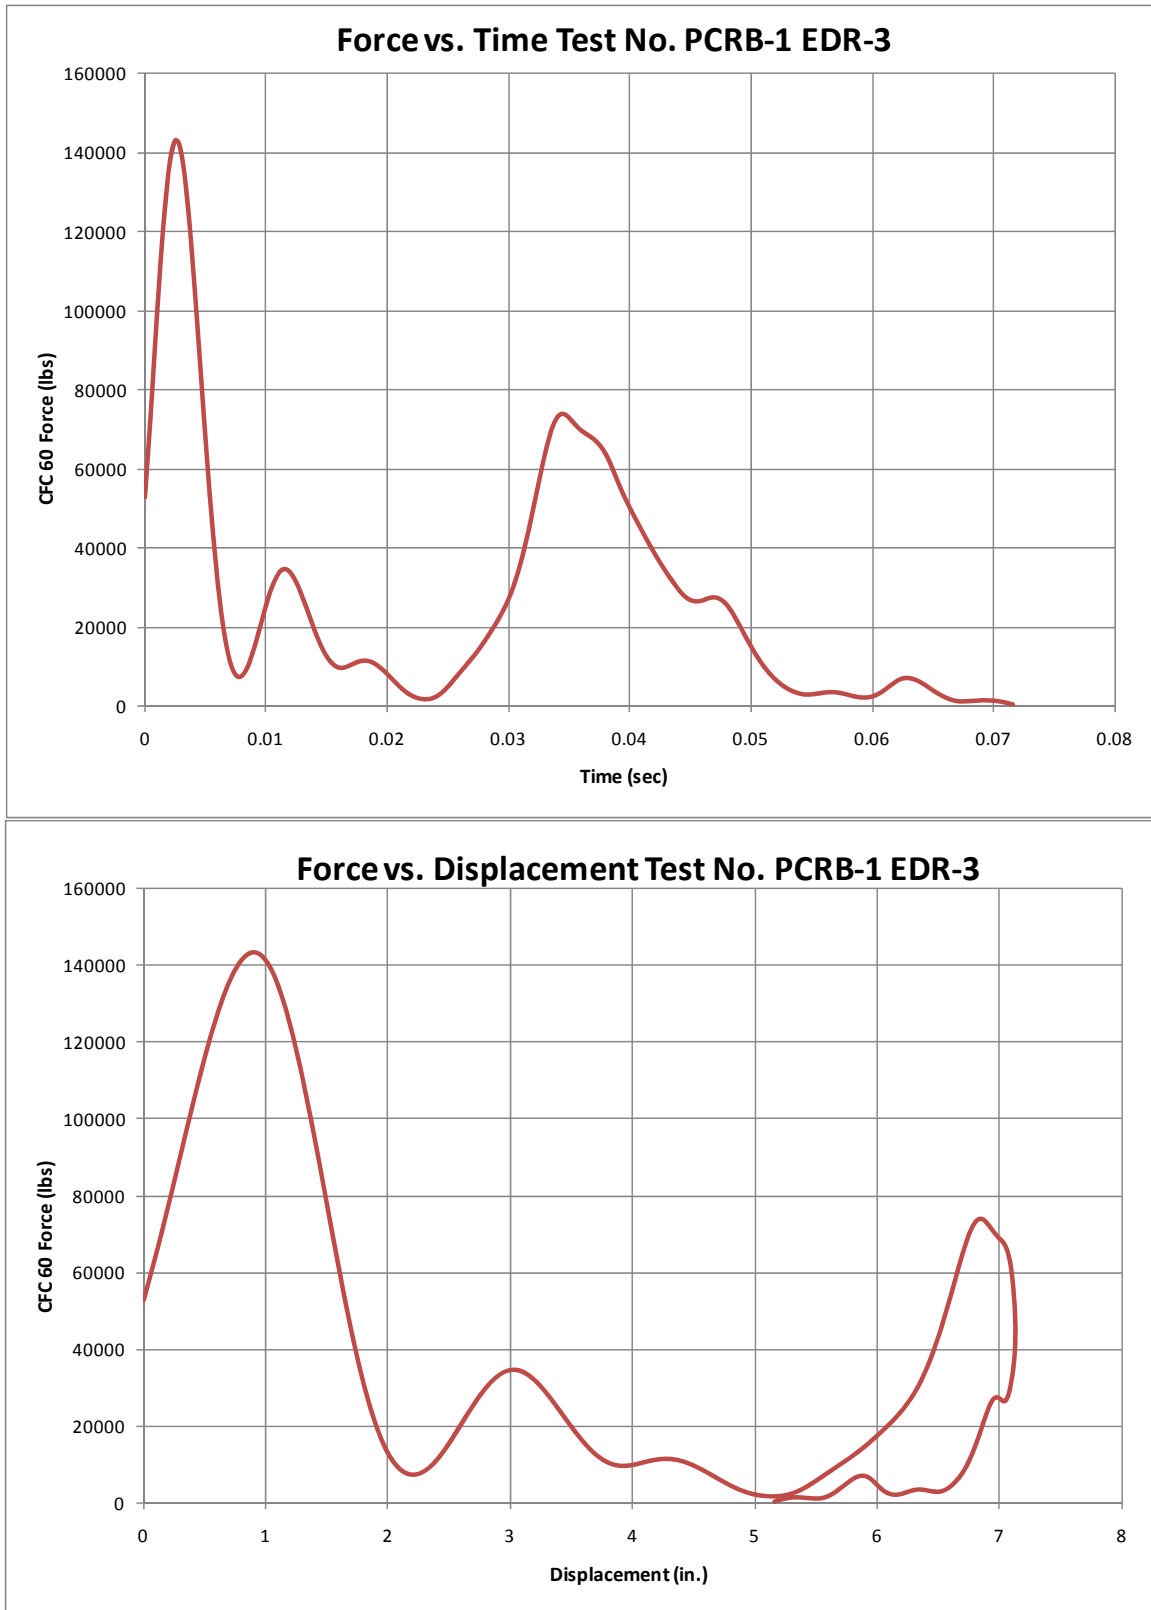
Figure 82. Data Analysis Plots, Test No. PCRB-1

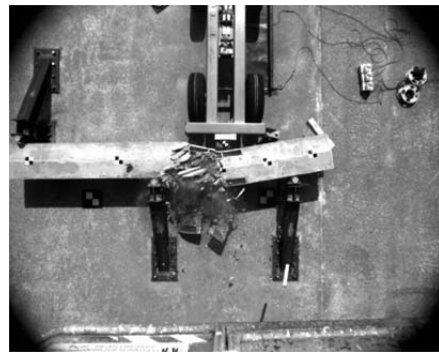
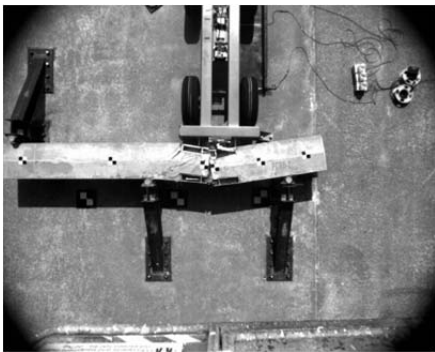
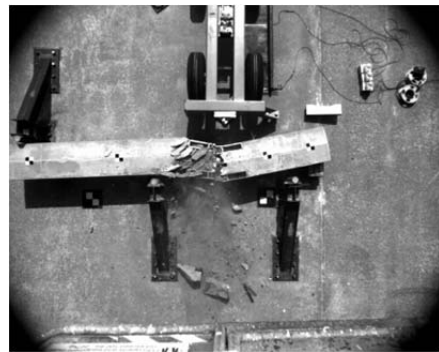
Figure 83. Sequential Photographs, Test No. PCRB-2

the system and began to redirect in the opposite direction. At 0.132 sec, the impact head was no longer in contact with the rail joint component. Also by this time, all of the concrete between the steel pockets of the long rail joint had broken apart. By 0.228 sec, the internal steel of the long rail segment was exposed. At 0.588 sec, the rail joint component had stopped rebounding from the impact and was no longer in motion. Sequential photographs of the impact event are shown in Figures 83 through 85.

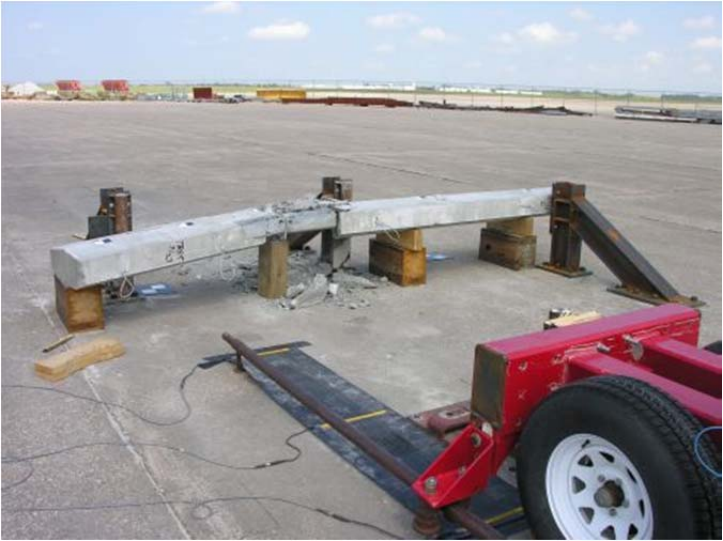
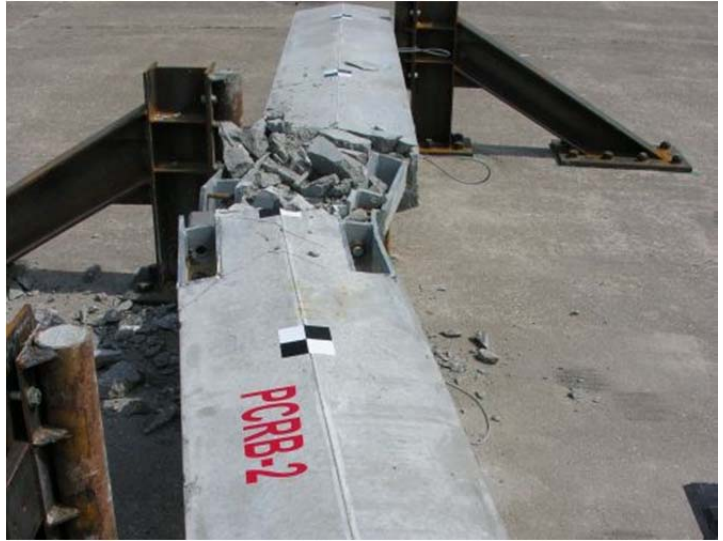
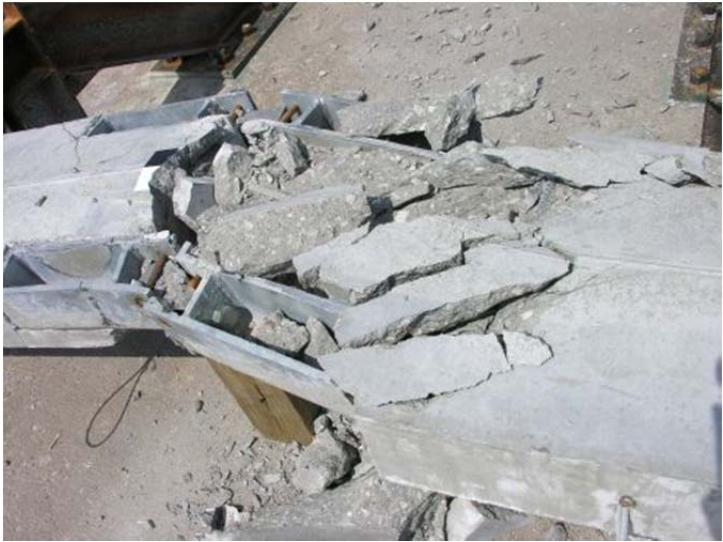
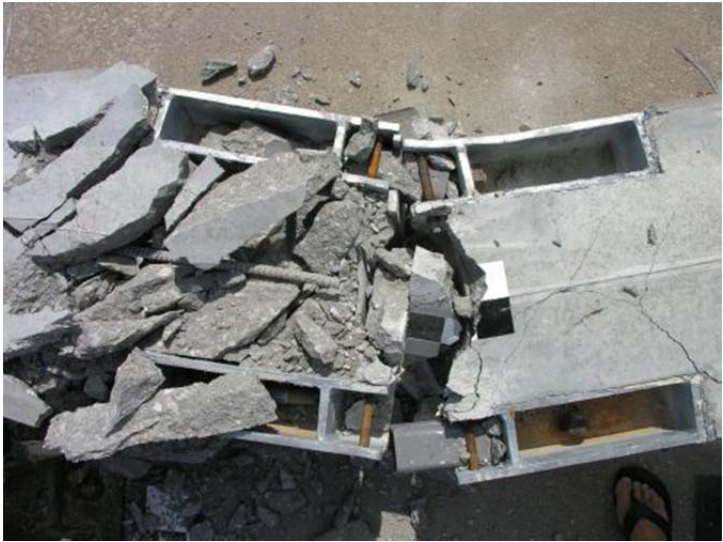
Figure 86. Component Damage, Test No. PCR-B-2

During bogie test no. PCRB-2, the rail-to-rail joint was severely damaged, but it held together, as shown in Figure 86. The concrete between the steel pockets of the long rail segment had completely broken apart. Only the internal steel rebar was preventing the loose concrete from falling to the ground. Due to the loss of concrete, the rebar anchoring the steel pockets to the rest of the long rail segment had bent. This allowed the pockets to rotate backward slightly. Concrete fragments had also broken off of the short rail segment near the joint and on the bottom face (as oriented in the test). Additional concrete cracks were found stemming from the steel pockets of both rail segments.

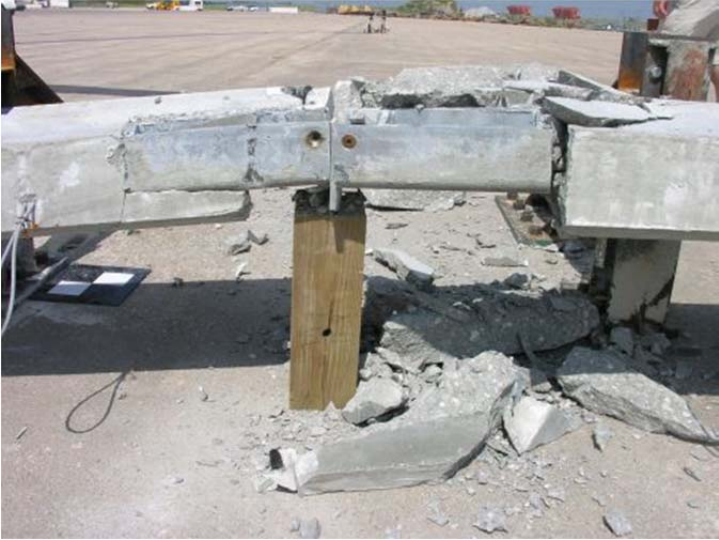
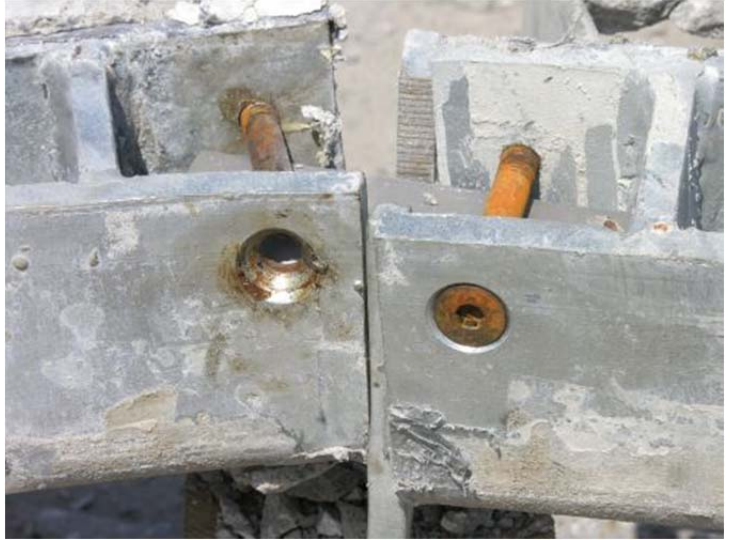
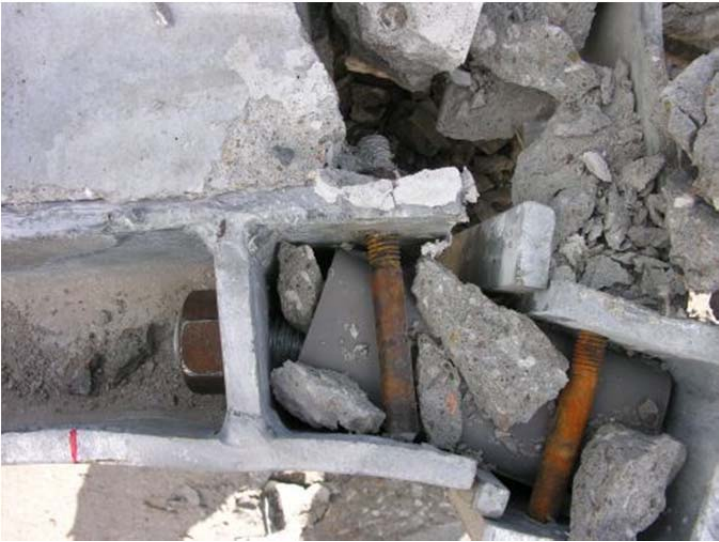
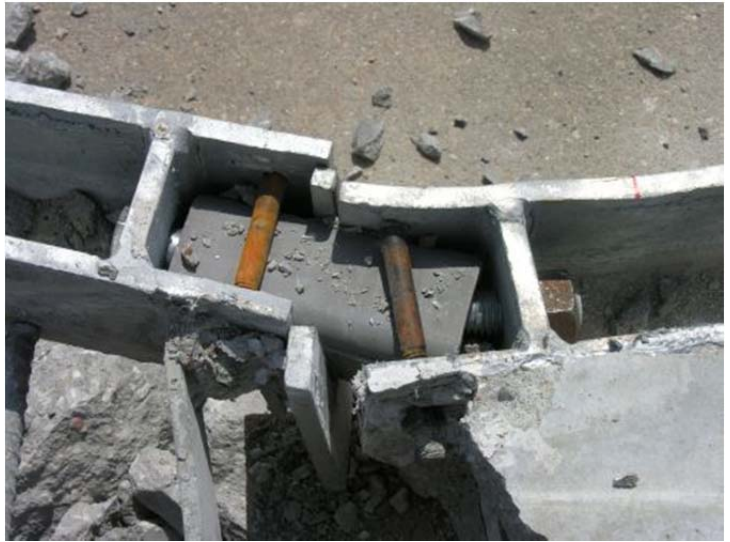
Figure 87. Component Damage - Front Pocket Assembly, Test No. PCRB-2

Damage to the front pocket assembly consisted mostly of deformations to the steel pocket walls. The exposed pocket wall of the short rail segment was bent outward, while the inner pocket wall of the long rail segment was bent toward the center of the rail, as shown in Figure 87. The bogie impact head had caused the pocket to pinch together slightly at the point of impact, and the shear bolt on the front pocket of the short rail segment had fractured at the base of the head. Also, the deformation in the joint caused the longitudinal bolt connecting the front pockets to bend.

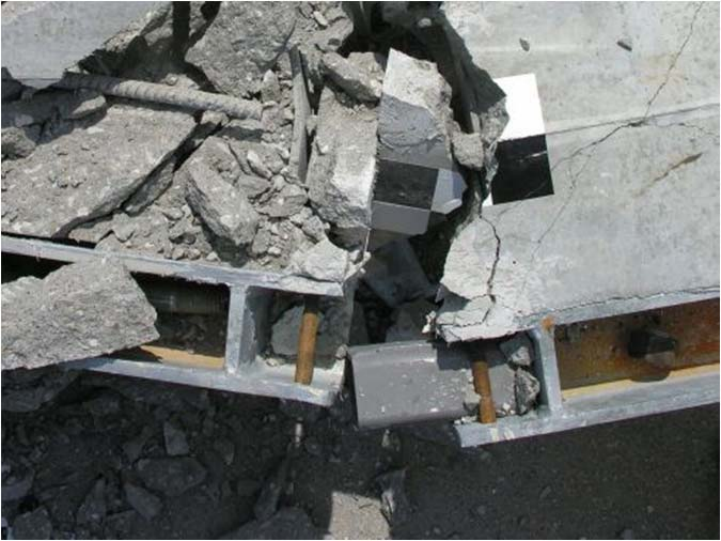
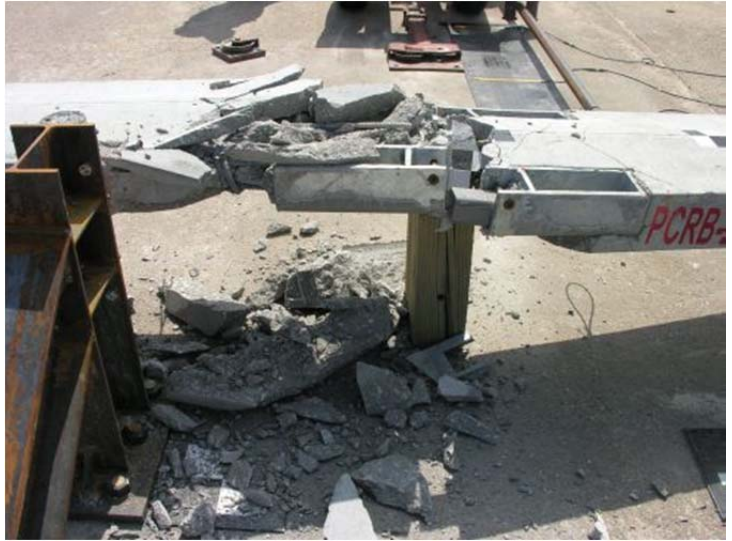
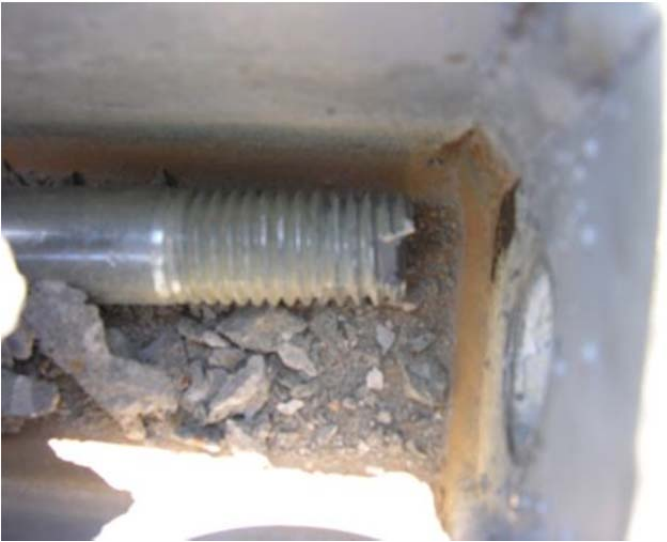
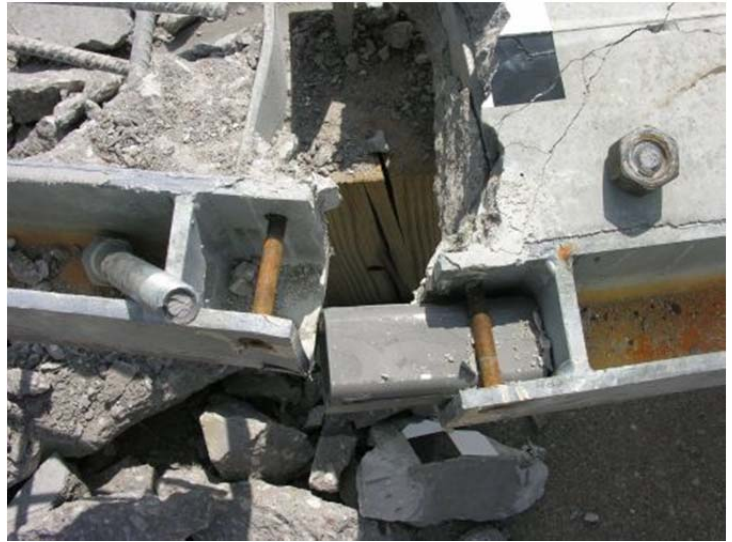
Figure 88. Component Damage – Back Pocket Assembly, Test No. PCRB-2

The tension bolt connecting the back pockets had completely fractured, as shown in Figure 88. The bolt had fractured through the threaded portion near the nut. The back side of the joint had widened apart, and the shear tube had popped out of the back pocket of the long rail segment.

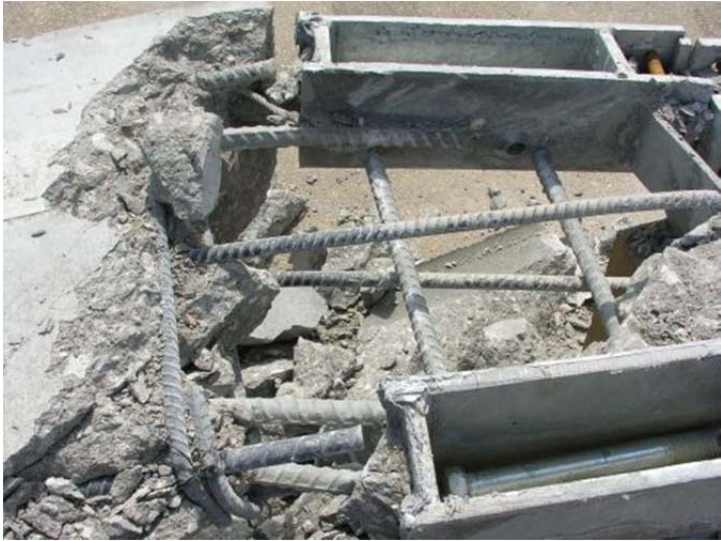
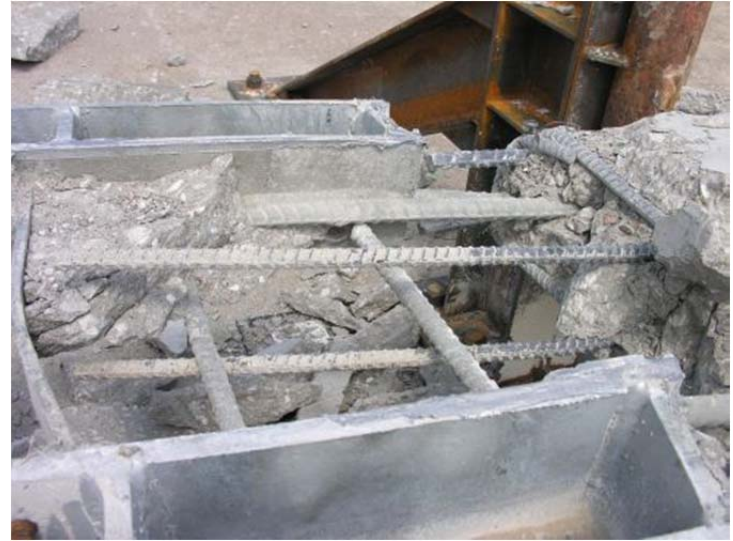
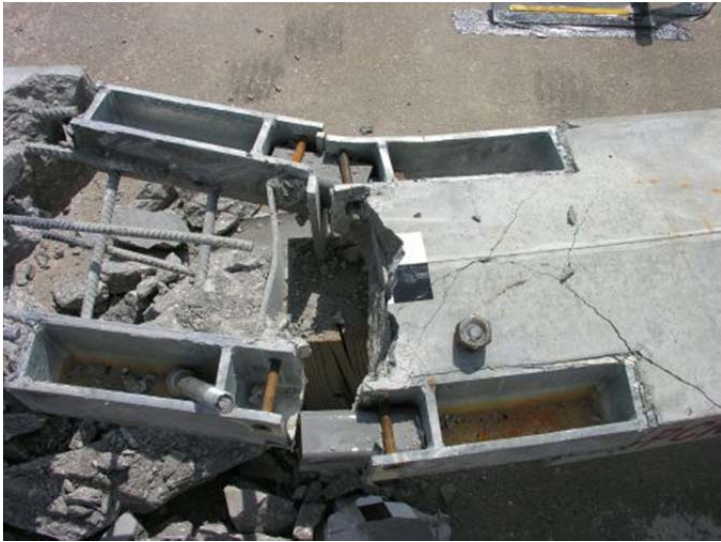
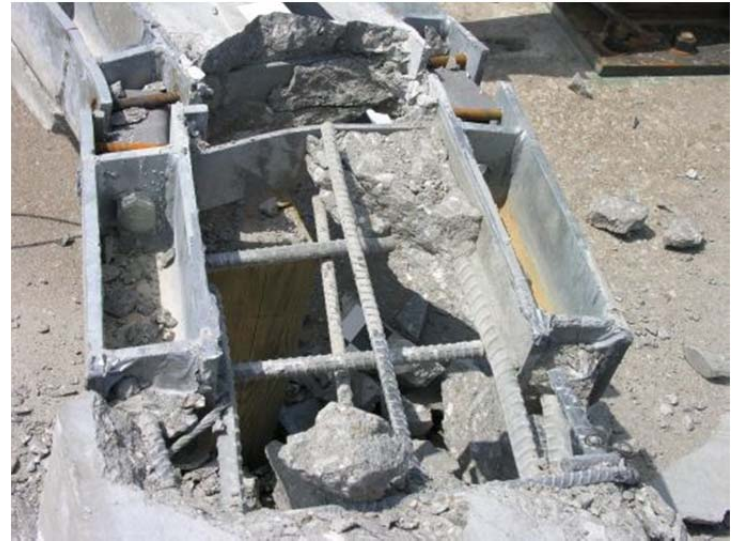
Figure 89. Component Damage – Loose Concrete Removed, Test No. PCRB-2

The loose concrete remaining on the rails was removed revealing damage to the interior steel reinforcement of the long rail segment. Similar to test no. PCRB-1, the butt welds used to attach rebar between the steel pockets had failed, as shown in Figure 89. The welds holding the shear plate to the steel pockets remained intact, but the shear plate itself was bent.

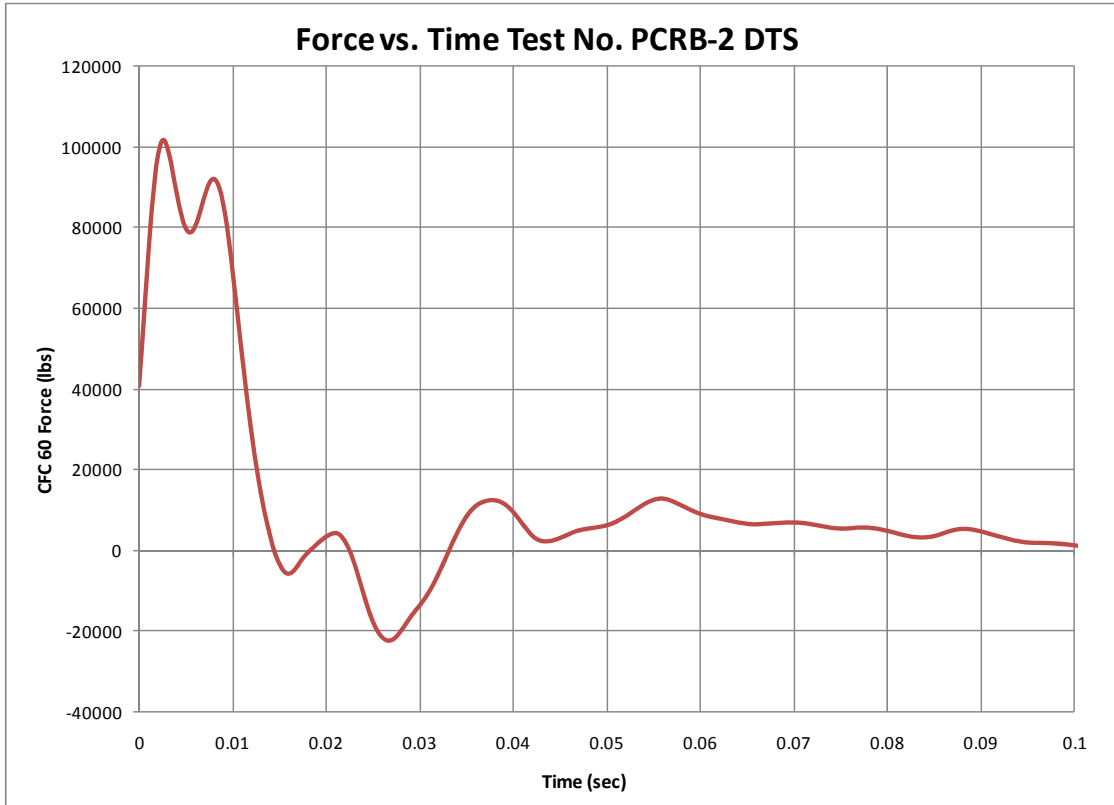
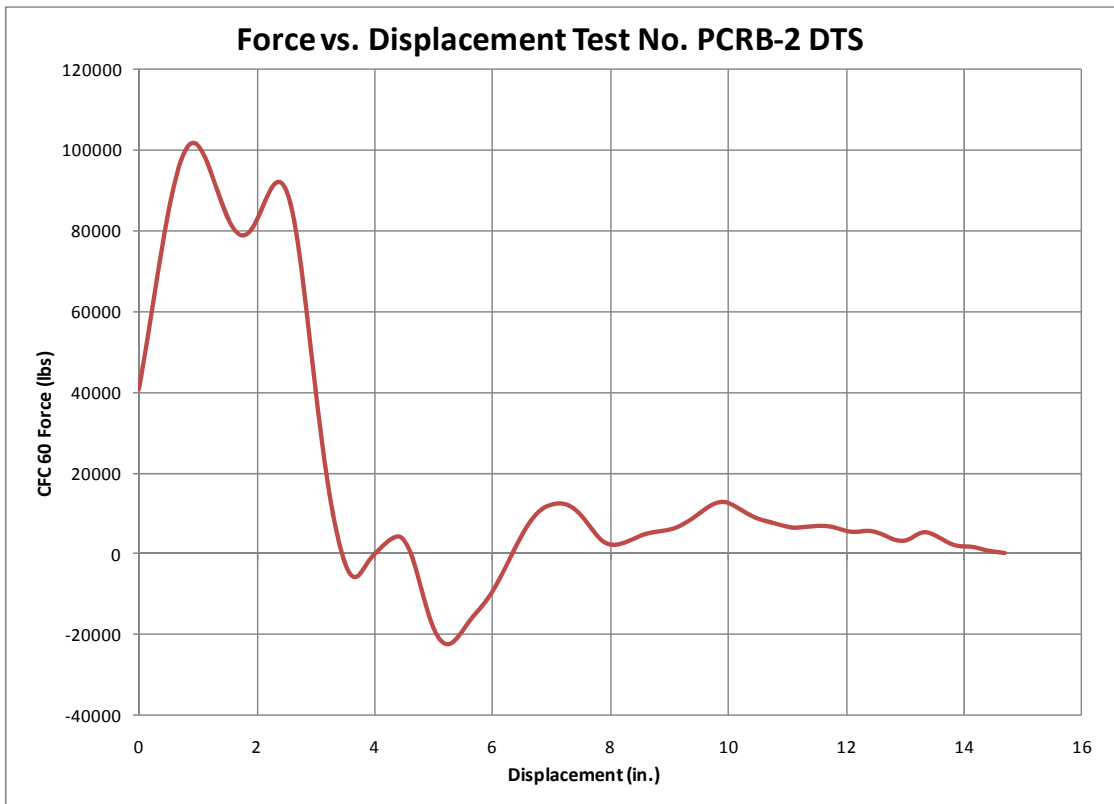
Figure 90. Data Analysis Plots, Test No. PCRB-2

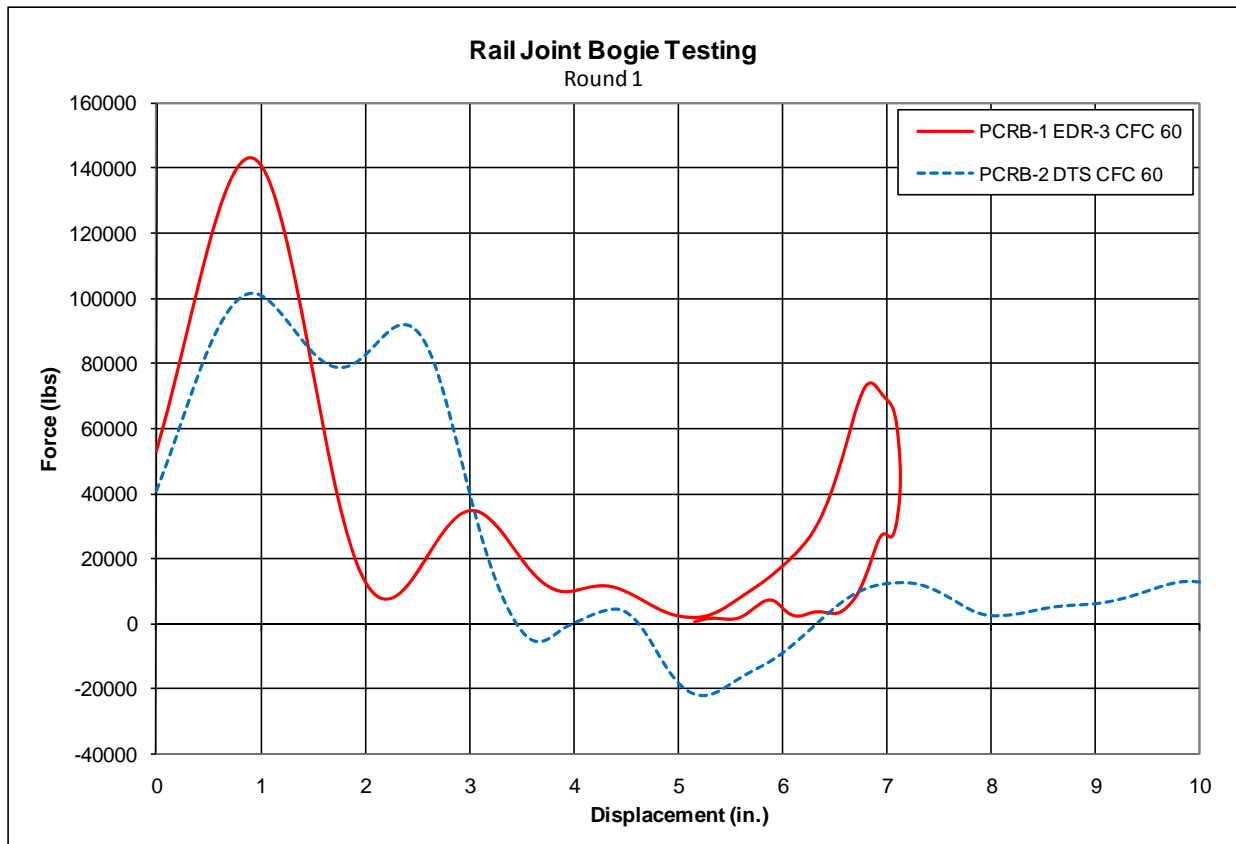
Recall from Section 6.2, an impact force of 62 kips (276 kN) would result in predicted shear and moment loads through the joint of 35 kips (156 kN) and 700 k-in (79 kN-m), respectively. As shown in Figure 91, both test nos. PCRB-1 and PCRB-2 initially exceeded this target impact force. However, the majority of the initial force spike observed in both tests was attributed to inertia. Thus, the actual strengths of the joints were much less than these inertial force spikes at 1 in. (25 mm) of displacement. Only the second force peak of test no. PCRB-2, which reached 92 kips (409 kN), demonstrated adequate strength. Also, neither of the joints demonstrated much ductility as both joints began to fail before 3 in. (76 mm) of deflection. Providing some measure of ductility to the joint increases the joints ability to absorb energy, decreases the forces in the joint and the railing and improves the overall toughness of the joint.

Figure 91. Data Comparison Plots, Round 1 Bogie Testing Results

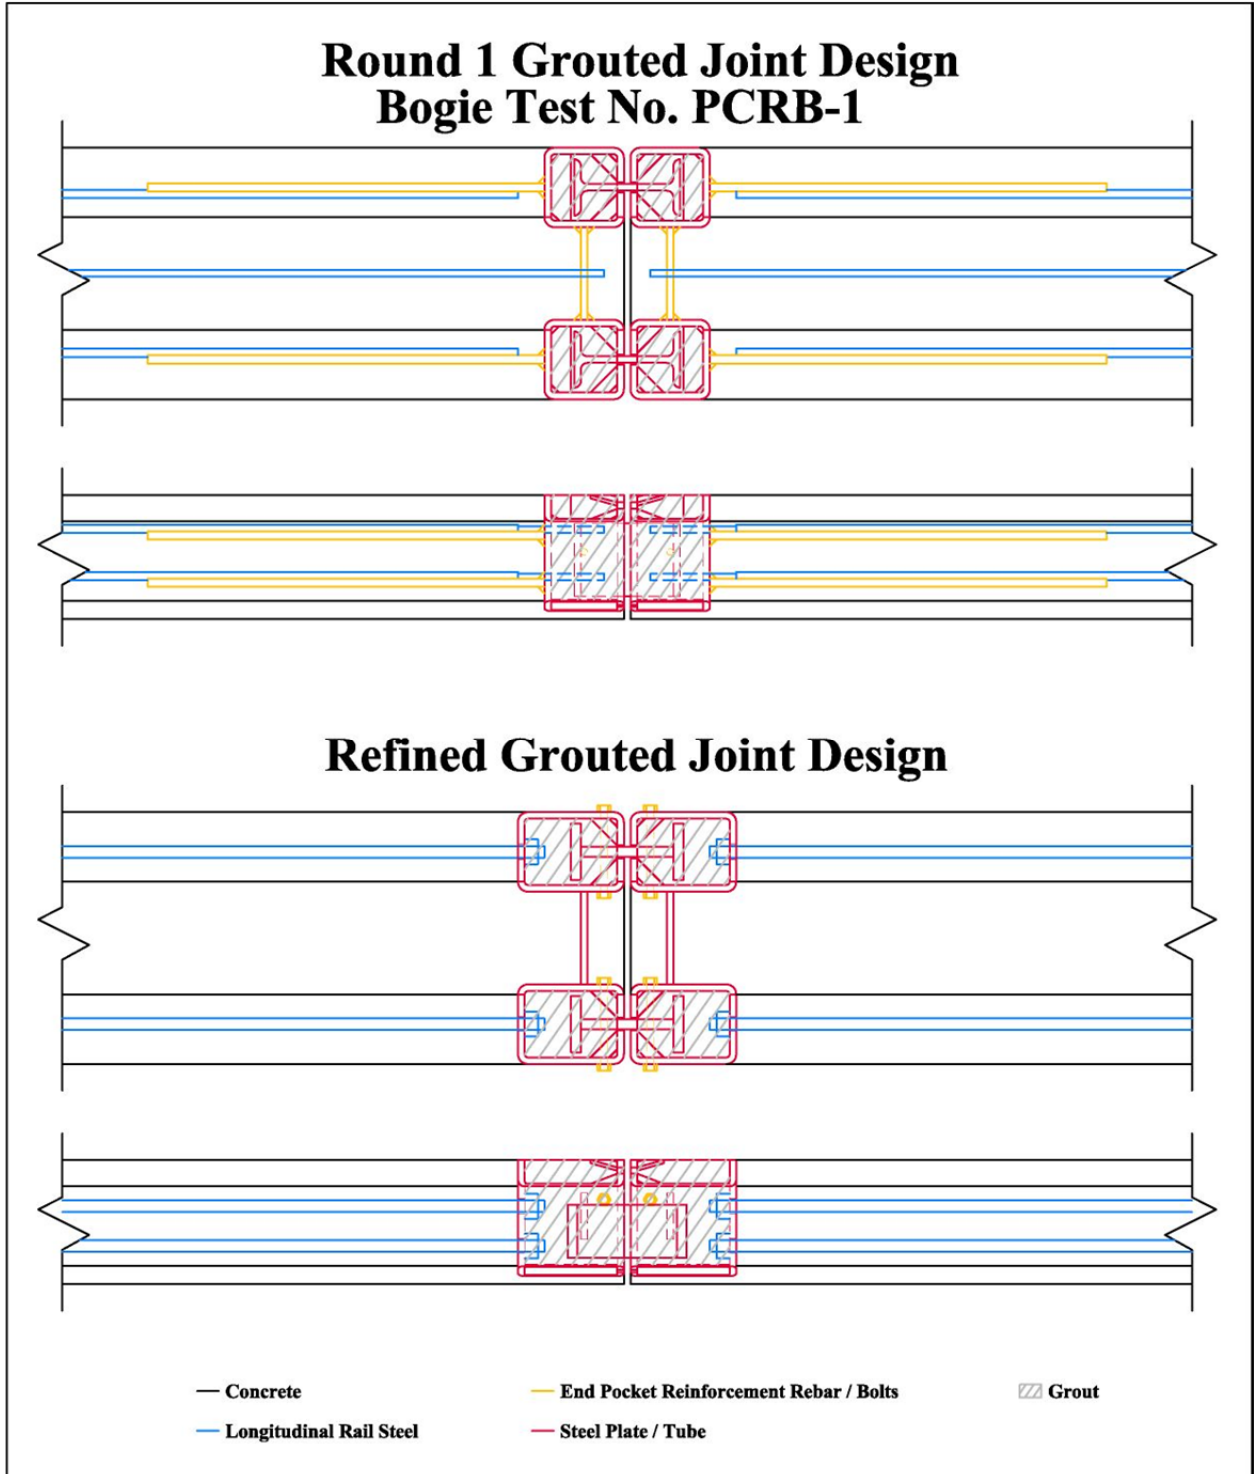
The biggest change to the grouted rail design was that the longitudinal steel of the rail was directly used to anchor the grout pockets. During test no. PCRB-1, rebar was attached to the back of each pocket using butt welds. A lap splice was used to transfer load from the anchorage rebar to the longitudinal rebar of the rail segment. These anchorage bars and the weak butt welds that connected them to the grout pockets were removed. Also, the no. 5 longitudinal rebar was changed to no. 7 threaded rebar. These threaded rebar were inserted through holes cut in the back of the grout pocket, and nuts were used to fasten the pocket to the longitudinal threaded bars. The increase in bar size from no. 5 bars to no. 7 bars increased both the pocket anchorage strength and the bending strength of the rail. With the increase in rail bending strength, the two no. 4 longitudinal bars in the center of the rail cross section were no longer necessary and were therefore removed. To fit the threaded rebar and nuts inside the pockets and still leave room for the steel I-section, 6 x 8 x ½-in. (152 x 203 x 13-mm) steel tubes were utilized for the pockets instead of the previous 6 x 6 x ½-in. (152 x 152 x 13-mm) tubes. Overall, these simple changes significantly increased both the strength of the grout pocket longitudinal anchorage and the rail bending strength. Further, these changes also eliminated all butt welds and reduced the number of longitudinal reinforcing bars in the rail.

Figure 92. Grout Rail Joint Improvements – Steel I-Shape Connector

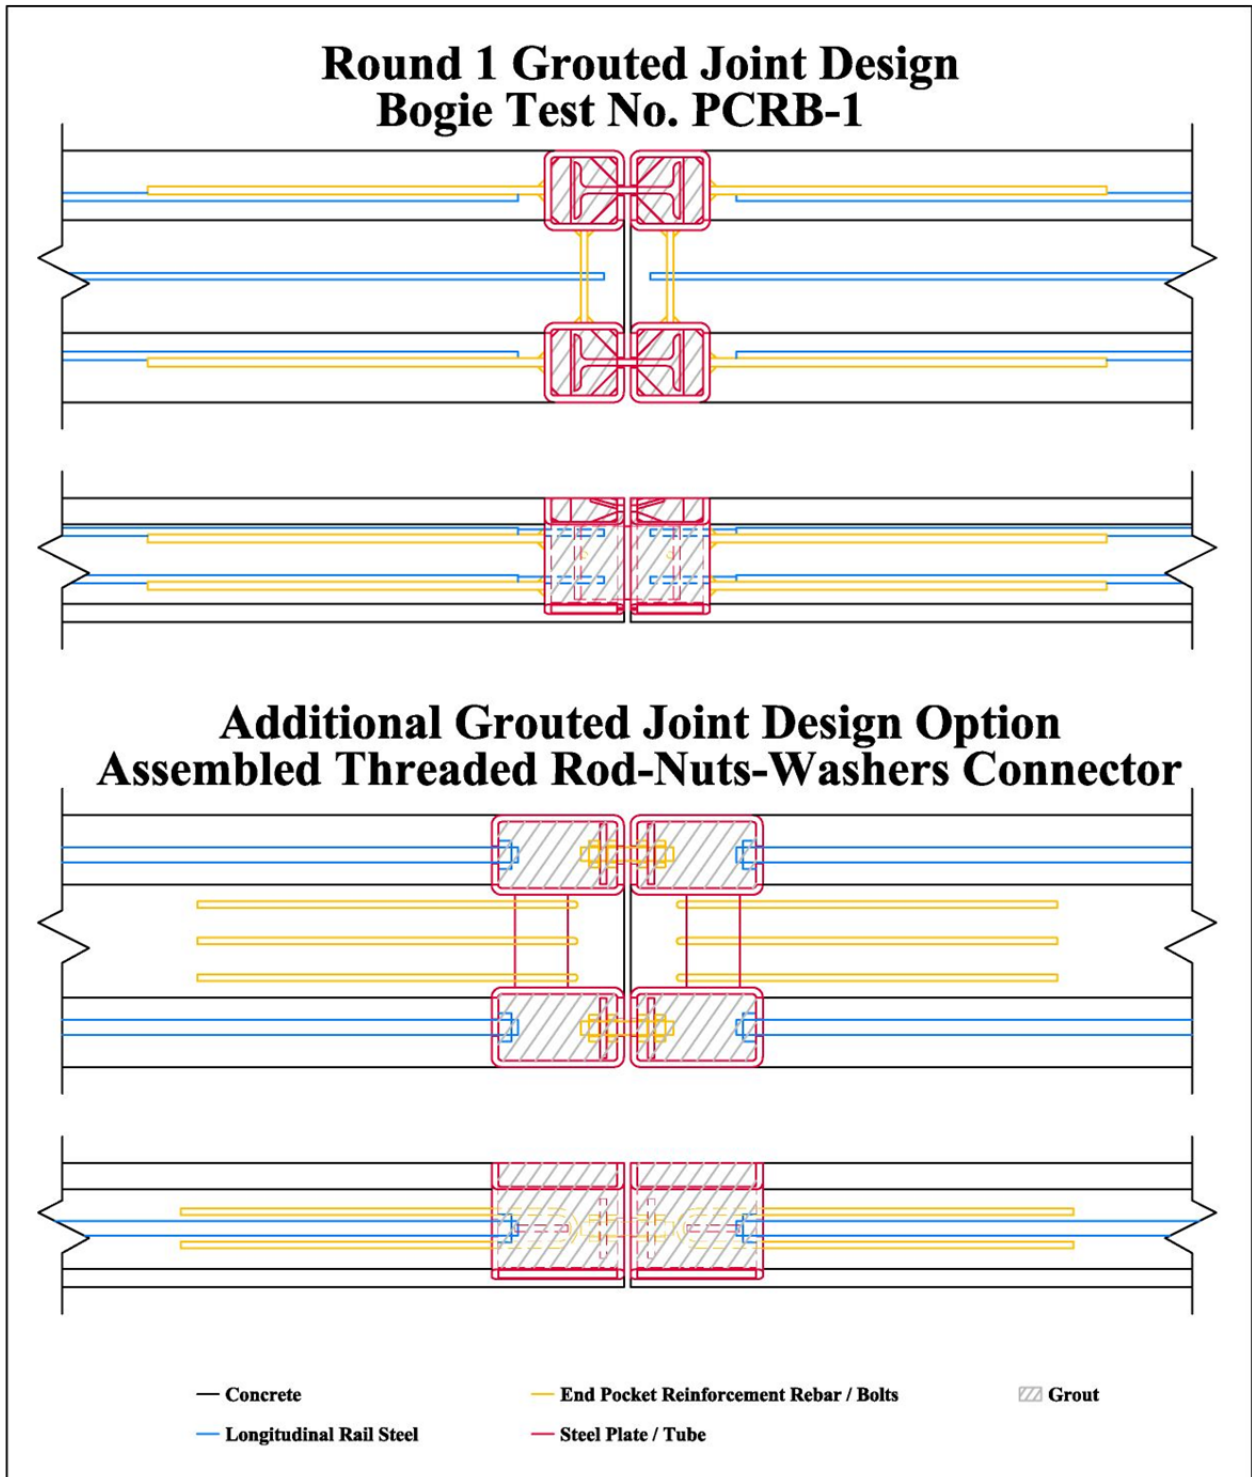
Lateral pocket anchorage consisted of a ½-in. (13-mm) thick shear plate running between the pockets. Fillet welds were used to fasten the shear plate to the grout pockets, thus removing the butt welds that failed during test no. PCRB-1. Also, three U-shaped no. 4 bars were wrapped around the plate and extended into the rail. These U-bars provided additional longitudinal pocket anchorage as well as reinforcement to prevent concrete failures on the plane directly behind the pockets.

Figure 93. Grout Rail Joint Improvements – Alternate Modifications

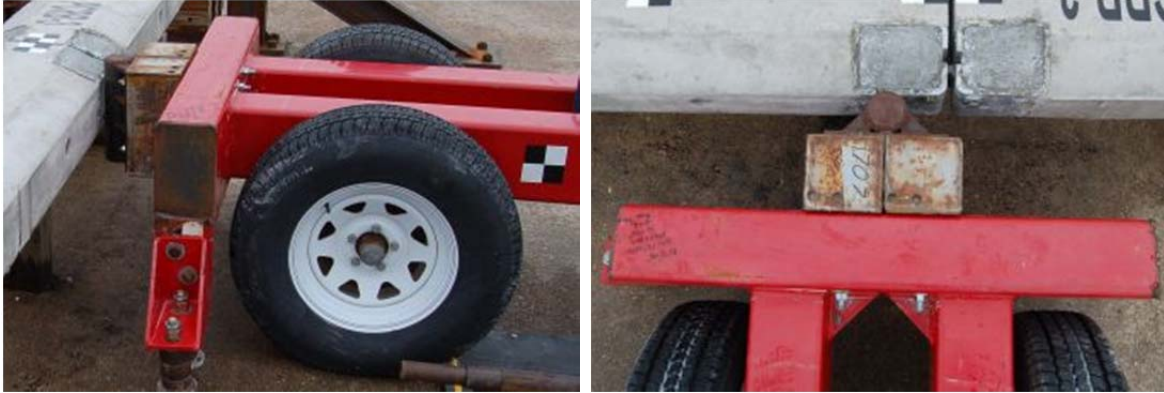
The same bogie vehicle from the first round of bogie testing was used during the second round of testing. However, the wooden blockouts used to offset the bogie head from the vehicle frame were damaged during test no. PCRB-2. As such, steel tubes were used instead of wooden blockouts to provide a more robust bogie head. These steel tubes were filled with concrete and capped with a steel plate, as shown in Figure 95. The weight of the bogie with the addition of concrete filled steel tubes to the impact head was 1,707 lbs (774 kg).

Figure 95. Bogie Impact Head with Steel Tube Blockouts
