NDOR Project No. SPR-P1(07) P596

PHASE I DEVELOPMENT OF AN AESTHETIC, PRECAST CONCRETE BRIDGE RAIL

MIDWEST ROADSIDE SAFETY FACILITY (MwRSF)

MwRSF Research Report No. TRP-03-239-12

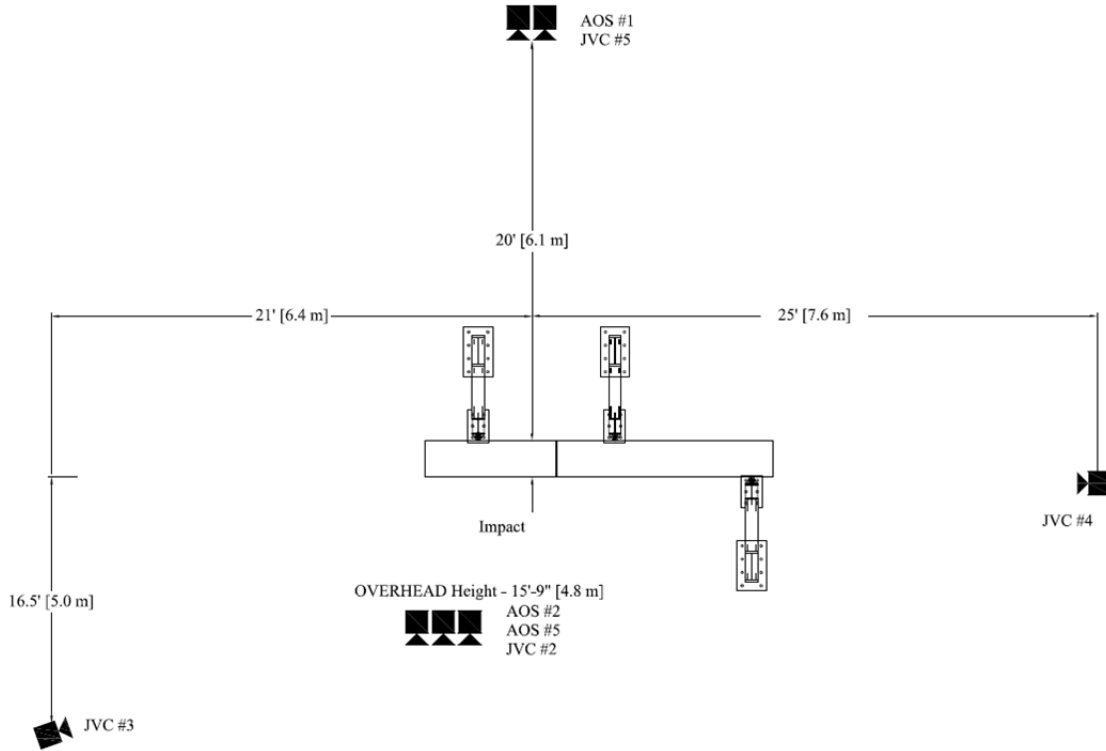
Figure 96. Camera Locations, Test Nos. PCRB-3 and PCRB-4

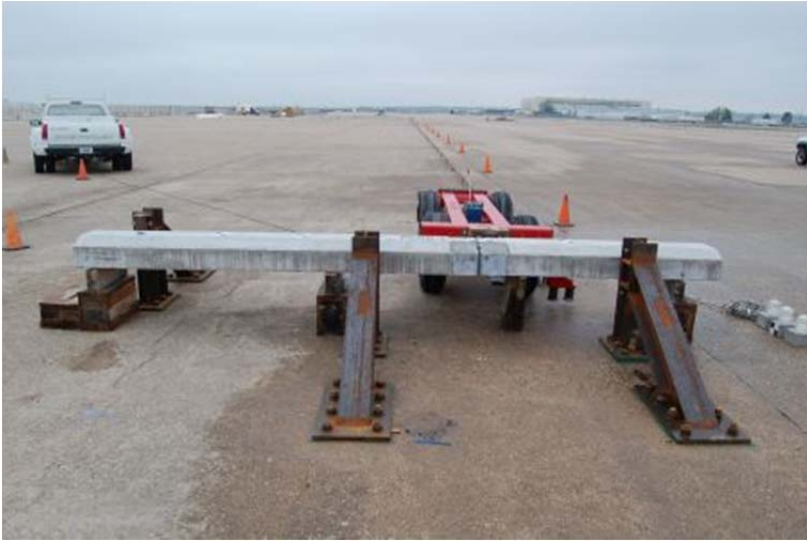
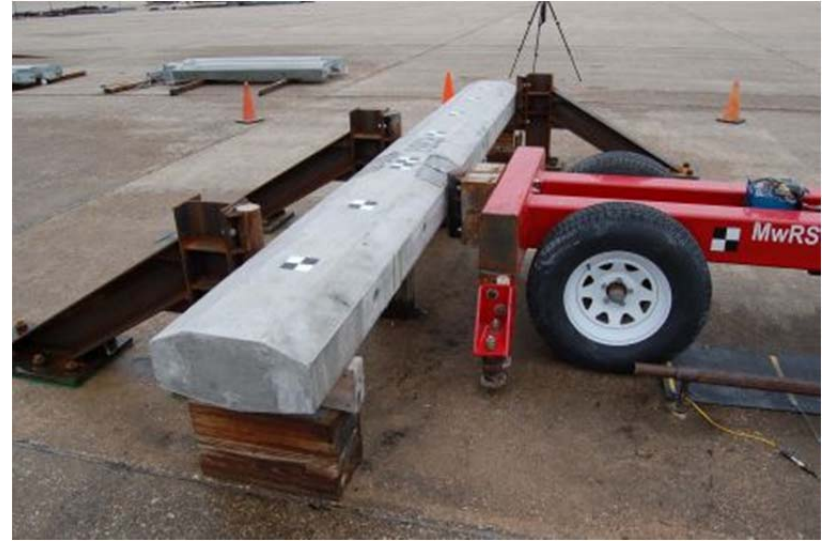
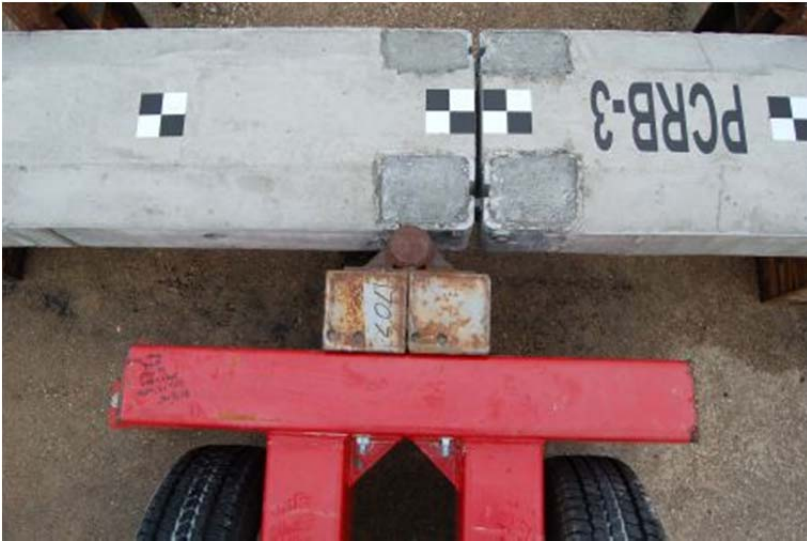
Figure 111. Rail Component Photographs, Test No. PCRB-3

The rail segments were placed on wooden support blocks and positioned as prescribed by Section 6.2 and Figure 48. To assemble the rail joint, two I-shape connectors were dropped into the pockets with the web spanning across the ½-in. (13-mm) wide gap between rail ends. Next, a 5⁄8-in. (16-mm) diameter shear bolt was inserted through the 1¹⁄₁₆-in. (17-mm) diameter holes of each pocket and turned through the fixed nut on the inside surface of each pocket. Once the connectors and shear bolts were in place, L&M Crystex grout with a strength of 10,000 psi (69 MPa) was used to fill the pockets and secure the steel I-shape connectors. Photographs of the assembled joint specimen are shown in Figure 111.

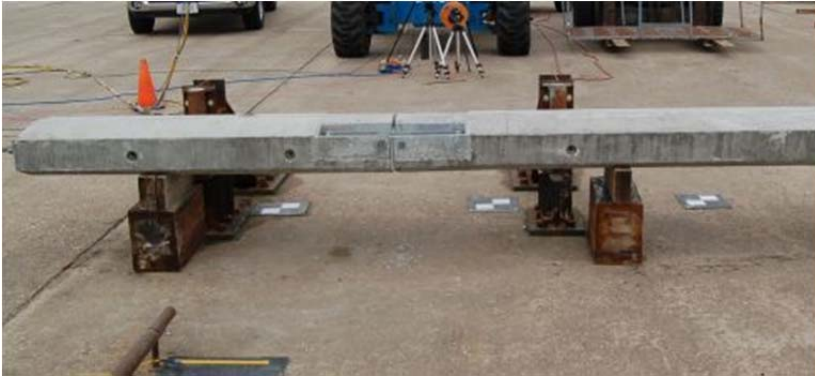
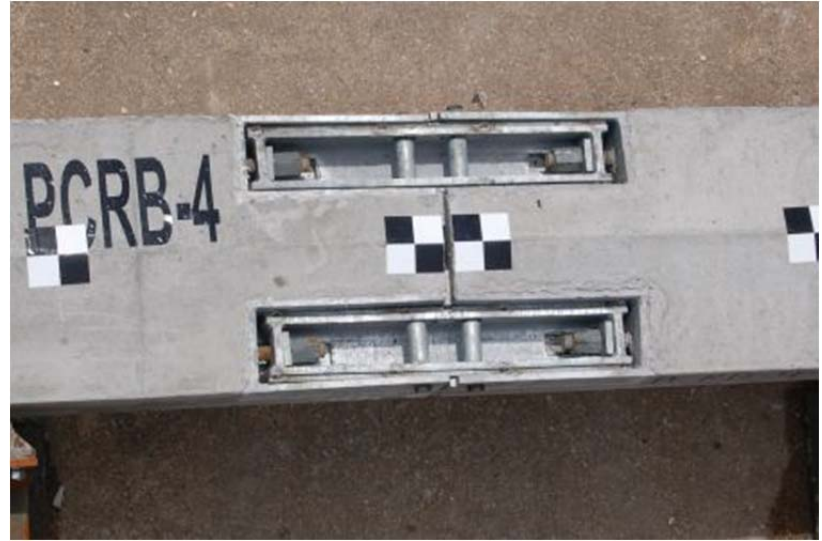
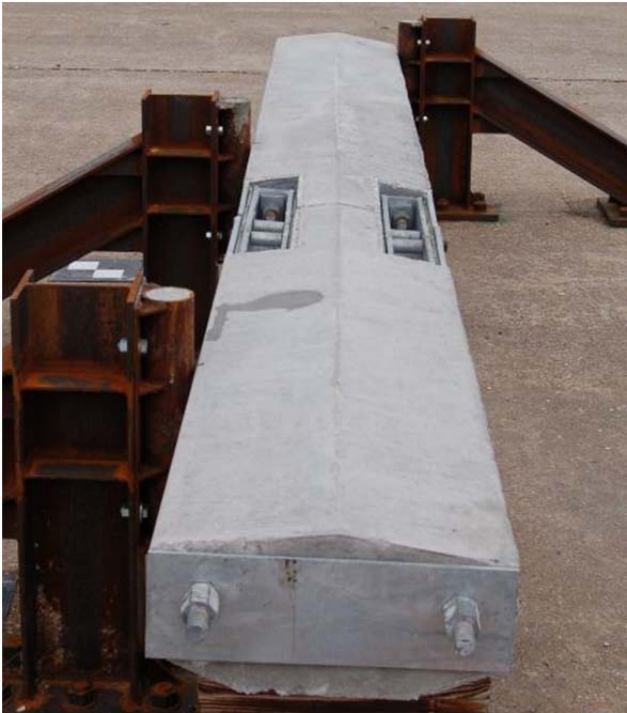
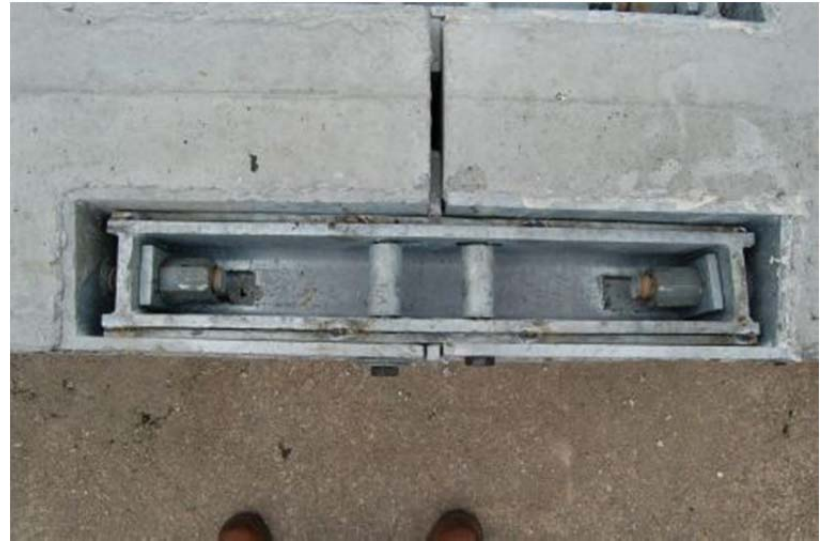
Figure 132. Rail Component Photographs, Test No. PCRB-4

Assembly of the joint began with the shear tube connector being inserted into adjacent pockets such that the longitudinal rail steel (i.e., threaded no. 8 bars) passed through the slots cut into the top of the connector and gusset plates. Next, washers and nuts were placed on the threaded no. 8 bars inside the shear tube connector to hold the connector in place. Shims were dropped into the ½-in. (13-mm) gap between rail ends and over the connectors. Then, the nuts were tightened which pulled the rail ends together on the shim plates and tied the longitudinal steel from adjacent rails together through the shear tube connector. Finally, shear bolts were slid into place through the pocket, shear tube connector, and collars and were fastened to the pocket by the nut welded to the inside of the pocket. Photographs of the assembled joint specimen are shown in Figure 132.

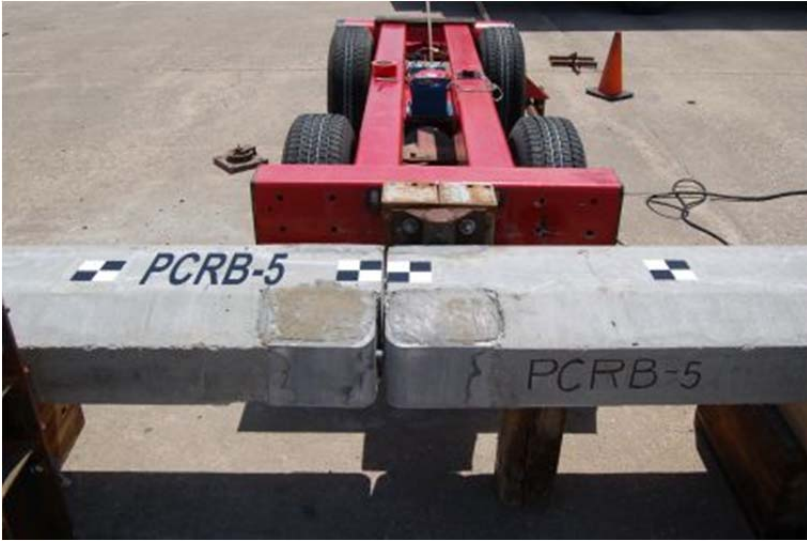
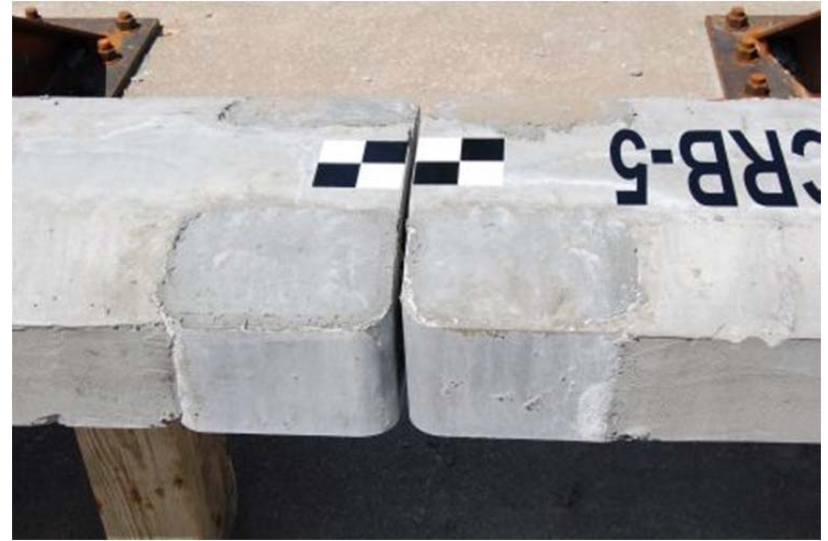
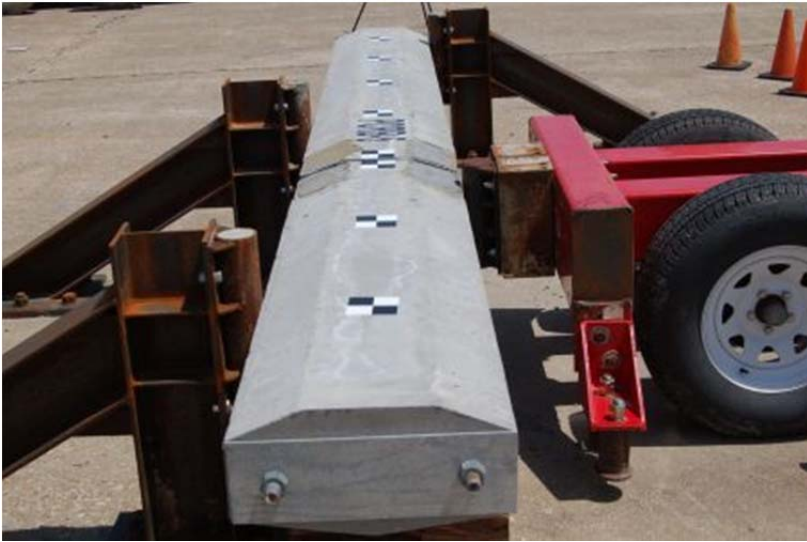
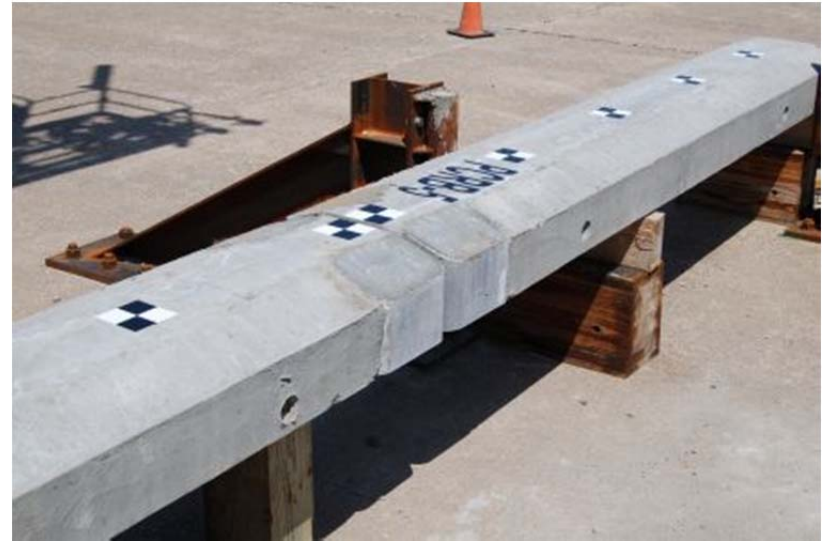
Figure 146. Rail Component Photographs, Test No. PCRB-5

Photographs of the assembled joint specimen are shown in Figure 146.

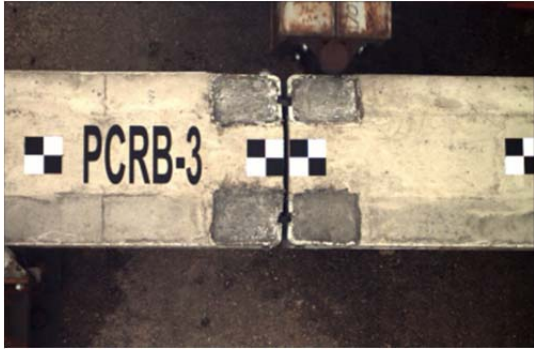
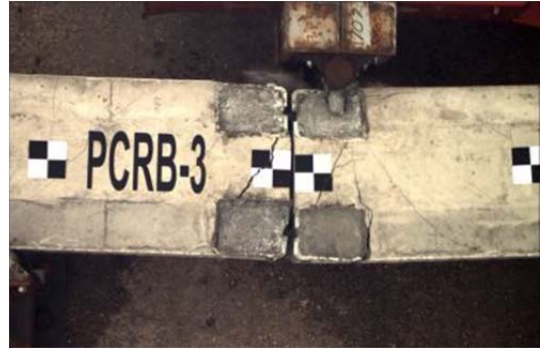
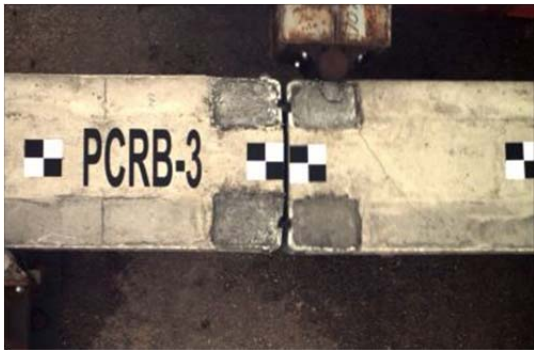
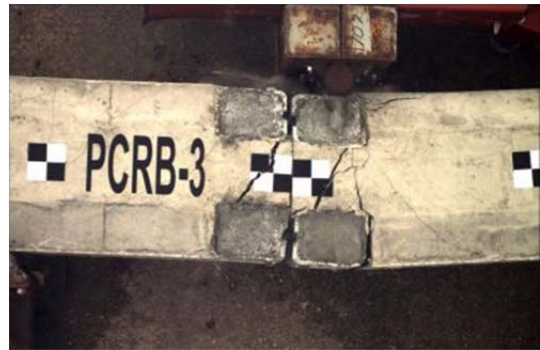
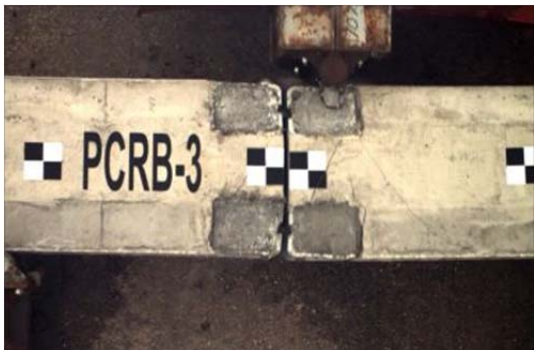
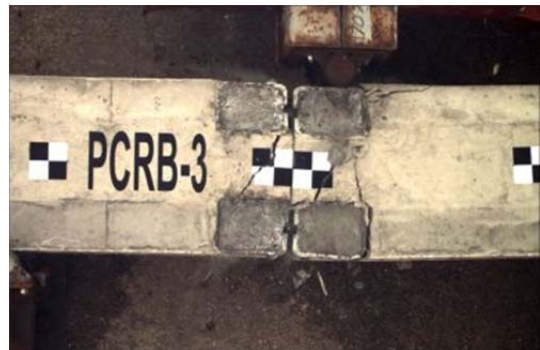
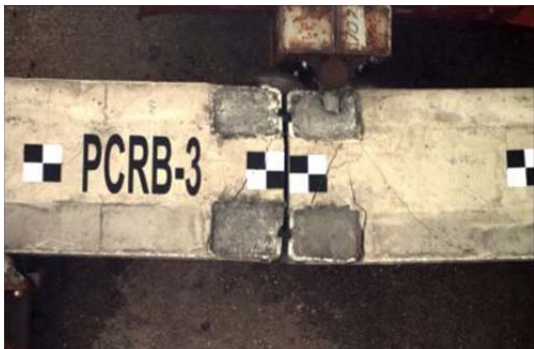
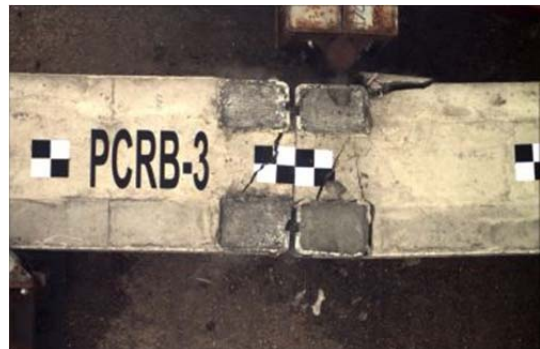
Figure 147. Sequential Photographs, Test No. PCRB-3

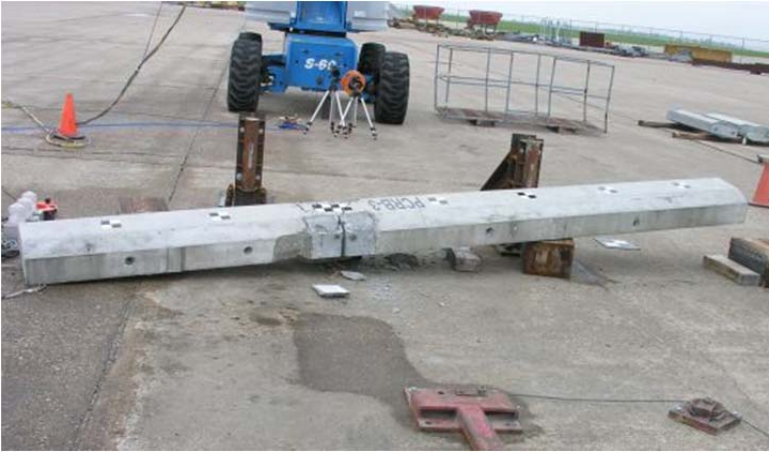
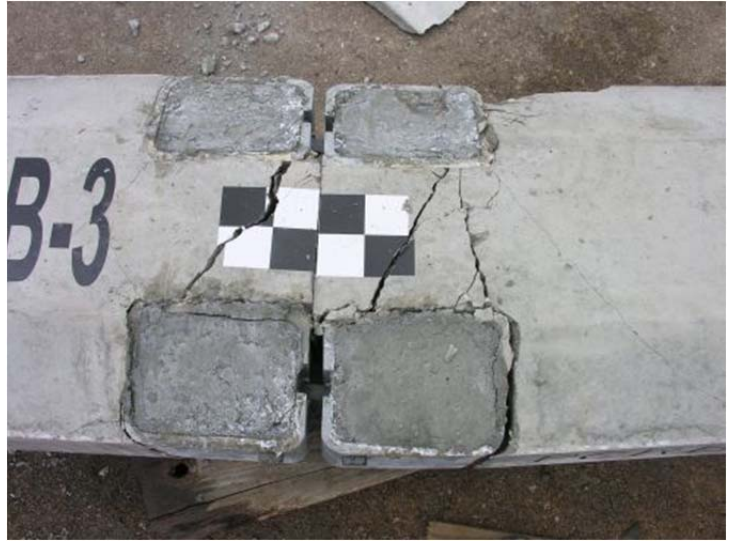
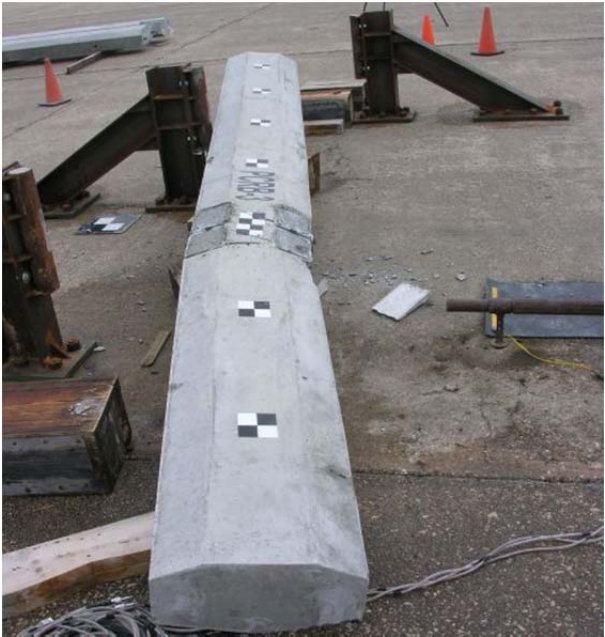
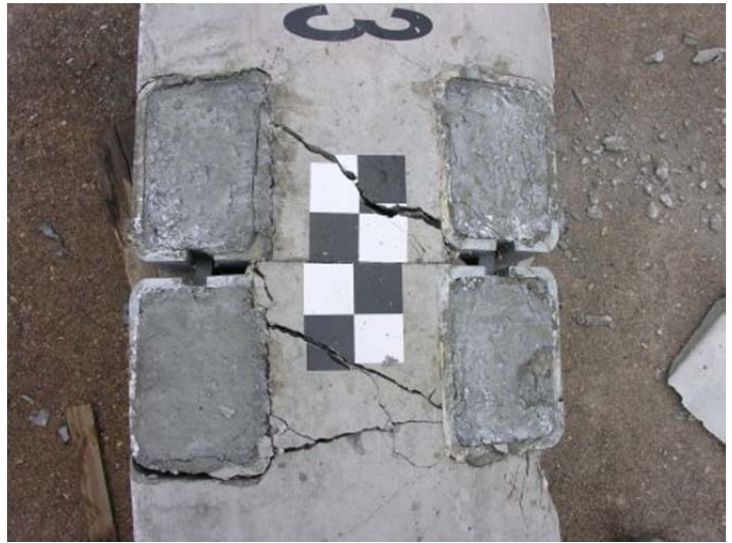
Figure 148. Component Damage, Test No. PCRB-3

Damage to the rail component consisted mainly of cracks and concrete spalling, as shown in Figures 148 through 150. Both rail segments suffered large shear cracks running between the front and back steel pockets. Also, the back pockets of both rails had separation cracks along the

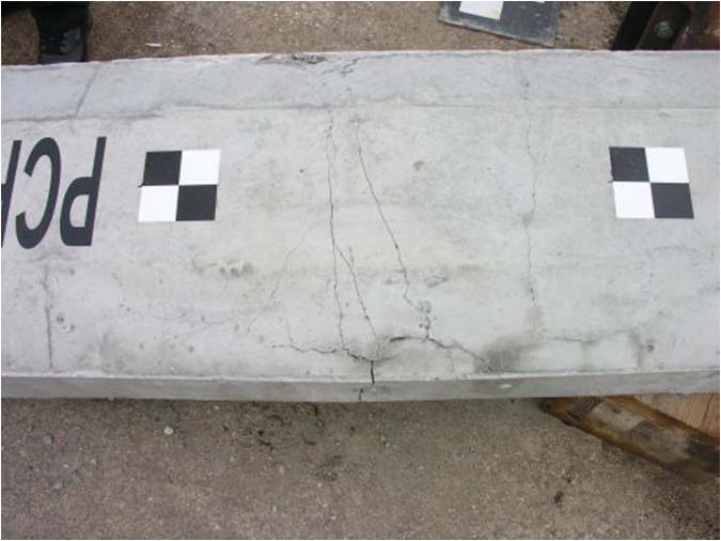
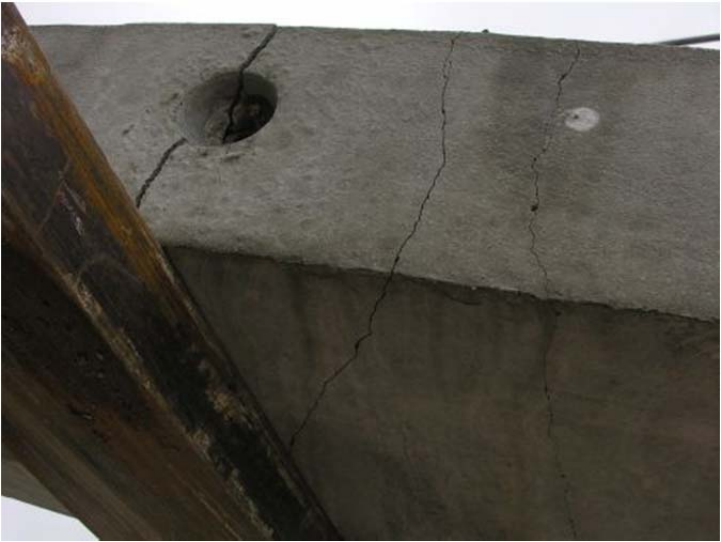
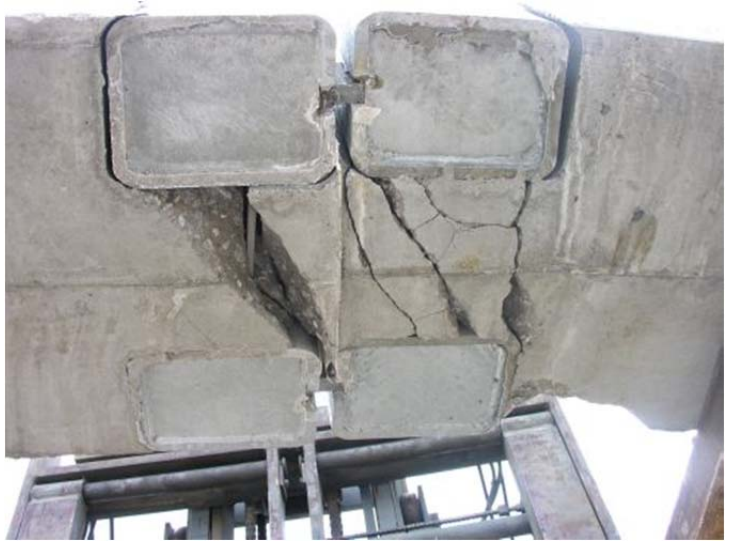
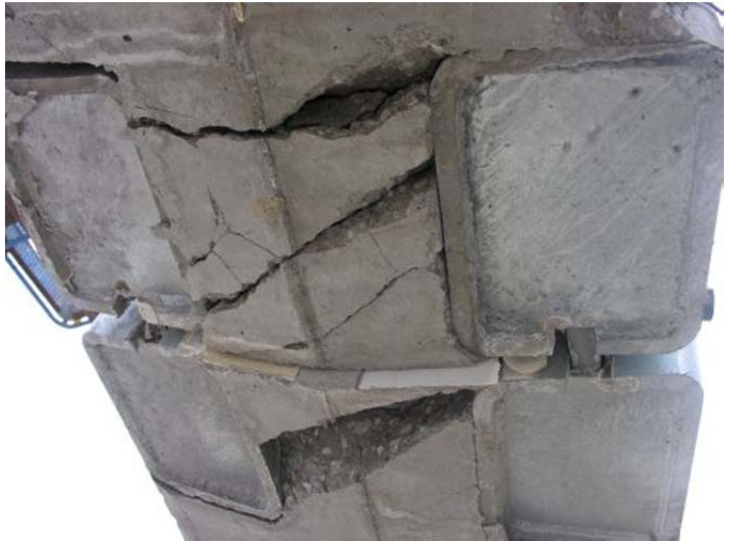
Figure 149. Component Damage – Steel Pockets, Test No. PCRB-3

The front pocket of the short rail segment was slightly indented from direct contact with the bogie impact head. Also, a small piece of grout had chipped off from the top surface of this grout pocket, as shown in Figure 149. A 6 x 6 in. (152 x 152 mm) area of concrete spalling was located on the front face of the short rail segment adjacent to the steel pocket. Finally, tension cracks were found in the long rail segment near the location of the middle anchor post support, as shown in Figure 150.

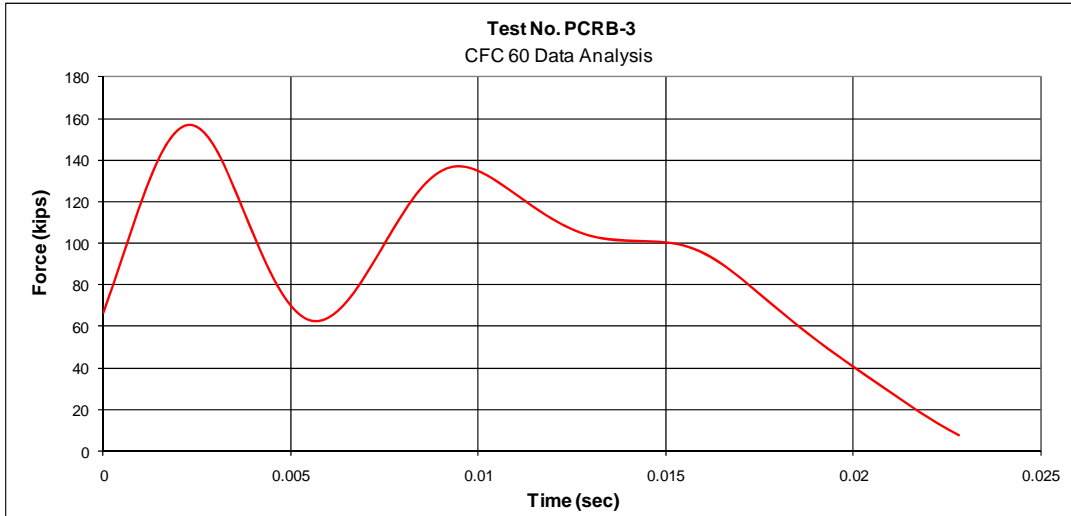
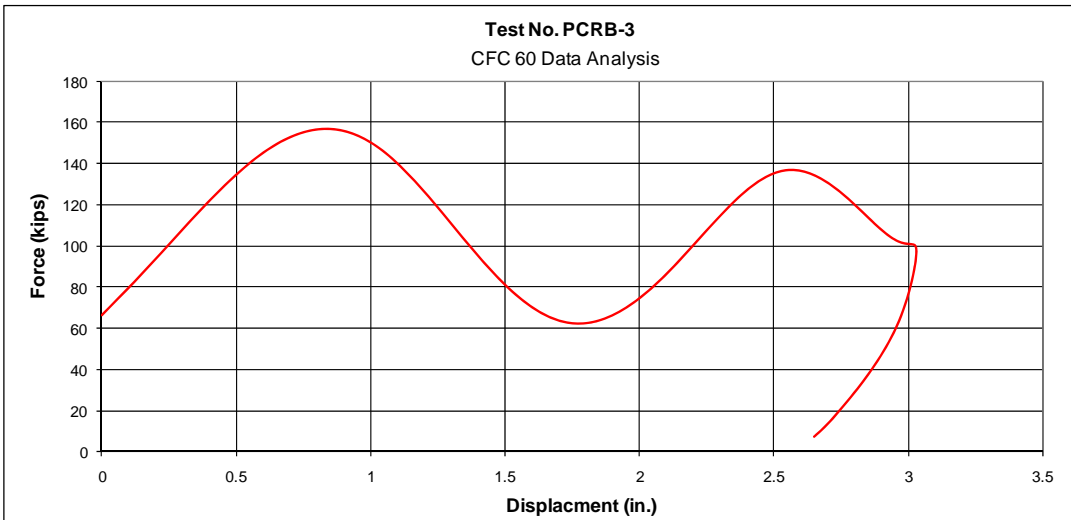
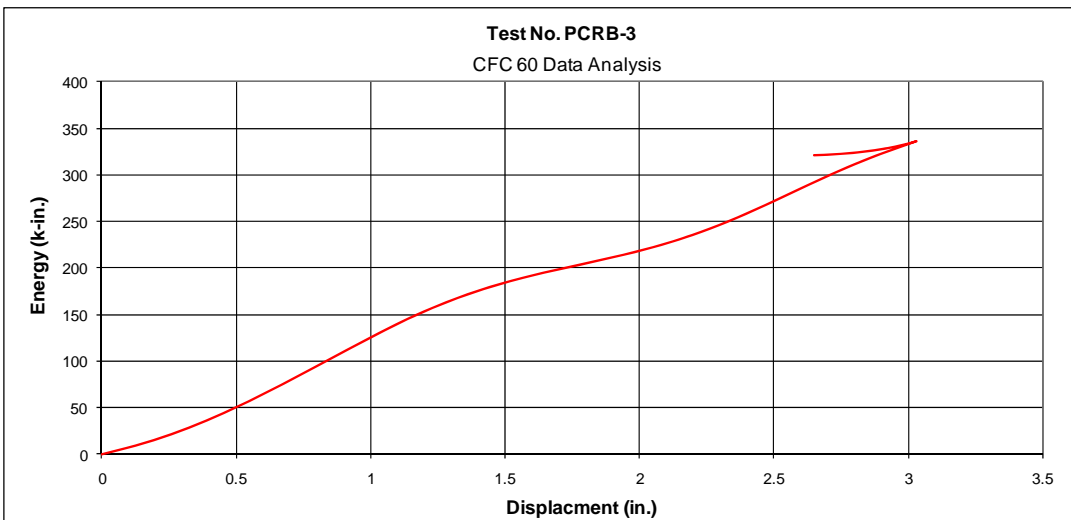
Figure 151. Data Analysis Plots, Test No. PCRB-3

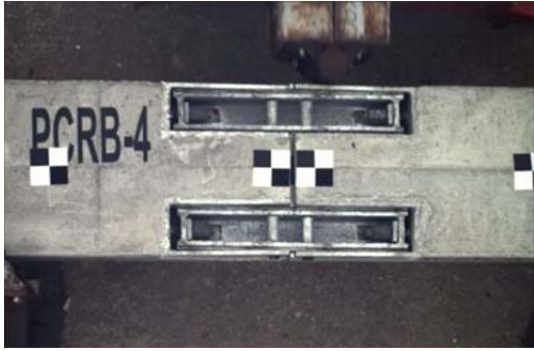
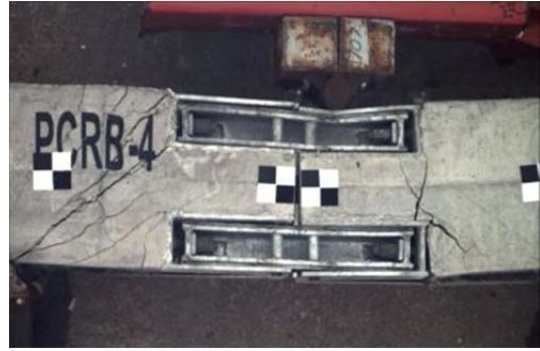
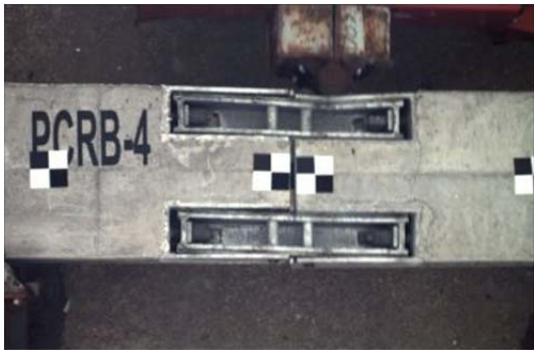
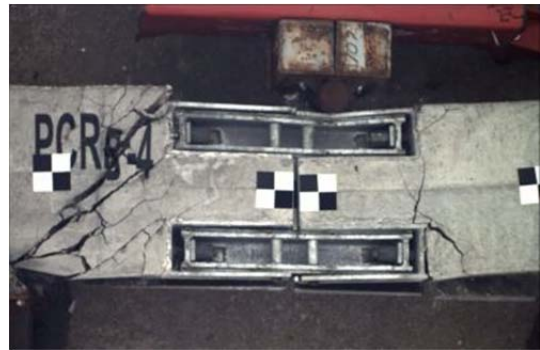
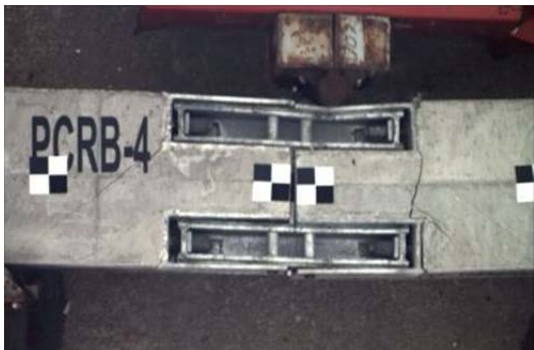
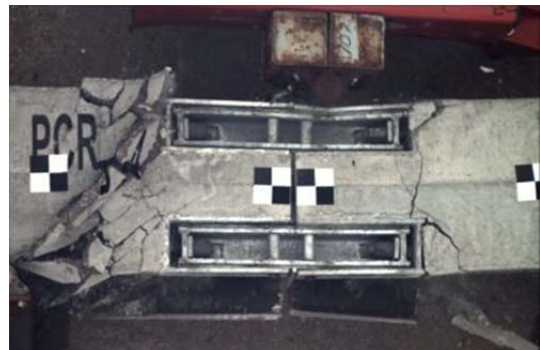
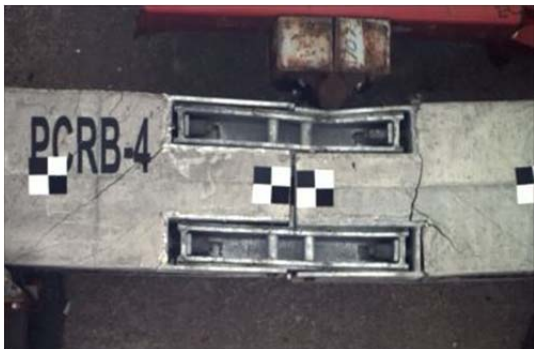
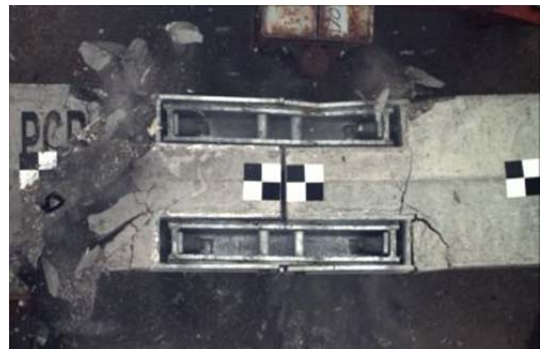
Figure 152. Sequential Photographs, Test No. PCRB-4

The 1,707-lb (774-kg) bogie vehicle impacted the concrete rail specimen 6 in. (152 mm) from the centerline of the joint at a speed of 23.4 mph (37.7 km/h). At 0.002 seconds after impact, the front steel pocket of the short rail segment had bent inward. A crack developed from the corner of this pocket toward the center of the rail. At 0.004 sec, a crack developed from the corner of the front pocket of the long rail segment to the center of the rail. At this same time, both rail segments were deflecting backward. At 0.006 sec, concrete cracks development stemming from the inside faces of the back steel pockets on both rail segments. At 0.008 sec, a separation crack had developed at the interface between the steel and concrete along the edge of the back pocket in the short rail segment. At this same time, the cracks stemming from the pocket edges in both rail segments continued to grow and widen. At 0.010 sec, cracks developed in the long rail segment near the middle anchor post. Also at this time, a concrete fragment broke free from the bottom surface (as oriented in the test) of the short rail segment adjacent to the back pocket. By 0.014 sec, the cracks in the long rail segment had combined and propagated to form a large crack spanning from the front steel pocket to the middle anchor post. At 0.022 sec, the rail component reached its maximum deflection of 2.4 in. (61 mm). At this same time loose fragments of concrete began to break away from the top surface (as oriented in the test) of the rail around the large crack in the long rail segment. At 0.024 sec, large concrete fragments broke away from the bottom (as oriented in the test) of both rail components underneath the pockets. At 0.046 sec, the bogie vehicle lost contact with the rail component as many concrete fragments broke free from the long rail segment adjacent to the pocket edges. At 0.120 sec, the back shim

plate slipped out of the joint and fell to the ground. Sequential photographs of the impact event are shown in Figures 152 and 153.

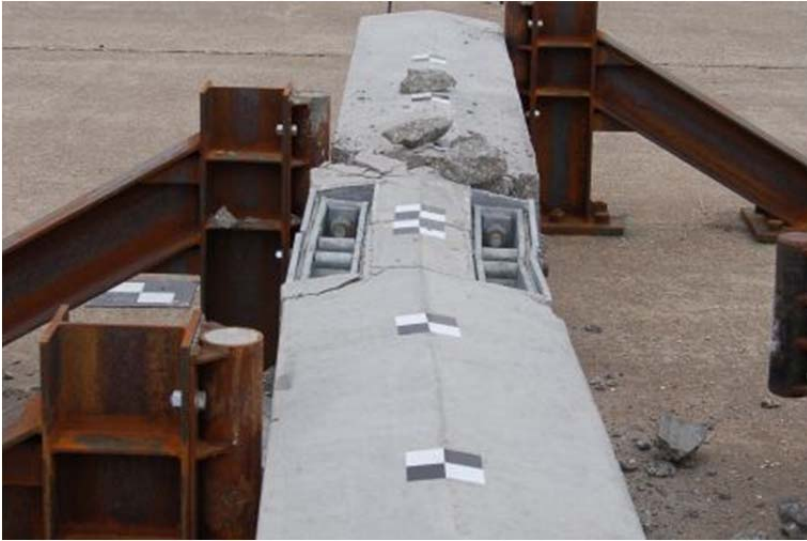
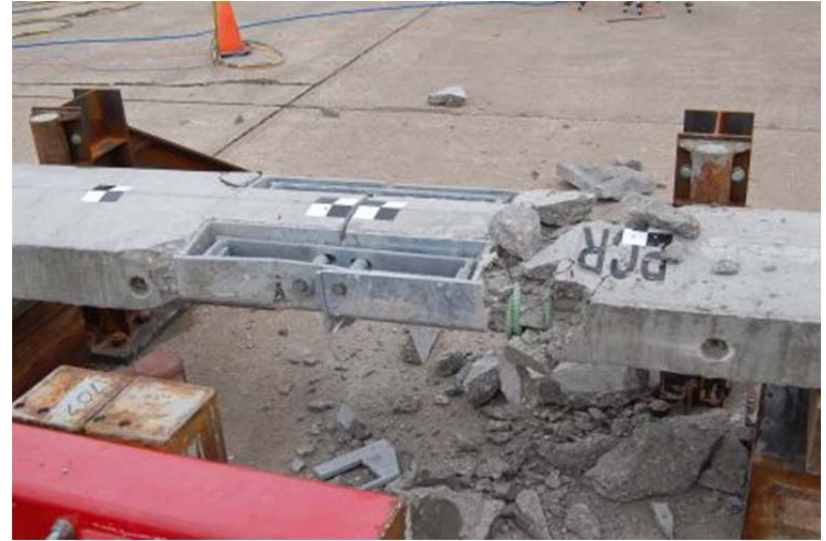
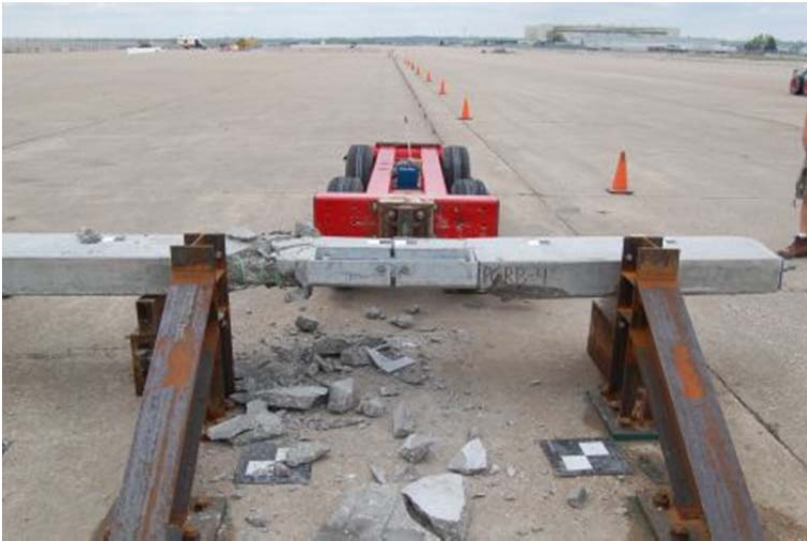
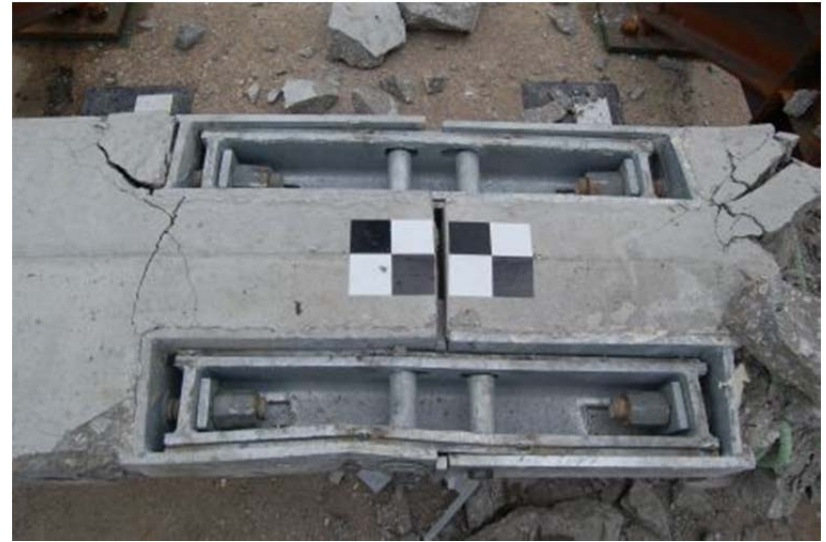
Figure 154. Component Damage, Test No. PCRB-4

Damage to the rail component consisted of bent steel hardware and concrete fracture, as shown in Figure 154. The steel joint hardware remained intact with only minor deformations. Both the front pocket of the short rail segment and the front shear tube connector were bent inward at the impact location, as shown in Figure 155. The shear bolt collar nearest to impact was pinched by the collapsing shear tube and prevented further deformation. In addition, the threaded rebar inside the back pocket of both rail segments were bent slightly inward, matching the curvature of the rail deformation during impact. The curvature also resulted in the back side of the joint opening approximately 1 in. (25 mm) and the back shim plate slipping out. However, if the rail were right side up, the shim would have been resting on the shear tube and would not have fallen to the ground.

Similar to previous test component damage, concrete cracks stemmed from the inside corner of all four steel pockets. On the short rail segment, cracks were found between the steel pockets and a loose concrete fragment was located adjacent to the back pocket, as shown in Figure 154. Also, spalling was located on the front face of the short rail segment adjacent to the front pocket. On the long rail segment, concrete fragments had broken free of the rail from the back edge of the pockets to the middle anchor post. This left the interior steel reinforcement exposed. Finally, large concrete fragments broke off of the bottom (as oriented in the test) of both rail segments exposing the internal steel rebar near the joint, as shown in Figure 156.

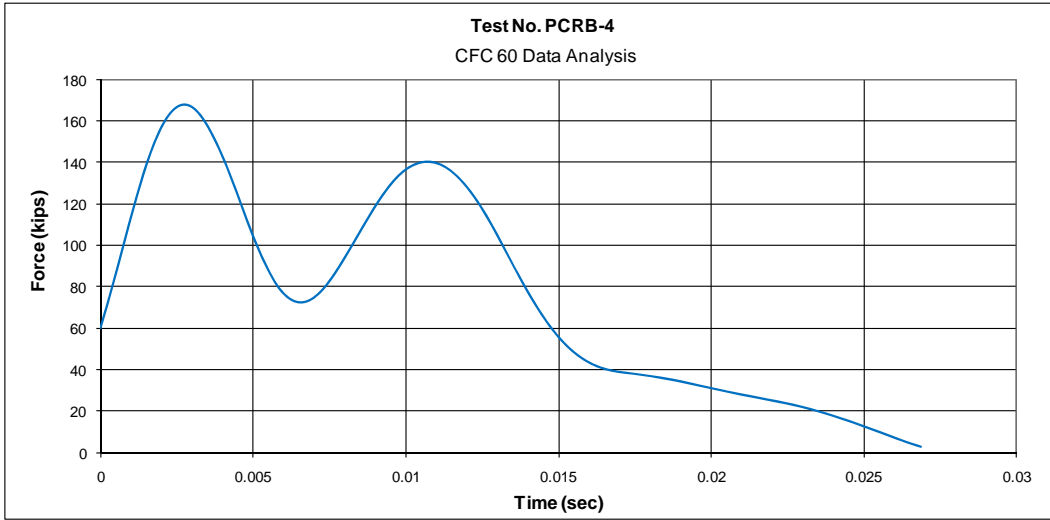
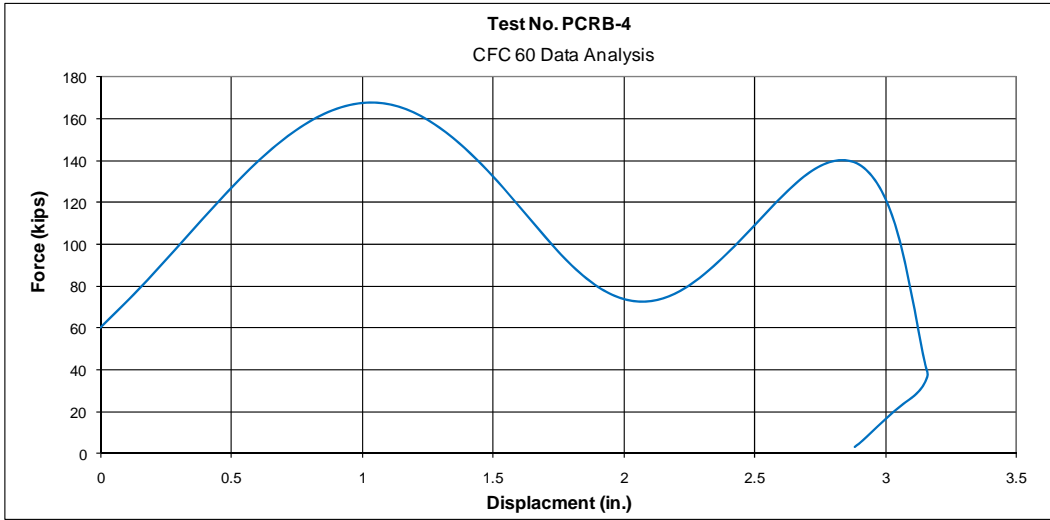
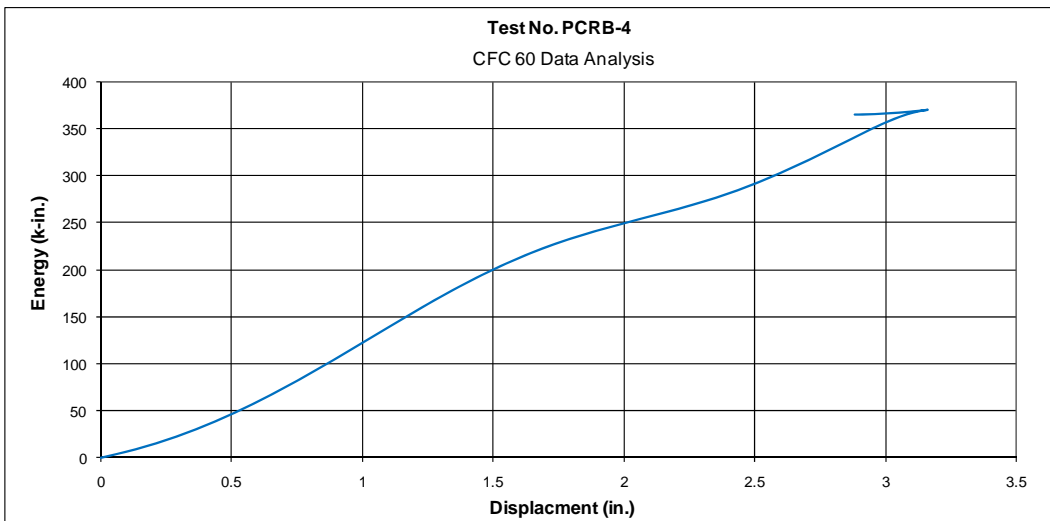
Figure 157. Data Analysis Plots, Test No. PCRB-4

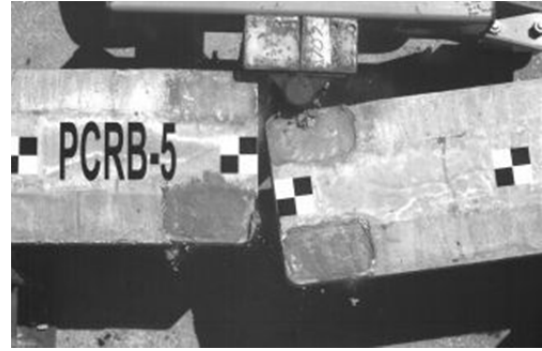
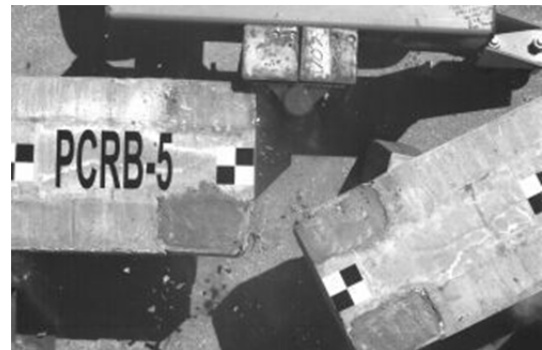
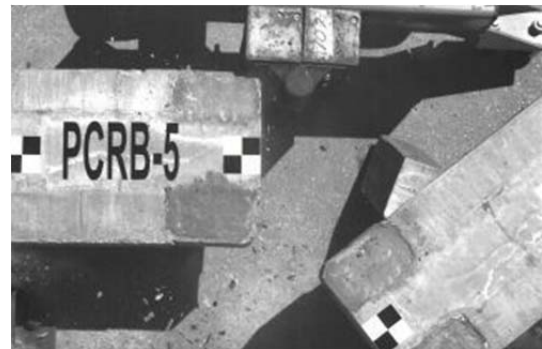
Figure 158. Sequential Photographs, Test No. PCRB-5

The 1,707-lb (774-kg) bogie vehicle impacted the rail joint specimen 6 in. (152 mm) from the centerline of the joint at a speed of 22.9 mph (36.8 km/h). At 0.002 seconds after impact, two cracks developed in the short rail segment as it deflected back. The first stemmed from the inside corner of the front pocket, while the second originated on the front face near the anchor post. At 0.004 sec, the long rail segment began to deflect. At this same time, a crack formed between the pockets of the short rail segment. At 0.006 sec, tension cracks developed in the long rail segment near the middle anchor post. At this same time, small pieces of grout began to chip away from the front pocket of the short rail segment. At 0.008 sec, the threaded rod connecting the back pockets had fractured. By 0.010 sec, or a deflection of 2.5 in. (64 mm), both threaded rod connectors had fractured. Thus, the joint had failed and the small rail segment was free to rotate about the end anchor post. At 0.018 sec, the right side of the impact head contacted the end of the long rail segment. At 0.020 sec, the impact head lost contact with the short rail segment which continued to rotate about the end anchor post. At 0.028 sec, the cracks near the middle of the long rail segment were expanding as the rail continued to deflect backward. Also at this time, the back face of the long rail segment began to spall near the middle anchor post. At 0.040 sec, the long rail segment reached a maximum deflection of 2.1 in. (56 mm). The bogie vehicle had traveled 6.5 in. (165 mm) into the system. Both the long rail segment and the bogie then began to redirect into the opposite direction. At 0.066 sec, the long rail segment lost contact with the bogie vehicle. Meanwhile, the short rail segment continued to rotate freely about the end anchor post. At 0.224 sec, the free end of the short rail segment contacted the bogie vehicle stopping the rotational movement. The segment came to rest laying perpendicular to its original

position approximately 2 ft (0.6 m) in front of the end anchor post. Sequential photographs of the impact event are shown in Figures 158 and 159.

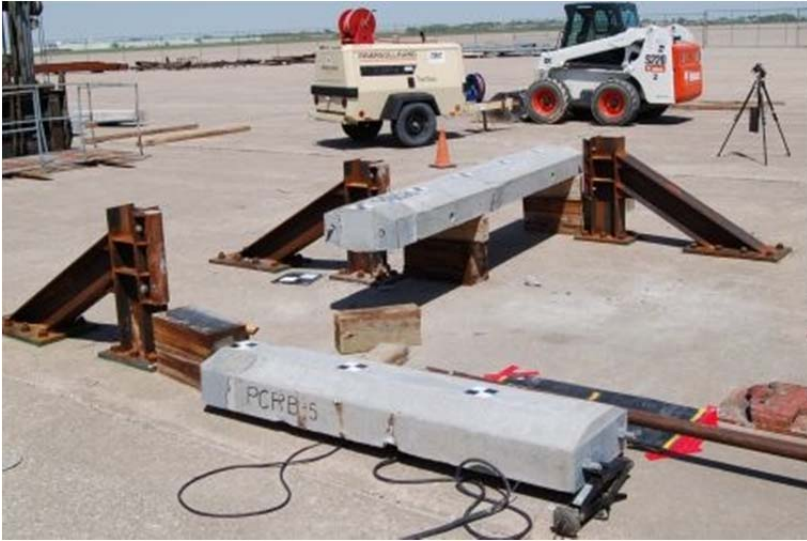
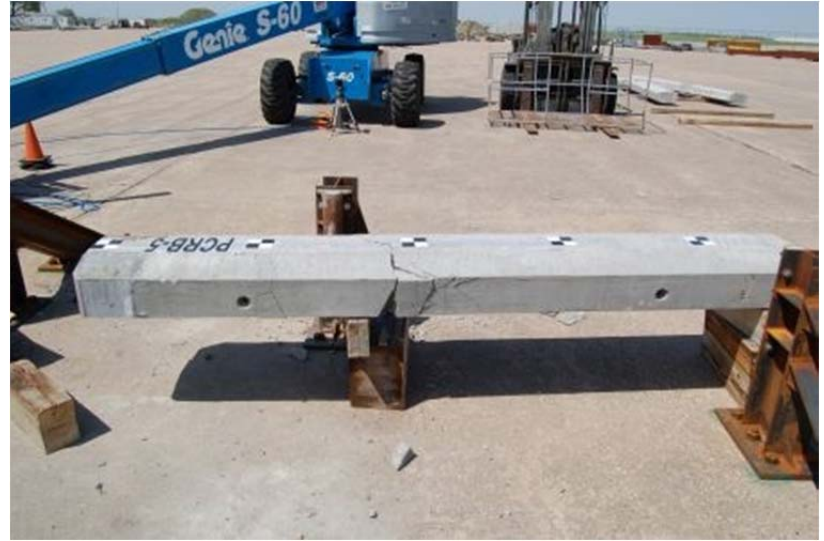
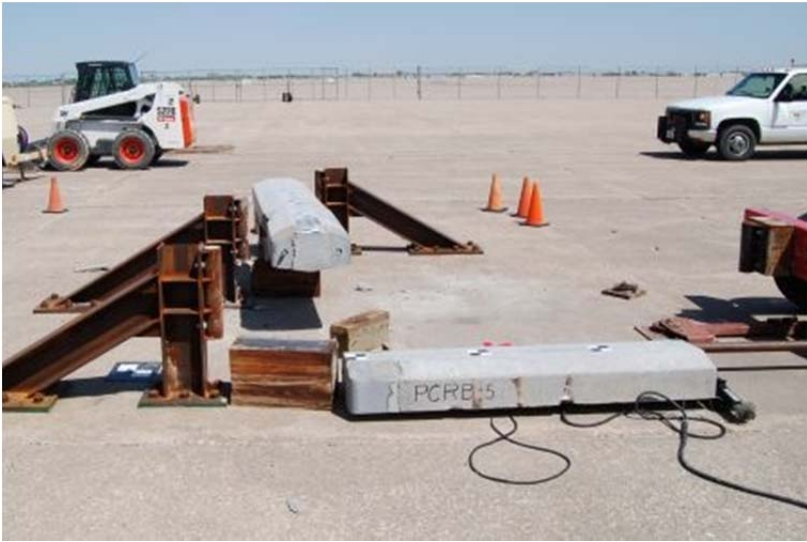
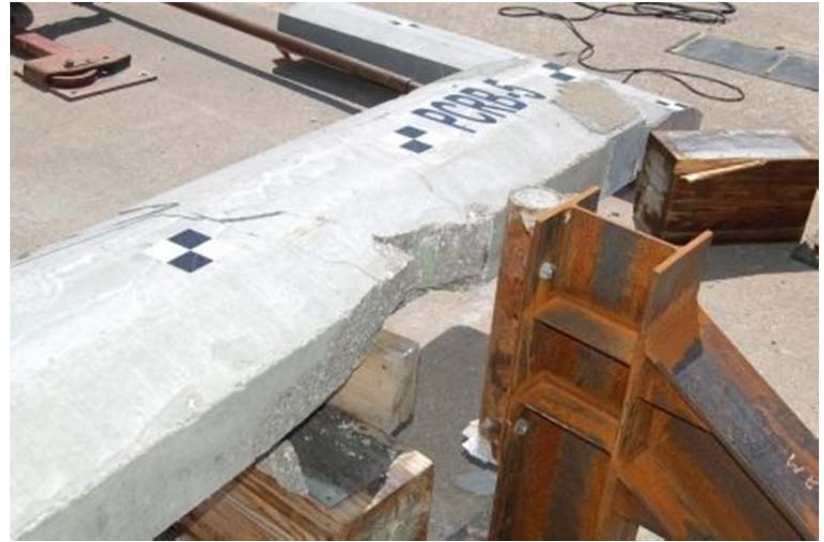
Figure 160. Component Damage, Test No. PCR-B-5

The joint for bogie test no PCRB-5 failed during the impact event. This caused the two rail segments to separate. As a result, the short rail segment ended up laying on the ground, perpendicular to its original position, as shown in Figure 160. The long rail segment remained atop the wooden support blocks, but had rotated slightly away from the anchor posts. Analysis of the threaded rods fracture patterns, as shown in Figure 162, revealed that the front threaded rod failed in shear, while the back threaded rod failed from a combination of tension and shear. Then combination tension and shear failure of the back threaded from was evidenced by the 45-degree fracture plane and the bending in the rod.

Damage to the long rail segment consisted mainly of bending cracks and concrete spalling, as shown in Figures 160 and 162. This damage was the result of the long rail segment absorbing all of the impact energy from the bogie after the joint failed. The concrete cracks spanned from the middle anchor post to the front face of the rail. Small fragments of concrete had broken off of the rail where the cracks met the front face of the segment. Concrete spalling was found on the back face of the segment around the middle anchor post bearing location. This
