NDOR Project No. SPR-P1(07) P596

PHASE I DEVELOPMENT OF AN AESTHETIC, PRECAST CONCRETE BRIDGE RAIL

MIDWEST ROADSIDE SAFETY FACILITY (MwRSF)

MwRSF Research Report No. TRP-03-239-12

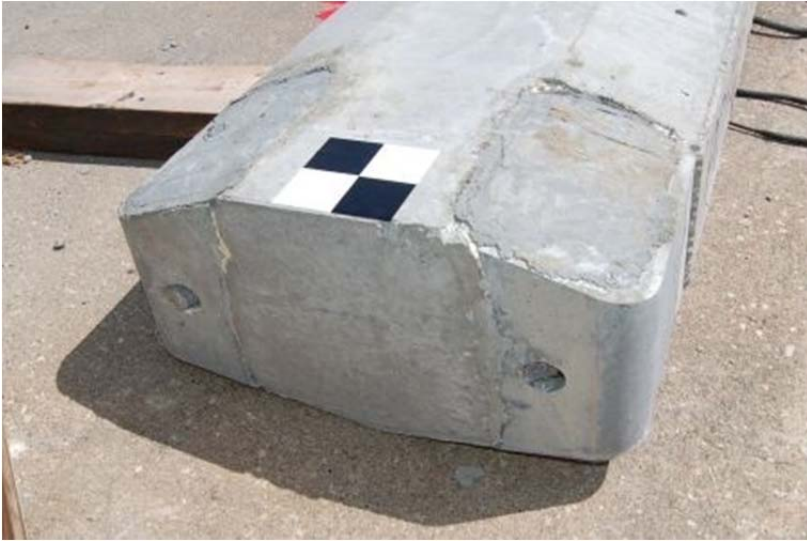
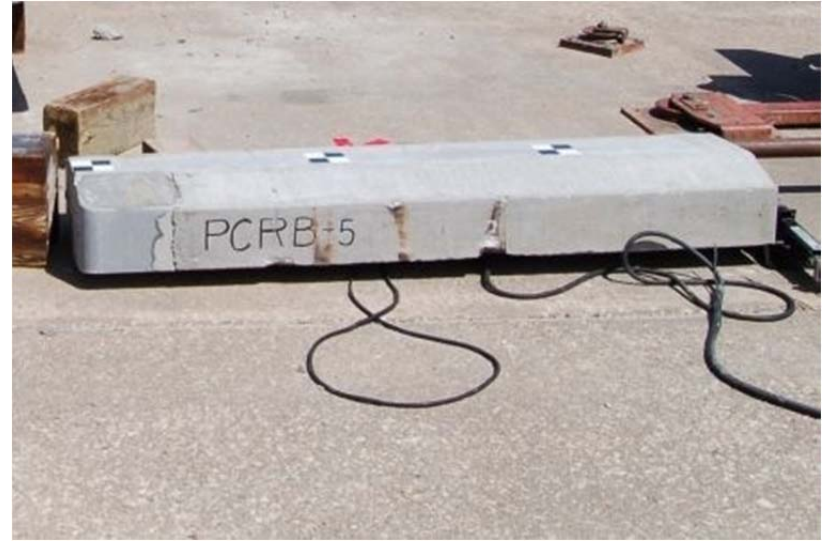
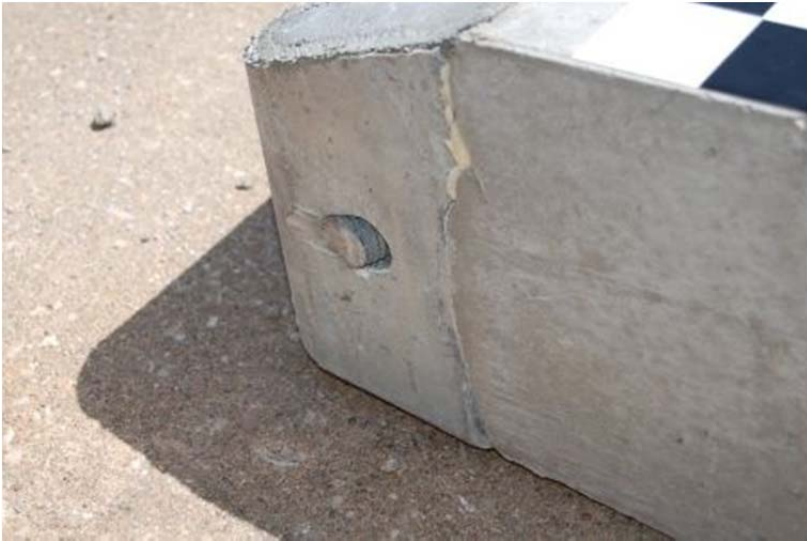
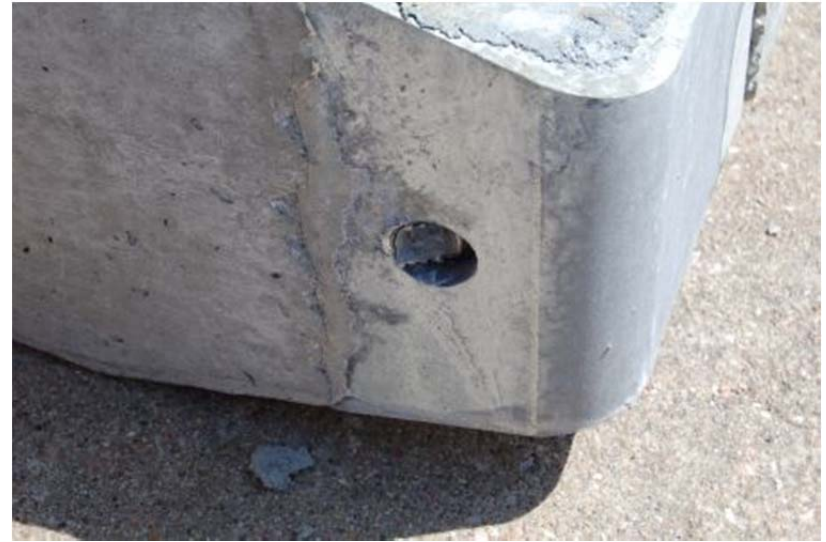
Figure 161. Component Damage – Short Rail Segment, Test No. PCRB-5

Damage to the short rail segment was minimal, as shown in Figure 161. A few concrete cracks were found in the middle of the segment near the original position of the anchor post, and another concrete crack was found spanning between the steel pockets. Also, contact marks on the short rail segment were located at the impact point and along the back face where the segment contacted the anchor post assembly while rotating.

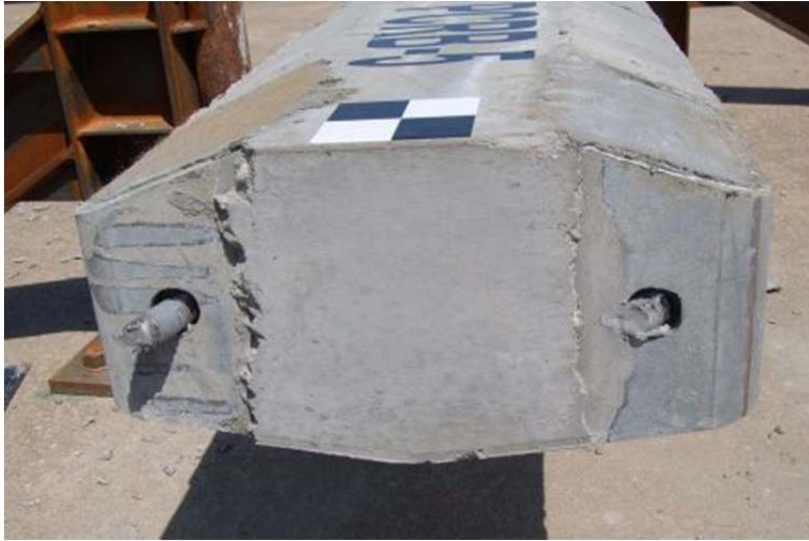
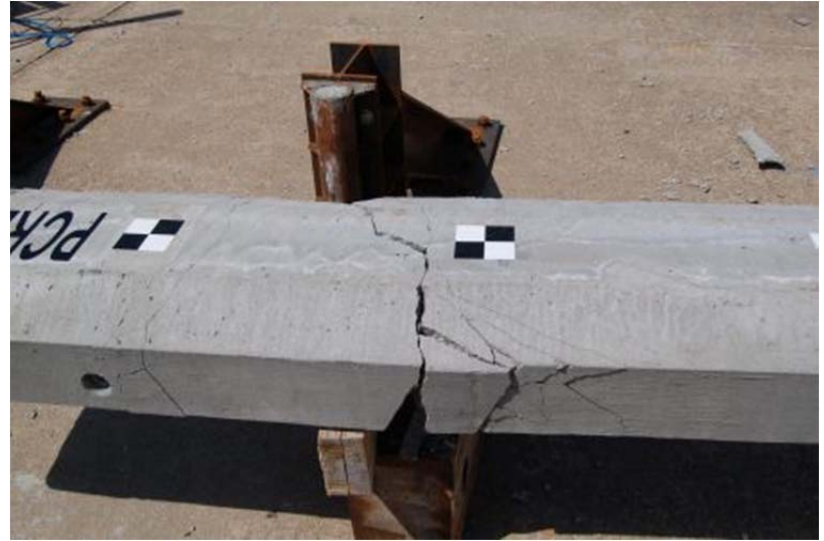
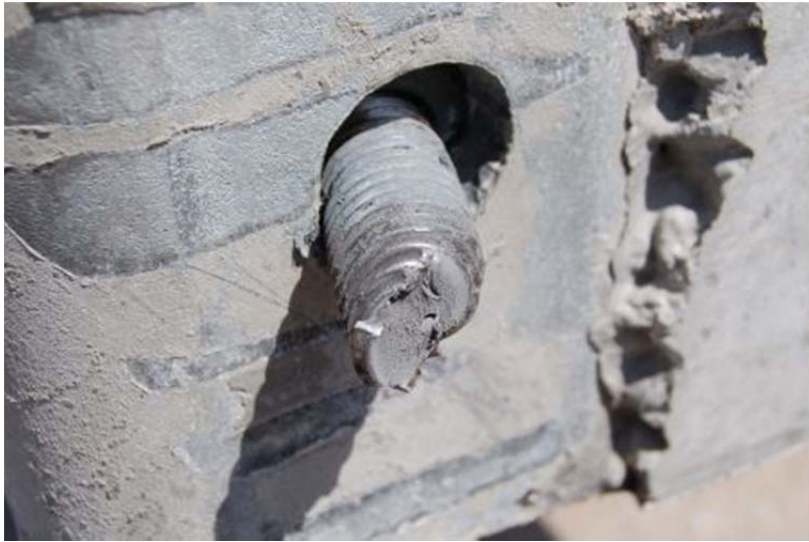
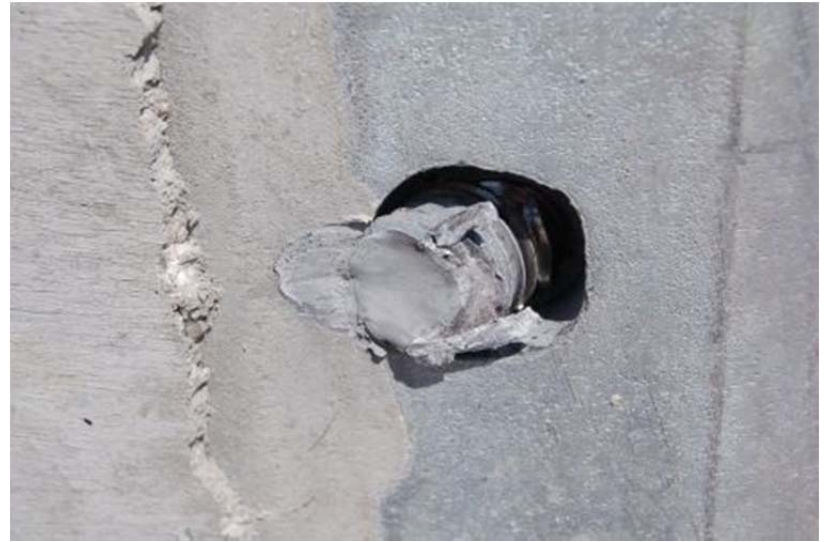
Figure 162. Component Damage – Long Rail Segment, Test No. PCRB-5

Damage to the long rail segment consisted mainly of bending cracks and concrete spalling, as shown in Figures 160 and 162. This damage was the result of the long rail segment absorbing all of the impact energy from the bogie after the joint failed. The concrete cracks spanned from the middle anchor post to the front face of the rail. Small fragments of concrete had broken off of the rail where the cracks met the front face of the segment. Concrete spalling was found on the back face of the segment around the middle anchor post bearing location. This

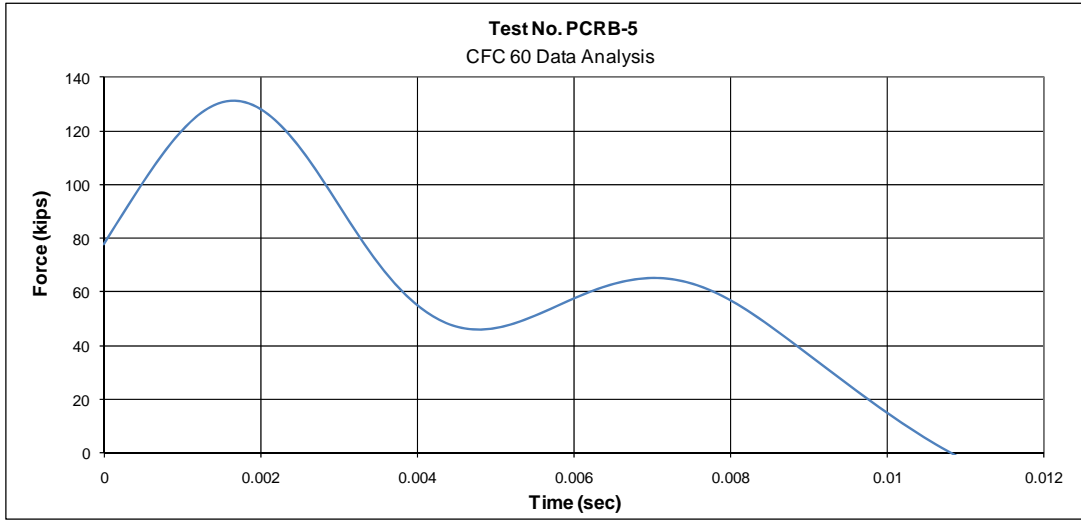
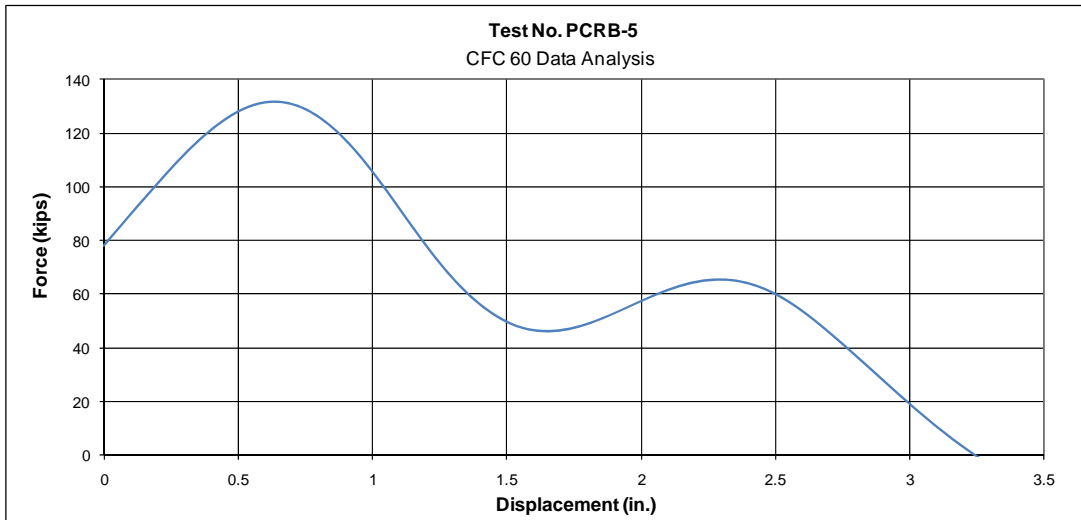
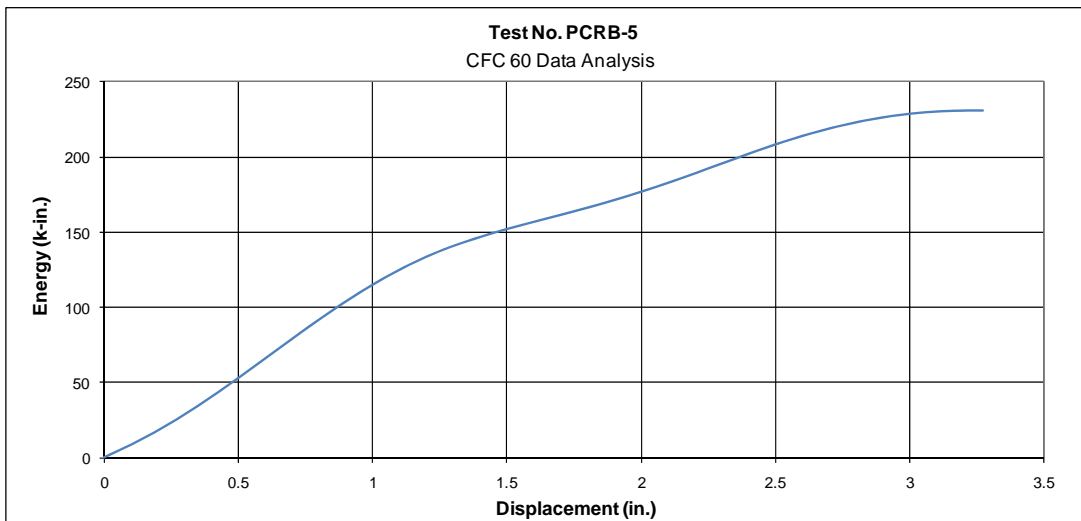
Figure 163. Data Analysis Plots, Test No. PCRB-5

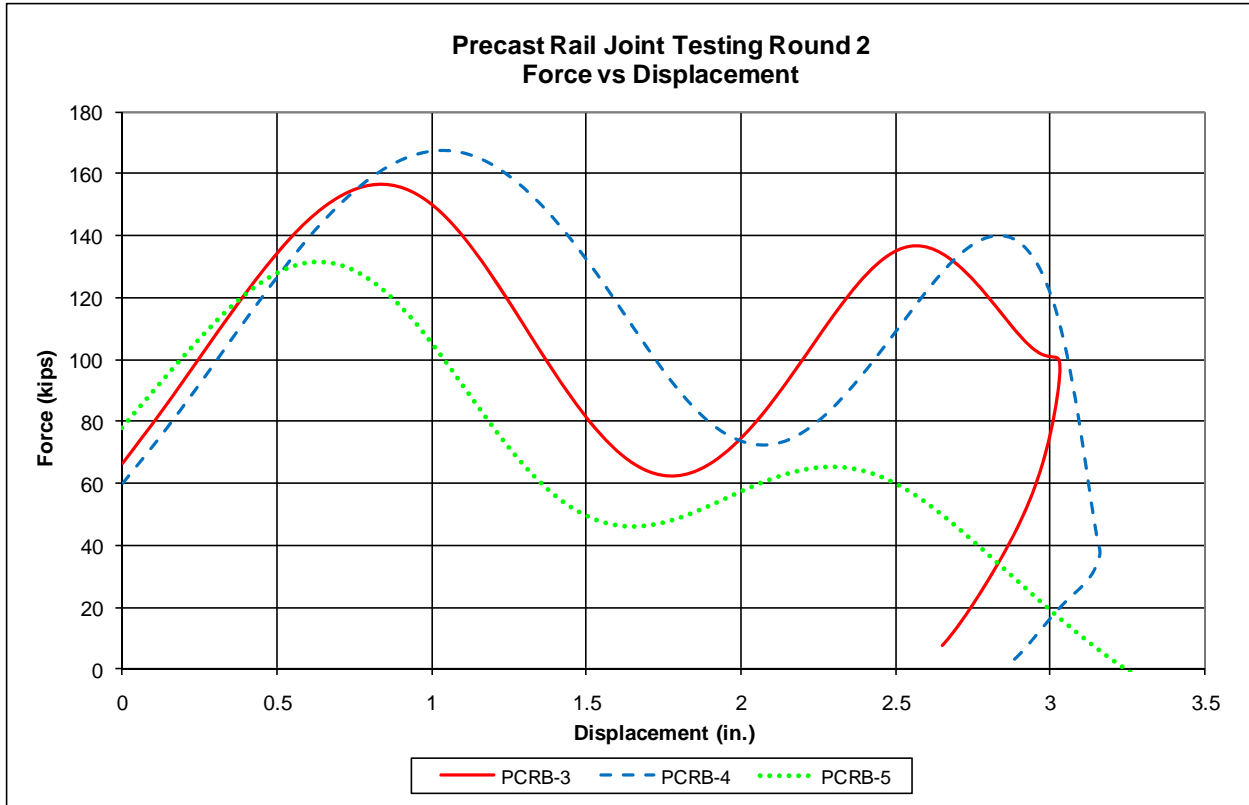
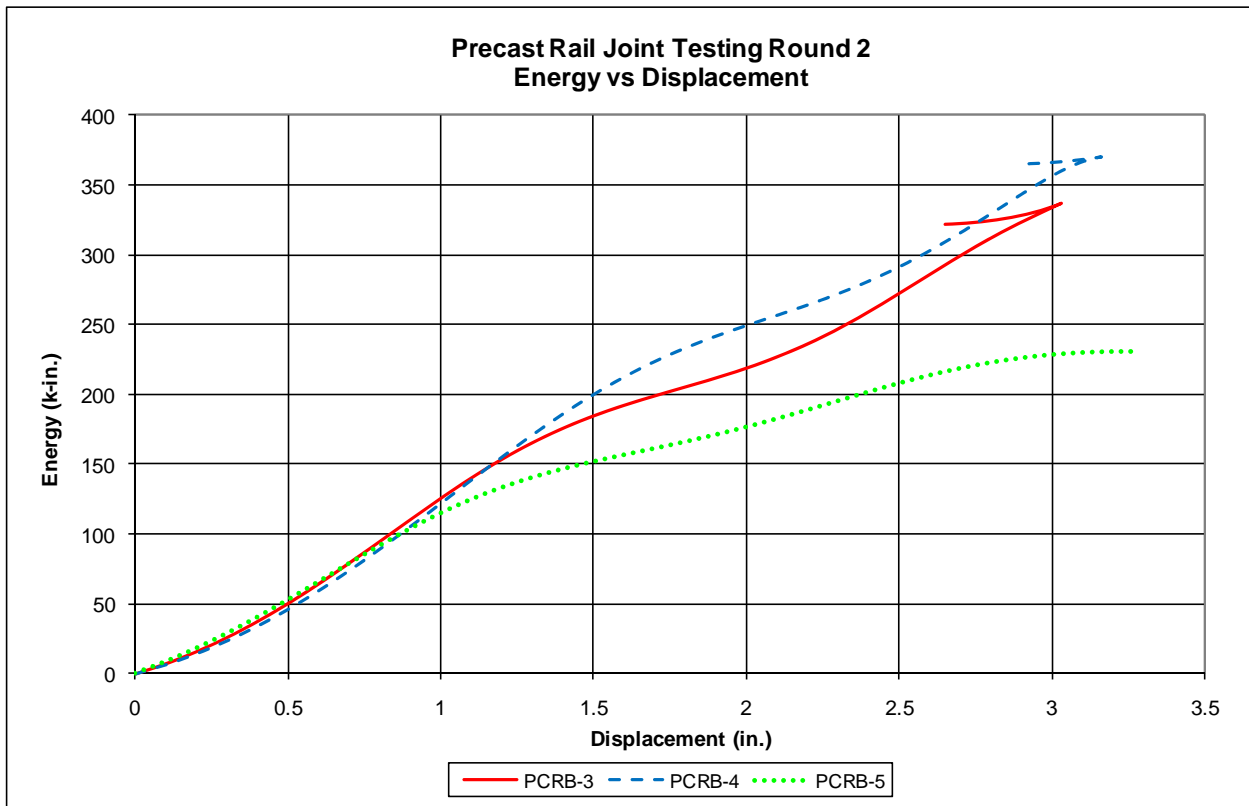
After the second round of bogie testing, only the grouted joint design from test no. PCRB-3 satisfied all design criteria and could be implemented into the precast bridge rail design. The dry joint from test no. PCRB-4 illustrated the ability to transfer the design loads between adjacent rail segments. However, the significant amount of concrete that broke free from the rails had the potential to cause problems on the bridge or roadway below. This joint would become a feasible option for precast bridge rails if the concrete above the pockets was better confined. The alternate grout joint from test no. PCRB-5 would require major changes to strengthen and improve ductility before it was a viable option. Thus, it was decided to proceed with the grouted joint design from test no. PCRB-3 while keeping in mind that the dry joint from test no. PCRB-4 could potentially be used if additional confinement steel were added to the joint design.

Figure 164. Data Comparison Plots, Round 2 Bogie Testing Results

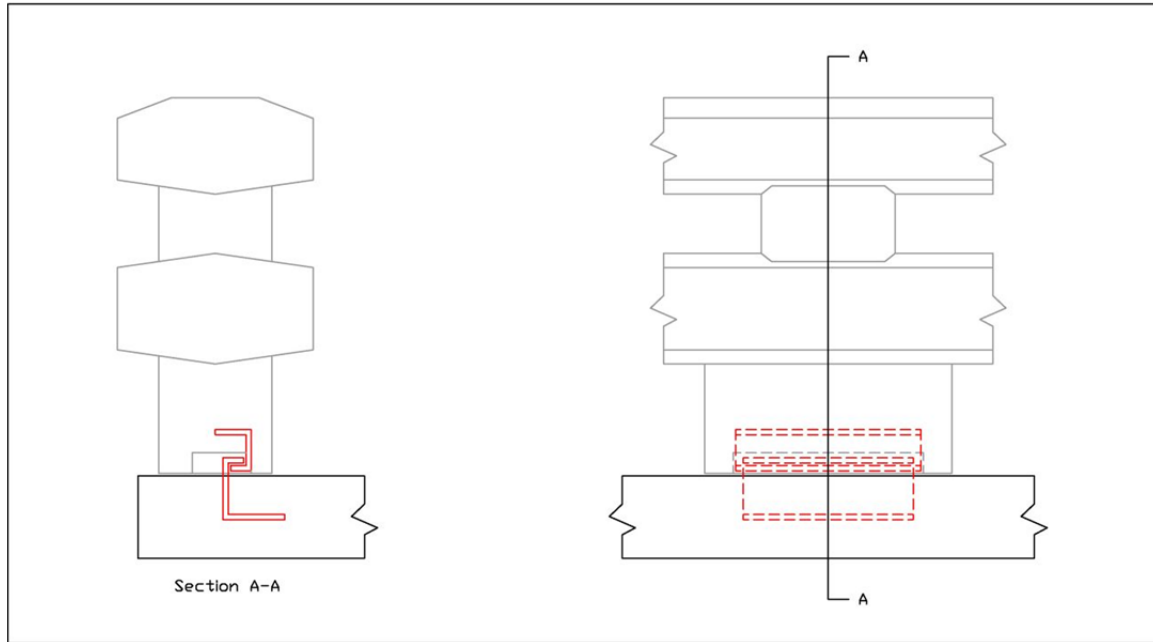
To install the rail segment, the segment would be lowered into position such that the post cavity fit over the exposed deck cleat. Then the segment would be pushed toward the edge of the deck so that the cleats would hook onto each other and lock the segment into place. No additional hardware would be necessary for this attachment method making it the simplest and quickest to assemble.

Figure 168. Deck Attachment C - Cleat

Two negative attributes could be identified with Deck Attachment C: (1) loss of rail symmetry and the possibility of a reversible rail segment and (2) damage to the cleat, or the deck, during an impact would require deck repairs or replacement. To prevent this damage, the cleat must be fabricated from strong, thick steel components, and extra deck reinforcement would be required to prevent the cleat from pulling out of the deck.

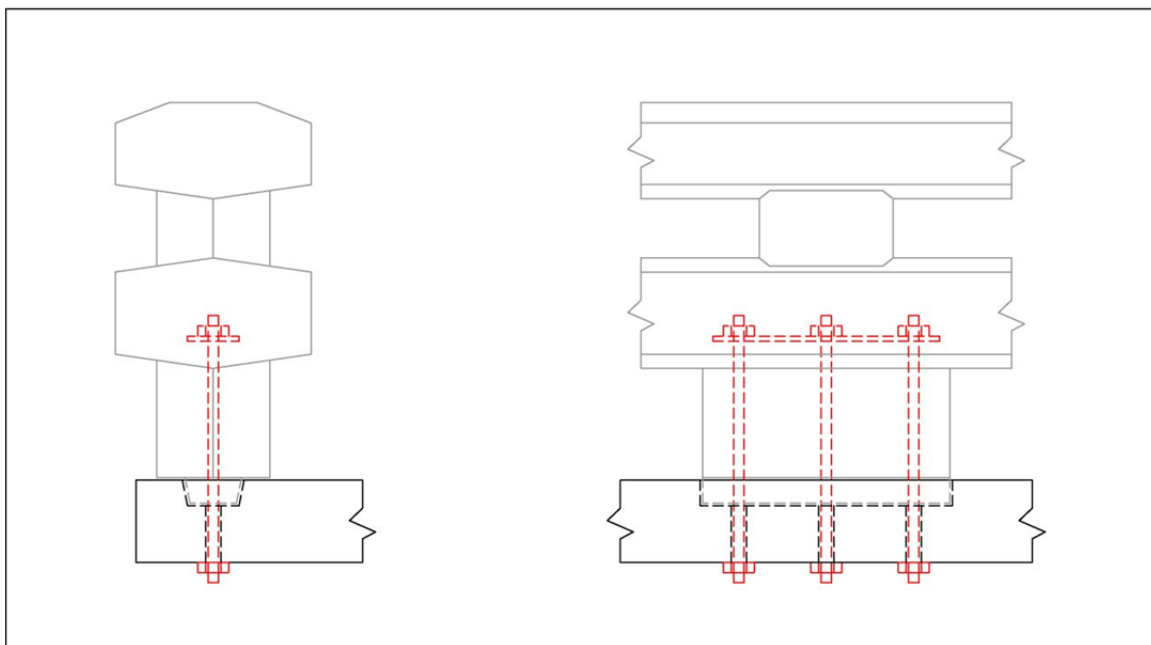
Although the channel created a strong, compact joint, the cavity in the deck resulted in a loss of deck thickness in a critically loaded area. The reduction in deck thickness ultimately would produce a corresponding reduction in both the bending and shear capacities of the deck. Consequently, the deck had an increased risk for structural damage during any significant impacts.

Figure 170. Deck Attachment E – Shear Channel

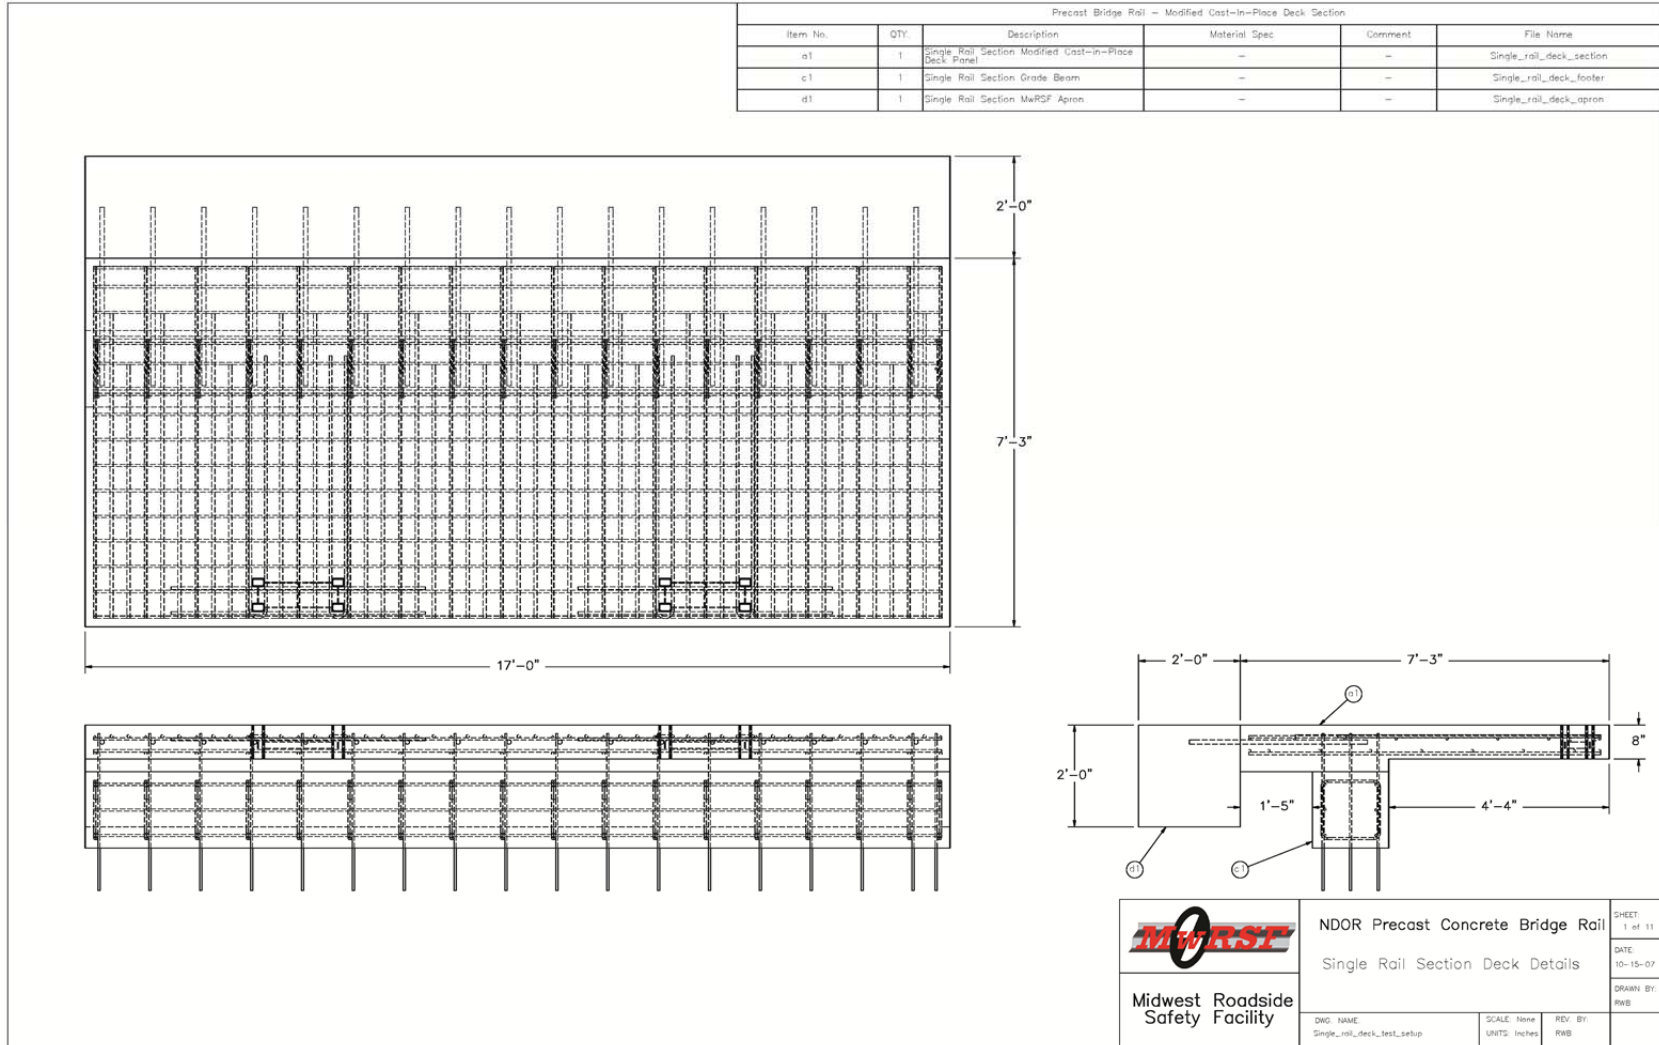
The proposed bridge deck reinforcing steel modification for attachment of the precast bridge rail design described herein was preliminary. Further revision of the design was anticipated following additional component level or full-scale testing of the precast bridge rail when mounted on a simulated bridge deck.

Figure 171. Schematic Details of Modified Bridge Deck Reinforcement

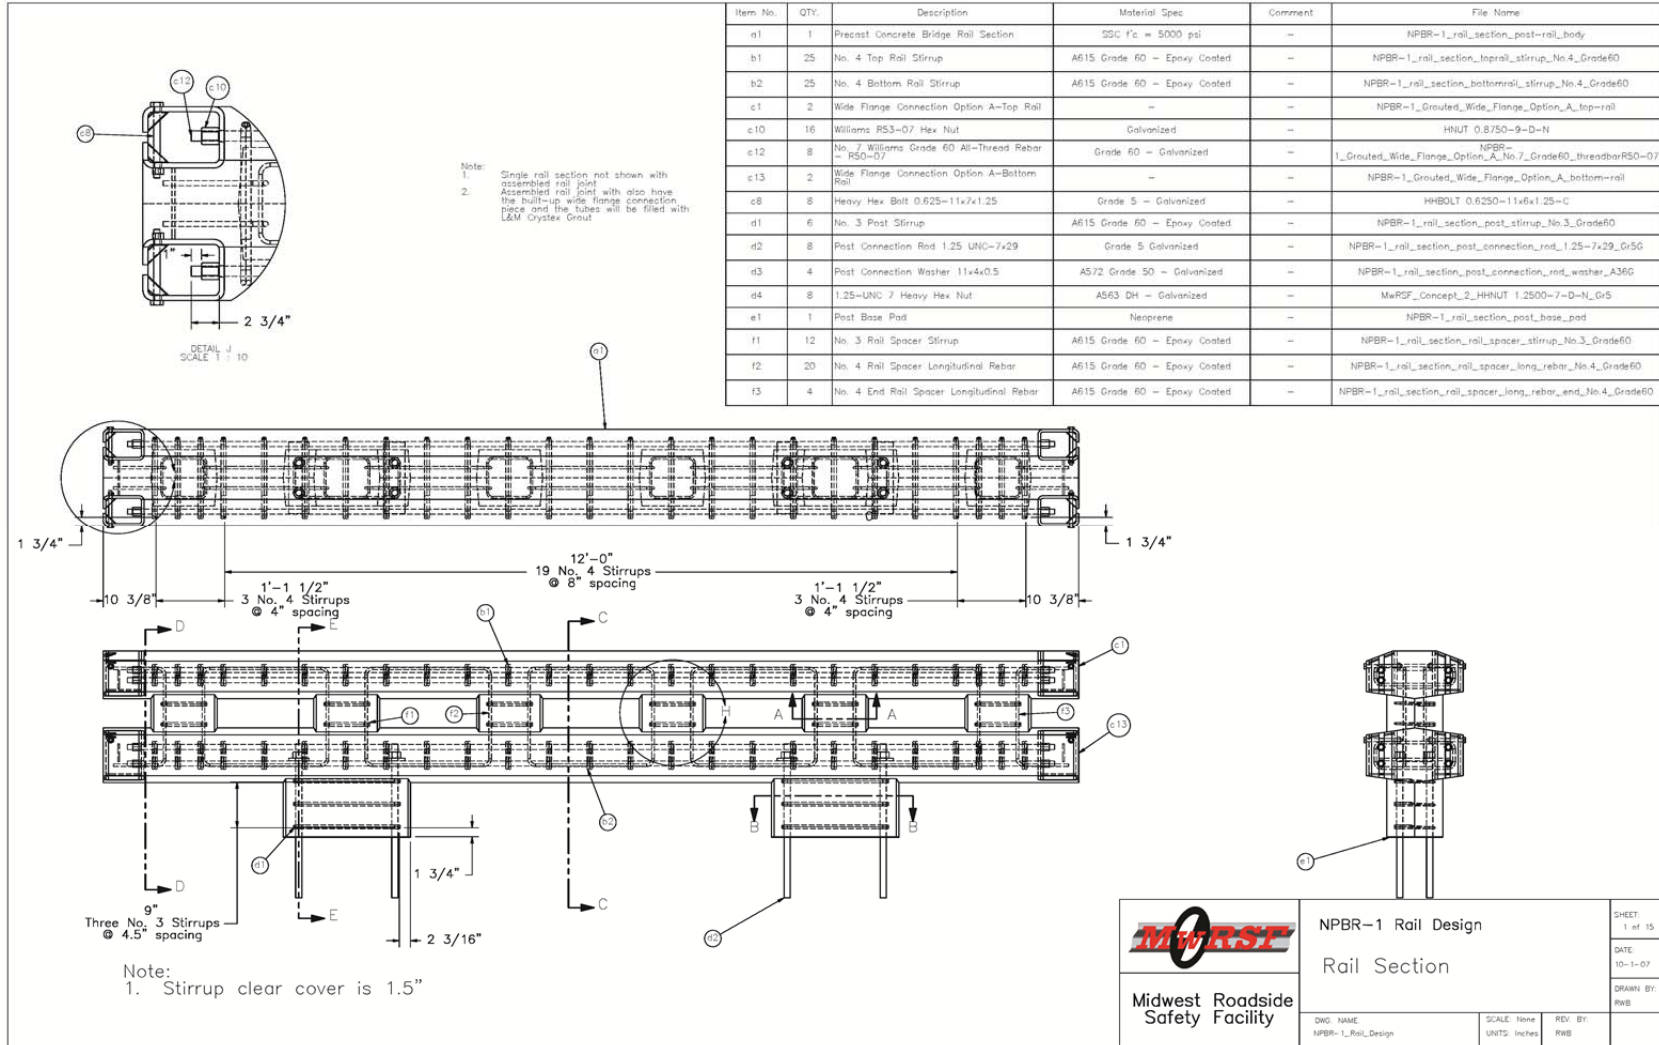
Figure 182. Precast Bridge Rail Segment CAD Details

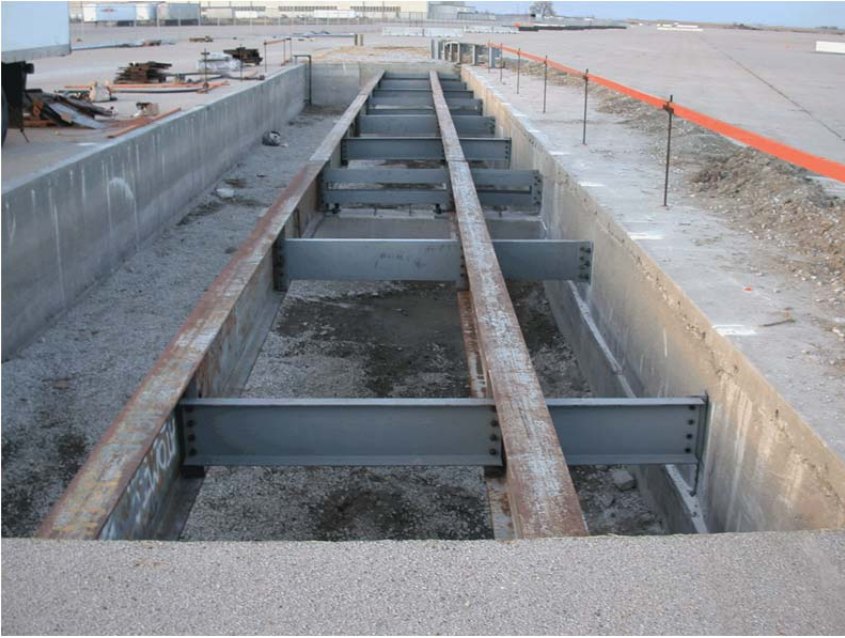
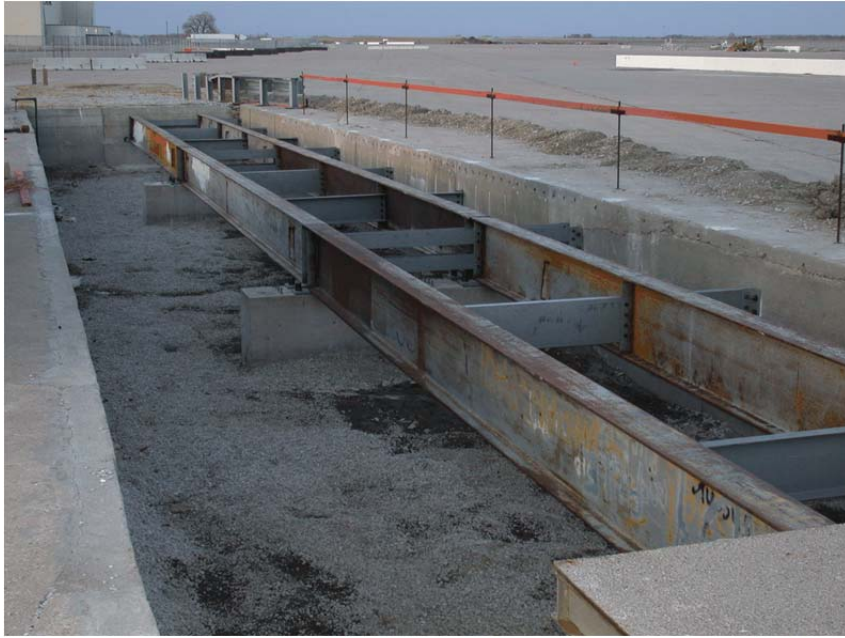
Figure 210. MwRSF Simulated Bridge Test Pit

The system details shown for the precast concrete bridge rail prototype were developed for implementation and installation of the system at the MwRSF test facility. As such, the bridge deck and system length are configured for full-scale crash testing in the MwRSF simulated bridge pit on an existing girder system, as shown in Figure 210. Actual field installation details would vary from what is shown herein.

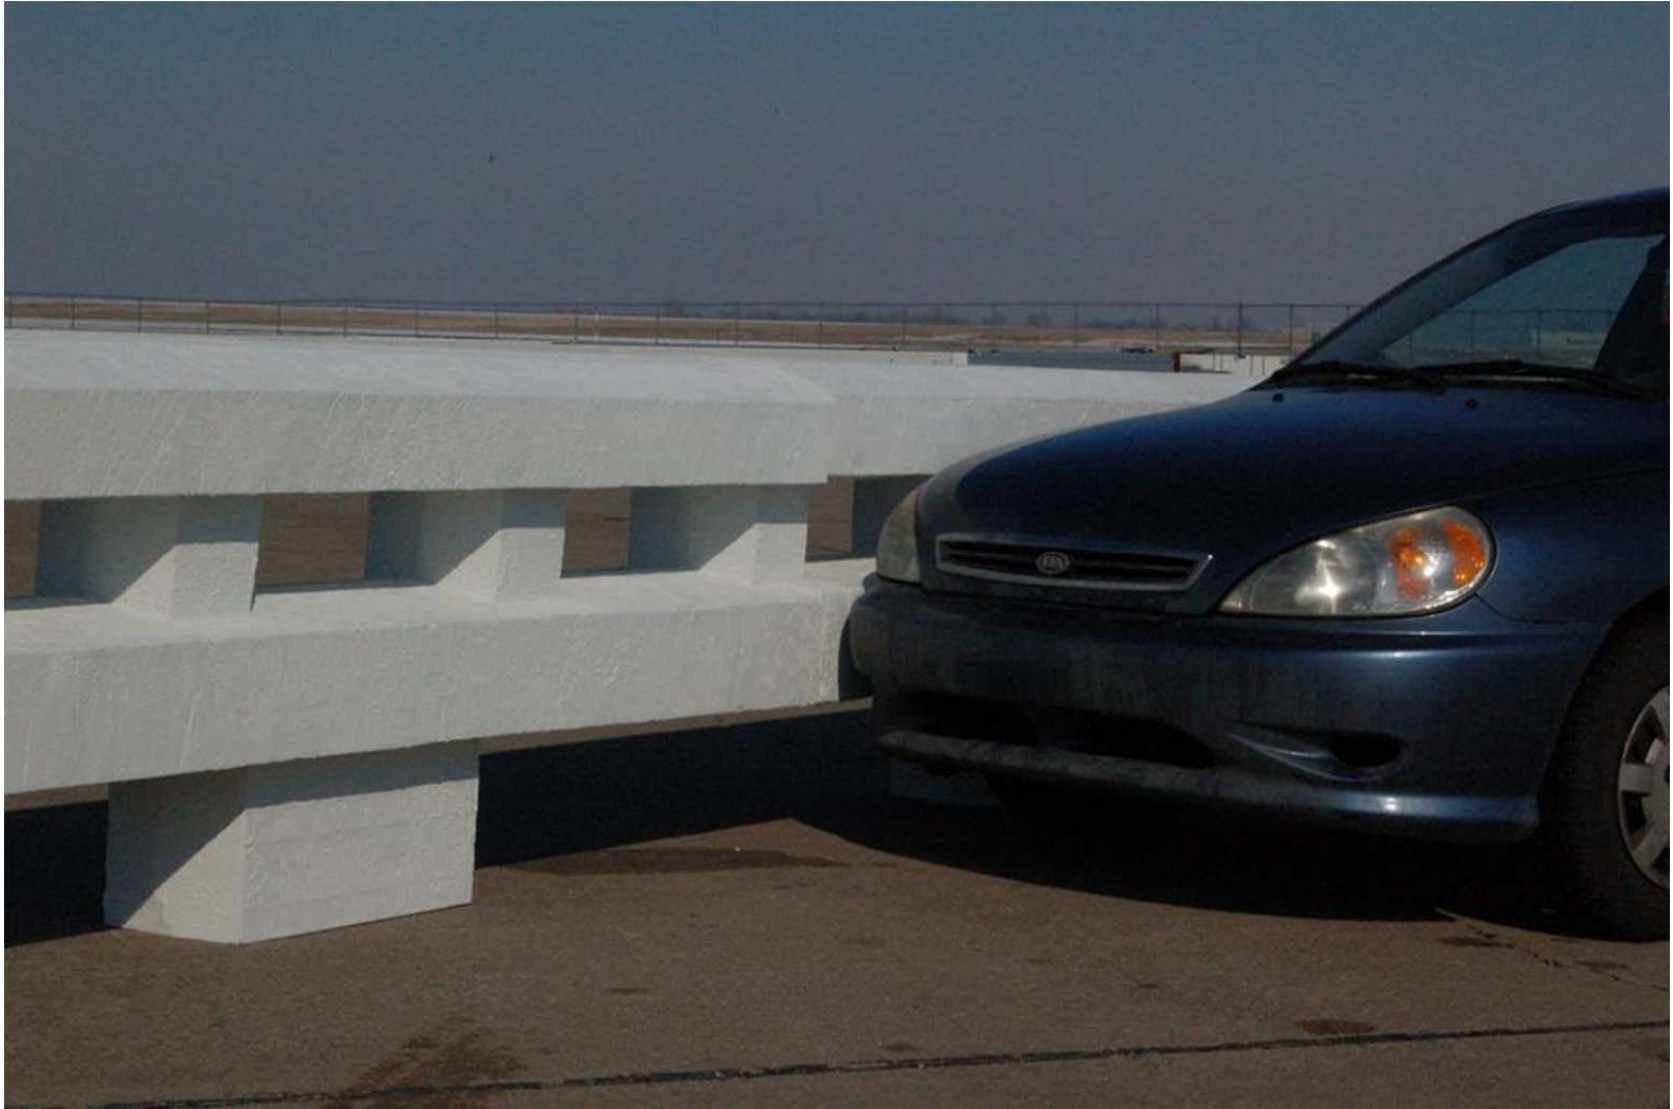
Figure 211. Precast Bridge Rail Foam Model with 1100C Vehicle

Finally, it should be noted that the new, precast bridge rail system was developed with considerations for aesthetic treatments including the shape of the rail itself, additional surface treatments, dyes, and medallions. In order to evaluate the potential aesthetics of the new bridge rail design, a full-scale model of a single rail section was formed from Styrofoam and photographs with various vehicle types to provide a better feel for the actual aesthetics of the design, as shown in Figures 211 through 213. In addition to the full-scale model, renderings were prepared of potential aesthetic treatments for both the open and closed rail sections, shown in Figures 214 through 220. Many of these aesthetic treatments would not be possible without the use of precast concrete construction techniques. These efforts demonstrated the improved aesthetic qualities of the new design as compared to more conventional concrete bridge rails.

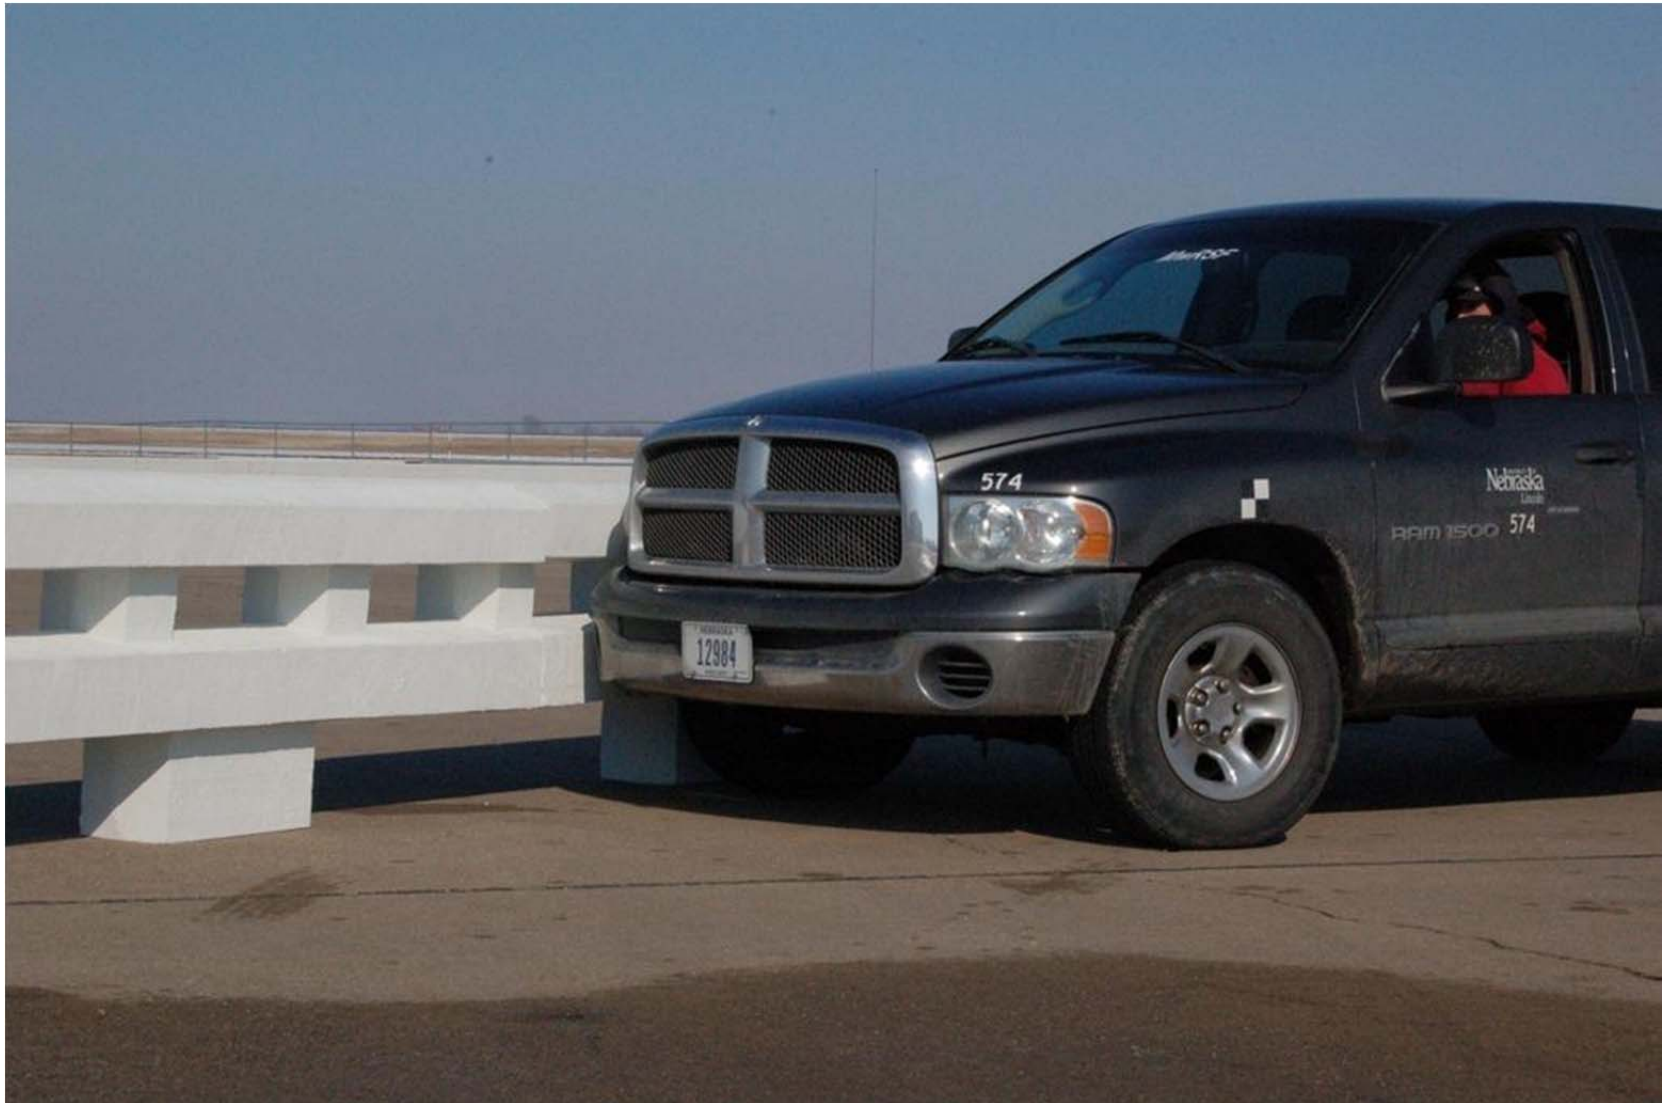
Figure 212. Precast Bridge Rail Foam Model with 2270P Vehicle

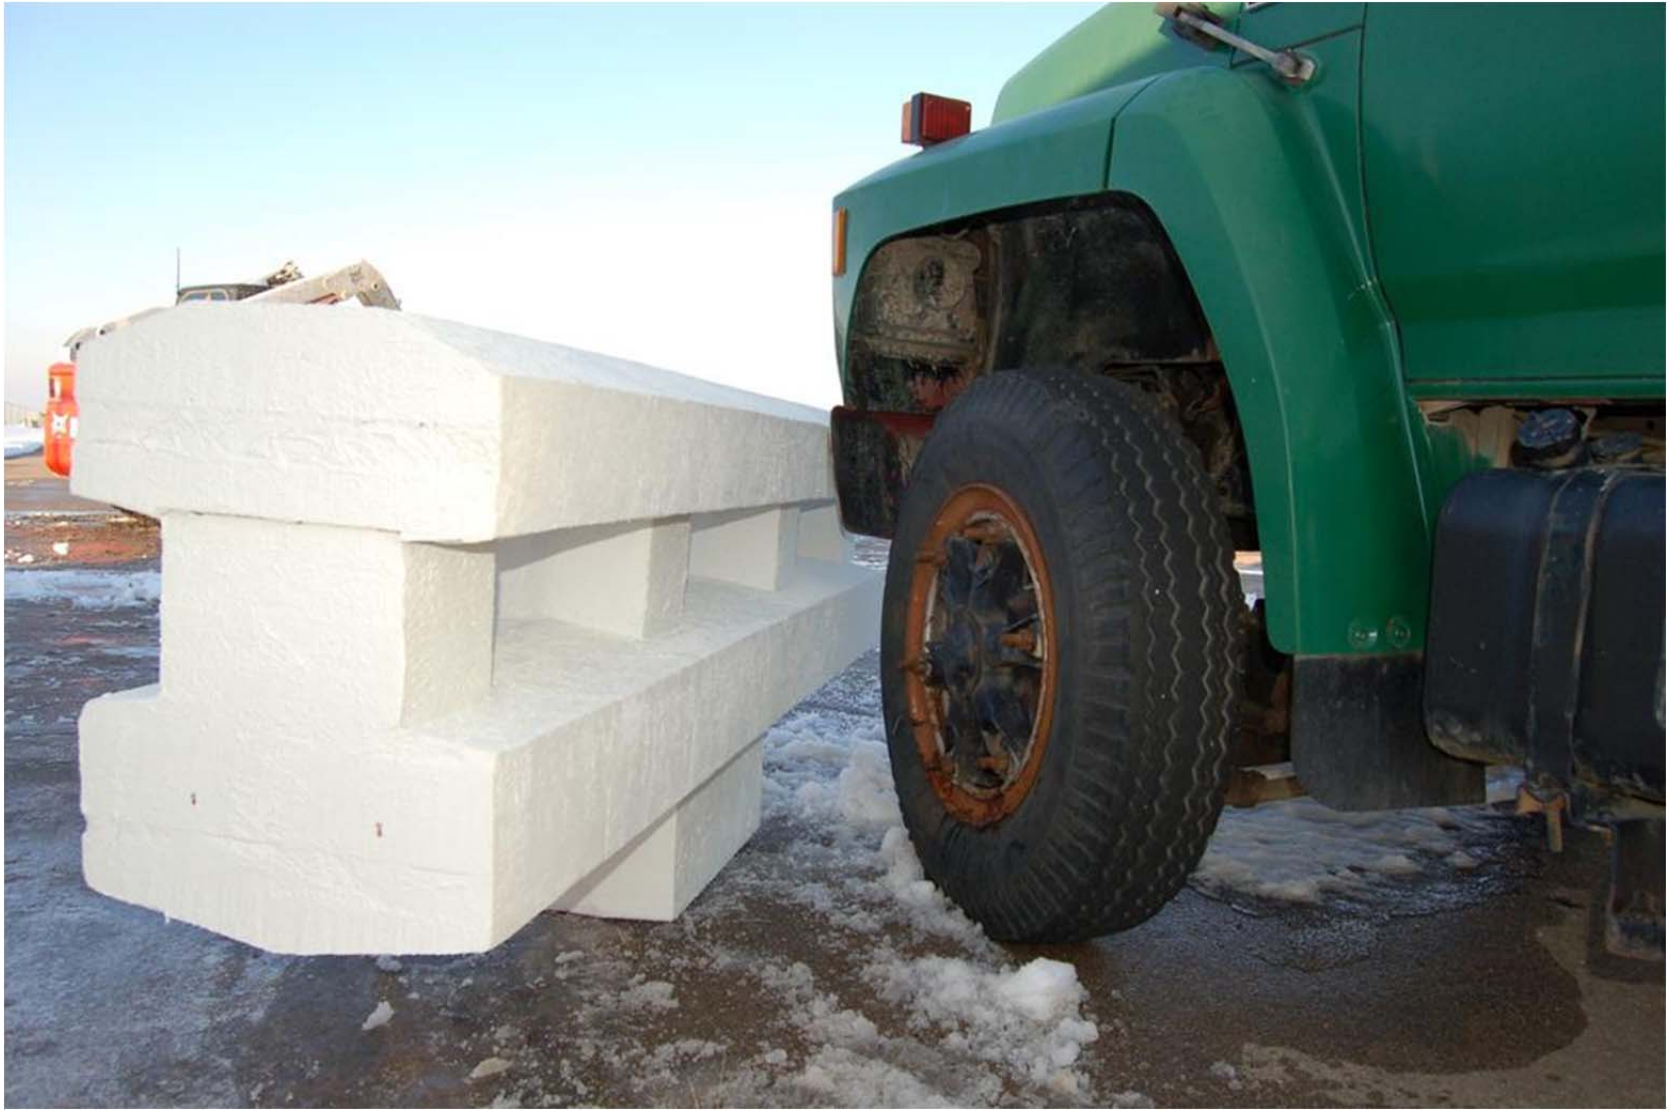
Figure 213. Precast Bridge Rail Foam Model with 10000S Vehicle
