# Formulating a Strategy for Securing High-Speed Rail in the United States

MTI Report 12-03

# FORMULATING A STRATEGY FOR SECURING HIGH-SPEED RAIL IN THE UNITED STATES

March 2013

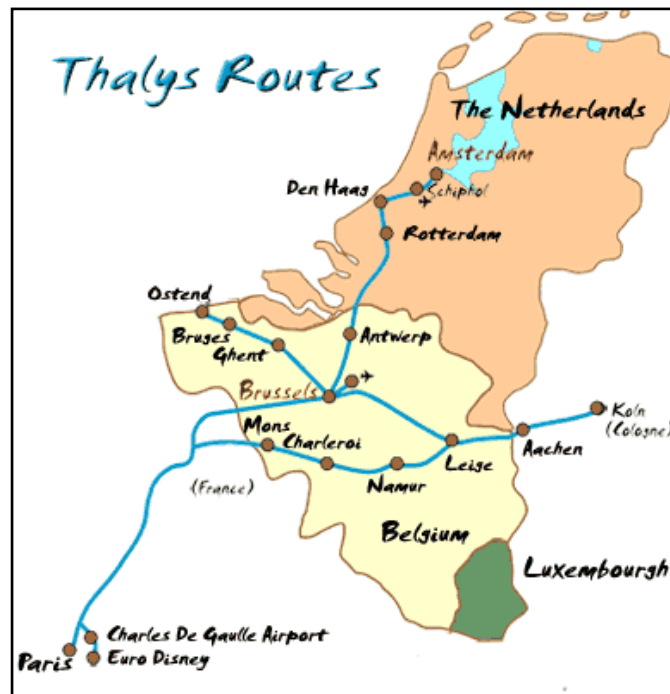
Figure 1. Thalys Route Map

Thalys is a joint service offered by the Belgian, French, and Dutch railways. The system is centered in Brussels, with three primary lines radiating outward (Figure 1). Two of the lines, one to Paris and one to Amsterdam, are also shared by the Eurostar service, and the third extends into Cologne, Germany. A fourth line extends northwest from Brussels to the city of Ostend, on the North Sea. A separate line leaves the Paris-Brussels line near the France-Belgium border, traveling through the cities of Mons, Charleroi, and Namur before joining the Brussels-Cologne line in Liege, essentially providing a southern bypass around Brussels. Service extensions now also include routes to Dusseldorf and Essen from Cologne and a line to Avignon and Marseille, south of Paris. Trains between Paris and Brussels, Brussels and Aachen, and Antwerp and Amsterdam use a variety of dedicated HSR lines. The remaining service runs primarily on conventional tracks.

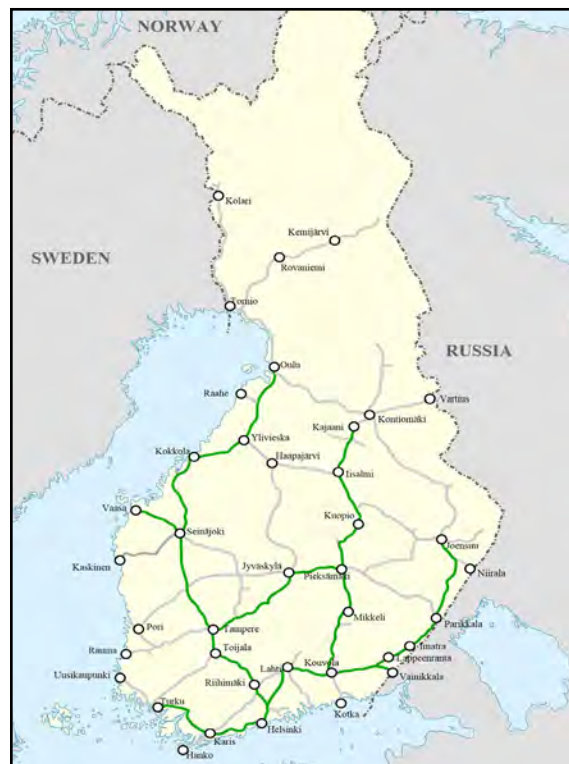
**Figure 2. VR Pendolino Route Map**

The state-owned VR (Figure 2) is responsible for managing the passenger and freight rail services in Finland. In 2010, the railway network infrastructure maintenance and construction functions were divested into the Finnish Transport Agency. Although the term Pendolino is a brand name of Fiat (later, Alstom) for a line or "family" of tilting trains, it is also the service brand used by the VG Group for their high-speed services. The service uses Pendolino (VR Class Sm3) trainsets built by Rautaruukki-Transtech between 2000 and 2006. The trains are capable of 140 mph service, although existing lines have limited their typical operation to less than 120 mph.

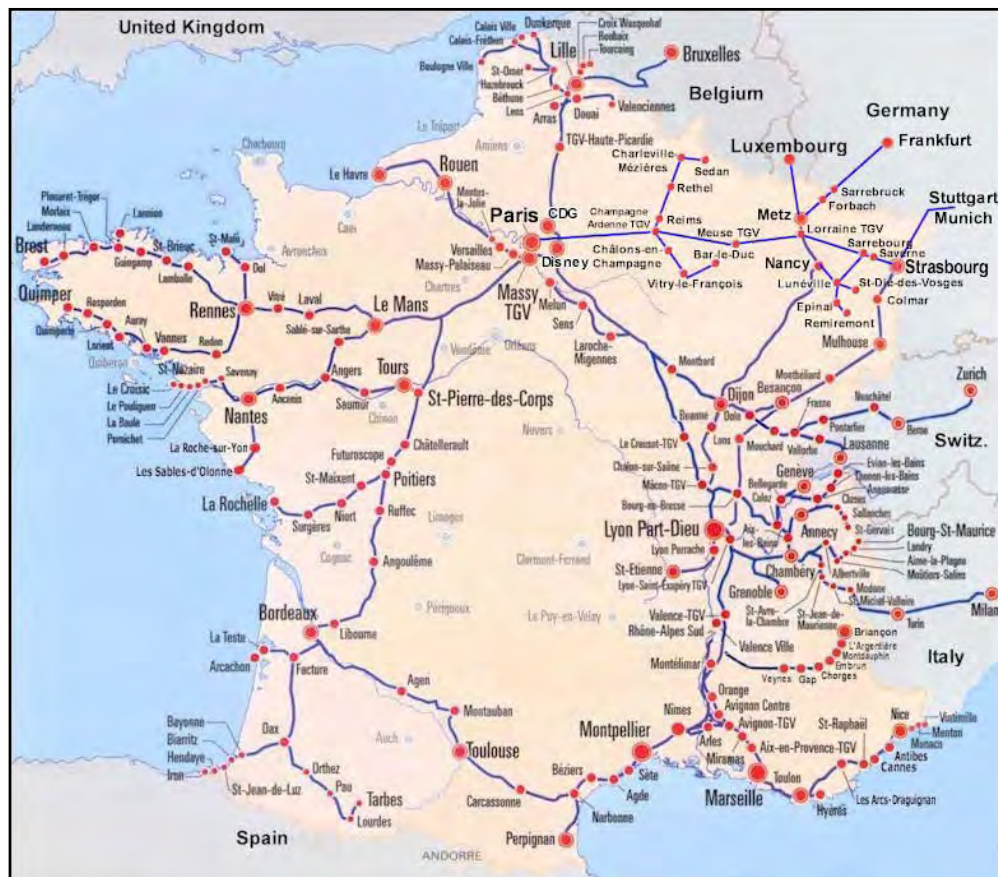
Figure 3. TGV Route Map

TGV runs high-speed trains on two types of lines: LGV and Lines Classiques. LGV lines were designed and built specifically for dedicated use by high-speed trainsets. They have no level road crossings, and they have ROW fences and barriers that significantly reduce or prevent trespassing by vehicles, humans, and animals, all of which can significantly damage and/or derail trainsets and lead to injuries and fatalities.

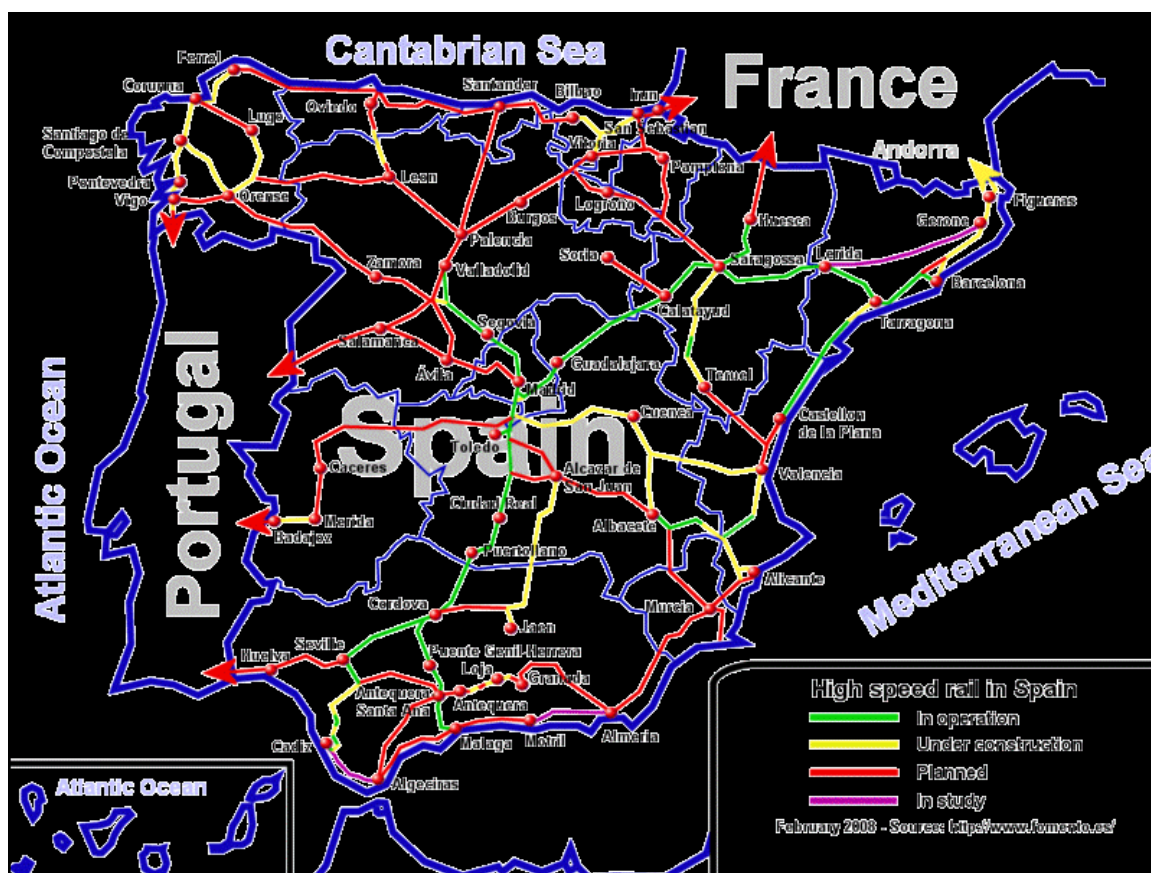
Figure 6. RENFE Route Map

Spain has the second largest network of HSR lines in the world (Figure 6). In 1941, its railways were nationalized, forming Red Nacional de los Ferrocarriles Españoles (RENFE). Since 2005, when an EU directive mandated the separation of track ownership from operations, the country's rail infrastructure has been under Administrador de Infraestructuras Ferroviarias (ADIF), which is responsible for the management, maintenance, and construction functions associated with RENFE, including high-speed-passenger and conventional, mixed-use lines.

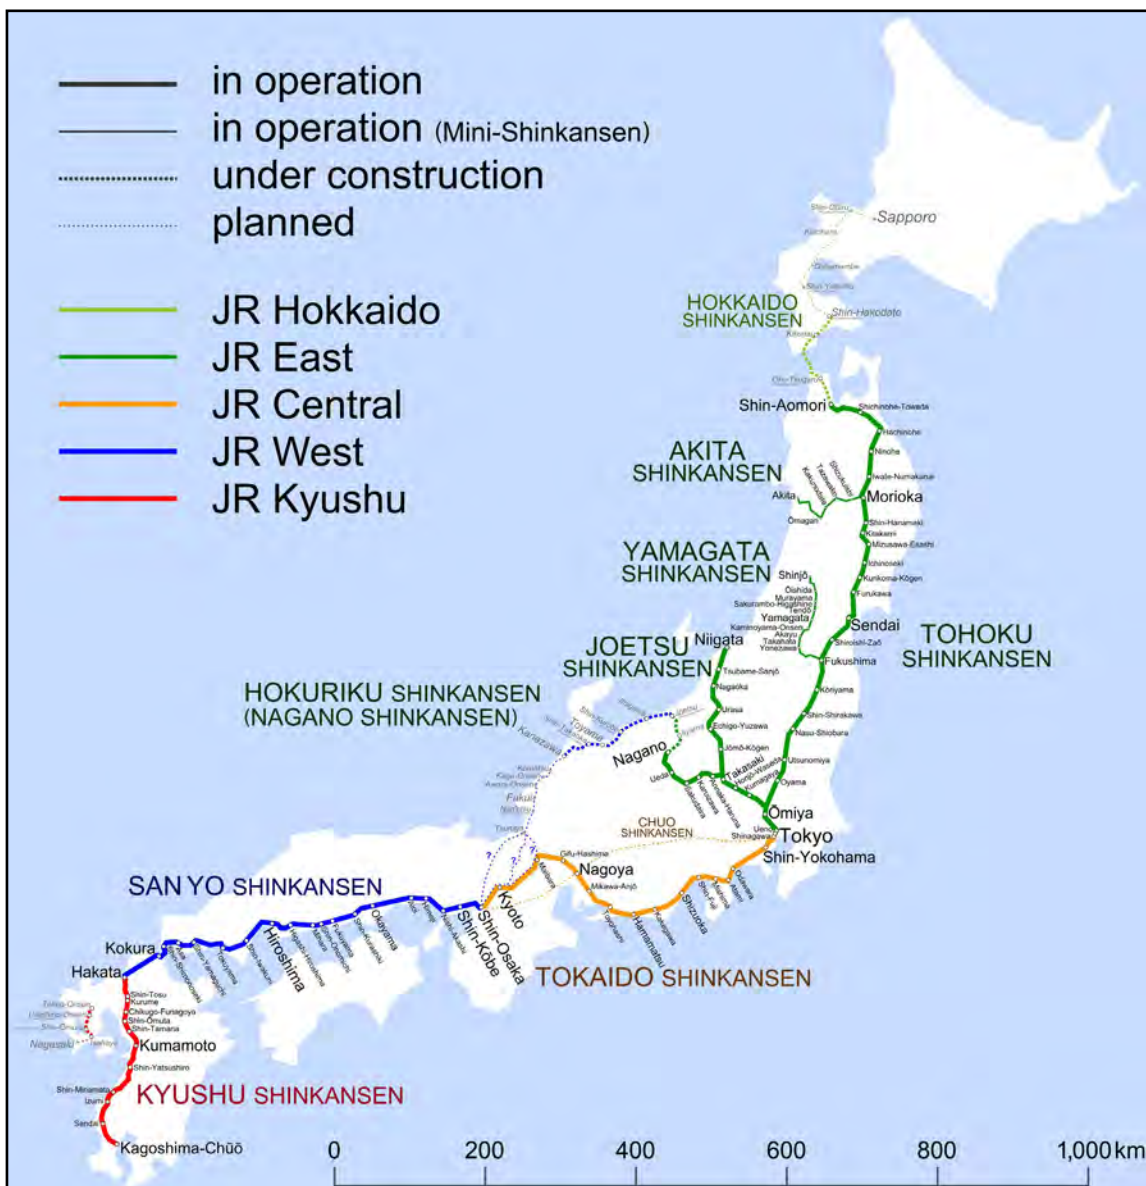
Figure 10. Shinkansen Route Map

Today, the Shinkansen network includes more than 1,600 route miles (Figure 10) and operates approximately 900 trains per day at speeds between 150 and 190 mph. It is owned and operated by five private companies of the JR Group: JR Kyushu, JR West, JR Central, JR Hokkaido, and the largest, by far, in terms of system size and passenger volume, JR East. These companies utilize 20 different styles and configurations of overhead electrically powered trainsets with power cars at each end. Capacities per trainset range from approximately 380 passengers on six- and seven-car sets to 1,200 passengers on 12-car bilevel trainsets and more than 1,300 on 16-car sets.

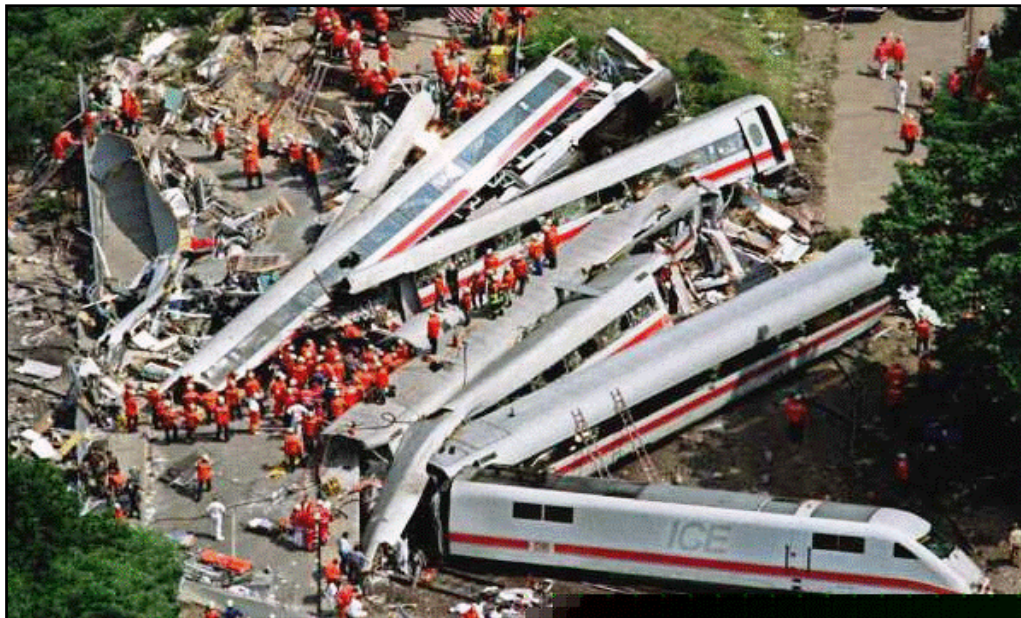
**Figure 13. The Eschede Incident Scene**

The lead power car stayed on the rails and came to a stop two miles down the line from the accident site. The first three coaches derailed but remained upright and came to a stop about 100 feet beyond the bridge. Coach four was moving fast enough to go under and clear the bridge before it collapsed. Car four was separated from the first three, derailed, and rolled over into trees along the ROW. Adding to the tragedy of the accident, two DB employees working along the ROW were crushed and killed by the car as it rolled over.

The fifth coach was actually severed by the collapsed bridge. The front half traveled about 300 feet past the bridge, while the rear half was crushed under the weight of the overpass. Car six was directly under the bridge at the time of the collapse and was completely flattened. Cars seven through 11 were all destroyed under or up against the remains of the bridge. The twelfth and final car of the train did not impact the bridge but was partially crushed by the rear power car, which, itself, received minimal damage. The train had a capacity of 743 passengers but was carrying only 287 at the time of the accident. The aftermath of the incident is shown in Figure 13.

A week after the incident, the final death toll reached 101, including the two DB employees who were working along the ROW. Eighty-eight passengers and crew were also injured in

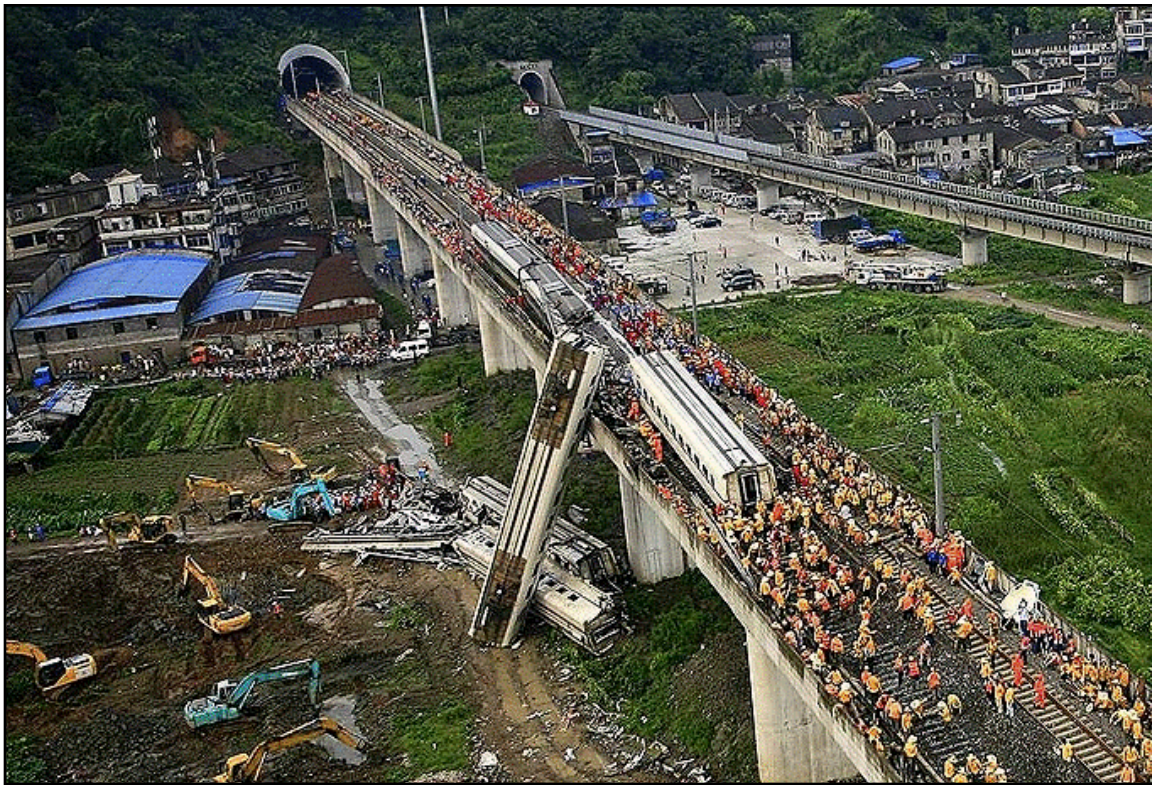
**Figure 14. The Aftermath of the Wenzhou Collision**

After seven minutes of trying to override the ATP system, the lead-train engineer was able to restart his train. Unfortunately, the train behind it had a green signal, so it was never directed to switch to visual running procedure and went past the signal at normal operating speed. Shortly after exiting a tunnel, the trailing train quickly came upon the lead train, which was just starting to move, and slammed into the rear end of it at 62 mph.

The last car of the lead train (a coach car with an engineer's cab) and the next three cars derailed and were knocked off the viaduct by the collision. Three of the cars fell 50 feet to the ground below, and one car ended up vertically—one end was on the ground and the other was leaning against the top of the viaduct. The lead coach/engineer's-cab car and the first car of the other train also derailed but remained on the viaduct. The first car was demolished by the impact, and the second car rode up on top of it. Although unconfirmed, it is speculated that most of the deceased were in the lead train cars that fell off the viaduct and the first car of the trailing train. Neither trainset design used articulated cars/bogies, but except for the six cars that derailed, the remainder of both trains stayed upright and linear with the track, the vast majority staying on the track. The aftermath of the collision is shown in Figure 14.

The lack of credible information regarding the incident or the post-incident response and investigations makes it difficult to identify lessons learned. The apparent cause seems to have been a poorly designed and/or inadequately tested and evaluated signal- and train control system that failed and did not communicate the presence of a train within a block to other trains in the area. In addition, similar to the ICE Eschede disaster, the severity of the incident was exacerbated by the environment in which the equipment failure occurred. The greatest number of fatalities and the most injuries and damage were caused by the car falling off the viaduct.

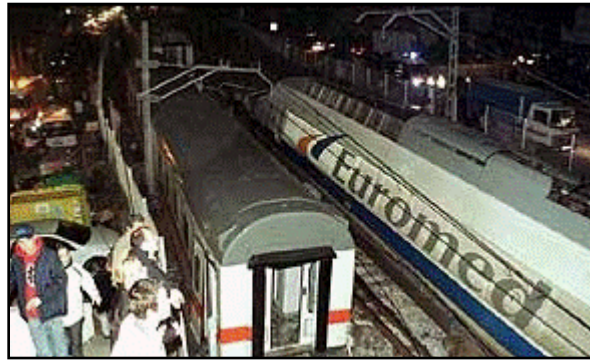
**Figure 15. RENFE Collision in Torredembarra**

The only significant incident on RENFE's entire HSR network occurred in March 2002 in Torredembarra, about 50 miles southeast of Barcelona. A Euromed train traveling at about 65 mph through the station to Barcelona collided with a commuter train. The commuter train had left the platform and was crossing over onto another track when it was struck by the Euromed traveling in the same direction. The commuter train was carrying approximately 350 passengers, and 290 were on the Euromed train. Two people were killed in the collision; which trains they were on is unclear. In addition, 142 people were injured, some of them seriously. Many were trapped in the wreckage, requiring extensive extrication efforts by the local emergency services. While there are no available data on how many injuries occurred on each train, eyewitness accounts referenced in several media stories stated that the majority were on the Euromed train. The aftermath of the incident is shown in Figure 15.
