Final Report

March 2013

END REGION DETAILING OF PRETENSIONED CONCRETE BRIDGE GIRDERS

Sponsor:
Florida Department of Transportation (FDOT)
Sam Fallaha, P.E. – Project Manager

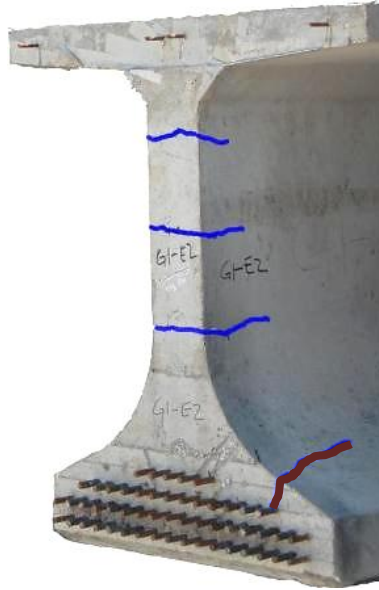
Figure 23–Web splitting (blue) and flange splitting (brown) cracks

Top flange cracks formed due to flexural stresses generated by the vertically eccentric prestressing. Top flange cracks are outside the scope of the FIB-54 test program. Web splitting (Figure 23) cracks also formed due to eccentric prestressing. As the prestress force was distributed from the bottom flange to the rest of the cross-section, the attendant vertical tension stresses caused cracks in the web. Flange splitting cracks were of primary interest in the FIB-54 test program. Flange splitting cracks were caused by horizontal eccentricity of prestressing, Hoyer expansion of strands, and self-weight reaction of the girders.

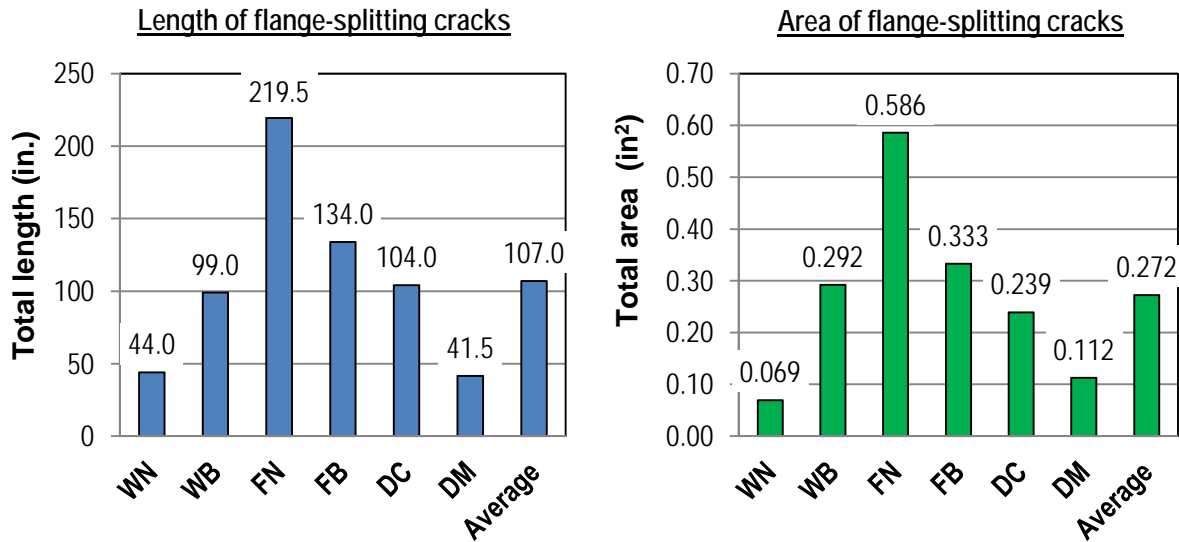
Figure 25–Flange splitting cracks girders W, F, and D

Each of the specimens listed in Figure 25 had the same Class of concrete, were fabricated at the same time, and were fabricated using the same procedures. Strand patterns, bearing plates, and confinement reinforcement varied among specimens. The most severe cracking, in terms of total length and area, occurred in specimens FB and FN. Severity of cracking in these specimens is attributed to the strand pattern. All of the fully bonded prestressing strands in these specimens were located in the outer portion of the flange. As discussed in the previous section, prestressing located in the outer portions of the flange caused transverse tension in the bottom flange. This transverse tension is culpable in the cracks observed in specimens FB and FN.

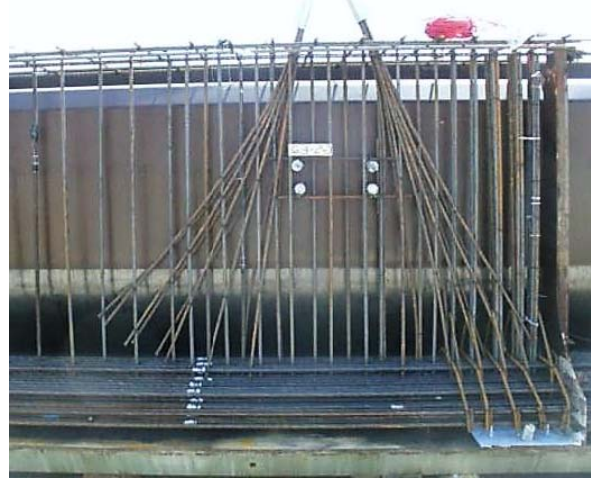
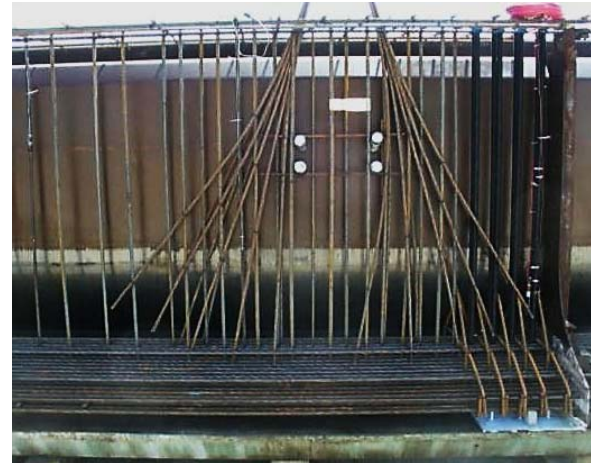
Figure 33–FIB-63 test specimens during construction

FIB-63 specimens were built at the same time as the phase 2 specimens from the FIB-54 test program. They were built by Standard Concrete Products of Tampa, FL. Photos of the test specimens during construction are shown in Figure 33

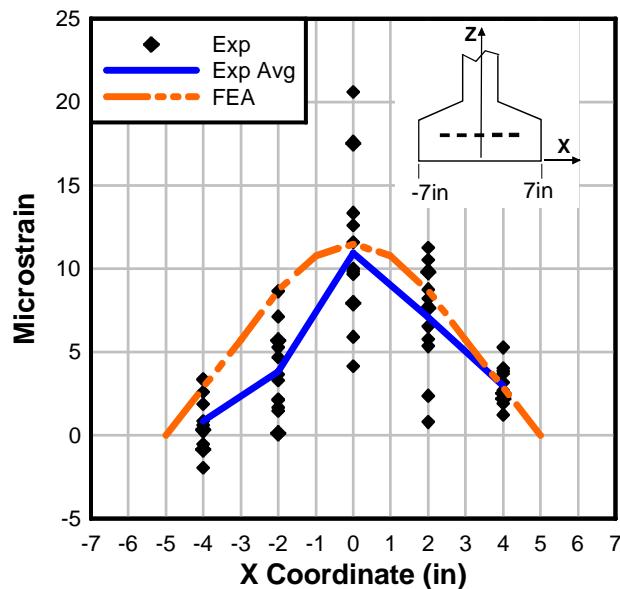
Figure 49–Small beam transverse (x-x) strain profile ($V = 15$ kip)

The FE model was validated using data from the small beam test program. Partial results from the validation study are shown in Figure 49, which compares experimental strain data (black diamonds) with the strain calculated using the FE model. As shown in the figure, the FE model was in good agreement with the experimental data. A mesh convergence study was also conducted to verify the adequacy of the mesh density. Based on the convergence study, a mesh density of 1 in. was deemed adequate for modeling specimens from the small beam test program.
