# **COST-EFFECTIVE TREATMENT OF EXISTING GUARDRAIL SYSTEMS**

## **MIDWEST ROADSIDE SAFETY FACILITY**

MwRSF Research Report No. TRP-03-254-13

May 5, 2013

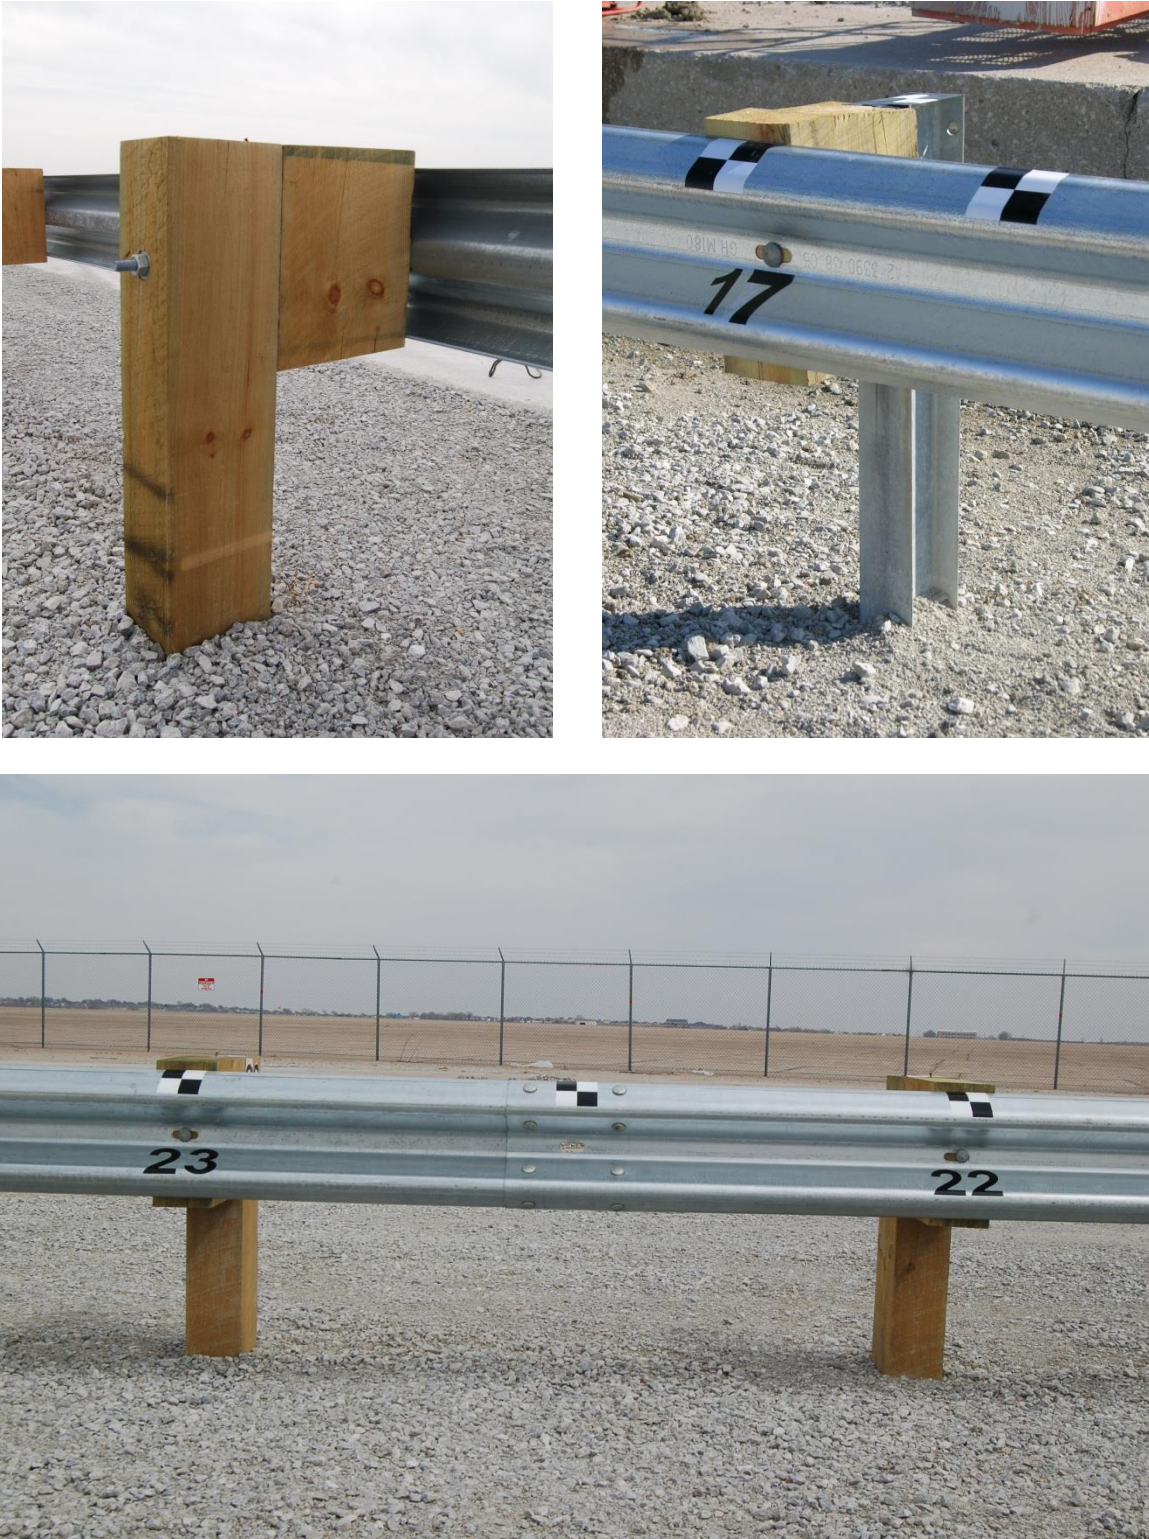
Figure 1. Midwest Guardrail System (MGS)

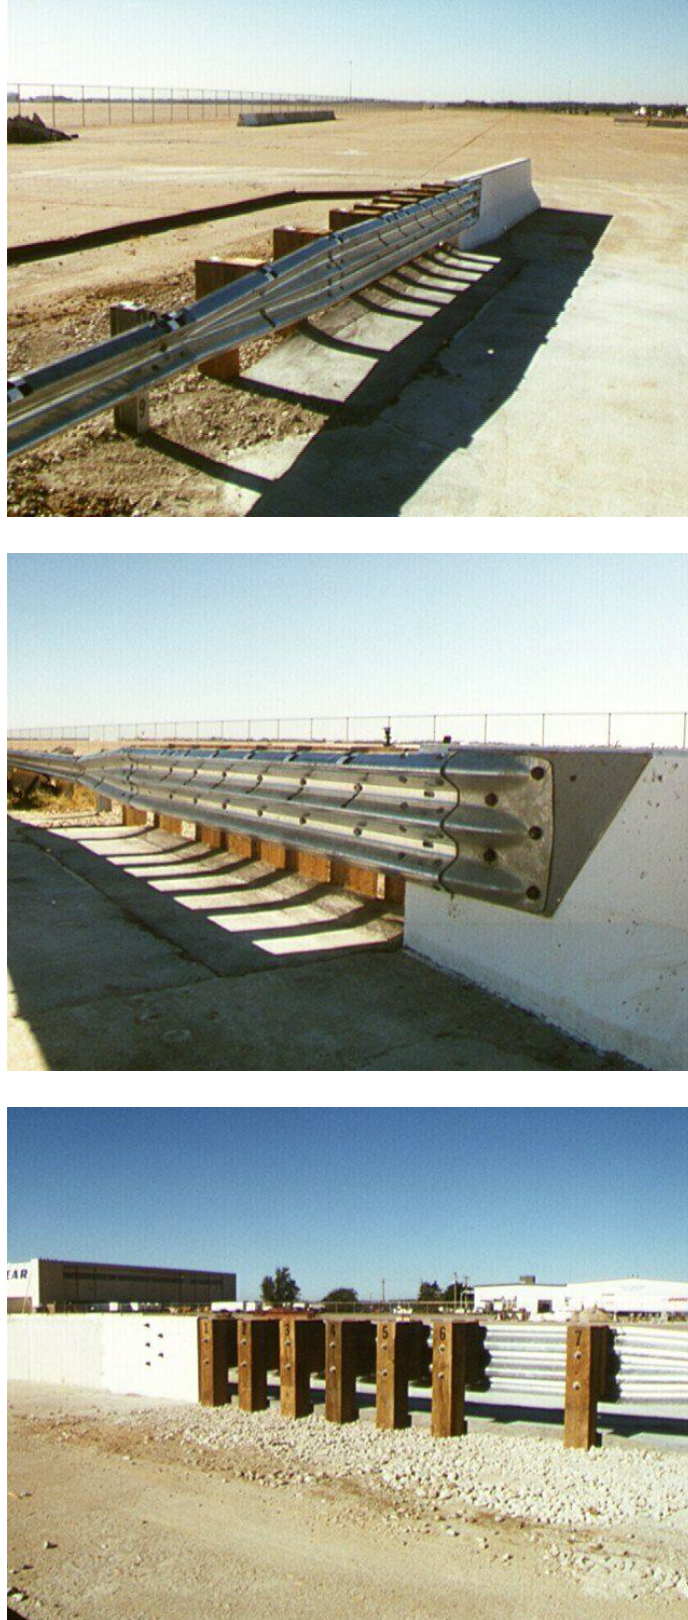
bridge rail is vehicle pocketing, where an errant vehicle deflects the semi-rigid W-beam far enough that the vehicle impacts the end of the rigid bridge rail, posing significant risk to the motorist. To mitigate this risk, the guardrail system is stiffened over a transition length. The particular stiffness of the guardrail is achieved by a combination of the following options: reducing post spacing; installing larger posts; mounting a thicker rail element; adding a nested three beam rail element to the transition; and creating a strong connection between the W-beam to the bridge rail element. To reduce the likelihood of wheel snagging on the end of the parapet, some transitions utilize a rubrail or curb. An example of a generic guardrail-to-concrete barrier transition that meets all NCHRP Report No. 350 criteria is shown in Figure 2 [41-42].

Figure 2. Generic W-Beam-to-Thrie Beam-to-Concrete Bridge Rail Transition

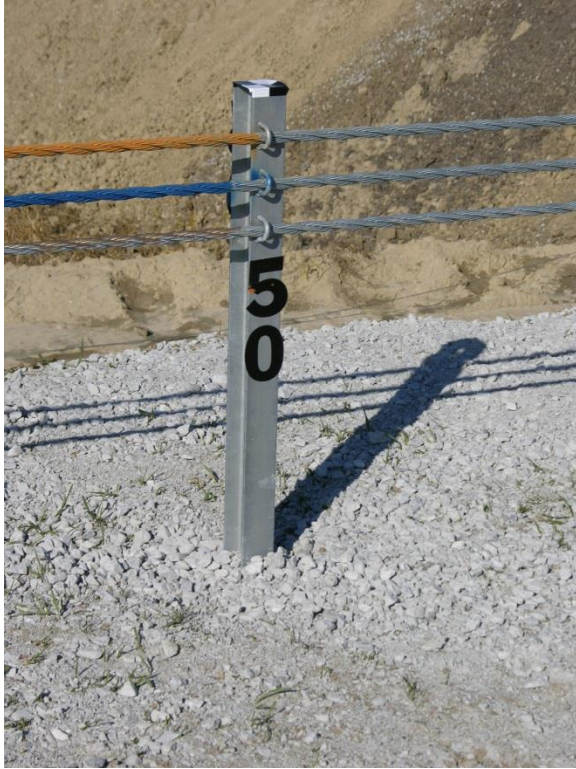
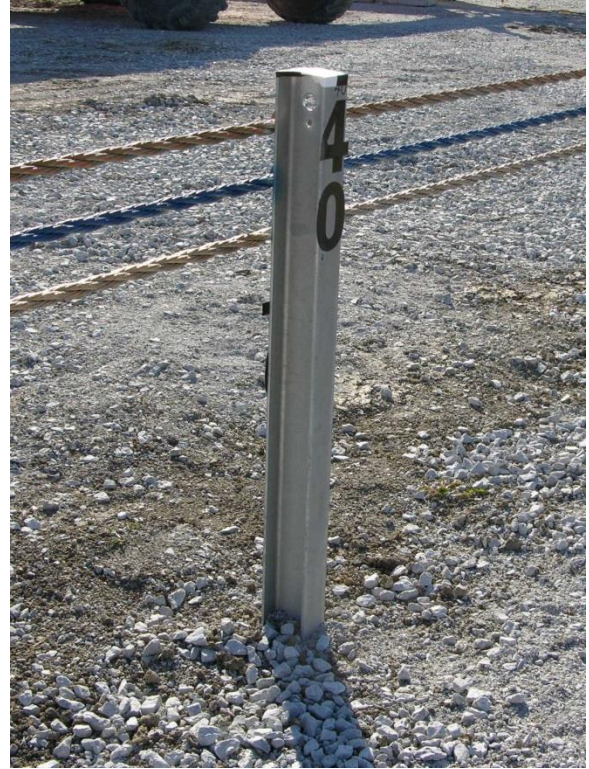
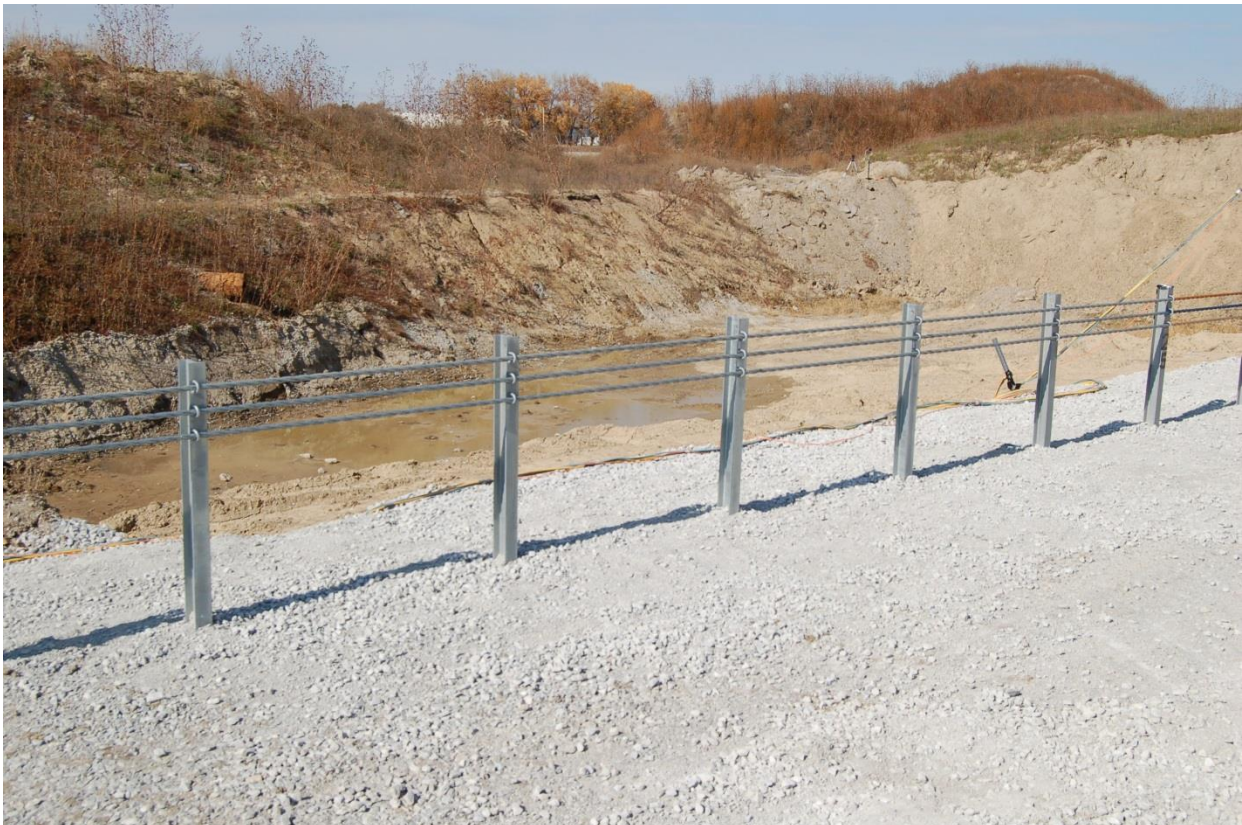
vehicle with less deflection and decreased maintenance. High-tension cable barrier systems are tensioned between 3 kips and 8 kips (13.4 kN and 35.6 kN). The cable-to-post connections for each system typically utilize a steel clip or rounded U-bolt. These connections are designed to release the cables from the posts to prevent development of localized stresses on the posts. A generic cable barrier system is an example of a low-tension, 3-cable median barrier [43] and is shown in Figure 3

Figure 3. Generic Three-Cable Low-Tension Barrier

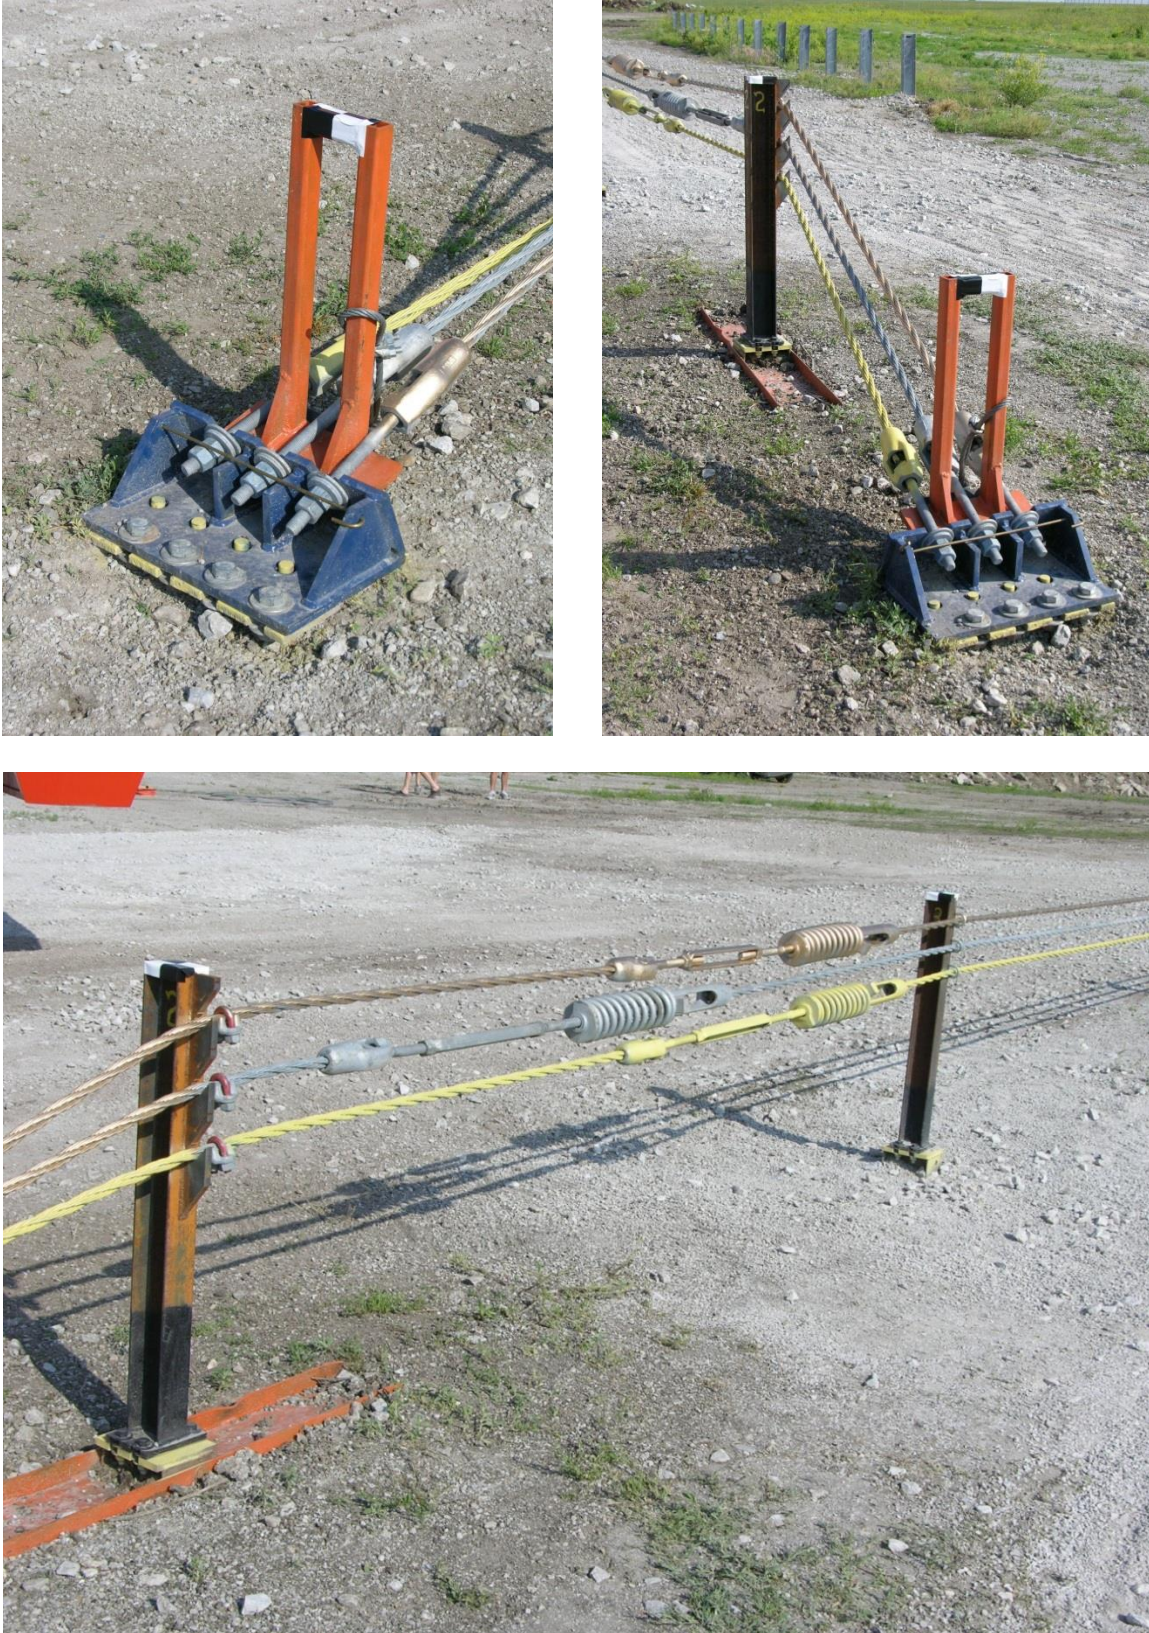
Figure 4. Generic Low-Tension Cable End Terminal

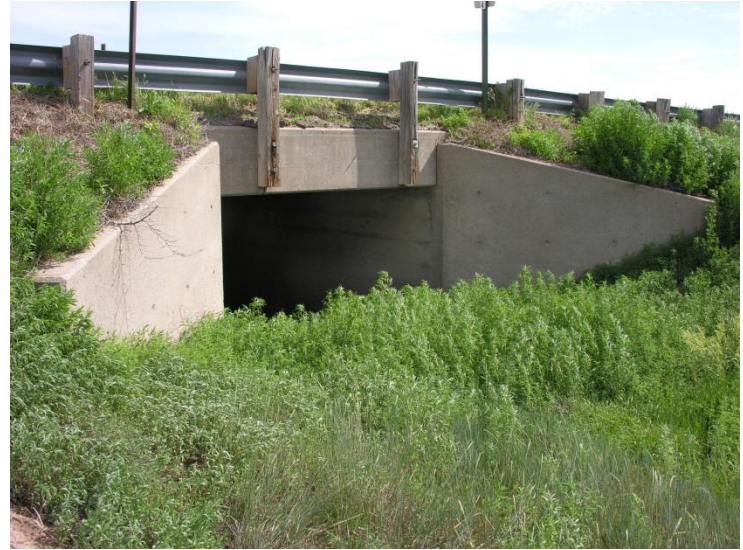
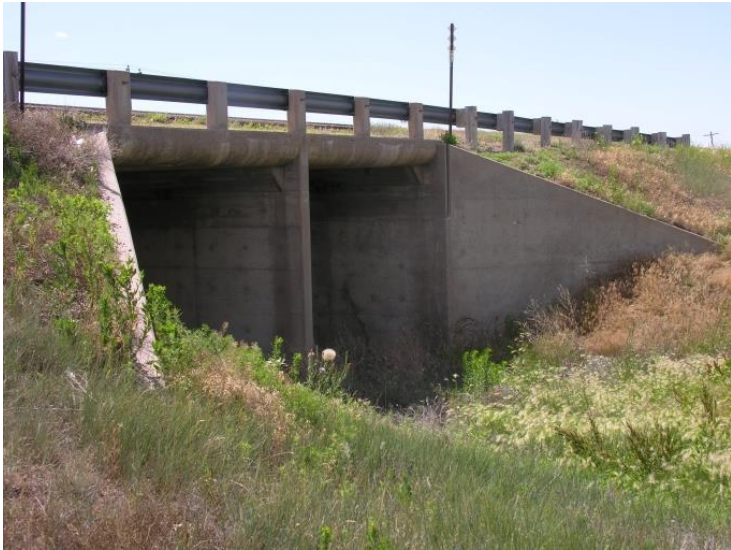
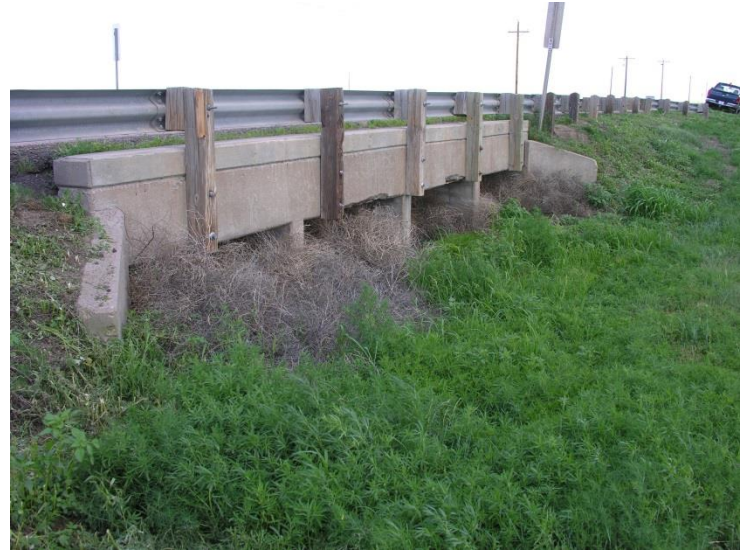
Figure 5. Examples of Shielded Culvert Systems

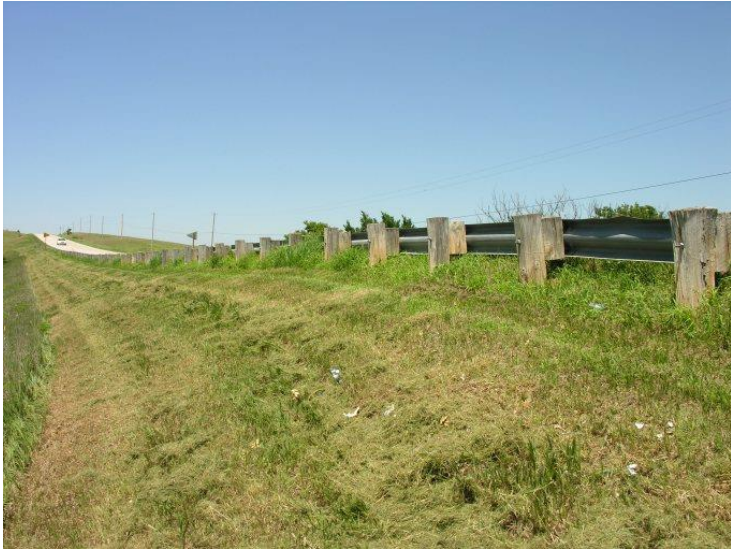
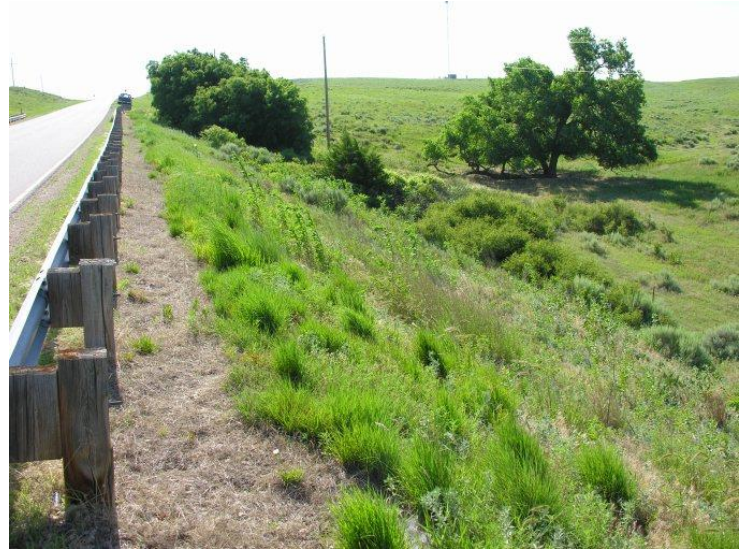
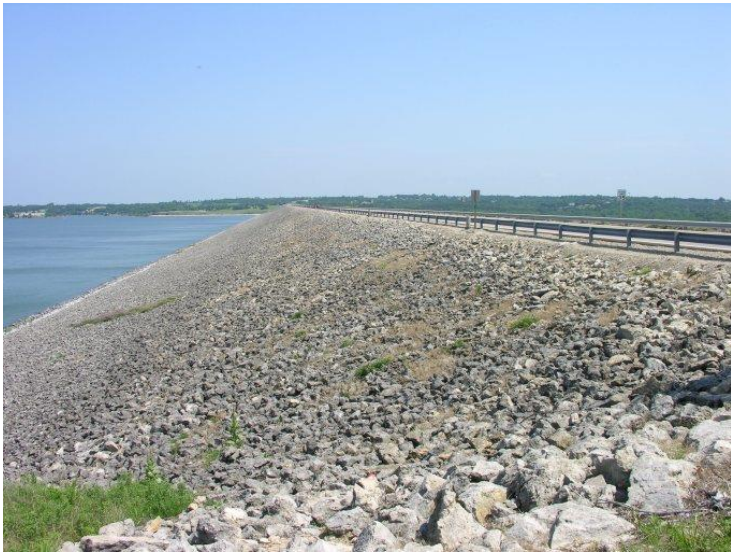
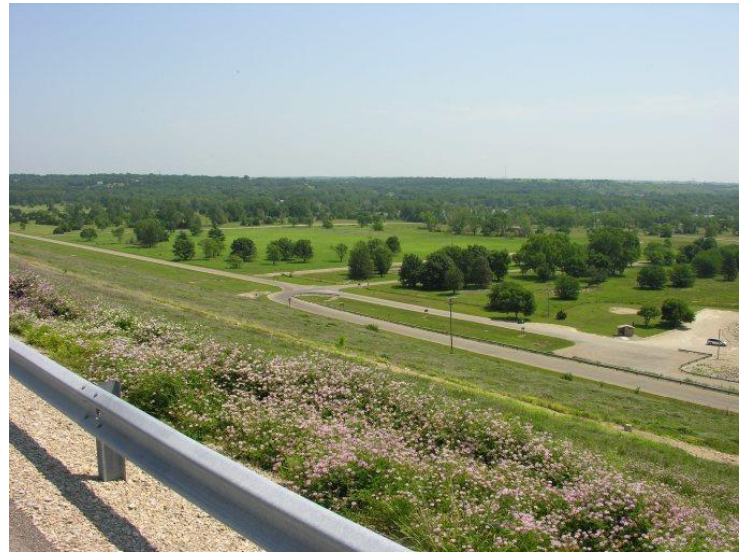
The roadside slopes that were documented in the field investigation varied in length, width, slope rate, drop height, and lateral offset away from the roadway. The length of the slope varied between 30 ft and 10,560 ft (9.1 m and 3,219 m). All slopes had a width greater than 30 ft (9.1 ft). The cross slope adjacent to the W-beam guardrail systems generally ranged between 5:1 and 1.5:1. The overall drop height of the slope varied between 7 ft and 15 ft (2 m and 4.6 m). The lateral offset from the face of the W-beam guardrail system to the slope break point ranged from 0 ft to 5 ft (0 m to 1.5 m). The cross slopes that were documented at existing W-beam guardrail systems are shown in Table 4. Examples of the documented roadside slopes are shown in Figure 6.

Figure 6. Examples of Shielded Roadside Slopes

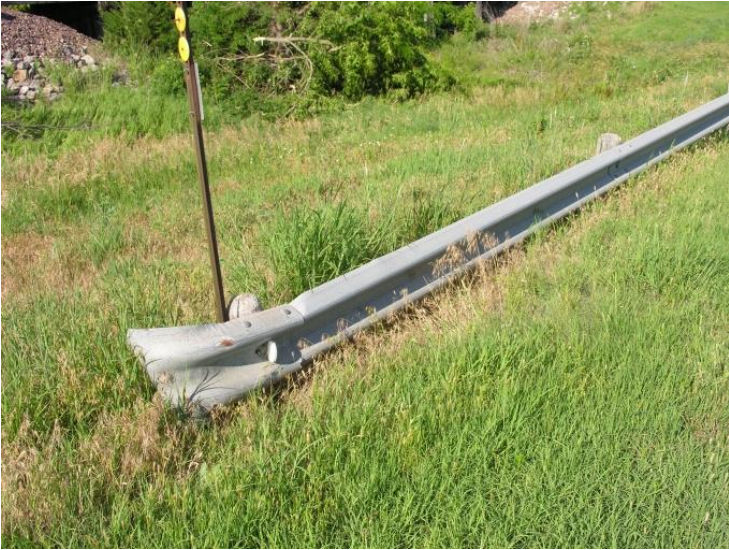
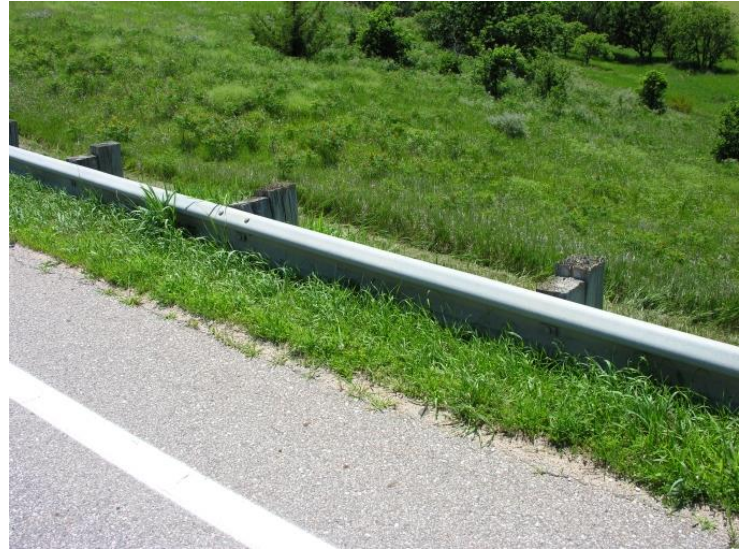
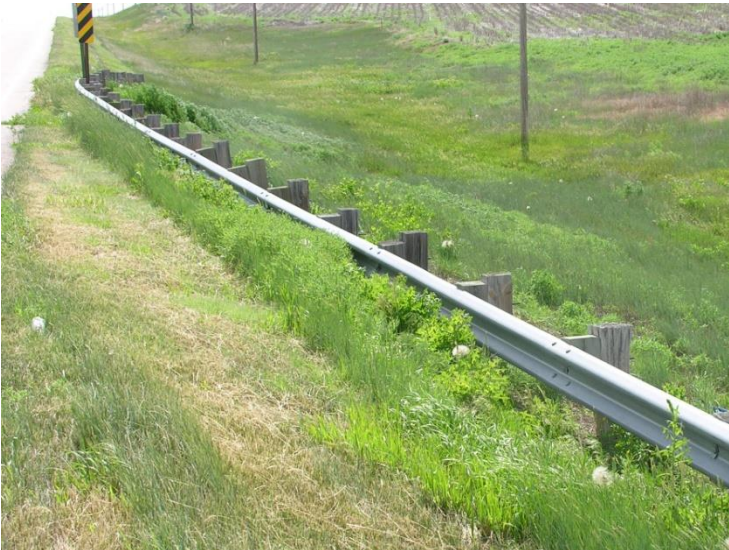
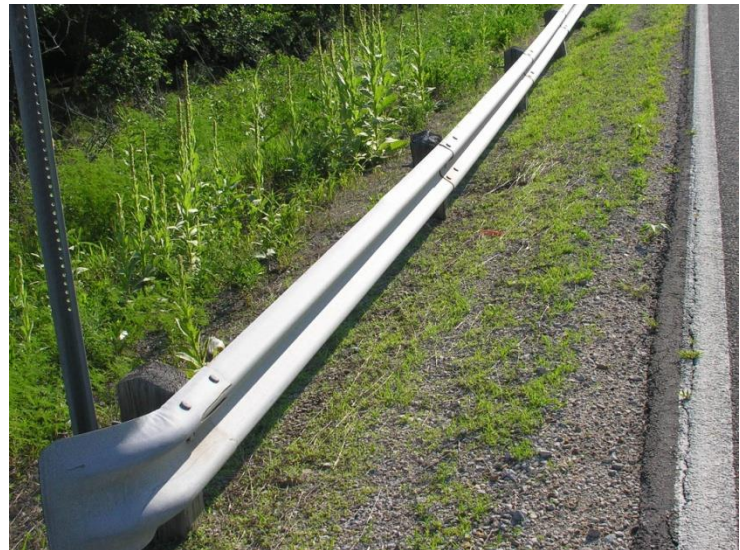
Figure 15. Examples of Low Heights for Existing W-beam Guardrail Systems

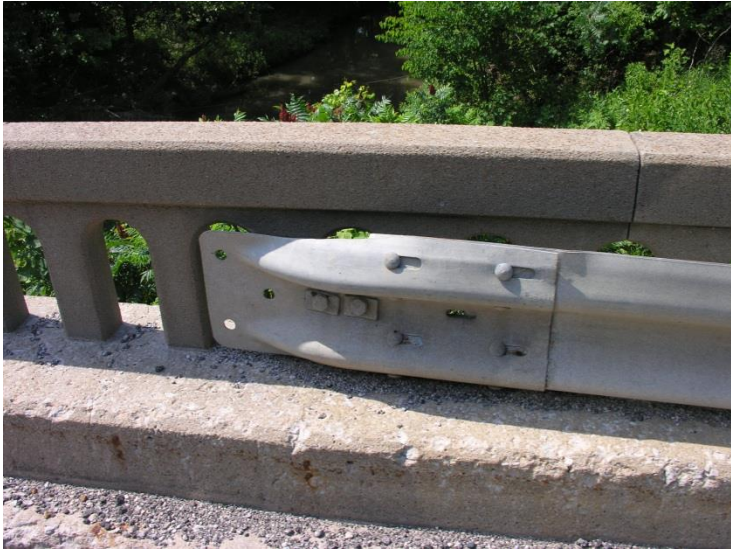
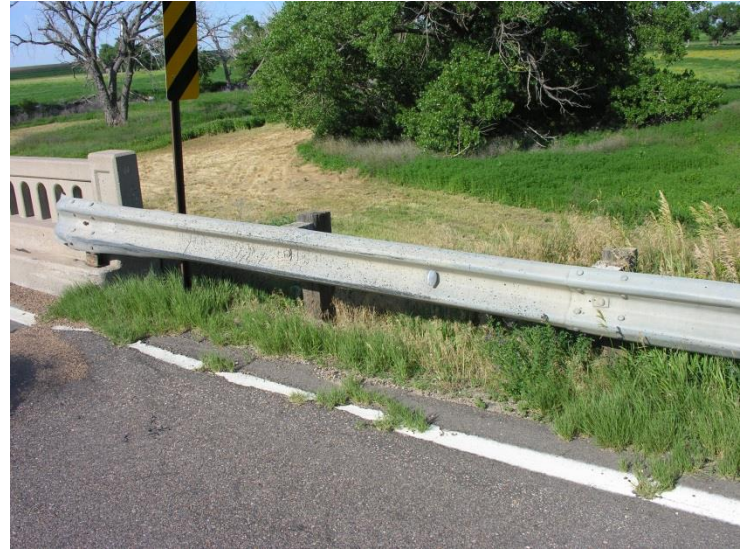
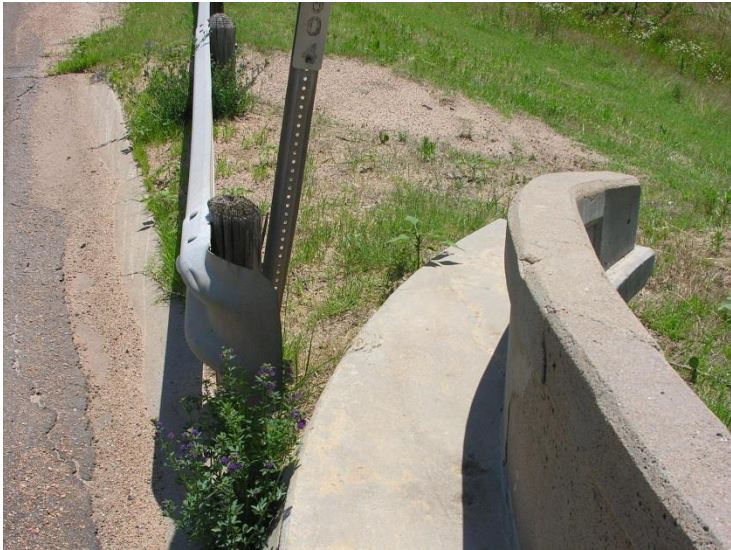
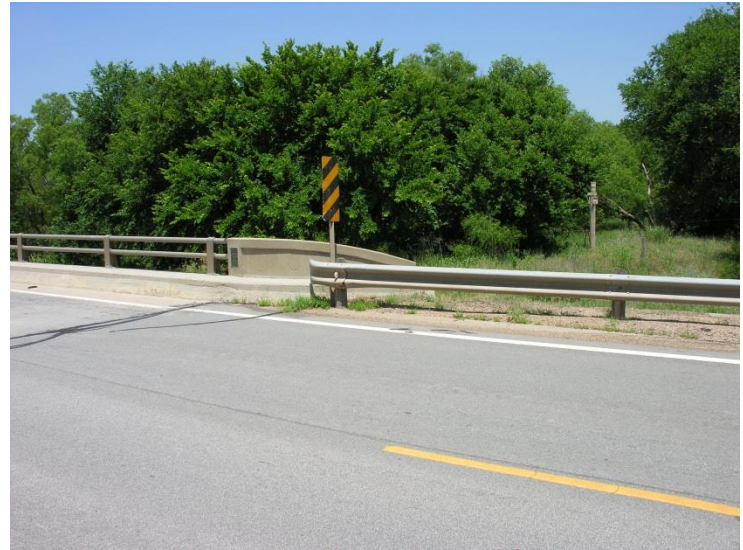
Figure 16. Examples of Existing W-beam Guardrail to Bridge Rail Transitions

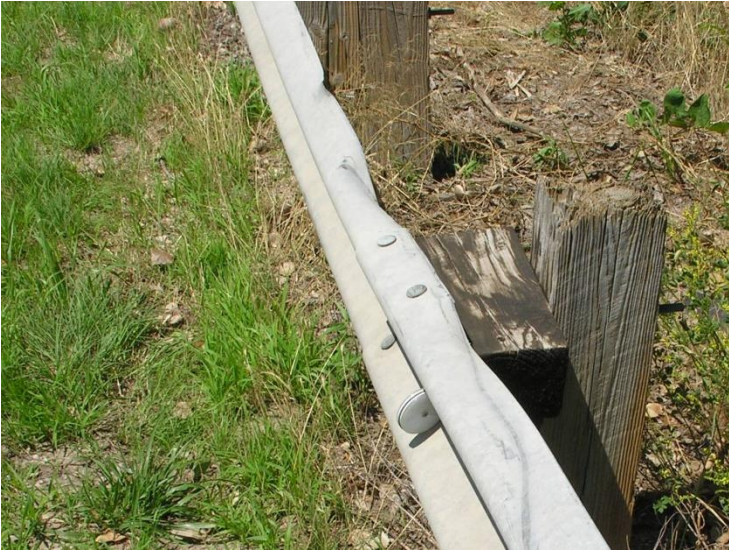
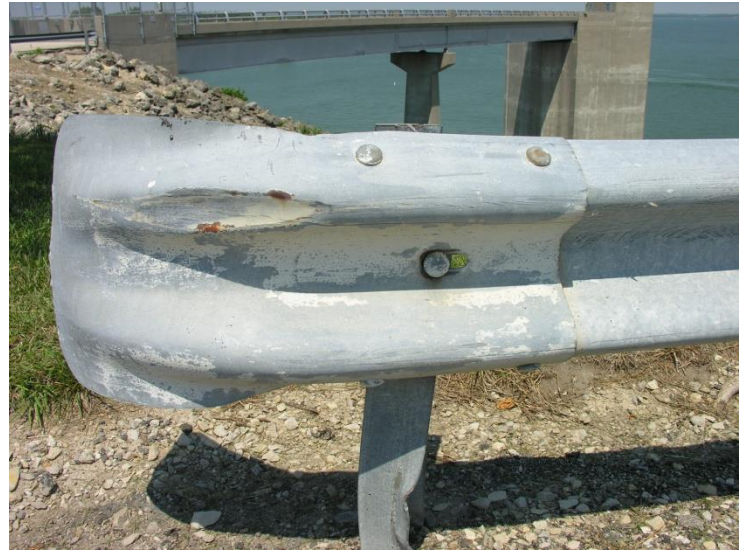
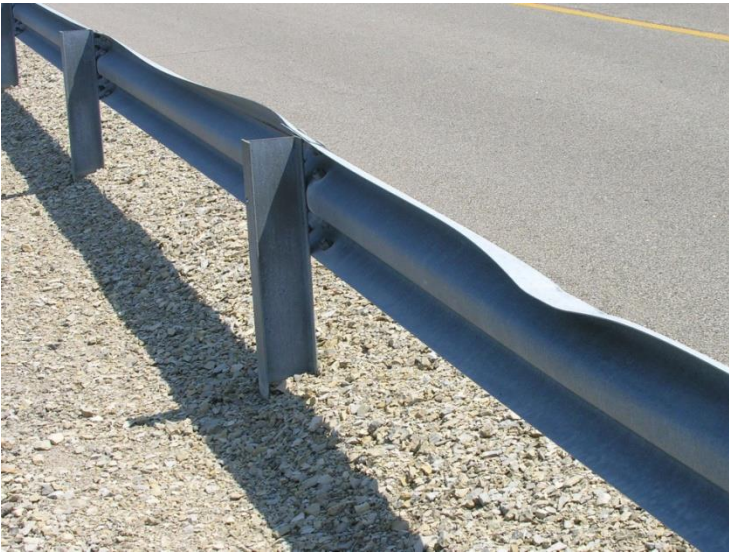
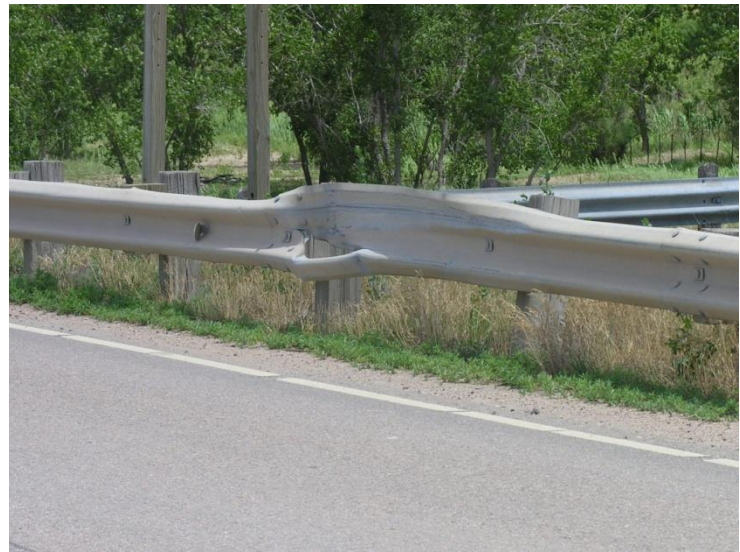
Figure 17. Examples of Rail Damage in Existing W-Beam Guardrail Systems

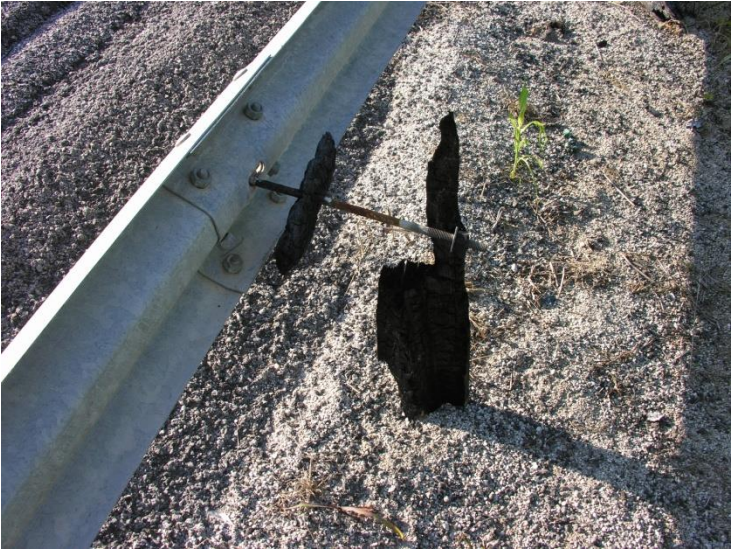
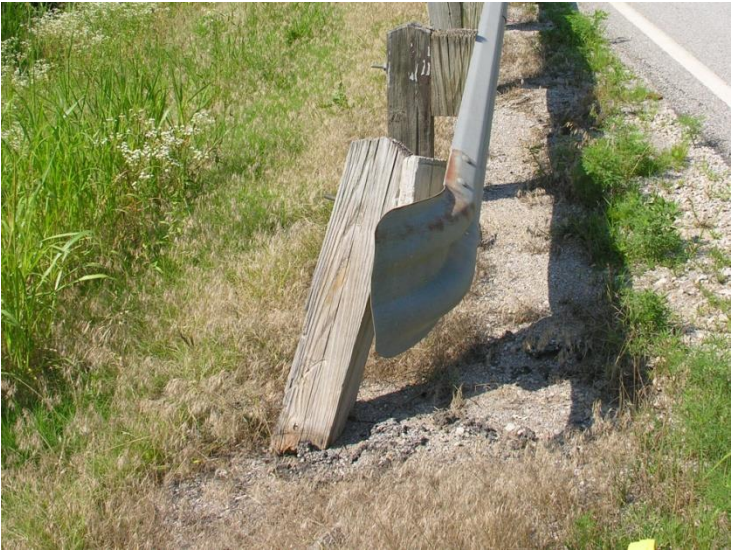
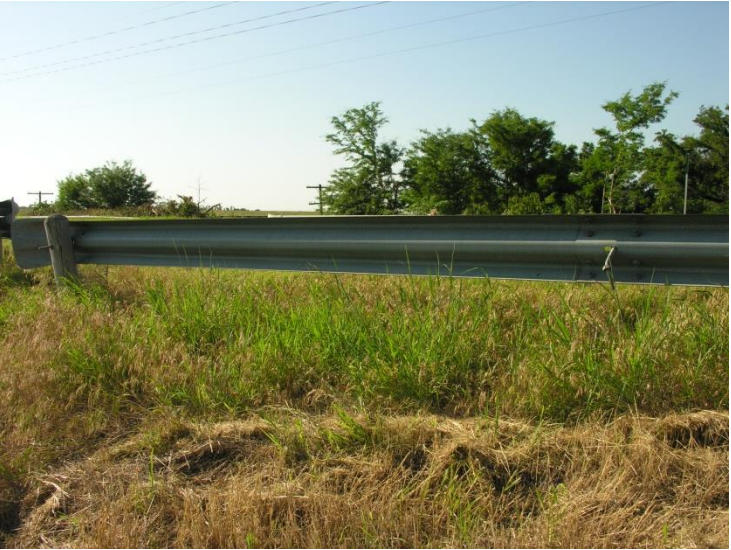
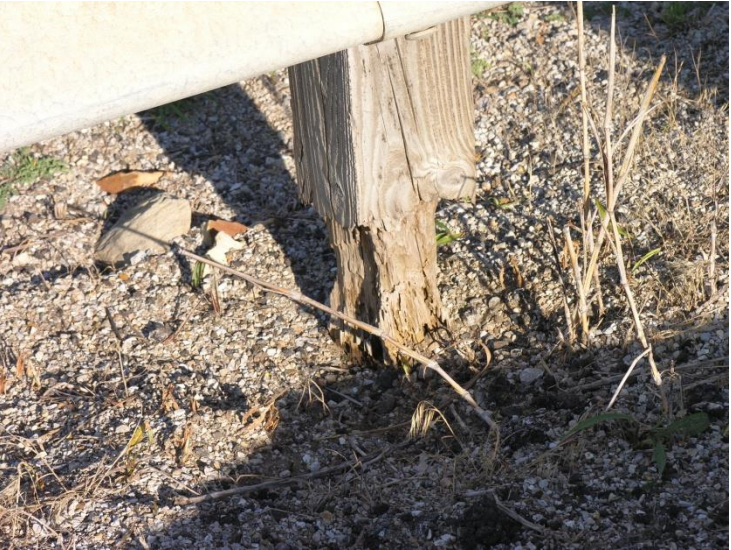
Missing posts are common deviations from current practice in existing guardrail systems. Posts can be missing and/or ineffective because of prior impacts, snowplow damage, rotting wood, insect damage, frost uplift, and faulty construction. A system with one or two missing posts may function adequately under a majority of vehicle impacts [51-52]. Thus systems with three or more missing posts should be considered for repair. This finding is not to say that

a system with a missing post doesn't need repair. Existing guardrail systems with missing posts may need to be repaired for the guardrail to act as intended. Examples of this deficiency are shown in Figure 18.

Figure 18. Examples of Missing and Inadequate Posts

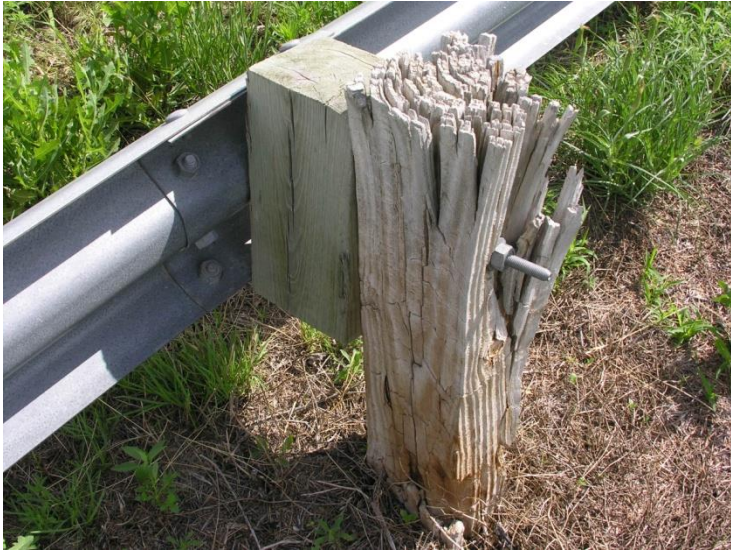
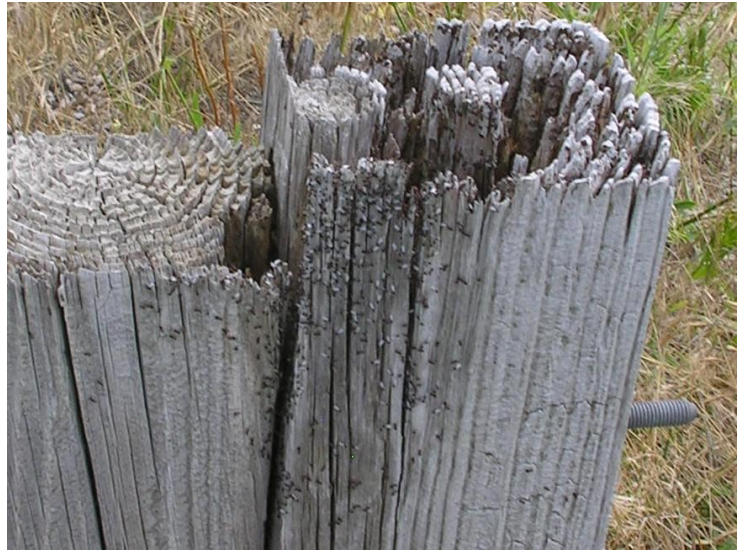
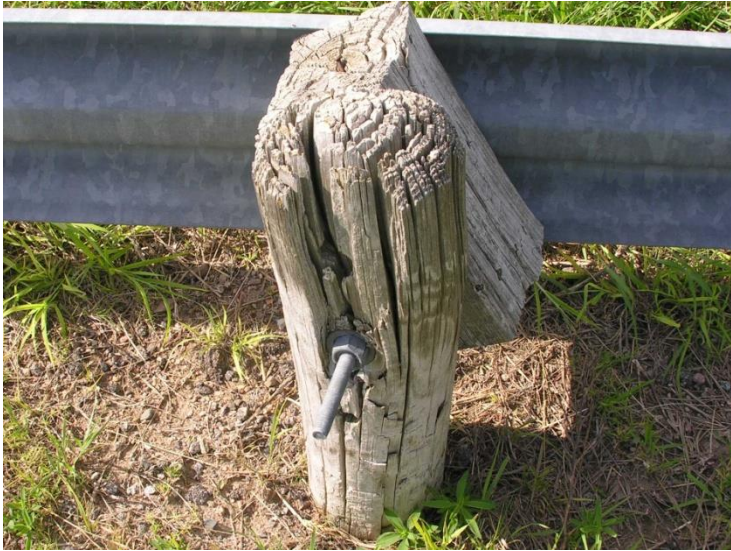
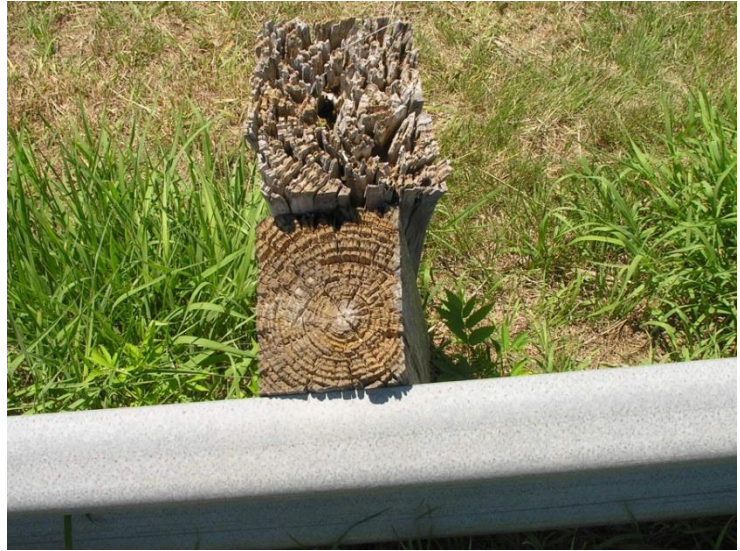
Figure 19. Examples Weathered and Decaying Post in Existing Guardrail Systems

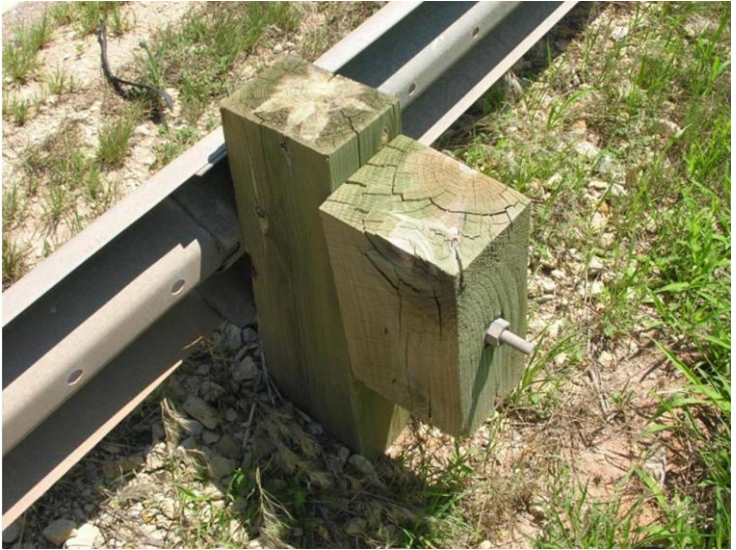
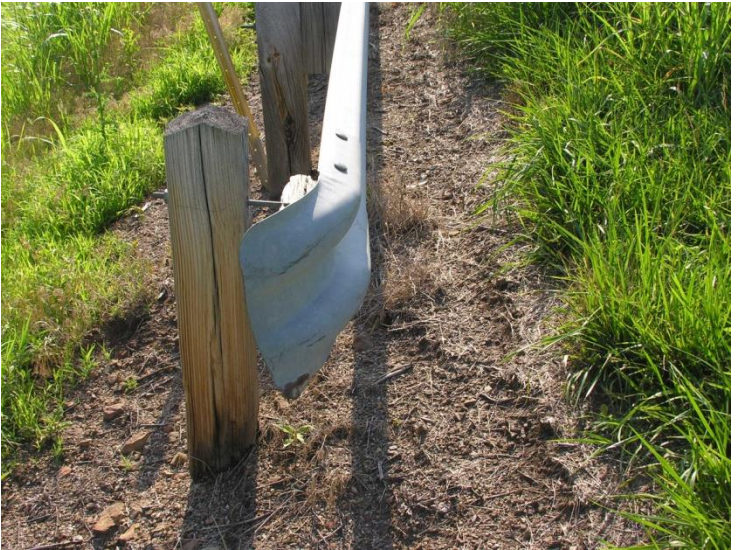
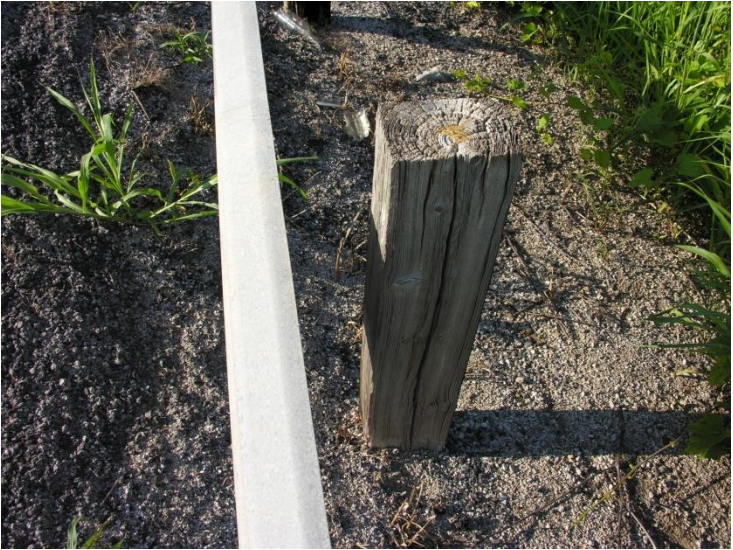
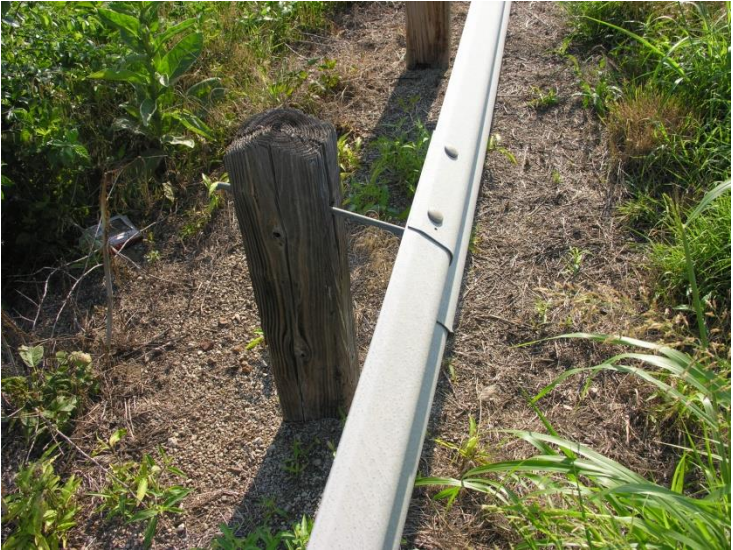
Many blockouts found in the field investigation were weathered, rotting, rotated off center, or absent from the system at various post locations, with the most critical state being missing blockouts. Blockouts offset the W-beam rail element laterally away from the posts to mitigate the amount of wheel snag on the posts as well as maintain rail height. Missing blockouts may cause a guardrail to deviate from the expected guardrail performance. Blockouts can be missing from a system because of prior impacts, snowplow damage, material rotting, insect damage, and/or faulty construction. The performance of a guardrail system with a missing blockout may be comparable to a system with no missing blockouts [52]. For this reason, w-beam guardrail systems with missing blockouts do not require immediate repair. Systems with missing blockouts from the field investigation are shown in Figure 20.

Figure 20. Examples Missing Blockouts in Existing Systems

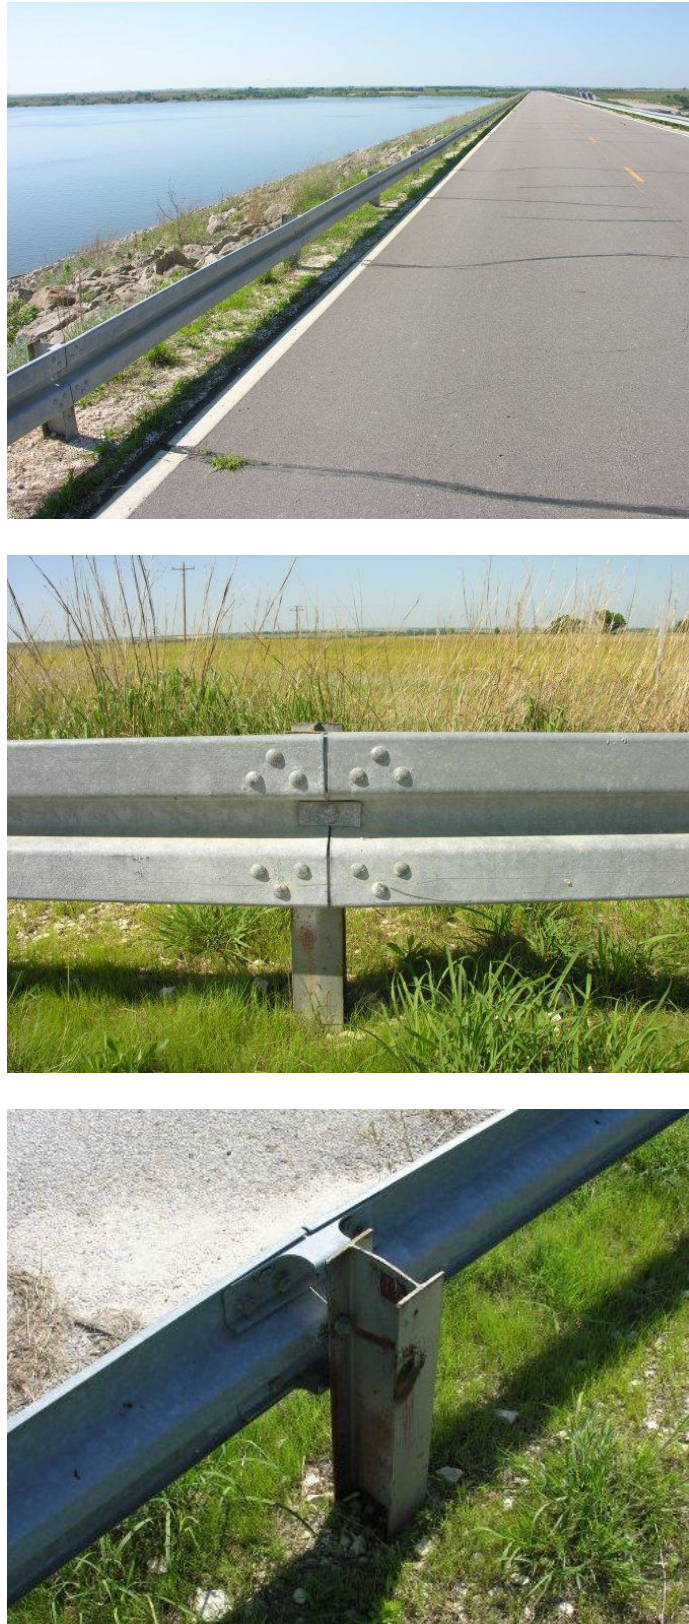
One documented barrier was regarded as a channel rail. The barrier appeared to be in good condition. The steel channel barrier was very similar to a typical W-beam guardrail and utilized steel W6x9 (W152x13.4) posts. Post spacing for the channel rail was 12 ft - 6 in. (3.8 m). Two steel brackets separated the rail from the posts. The upstream and downstream end treatments of the channel rail were blunt ends with no anchorage. Rail splices were located at

each post location with twelve  $\frac{5}{8}$ -in. (16-mm) splice bolts. The steel channel rail shielded the slope of a dam. Photographs of the channel rail system are shown in Figure 25.

Figure 25. Examples of Channel Rail Systems

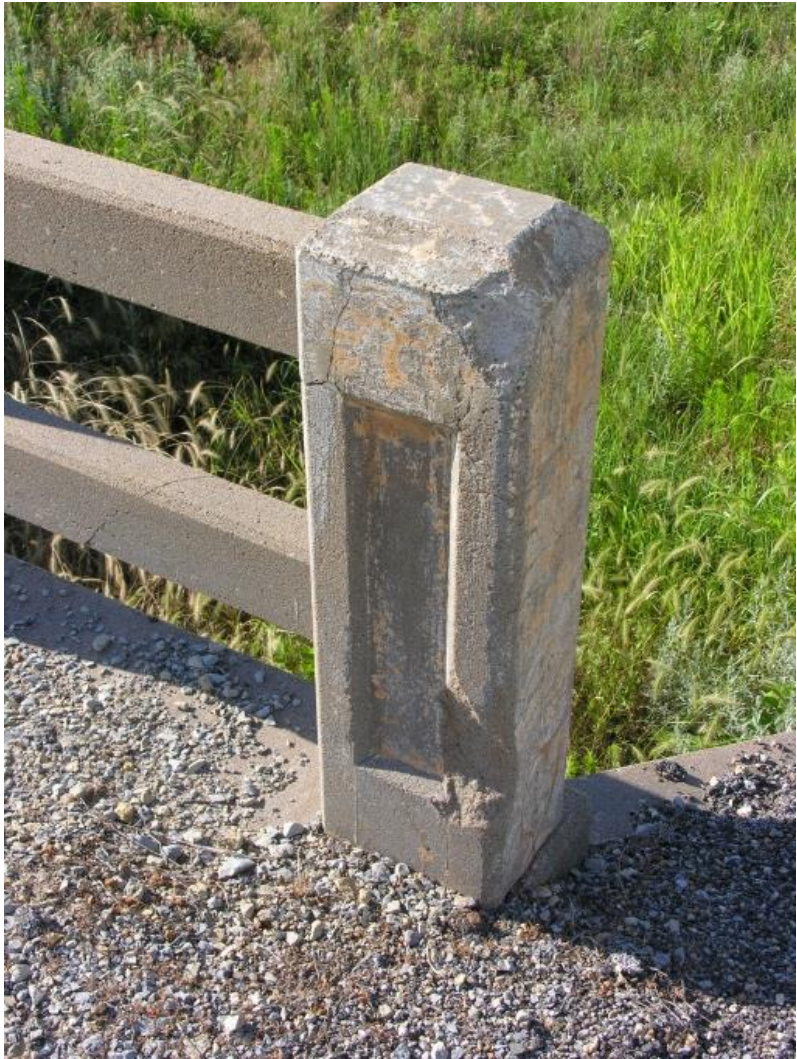
One concrete rail with concrete posts over a culvert was discovered in the field investigation. The barrier was in good condition with minor cracks. The posts were 12 in. x 9 in. x 39 in. (305 mm x 229 mm x 991 mm) with a 48-in. (1,219-mm) post spacing. The barrier was not equipped with an end treatment. In some situations this barrier may pose a more severe obstacle than the obstacle it was shielding. Photographs of the concrete post and rail system are shown in Figure 26.

Figure 26. Examples of Concrete Post and Rail System
