# In-Service Evaluation of Major Urban Arterials with Landscaped Medians—Phase III

WA-RD 636.3

June 2013

**WSDOT Research Report**

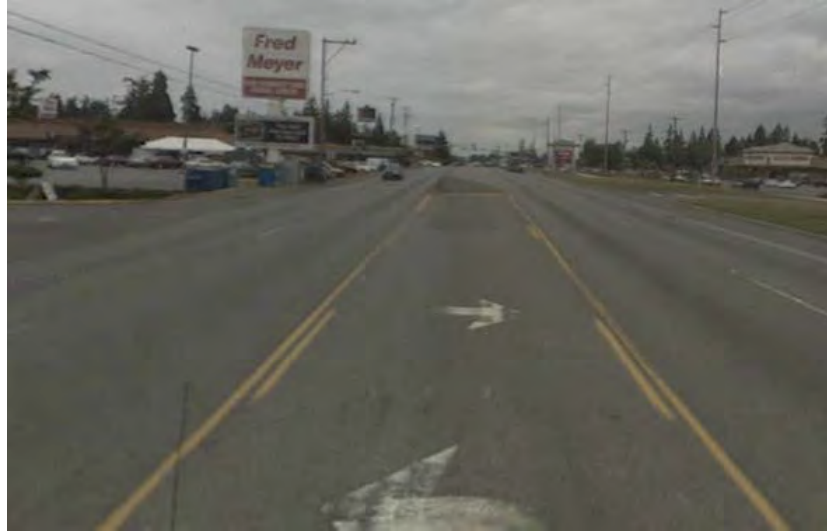
**Figure 1: Example of a Two-Way Left Turn Lane (TWLTL) with Limited Access Control<sup>1</sup>**

The typical historic cross-section of SR 99 within the metropolitan region consisted of five to seven lanes, including a center, two-way left turn lane (TWLTL). In general, the paved shoulders were wide, with sidewalks present at only a few locations. Figure 1 shows an example of a typical roadway section with TWLTL and minimal access control.

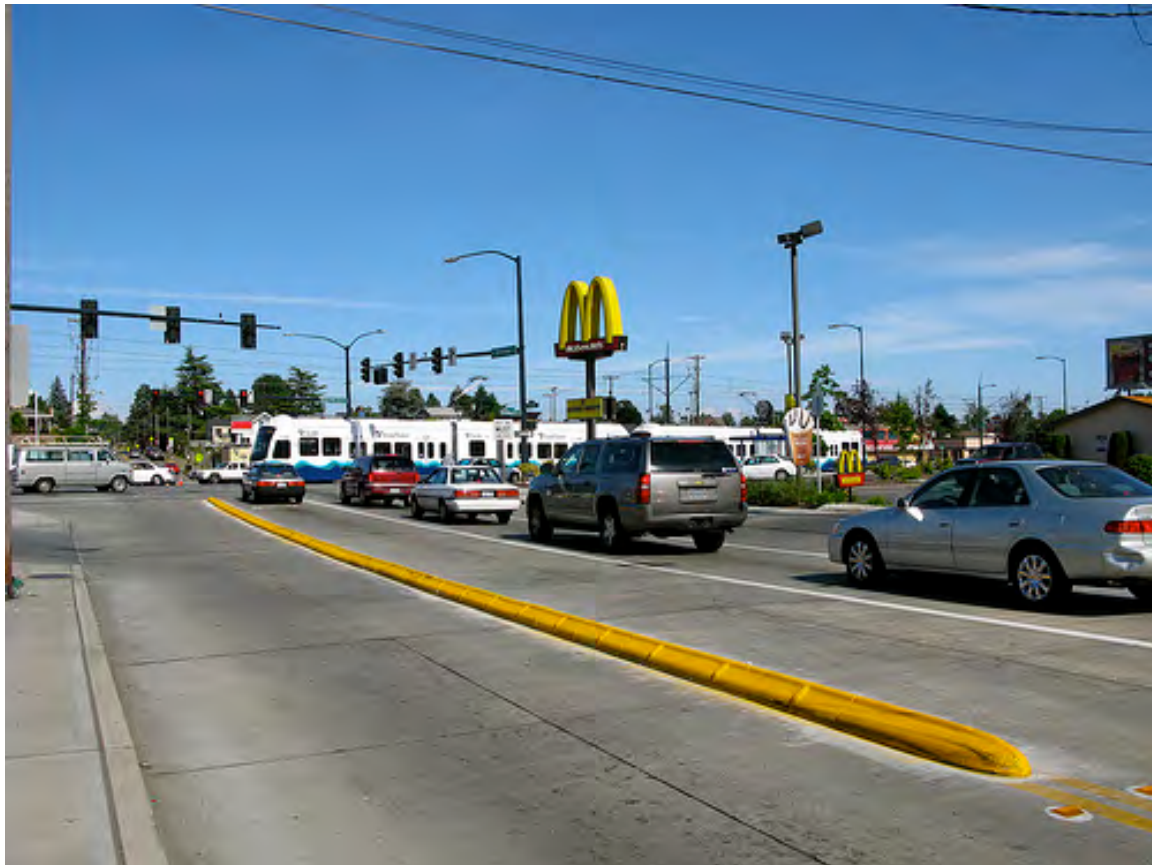
**Figure 2: Example of a C-Curb<sup>2</sup> Separating Directions of Traffic**

Access to commercial and private properties was minimally controlled. At a few locations there was no TWLTL or a low, asphalt-covered median and C-curb (see Figure 2) separating the two directions of traffic. At many intersections, dedicated right and left turn lanes existed. In general, the aspect was of a wide, uncontrolled asphalt streetscape with cars moving in every direction. There was almost no provision for the comfort and safety, of pedestrians, though many pedestrians travel through and across the SR 99 corridor. The land use was, and remains, primarily commercial strip development.

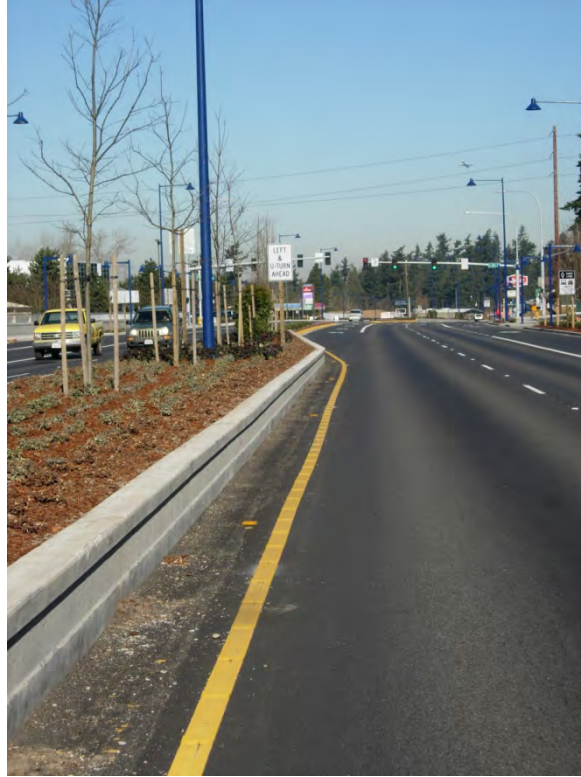
**Figure 5: Des Moines Median Treatment: Trees Behind a Low Profile Barrier<sup>23</sup>**

The Des Moines Pacific Highway (SR 99) redevelopment project extended from the Kent–Des Moines Road to S. 216<sup>th</sup> Street (MP 15.49 to 16.51), a distance of 1.02 miles. The improvements involved widening the existing five-lane road to a seven-lane section that included two general-purpose lanes in each direction, one BAT lane in each direction, and a landscaped median with mid-block left turn pockets and left turn lanes at the intersections. The median treatment used in this section was an 18-inch, low profile barrier. Figure 5 provides a picture of this barrier with tree treatment. The project also installed two new traffic signals at S. 220<sup>th</sup> Street and S. 224<sup>th</sup> Street, curbs, gutters and sidewalks, pedestrian and street lighting, and a new storm drainage system. The construction was completed in January 2005.
