**IMPLEMENTING SPEED REDUCTIONS
AT SPECIFIC INTERSTATE
WORKZONES FROM 65 MPH TO 35 MPH**

Final Report

SPR 751

John A. Gambatese, Fan Zhang, and Ali Moghaddam Vahed
School of Civil and Construction Engineering
Oregon State University
220 Owen Hall
Corvallis, OR 97331

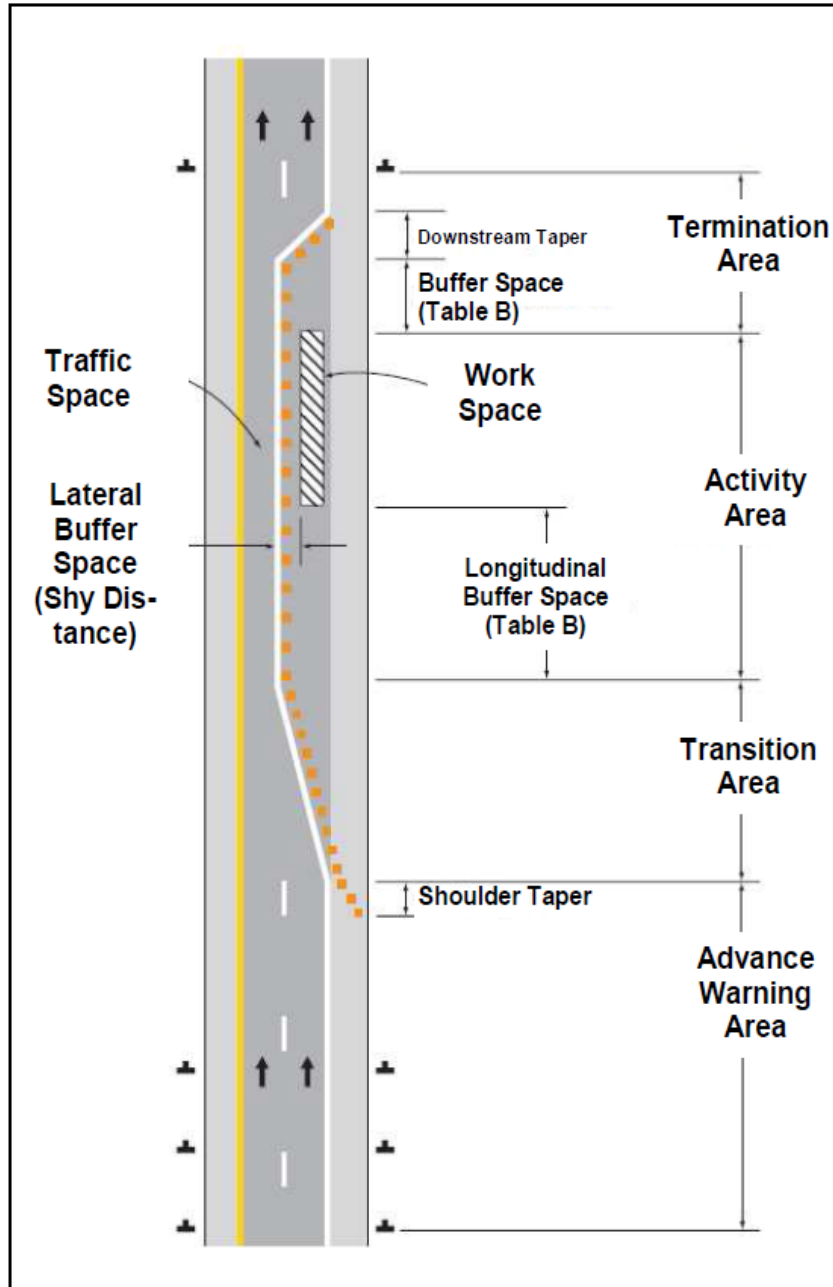
The enforceable work zone is defined as starting from the first warning sign, which is usually the “Road Work Ahead” sign, to the “End Road Work” sign. Messages displayed on electronic signs or other advance warning signs, such as “Road Work Next XX Miles,” are not considered the first warning sign. A work zone is composed of four distinct areas, as showing in Figure 2.1. These areas are the: 1) advance warning area, 2) transition area, 3) activity area, and 4) termination area.

Figure 2.1: Four Areas in a Work Zone (ODOT 2011)

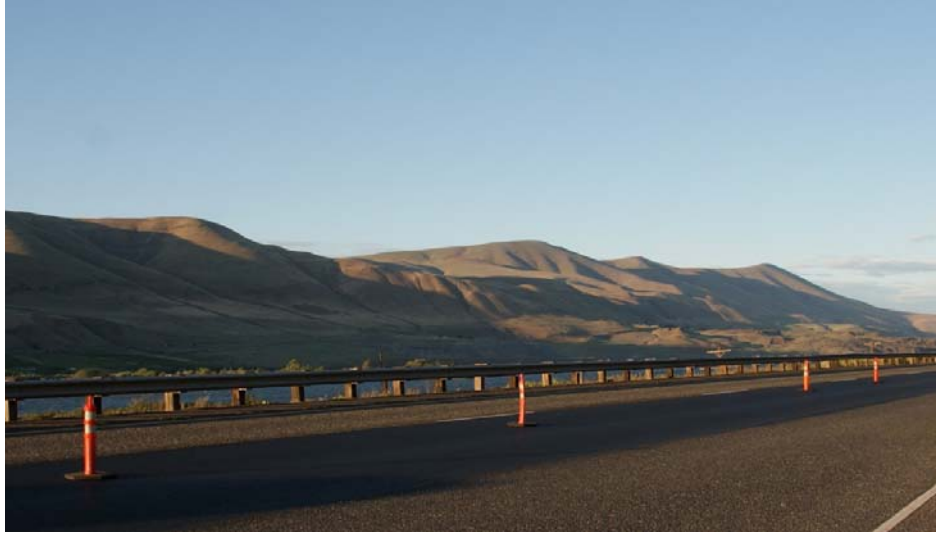
Tubular and Conical Markers – Tubular and conical markers (tubes and cones) are the most commonly-used channelizing devices for delineating the roadway and directing traffic through the work zone. These devices are effectively used to override existing pavement markings for short-duration applications (less than three days). Figure 2.2 shows tubular markers being used to delineate an edge of a travel lane on a roadway.

Figure 2.2: Tubular Markers on Roadway

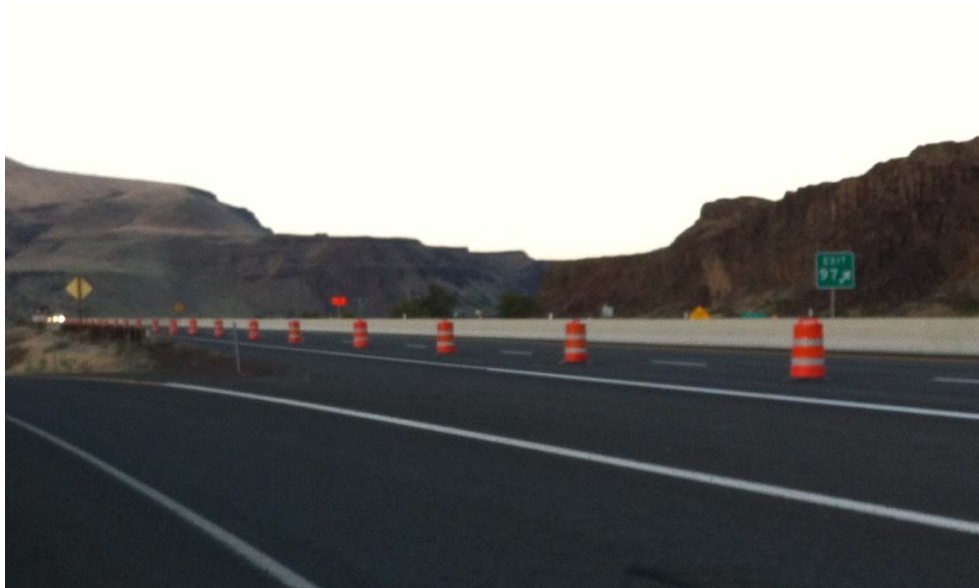
Figure 2.3 shows plastic drums in use on a roadway.

Figure 2.3: Plastic Drums on Roadway

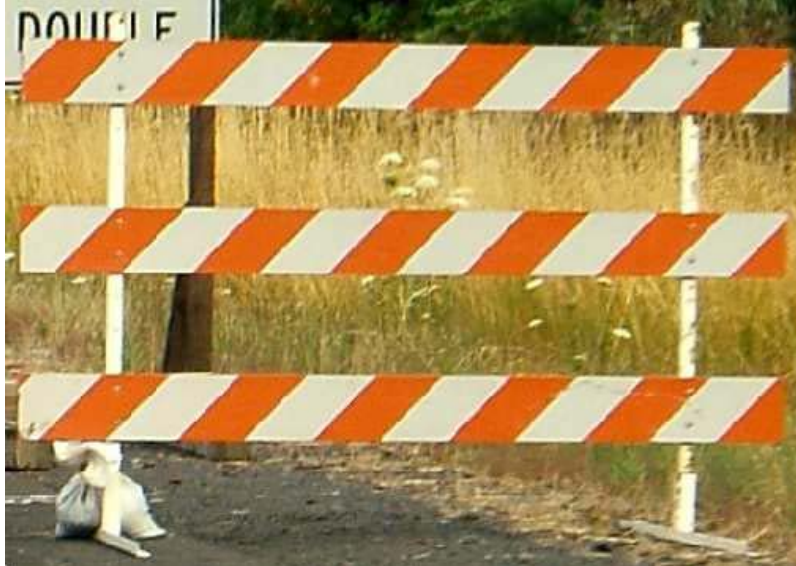
Type I, II and III Barricades – Barricades are used for several purposes, including delineating temporary signs mounted on temporary sign supports (TSS). Barricades may be placed at regular intervals within a closed lane to remind drivers that the lane is unavailable to them, and placed at the point of closure. Figure 2.4 shows an example of a Type III barricade.

Figure 2.4: Type III Barricade (ODOT 2011)

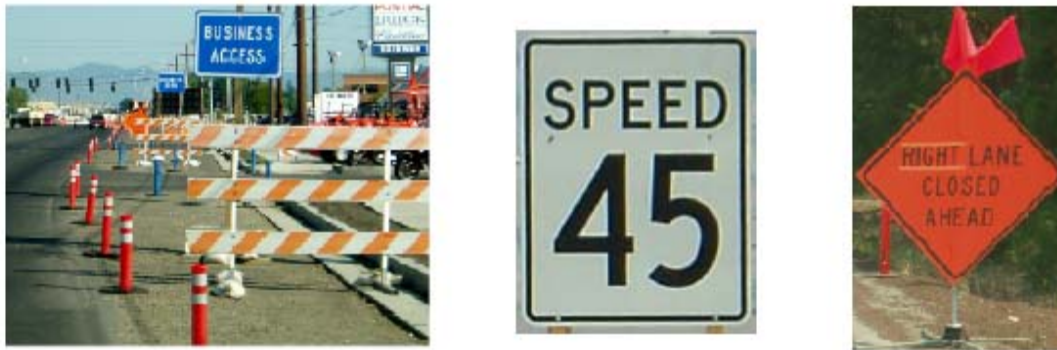
Temporary Signs – Temporary signage is used to convey regulatory, guidance, and warning messages in place of permanent signage during roadway construction and maintenance operations. Figure 2.5 shows several examples of temporary signs.

Figure 2.5: Examples of Temporary Signs (ODOT 2011)

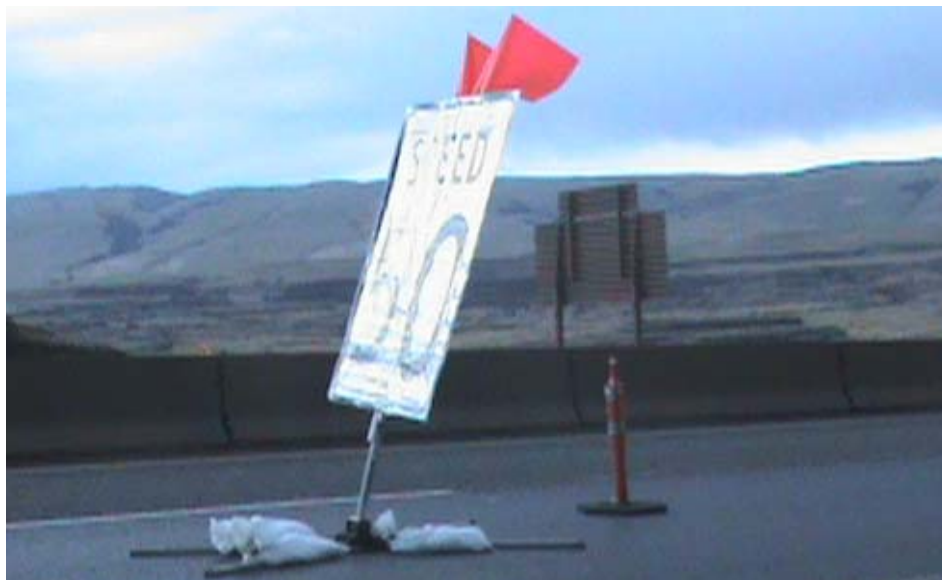
Portable Sign Support (PSS) – A portable sign support is used to mount a roll-up sign for short-term or intermittent work. A PSS is only to be installed for a maximum of 48 consecutive hours according to ODOT construction contracts. If the sign is needed for a longer period of time, the sign should be installed on a TSS or post. A PSS should be removed when workers are not present. Figure 2.6 shows an example of portable sign support supporting a regulatory speed sign.

Figure 2.6: Portable Sign Support

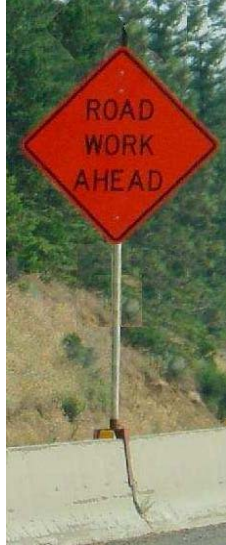
Concrete Barrier Sign Support – Concrete barrier sign supports are used to install temporary signs on concrete barrier where space for a TSS or post-mounted sign is not available. The support provides a connection directly to the top of the concrete barrier. Figure 2.7 shows an example of a concrete barrier sign support.

Figure 2.7: Concrete Barrier Sign Support (ODOT 2011)

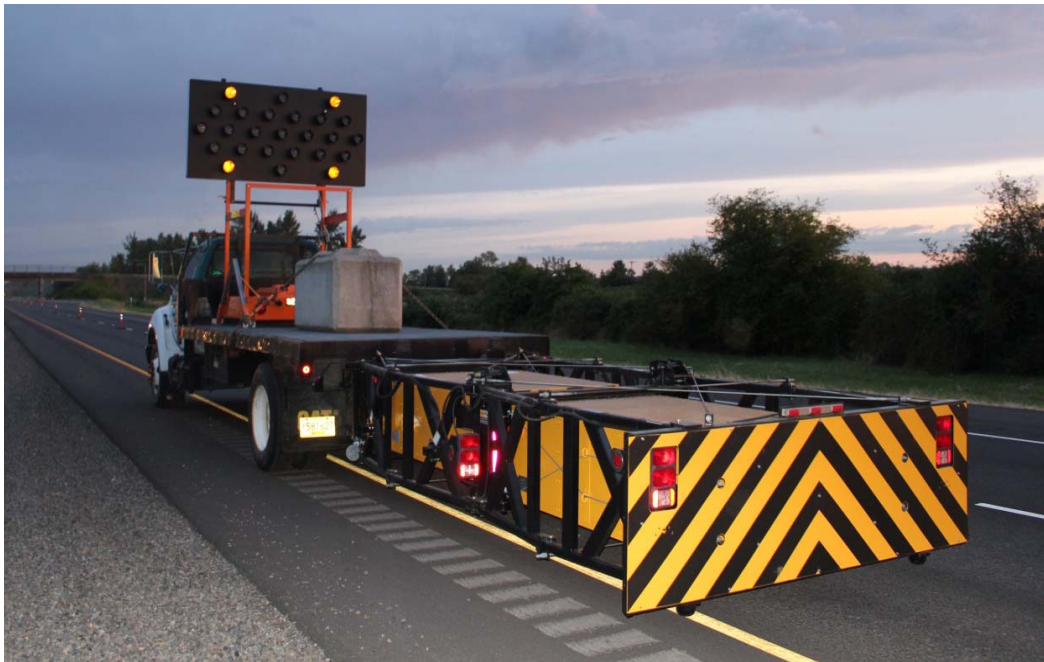
Temporary Impact Attenuators – Temporary impact attenuators, also called crash cushions, are crashworthy systems that mitigate the effects of errant vehicles that strike obstacles. When struck by a vehicle, the impact attenuator is designed to lessen the impact of the crash on the traveling vehicle and on the supporting structure. A truck mounted attenuator (TMA) is a mobile impact attenuator attached to a work or shadow vehicle that is used to temporarily protect objects or a work area. One or more TMAs are usually located in advance of an object, work area, equipment, or workers. A TMA should not be used for long-term protection of barrier or other fixed objects. Figure 2.8 shows an example of a TMA.

Figure 2.8: Truck Mounted Attenuator and Sequential Arrow Board

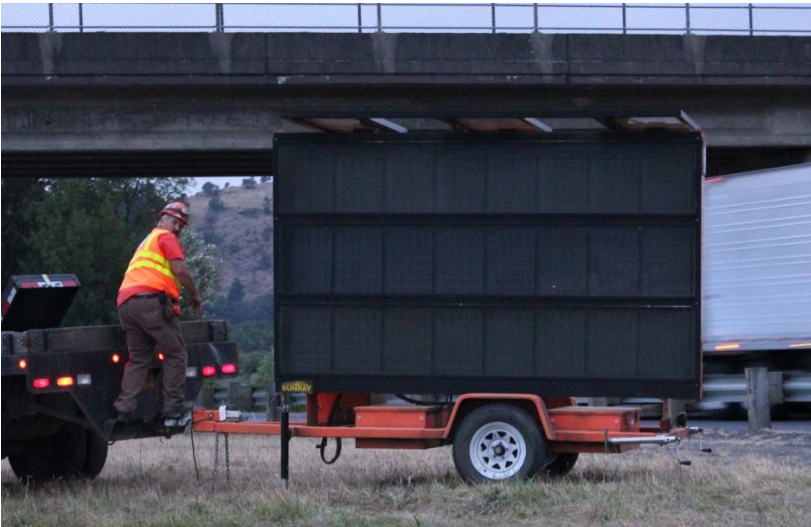
Portable Changeable Message Sign (PCMS) – PCMS’s are large lighted signs used to display programmable, dynamic messages that reflect upcoming work zone conditions to be encountered by approaching traffic. PCMS’s can be mounted on either a trailer or work vehicle. Figure 2.9 shows an example of trailer-mounted PCMS. Figure 2.10 shows an example of a work vehicle-mounted PCMS.

Figure 2.9: PCMS on Trailer

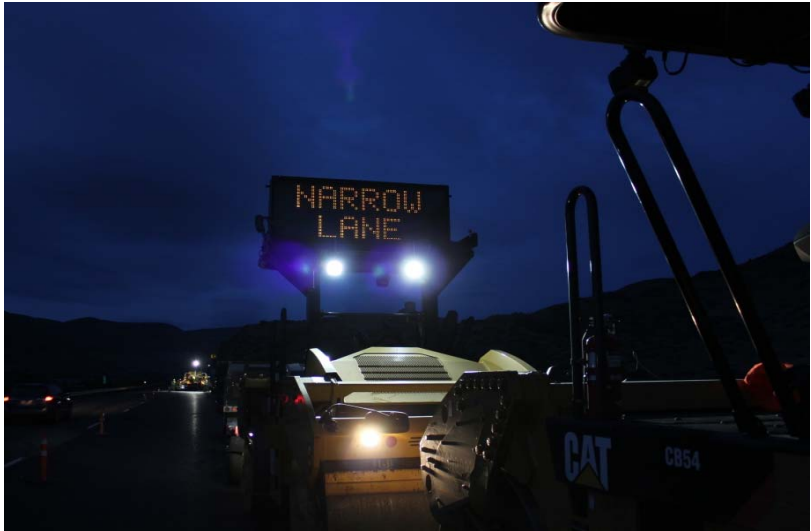
Figure 2.10: PCMS on Roller

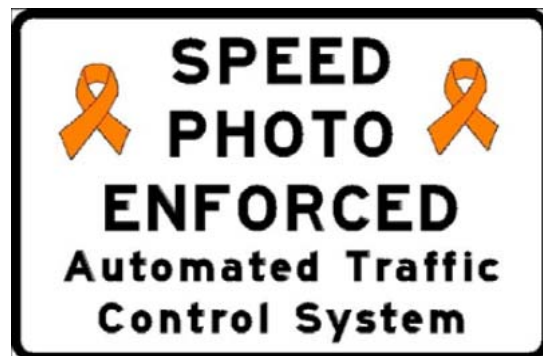
The Illinois DOT conducted a research study to explore the effect of speed photo-radar enforcement (SPE), also referred to as “automated speed enforcement” (Benekohal *et al.* 2010). In this research study, an advanced warning sign (shown in Figure 2.11) was placed on the roadway to inform the motorists of the implementation of SPE in the work zone. A self-contained van was used to implement the SPE as shown in Figure 2.12. Figure 2.13 provides a graphical view of how the SPE system works.

Figure 2.11: Special Signs for Speed Photo Enforcement (Benekohal *et al.* 2010)

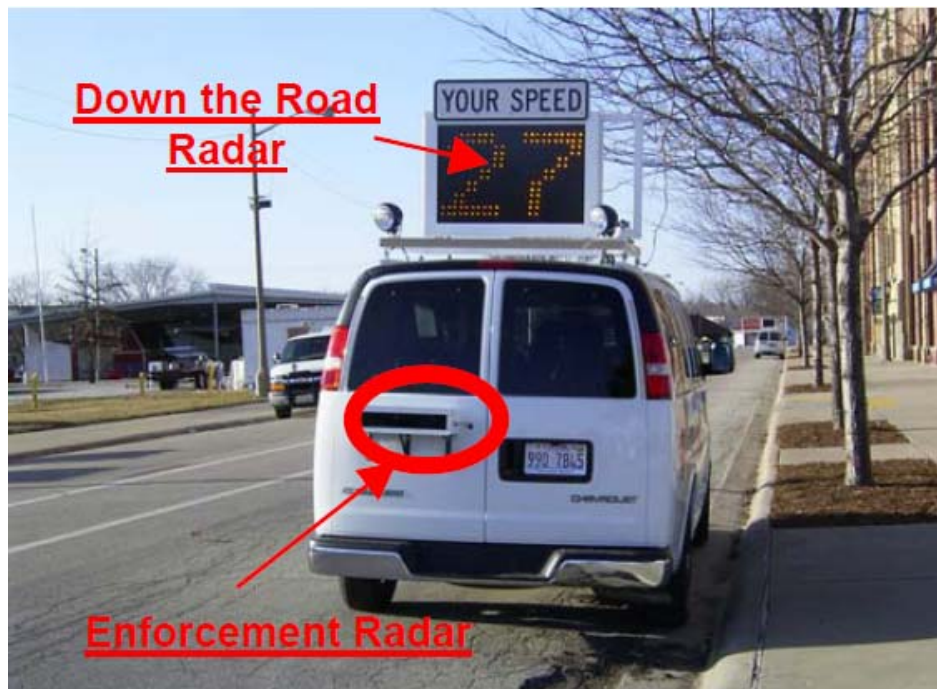
Figure 2.12: Photo Enforcement Vehicle (Benekohal *et al.* 2010)

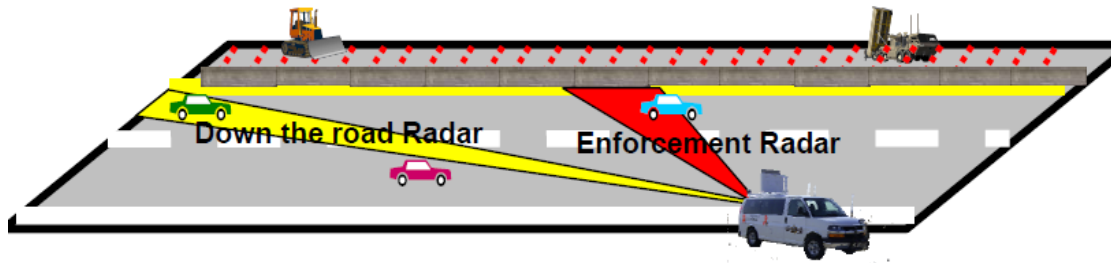
Figure 2.13: Operation of the Photo Enforcement (*Benekohal et al. 2010*)

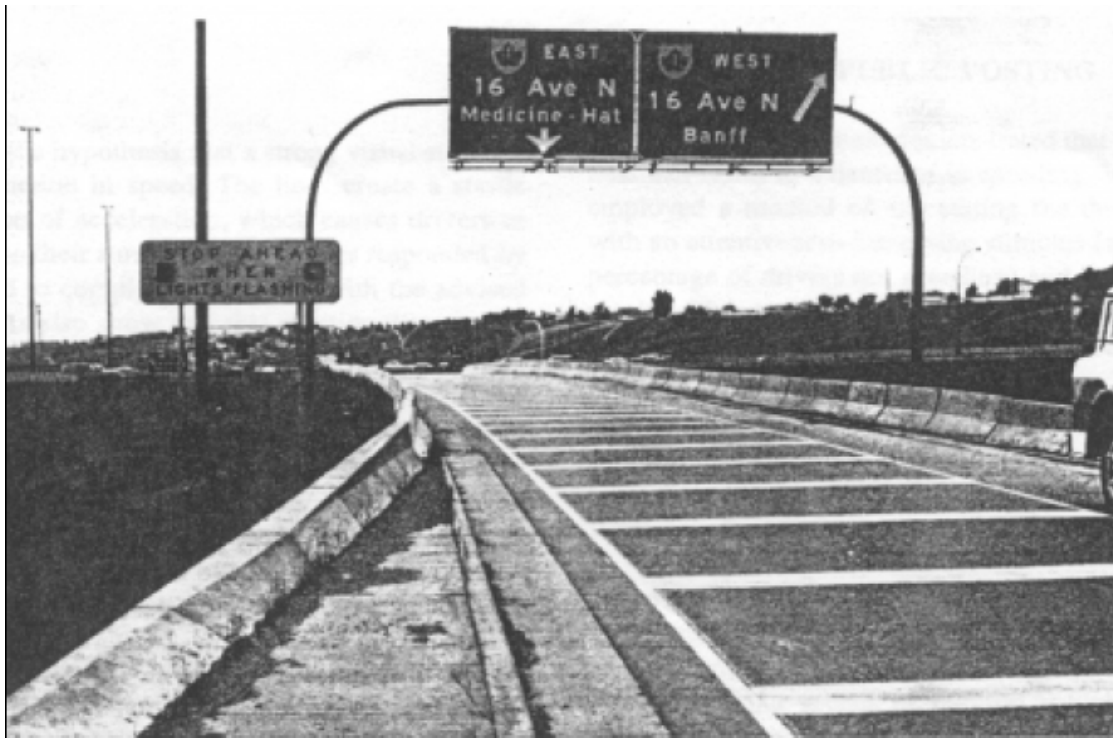
Meyer (2004) tested the application of optical speed bars within a highway work zone. Optical speed bars, also known as transverse strips, are innovative pavement markings that have been used to reduce traffic speed on curves and in other high risk locations. This technique has been used in several countries, most notably Great Britain, where the technique has become a typical device used at approaches to roundabouts. Figure 2.14 shows an example of optical speed bars. Meyer tested the effects of different optical speed bar patterns on traffic speed, and concluded that the pattern did not appear to have any effect on traffic speed or speed variations.

Figure 2.14: Optical Speed Bars (*Meyer 2004*)

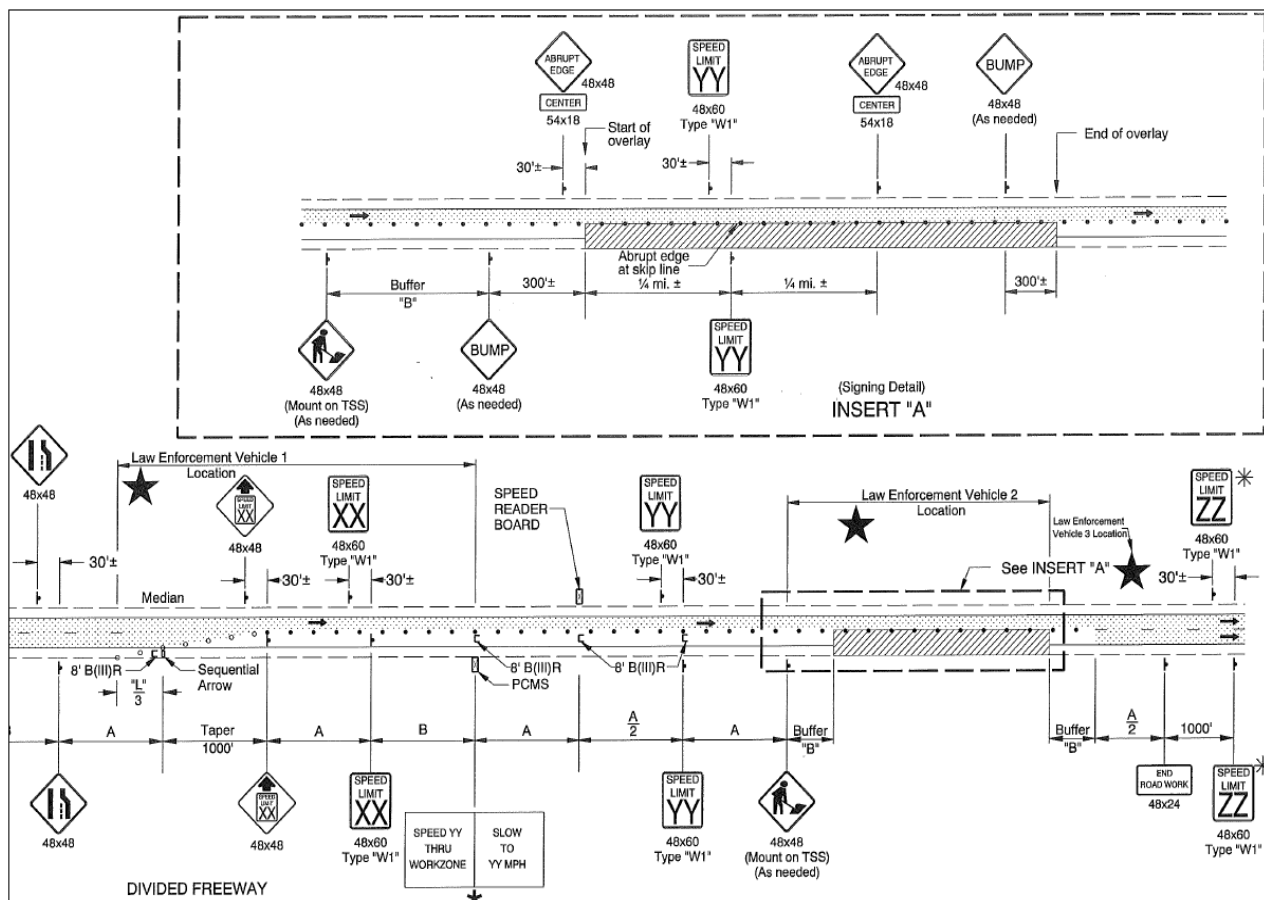
Figure 2.15 shows the work zone traffic control plan for the pilot study. Three law enforcement vehicles were used. The first officer parked his vehicle at the beginning of the taper. The second OSP officer parked at the beginning of the work starting point. Finally, the third officer was placed downstream at the end of the work zone. An intermediate speed limit 'XX' sign was placed at the end of taper. This sign was followed by a radar speed reader board showing vehicle's speed. The final work zone speed limit 'YY' sign was placed after the speed reader board, but before the start of paving work. For the pilot study, the intermediate speed was 50 mph, and the final work zone speed was 35 mph.

Figure 2.15: Pilot Study Traffic Control Plan Using Two Stage Speed Reduction

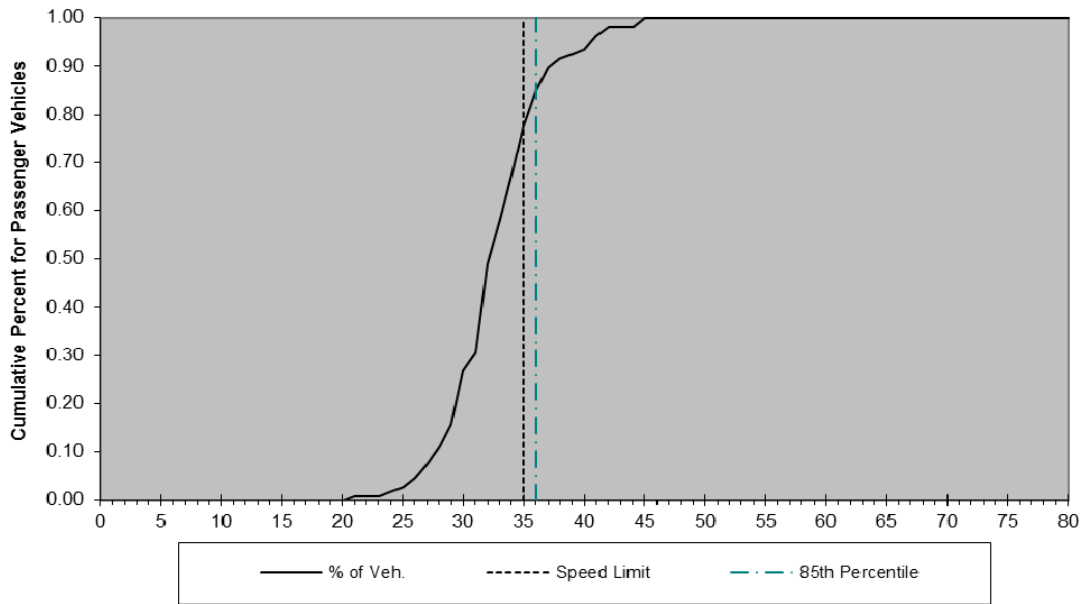
Speed data on the project was collected on September 9, 2011 from 12:45am to 4:45am (early Friday morning). The speeds were recorded by a handheld radar speed gun located near the paver, in the northbound direction at approximately MP 169. The speeds of free flowing passenger vehicles and commercial trucks were recorded, and are summarized in Figure 2.16 and Figure 2.17: Pilot Study Speed Data Summary for Commercial Trucks. Figure 2.16 shows the data summary for passenger vehicles, and Figure 2.17 shows the data summary for commercial trucks.

Figure 2.16: Pilot Study Speed Data Summary for Passenger Vehicles

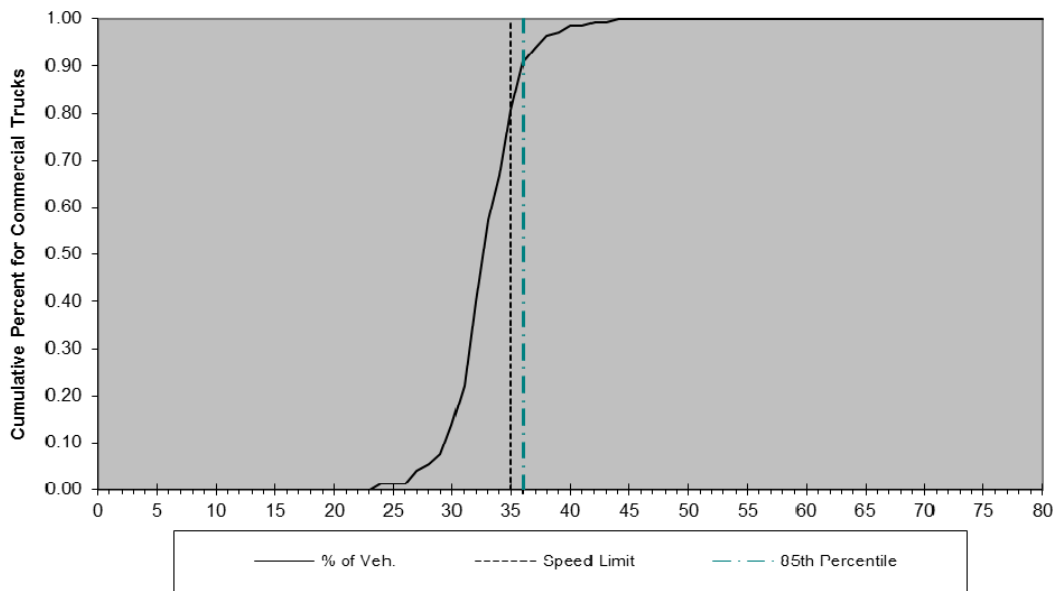
Figure 2.17: Pilot Study Speed Data Summary for Commercial Trucks

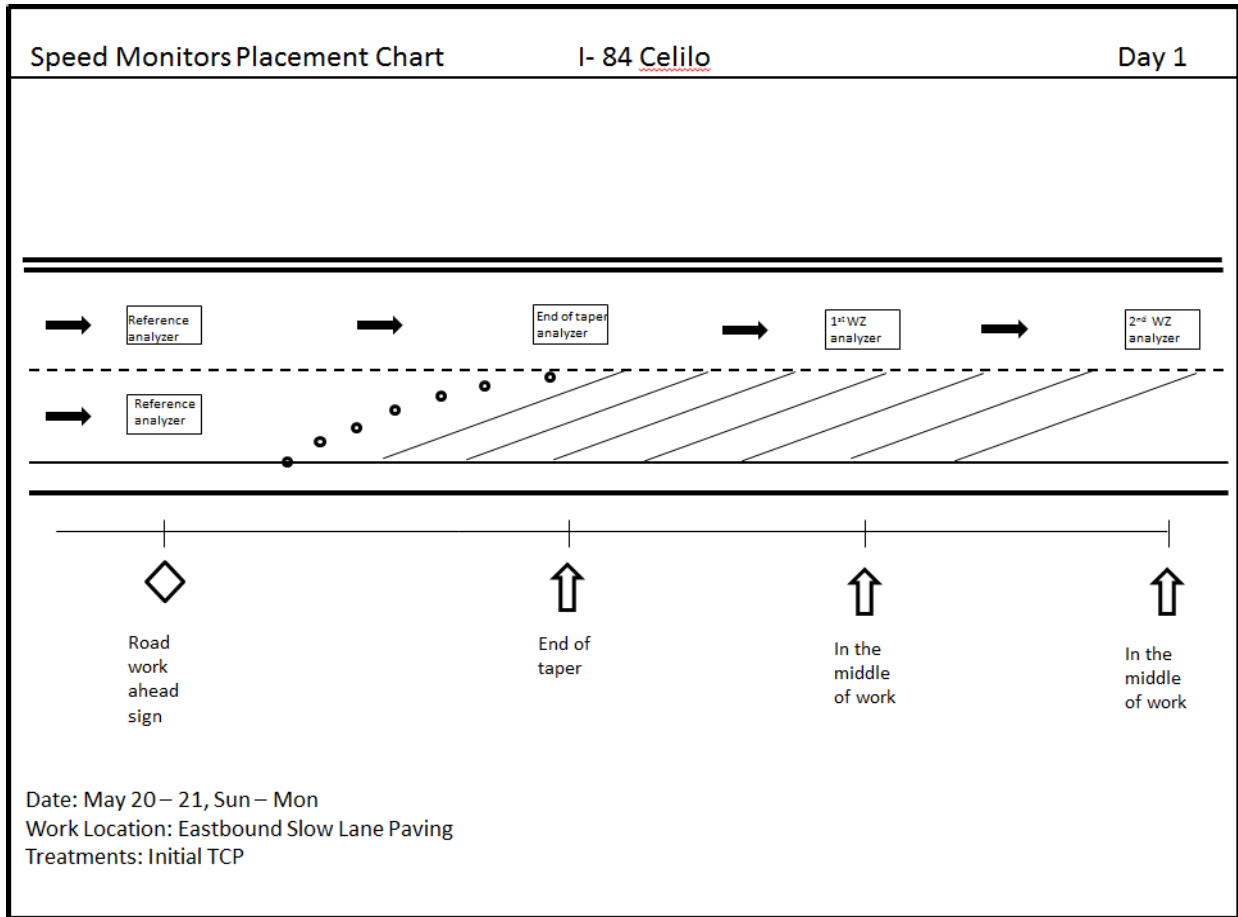
analyzers were placed in the travelling lane at different points in the work zone. The actual location and spacing of the last two analyzers in the work zone was dependent on the amount and location of work being performed on that night. Figure 3.3 shows an example of a plan view of the portable traffic analyzer placement for a typical night. No traffic analyzers were placed beyond the end of the work zone.

Figure 3.3: Plan View Drawing Showing Location of Traffic Analyzers

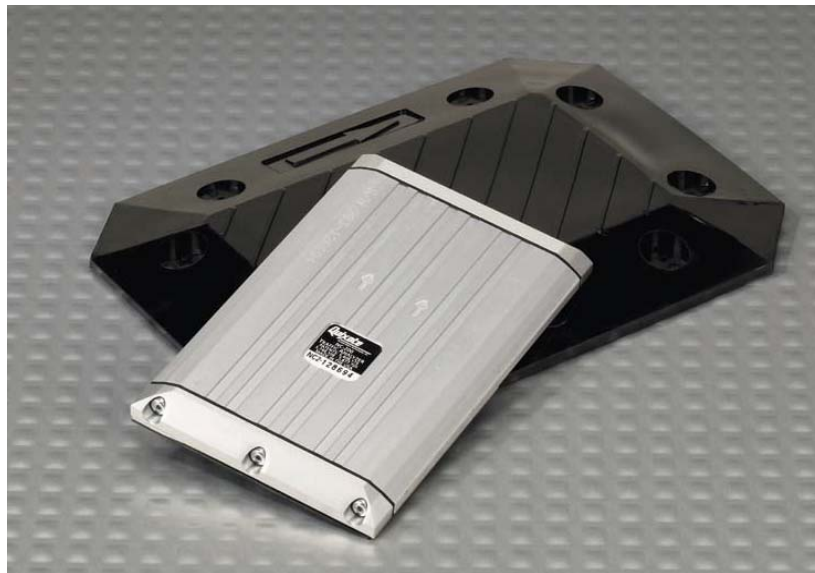
The portable traffic analyzer NC-200 is manufactured by Vaisala. Figure 3.4 shows an example of the traffic analyzer and a cover used to protect it on the roadway.

Figure 3.4: Potable Traffic Analyzer NC-200 (Vaisala 2012)

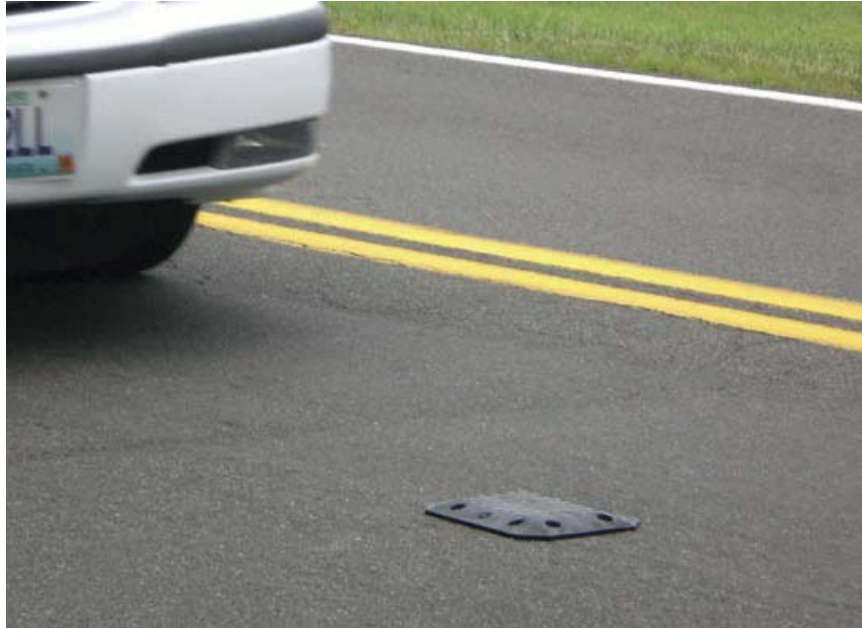
The traffic analyzer manufacturer indicates that the analyzer be nailed down to the pavement through nail holes on the cover as shown in Figure 3.5. However, for highway preservation projects, it is unrealistic to put nail holes in the newly paved asphalt mat, and the short duration of use (one night of work) each time the analyzer is used makes it inefficient to nail down the analyzers. Therefore, an alternative method to fix the analyzer on the roadway was used. The analyzers were secured to the pavement using adhesive tape which completely covered the analyzer cover and the analyzer. Figure 3.6 shows an example of how to use adhesive tape to keep the analyzer at the desired location.

Figure 3.5: Placement of Portable Traffic Analyzer by Nails (*Vaisala 2012*)

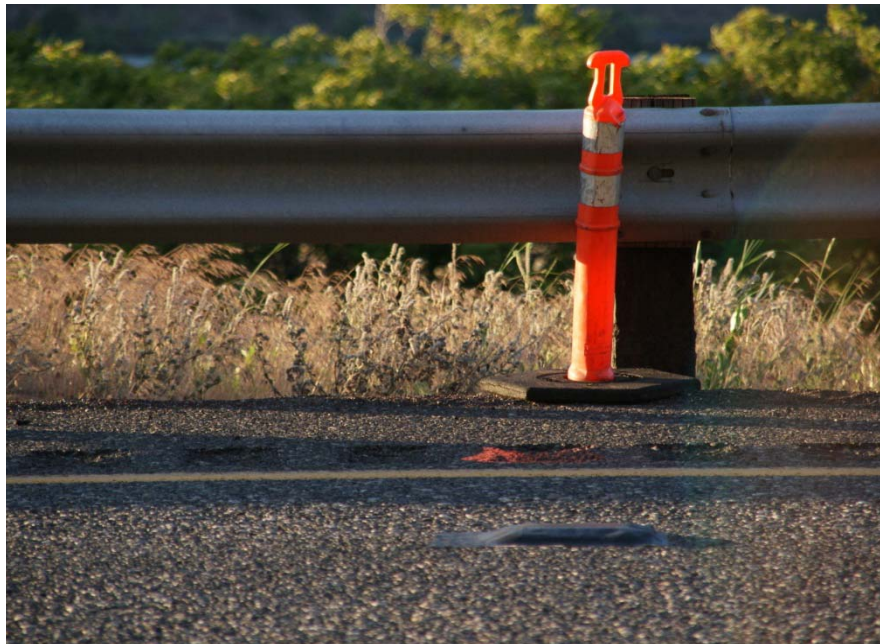
Figure 3.6: Placement of Portable Traffic Analyzer by Adhesive Tapes

The adhesive tape used in this project was Tapecoat M860 Pavement Repair Coating. It is primarily used to repair cracks in concrete and asphalt surfaces. According to the data sheets provided by the manufacturer, Tapecoat M860 is made of a pre-formed, cold-applied, self-adhering material that is impermeable to water and salt (*Tapecoat 2012*).

1. The tape is very sticky, not only to the pavement but also to the cover used to protect the portable traffic analyzer. It is very difficult to remove the tape from the cover after each usage. A simple solution was found to solve this problem. The researchers put a piece of thick paper, which is about the same size as the cover, on the cover to separate the tape from the cover so that the tape did not directly contact the cover. Only the perimeter of the tape contacted and stuck to the pavement.

2. The tape performs poorly in wet conditions. The tape material is waterproof, but the water can penetrate the pavement around it and affect the adhesive layer from underneath. After the adhesive layer loses its strength, it is very easy to dislodge the cover and the analyzer when impacted by the high-speed traffic.

3. The tape performs poorly under high temperatures. The tape's adhesive layer softens significantly under high temperatures. When the adhesive layer softens, it is very easy for the cover and the analyzers to be dislodged by the on-going high-speed traffic. Therefore, it was not acceptable to place the tape directly on the roadway during high temperature summertime conditions. If traffic data is to be recorded in a high temperature environment, alternative ways to place the analyzer on the ground need to be used.

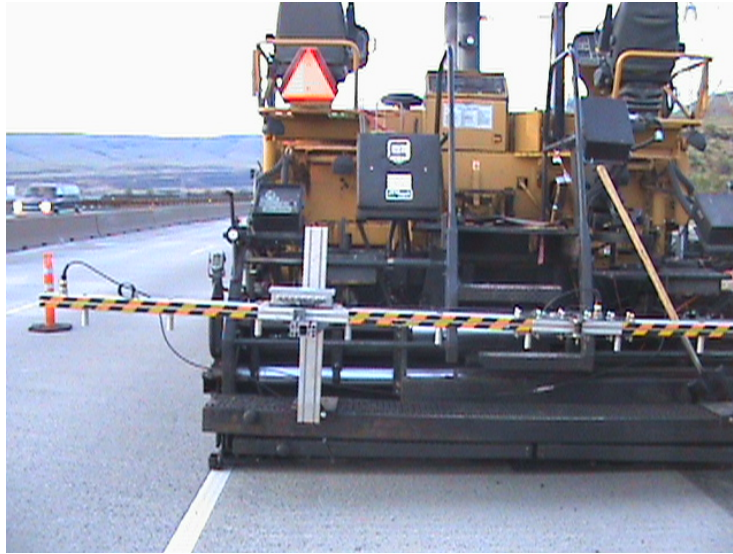
ODOT tried a piece of new equipment on the paver on Day 1. A temperature sensor was attached to the back of the paver to automatically measure the temperature of the pavement. The temperature sensor is shown in Figure 3.8 (yellow and black bar on back of paver with attachments). The sensor measures the temperature of the newly paved asphalt mat and records the location of the measurement. If ODOT is going to use this temperature sensor on all pavers, it will be much easier to know exactly where the paver is at different times during the work period.

Figure 3.8: Pavement Temperature Sensor on Paver

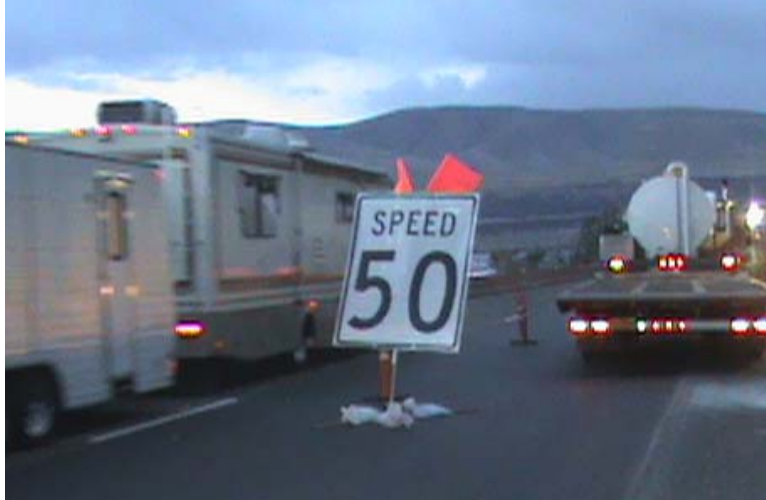
The treatment for Day 2 consisted of regulatory speed signs reducing the speed limit to 50 mph (Figure 3.9). The speed reduction began after the taper, and additional reduced speed signs were placed periodically throughout the work zone. The speed reduction did not overlap with the taper down to one lane. PCMS signs on rollers were turned on at the beginning of the work, but turned off after researchers reminded the roller operators that they were not supposed to be turned on for that day.

Figure 3.9: Temporary 50 mph Speed Sign on I-84 Case Study Project

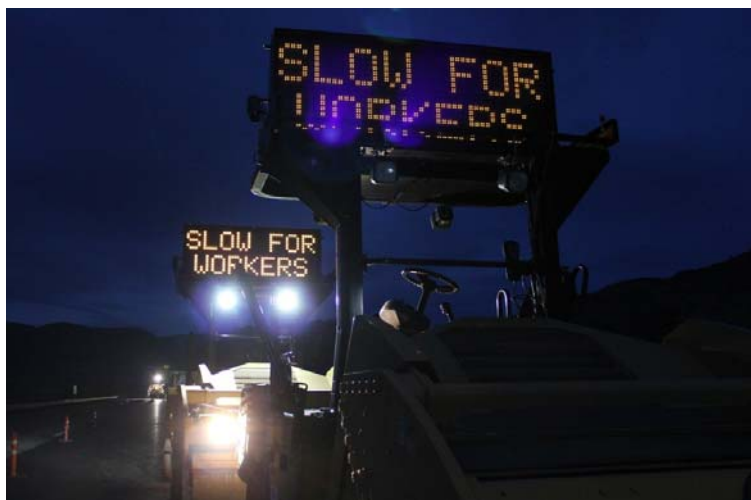
Day 3 included eastbound slow lane paving from MP 91.056 to 92.675. The PCMS signs on the rollers were turned on. On the finish roller, the message alternated every few seconds between "Slow for Workers" and "Narrow Lane". On the intermediate roller, the message alternated every few seconds between "Workers on Road" and "Slow for Workers" (Figure 3.10). The same messages were used on the rollers throughout the study when the PCMS signs were turned on.

Figure 3.10: PCMS on Rollers for I-84 Case Study Project

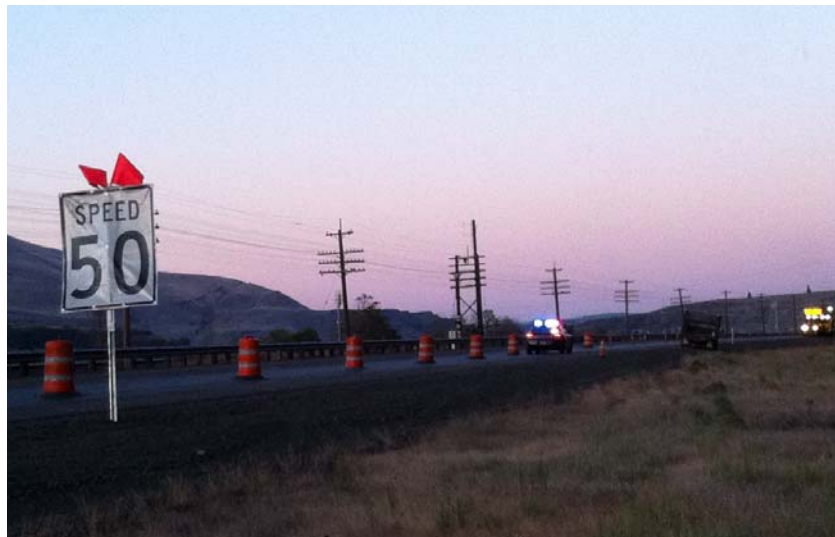
Paving continued on the eastbound slow lane from MP 94.665 to 96.786. On this day, an OSP officer parked on the site rather than patrol around the site. The officer parked his vehicle within the closed lane at the end of the taper such that his car was visible to oncoming traffic as shown in Figure 3.11. Figure 3.11 also shows an example of putting temporary signs on a permanent reflecting pole. This placement depends highly on the location and availability of poles.

Figure 3.11: OSP Parked at the End of Taper with Lights On

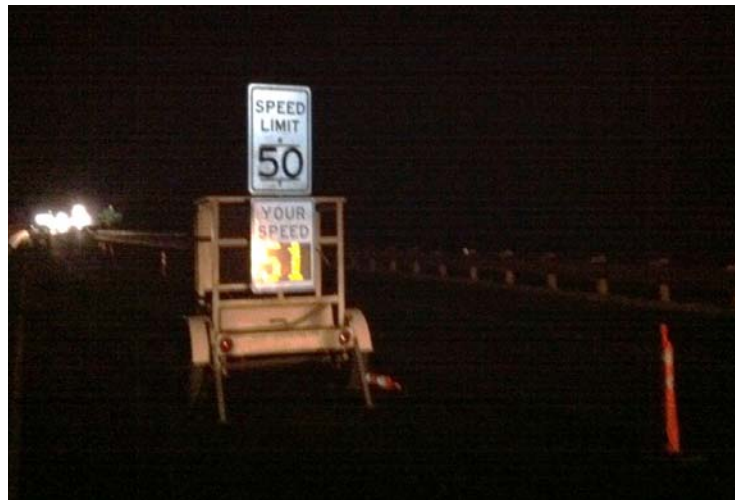
in the closed lane such that it was visible to the passing traffic. The display remained in place and was not relocated as the paving operation moved up the roadway.

Figure 3.12: Radar Speed Monitoring Display

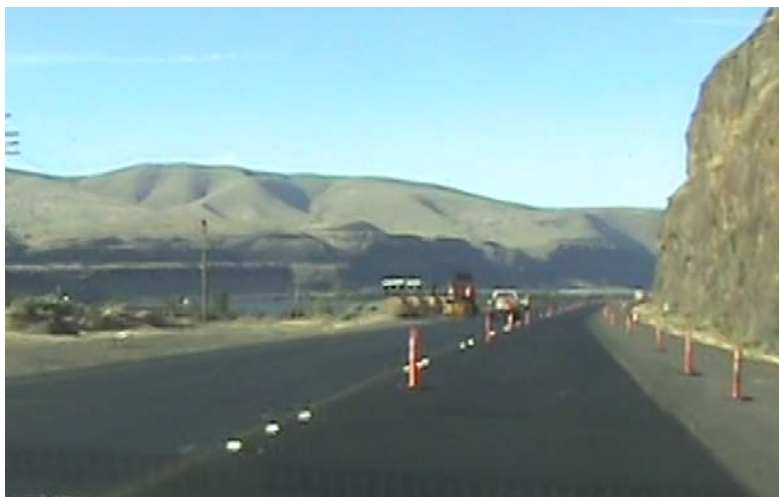
Day 7 included eastbound fast lane paving from MP 90.40 to MP 92.50. The treatment applied was tubular markers on both sides of the travel lane (Figure 3.13). The contractor received permission from ODOT to start the work earlier in the day, so the grinding work started at 6:15pm and paving started at 9:20pm.

Figure 3.13: Tubular Markers on Both Sides of Travel Lane

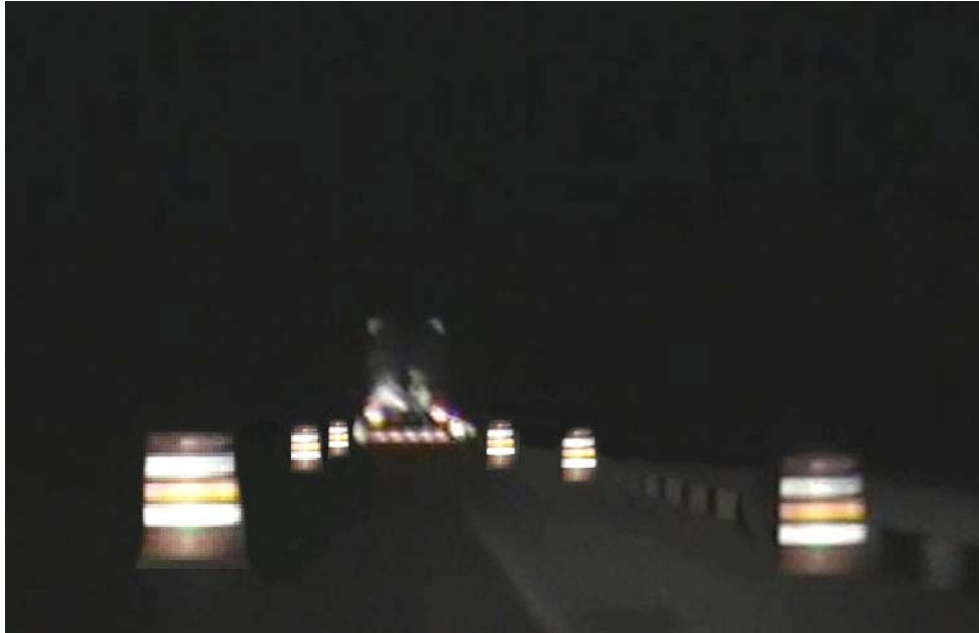
Paving on Day 8 was in the eastbound fast lane from MP 92.498 to MP 94.10. The treatment applied on this day was drums on both sides of the travel lane (Figure 3.14). An additional line of drums was added to narrow down the lane width from 22 feet to 15 feet. Not enough drums were available for the entire length of the closure. Drums were placed as far as possible on both sides. When no more drums were available, the drums were replaced by tubular markers on both sides of the travel lane for the remainder of the lane closure.

Figure 3.14: Drums on Both Sides of Travel Lane

The resources required to put out the drums (barrels) on both sides of the travelling lane were an extra TMA pickup truck, a cone truck, extra drums, six people, and two extra hours. In addition, it took a longer length of time to pick up the drums. One worker was always in a dangerous position standing behind the cone truck to load the drums. Of those people interviewed (four interviews), it was felt that the reflectivity of the drums was so overwhelming that it might create a hazard for the motorists. Additionally, with drums on both sides, the drums were more frequently struck by the passing vehicles. The additional drums can become an obstacle and hazard. As a result, it was felt by many of those interviewed that locating drums on both sides of the travelling lane was a dangerous situation for the motorists.

Overall, according to those interviewed, it was agreed that drums were good for the taper, and maybe on one side to replace the tubular markers, but not good for use on both sides of the travel lane.

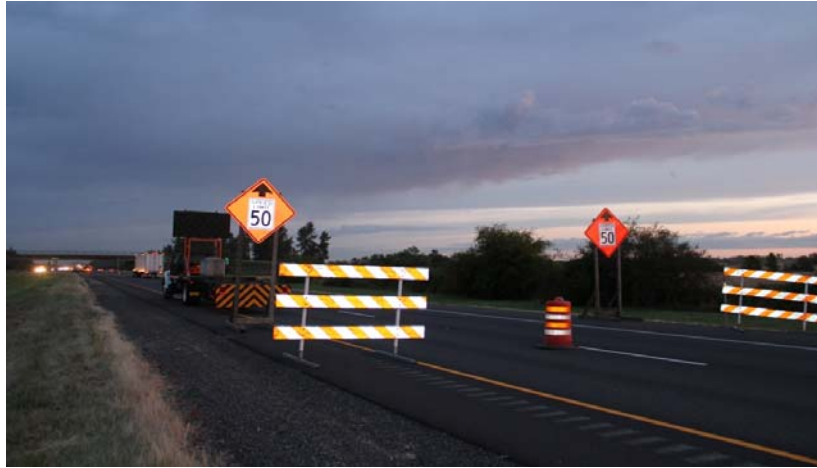
The paving for this night took place in the southbound, fast lane (A lane), and the treatment was the typical TCP plus the temporary 50 mph advisory signs. The contractor was asked to use a TSS to support the signs. To do so, the contractor needed a large truck to haul the TSS to the desired location. This process took additional time. Figure 3.16 shows an example of using a TSS to support a temporary sign.

Figure 3.16: Temporary Signs on TSS

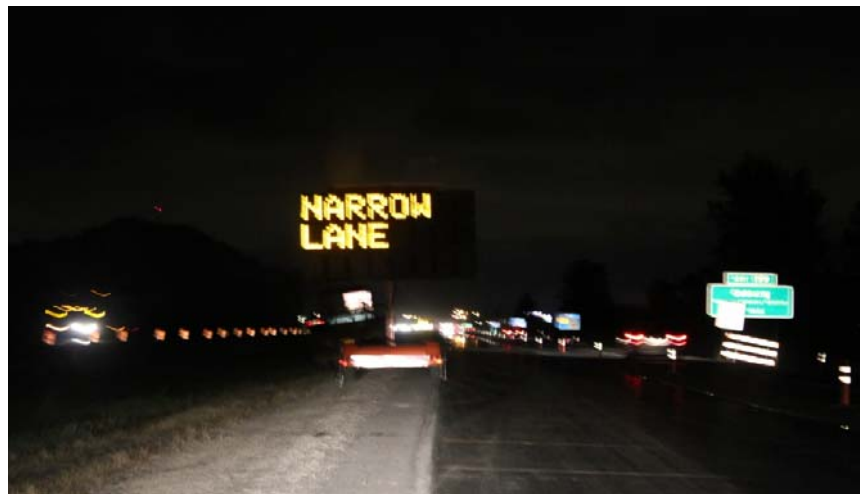
Paving in the southbound, fast lane continued on Day 4. The treatments during the paving operation were the typical TCP, 50 mph signs, and PCMS signs on trailers. Figure 3.17 shows an example of a PCMS sign on a trailer located on the median.

Figure 3.17: PCMS Sign on Trailer for I-5 Case Study Project

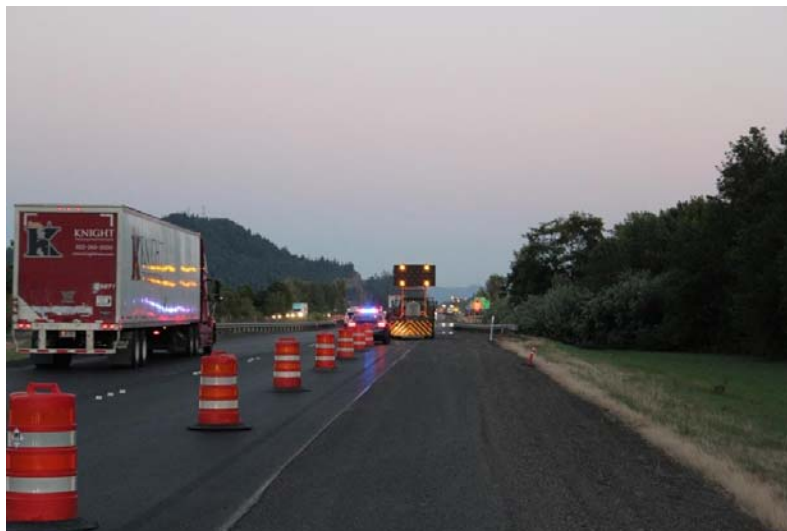
Paving on the southbound, slow lane continued on this night. The treatments included the typical TCP, 50 mph signs, and an OSP officer parked at the end of taper. The officer parked on the jobsite from 8:00pm until 1:00am. Figure 3.18 shows where the OSP officer parked. As seen in the figure, the officer parked his vehicle at the end of the taper and immediately upstream of a truck with a TMA.

Figure 3.18: OSP Parked at the End of Taper for I-5 Case Study Project

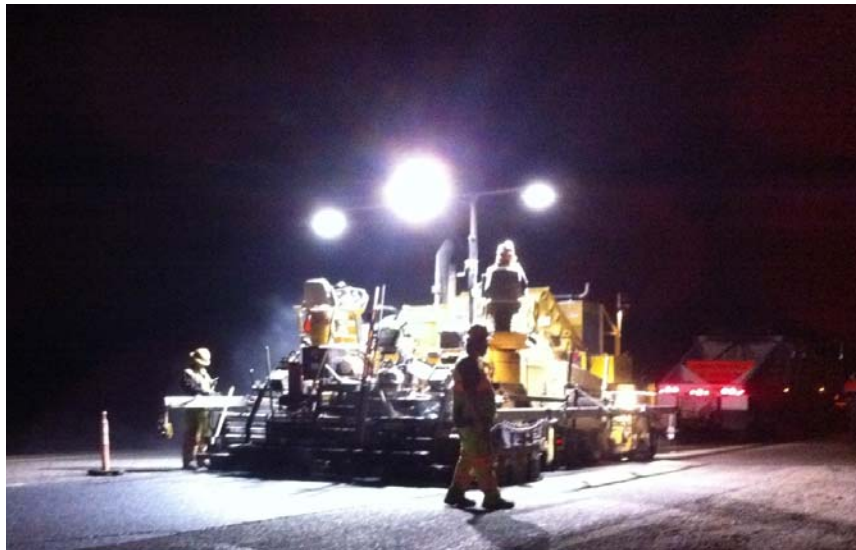
The lights on the paver that were used to illuminate the work area were very bright (see Figure 4.1). As a result, the asphalt truck drivers had difficulty seeing the oncoming traffic when they tried to pull out of the paving lane into the travel lane. The lights on the paver were so bright that they reduced the visibility of the asphalt truck drivers, and the drivers needed a ground crew member to tell them when it was safe to pull out into the travel lane. However, there were some advantages of using bright lights. Those working on the ground around the paver were more visible to motorists, and the bright lights drew the motorists' attention to the construction work and made them more aware of what was going on.

Figure 4.1: Paver for I-84 Project

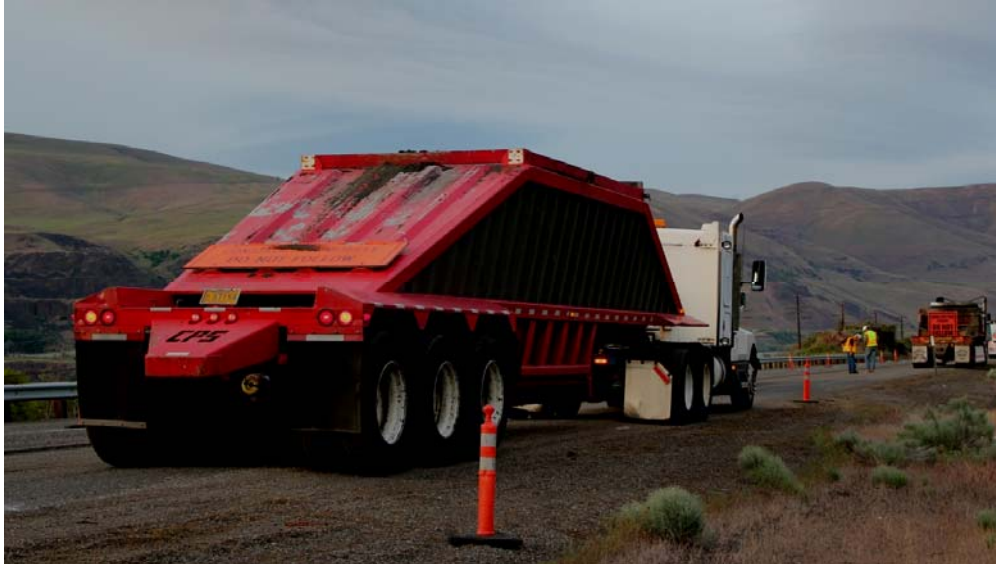
ODOT specification 00225.02 – General Requirements requires the installation of a “CONSTRUCTION VEHICLE DO NOT FOLLOW” sign on rigid substrate on the back of all material or equipment delivery vehicles (Figure 4.2) for all freeway and high-speed, multi-lane projects. The sign is intended to instruct the driver in the vehicle behind the asphalt truck to not follow the truck. However, not all of the contractor asphalt trucks used on the project had a sign on the back. In some instances, unfortunately some motorists mistakenly followed the asphalt truck into the paving lane which created a dangerous situation. It should be noted that the sign could be misinterpreted. That is, when the asphalt truck is simply traveling down the through lane, the succeeding vehicles should follow the truck and not go into the paving lane. However, when the truck pulls into the paving lane, the vehicles should not follow the truck. Drivers in trailing vehicles may not know when to follow the truck and when not to, especially under nighttime conditions in a crowded and active work zone and when there are large distances between the tubular markers.

Figure 4.2: Contractor Asphalt Trucks
